**Asset #02783**(Routine, Underwater type 2)**SH 14/Stone County over ROCKY BAYOU****Location: 2.5 MI E JCT SH 5 SO****Team Lead: Floyd Haley Inspection Date: 05/02/2024**

Asset #02783(Routine, Underwater type 2)

SH 14/Stone County over ROCKY BAYOU

Location: 2.5 MI E JCT SH 5 SO

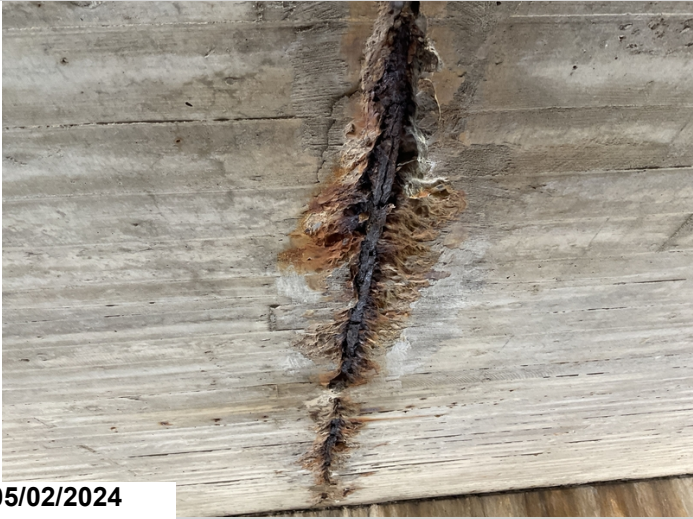
Span 10, Centerline: Spalling with exposed reinforcing steel with section loss. CS3.

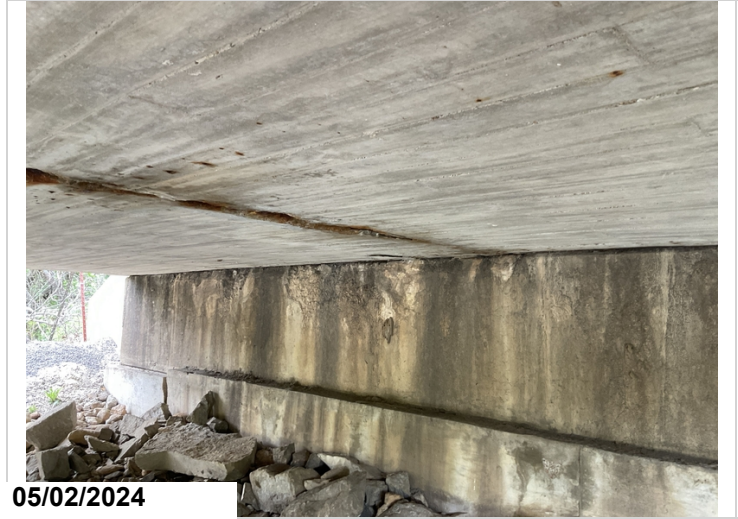
Abutment 2: Spalling.

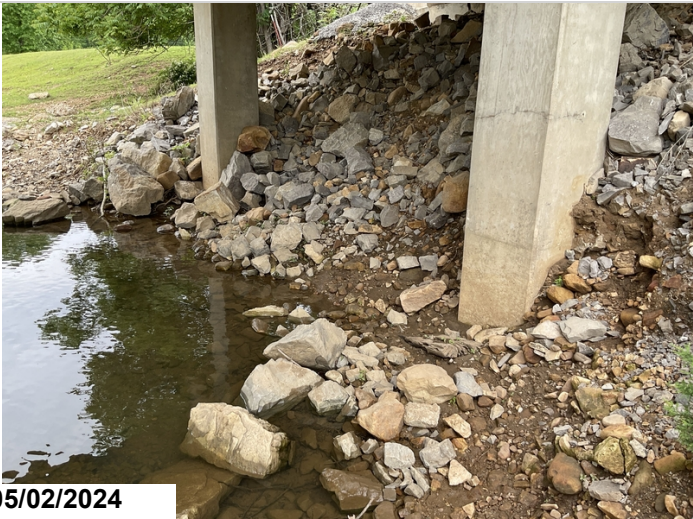
Bent 9, Columns: Embankment erosion.

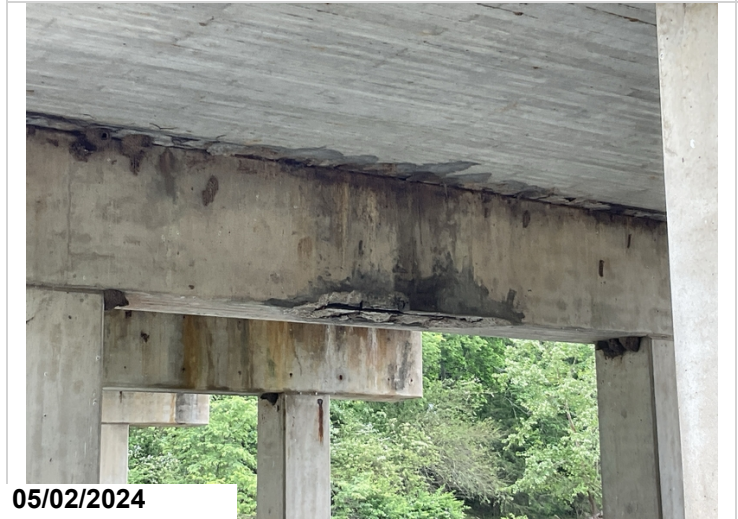
Bent 7, Ahead, Bottom: Spalling with exposed reinforcing steel with section loss. CS3.

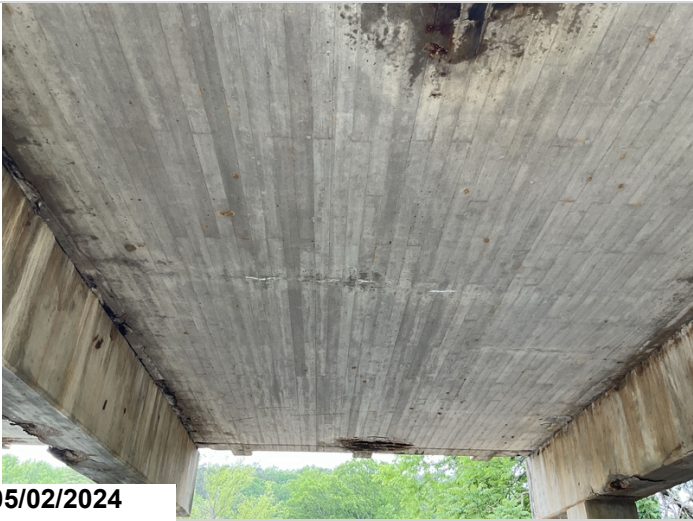
Span 9, Undersurface: Longitudinal cracking with efflorescence. CS2

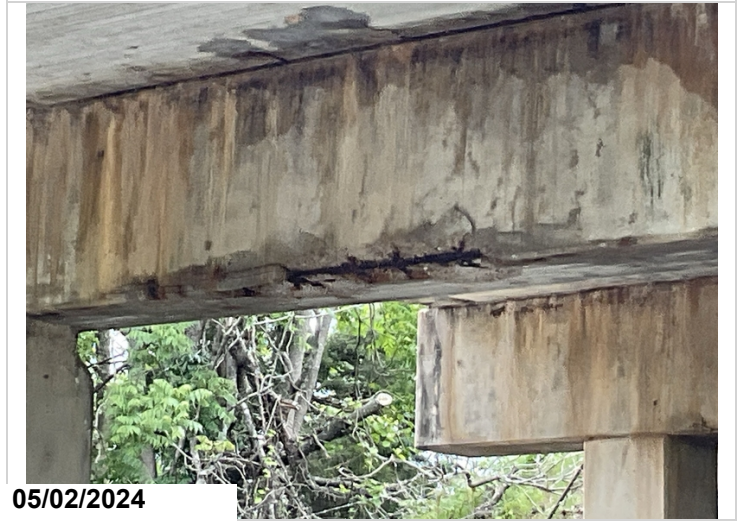
Bent 8, Back, Bottom: Spalling with exposed reinforcing steel with section loss. CS3..

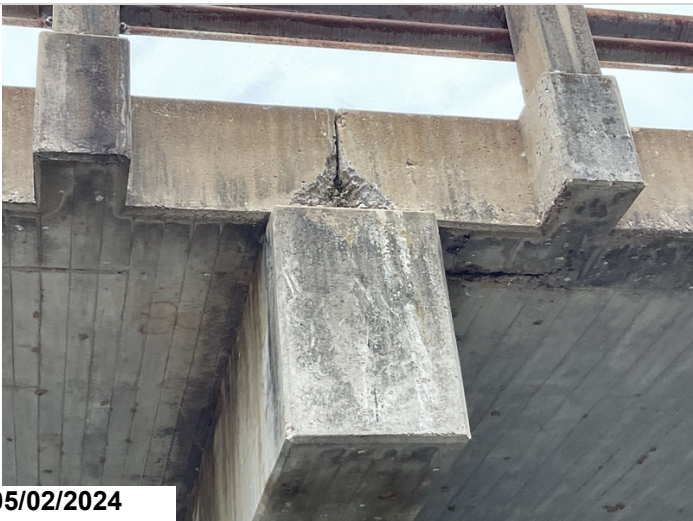
Spans 6 & 7, Bent 6: Typical spalling to edge of Slab.

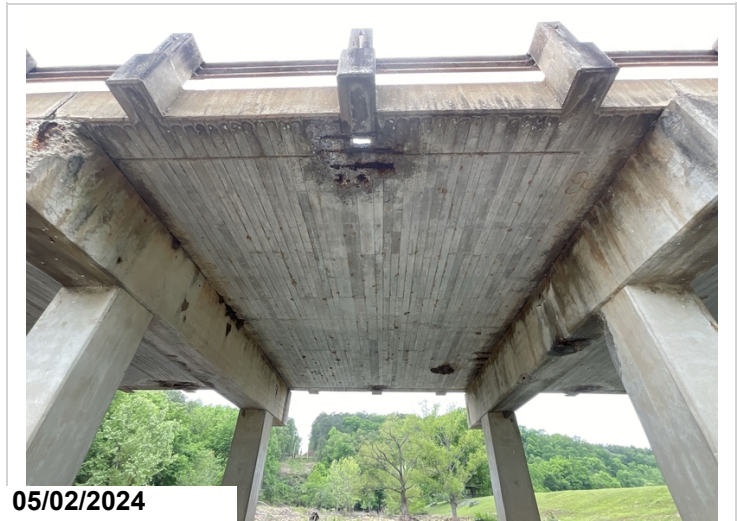
Span 6, Drains: Spalling with exposed reinforcing steel. CS3.

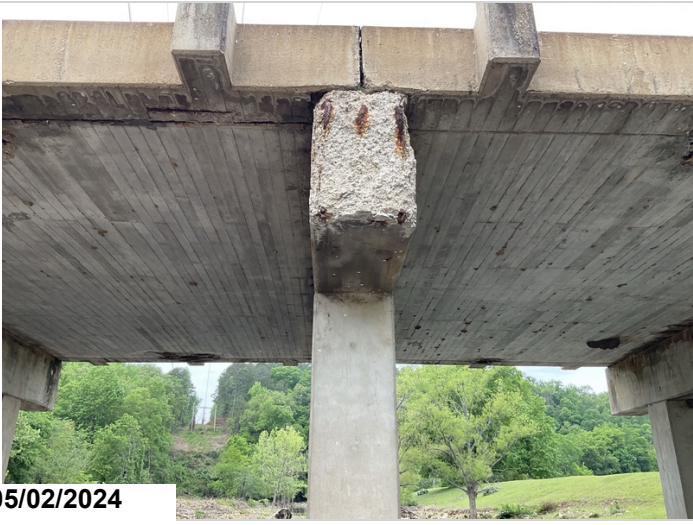
Bent 5, Right: Spalling with exposed reinforcing steel with section loss. CS3.

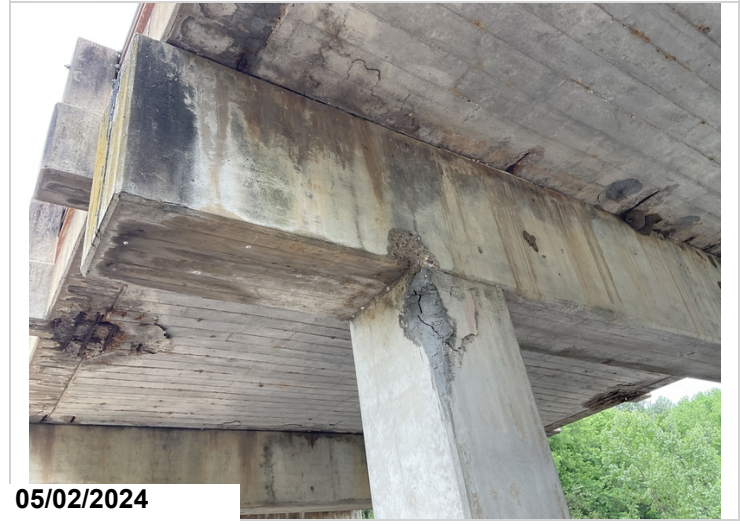
Bent 4, Ahead, adjacent to Column 2: Spalling. CS3.

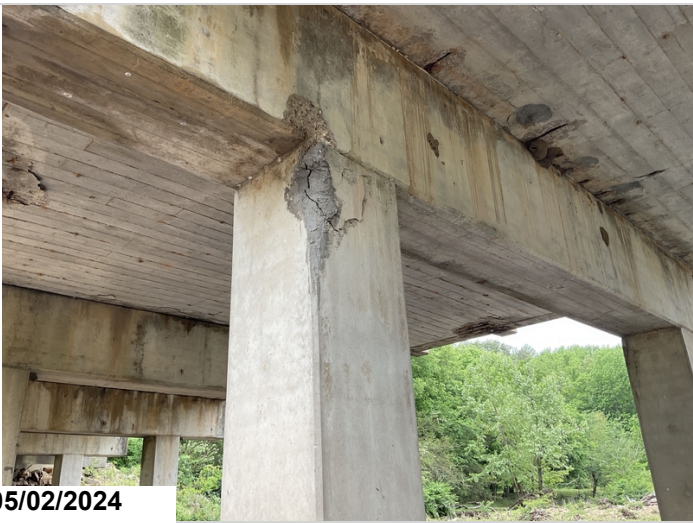
Bent 4, Column 2: Delaminated.

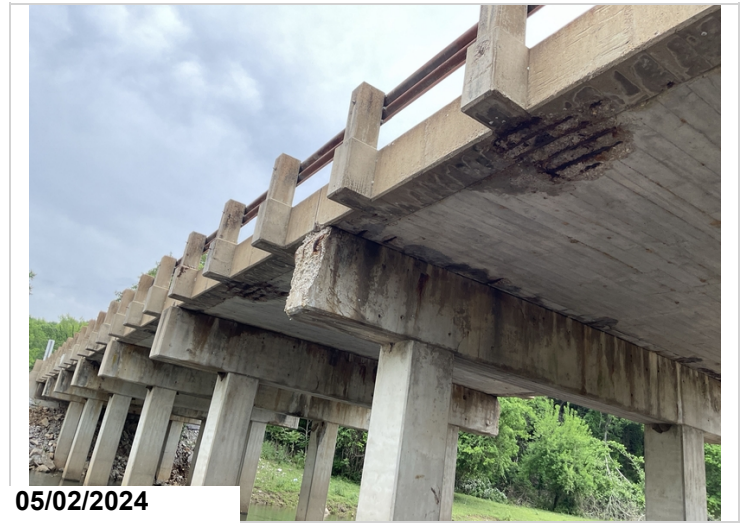
Bent 4, Left: Spalling with exposed reinforcing steel with section loss. CS3.

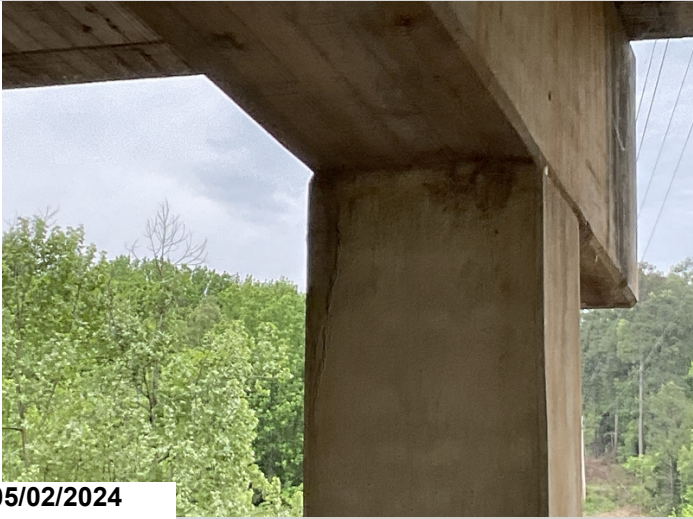
Bent 3, Column: Typical vertical cracking.

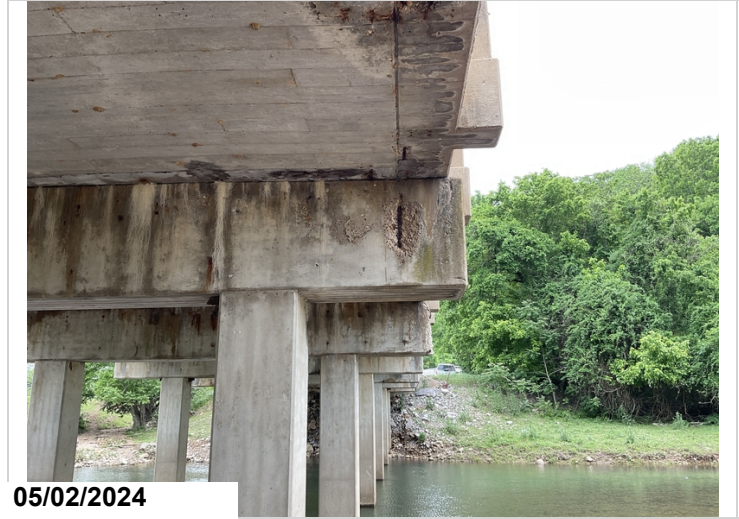
Bent 4, Back, Right: Spalling with exposed reinforcing steel. CS3.

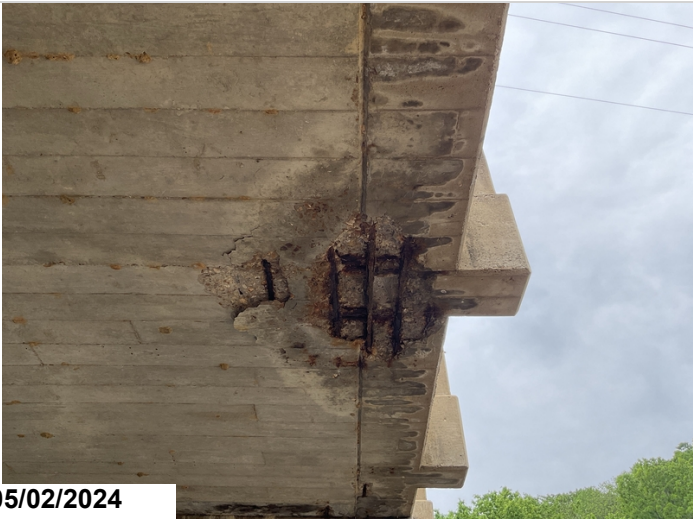
Span 4, Drains: Spalling with exposed reinforcing steel with section loss. CS3.

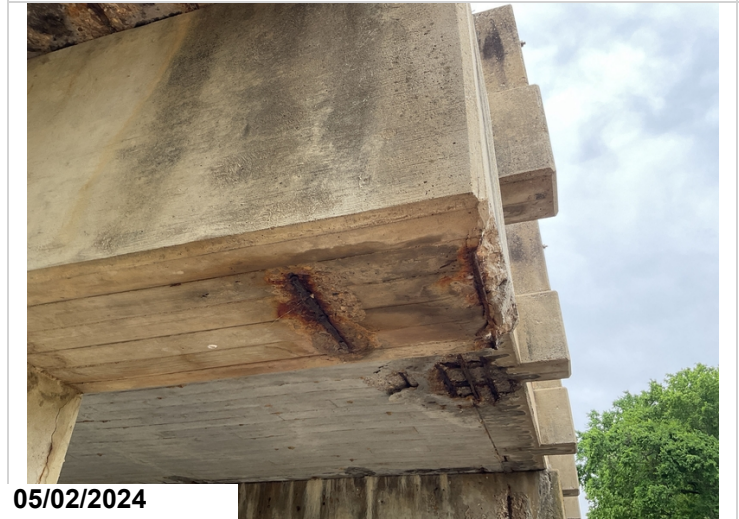
Bent 3, Bottom, Right: Spalling with exposed reinforcing steel with section loss. CS3.

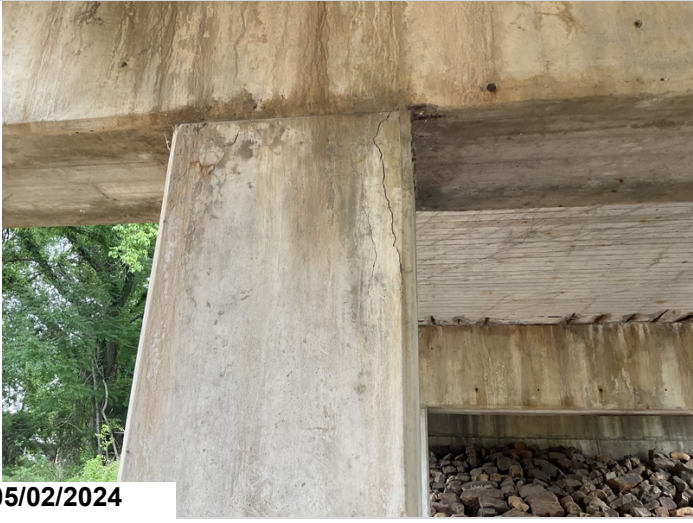
Bent 2, Columns: Typical vertical cracking. CS2.

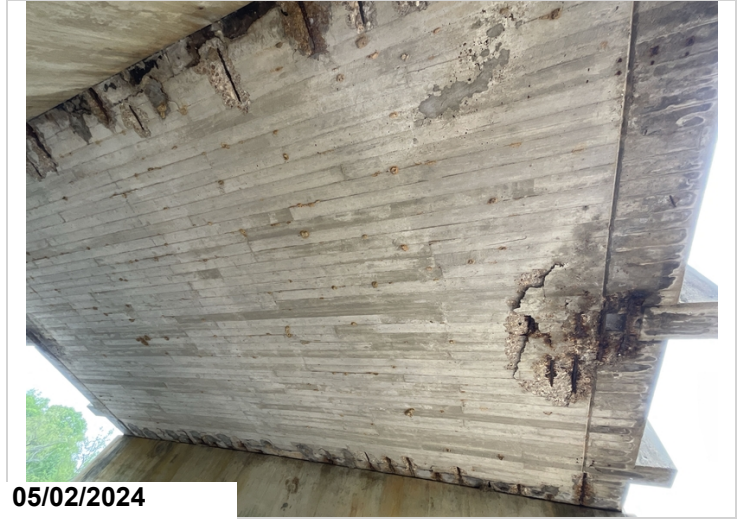
Span 3: Numerous spalls with exposed reinforcing steel section loss. CS3.

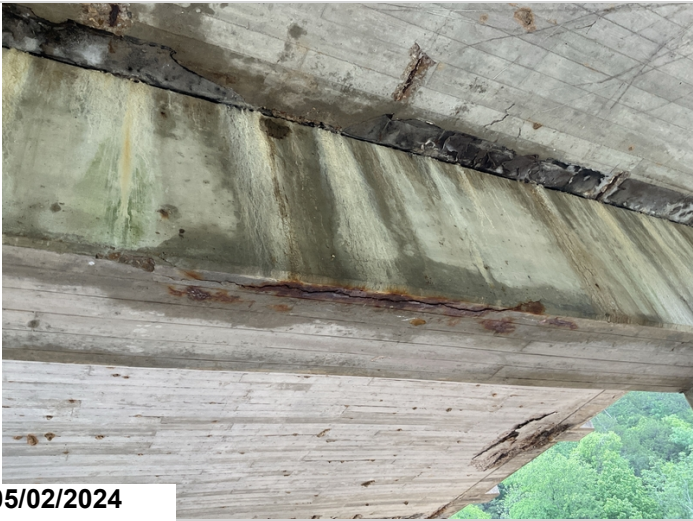
Bent 1, Bottom, Back: Wide cracking with rust staining. CS3.

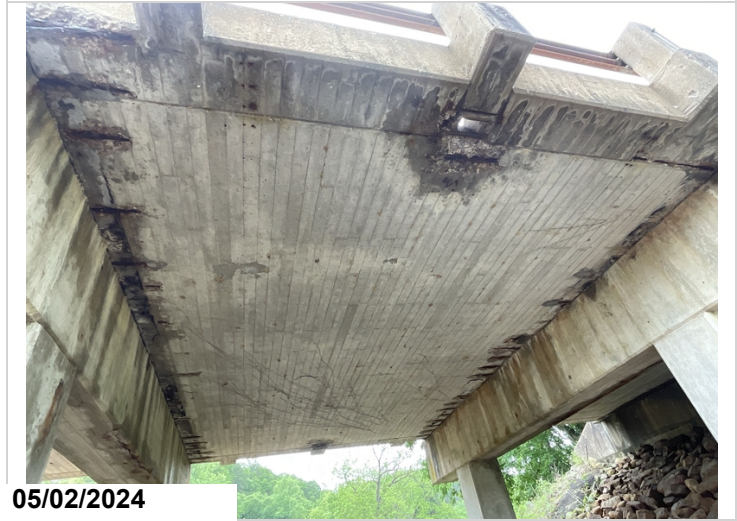
Span 2: Numerous spalls with exposed reinforcing steel section loss. CS3.

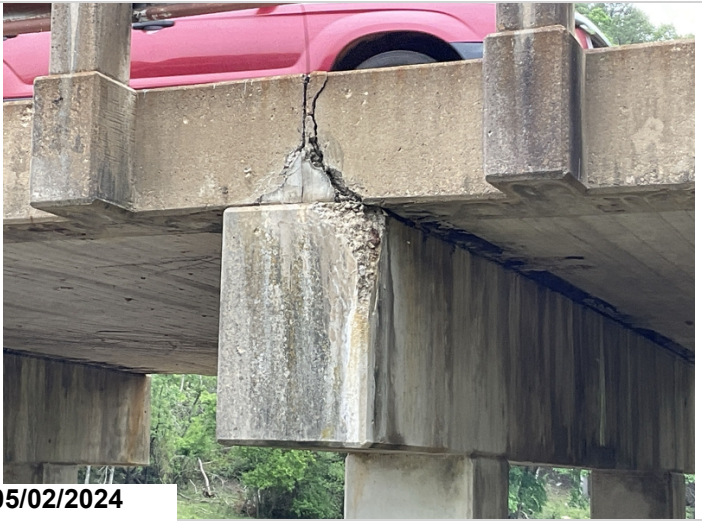
Bent 1, Left: Spalling with exposed reinforcing steel with section loss. CS3.

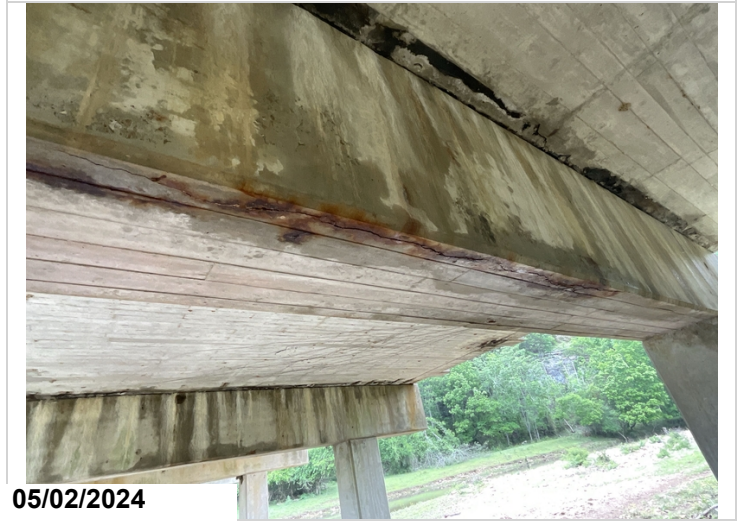
Bent 1, Bottom, Back: Delaminated area for 10'.

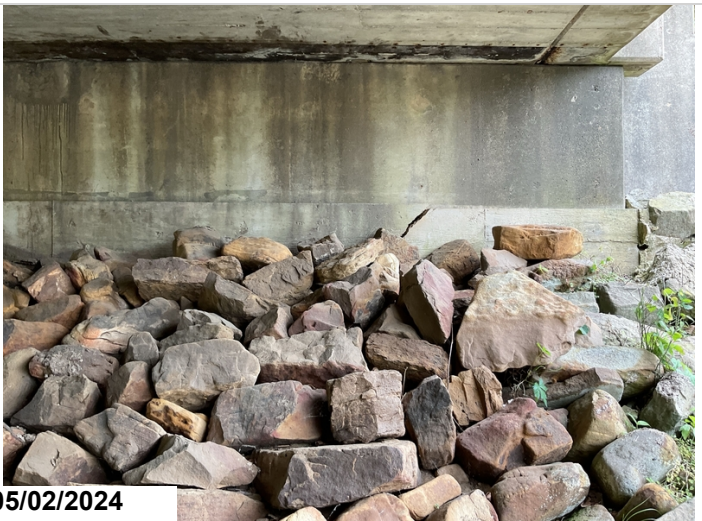
Abutment 1, 8' from Left: Large diagonal cracking.

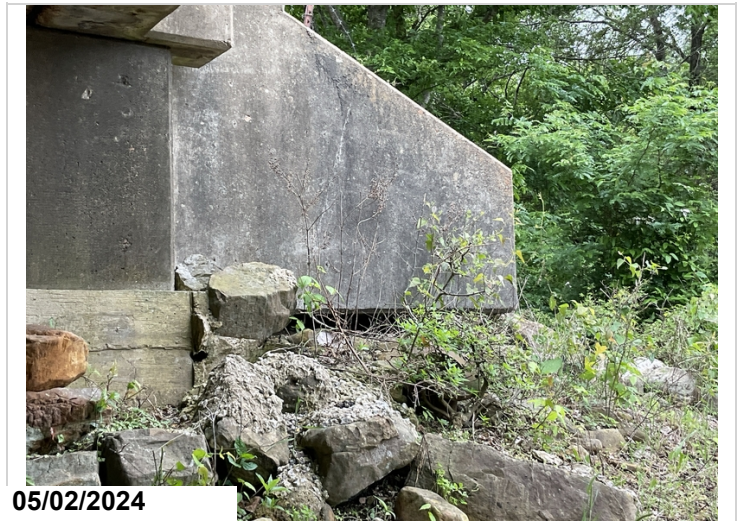
Abutment 1, Left Wing Wall: Undermining.

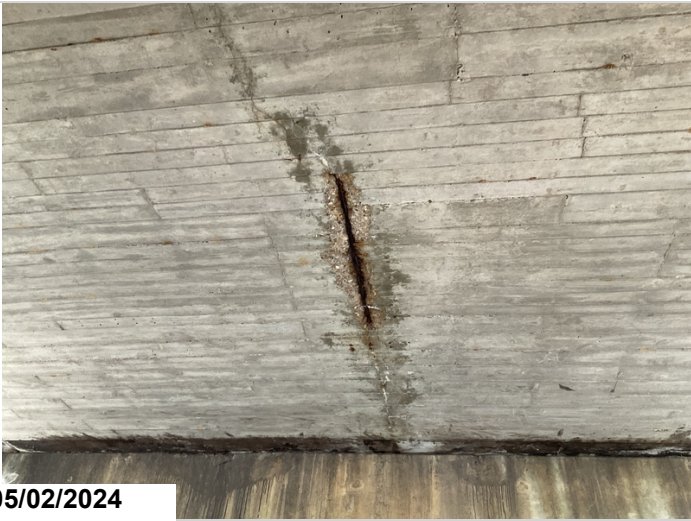
Span 1, Centerline: Spalling with exposed reinforcing steel with section loss. CS3.

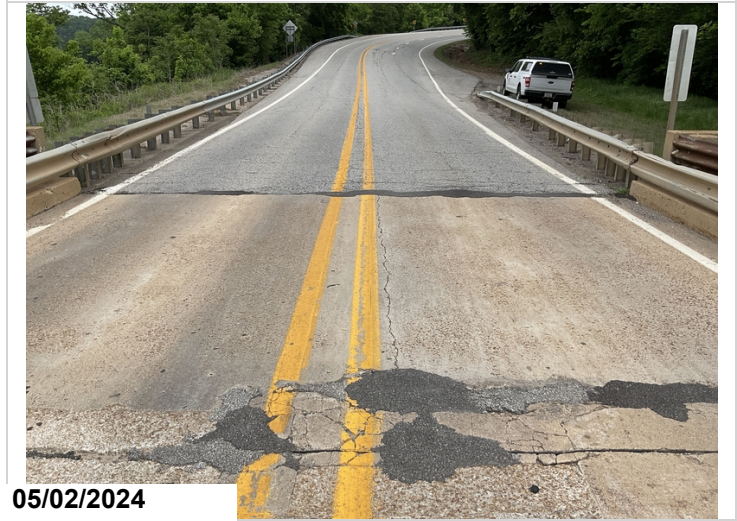
Span 10: Longitudinal cracking. CS3.

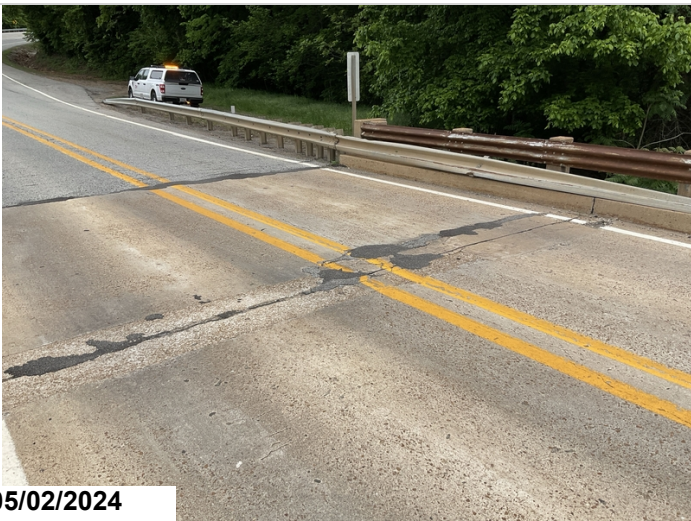
Joint at Bent 9: Patched & unsound patched areas.

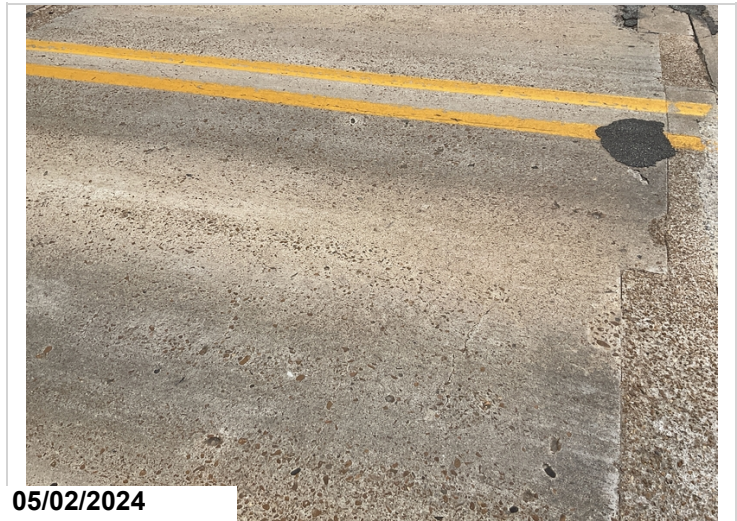
Span 9: Map cracking. CS3.

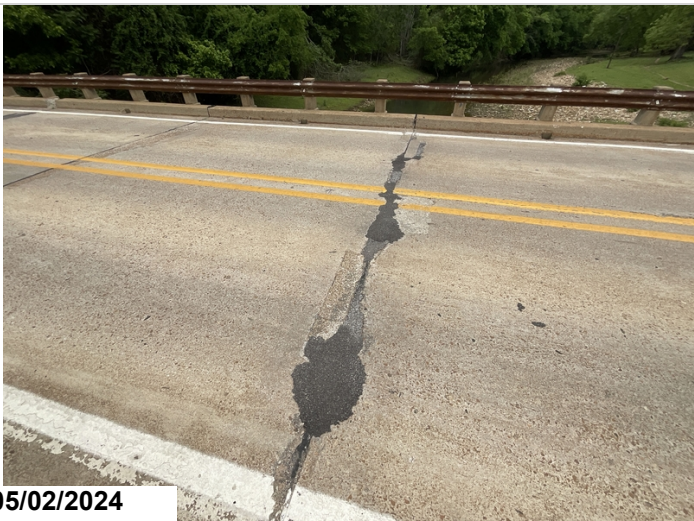
Joint at Bent 6: Unsound patched areas.

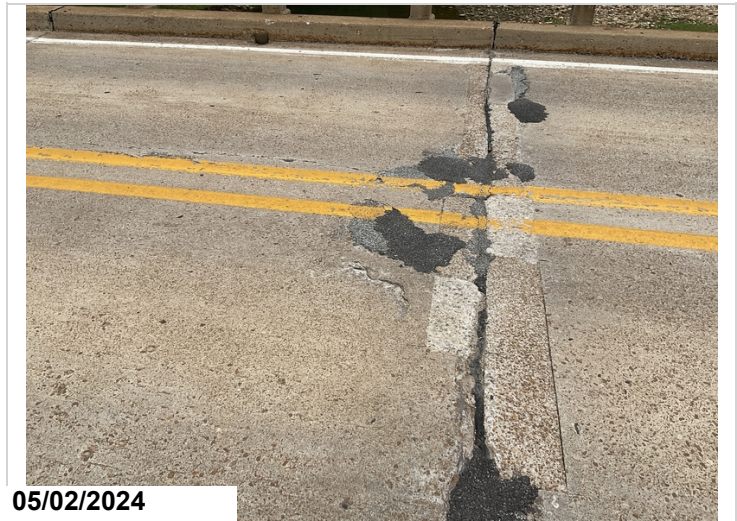
Span 6, Bent 5, near Centerline: Unsound patches & delaminated area.

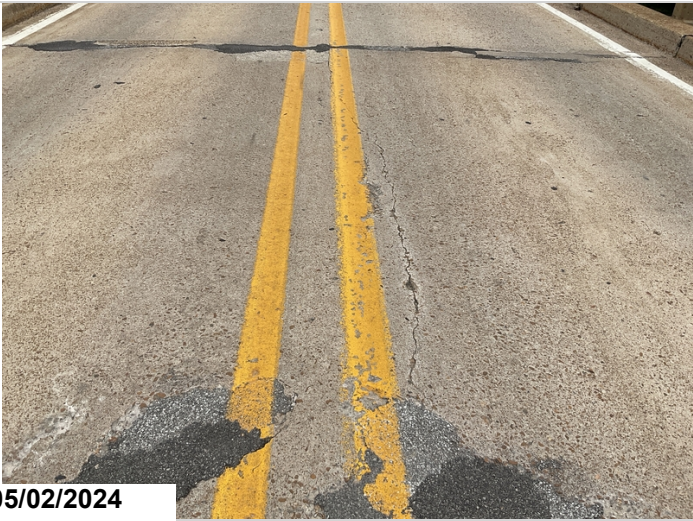
Span 6: Longitudinal cracking. CS3.

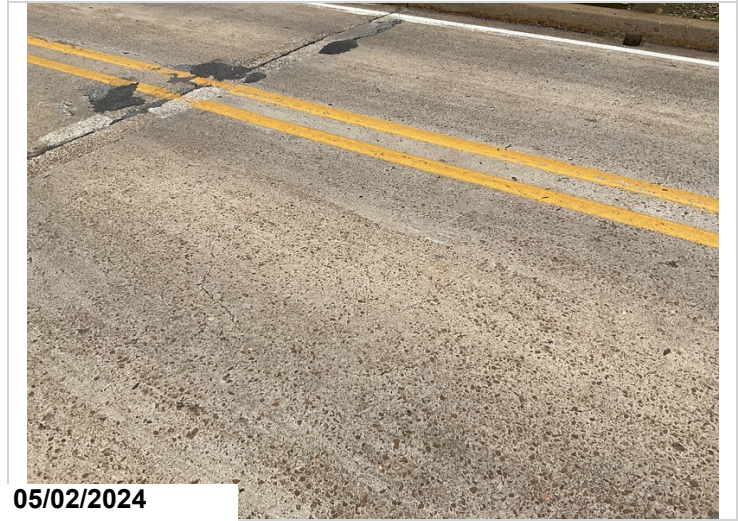
Span 5: Longitudinal & transverse cracking. CS3.

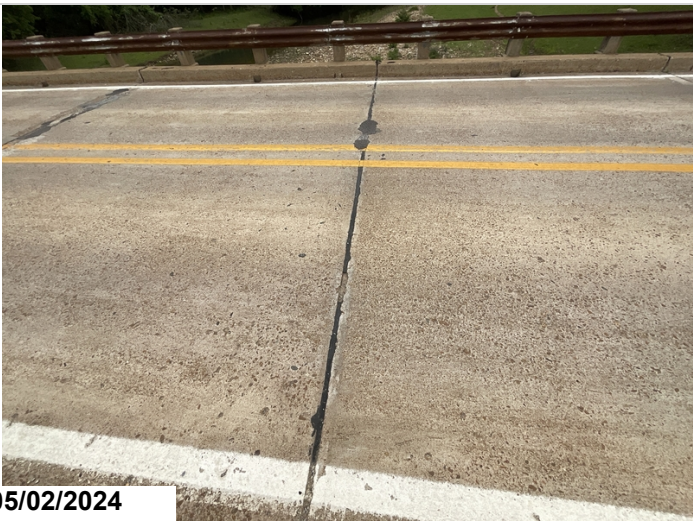
Joint at Bent 3: Seal adhesion failure.

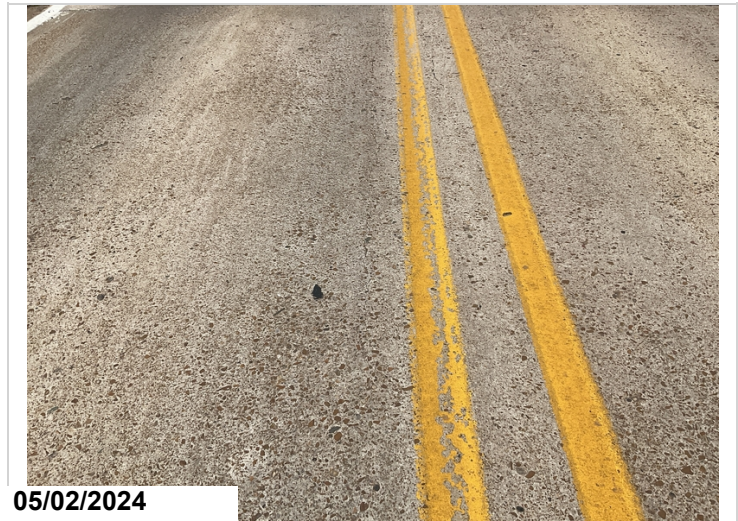
Span 3: Longitudinal cracking. CS3.

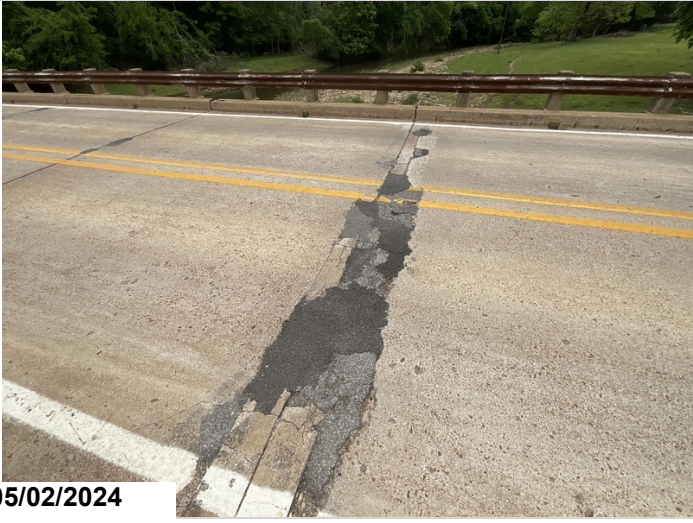
Joint at Bent 2: Unsound patched areas.

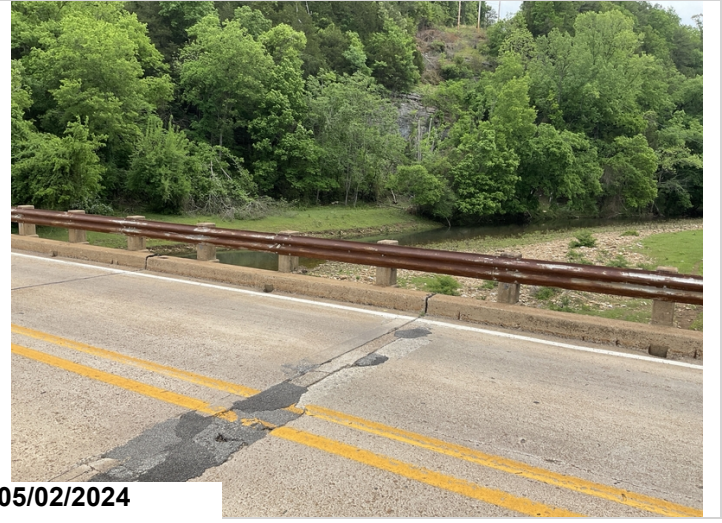
Bridge Railing: Surface corrosion typical throughout the Structure.

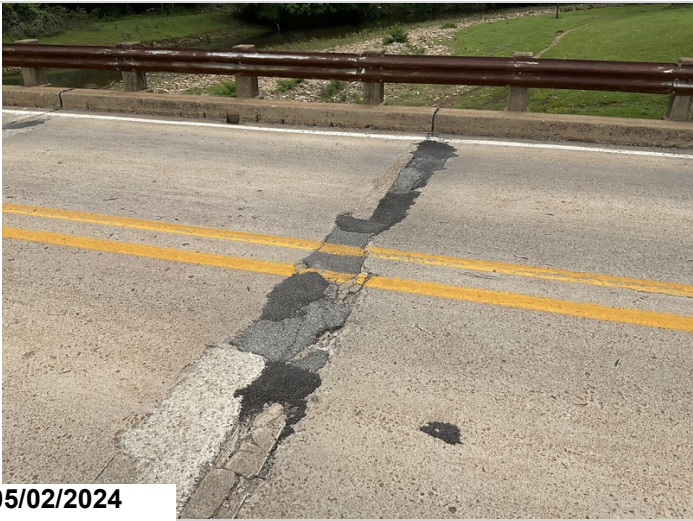
Joint at Bent 1: Unsound patched areas.

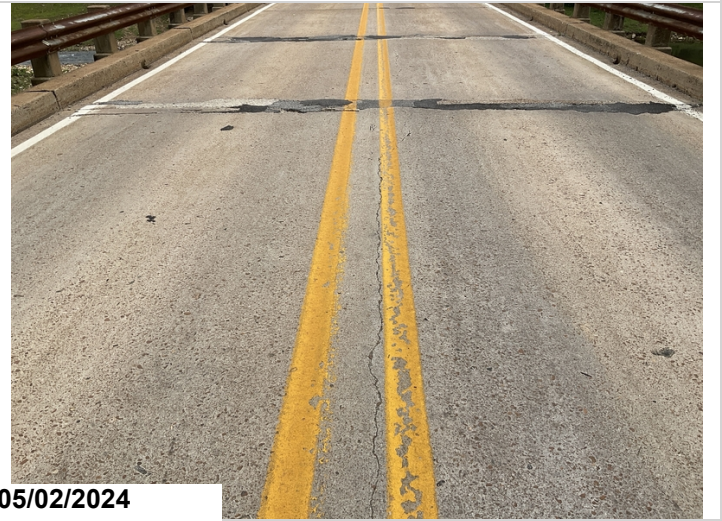
Spans 1 & 2: Longitudinal cracking. CS3.

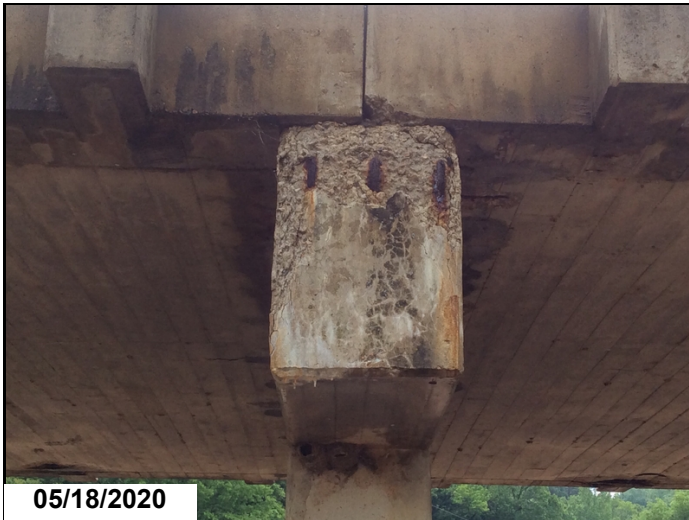
Bent 4 Left. Spalls with rebar exposed to end of Cap.

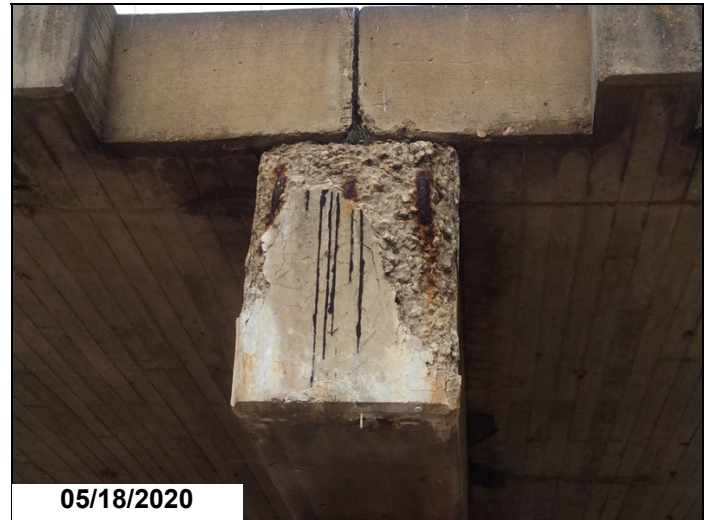
Bent 5 Right. Spalls with rebar exposed to end of Cap.

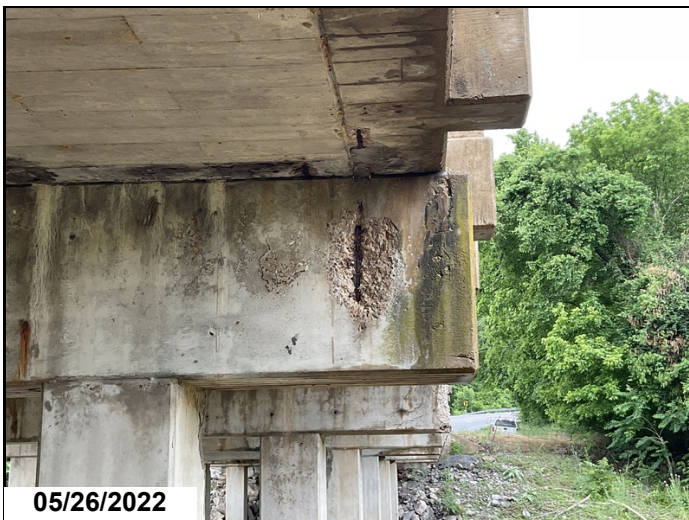
Bents 3 - 5, and 7 - 9 Spalls with corroded rebar exposed to caps.

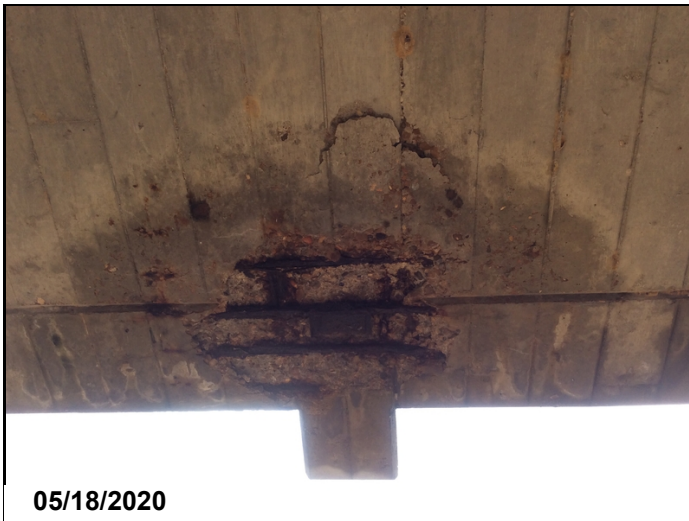
Spalls with corroded rebar exposed to soffit @ drain opening @ Right side of Span 4.

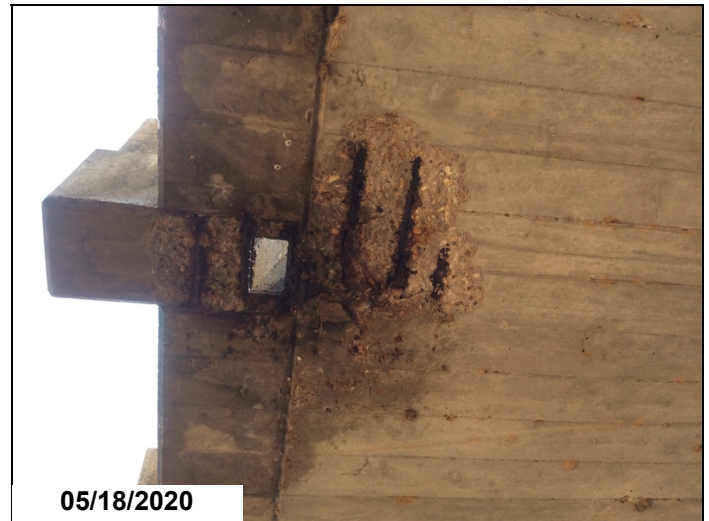
Spalls with corroded rebar exposed to soffit @ drain opening @ Left side of Span 4.

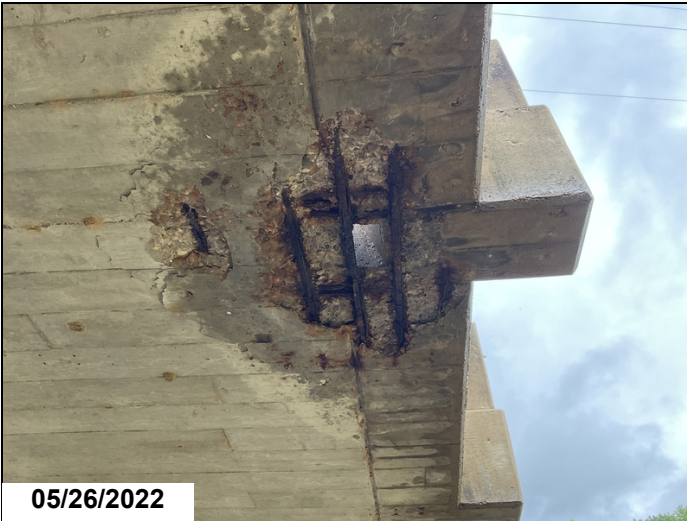
Spans 1 - 10 Spalls with corroded rebar exposed to soffit
and at drain openings. Cracks / spalls to edges of deck
over Bents 1 - 9

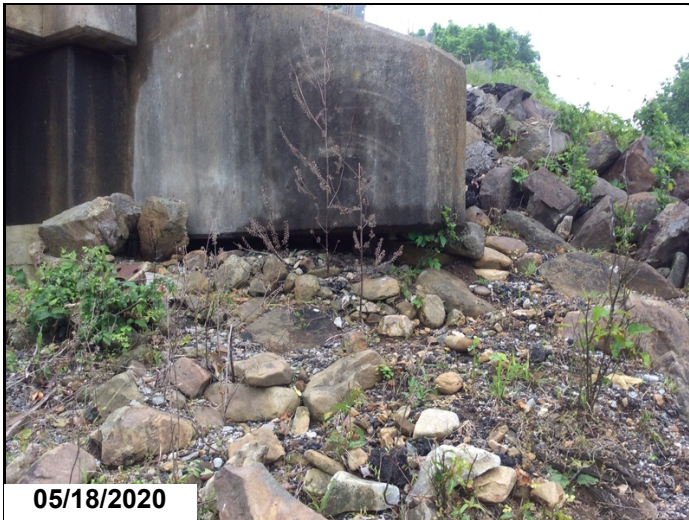
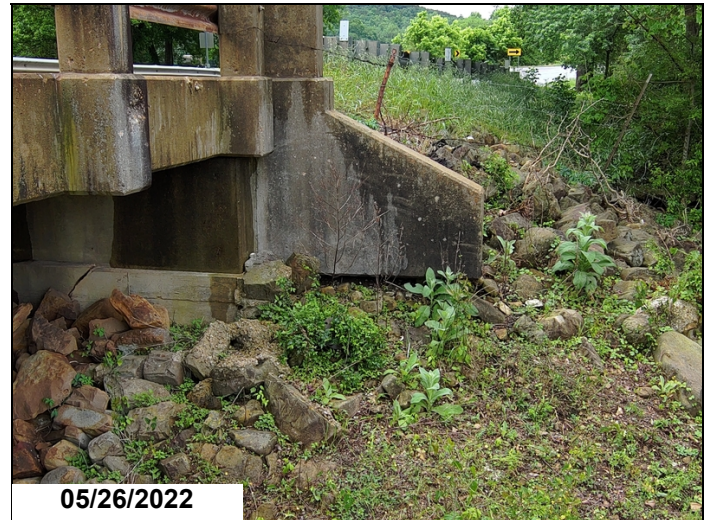
Abutment 1 Left wing.

Left wing is undermined 6" down and 1' back under.

Abutment 1: Left wing is undermined 6" down and 1' back under.

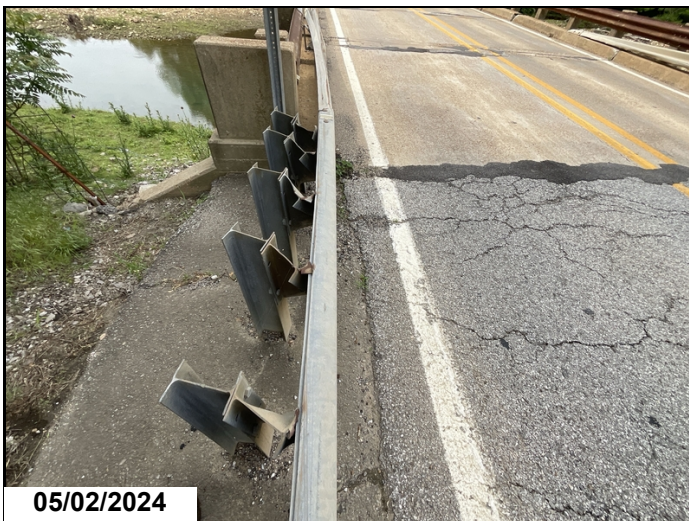
Abutment 2, Right, Transition: Damage.

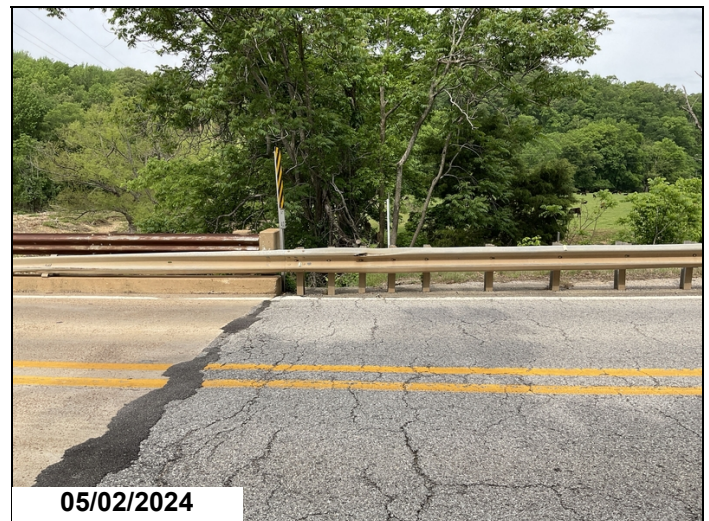
Abutment 2, Left, Transition: Damage.

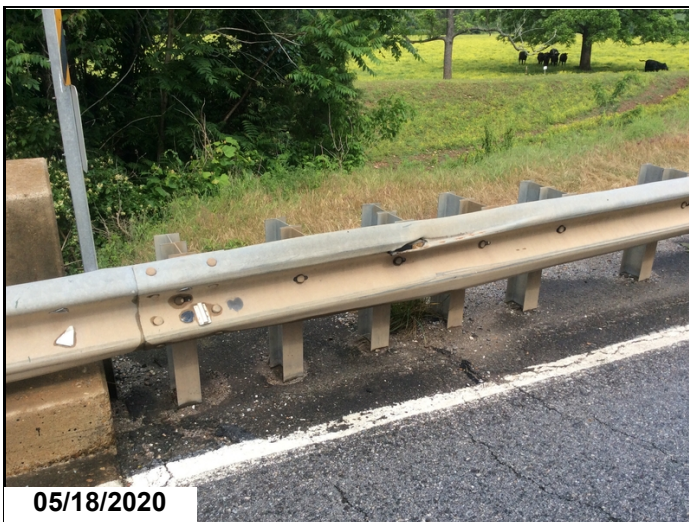
Left bridge rail @ Abutment 2. Collision damage.

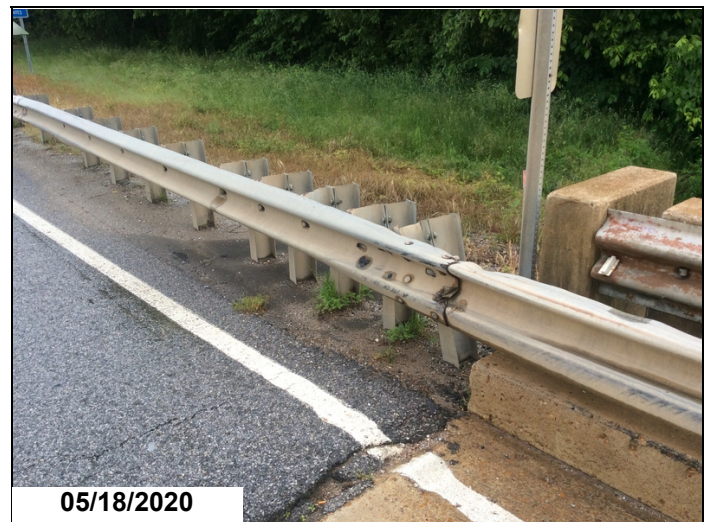
Right bridge rail @ Abutment 2. Collision damage.

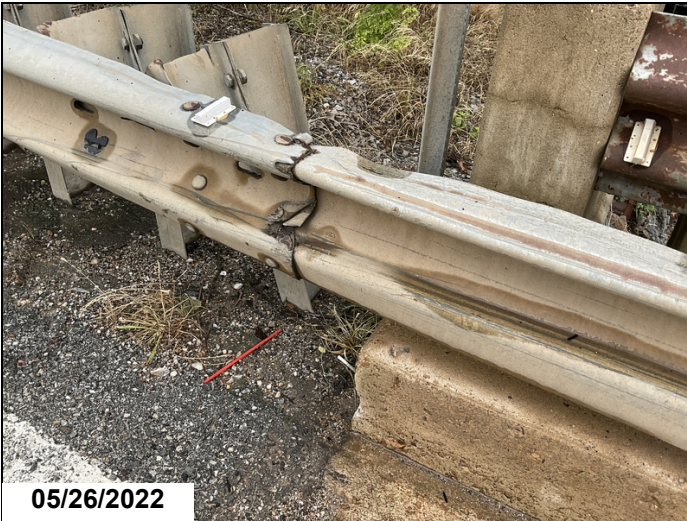
Left and Right approach rails at Abutment 2 Approach
rails have collision damage.

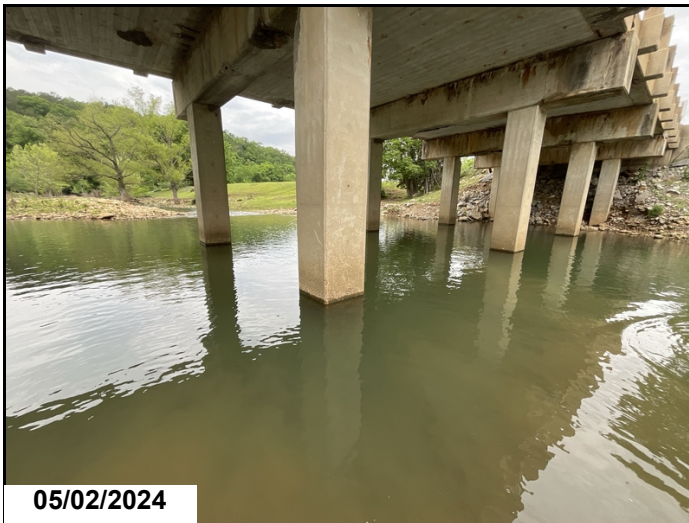
Bents 5 - 8: Scour.

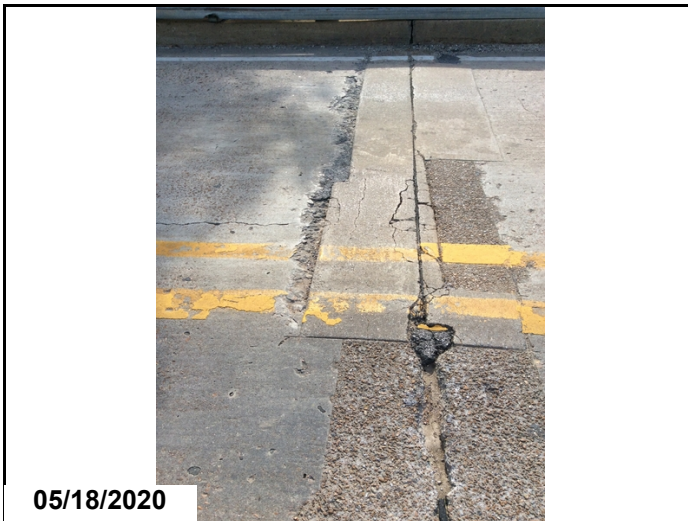
Span 10: Spalls to deck at joint.

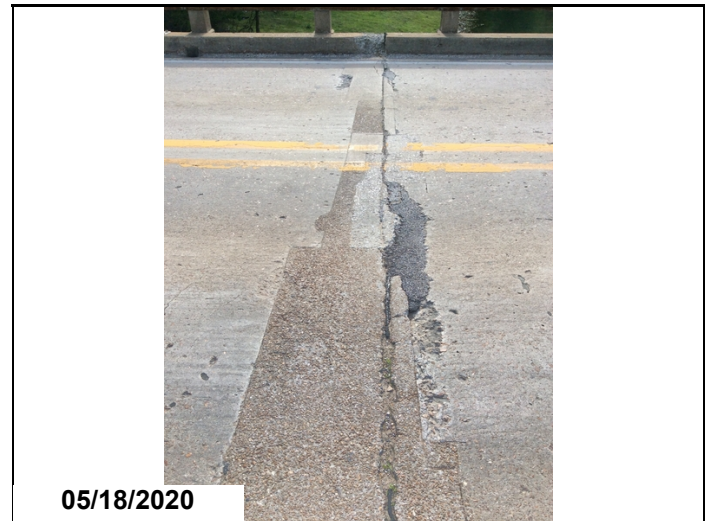
Spans 8 & 9 have spalls at joints.

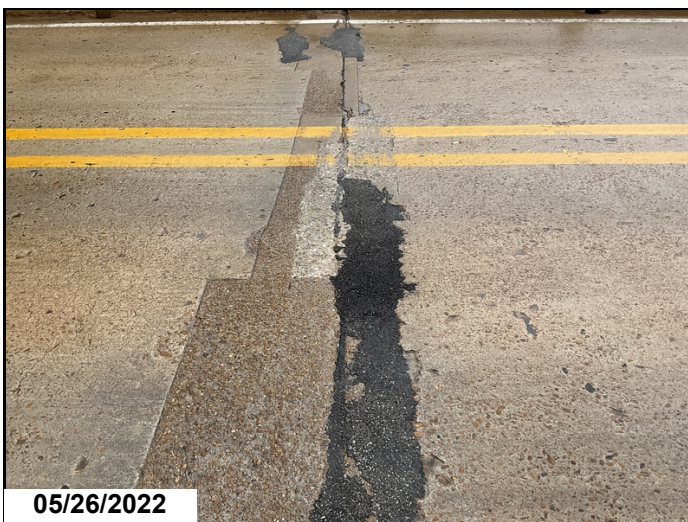
Spans 5, 6, 9 & 10 have spalls to deck.Span 8
