Asset #05407(Routine, Underwater type 2)

SH 14/Stone County over MILL CREEK

Location: 14.2 MI EAST JCT SH 5 SO.

Team Lead: Floyd Haley Inspection Date: 04/03/2024

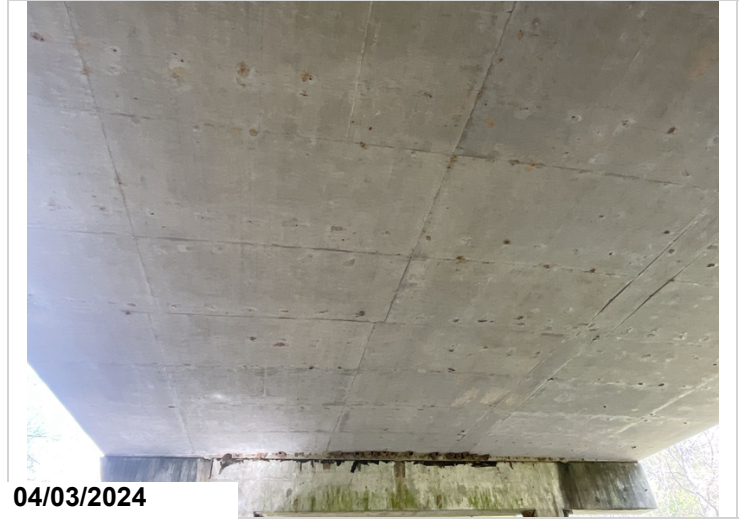
Superstructure is in overall Satisfactory condition with undersurface of deck having minor hairline cracking, areas of delamination and spalling with reinforcing steel exposed around drain openings and outside edges of deck over bents.

Typical undersurface.

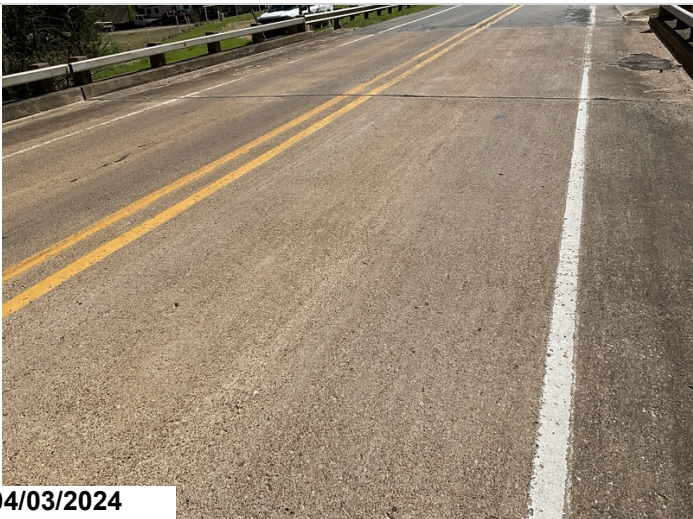
Deck is in overall Satisfactory condition with areas of moderate abrasion to deck . Undersurface of deck has minor hairline cracking, areas of delamination and spalling with reinforcing steel exposed around drain openings and outside edges of deck over bents.

Typical deck.

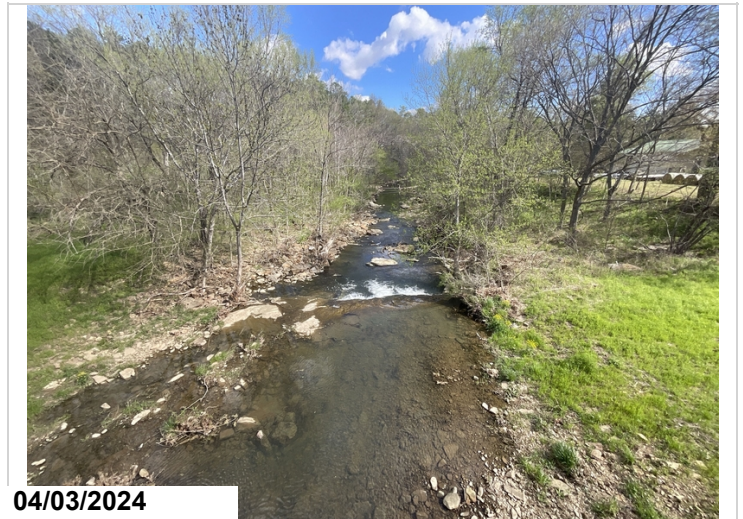
Left side of bridge: Channel view.

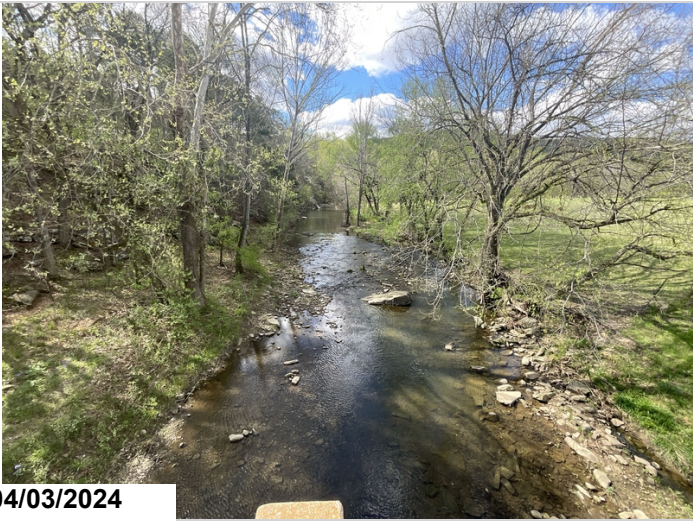
Right side of bridge: Channel view.

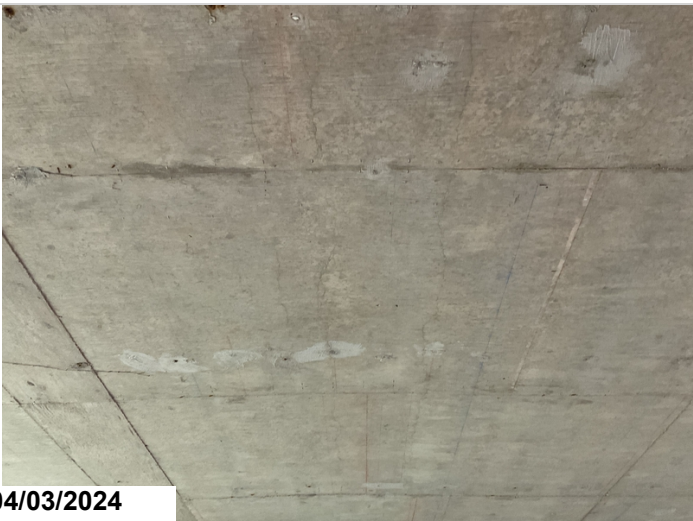
Span 5: minor hairline longitudinal cracking.

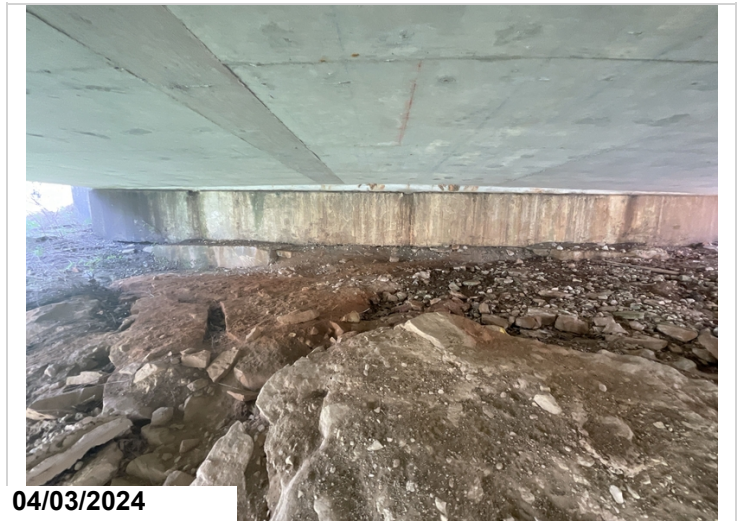
(205) Bent 3 -Minor local scour @ Columns 1 & 2.							
215	Reinforced Concrete Abutment	LF	102	102	0	0	0
(215) Abutment 2: minor embankment erosion.							
234	Reinforced Concrete Pier Cap	LF	144	114	29	1	0
1010	Cracking	LF	29	0	29	0	0
1090	Exposed Rebar	LF	1	0	0	1	0

Abutment 2: minor embankment erosion.

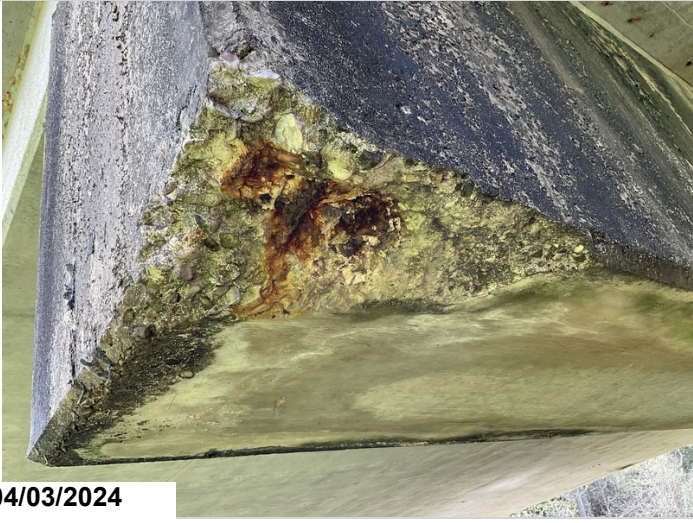
Substructure is in overall Good condition with areas of minor hairline cracking along bottom of all caps and a spall with reinforcing steel exposed to Left end of cap @ Bent 1.

(234) Deep spall with reinforcing steel exposed to Left end of cap @ Bent 1.CS3 Minor cracking to bottom of all caps.							
301	Pourable Joint Seal	LF	136	0	0	136	0
2320	Seal Adhesion	LF	136	0	0	136	0

Bent 1, Left, Bottom: spalling with exposed reinforcing steel. CS3.

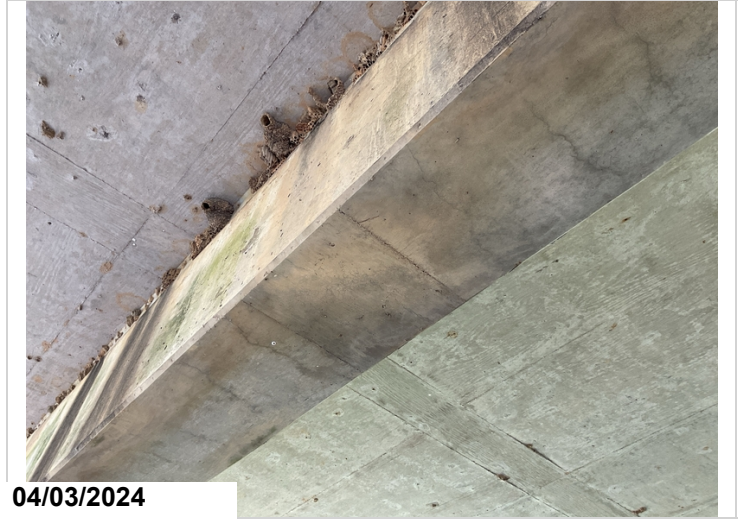
Bents 1, 2, 3, & 4, Bottom: cracking. CS2.

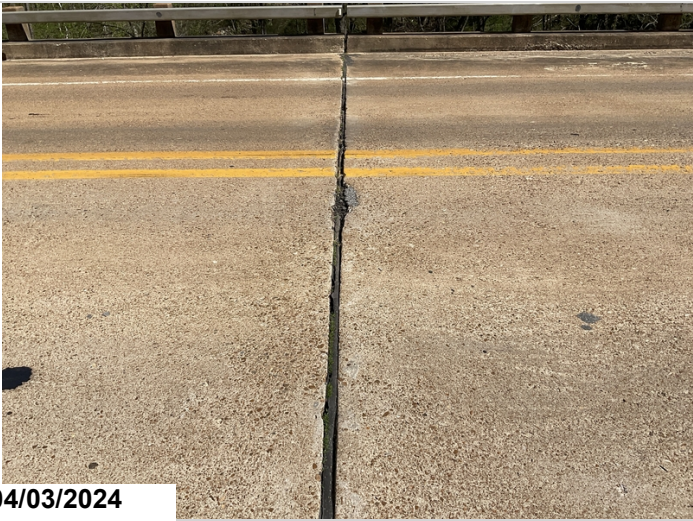
(301) Pourable joint seals: Adhesion failure. CS3.							
330	Metal Bridge Railing	LF	350	350	0	0	0

Joints at Bents 1 - 4: Typical seal adhesion failure. CS3.

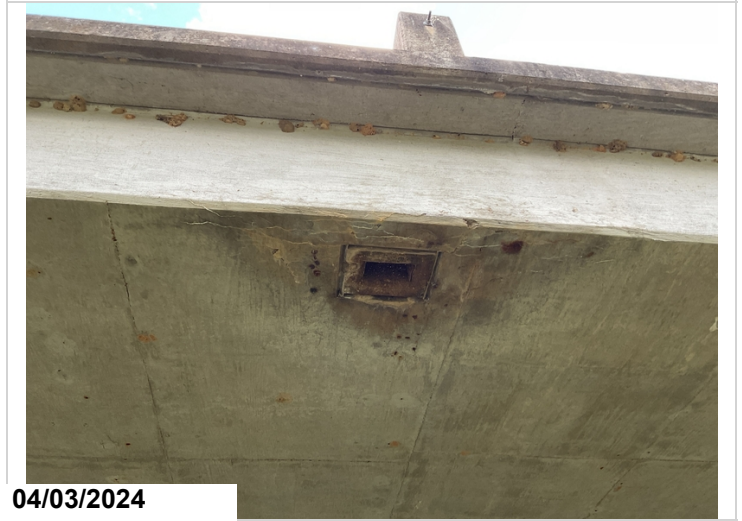
Span 4, Right drain: delaminated with minor efflorescence.

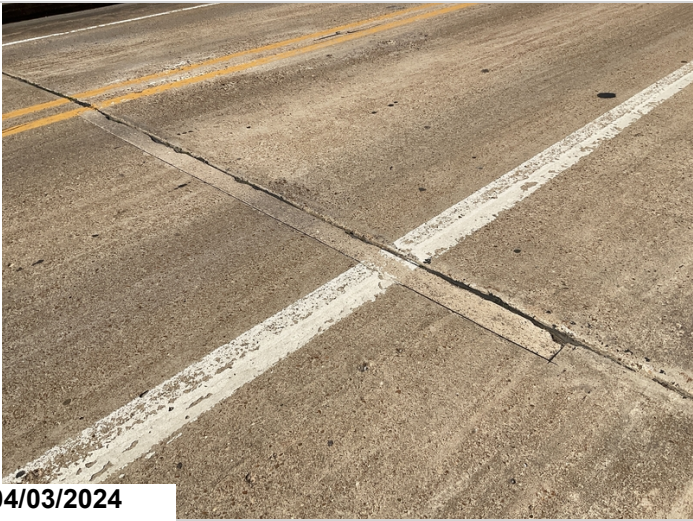
Span 2, Bent 1: 13' patched area in Left lane. CS2.

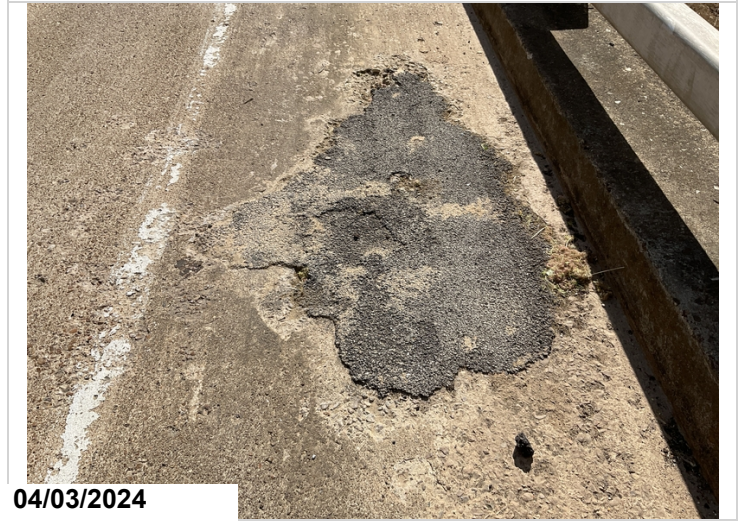
Span 5, Right gutter line: unsound patch.

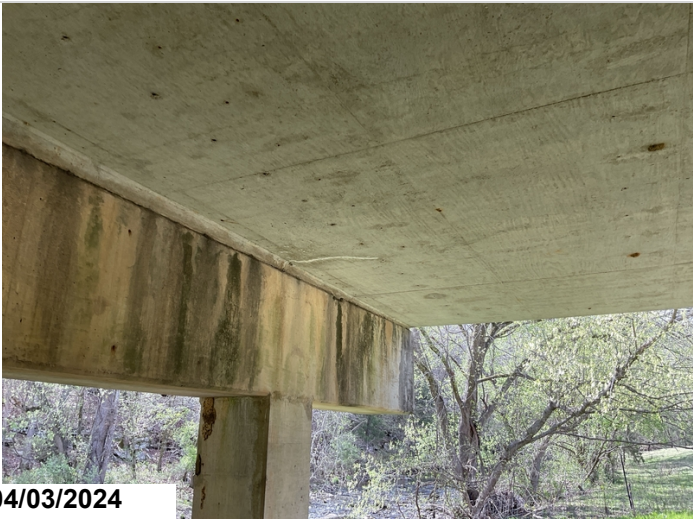
Span 1, Bent 1: cracking with efflorescence.

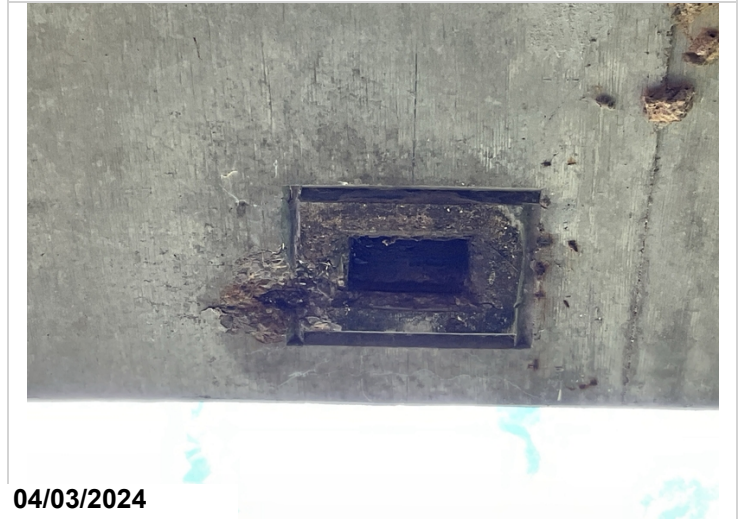
Span 4, Left & Right drains: spalling with exposed reinforcing steel. CS3.

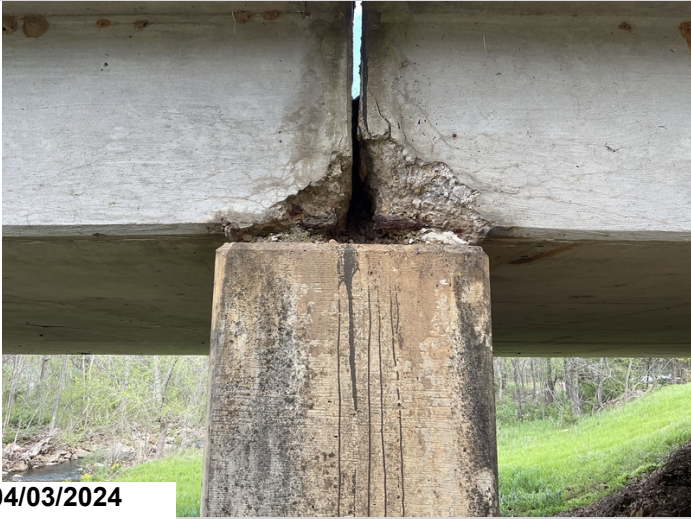
Spans 4 & 5, Bent 4, Right & Left edge of slab: spalling with exposed reinforcing steel. CS3.

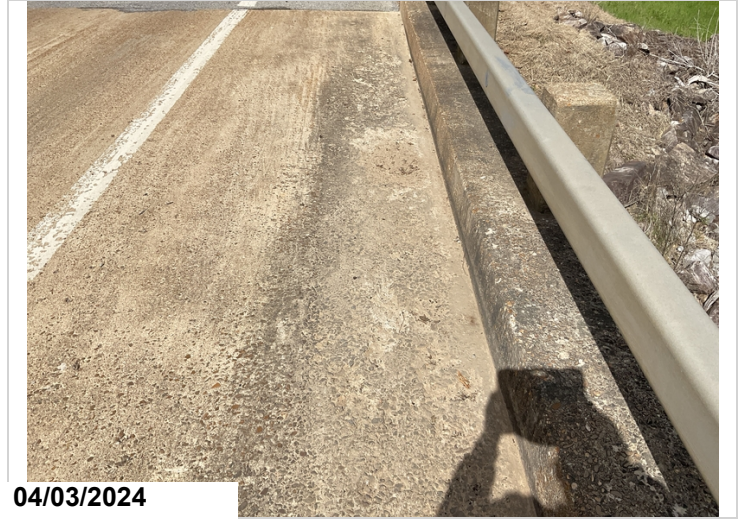
Span 1, Left gutter line: moderate abrasion. CS3.

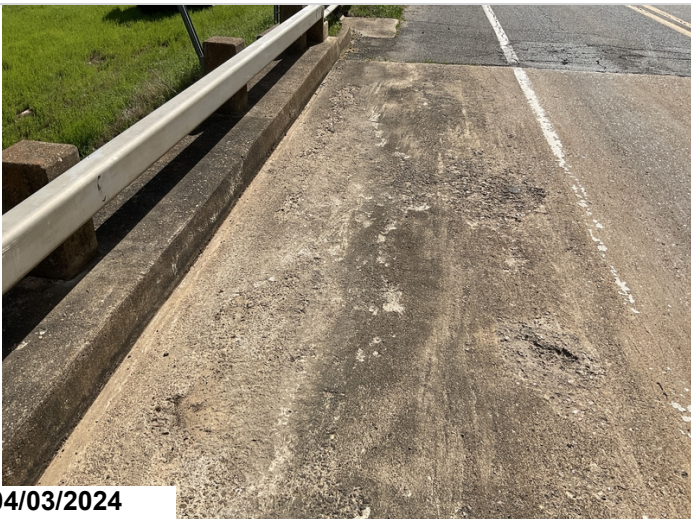
Span 5, Right & Left gutter lines: moderate abrasion. CS3.

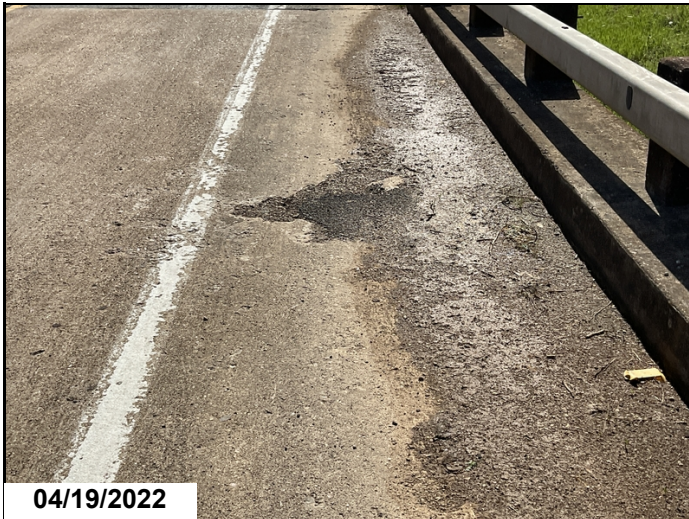
Span 5: Moderate to severe abrasion to Left & Right Gutter Lines.

Type of Work: Deck Repair

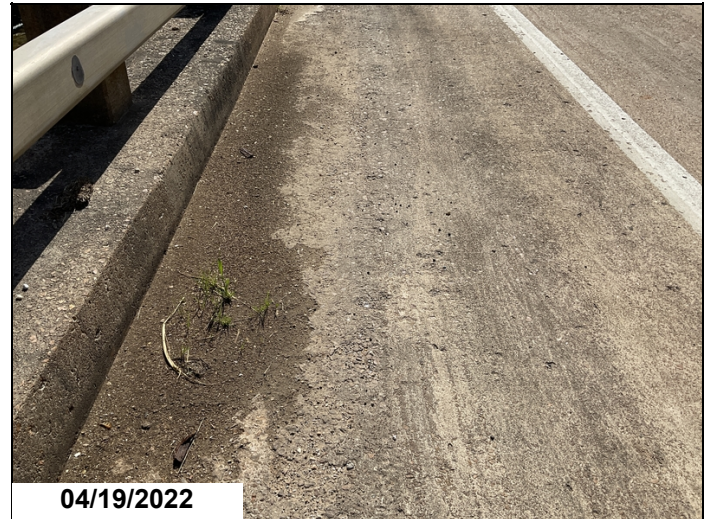
Spans 1 & 2: Moderate to severe abrasion to Left Gutter Line.

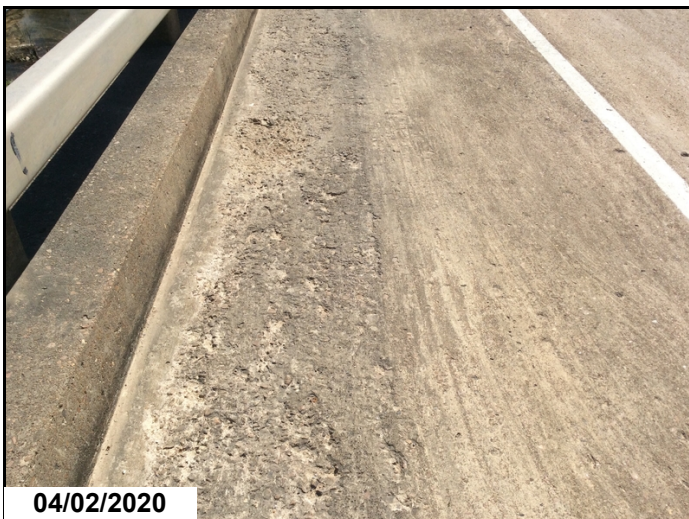
Severe scaling to Left gutter line @ Span 1

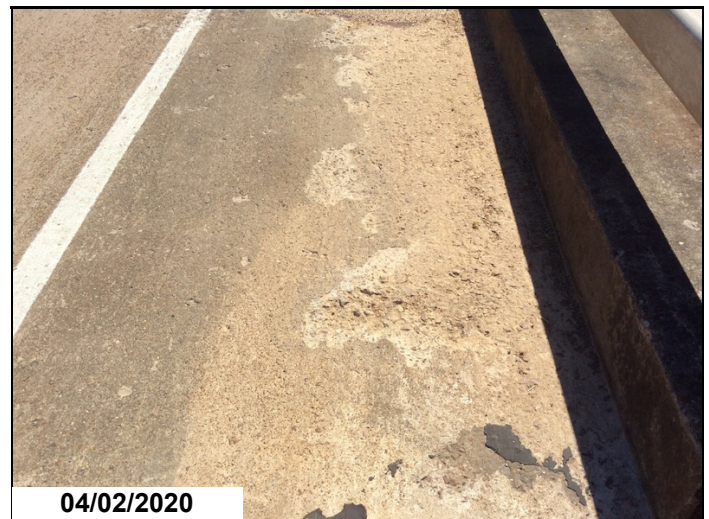
Severe scaling to Right gutter line @ Span 5 Right.

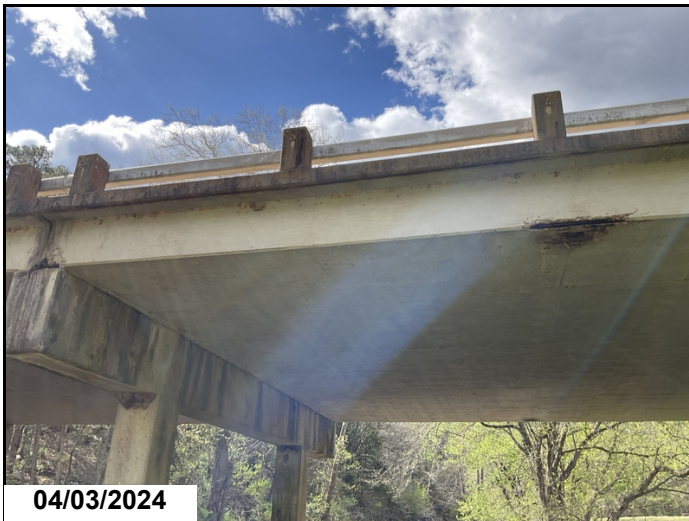
Span 2, Left edge of slab, Midspan & Bent 2: spalling with exposed reinforcing steel.

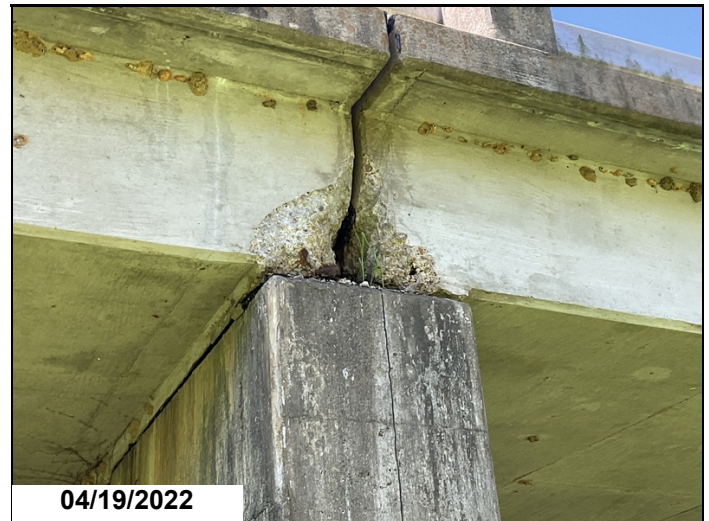
Spalls to Outside Edge of Deck @ Bents 2 & 4Lt side of bent 4.

Type of Work: Superstructure Repair

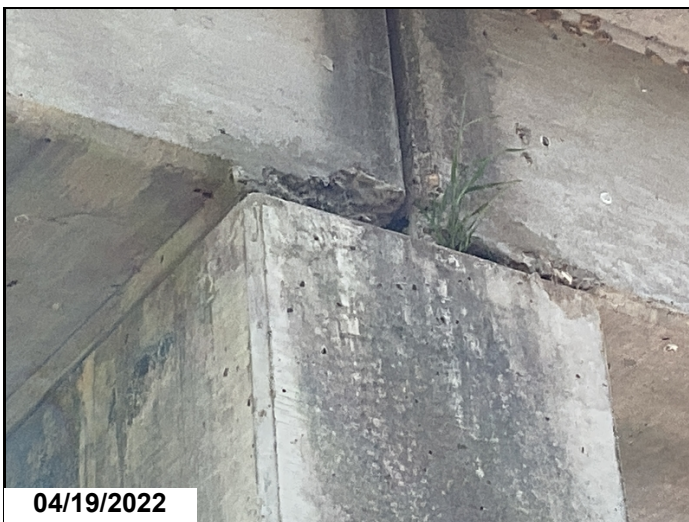
Spalls to Outside Edge of Deck @ Bents 2 & 4Rt side bent 2.

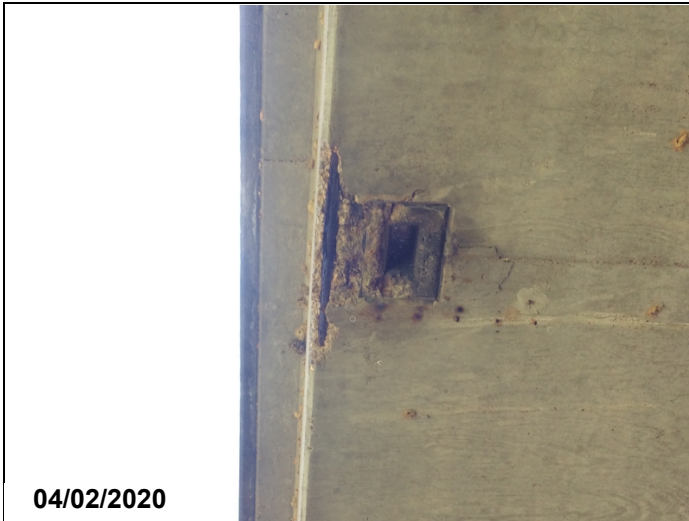
Spall with 3' rebar exposed to outside of deck @ Span 2 Left.

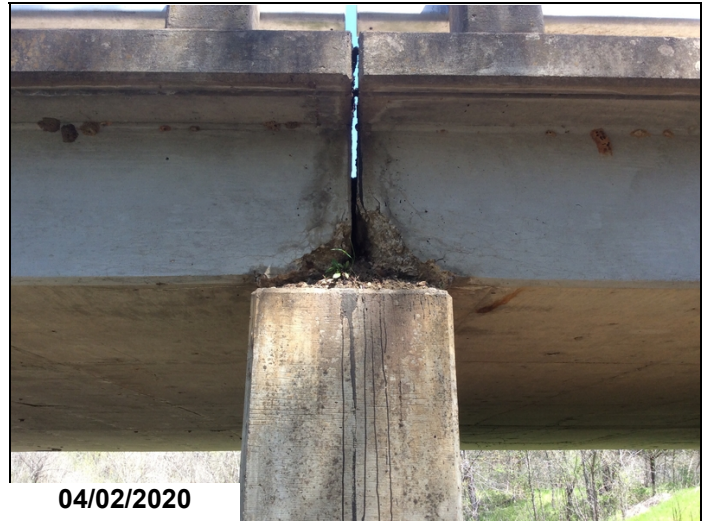
Deep Spalls to deck over cap @ Right edge of Bent 4.
(Typical of Bent 4 Left & Right & Bent 2 Left.)
