Asset #05408(Routine, Underwater type 2)

SH 14/Stone County over CONDITT CREEK

Location: 16.4 MI EAST JCT SH 5 SO.

Team Lead: Floyd Haley Inspection Date: 04/03/2024

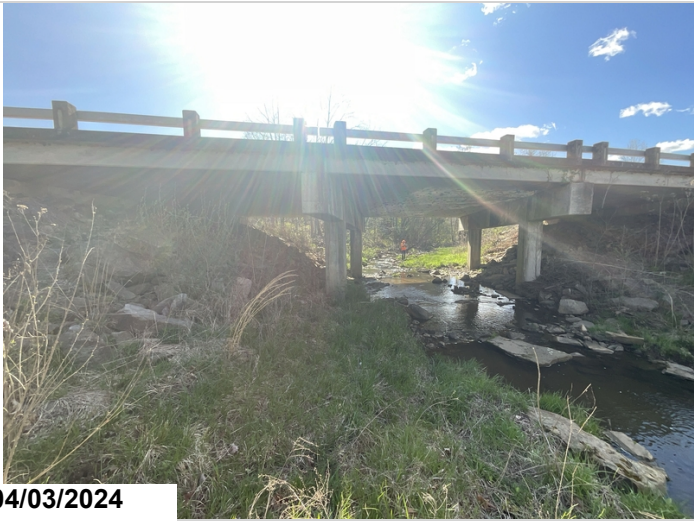
Elevation.

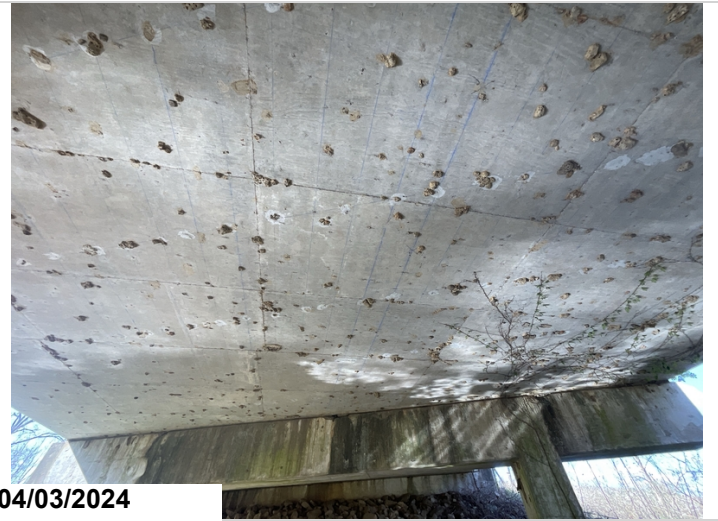
Typical undersurface.

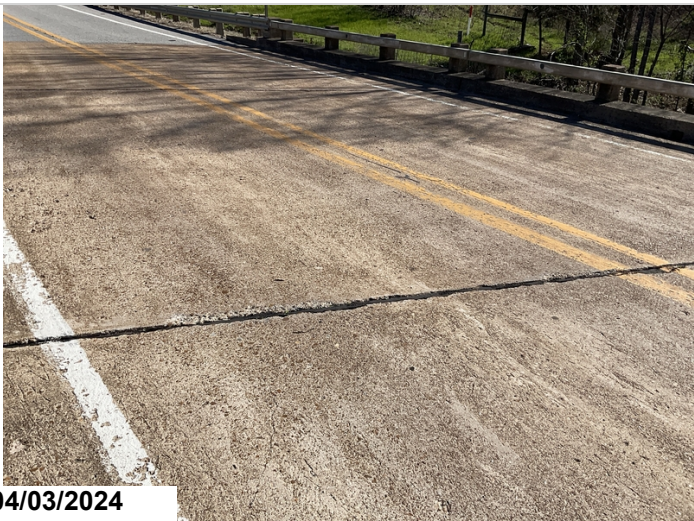
Typical deck.

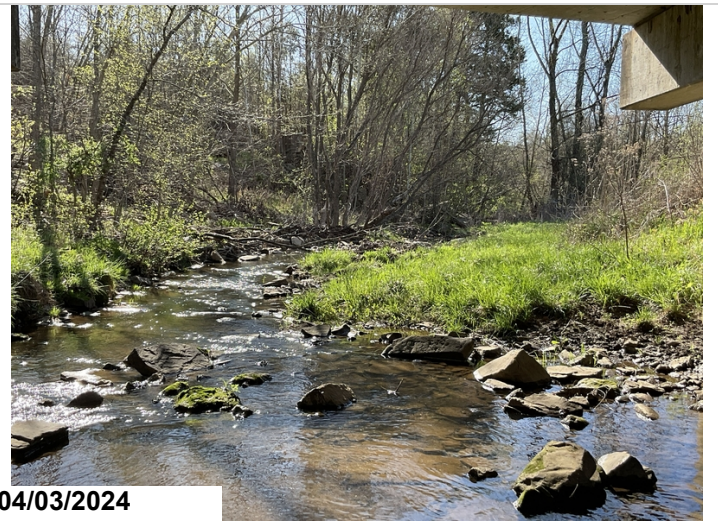
Left side of bridge: Channel view.

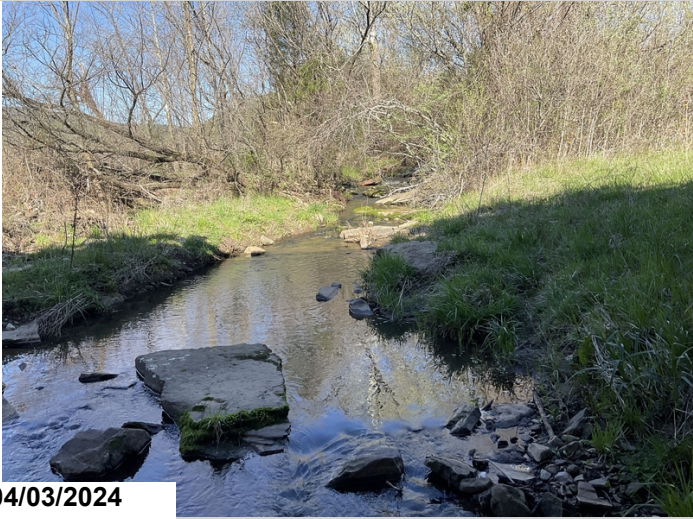
Right side of bridge: Channel view.

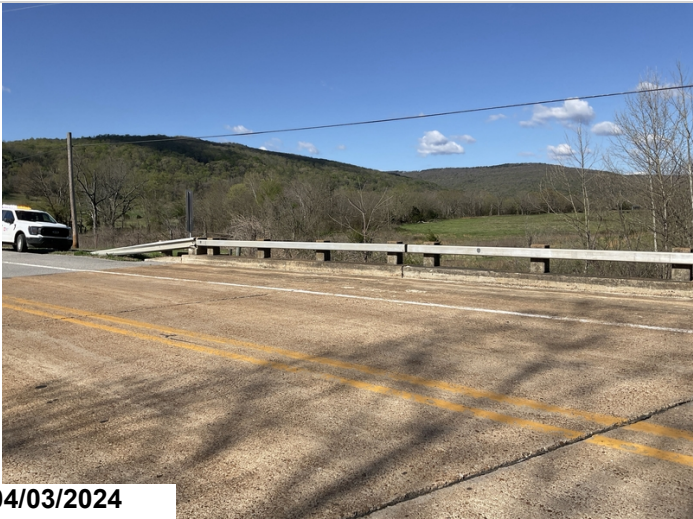
Typical bridge railing.

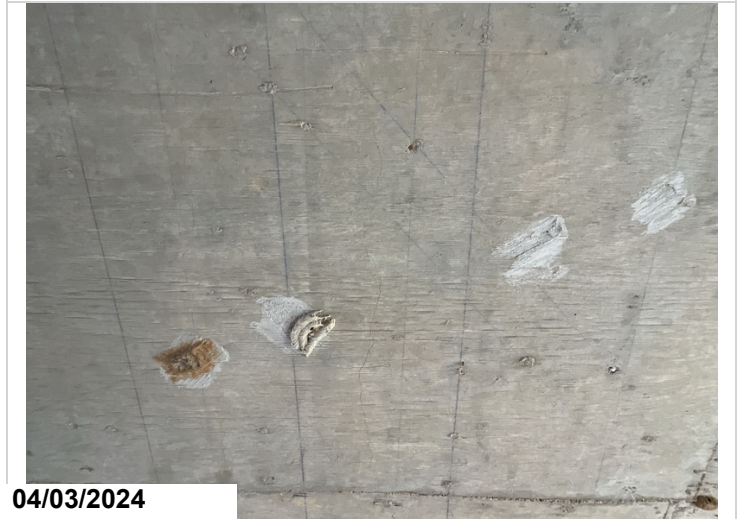
Spans 1 - 3: typical minor cracking to undersurface of deck.
CS2

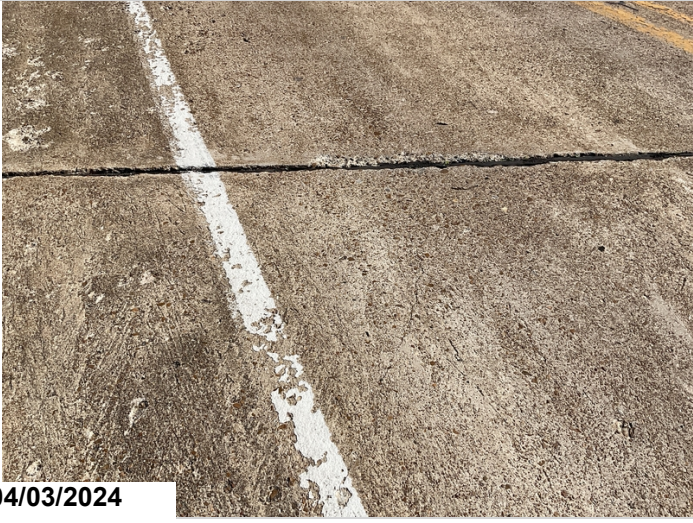
Spans 2 & 3: longitudinal cracking to deck. CS2

A-54 - Sealable Deck Cracks (Yes)

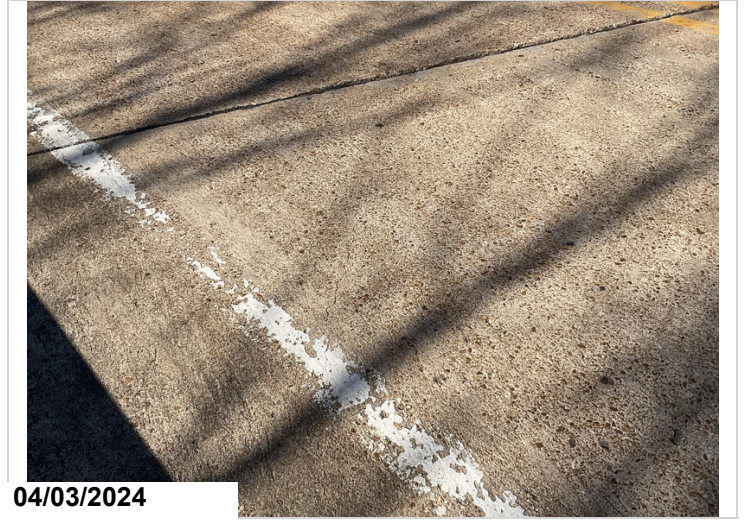
Span 1: diagonal cracking to deck. CS2.

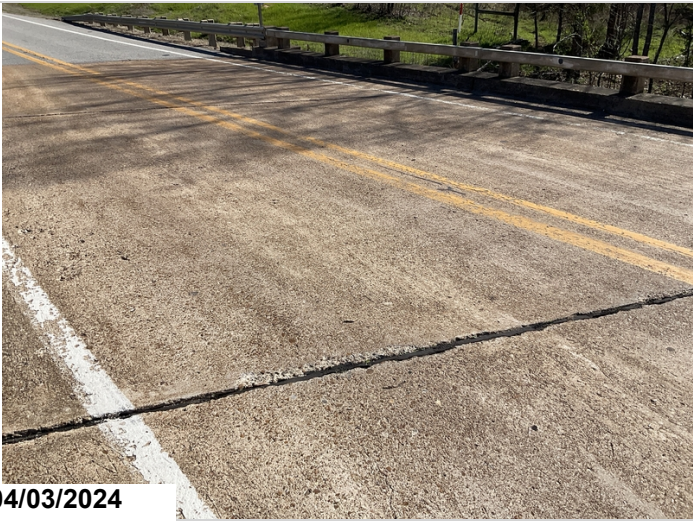
Spans 1 - 3: Minor abrasion to deck. CS2.

A-61 - Polymer Overlay Advised (Yes)

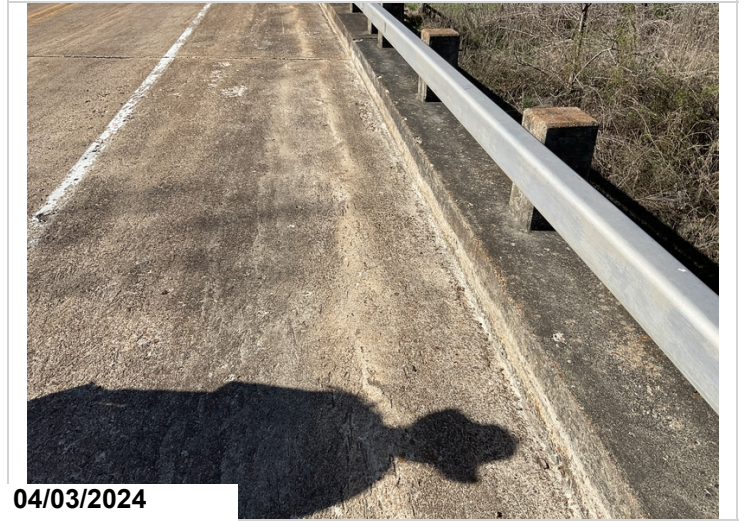
Spans 1 - 3, Right & Left gutter lines: Moderate abrasion to deck. CS3

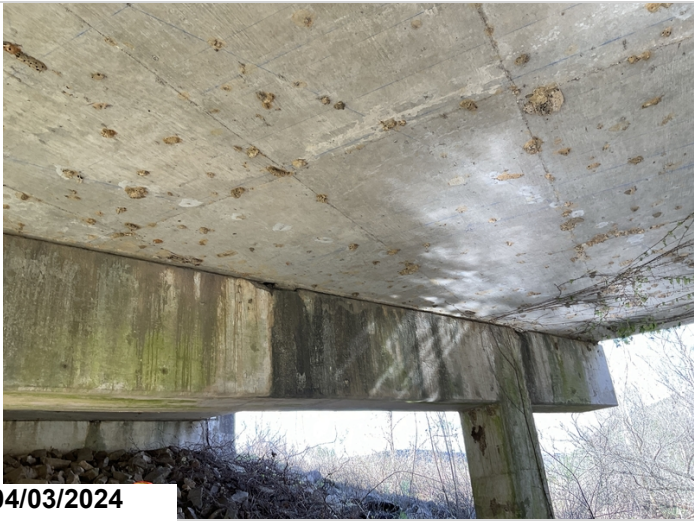
Bent 2, Back, Keyways: spalling.

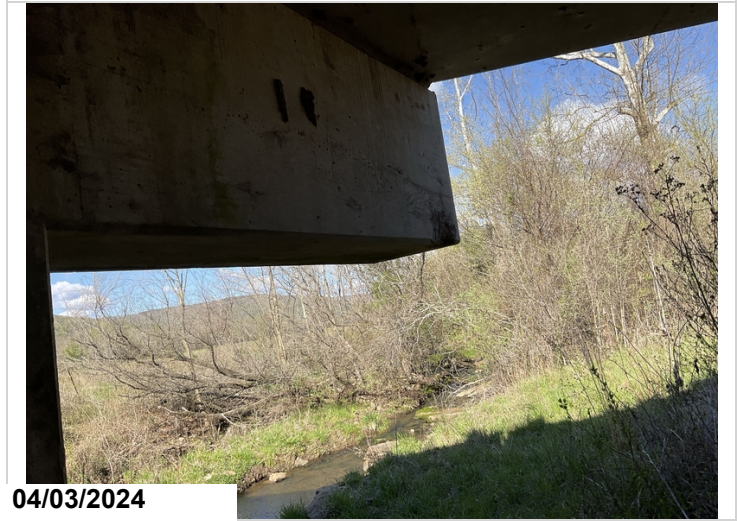
Bent 1, Back, Right: spalling. CS3.

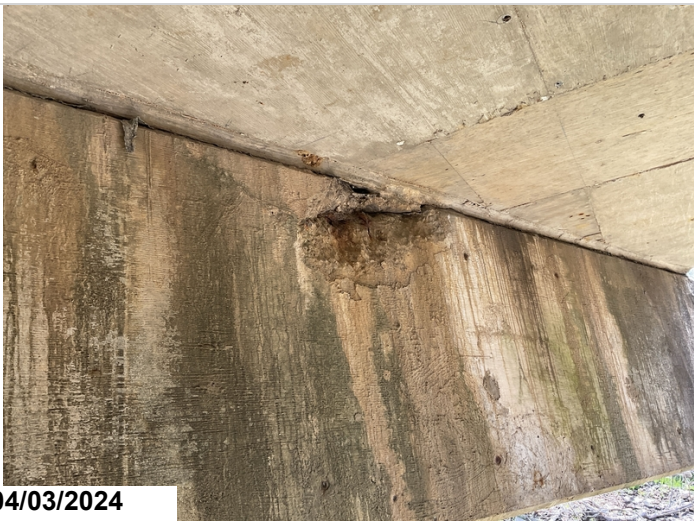
Substructure is in overall Satisfactory condition with areas of delamination and patches to cap @ Bent 1 & efflorescent cracking & spalls with reinforcing steel exposed to cap @ Bent 2. Footings are also exposed at Column 1, Bent 1 & Column 2 , Bent 2.

Bent 2, Ahead, adjacent to Column 1: Spalling to cap with exposed reinforcing steel. CS3.

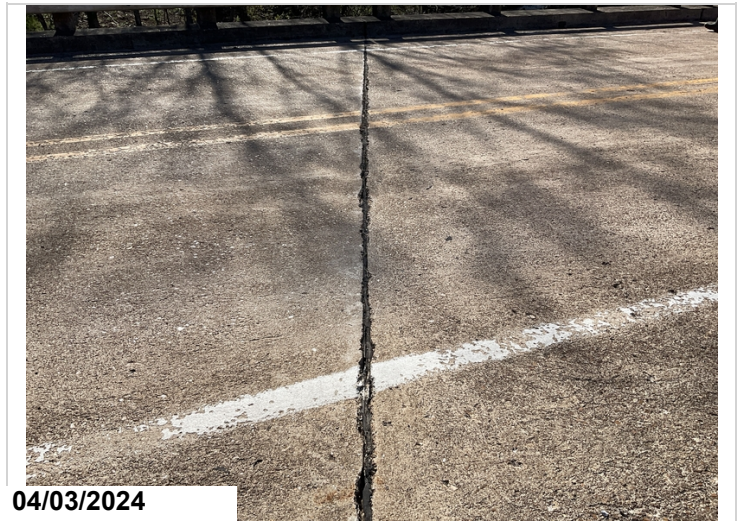
Joints at Bents 1 & 2: Seal adhesion failure. CS3.

A-56 - Joint Cleaning/Flushing Needed (Yes)

A-59 - Joint Repair Needed (Yes)

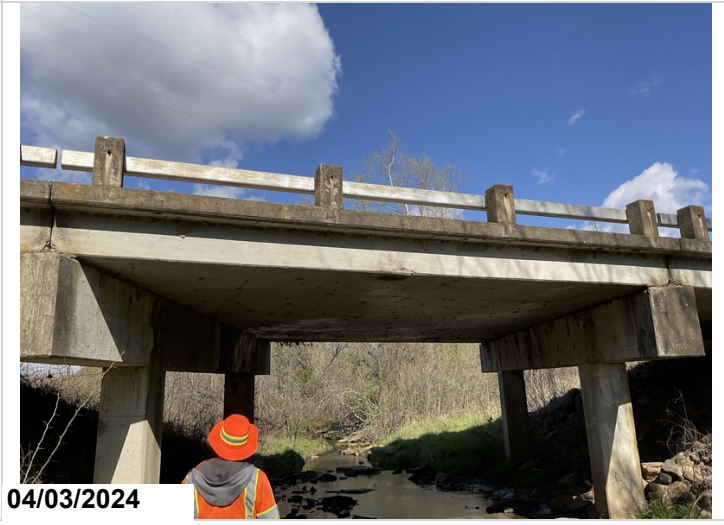
Spans 1 & 2, Bent 1, Left edge of slab: spalling. CS3. Spans 2 & 3, Bent 2, Left edge of slab: spalling. CS3.

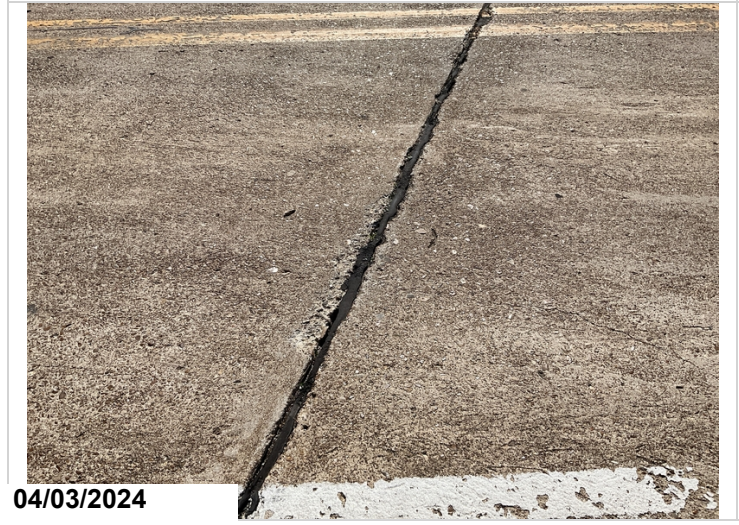
Span 2, Bent 2: spalling to deck. CS3.

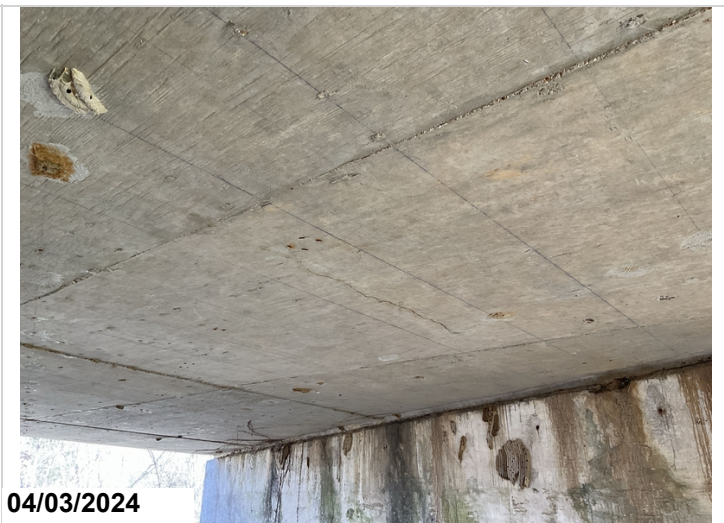
Superstructure is in overall Satisfactory with areas of cracking, some having rust stains & spalling to undersurface & outside edges of deck.

Span 3: longitudinal cracking with rust staining to undersurface of deck. CS3.
