Asset #05409(Routine, Underwater type 2)

SH 14/Stone County over WALLACE CREEK

Location: 16.4 MI EAST JCT SH 5

Team Lead: Floyd Haley Inspection Date: 04/03/2024

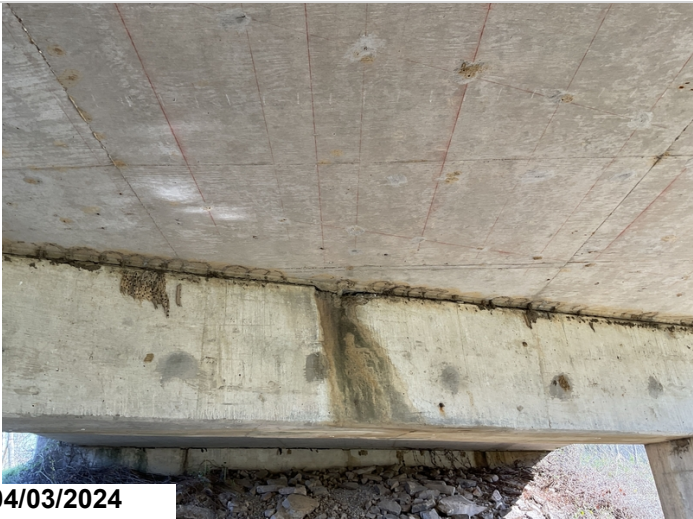
(234) Bent 1: 1' spall to cap over center keyway on ahead side. Bent 1: 2' delaminated area to cap over Column 1 ahead side. Efflorescent cracking to cap @ Bent 2.							
301	Pourable Joint Seal	LF	73	0	0	73	0
2320	Seal Adhesion	LF	73	0	0	73	0

Bent 1, Ahead: Spalling to cap at key way. CS3Bent 1, adjacent to Column 1, Ahead: Delaminated area to cap.

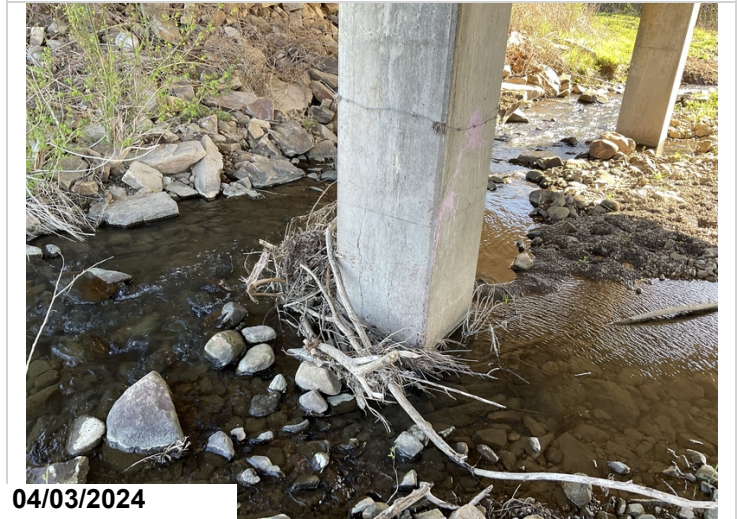
(205) Vertical cracking to Column 2 @ Bent 1.							
215	Reinforced Concrete Abutment	LF	86	86	0	0	0
234	Reinforced Concrete Pier Cap	LF	79	73	4	2	0
1080	Delamination/Spall/Patched Area	LF	3	0	2	1	0
1120	Efflorescence/Rust Staining	LF	3	0	2	1	0

Bent 1, Column 2: vertical cracking.

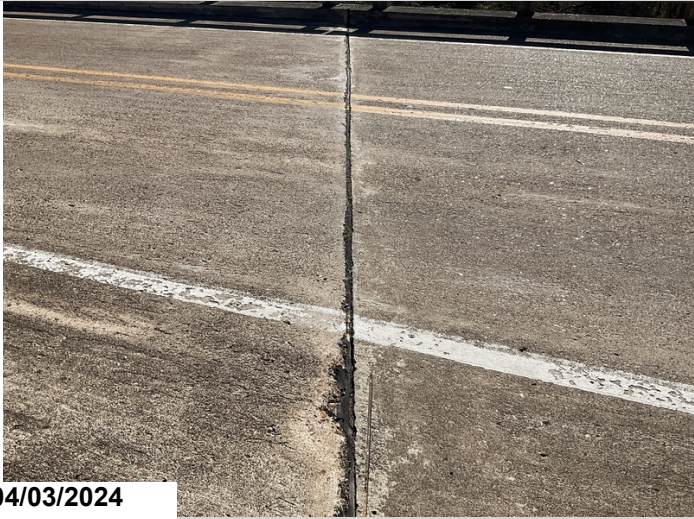
(301) Pourable joint seal: Adhesion failure.							
330	Metal Bridge Railing	LF	210	210	0	0	0

Joints at Bents 1 & 2: Seal adhesion failure.

A-59 - Joint Repair Needed (Yes)

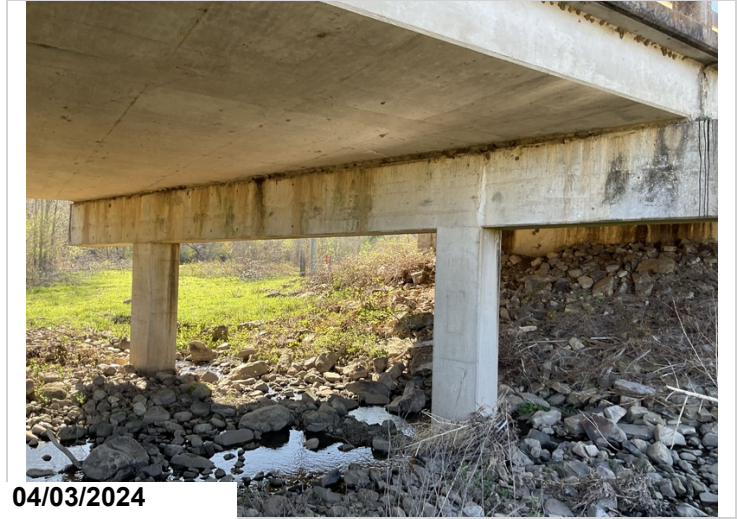
Bent 2, Back: cracking with efflorescence.

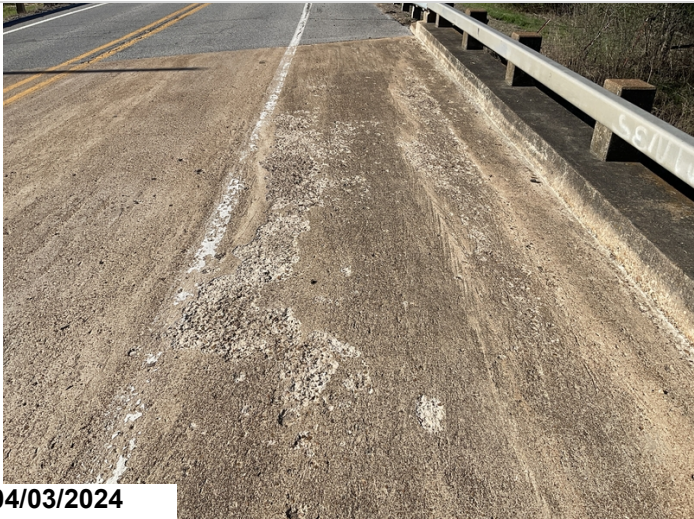
Span 3, Right & Left gutter line: Moderate to heavy abrasion to deck. CS3.

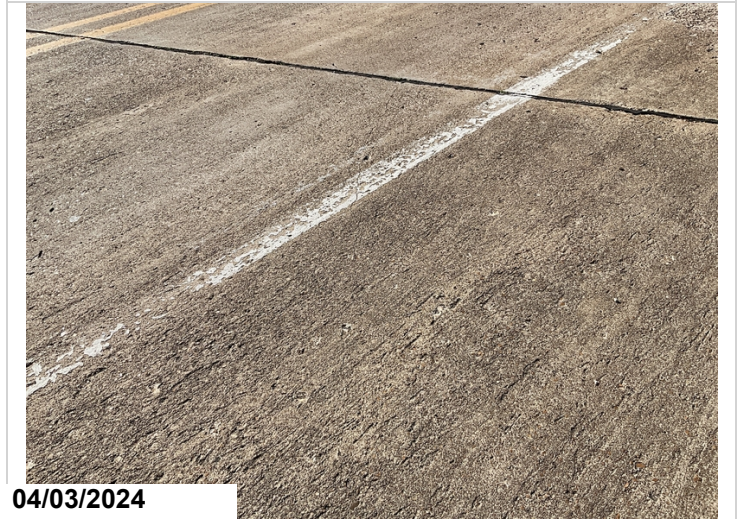
Span 2: Diagonal cracking to deck. CS3.

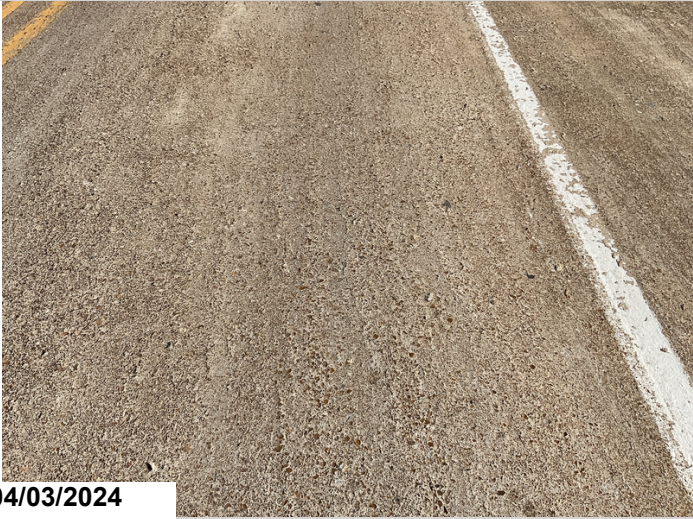
Span 1: Longitudinal cracking to deck. CS2.

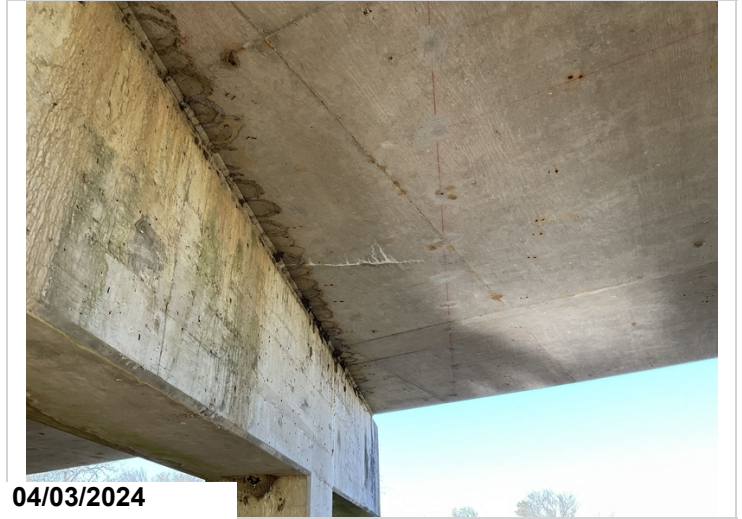
Span 2, Bent 2: Cracking with efflorescence to undersurface of deck. CS2.

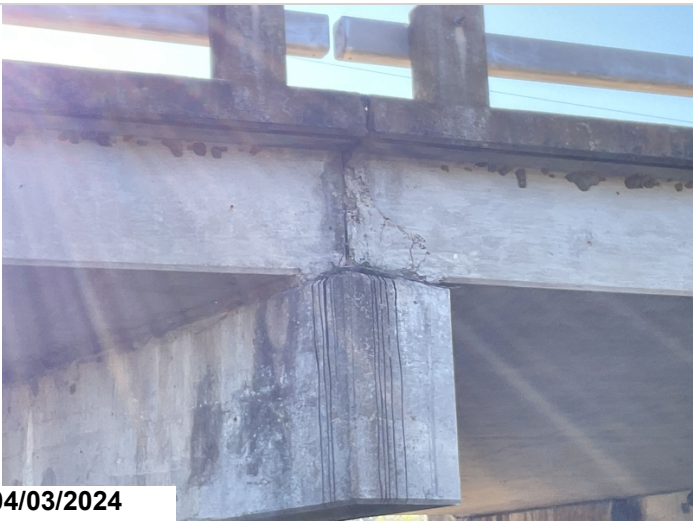
Span 3, Bent 2, Right & Left edges of slab: spalling.

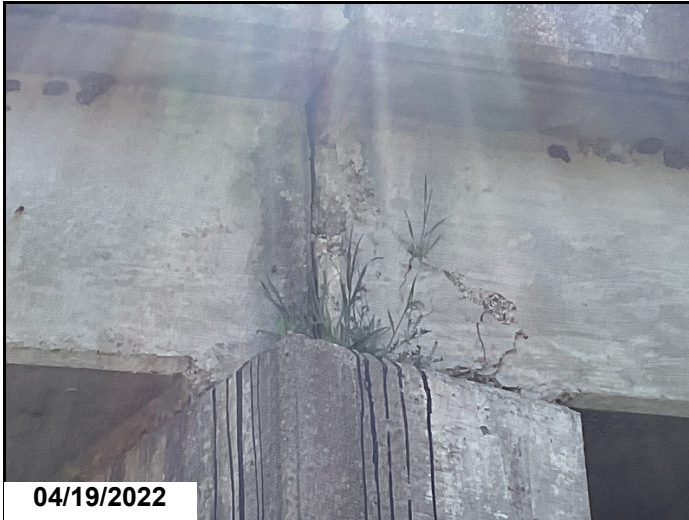
Spall to Lt & Rt outside edge of deck @ bent 2.

Spall to Lt & Rt outside edge of deck @ bent 2.Rt side.
