Asset #05410(Routine, Underwater type 2)

SH 14/Stone County over EVETTS CREEK

Location: 4.11 MI NW INDEPENDENCE

Team Lead: Floyd Haley Inspection Date: 04/03/2024

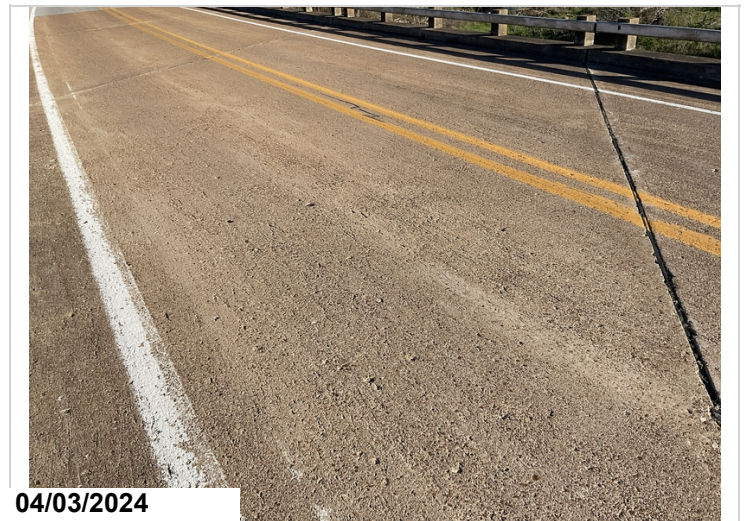
Spans 1 - 4: Abrasion to deck. CS2.

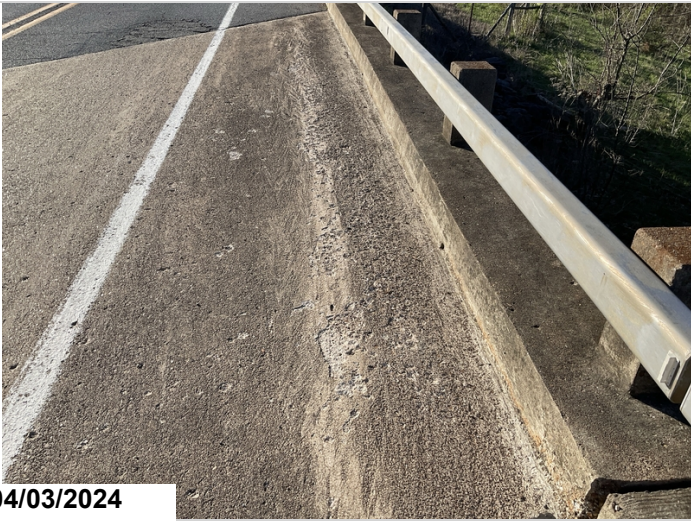
Deck is in Satisfactory condition with diagonal & horizontal cracking, abrasion, a patched area @ Span 1 & a spalled area @ Span 4. Span 4 also has area of Moderate abrasion in Right gutter line.

Span 4, Right gutter line: 30' of moderate abrasion to deck.
CS3.

A-61 - Polymer Overlay Advised (Yes)

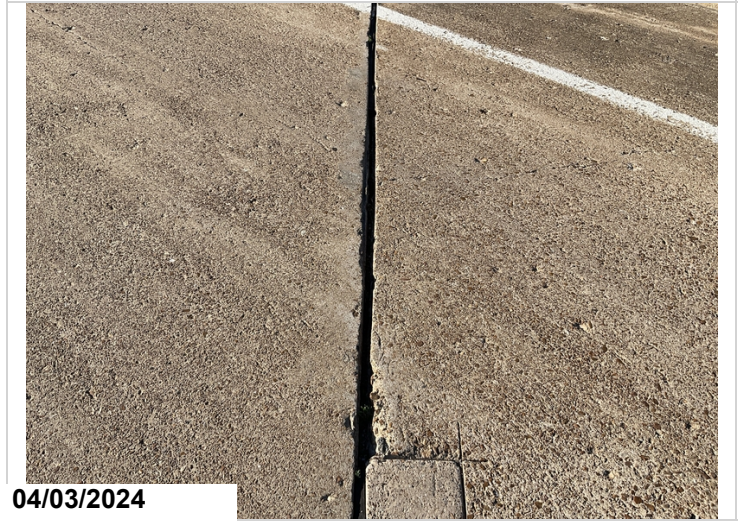
(301) Pourable joint seals: Adhesion failure. 8' Pourable joint seal is missing @ Bent 1. CS4							
330	Metal Bridge Railing	LF	280	280	0	0	0

Joint at Bent 1: Total adhesion failure for 8'. CS4.

A-59 - Joint Repair Needed (Yes)

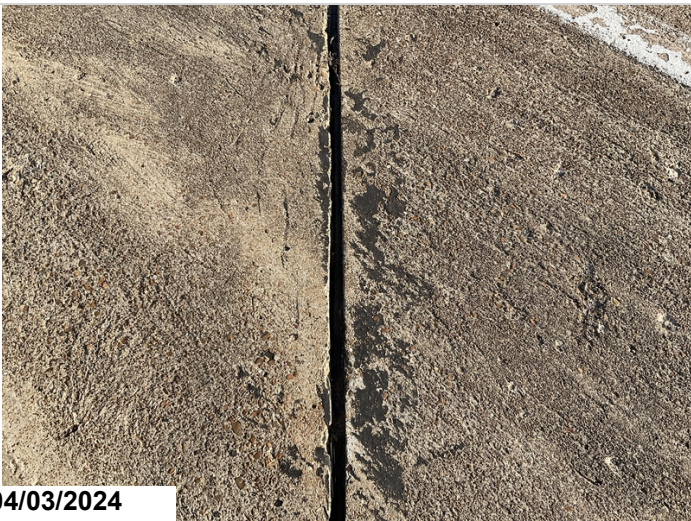
Joint at Bent 3: Typical adhesion failure.

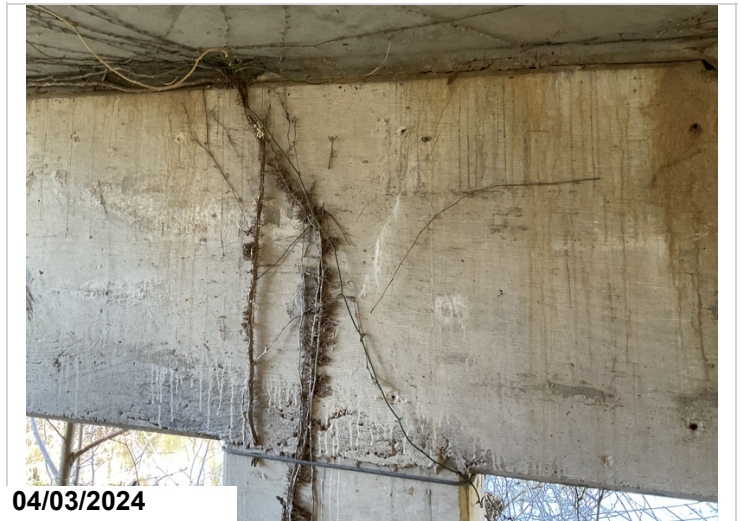
Bent 3, Ahead, adjacent to Column 3: Cracking with
efflorescence to cap. CS2.

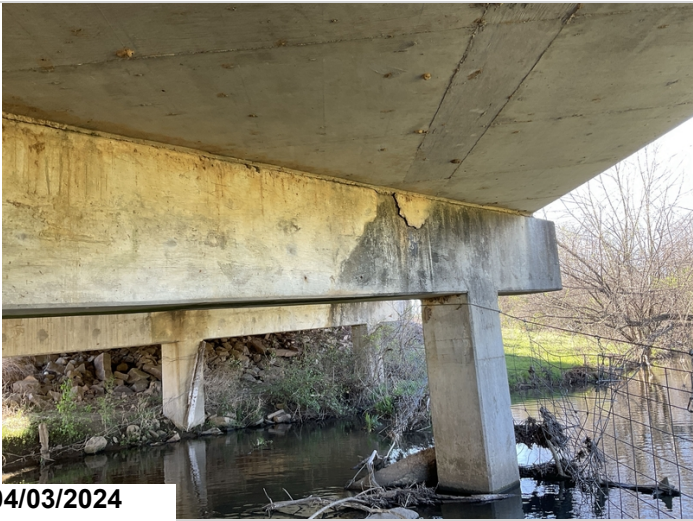
Bent 2, Back, Keyways: Delaminated areas to cap.

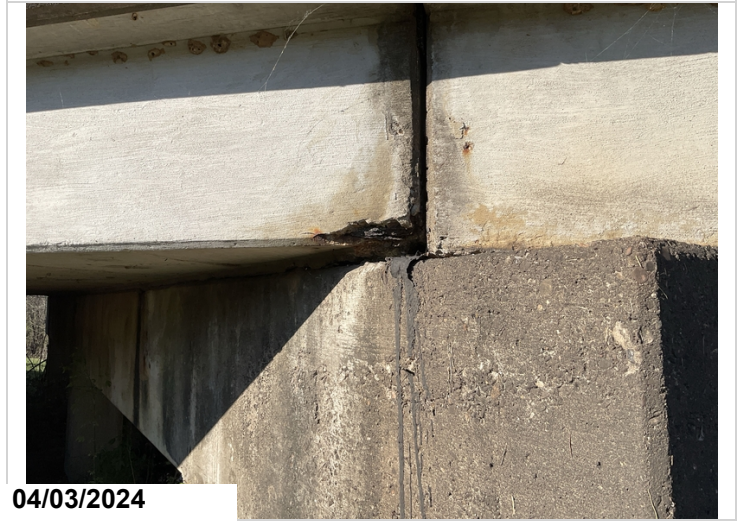
Span 4, Bent 3, Left: Spalling with exposed reinforcing steel to outside edge of deck. CS3.

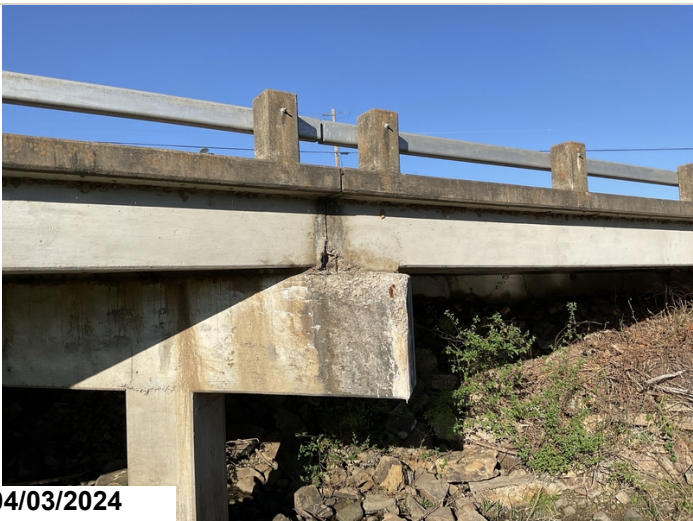
Spans 1 & 2, Right, Bent 1: Spalling with exposed reinforcing steel to outside edge of deck. CS3.

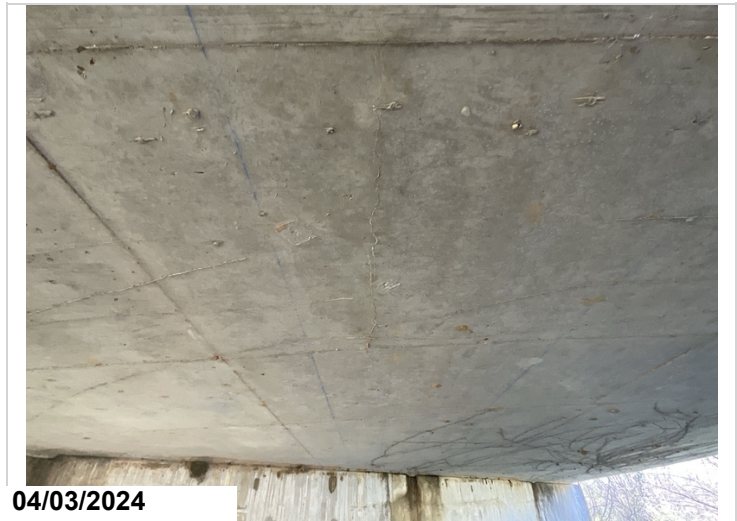
Span 3: Longitudinal cracking with efflorescence to underside of deck CS2.

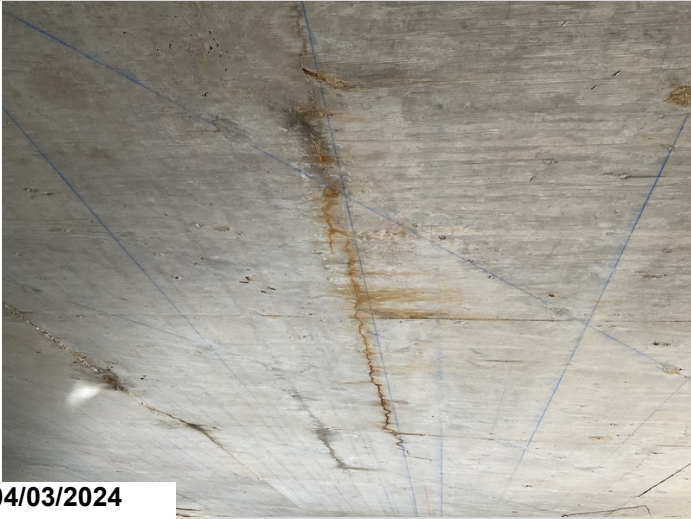
Span 1, Centerline: Cracking with rust staining to underside of deck. CS3.

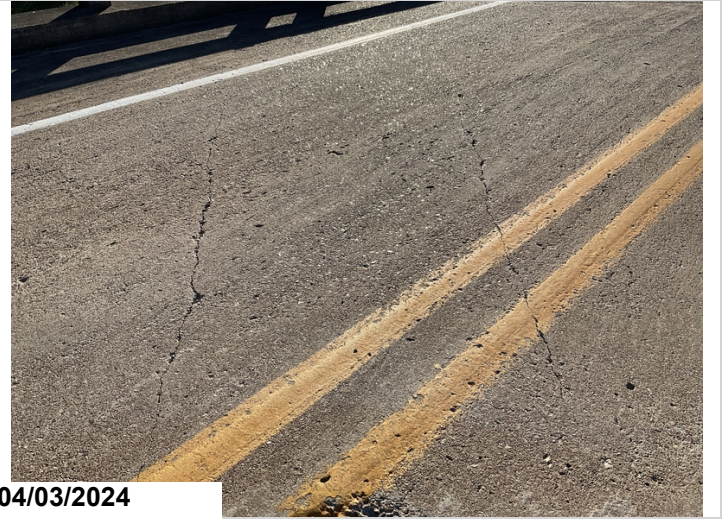
Span 3: Diagonal cracking to deck. CS3.

A-54 - Sealable Deck Cracks (Yes)

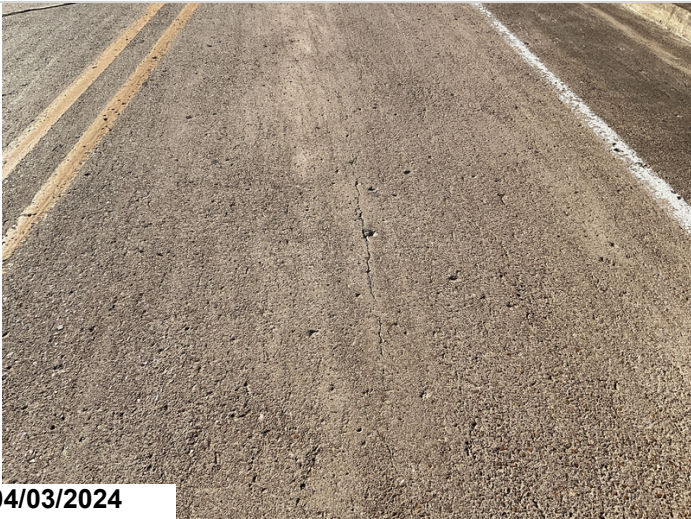
Span 2: Longitudinal cracking to deck. CS3.

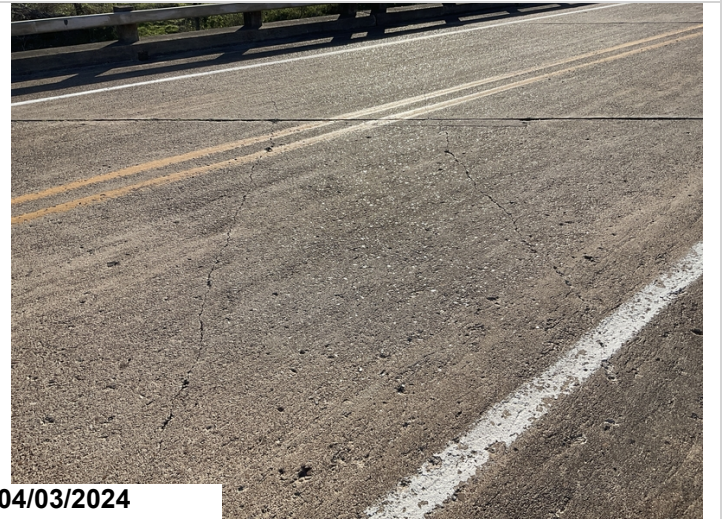
Spans 1 & 2: Diagonal cracking to deck. CS3.

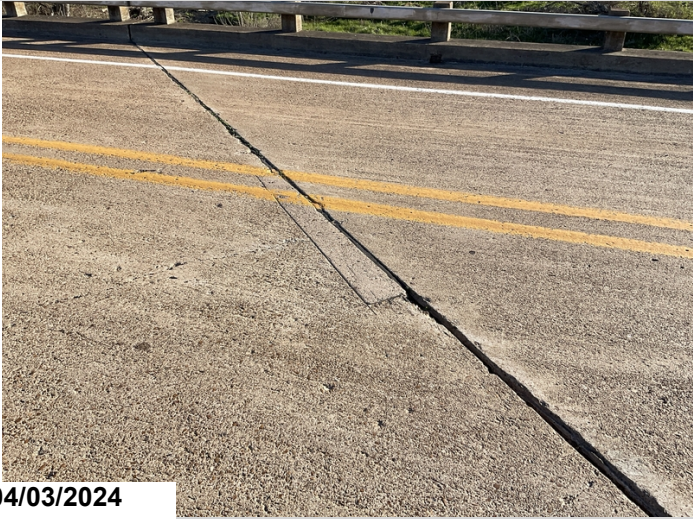
Span 1, Bent 1: 6' Patched area to deck.

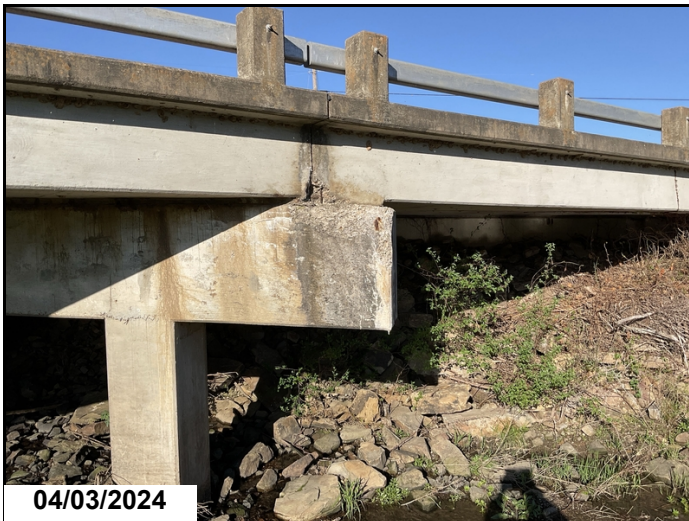
Bent 1, Left, Ahead: spalling with exposed reinforcing steel. CS3.

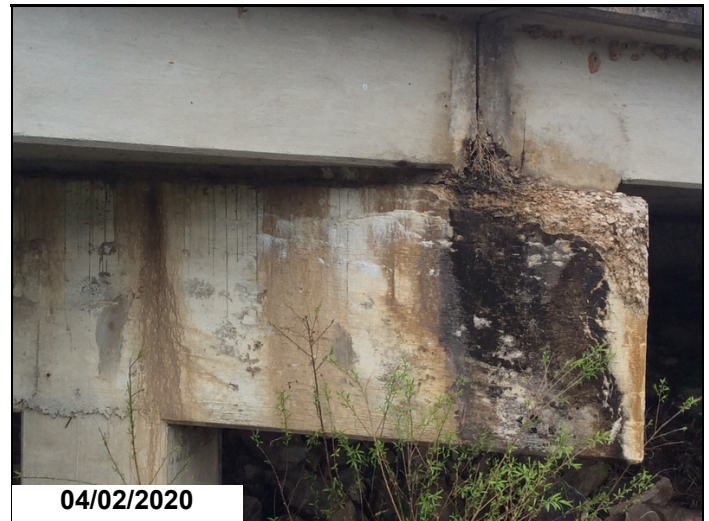
(234) Bent 1 - Minor spalls to bottom of cap between Columns 2 & 3 from heat damage. Spall with reinforcing steel exposed to Left end of cap. CS3 4' Efflorescent map cracking & spalling to Left end of cap. Small delaminated area to back side of cap over Column 3. Bent 2 - Spall to cap @ keyway over Column 2 & delaminated area to cap near Columns 1 & 3 on backside. Bent 3 - efflorescent cracking to ahead side of cap over Column 3.							
301	Pourable Joint Seal	LF	147	0	89	50	8
2320	Seal Adhesion	LF	147	0	89	50	8

Efflorescent cracking & spalls to Left end of cap @ Bent 1.
