Asset #06003(Routine, Underwater type 2)

SH 14/Stone County over BRIAR CREEK

Location: 1.26 MI NW INDEP CO LINE

Team Lead: Floyd Haley Inspection Date: 04/09/2024

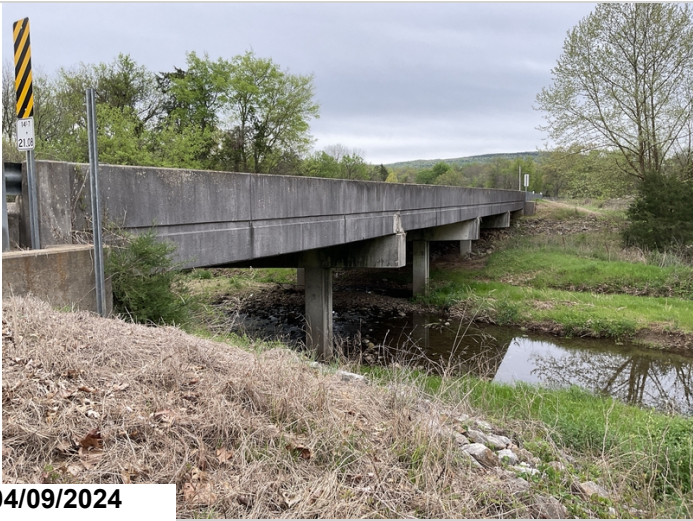
Elevation.

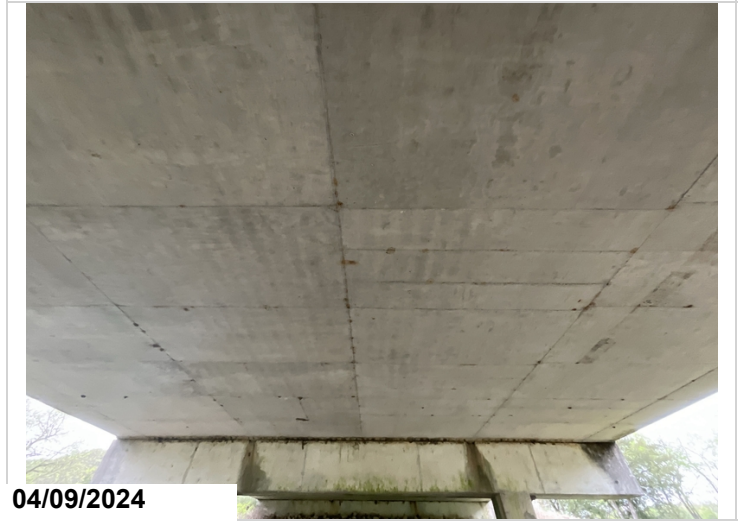
Typical undersurface.

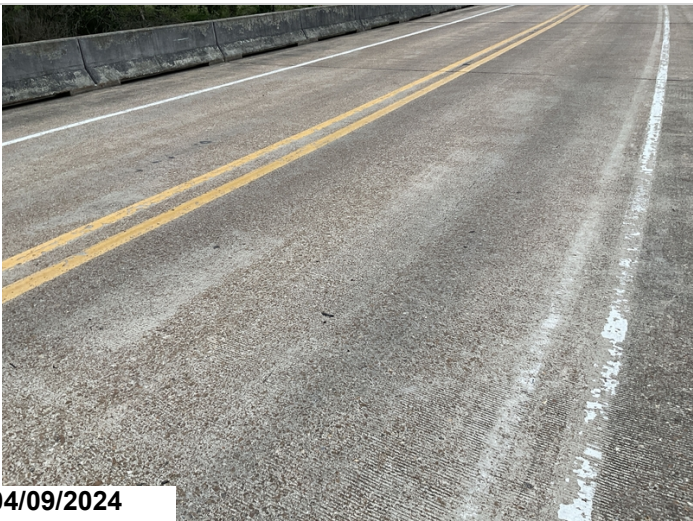
Deck is in overall Good condition with minor abrasion to entire surface of deck.

Typical deck.

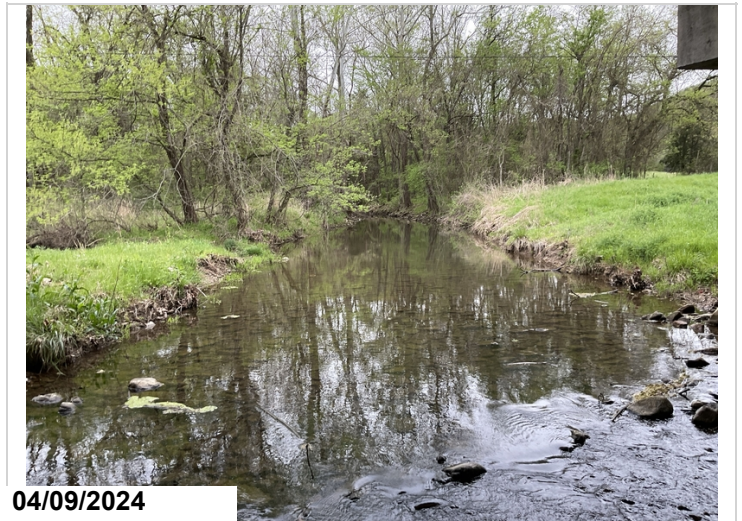
Right side of bridge: Channel view.

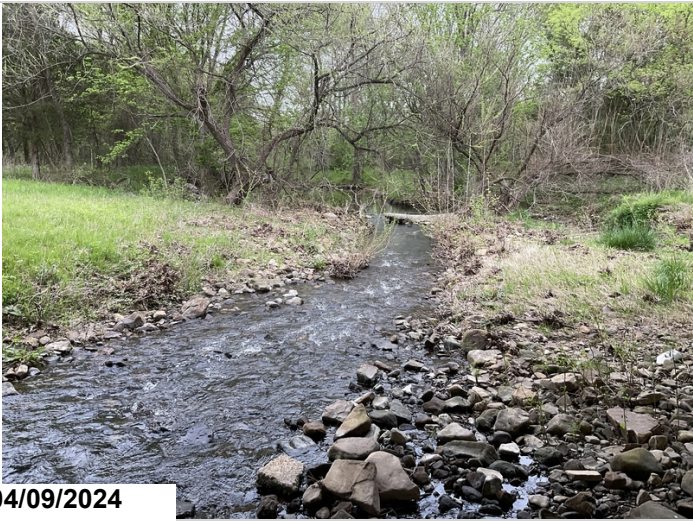
Left side of Bridge: Channel view.

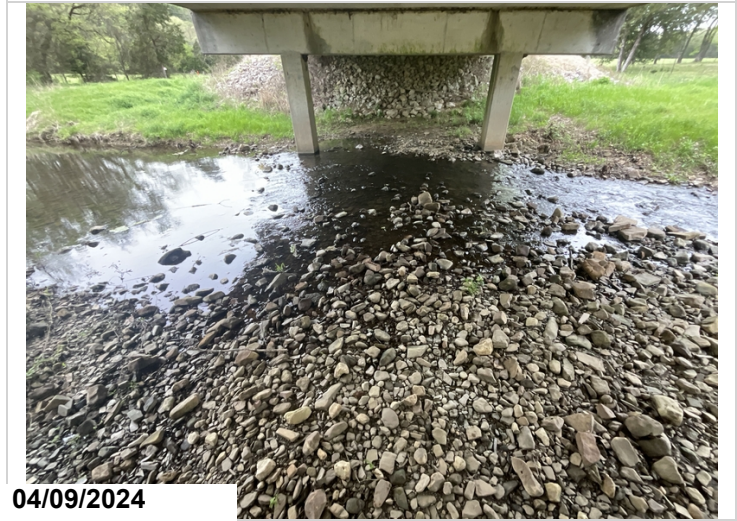
Span 2: Channel view.

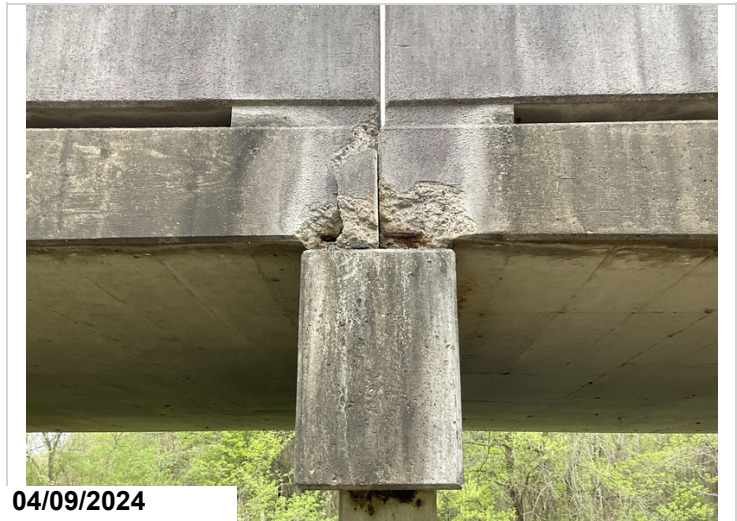
Superstructure is in overall Satisfactory condition with areas of cracking & spalling, with some spalls have reinforcing steel exposed, to outside edges of deck over bents.

(38) Minor abrasion to deck @ all spans. Spalls with 5' reinforcing steel exposed to outside edge of deck over Bents 1, 2 & 3. Minor vertical cracking to outside edge of deck over Bents 1, 2 & 3. Spalling to outside edges of deck over bents. Span 4, Abutment 2, Right: spalling. CS3.							
205	Reinforced Concrete Column	EA	6	3	2	1	0
1080	Delamination/Spall/Patched Area	EA	1	0	0	1	0
6000	Scour	EA	2	0	2	0	0

Spans 2 & 3, Bent 2, Left edge of slab: spalling with exposed reinforcing steel with section loss. CS3.

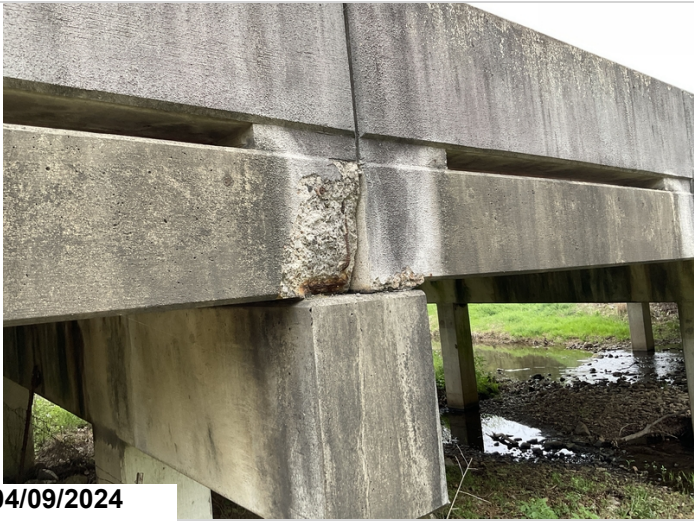
Span 4, Bent 3, Left edge of slab: spalling with exposed reinforcing steel with section loss. CS3.

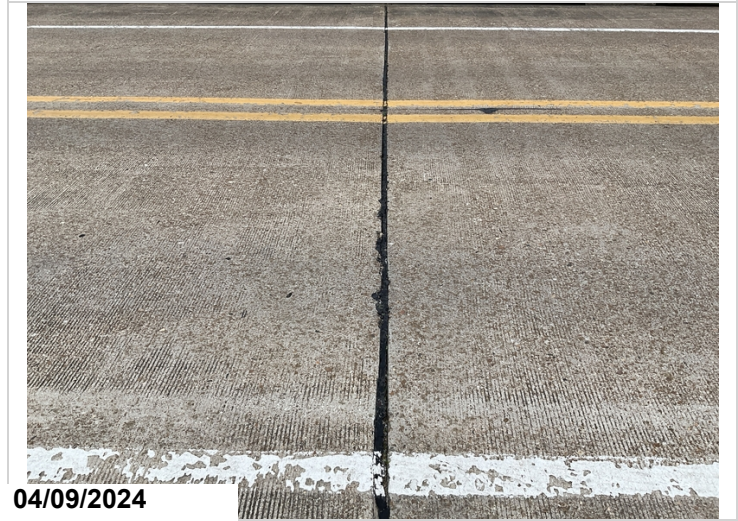
(301) Pourable Joints: Adhesion failure							
331	Reinforced Concrete Bridge Railing	LF	280	280	0	0	0

Joint at Bent 2: typical seal adhesion failure. CS3.

**A-59 - Joint Repair Needed (Yes)**

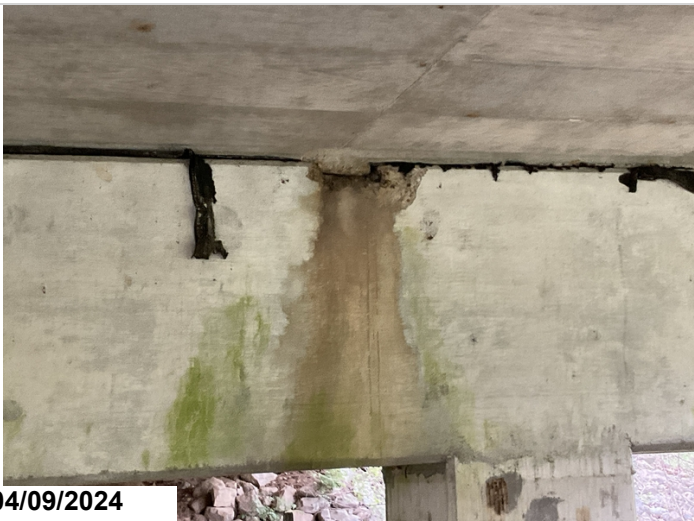
(234) Bents 1 & 3: Vertical cracking to caps. Bent 2 - 3 efflorescent cracks to cap. Bent 3 - 1' spall with no rebar exposed to keyway on Right end @ backside.							
301	Pourable Joint Seal	LF	102	12	45	45	0
2320	Seal Adhesion	LF	90	0	45	45	0

Bent 3, Back, Right Keyway: spalling. CS3.

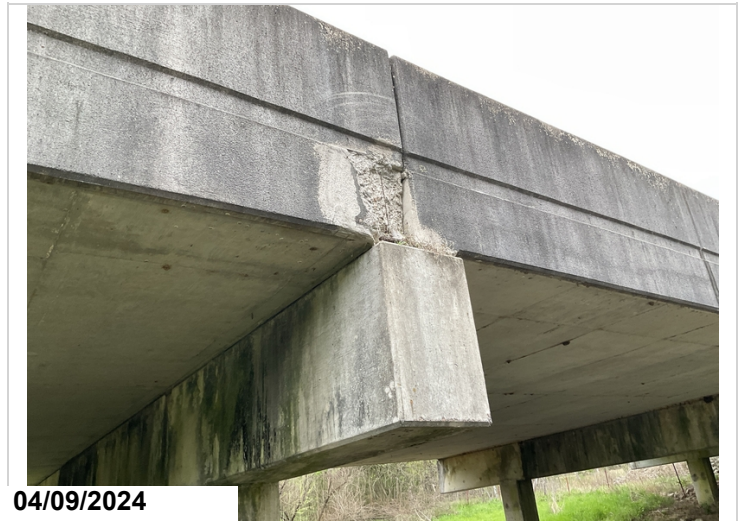
Span 1, Bent 1, Right edge of slab: large spall with exposed reinforcing steel with no section loss. CS3.

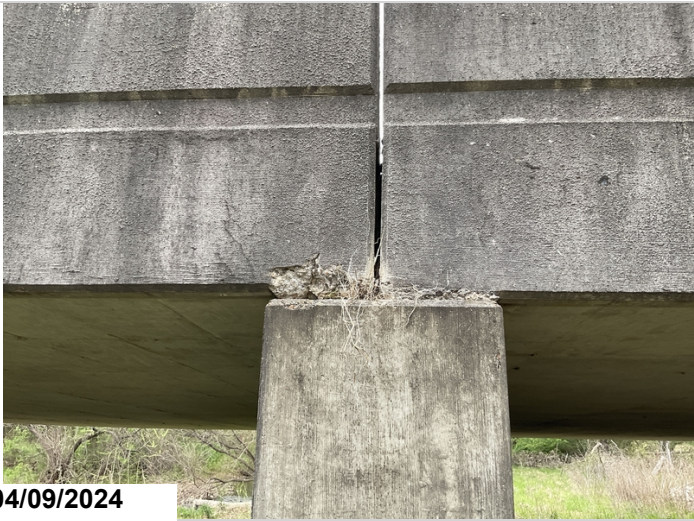
Span 3, Bent 3, Right edge of slab: spalling. CS3.

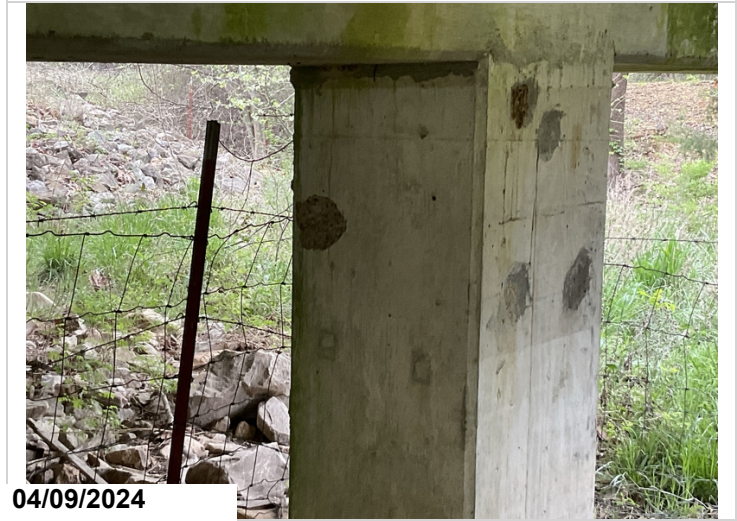
(205) Bent 2 Columns 1 & 2: Minor local scour. Bent 3 Column 2: Spall.							
215	Reinforced Concrete Abutment	LF	104	104	0	0	0
234	Reinforced Concrete Pier Cap	LF	111	102	7	2	0
1010	Cracking	LF	4	0	4	0	0
1080	Delamination/Spall/Patched Area	LF	1	0	0	1	0
1090	Exposed Rebar	LF	1	0	0	1	0
1120	Efflorescence/Rust Staining	LF	3	0	3	0	0

Bent 3, Column 2: spall. CS3.

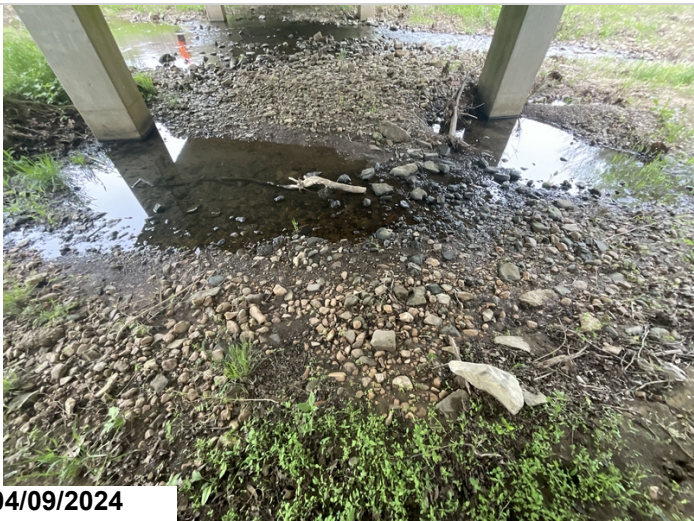
Bent 2, Columns 1 & 2: minor localized scour. CS2.

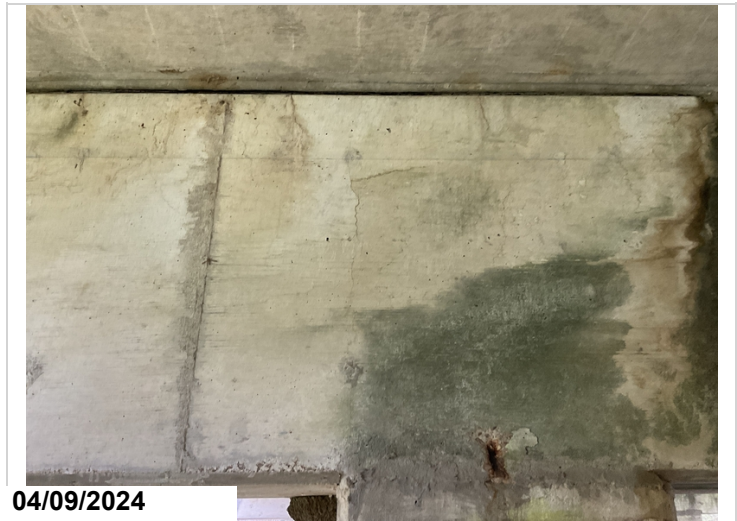
Bent 1, Back, adjacent to Column 1: vertical cracking. CS2.

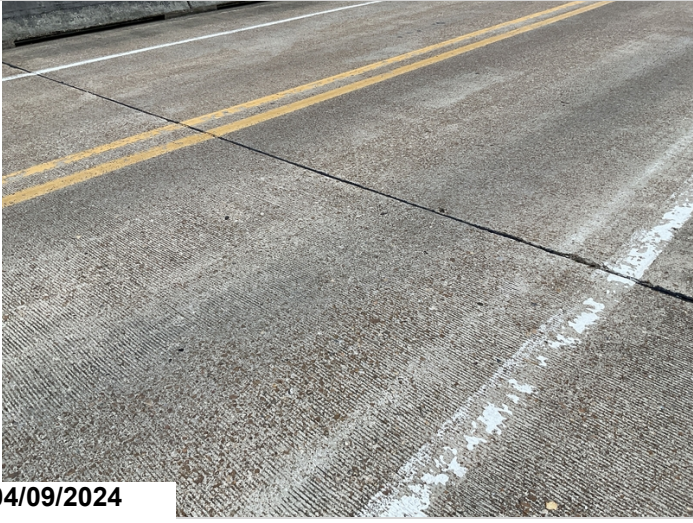
Spans 1 - 4: minor abrasion throughout structure. CS2.

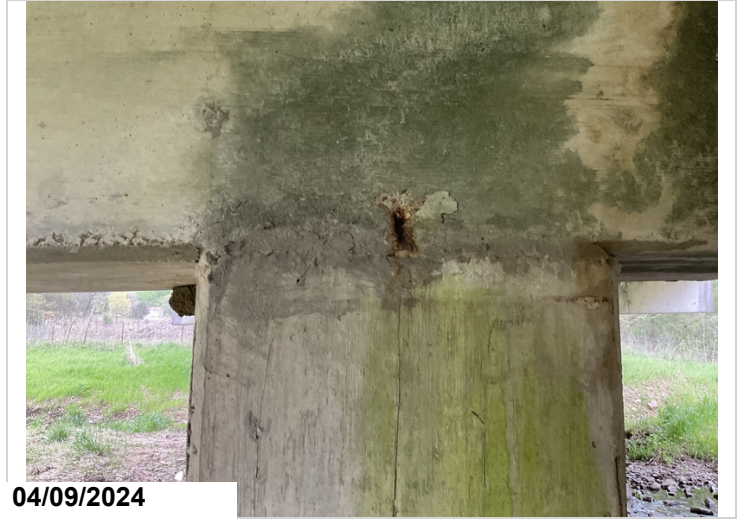
Bent 1, Back, adjacent to Column 1: exposed reinforcing steel with section loss. CS3.

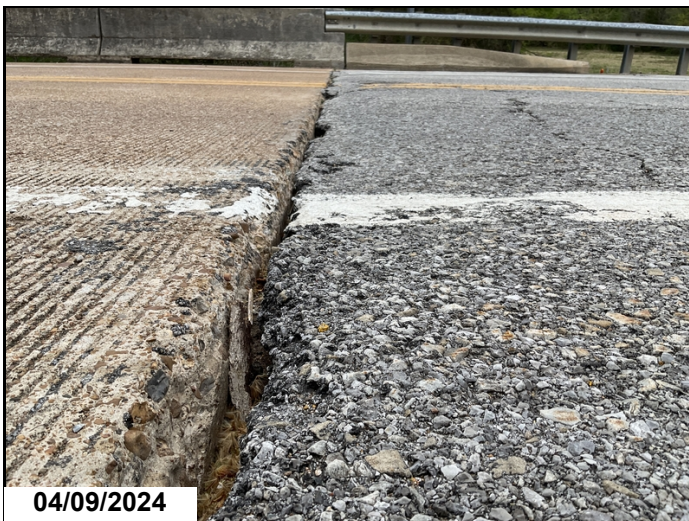
Approaches have settled at Abutments 1 and 2.

Abutment 2, Approach roadway: settlement.

Type of Work: Approach Leveling/Maintenance

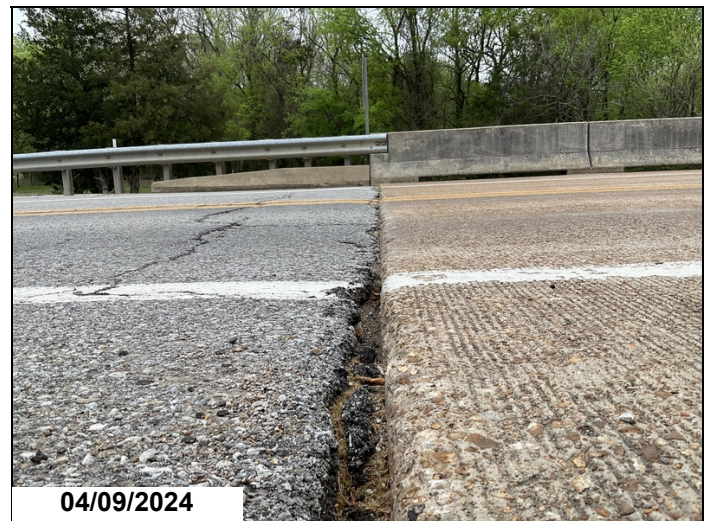
Abutment 1, Approach roadway: settlement.

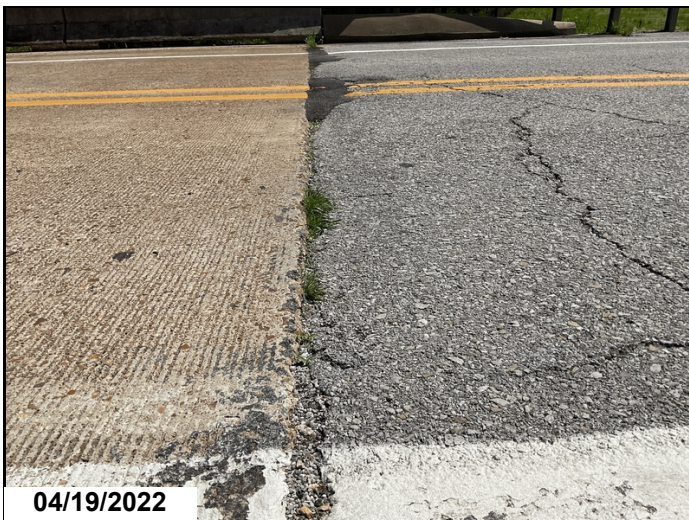
Approach roadwaysApproaches have settled at  
Abutments 1 and 2.Abutment 2.

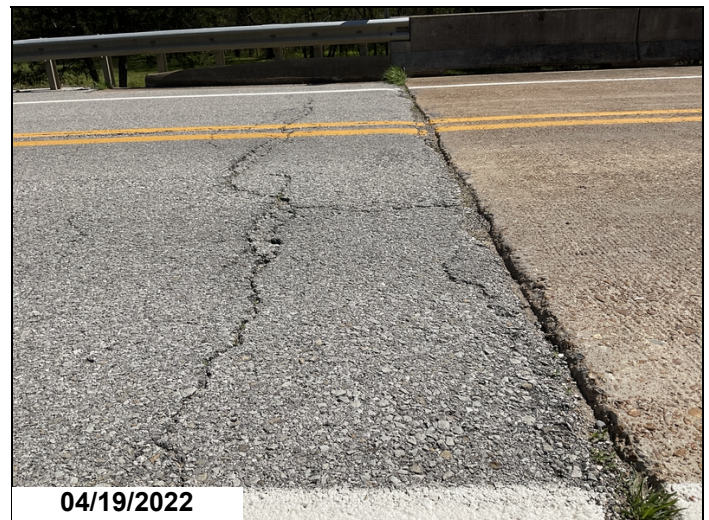
Approach roadwaysApproaches have settled at  
Abutments 1 and 2.Abutment 1.

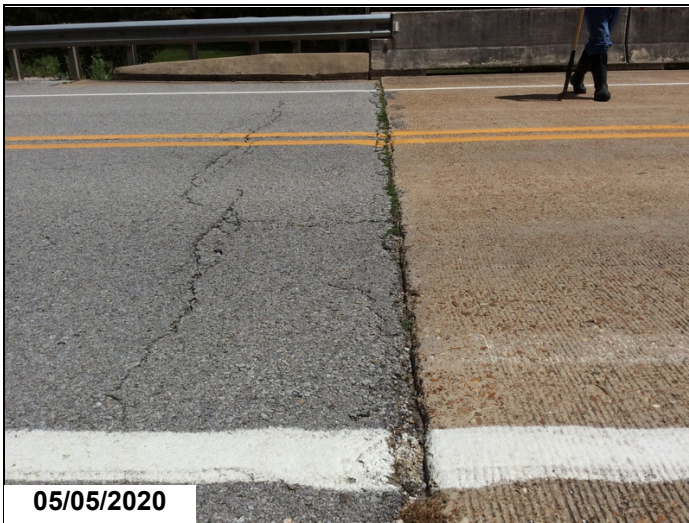
Approach roadway settlement @ Abutment 1.

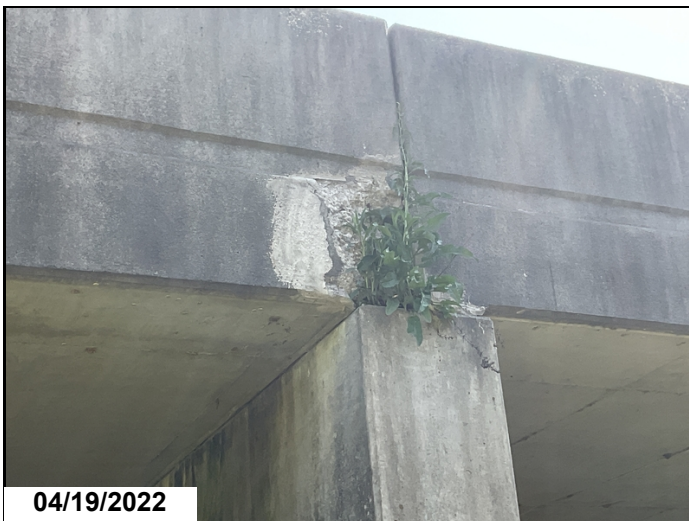
04/19/2022

Spalls with rebar exposed to outside edges of deck over caps.

Bents 1 - 3 Spalls with rebar exposed to outside edges of deck over caps.

**Type of Work:** Superstructure Repair

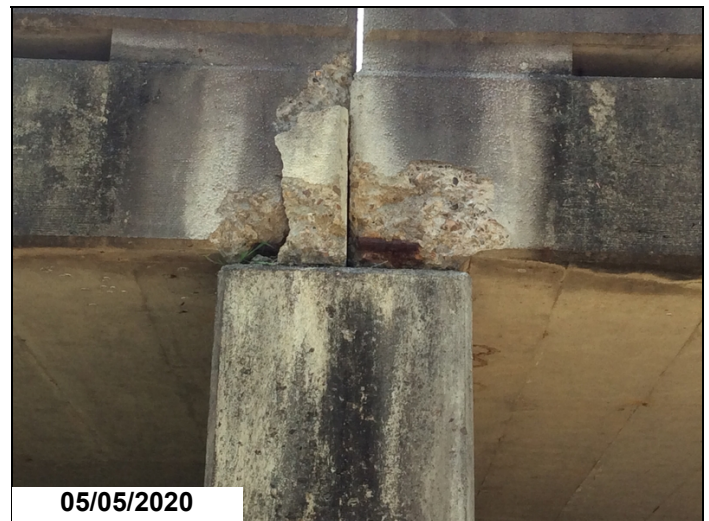
05/05/2020

Bent 2 Left.

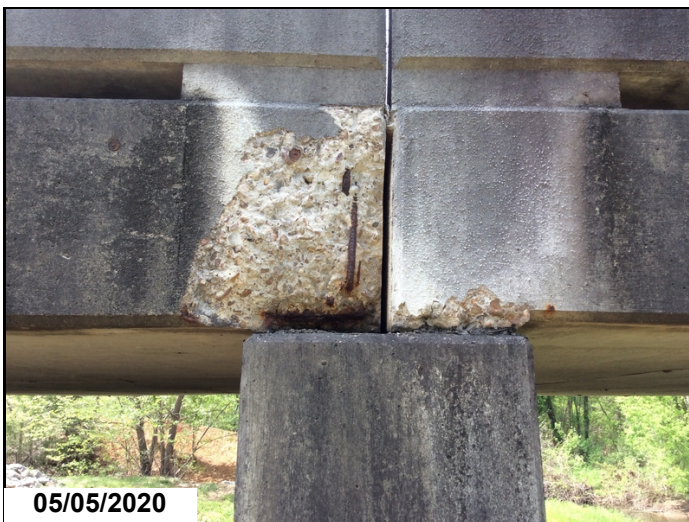
05/05/2020

Bent 3 Left.
