Asset #06004(Routine, Underwater type 2)

SH 14/Stone County over WOLF BAYOU

Location: .18 MI W INDEP CO LINE

Team Lead: Floyd Haley Inspection Date: 04/09/2024

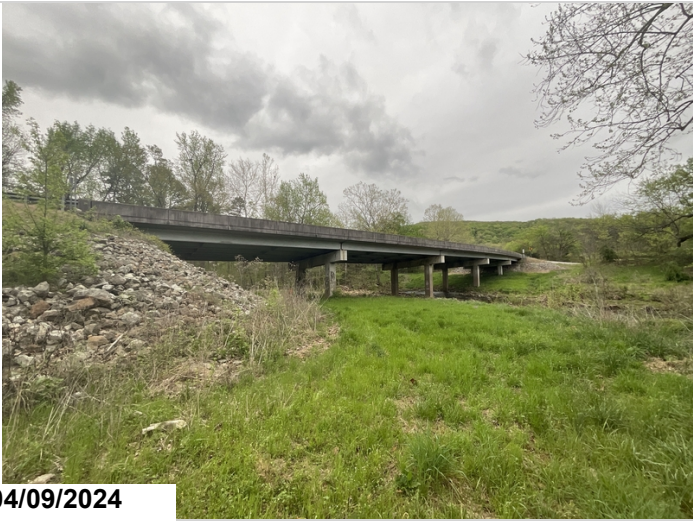
Elevation.

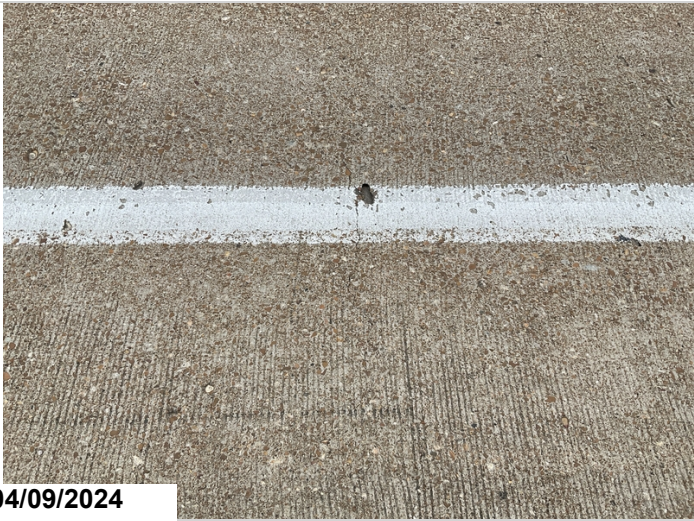
Span 4: transverse cracking. CS3.

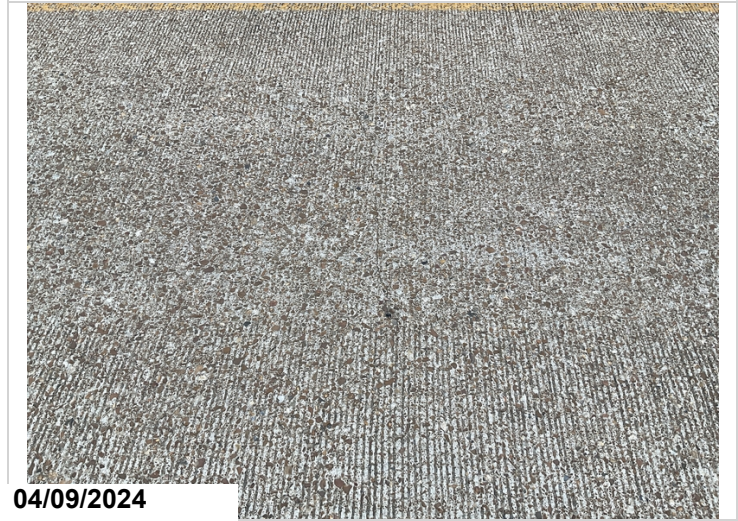
Span 2: transverse cracking. CS2.

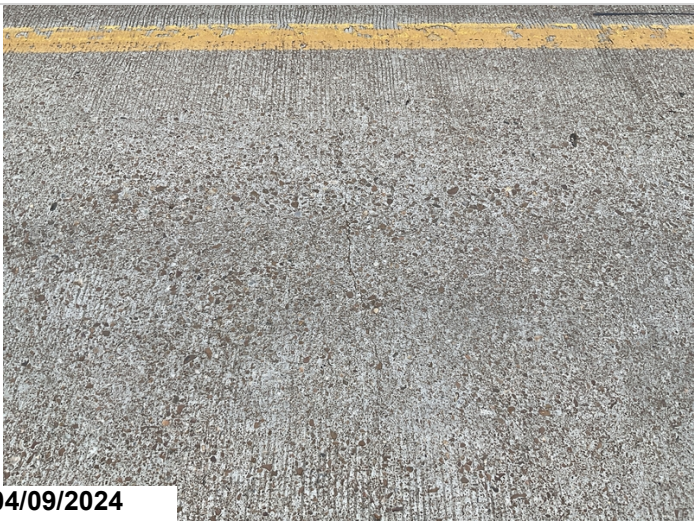
Span 1: Transverse cracking. CS3.

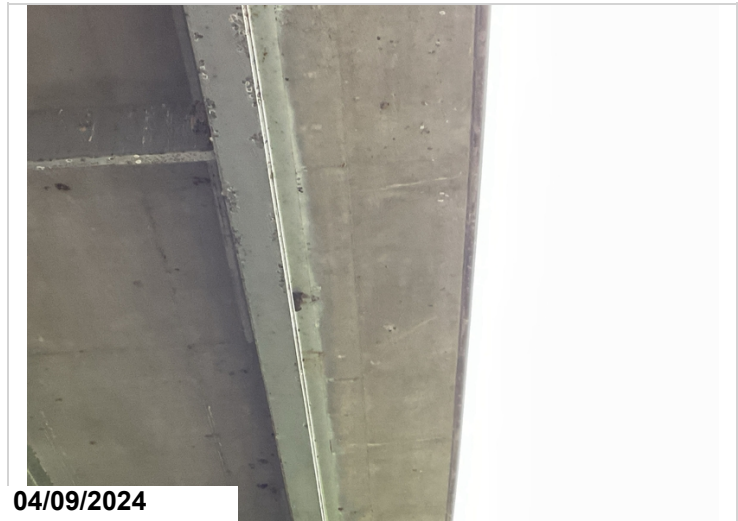
Span 3, Right overhang: cracking with efflorescence. CS2.

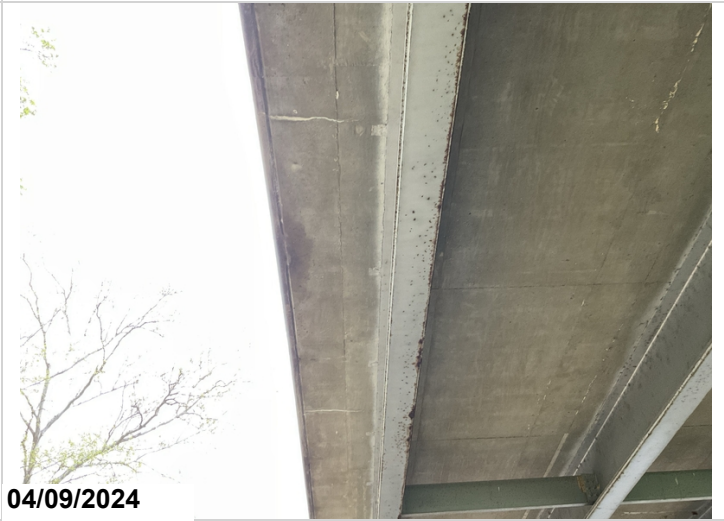
Span 2, Left overhang: cracking with efflorescence. CS2.

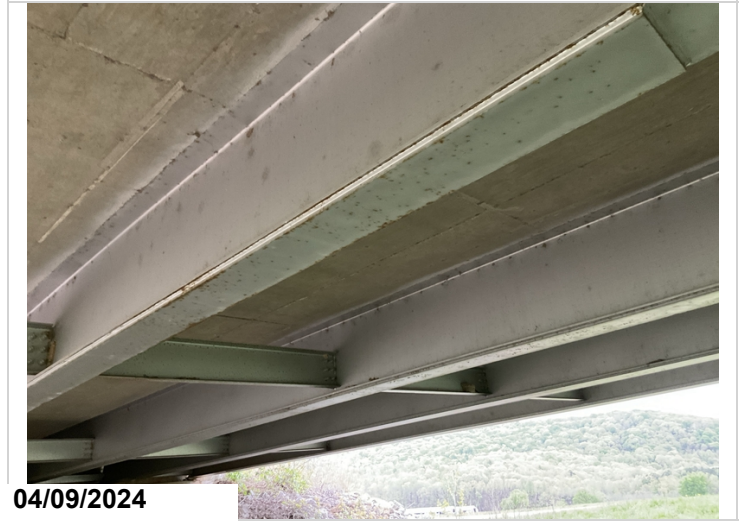
(107) Girders: Light rust to bottom flange of all girders. Rust with minor section loss to web below haunch at ends of girders and to bottom flange of few girders throughout.							
205	Reinforced Concrete Column	EA	8	6	2	0	0
1190	Abrasion/Wear (PSC/RC)	EA	2	0	2	0	0

Spans 1 - 5, Girders: scattered areas of surface corrosion. CS2.

**A-60 - Full Beam Painting Needed (Yes)**

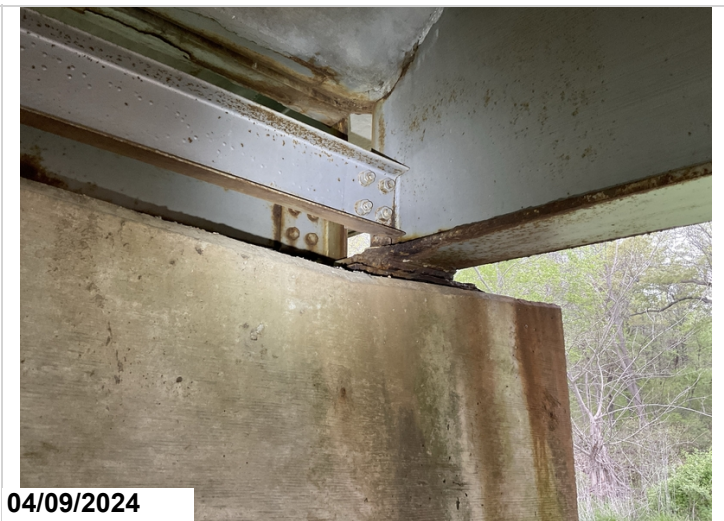
Span 5, Bent 4, Girders 1 & 2: active corrosion with flaking rust. CS3.

**A-57 - Beam End and Bearing Painting Needed (Yes)**

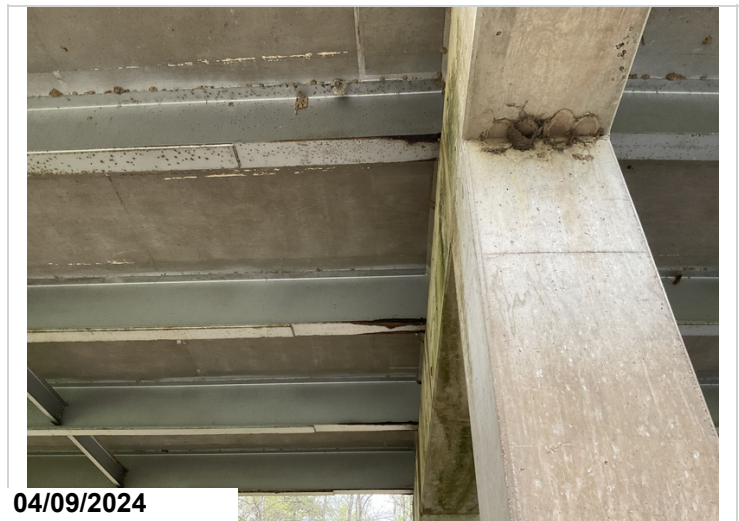
Span 2, Girders 2 - 4, Bent 2: active corrosion with flaking rust. CS3.

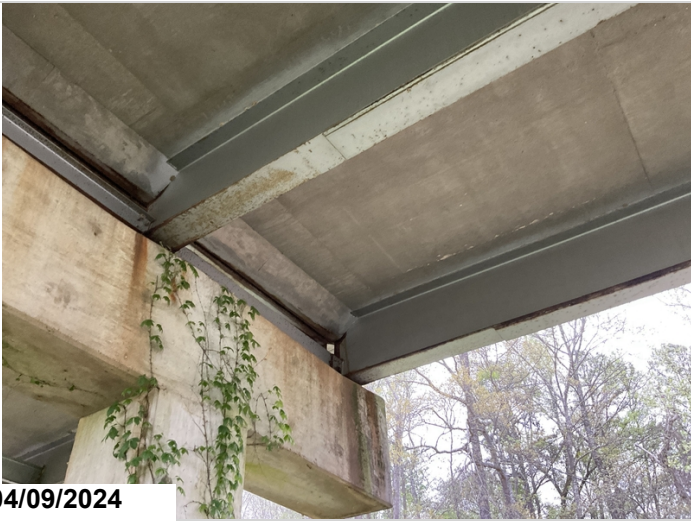
Span 2, Girders 1 - 4, Bent 1: active corrosion with flaking rust near girder ends. Girder 1: flaking rust along bottom flange to first diaphragm. CS3

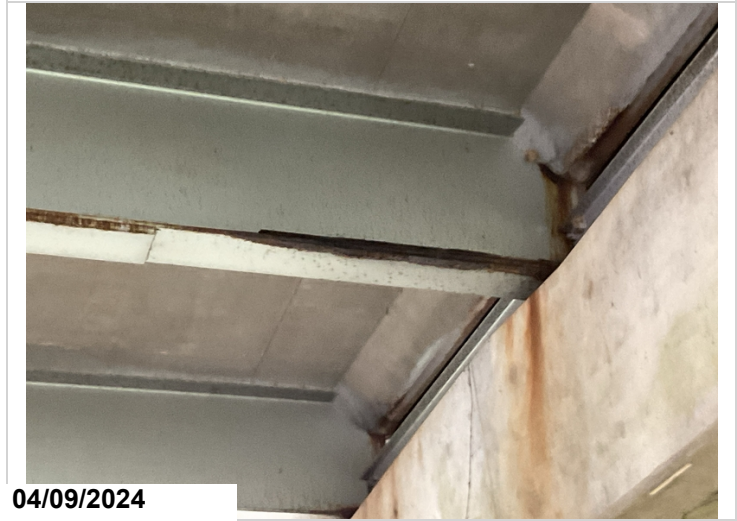
Span 1, Girder 2, Bent 1: active corrosion with flaking rust. CS3.

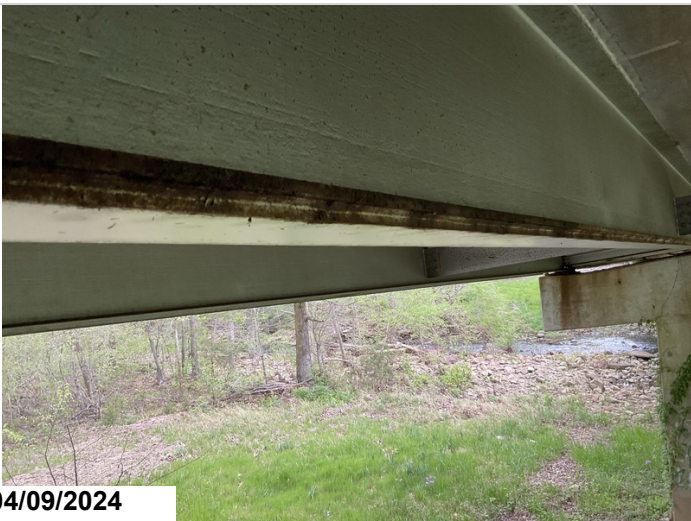
Span 1, Girder 2: active corrosion with flaking rust. CS3. 10'.

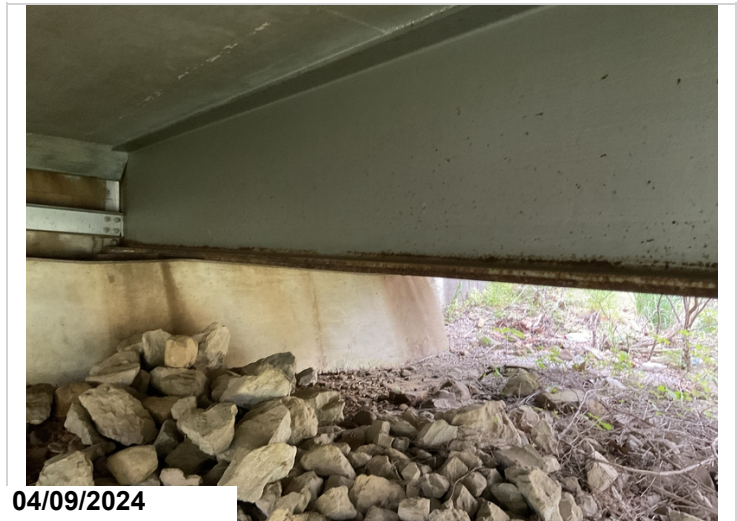
Span 1, Girder 2: surface corrosion. CS2.

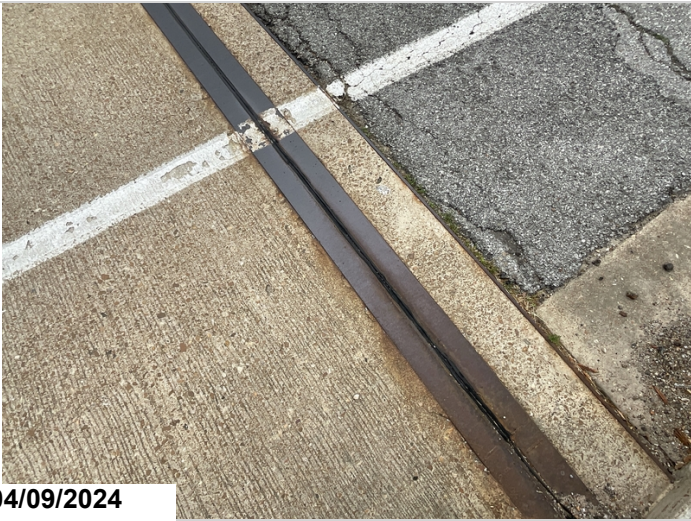
Joint at Abutment 1: seal cracking.

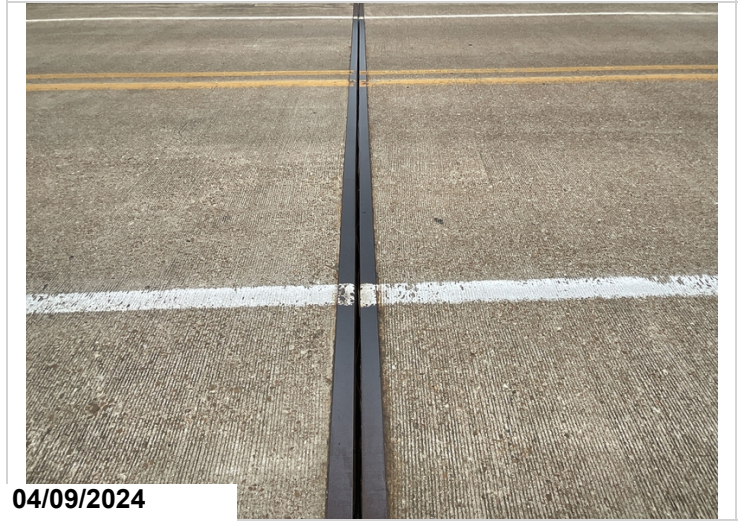
(302) Bent 2 - 25' of Compression joint seal has dropped out and is no longer functioning. Bent 4 - 6' of Joint seal has adhesion failure. Joint seals are cracked at various locations throughout.

Joint at Bent 2: adhesion failure. CS3. Joint at Bent 4: adhesion failure. CS2.

**A-59 - Joint Repair Needed (Yes)**

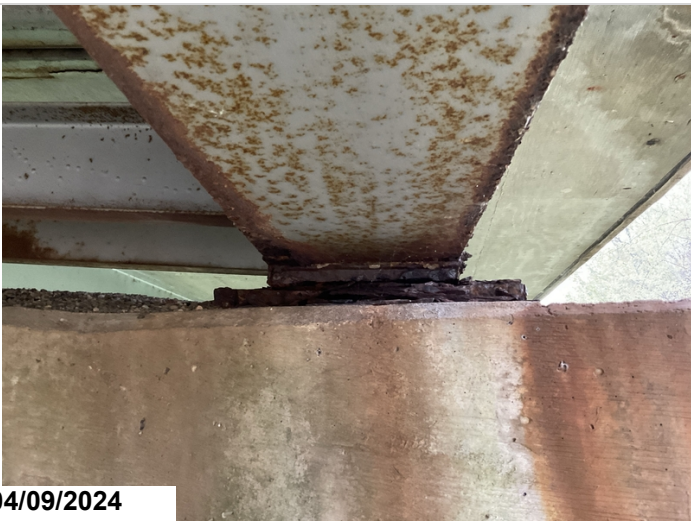
Span 5, Bent 4, Bearings 1 - 4: active corrosion with pack rust. CS3.

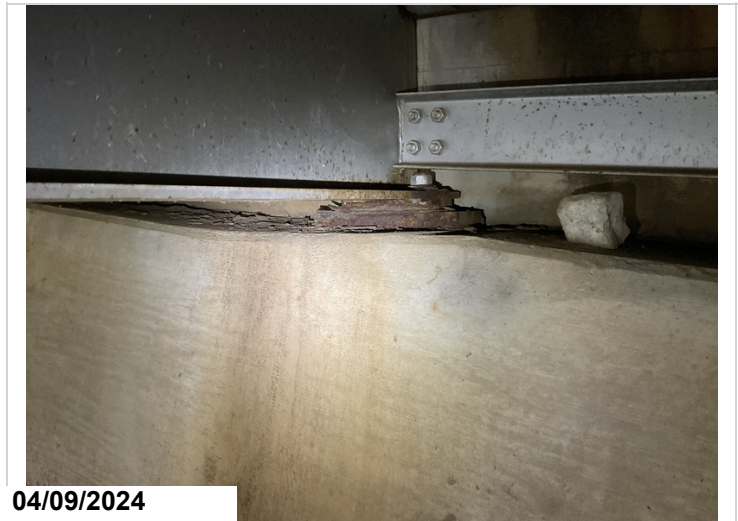
Span 1, Abutment 1, Bearing 3: active corrosion with pack rust. CS3.

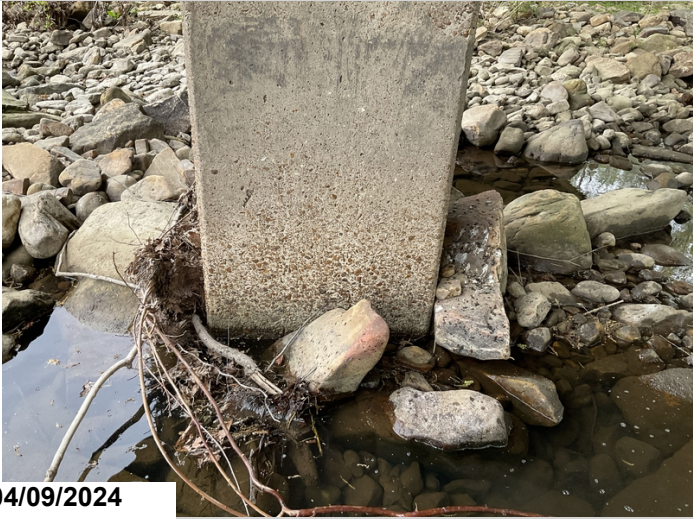
(205) Bent 2 Columns 1 & 2: Minor abrasion.							
215	Reinforced Concrete Abutment	LF	88	82	6	0	0
1120	Efflorescence/Rust Staining	LF	2	0	2	0	0
1130	Cracking (RC and Other)	LF	4	0	4	0	0

Bent 2, Columns 1 & 2: minor abrasion. CS2.

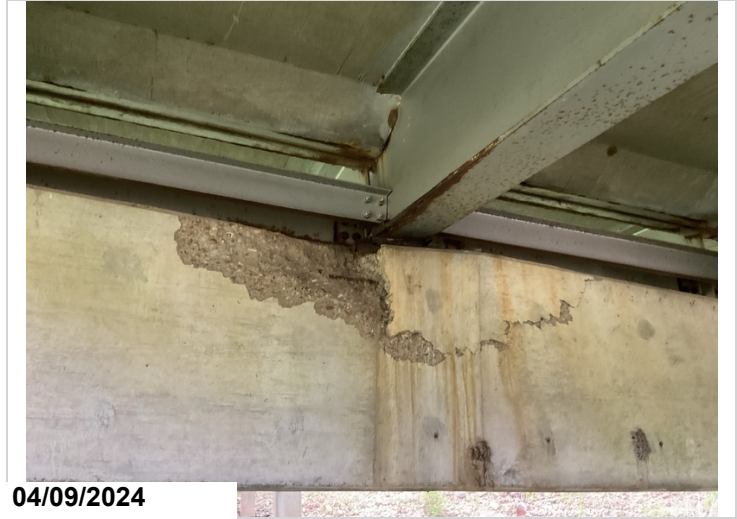
(234) Few minor vertical cracks to caps. Bent 4: 1 rusty crack to cap on Left end. CS3 1' reinforcing steel exposed to ahead side. CS2 2' spall to ahead side. CS3 4' delaminated area to ahead side. CS2							
302	Compression Joint Seal	LF	218	142	15	36	25
2320	Seal Adhesion	LF	31	0	0	6	25
2340	Seal Cracking	LF	45	0	15	30	0

Bent 4, Ahead, adjacent to Girder 3: spalling with exposed reinforcing steel with no section loss and delaminated.

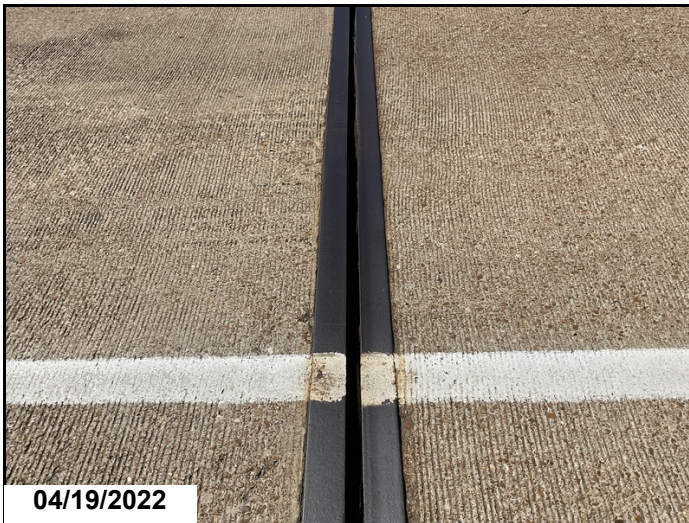
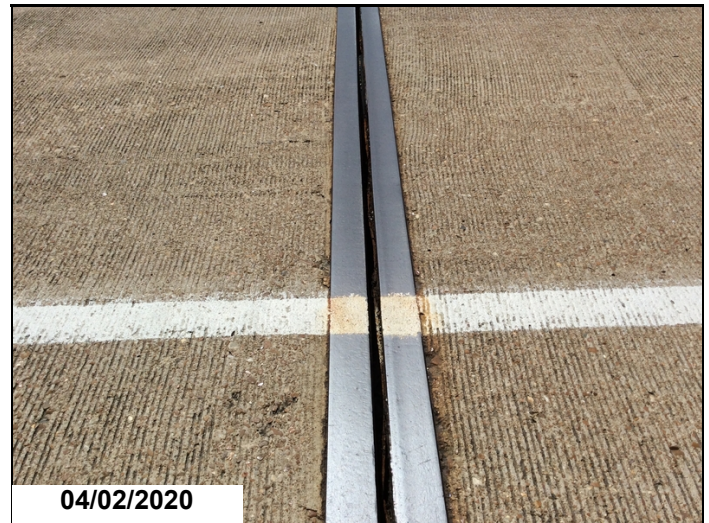
25' of Compression joint seal @ Bent 2 has dropped out and is no longer functioning.

**Type of Work:** Joint Repair

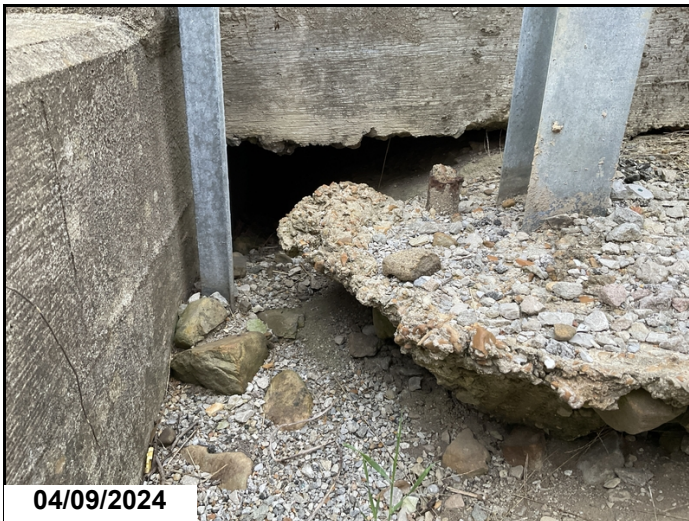
Abutment 1, Left, Approach Gutter: 3' undermining.

**Type of Work:** Approach Leveling/Maintenance

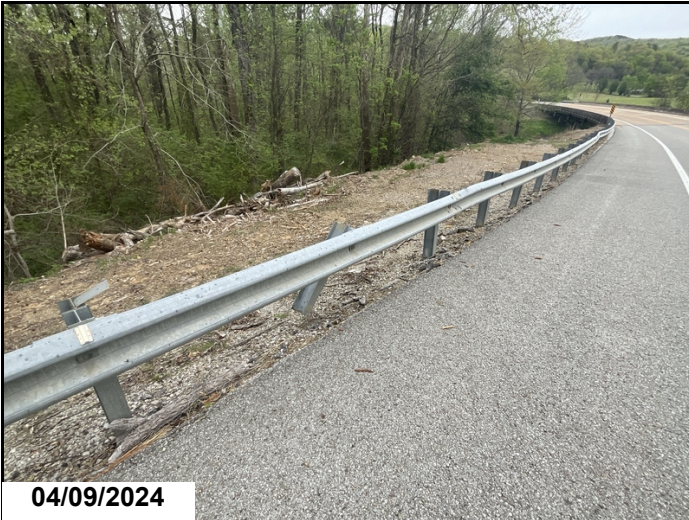
Abutment 1, Left Approach Railing, 5th post from beginning of railing: broken.
