**Asset #03318**(Routine, Underwater type 2)

**SH 31 White County over BULL CREEK**

**Location: 0.1 MI N JCT US 67 & 31**

**Team Lead: Nathan Edwards, Inspection Date: 06/09/2022**

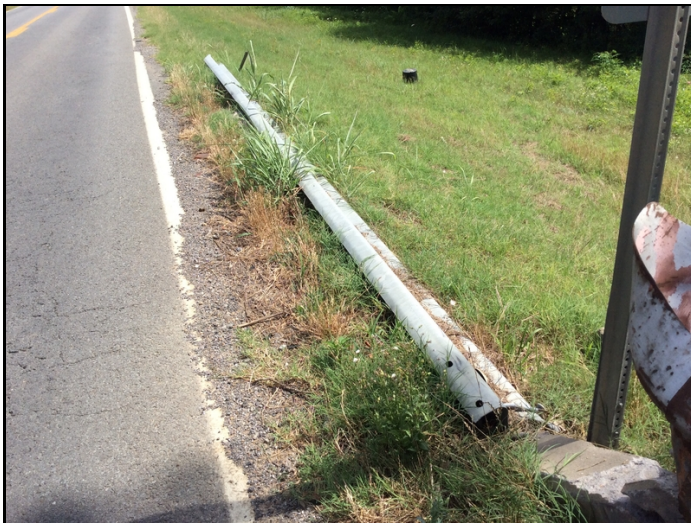
Right Approach Rail @ Abutment 2 has severe collision damage & is not functioning.

Rail has been repaired.

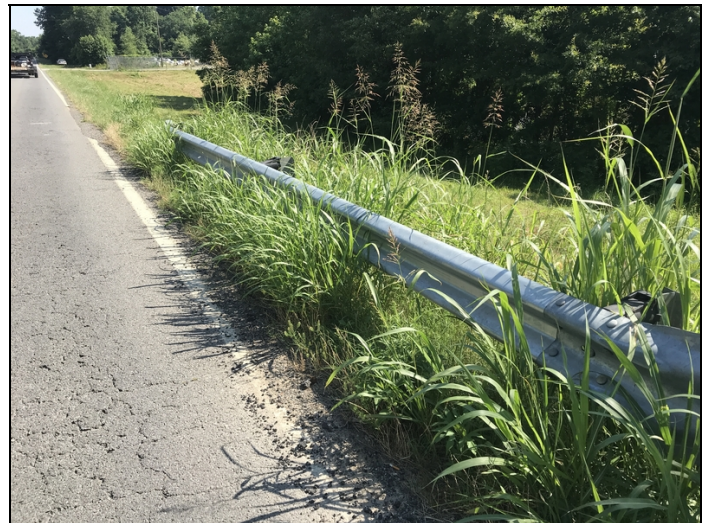
Right Approach Rail @ Abutment 2 has severe collision damage & is not functioning.  
Repaired.(Remove)

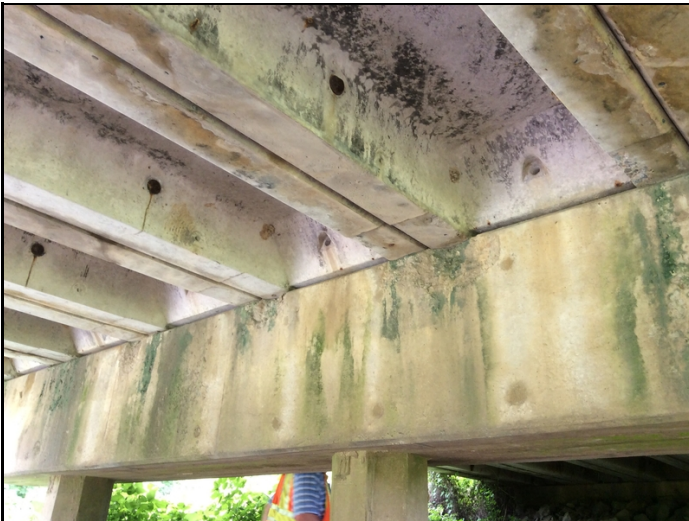
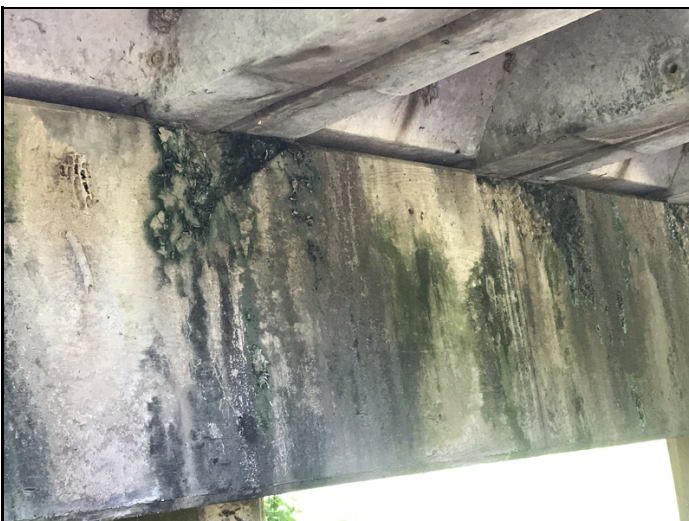
(234) Bent 2 - Spall to cap under Units 2, 4, 5, 6 & 7 with no rebar exposed. Bent 4 - Spall to cap under Unit 5.

Spalls to cap at Bents 2 & 4.

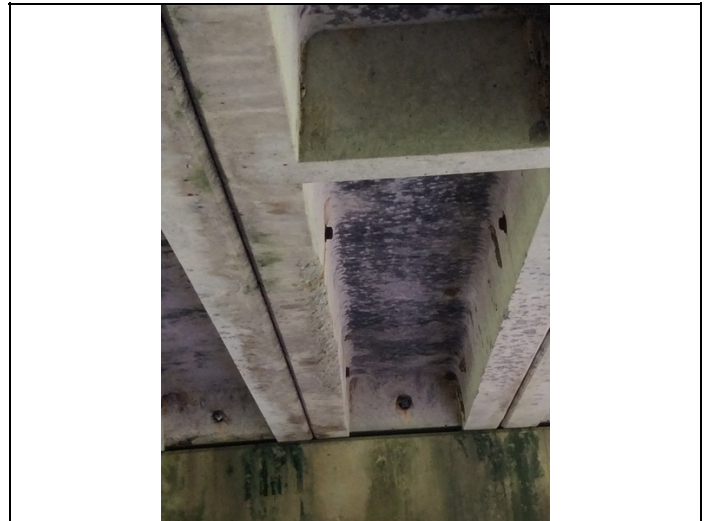
Spalls to Units 1 & 3 at Span 4. No rebar exposed.

Spalls to Units 1 & 3 at Span 4.  
No rebar exposed.

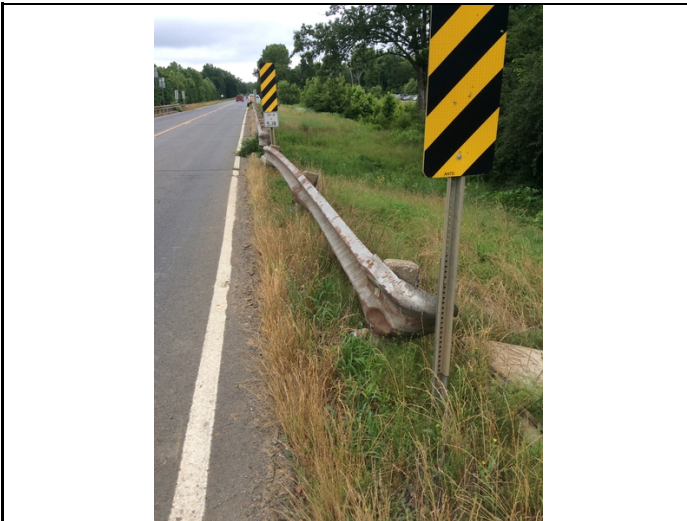
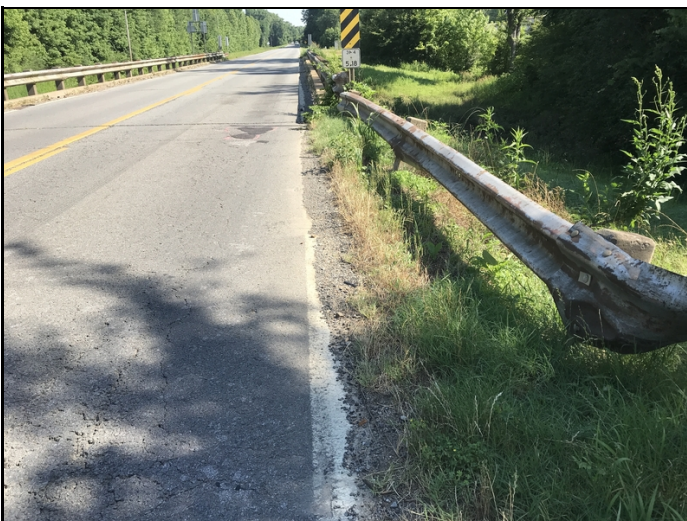
Collision damage to right rail & post at Abutment 1

Collision damage to right rail & post at Abutment 1.

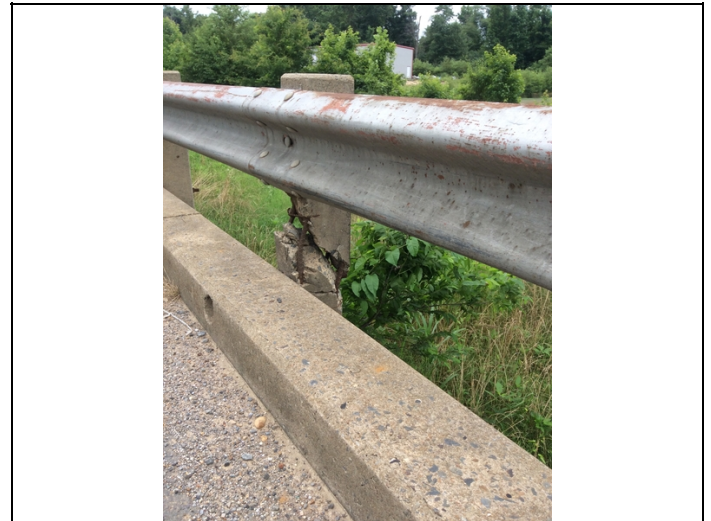
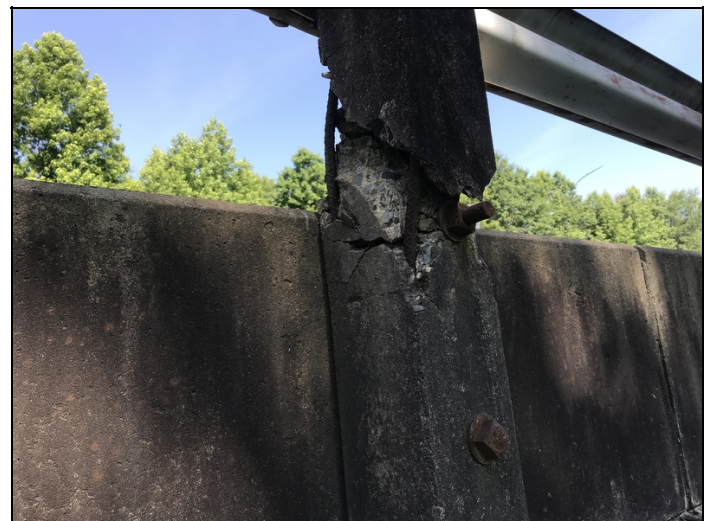
Collision damage to right rail and 5th post at Span 4.

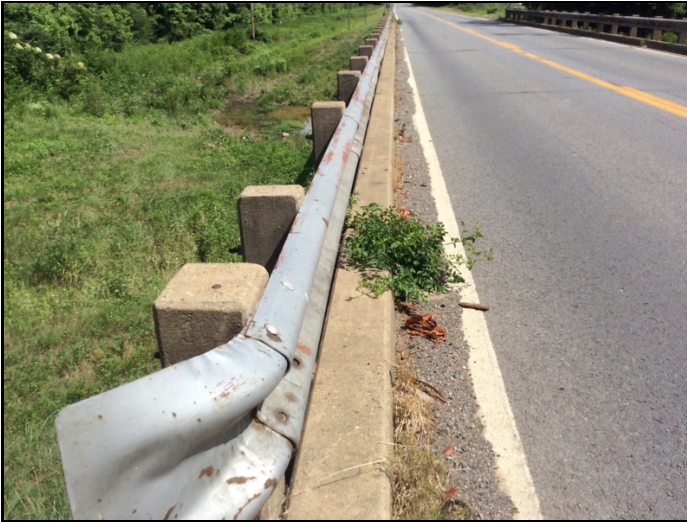
Debris in Left gutterline.

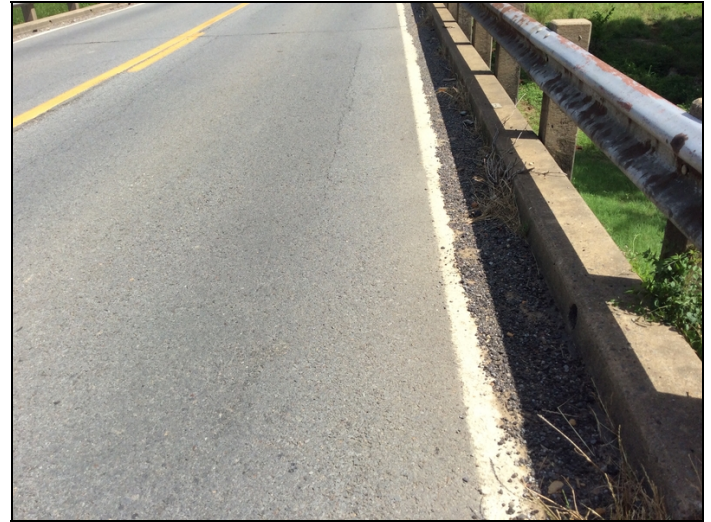
Debris in Right gutterline.
