Asset #03319(Routine, Underwater type 2)

SH 31 White County over BULL CREEK

Location: 0.3 MI N JCT US 67 & 31

Team Lead: Nathan Edwards, Inspection Date: 06/09/2022

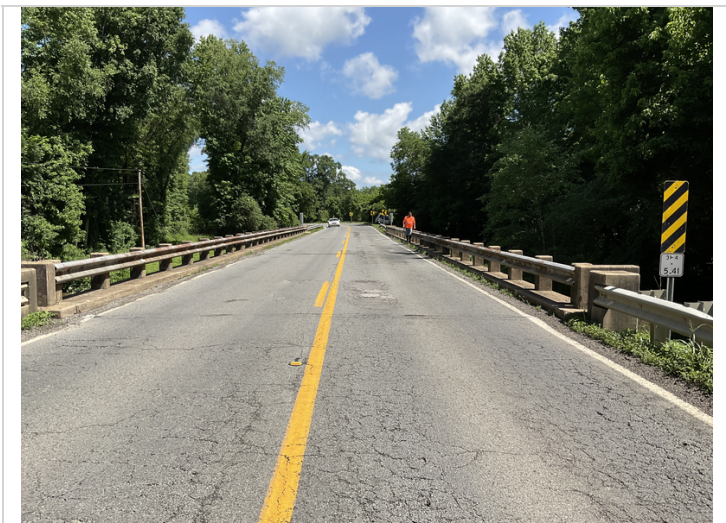
Roadway with Log Mile running South to North.

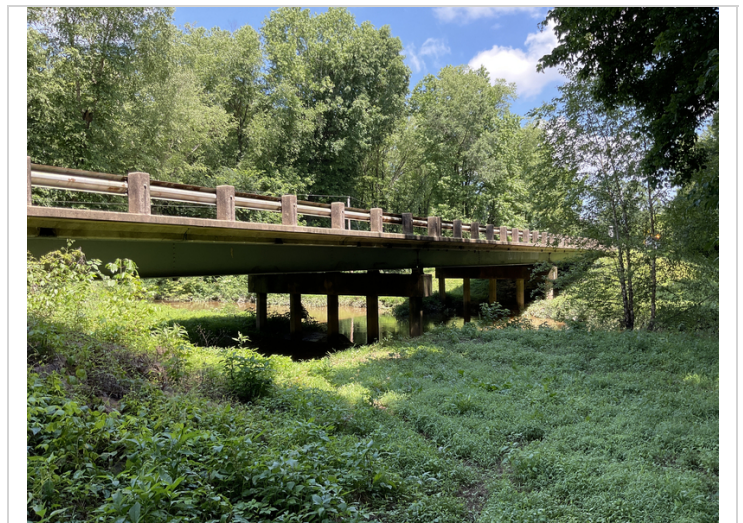
Elevation with Log Mile running to the Right.

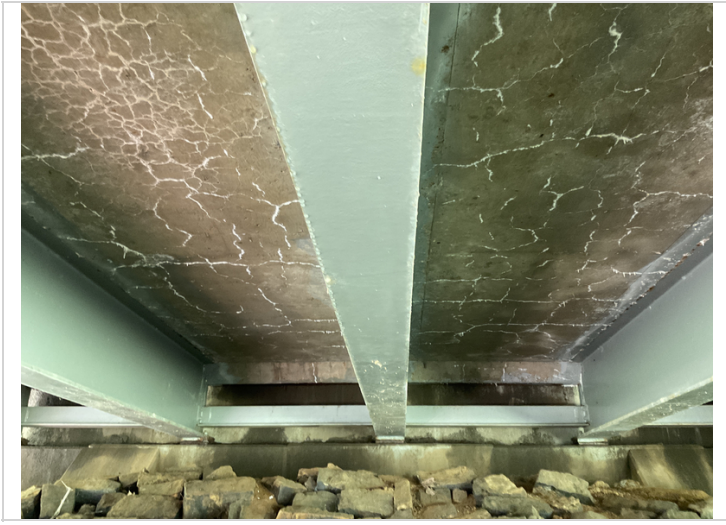
Efflorescent map cracking to soffit @ Span 1.(#3)

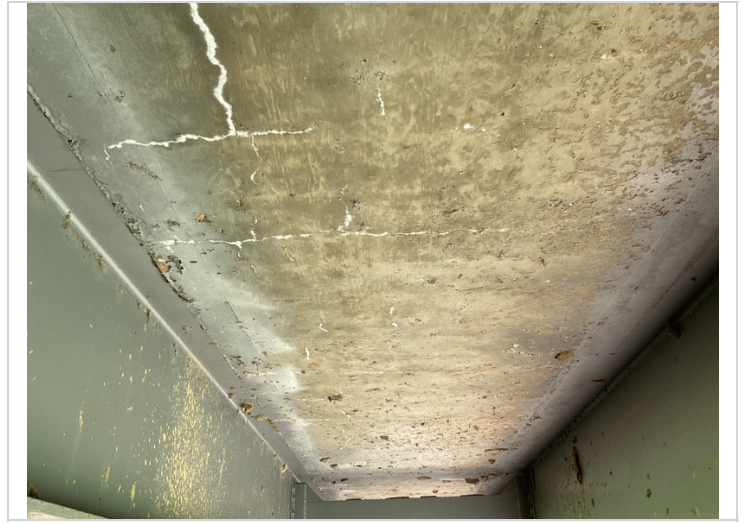
Efflorescent cracking to soffit @ Span 1.(#2 typical)

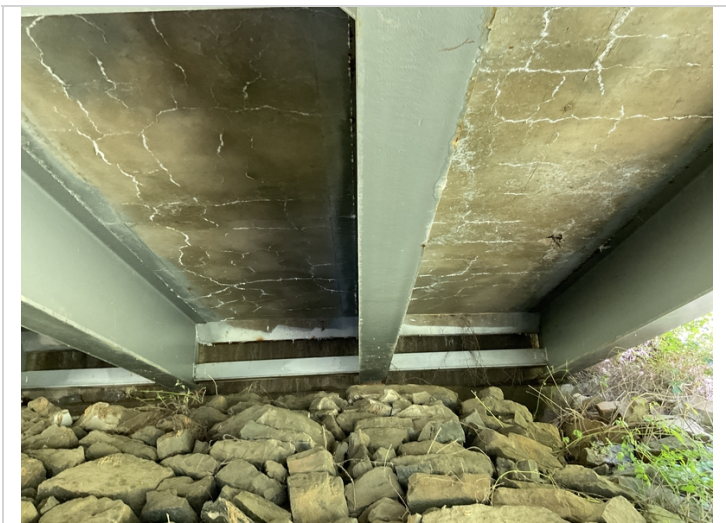
Efflorescent map cracking to soffit @ Span 3.(#3)

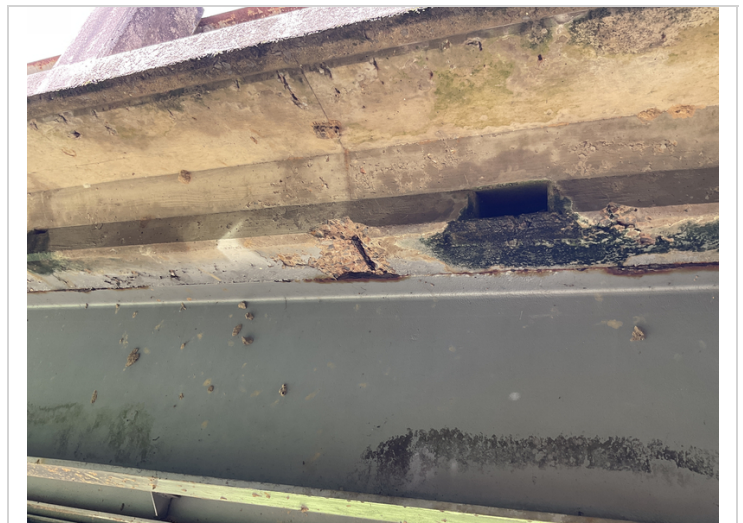
Spall with rebar exposed with s/l to Right overhang @ Span 1.

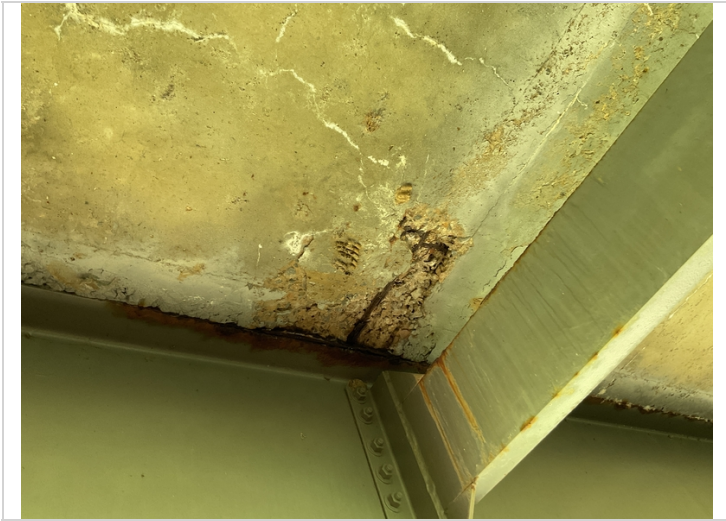
Spall with rebar exposed with s/l to soffit @ Span 3.(#3)

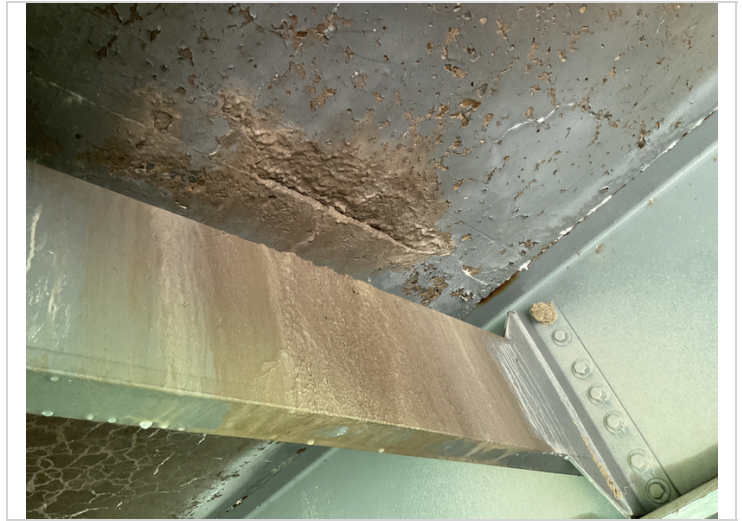
Spall to soffit between Girders 3 & 4 @ Span 1.(#3)

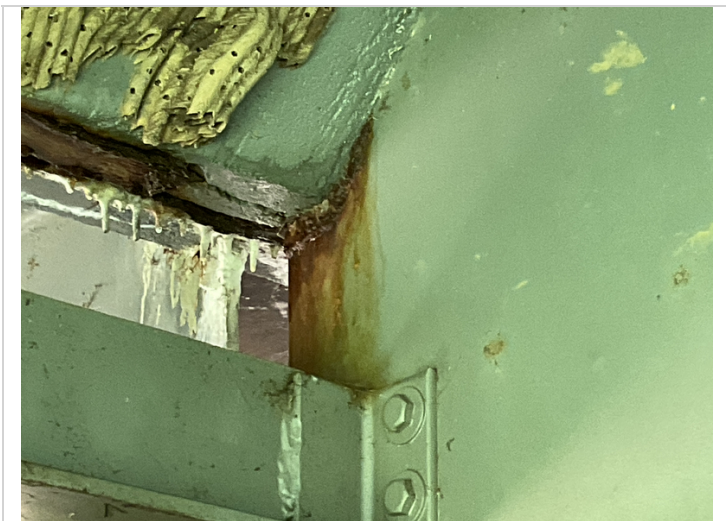
Rust with s/l to web below haunch @ Girder 2 @ end of Span 1.(#3 typical)

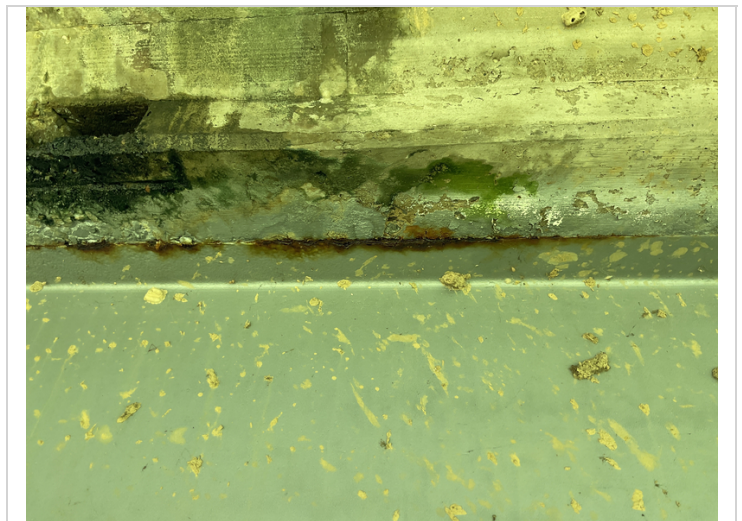
Pack rust between top flange & deck @ Girder 1 @ Span 1.  
(#3)

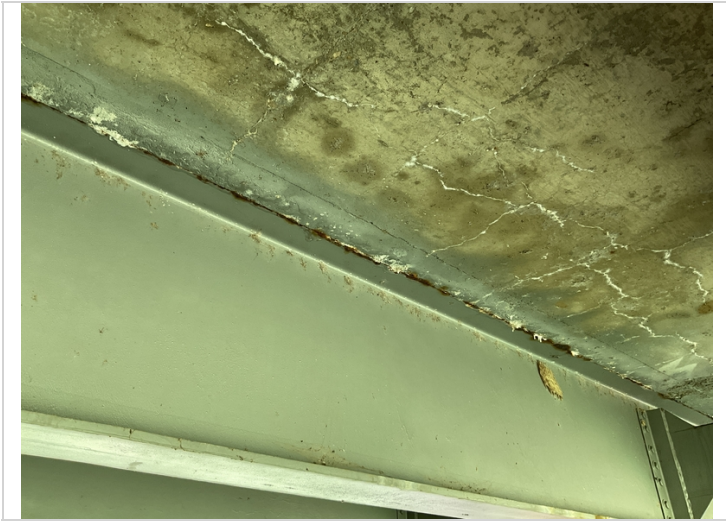
Typical rust to top flange @ all spans.(#2)

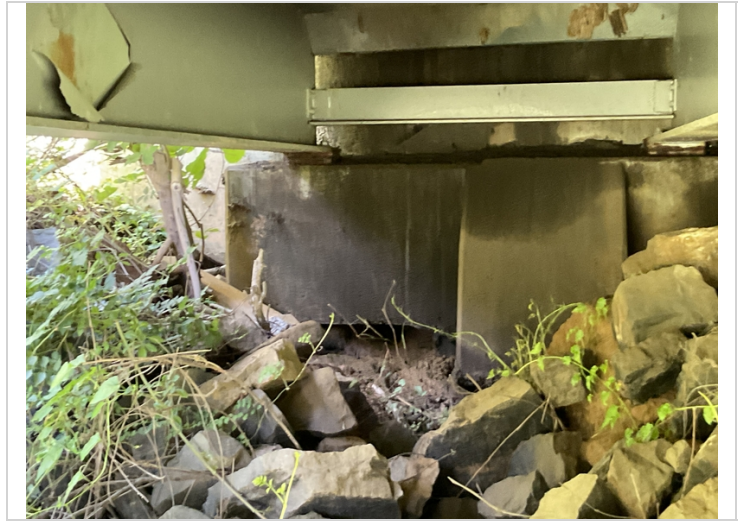
(215) Scour 1' below & back under Left end of Abutment 2. Scour to Right end of Abutment 2.							
227	Reinforced Concrete Pile	EA	10	0	10	0	0
6000	Scour	EA	10	0	10	0	0

Scour 1' below & back under Left end of Abutment 2.(#3)

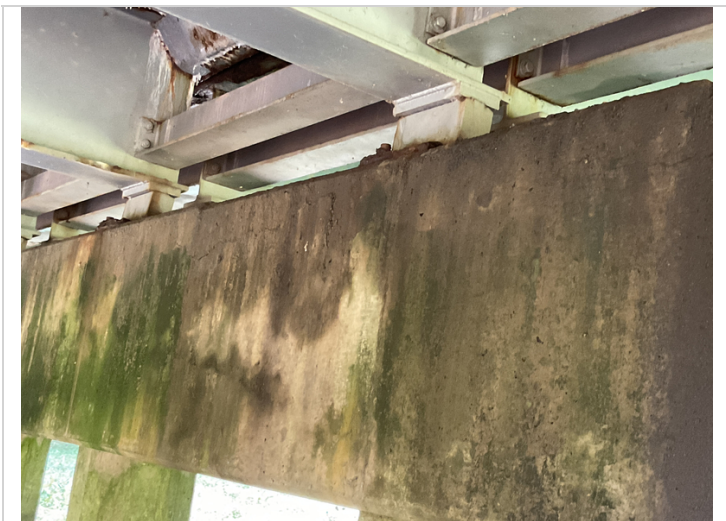
ELEMENTS	DESCRIPTION	UNITS	TOTAL	CS1	CS2	CS3	CS4
(234) Bent 1 - Horizontal crack between Girders 1-3 on ahead side. Bent 2 - Minor cracking over Pile 3.							
305	Assembly Joint without Seal	LF	97	0	0	97	0
2350	Debris Impaction	LF	97	0	0	97	0

Horizontal cracking to ahead side of cap @ Bent 1.

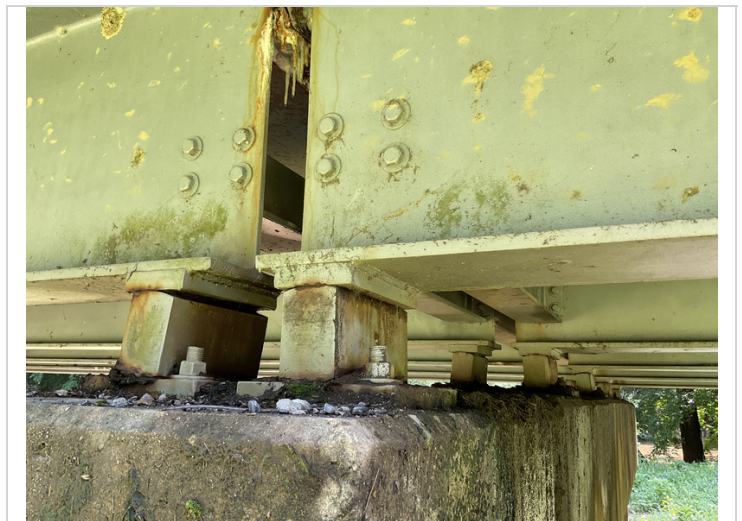
Rust @ pack rust to Moveable Bearings @ Bent 1.(#3 typical)

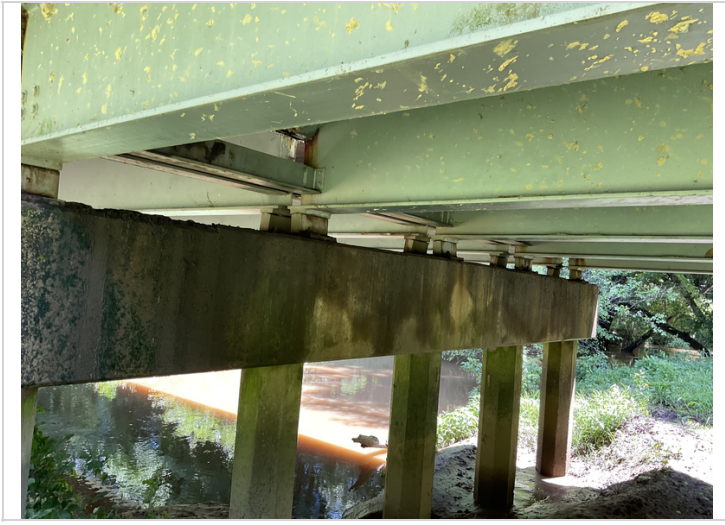
(311) Bearings rusting at Bent 2 & 3. Moveable Bearings @ beginning of Span 2 are rotated back.							
313	Fixed Bearing	EA	15	3	4	8	0
1000	Corrosion	EA	12	0	4	8	0
515	Steel Protective Coating	SF	45	45	0	0	0

Moveable Bearings @ beginning of Span 2 are rotated back.

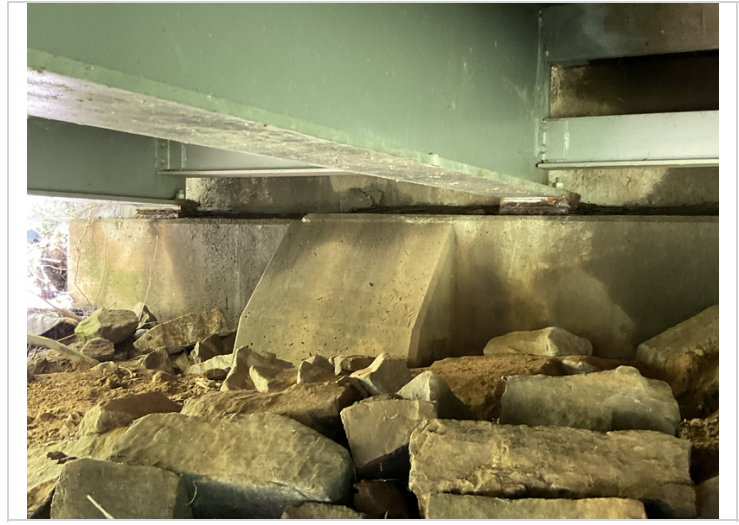
Rust with pack rust to Fixed Bearings @ Abutment 1.(#3)

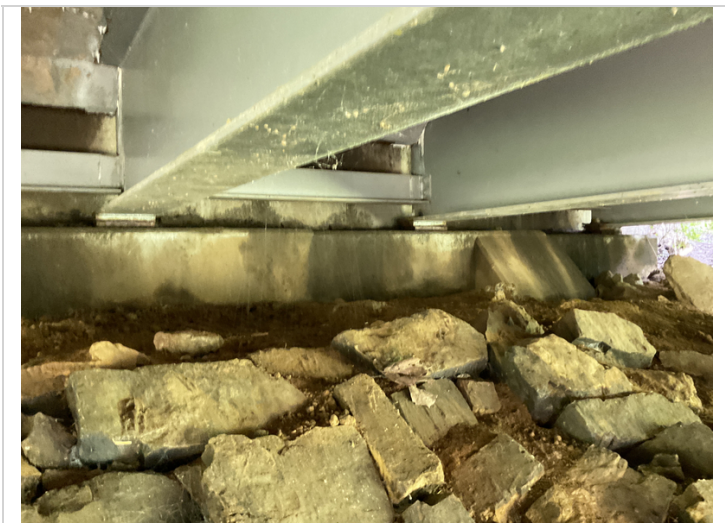
Rust to Fixed Bearings @ Abutment 1.(#2)

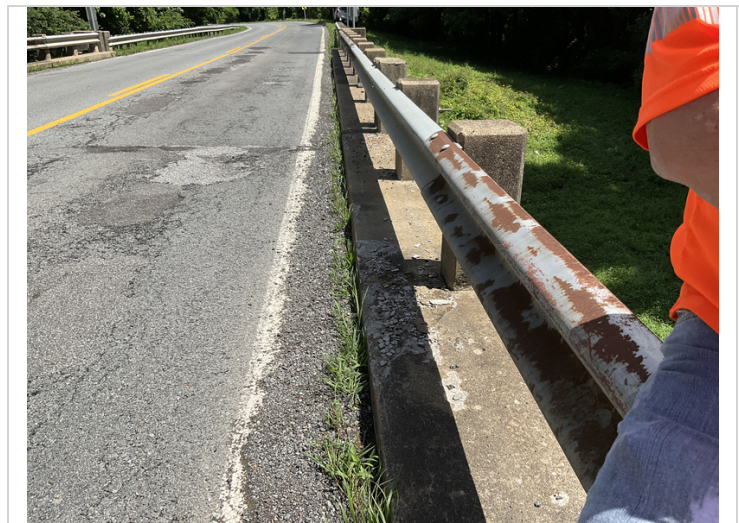
Deterioration & spalling to Right curb Spans 2 & 3.

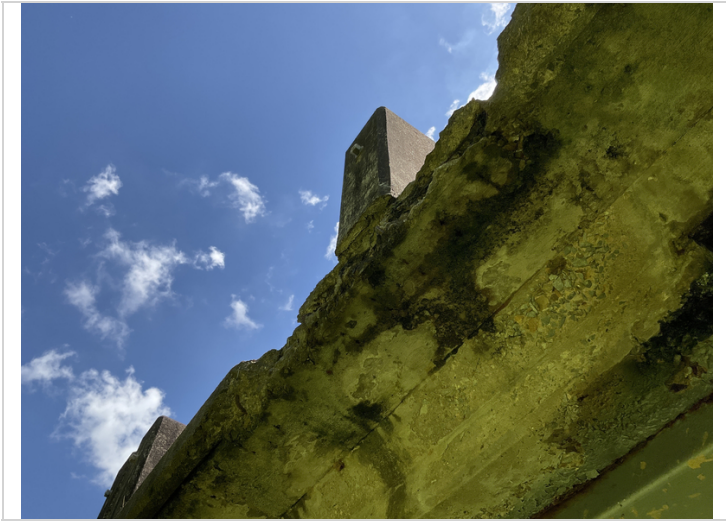
Damage to Left outside edge of curb @ Span 1.

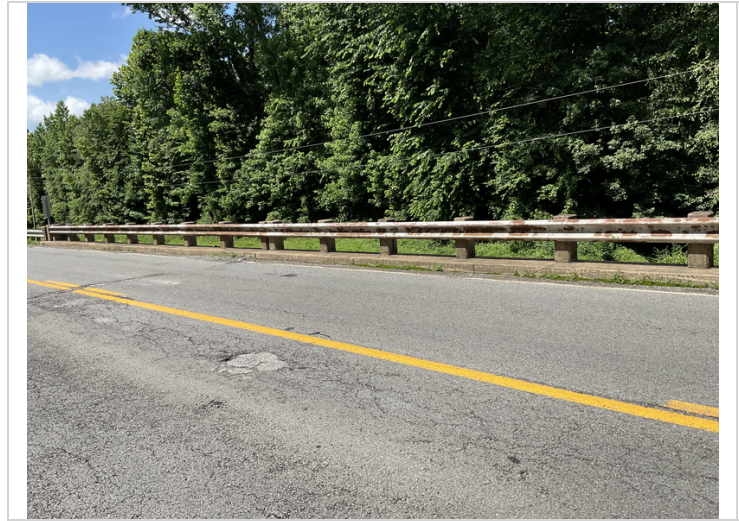
Typical rust to rails.

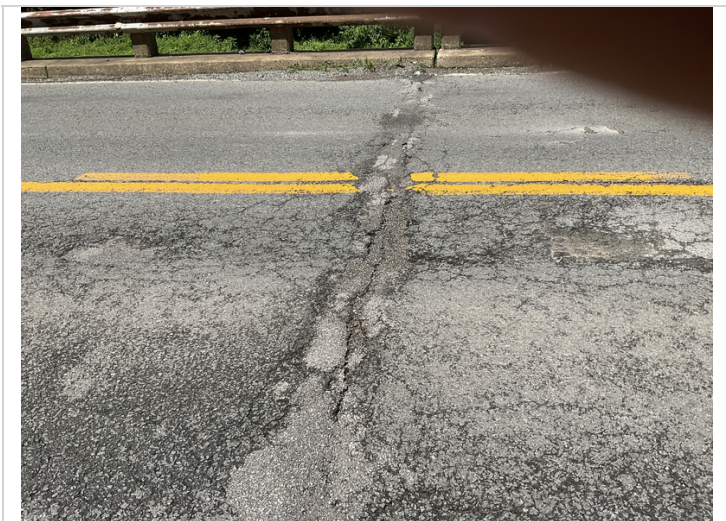
Debris impactation to joints.(#3)

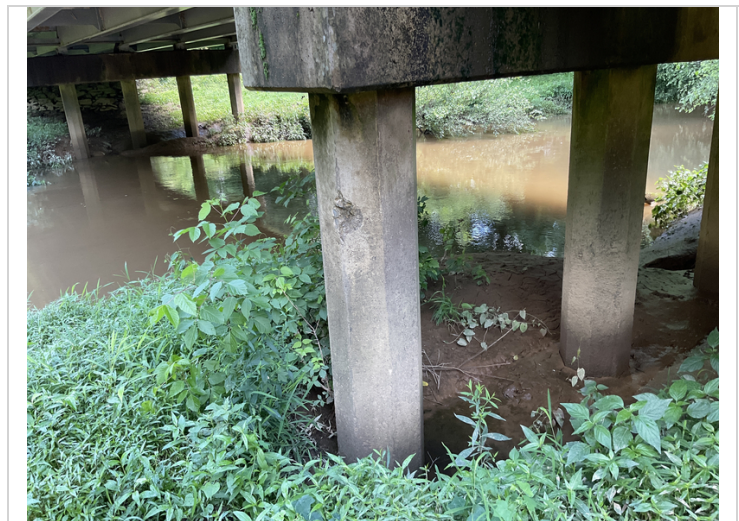
(227) Minor erosion at Bents 1 & 2.							
234	Reinforced Concrete Pier Cap	LF	51	40	3	8	0
1130	Cracking (RC and Other)	LF	11	0	3	8	0

Scour to piles @ Bents 1 & 2.(#2)

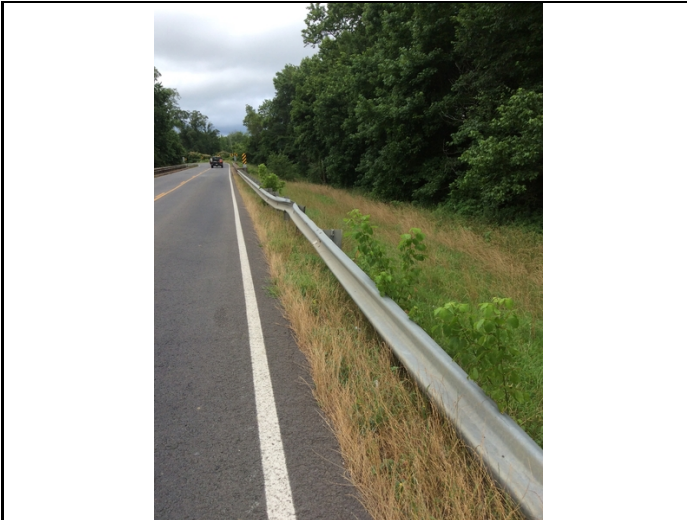
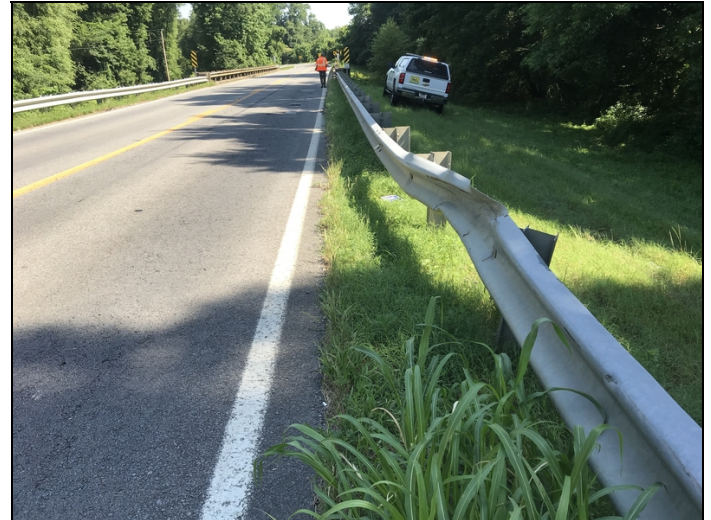
Approach guard rail damage on Right at Abutment 1.

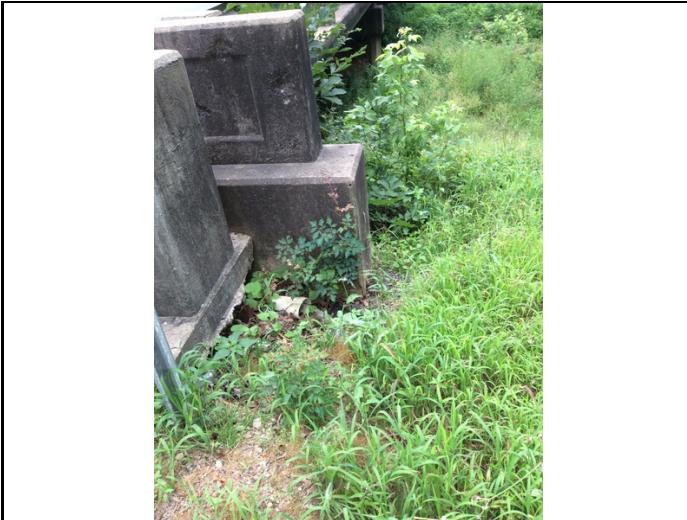
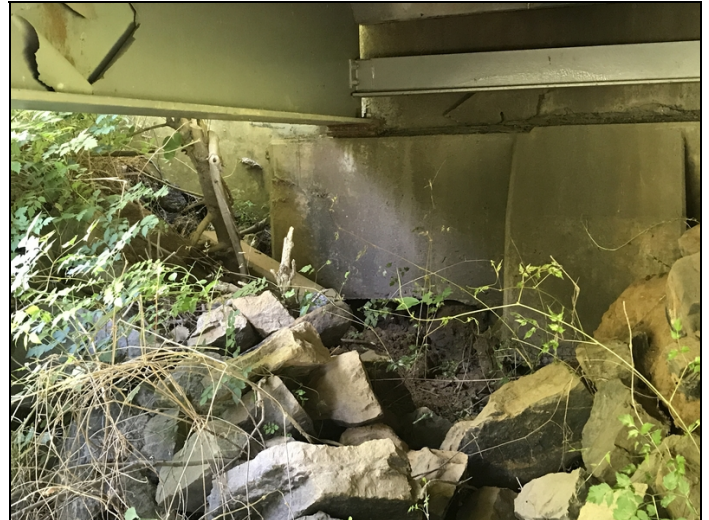
Embankment has settled to left end of Abutment 2.

Embankment has settled to left end of  
Abutment 2.

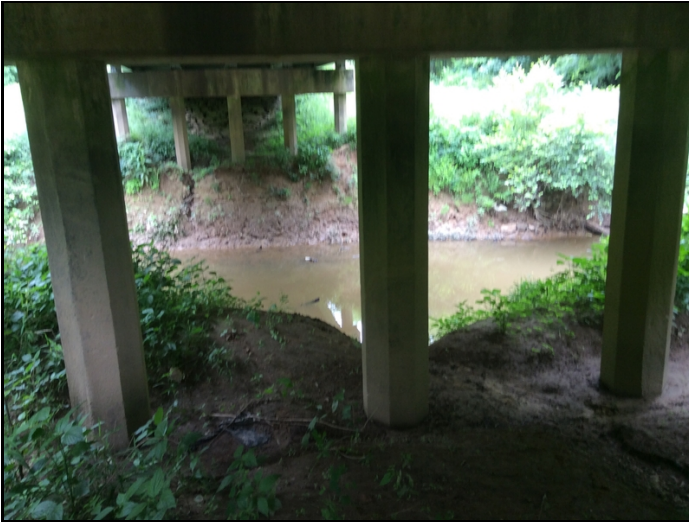
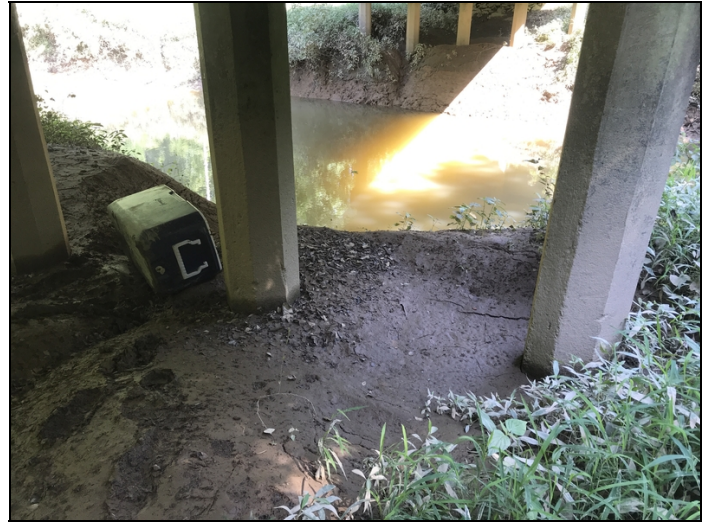
Erosion/scour to slope around Bents 1 & 2.

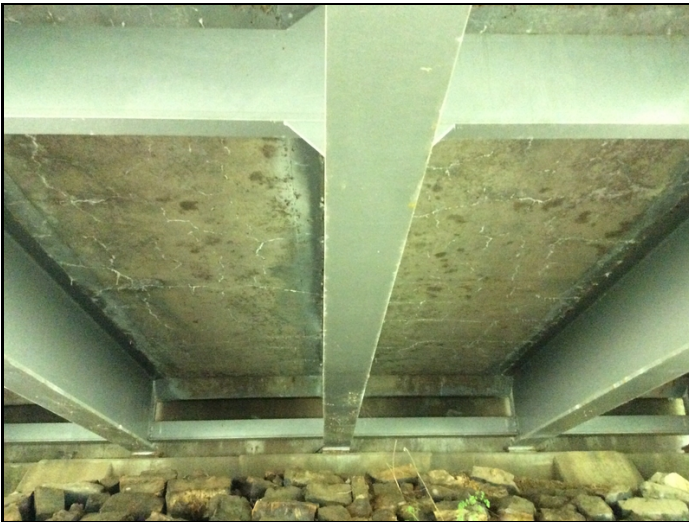
Efflorescent cracking to deck below.

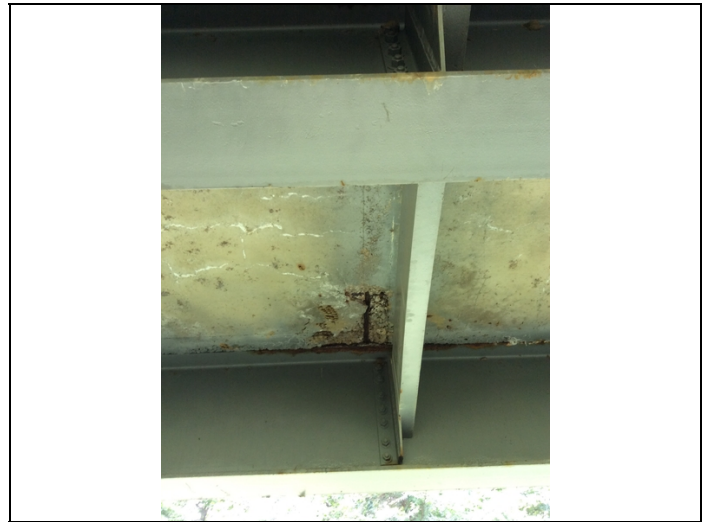
Spall with 1.5' of rebar exposed to deck below between Girders 4 & 5 at Span 3.

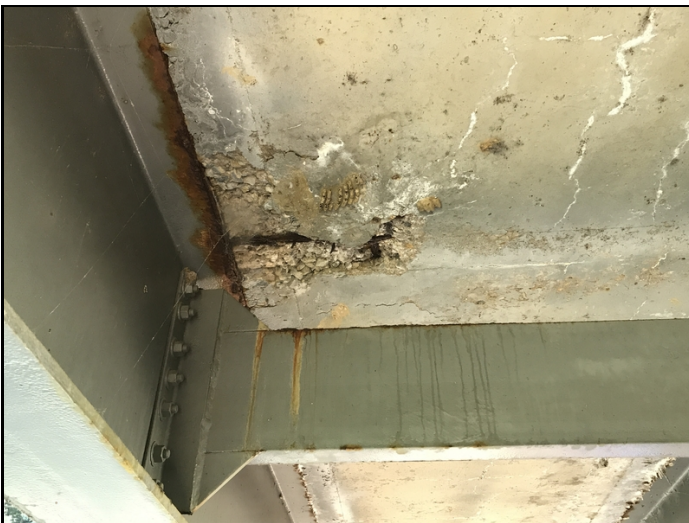
Spall with 1.5' of rebar exposed to deck below between Girders 4 & 5 at Span 3  
Efflorescent Cracking to deck below at all spans.

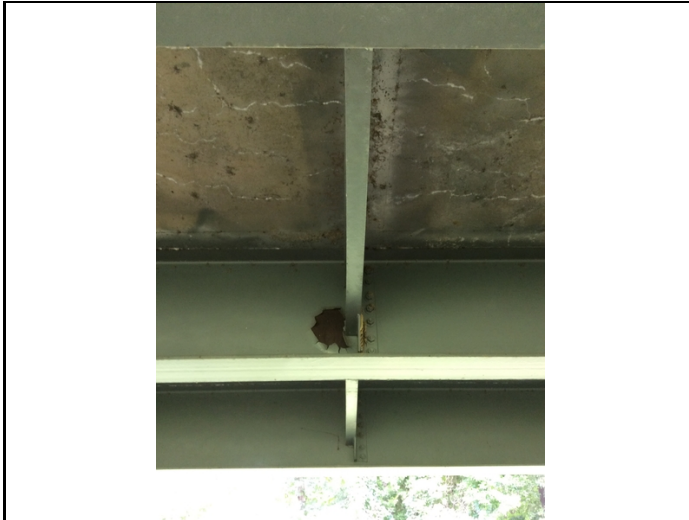
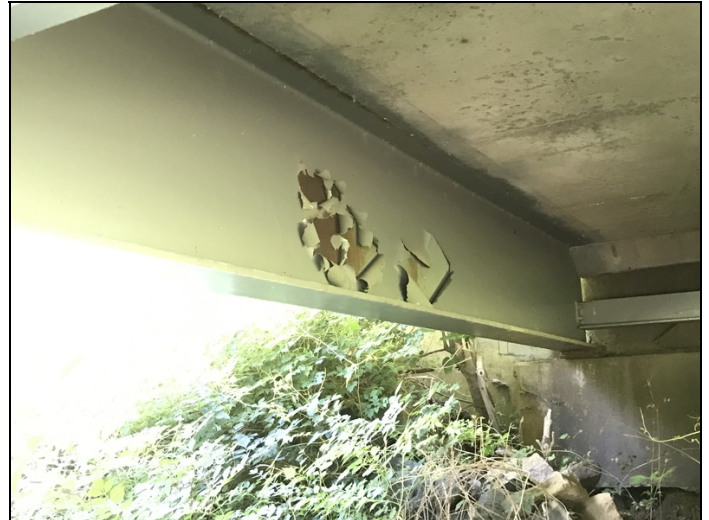
Areas of peeling paint to Girders 1 & 2 at Span 3.

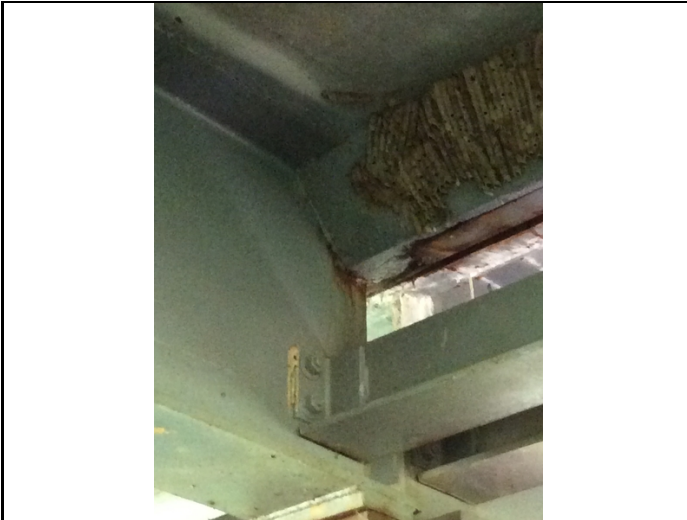
Existing pitting & section loss to webs of girders at all spans.

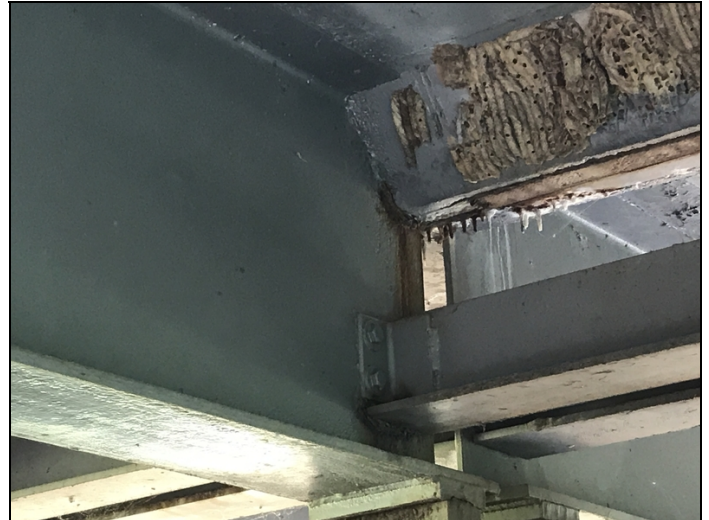
Existing pitting & section loss to webs of girders below paving haunch at all spans.
