## Bridge 01446 Inspection Report

Asset #01446(Routine, Underwater type 2)

SH 367 White Co. over LAWRENCE BAYOU

Team Lead: Seth Foreman Inspection Date: 08/18/2025

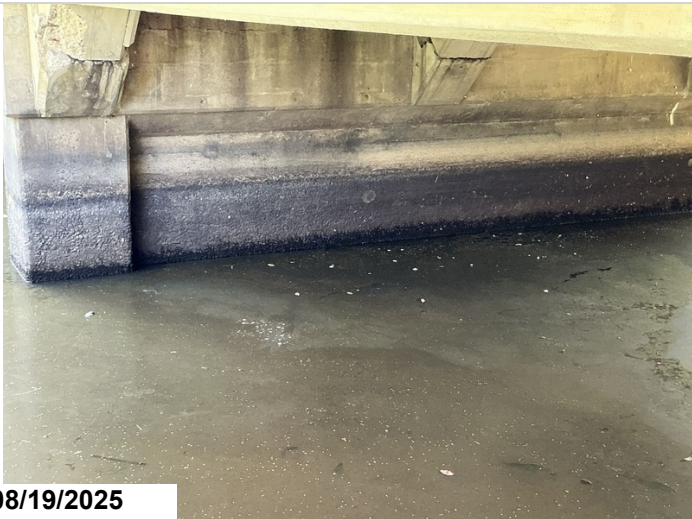
| ELEMENTS | DESCRIPTION | UNITS | TOTAL | CS1 | CS2 | CS3 | CS4 |
|---|---|---|---|---|---|---|---|
| (210) Abrasion to full width of pier wall. 21' CS2 | | | | | | | |

Heavy abrasion at water level to abutments 1 and 2 and bent 1.

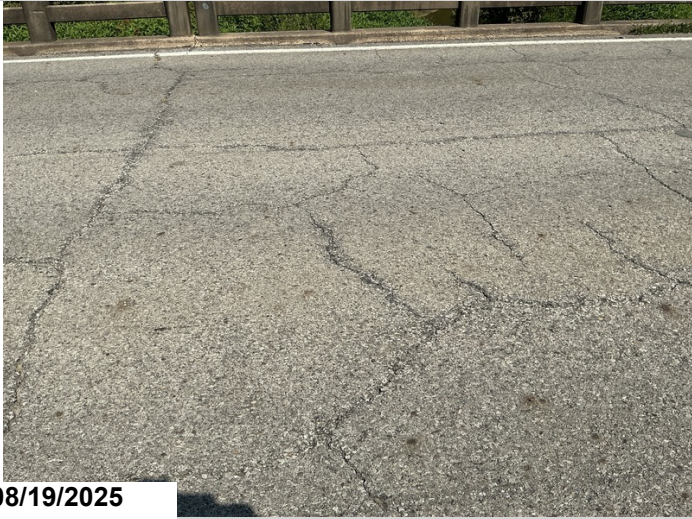
| ELEMENTS | DESCRIPTION | UNITS | TOTAL | CS1 | CS2 | CS3 | CS4 |
|---|---|---|---|---|---|---|---|
| (510-16) Cracking to asphalt overlay. 485' CS3 | | | | | | | |

Cracks to asphalt wearing surface.

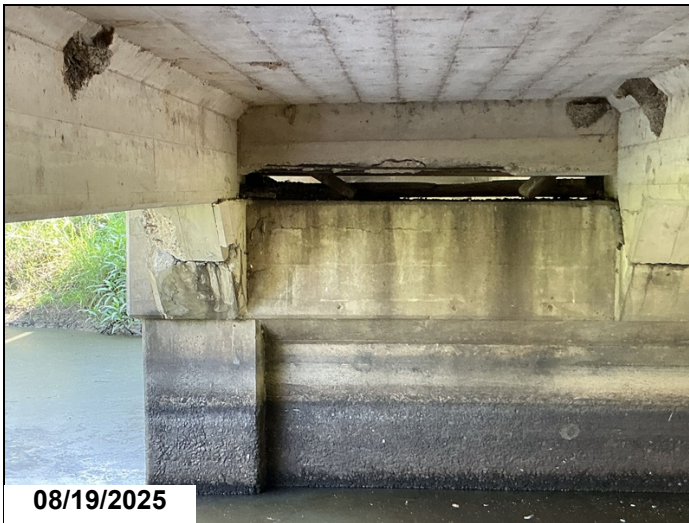
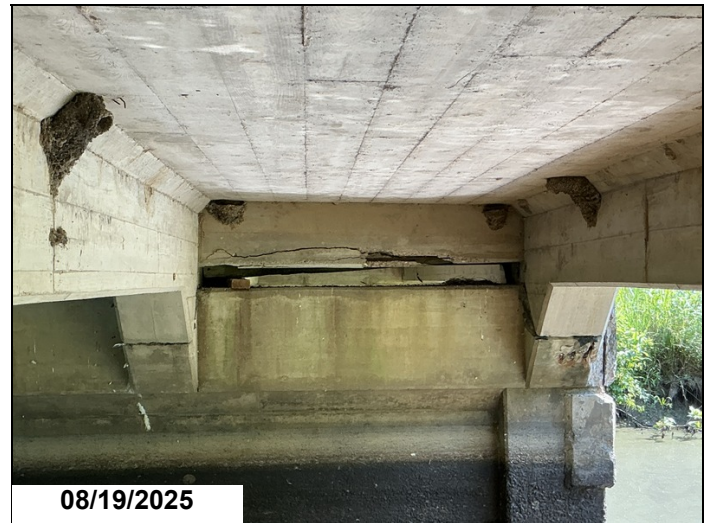
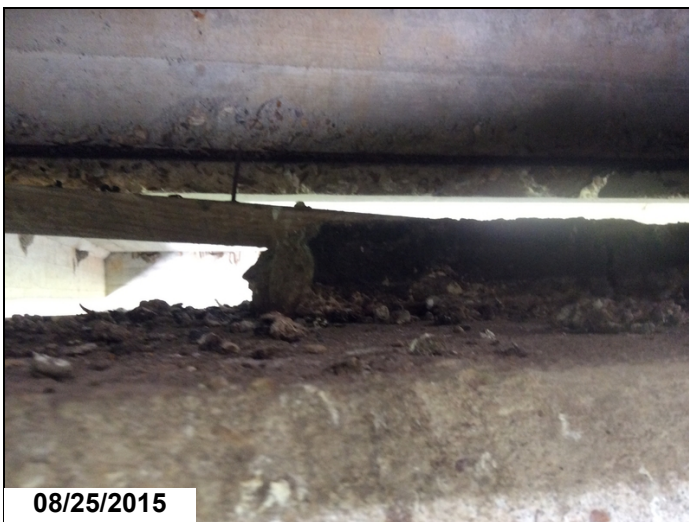
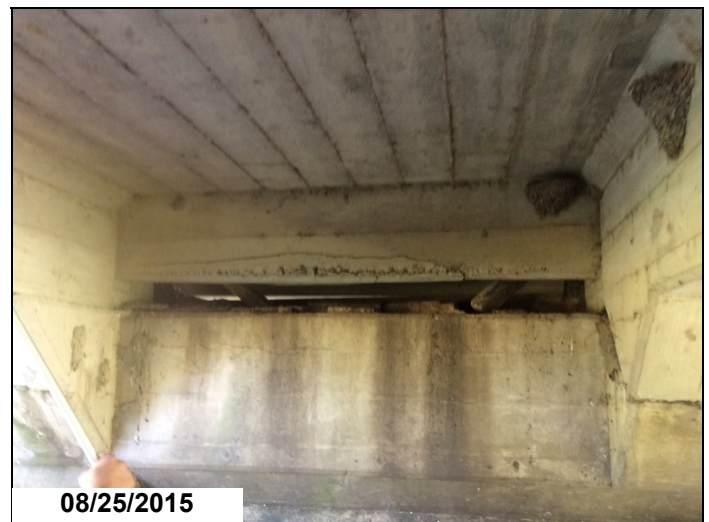
Cracking & spalls with rebar exposed to diaphragms between Girders 1-4 @ Bent 1.

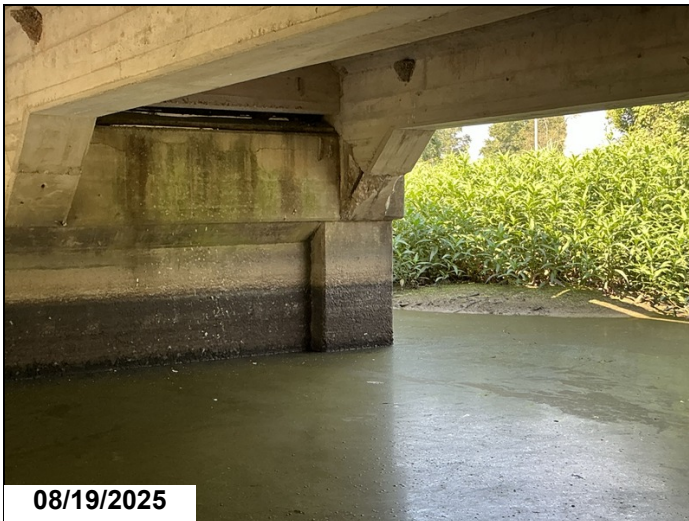
08/19/2025

Span 2, Girder 1 has spall with 1' rebar exposed to concrete Haunch.

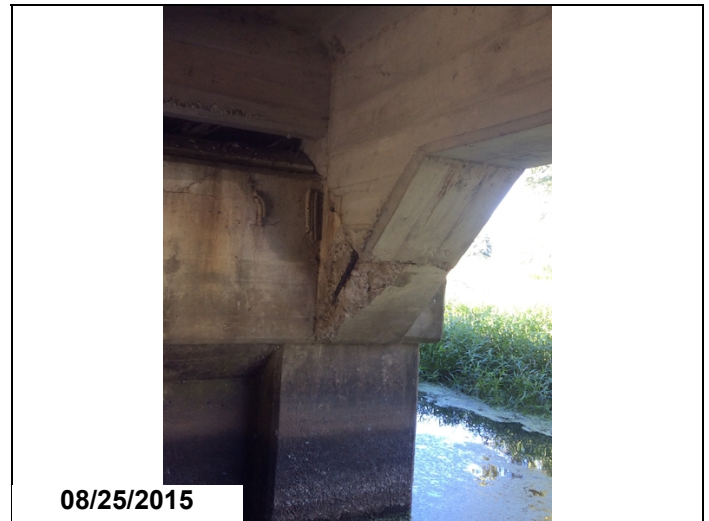
08/25/2015

Span 2 Girder 1 has spall with 1' rebar exposed to concrete Haunch.

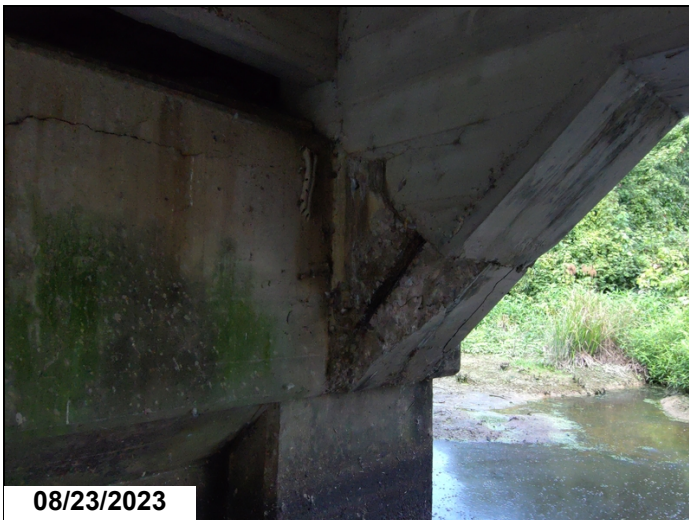
08/23/2023

Span 2, Girder 1 has spall with 1' rebar exposed to concrete Haunch.

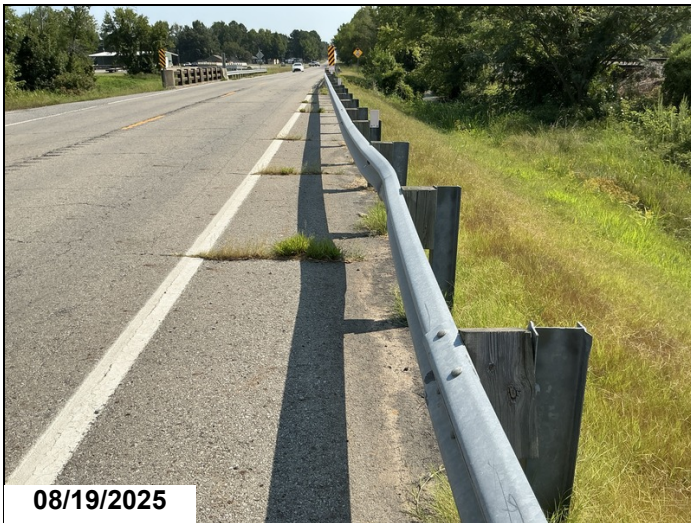
08/19/2025

| ELEMENTS | DESCRIPTION | UNITS | TOTAL | CS1 | CS2 | CS3 | CS4 |
|---|---|---|---|---|---|---|---|
| (331) Damage to concrete end post @ Abutment 1 Left. | | | | | | | |

Impact damage to right guard @ approach at Abutment 1.

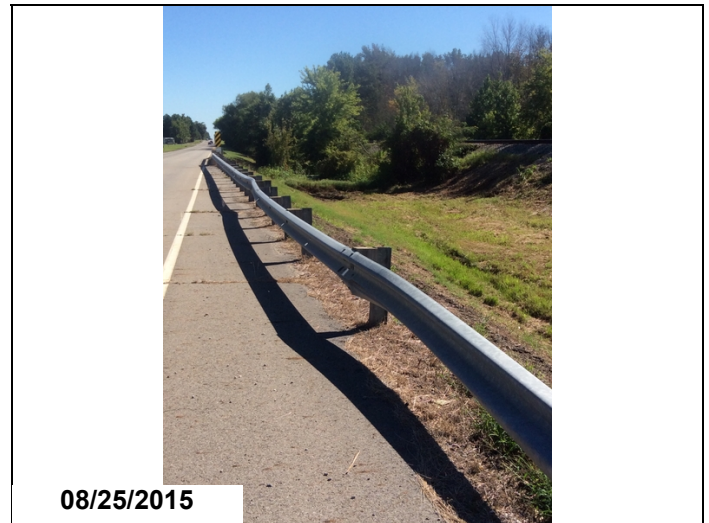
08/25/2015

Impact damage to right guard @ approach at Abutment 1.

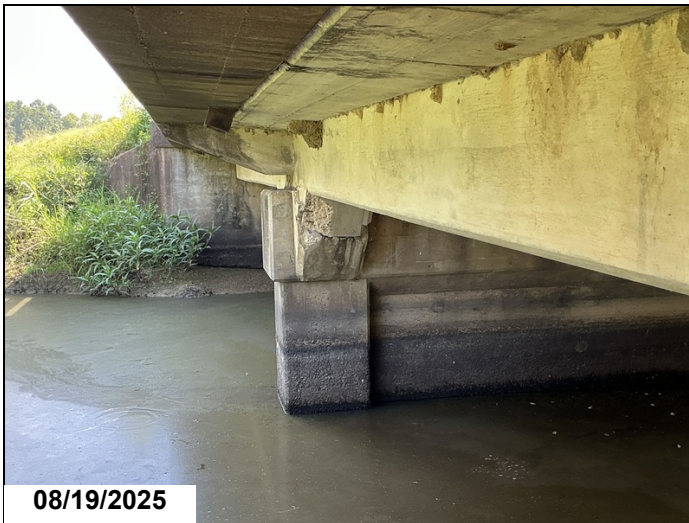
Spall with 1' of rebar exposed to concrete haunch of Girders 1 and 4 @ Span 1.

Spall with 1' of rebar exposed to concrete haunch of Girders 1 and 4 @ Span 1.( Girder 1)

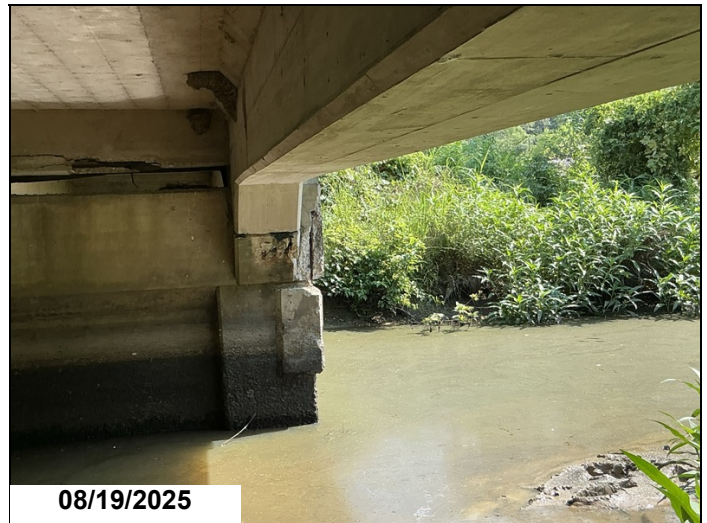
Spall with 1' of rebar exposed to concrete haunch of Girders 1 and 4 @ Span 1.( Girder 2)

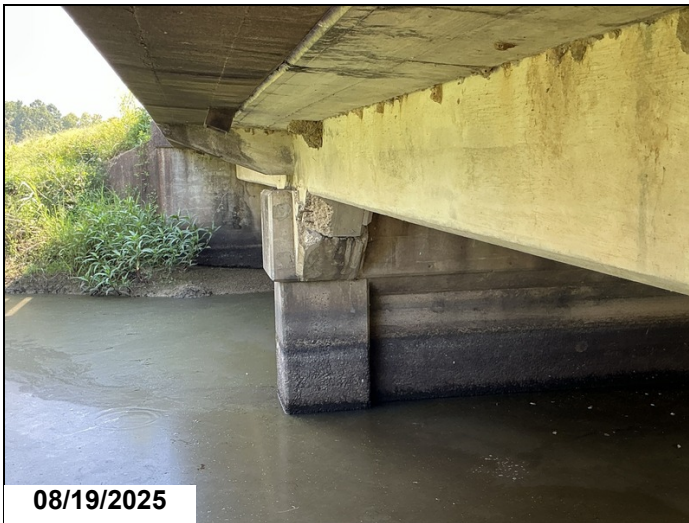
Spall with 1' of rebar exposed to concrete haunch of Girders 1 and 4 @ Span 1.( Girder 1)

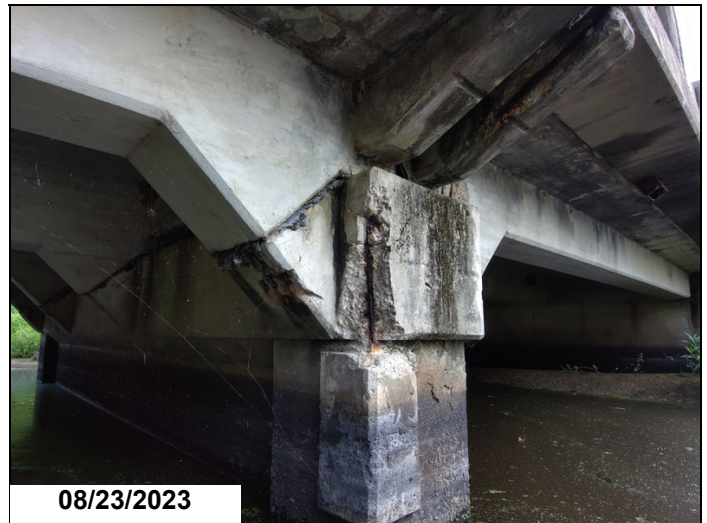
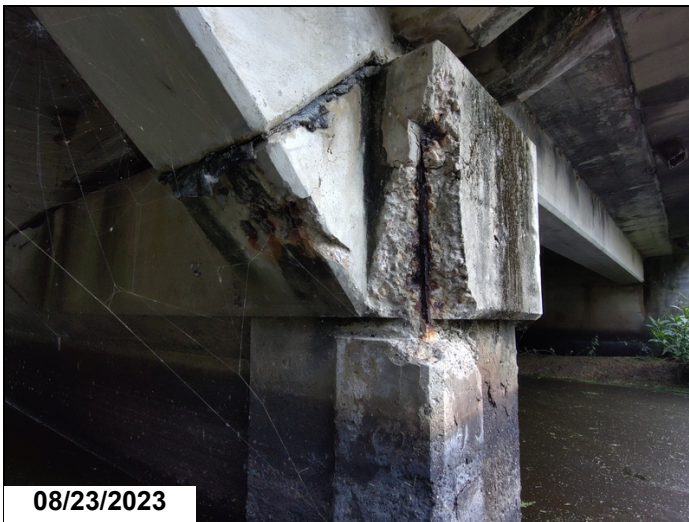
| ELEMENTS | DESCRIPTION | UNITS | TOTAL | CS1 | CS2 | CS3 | CS4 |
|---|---|---|---|---|---|---|---|
| (234) Bent 1:<br>5' horizontal crack to backside of cap between girders 1 & 2. 5' CS3<br>3' spall with 2' of rebar exposed to right end of cap. 1' CS3 (spall), 2' CS3 (rebar)<br>5' horizontal crack to ahead side of cap between girders 1 & 2. 5' CS3<br>2 vertical efflor cracks to cap on ahead side. 2' CS3 | | | | | | | |

Large spall with rebar exposed to the right end of cap @ Bent 1.
