## Bridge 01462 Inspection Report

SH 367 White Co. over GUM BAYOU

Location: 1.10 MI NE JCT OF SH 31

Team Lead: Seth Foreman Inspection Date: 09/09/2025

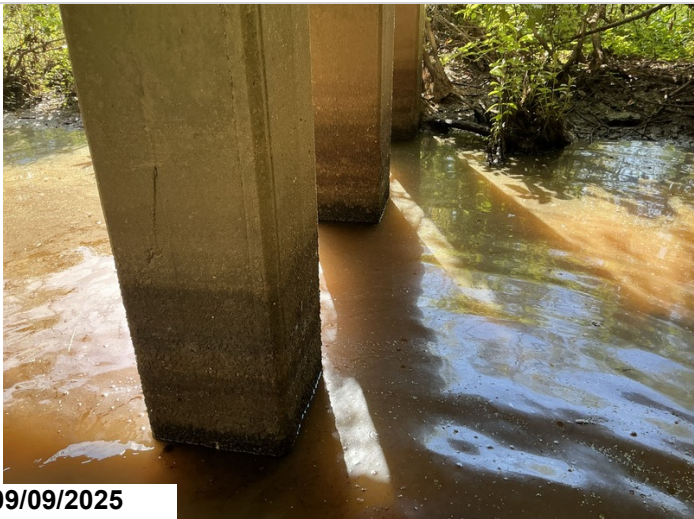
Abrasion to bottom of columns at bents 1 - 4.

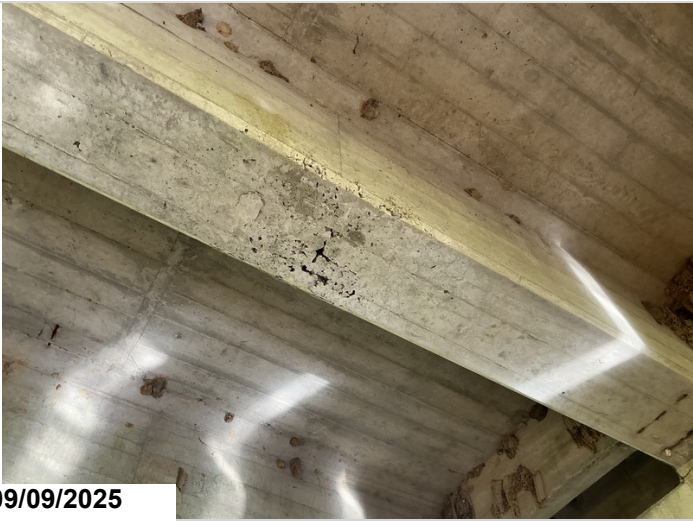
Honeycomb area with exposed rebar to girder 2 end of span 3.

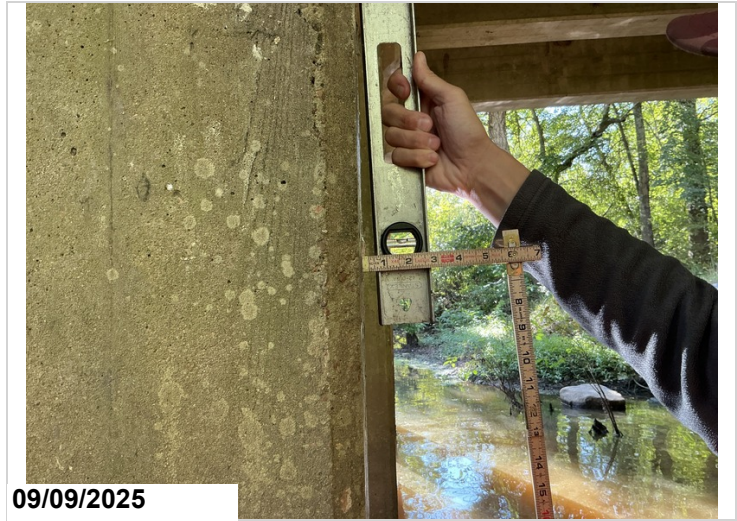
Overall substructure is in fair condition with spalls with rebar exposed and scour to abutments 1 & 2 with piles exposed. Bents 1 and 2 are rotated back 5/8".

Bents 1 and 2 are rotated back 5/8".

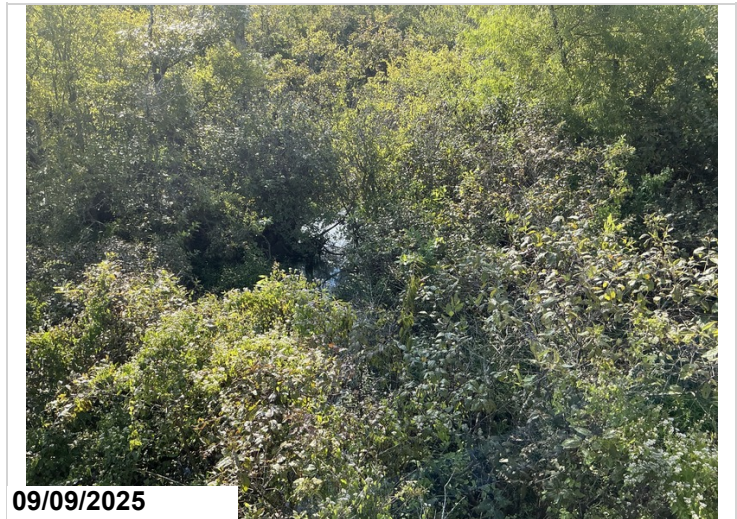
Right channel.

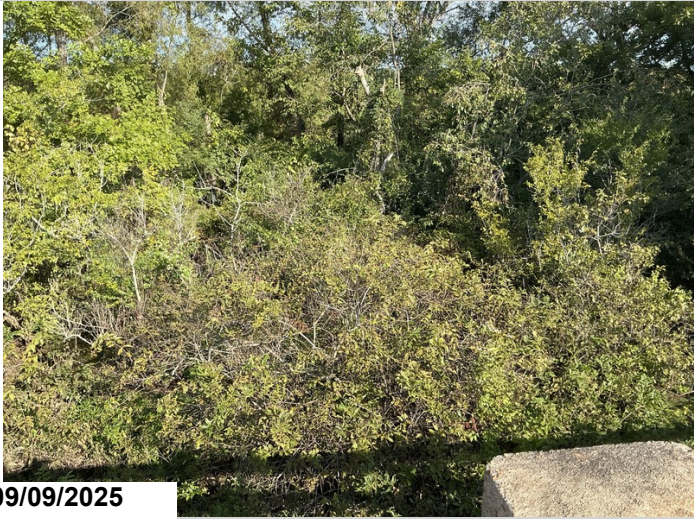
Left channel.

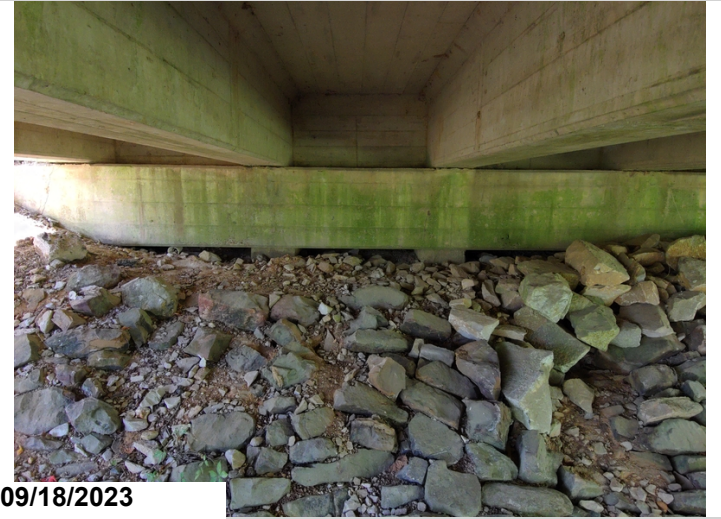
Abutment 1 has settlement with 2 Piles exposed.

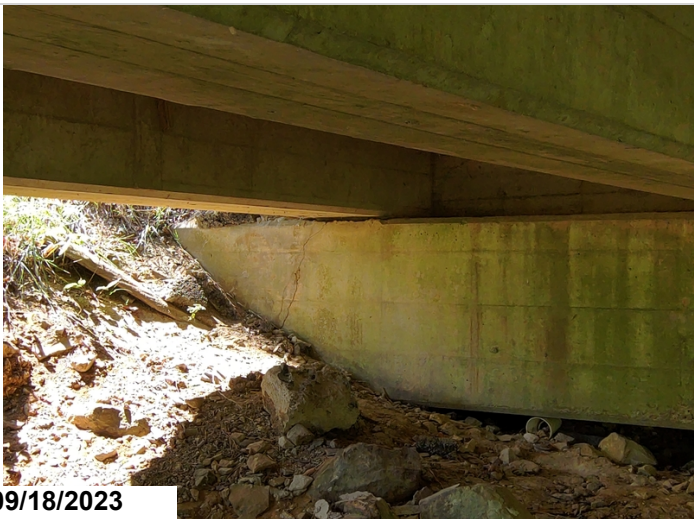
Large crack to Rt side of Abutment 1.

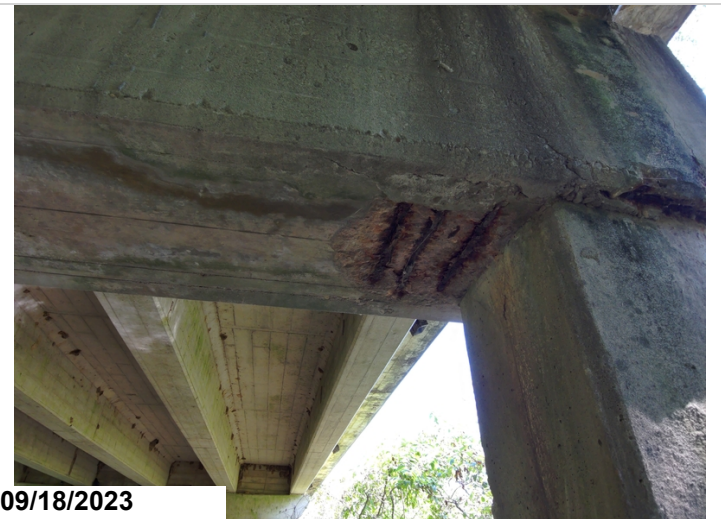
Spalls with rebar exposed to caps @ Bents 1 - 3.

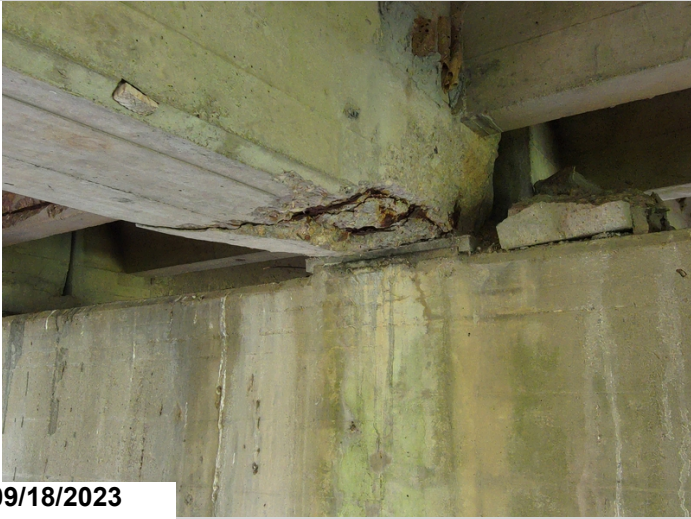
Loss of bearing area @ ends of Girders 3 & 5 @ beginning of Span 4.

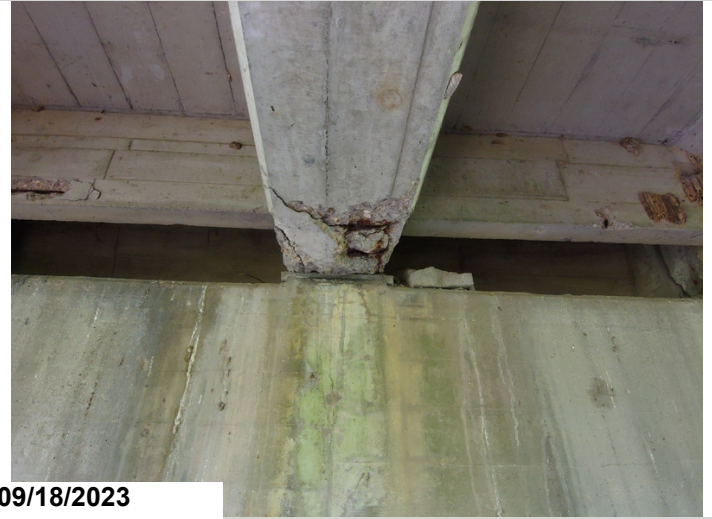
Loss of bearing area @ ends of Girders 1, 2 & 3 @ beginning of Span 2.

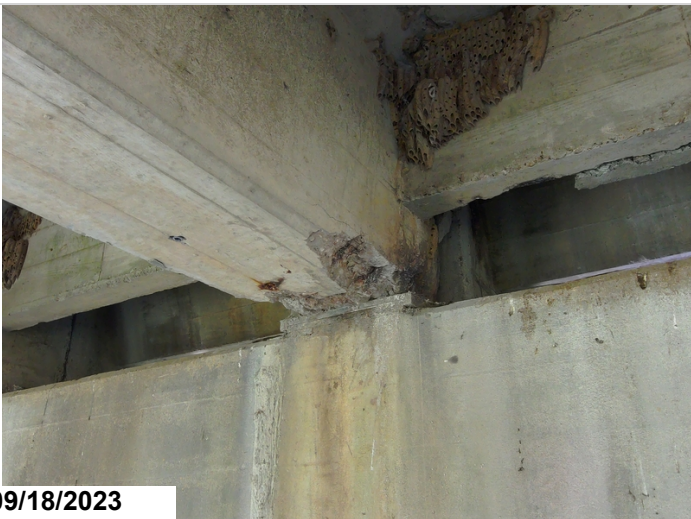
Loss of bearing area @ ends of Girders 1, 2 & 3 @ beginning of Span 2.

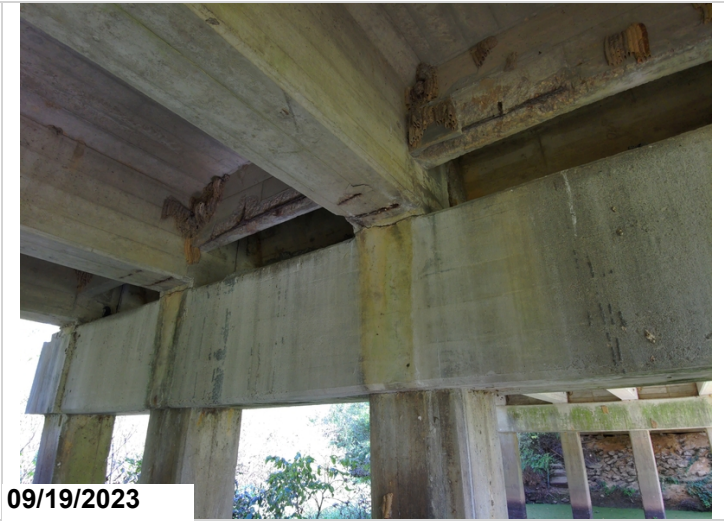
Spalls with rebar exposed to Girders @ Spans 1 - 5.  
Girder 3, span 3.

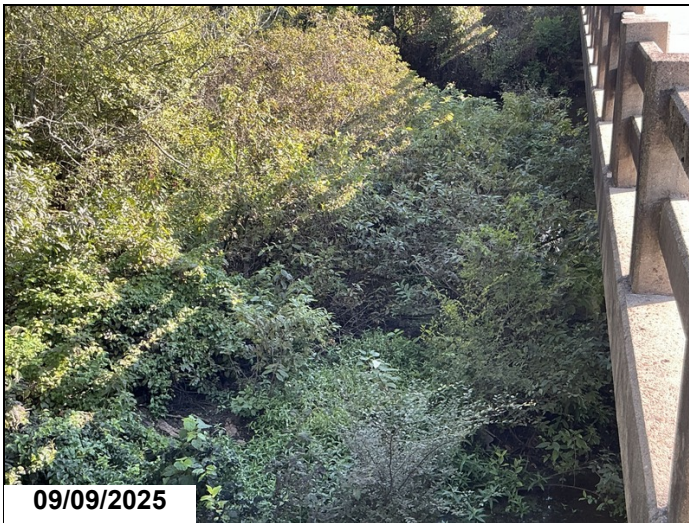
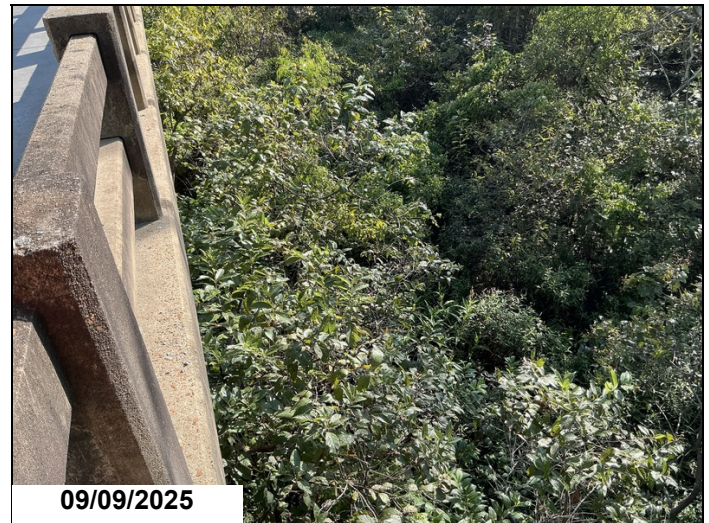
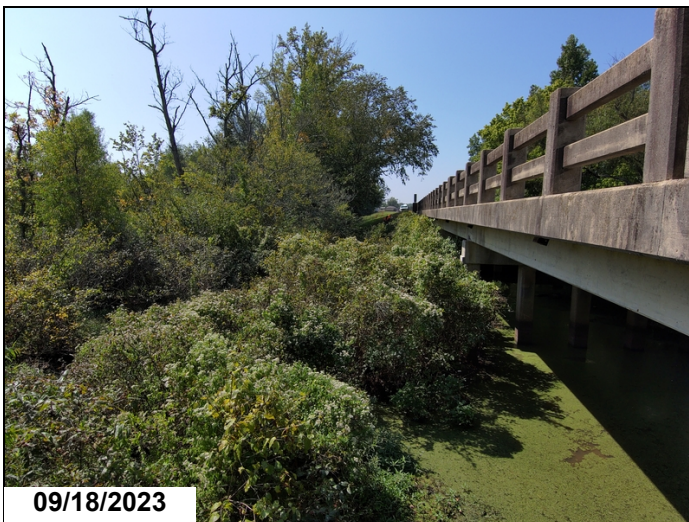
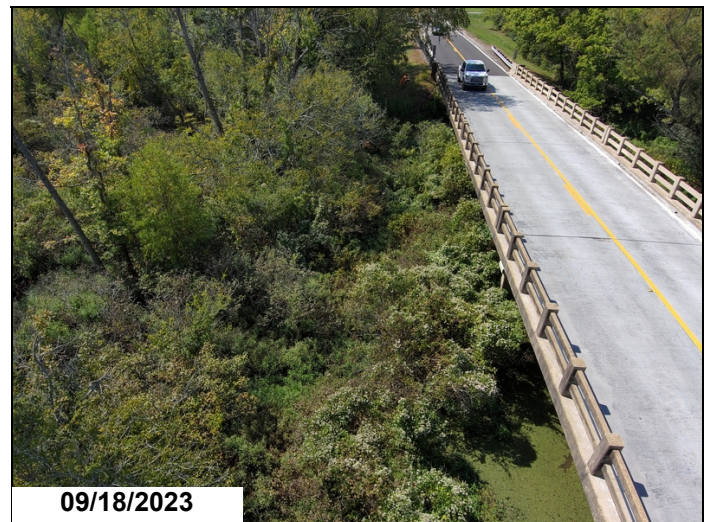
Heavy vegetation on Left & Right sides of bridge.

| Type of Maintenance | Is Recommended? |
|---|---|
| A-64 - Vegetation Removal Requested | Yes |

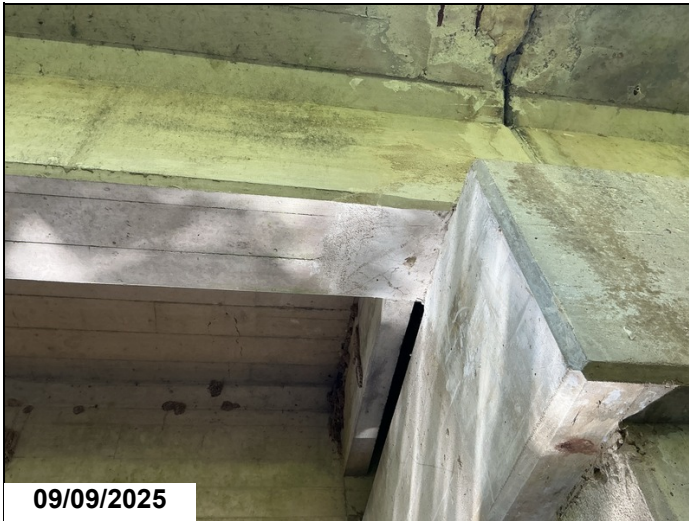
Loss of bearing area @ ends of Girders 1, 2 & 3 @ beginning of Span 2. REPAIRED

REPAIRED

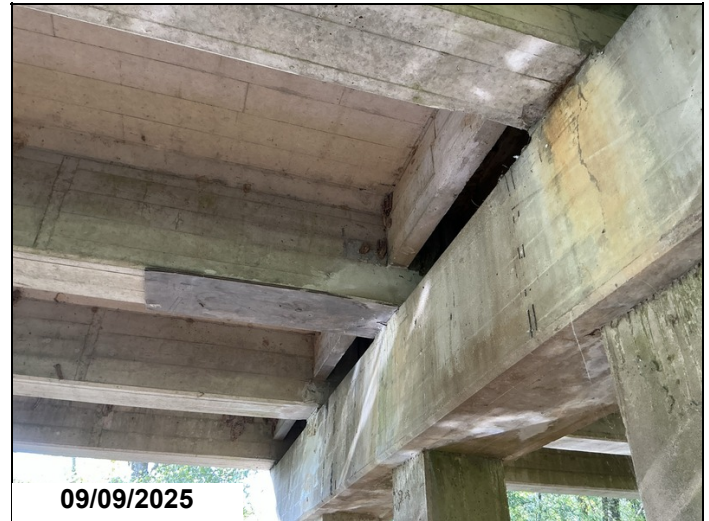
Loss of bearing area @ ends of Girders 1, 2 & 3 @ beginning of Span 2. REPAIRED

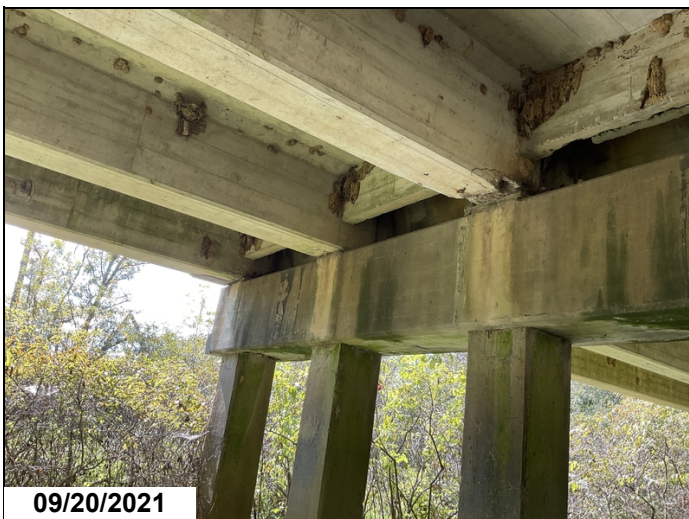
Loss of bearing area @ ends of Girders 3 & 5 @ beginning of Span 4.

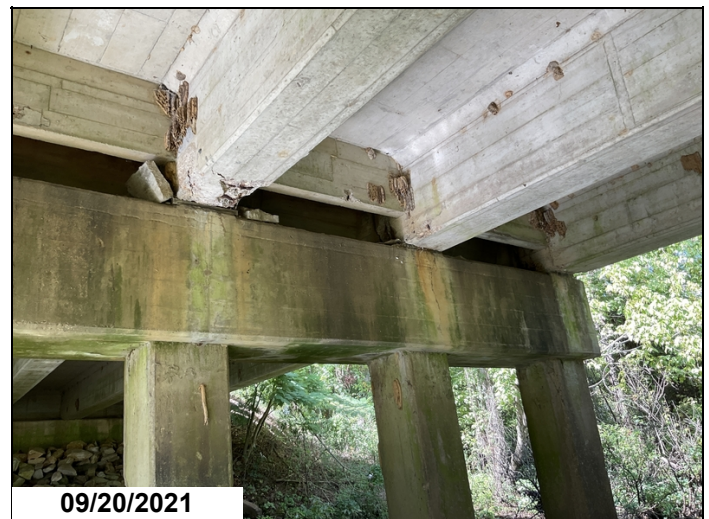
Loss of bearing area @ ends of Girders 1, 2 & 3 @ beginning of Span 2.

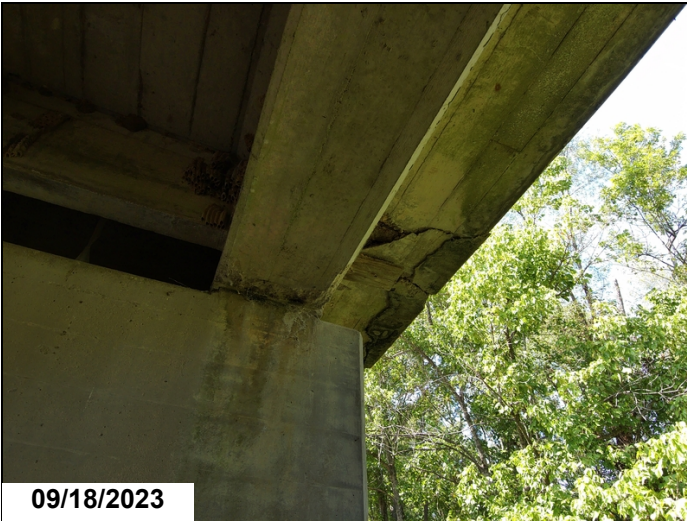
Loss of bearing area @ ends of Girders 3 & 5 @  
beginning of Span 4.  
Girder 5

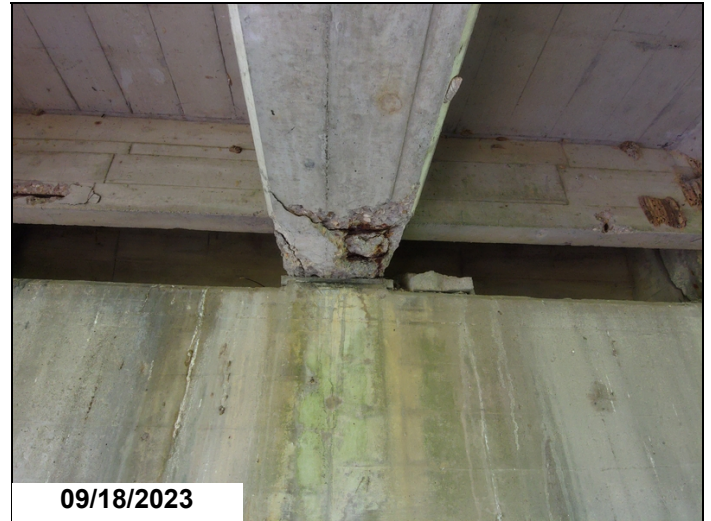
Loss of bearing area @ ends of Girders 1, 2 & 3 @  
beginning of Span 2.

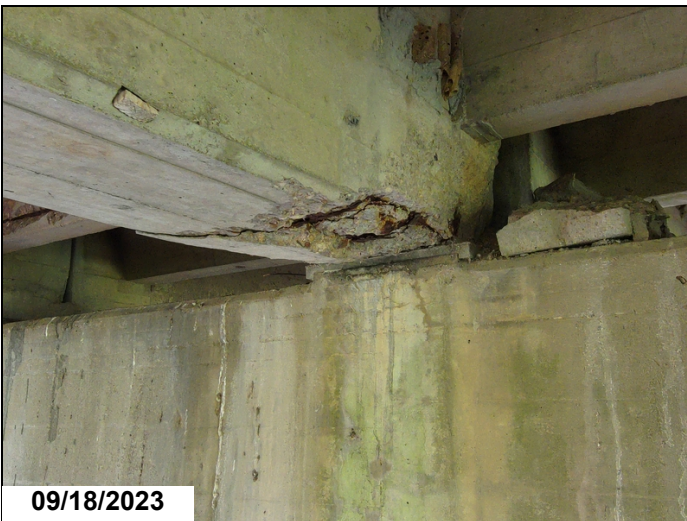
Loss of bearing area @ ends of Girders 1, 2 & 3 @  
beginning of Span 2.

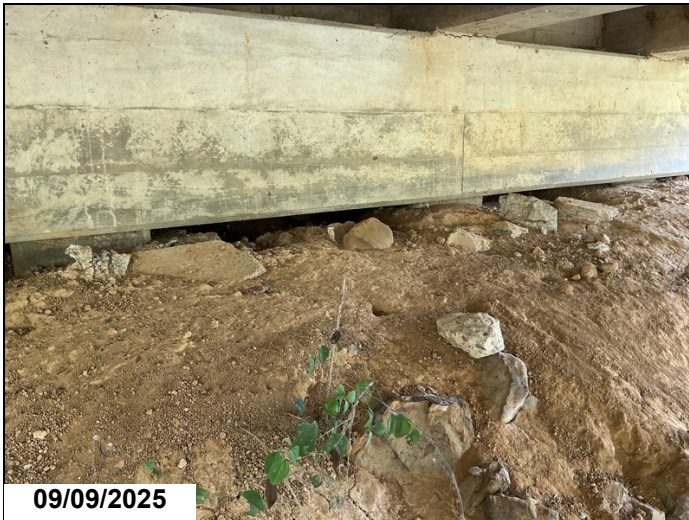
Abutment 2 has settlement with 3 Piles exposed.

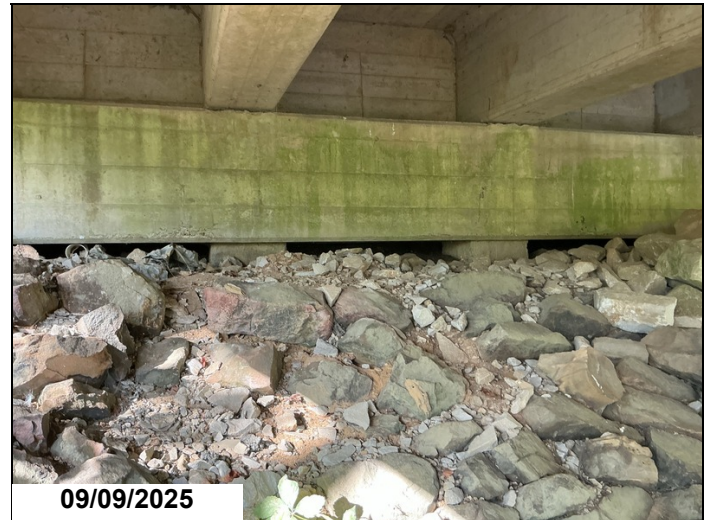
Abutment 1 has settlement with 2 Piles exposed.

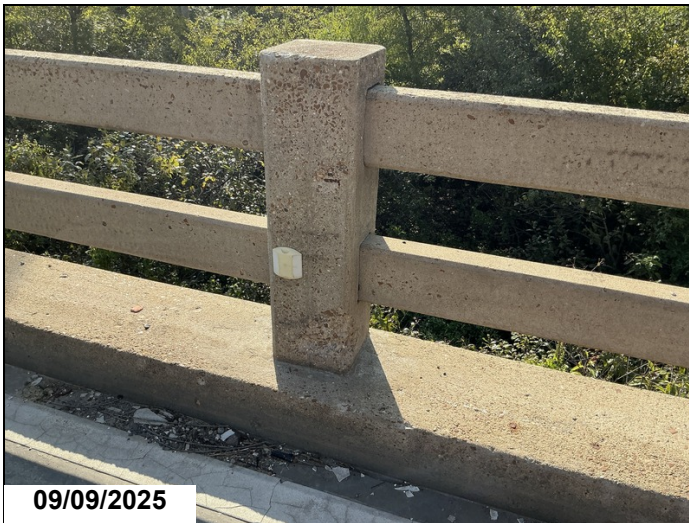
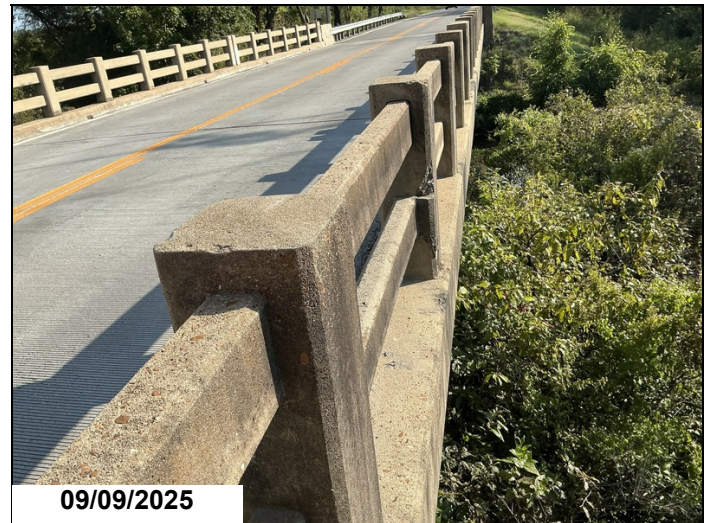
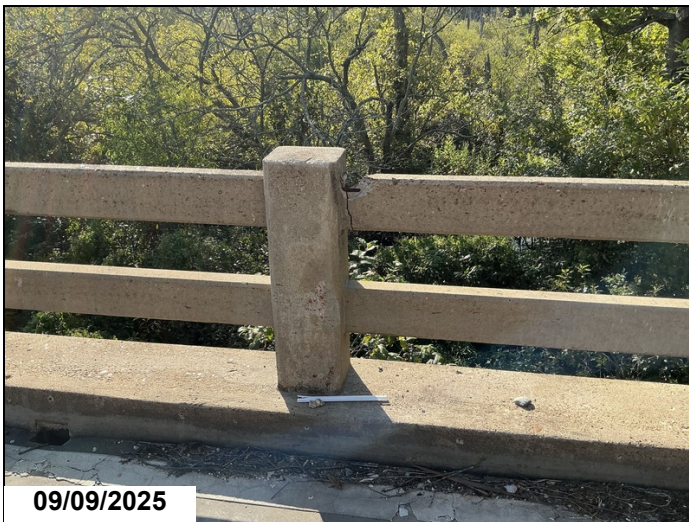
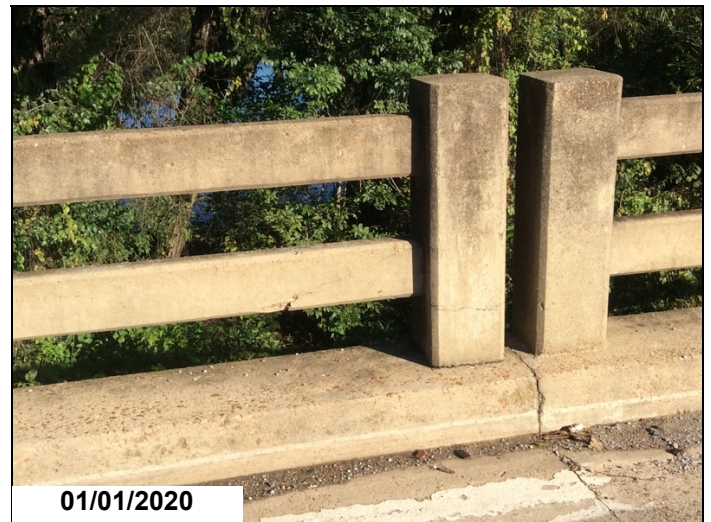
| ELEMENTS | DESCRIPTION | UNITS | TOTAL | CS1 | CS2 | CS3 | CS4 |
|---|---|---|---|---|---|---|---|
| (331) Concrete railing & post cracking & spalling<br>SEE FORM III for detailed descriptions and locations of deficiencies. | | | | | | | |

Random cracking & spalls to concrete post & bridge railing @ all spans

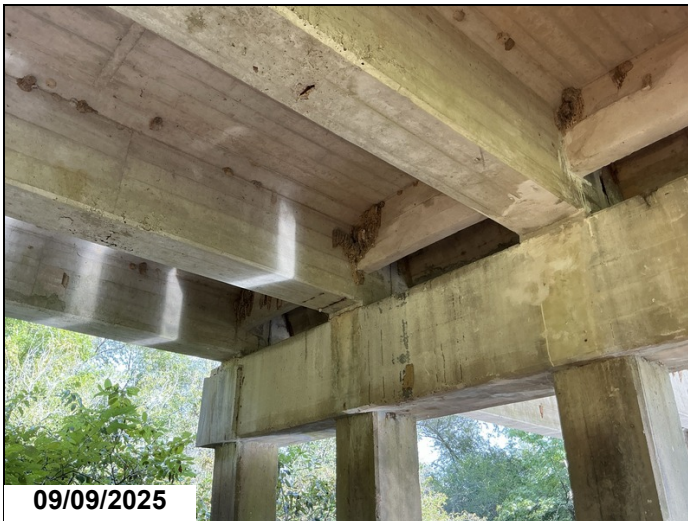
Spalls with exposed rebar to girders 2 and 5 end of span 3.(Girder 2)

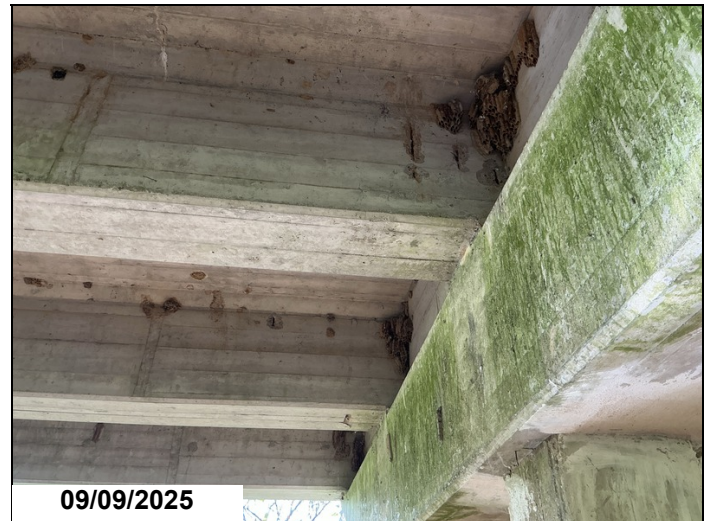
Spalls with exposed rebar to girders3 and 4 at beginning of span 3.

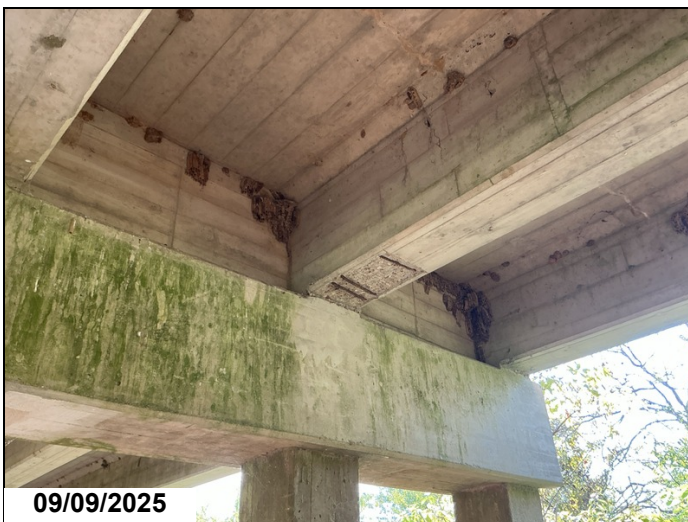
Spall with exposed rebar to girder 4 at end of span 2.

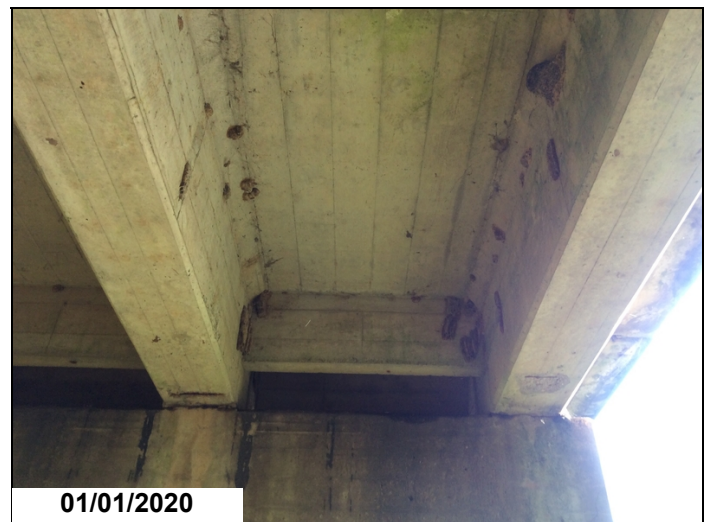
Spalls with rebar exposed to Girders @ Spans 1 - 5.

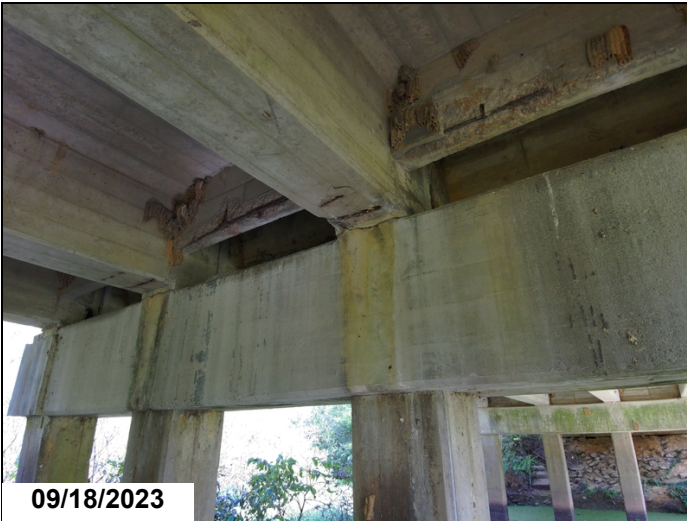
Spalls with rebar exposed to Girders @ Spans 1 - 5.  
Girder 3, span 3.

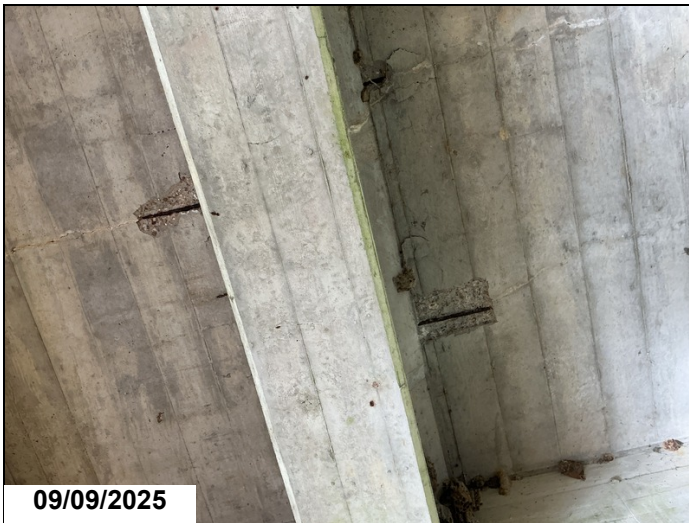
Spalls with exposed rebar to undersurface beginning of span 3.

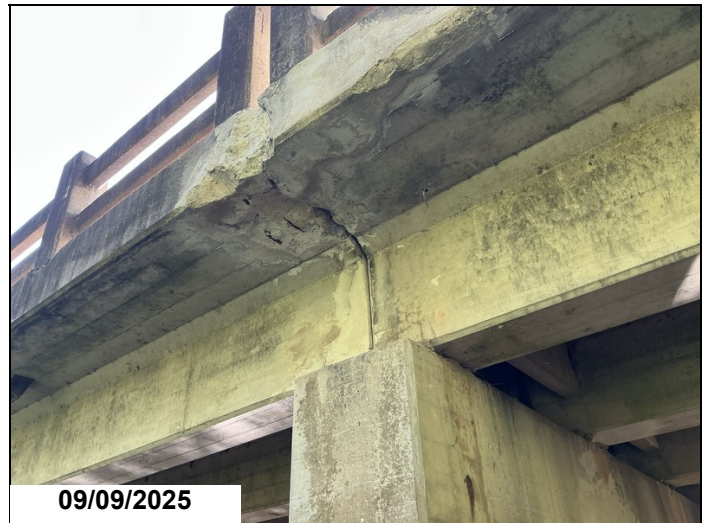
Undersurface has Spalls with rebar exposed at various locations @ Spans 1 thru 5

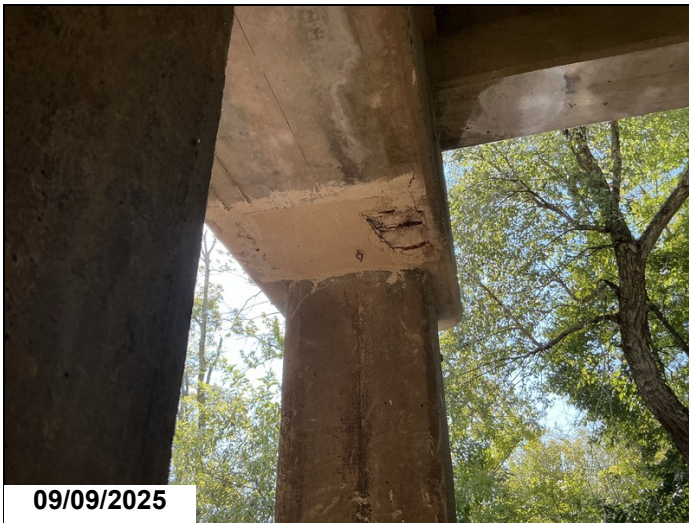
Spall with exposed rebar to bottom of cap right side of bent 1.

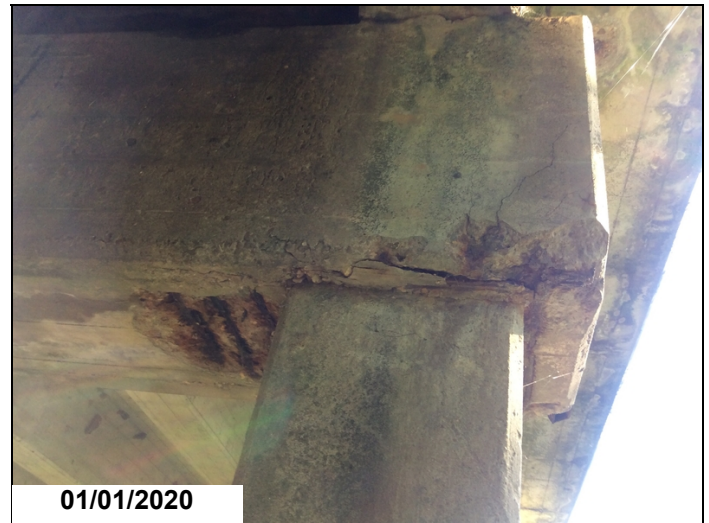
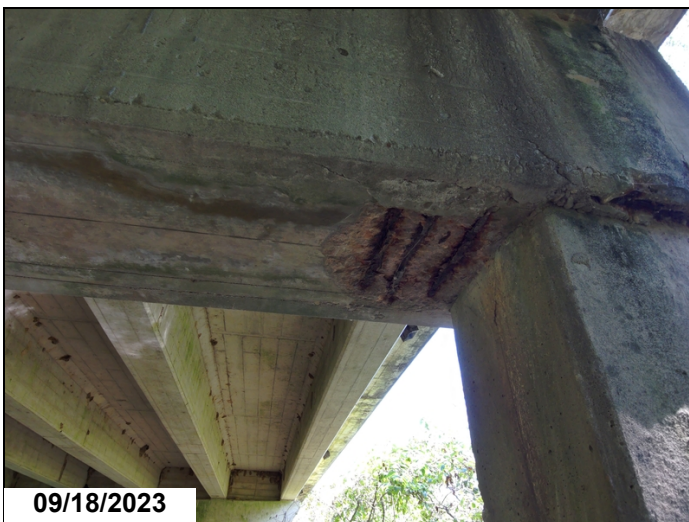
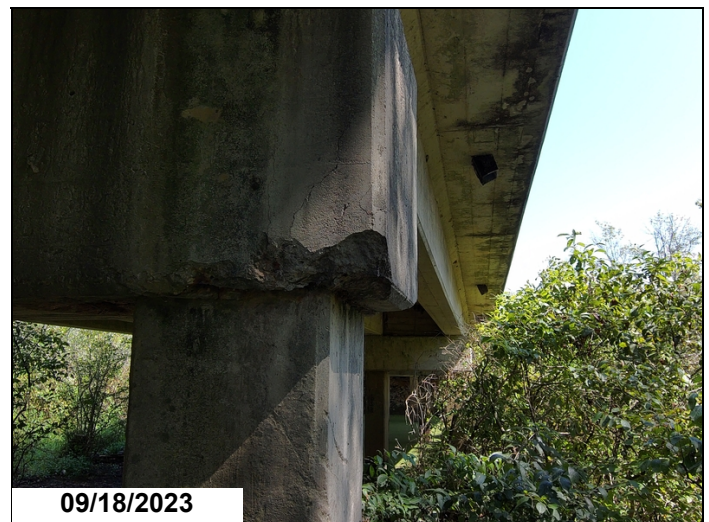
| ELEMENTS | DESCRIPTION | UNITS | TOTAL | CS1 | CS2 | CS3 | CS4 |
|---|---|---|---|---|---|---|---|
| (234) Bent 1 -<br>Spall with 3' rebar exposed to bottom of cap between Piles 4 & 5. 3' CS3<br>Cracks to back of cap over Piles 2 & 3. 2' CS2<br>Bent 2 -<br>Area of delamination to bottom of cap. 2' CS2<br>Bent 3 -<br>Spall with 3' rebar exposed to bottom of cap between Piles 4 & 5. 3' CS3 | | | | | | | |

Spalls with rebar exposed to caps @ Bents 1 - 3.
