## Bridge 06797 Inspection Report

Asset #06797 (Routine, Underwater type 2)

SH 367 White Co. over Bull Bayou

Team Lead: Seth Foreman Inspection Date: 06/22/2026

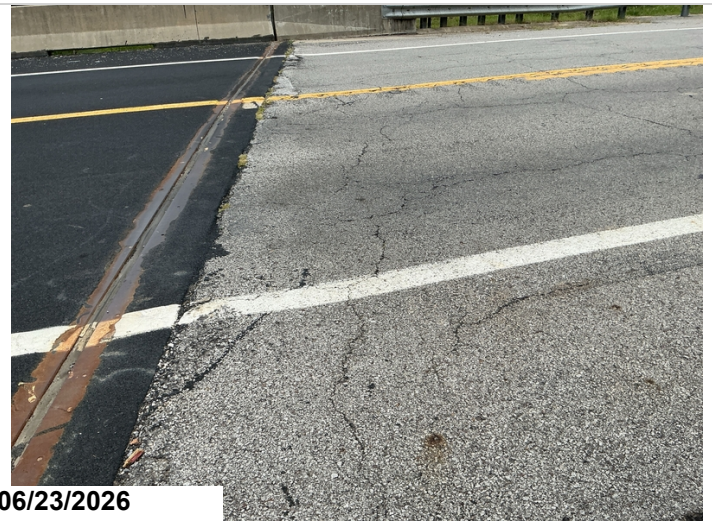
Roadway settlement at abutments 1 and 2.

| Type of Maintenance | Is Recommended? |
|---|---|
| A-66 - Approach minor pothole/leveling needed | Yes |

Roadway settlement at abutments 1 and 2.

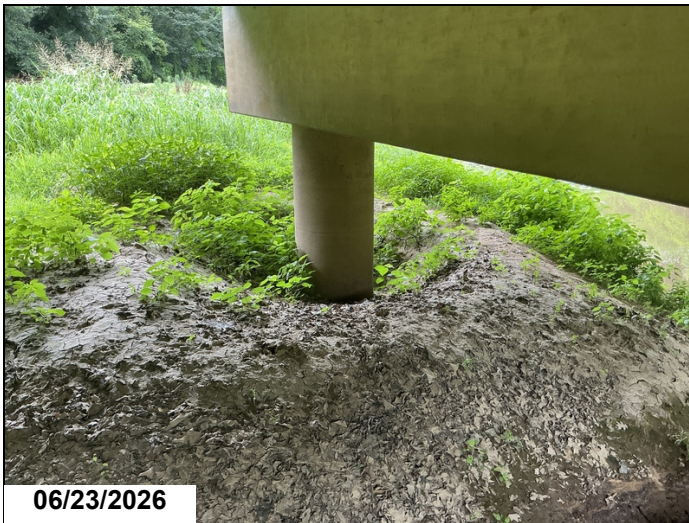
1' - 2' Scour to Column 1 & 2 at Bents 1, 2 & 3.

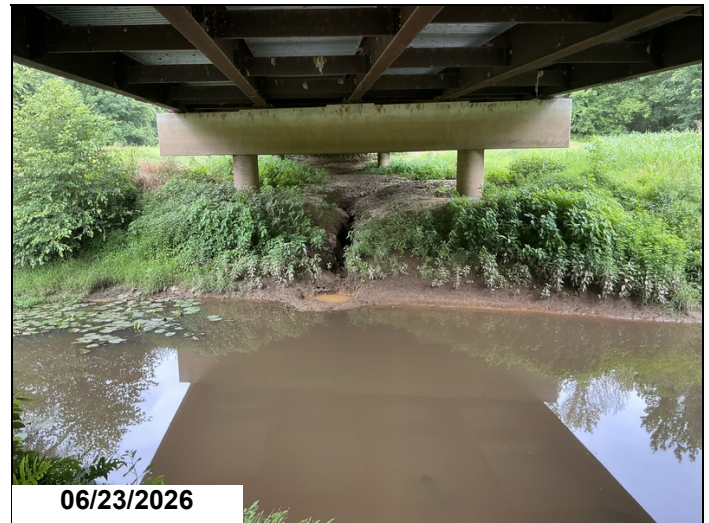
1' - 2' Scour to Column 1 & 2 at Bents 1, 2 & 3.

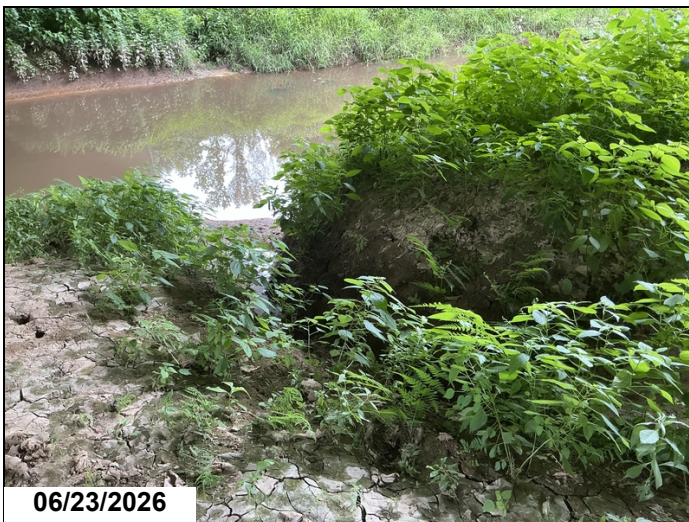
1' - 2' Scour to Column 1 & 2 at Bents 1, 2 & 3.

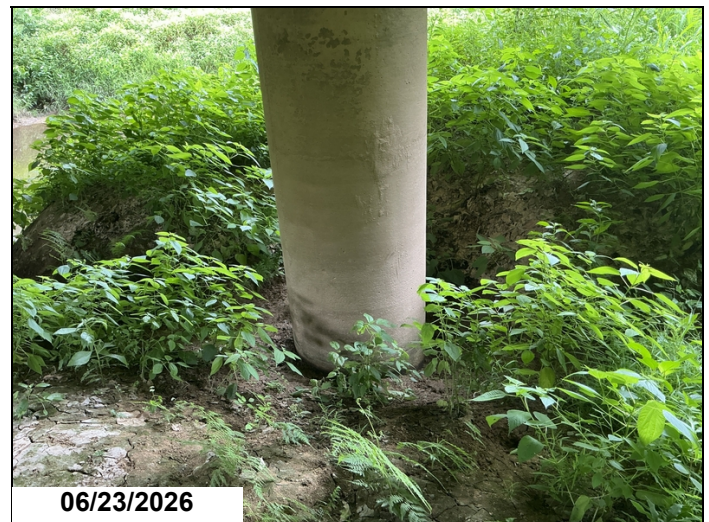
1' - 2' Scour to Column 1 & 2 at Bents 1, 2 & 3.

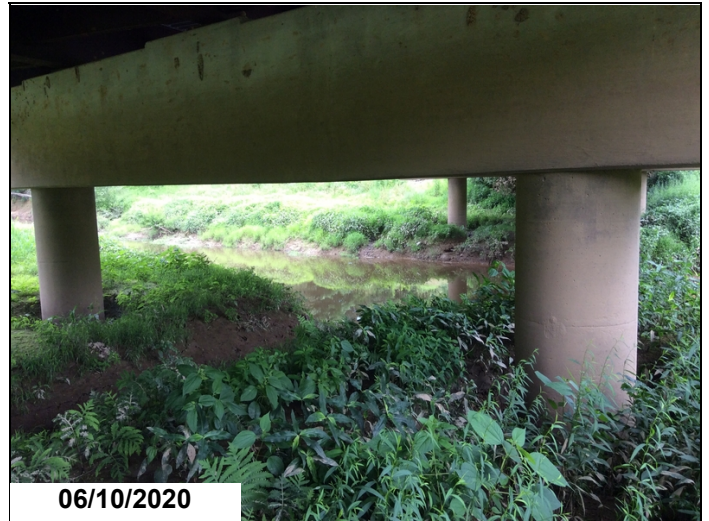
| ELEMENTS | DESCRIPTION | UNITS | TOTAL | CS1 | CS2 | CS3 | CS4 |
|---|---|---|---|---|---|---|---|
| (205) Bents 1 - 3 have scour at Left & Right columns. 6 CS2 | | | | | | | |

Scour to Column 1 & 2 at Bents 1, 2, & 3.

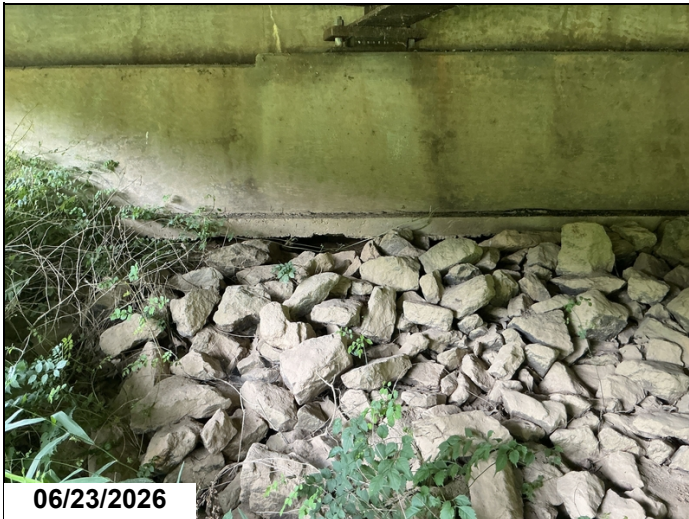
| ELEMENTS | DESCRIPTION | UNITS | TOTAL | CS1 | CS2 | CS3 | CS4 |
|---|---|---|---|---|---|---|---|
| (215) Abutment 1 Right & Abutment 2 Left - Embankment eroded 6" down & 2' back under. 25' CS2<br>Abutment 1: has 2 vertical efflorescent cracks. 1' CS2 and 1' CS3<br>Abutment 2: has 6 vertical efflorescent cracks, some have rust. 6' CS3 | | | | | | | |

Embankment has eroded 6" below & 2' back under bottom of Abutment 1 Right & Abutment 2 Left.(Abutment 1)

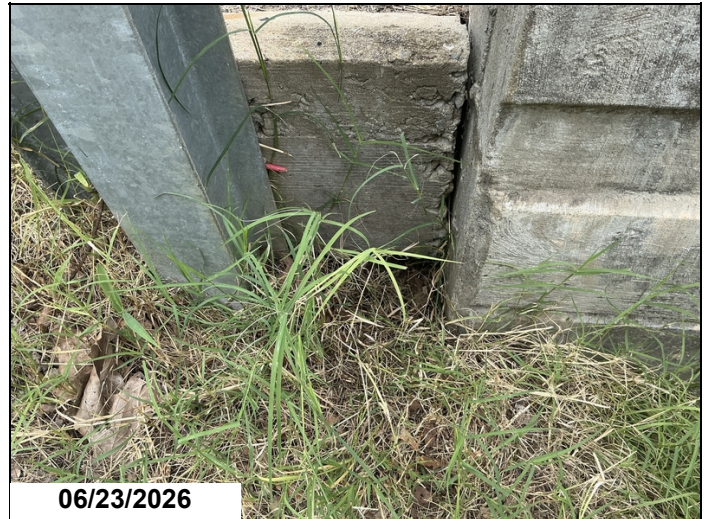
Scour 2' back under behind Lt side of abutment 2.

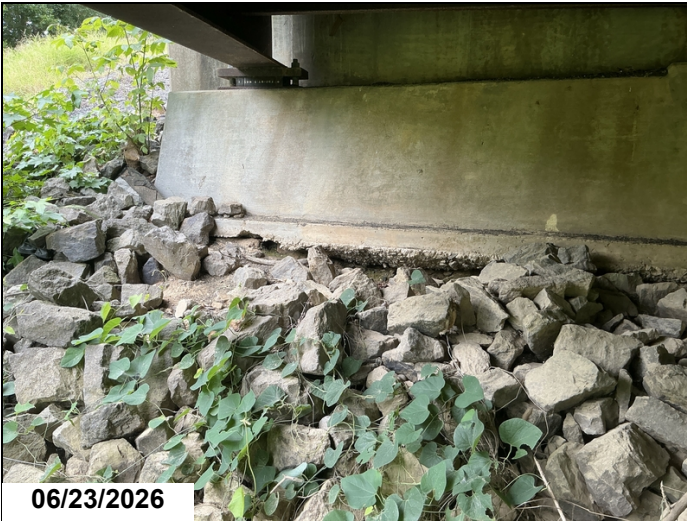
Embankment has eroded 6" below & 2' back under bottom of Abutment 1 Right & Abutment 2 Left.(Abutment 2)

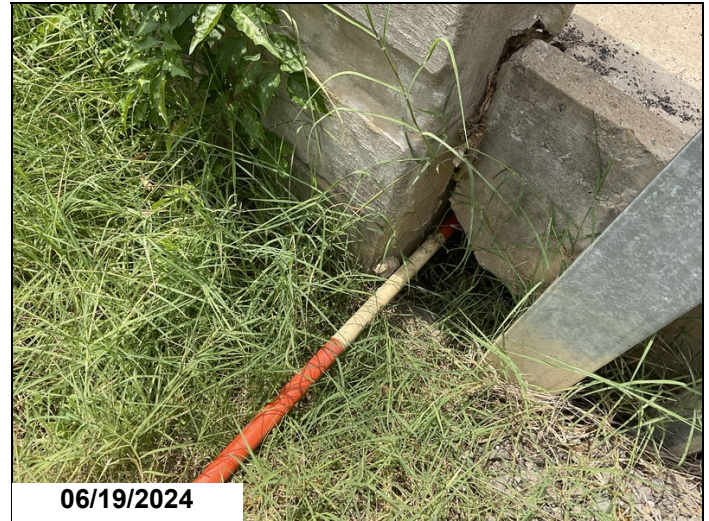
Scour 2' back under behind Lt side of abutment 2.

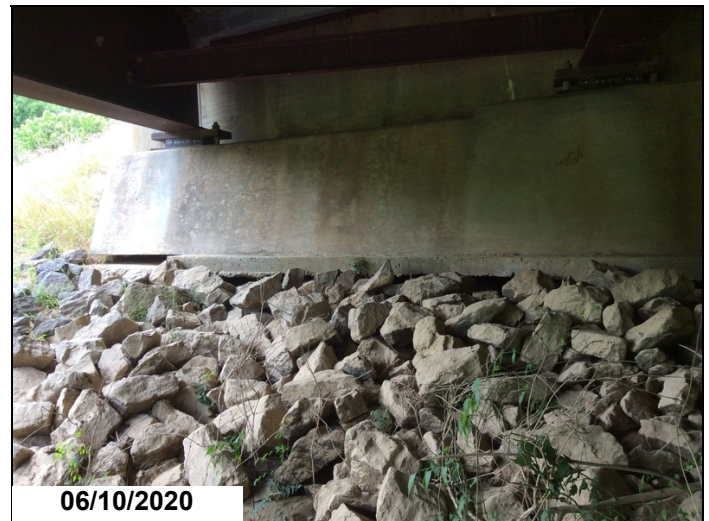
Embankment has eroded 6" below & 2' back under bottom of Abutment 1 Right & Abutment 2 Left.

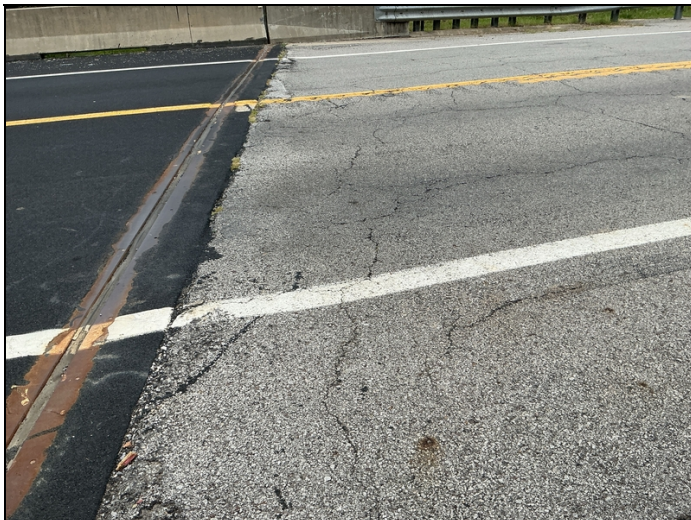
Roadway settlement at abutments 1 and 2.
