Asset #05337(Routine)

SH/16 White County over PANTHER CREEK

Location: 1.9 MI SE JCT 310

Team Lead: Kerry Little Inspection Date: 03/18/2024

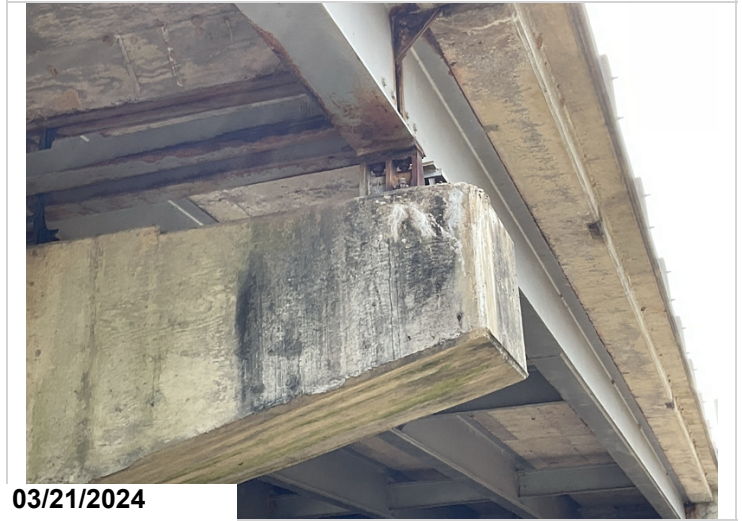
Efflor cracks to Rt ahead side of cap @ bent 1.

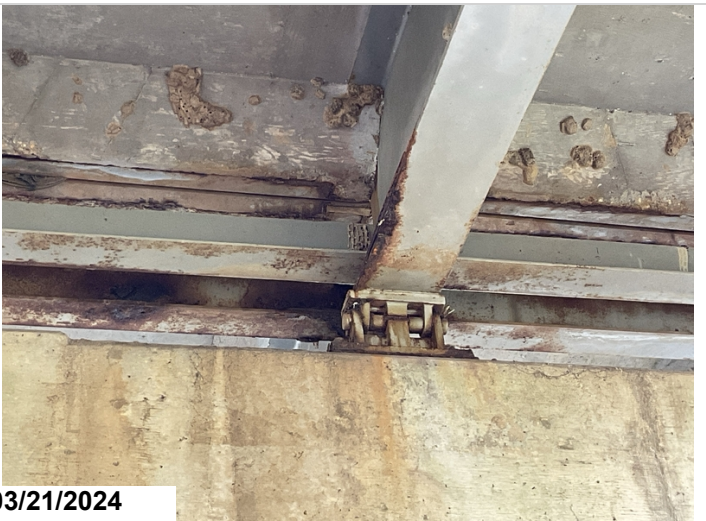
Typical corrosion to girders @ end of spans.  
Girder 5, end of span 2.

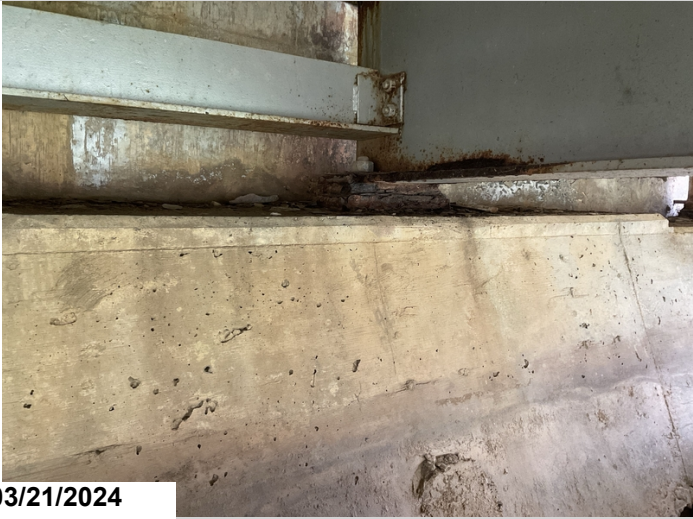
Typical (#3) corrosion to bearings 1 - 5 @ abutment 1.

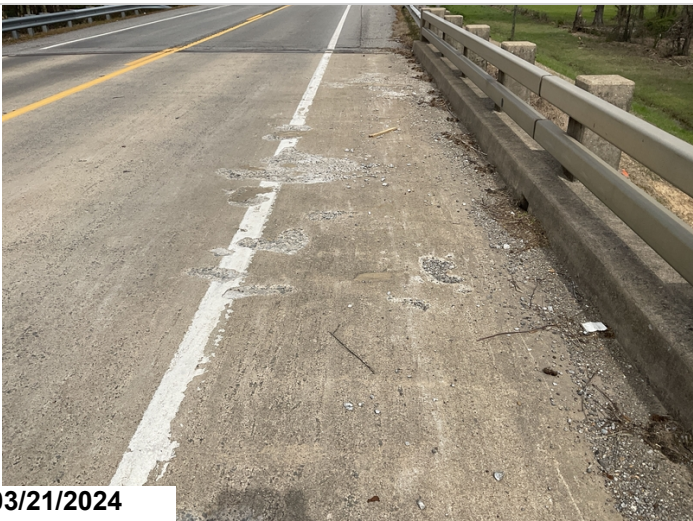
Spalls to deck @ span 1.

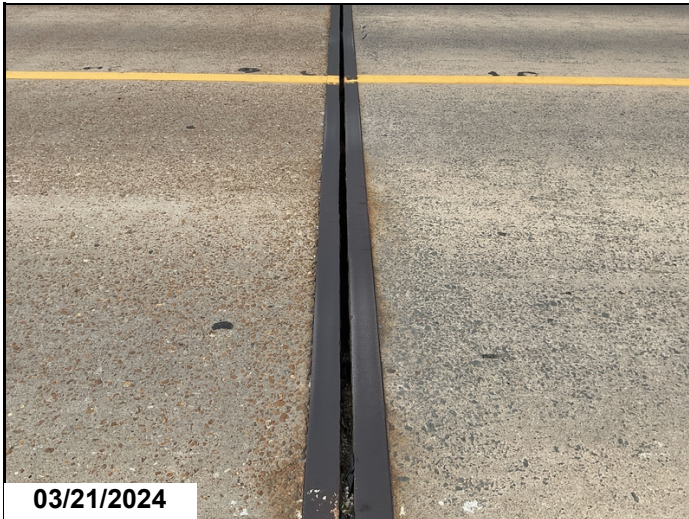
All Compression Joint Seals cracked, deteriorated & leak.  
Bent 1 - 22' Joint seal has failed.  
Bent 4 - 15' Joint seal has failed.

Bent 1 - 22' Joint seal has failed.

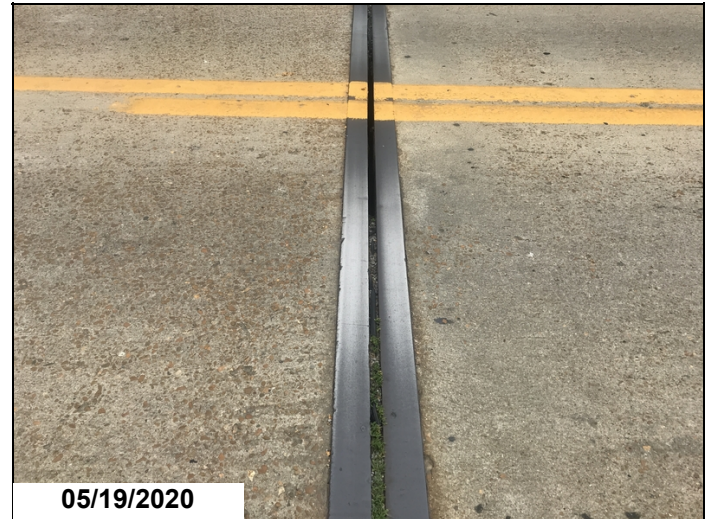
All Compression Joint Seals cracked, deteriorated & leak.  
Bent 1 - 6' Joint seal has failed.  
Bent 4 - 8' Joint seal has failed.

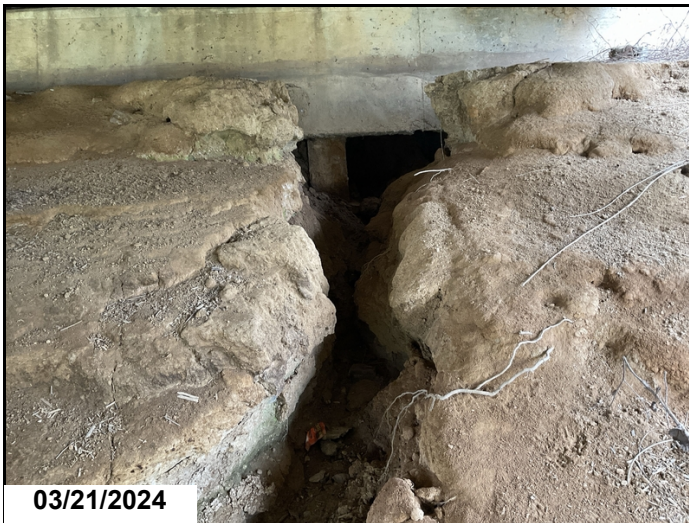
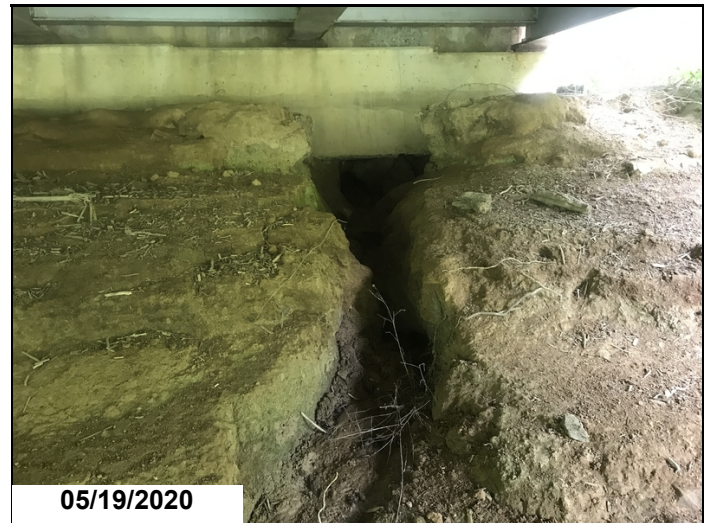
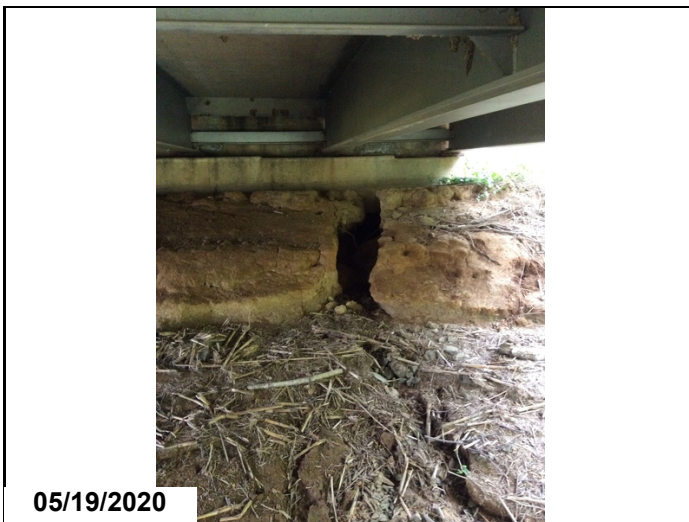
Erosion to slope at Abutment 1.

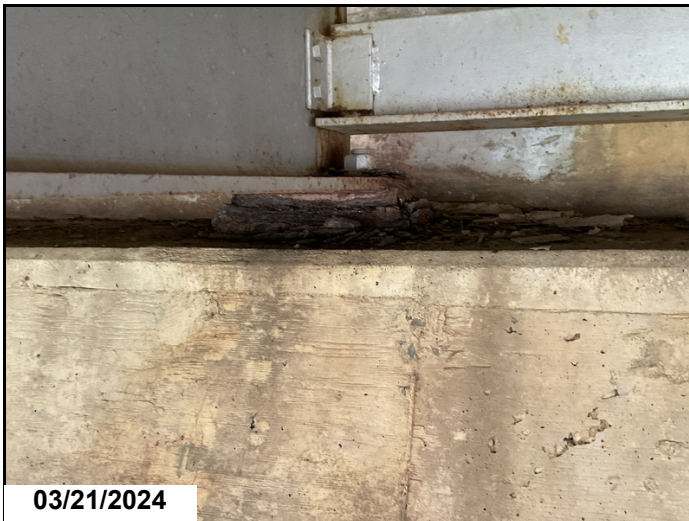
Rust/pack rust & section loss to moveable Bearing Assemblies at all Spans.  
Typical rust to bearings 1 - 5 @ abutment 1.

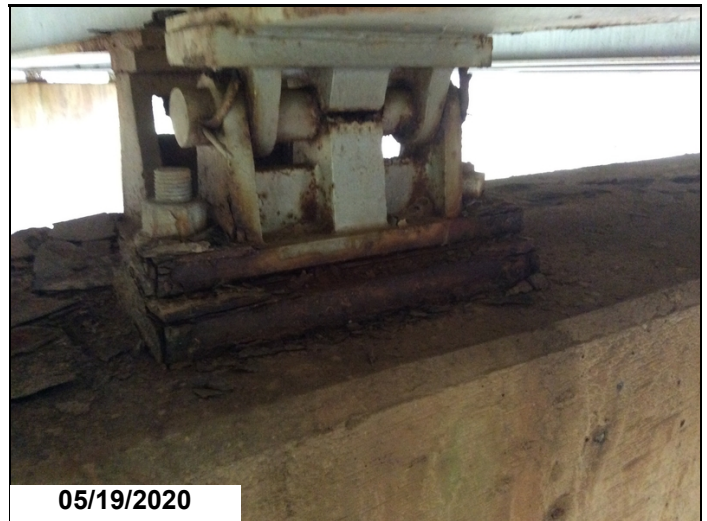
Rust/pack rust & section loss to moveable Bearing Assembly at all Spans.

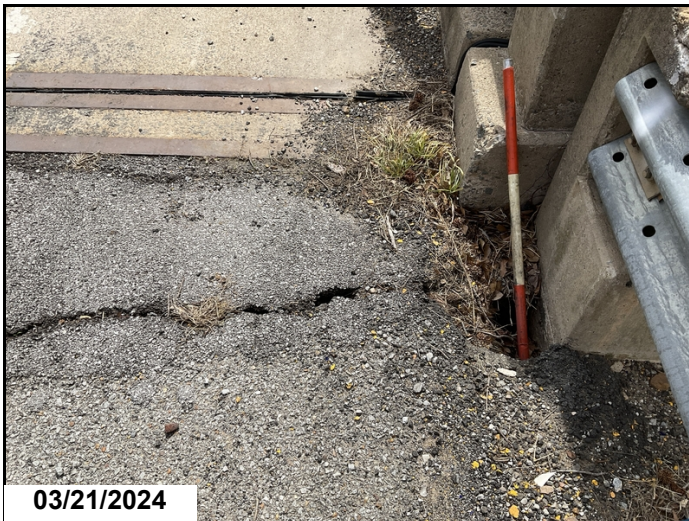
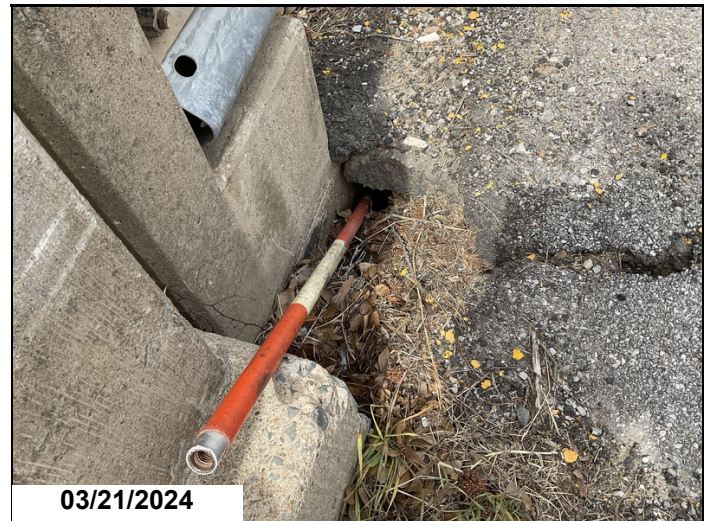
1'x1'x2' down Erosion to edge of roadway to Rt end of abutment 1.

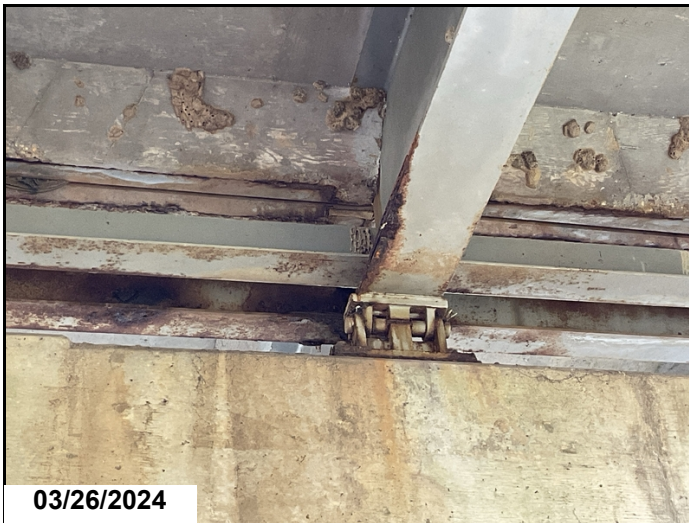
All spans have areas of corrosion and/or pack rust @ webs & lower flange @ ends of girders.

03/26/2024  
Typical corrosion to girders @ end of spans.  
Girder 5, end of span 2.

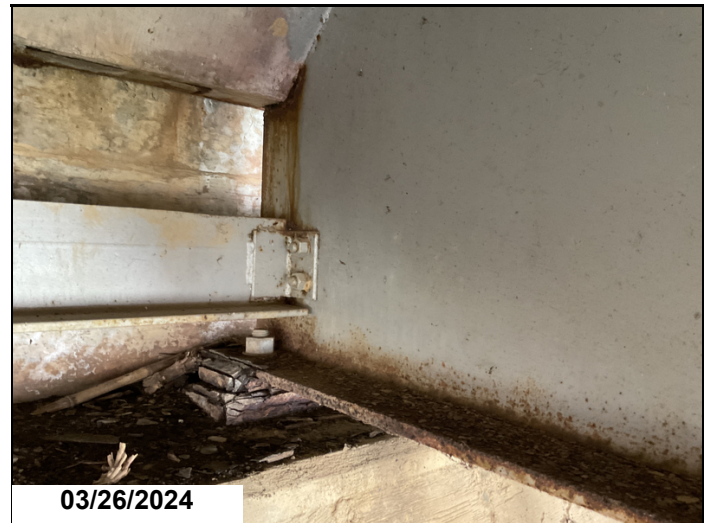
03/26/2024  
Rust with s/l to web below haunch @ Girder 3 @  
Abutment 1.(#3,

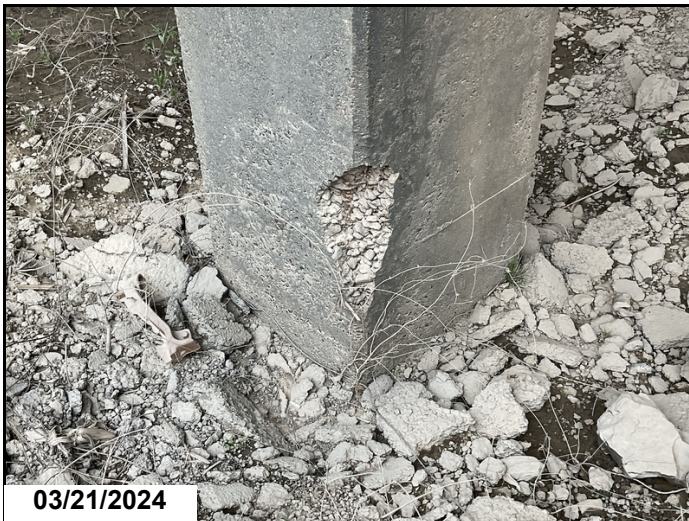
03/21/2024

Bent 1, Column 2 has spall/honeycomb area on ahead side with 3" rebar exposed.

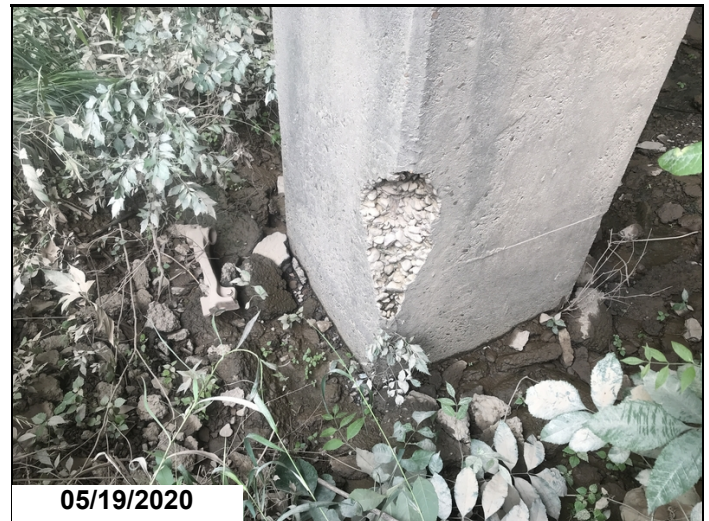
05/19/2020

Bent 1, Column 2 has spall/honeycomb area on ahead side with 3" rebar exposed.

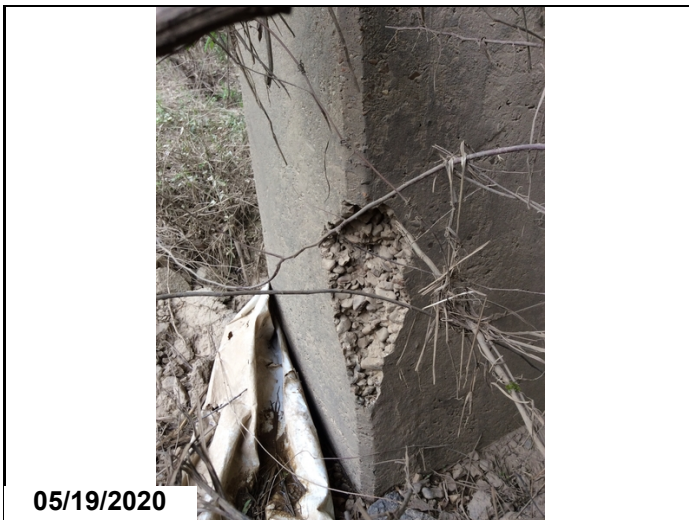
05/19/2020

Bent 1, Column 2 has spall/honeycomb area on ahead side w/t 3" rebar exposed.

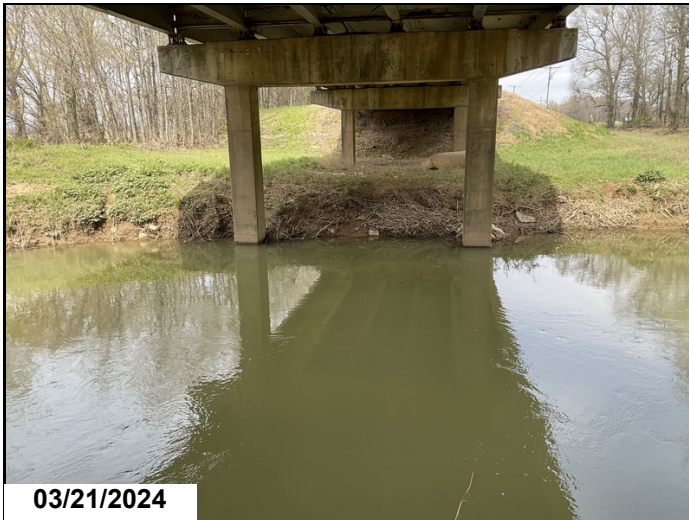
Scour at Bent 2.

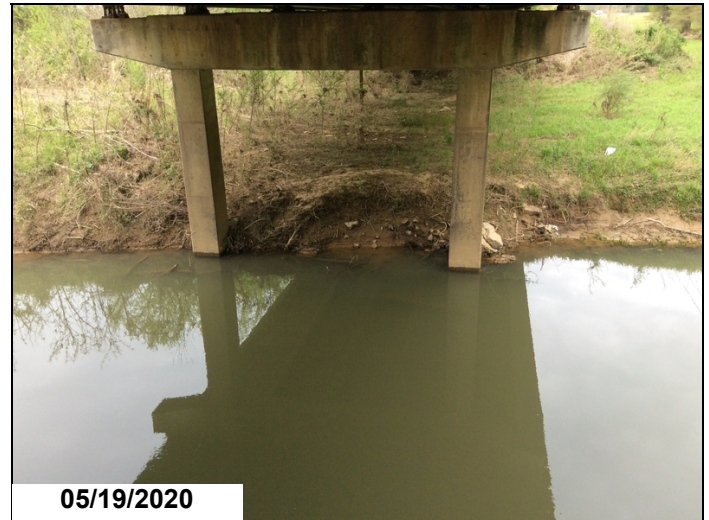
Scour to bent 2.

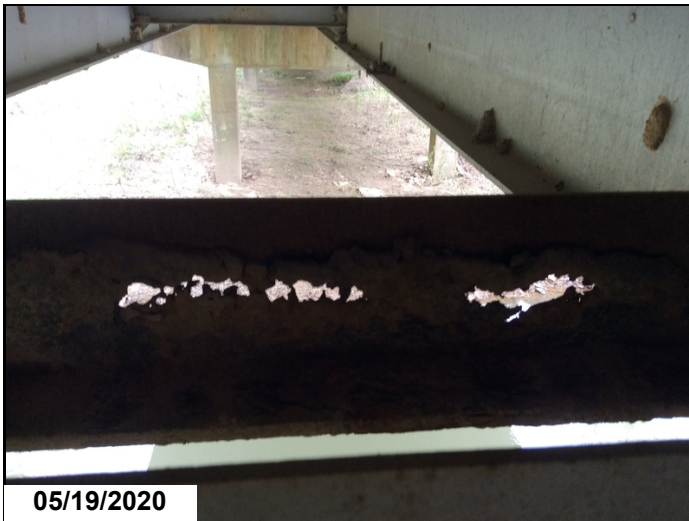
Span 3 between Girders 2 & 3  
Beginning of Span.

Holes in Diaphragm at Beginning of Span 2 between Girders 2 - 4 & Span 3 between Girders 2 - 5 at Beginning of Span.

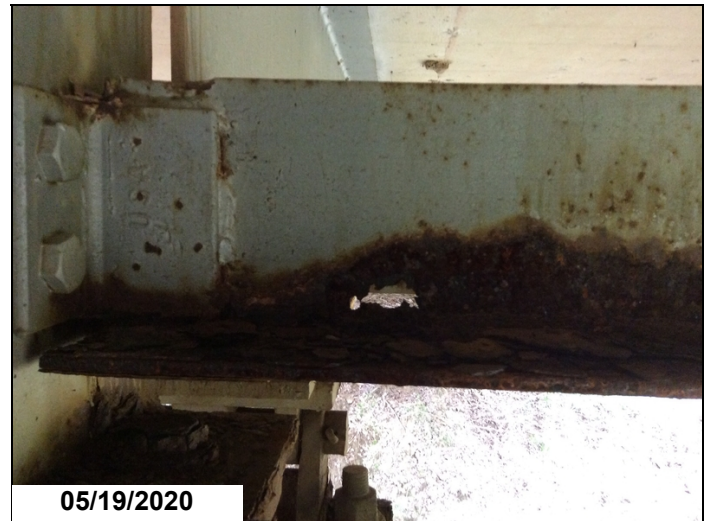
Holes in Diaphragm at Beginning of Span 2 between  
Girders 2 - 4.  
Beginning of Span 3 between Girders 2 & 3.

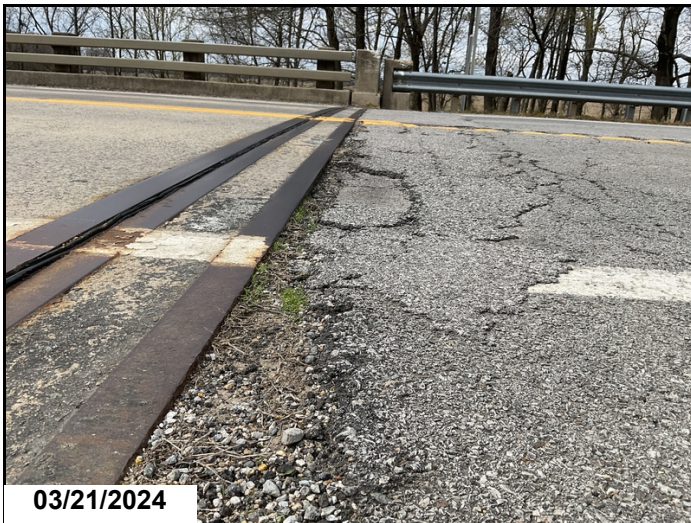
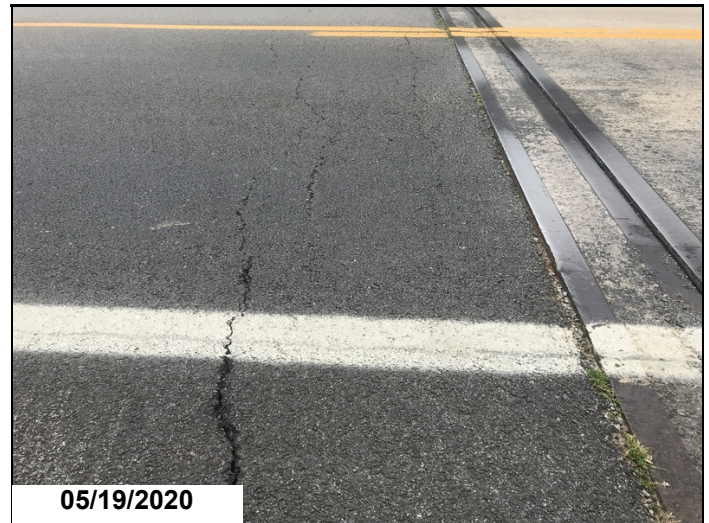
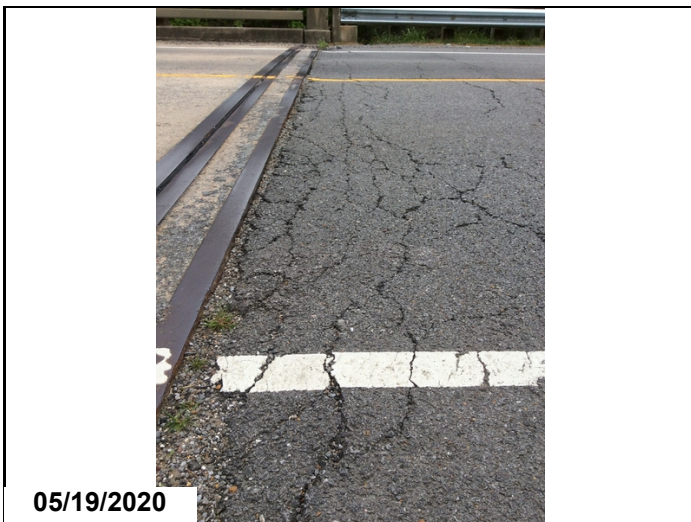
Visible settlement to Roadway at Abutment 1 & 2.
