Asset #05338(Routine)
SH 16 White County over BIG CREEK
Location: .8 MI N JCT SH 310

Team Lead: Kerry Little Inspection Date: 03/21/2024

General Observation

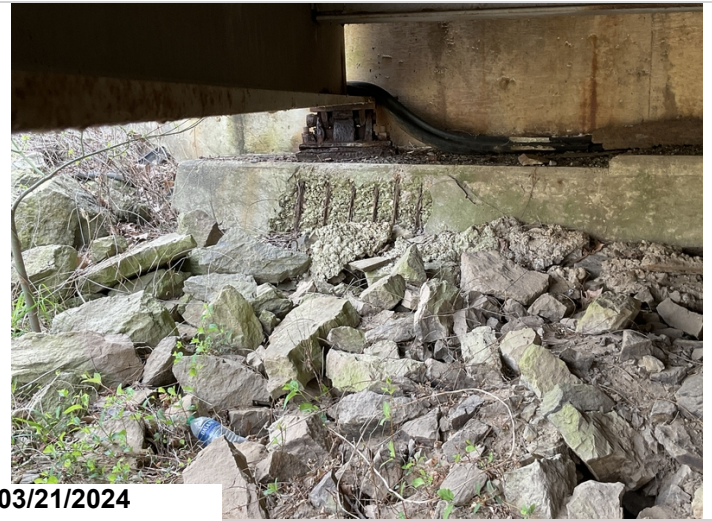
(215) Abut. 1 - Erosion behind Lt. wing 2' down 3' back under. Debris on cap. Vertical cracks to abut. Few with rust. Abut. 2 - Debris on cap. 3' spall with 6' rebar exposed near Lt. end. Rebar 3' CS3 2' delam. to Lt. end of cap. 2' CS2 Vertical cracks to abut. Few with rust. Cracks 9' CS2 Efflor/Rust 3' CS3							
234	Reinforced Concrete Pier Cap	LF	75	75	0	0	0
302	Compression Joint Seal	LF	87	0	0	12	75
2310	Leakage	LF	75	0	0	0	75
2340	Seal Cracking	LF	12	0	0	12	0

3' Spall with 6' of (#3) rebar exposed to Abutment 2 on Left end.(#3)

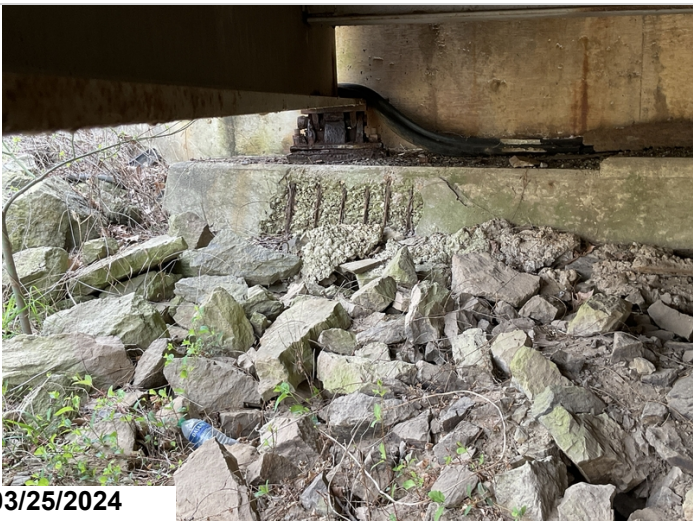
3' Spall with 6' of (#3) rebar exposed to Abutment 2 on Left end.(#3)

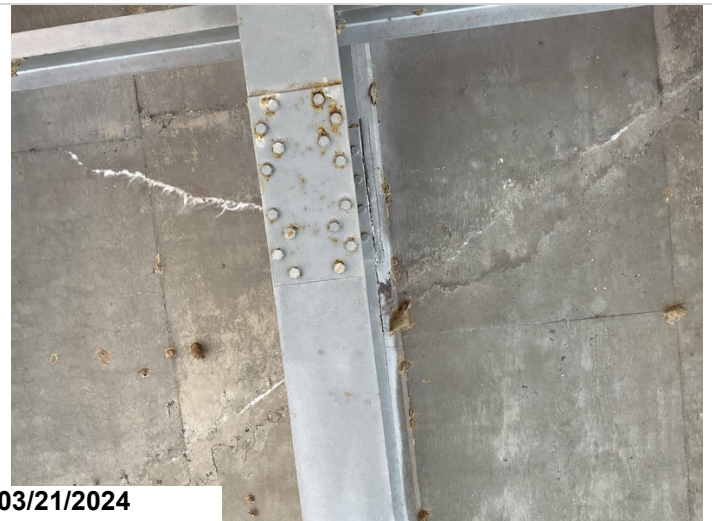
Typical efflorescence cracks to undersurface @ span 2.

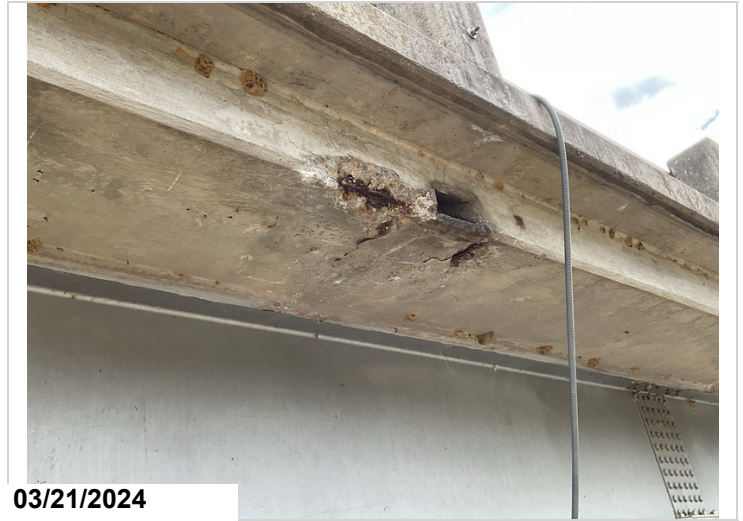
Span 2 - Spall to soffit with 2' rebar exposed near 1st drain on Right.

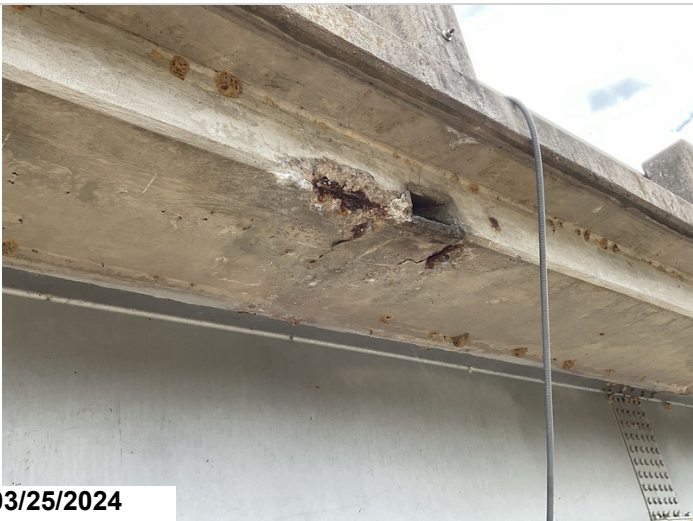
Span 2 - Spall to soffit with 2' rebar exposed near 1st drain on Right.

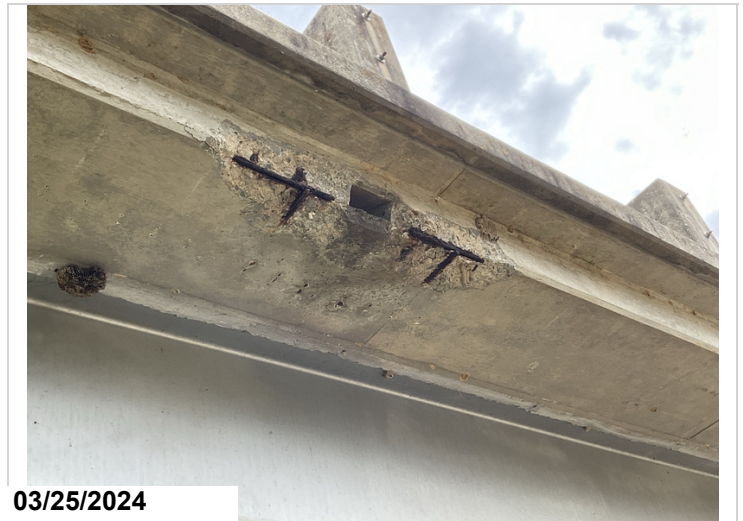
Span 1 has spall with 2' rebar exposed to soffit @ 2nd drain opening on Right.

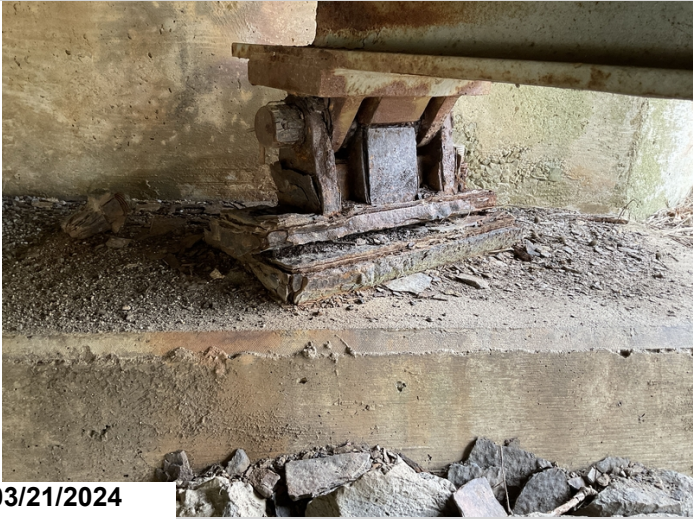
(311) Span 1 @ beg. of span: Bearing 1 - Bearing has pack rust/section loss and 1 anchor bolt missing. Connection 1 CS3 Bearing 2,3,4,5 - Bearing has pack rust/section loss. 4 CS3 Span 4 @ end of span: Bearing 1,2 - Bearing has pack rust/section loss. 1 CS3 Bearing 3 - Bearing has pack rust/section loss and 1 anchor bolt missing. Connection 1 CS3 Bearing 4 - Bearing has pack rust/section loss. 1 CS3

Typical (#3) rust & pack rust to Moveable Bearings.
Girder 1, Abutment 1.

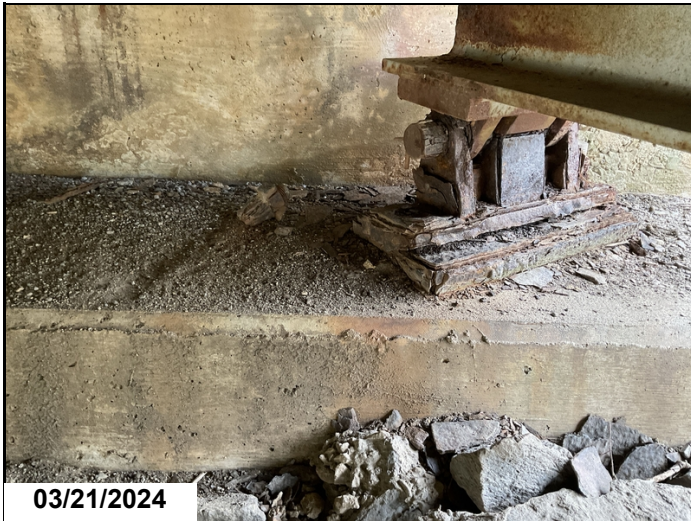
Anchor bolt missing to Bearing 1 at Abut. 1

Anchor bolt missing to Bearing Assembly 1 at Abutment 1.

Type of Work: Bearing Repair/Replacement

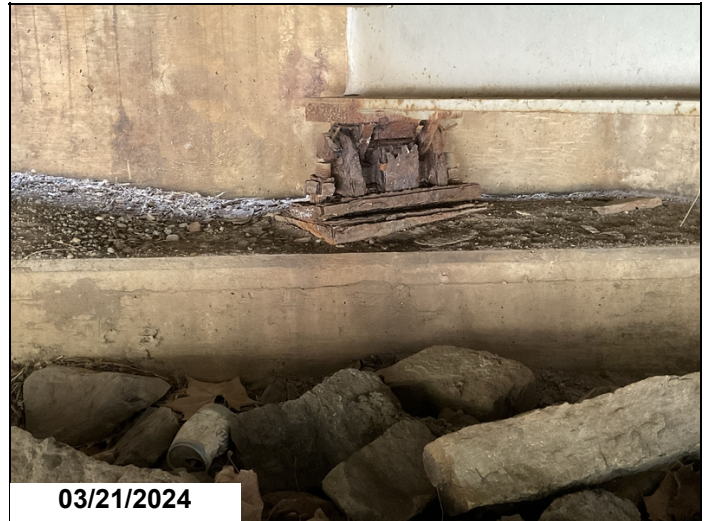
Rust with pack rust to moveable bearings at Abutments 1 & 2.

Rust, corrosion & flaking to moveable bearings at Abutments 1 & 2. Abutment 1, bearing 2.

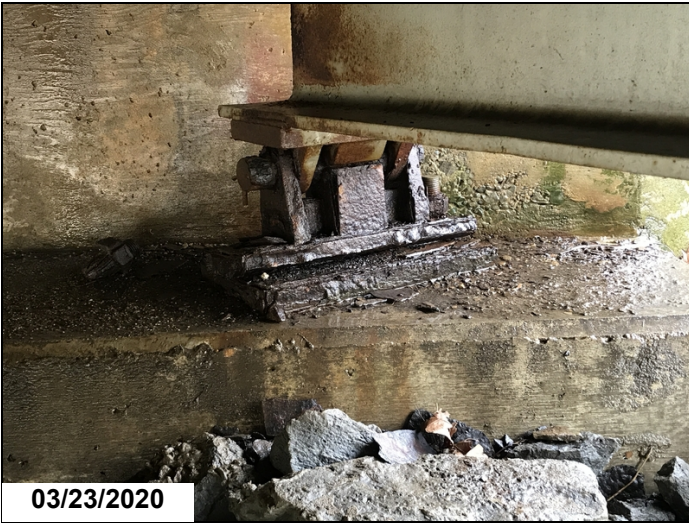
Rust, corrosion & flaking to moveable bearings at
Abutments 1 & 2.

Anchor bolt missing to Bearing Assembly 1 at Abutment
1.

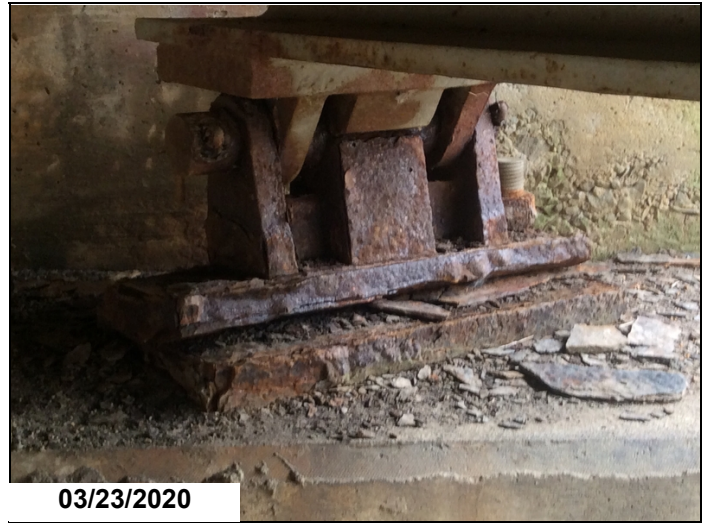
Rust, corrosion & flaking to moveable bearings at
Abutments 1 & 2.

Anchor bolt missing to bearing assembly 1 at Abutment 1.

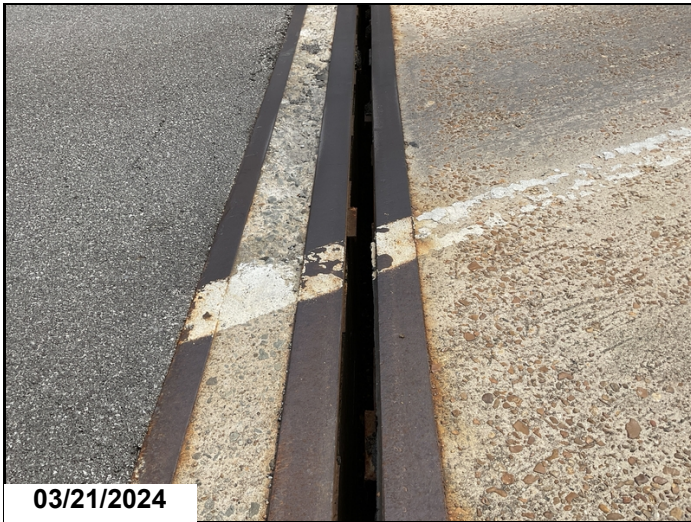
(302) Abutment 1 - 31' joint seal has failed. 31' CS4 12' joint seal is cracked. 12' CS3 Abutment 2 - All of joint seal has failed. 44' CS4							
311	Movable Bearing	EA	15	5	0	10	0
1000	Corrosion	EA	7	0	0	7	0
1020	Connection	EA	3	0	0	3	0
515	Steel Protective Coating	SF	30	10	0	0	20
3440	Effectiveness (Steel Protective Coatings)	EA	20	0	0	0	20

31' of compression joint seal has lost adhesion & is missing @ Abutment 1.

Type of Work: Joint Repair

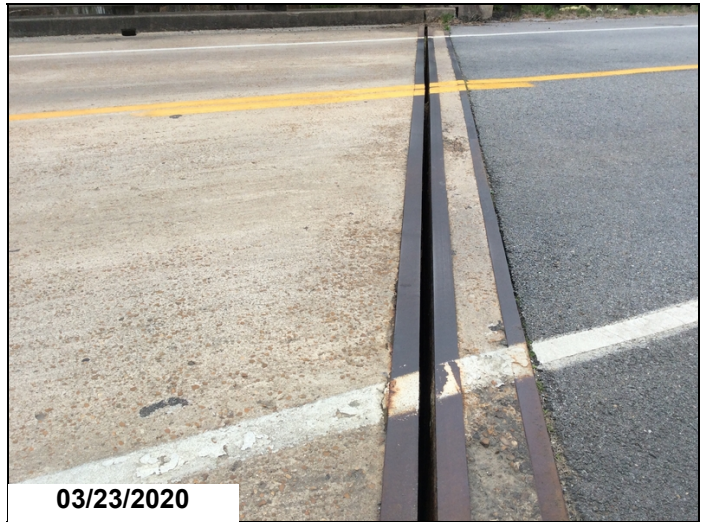
44' of compression joint seal has lost adhesion & is missing @ Abutment 2.

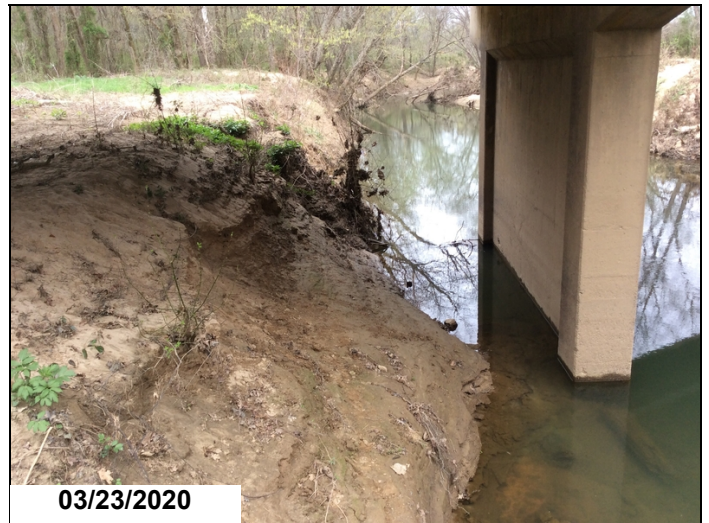
(210) Bent 2 - Moderate scour @ pier wall & embankment of Span 2. 13' CS3 Pier wall has abrasion @ water level. 10' CS2 3' CS3							
215	Reinforced Concrete Abutment	LF	102	85	11	6	0
1080	Delamination/Spall/Patched Area	LF	2	0	2	0	0
1090	Exposed Rebar	LF	3	0	0	3	0
1120	Efflorescence/Rust Staining	LF	3	0	0	3	0
1130	Cracking (RC and Other)	LF	9	0	9	0	0

Moderate scour @ Bent 2 & to embankment @ Span 3.

Type of Work: Channel Work/Drift Removal

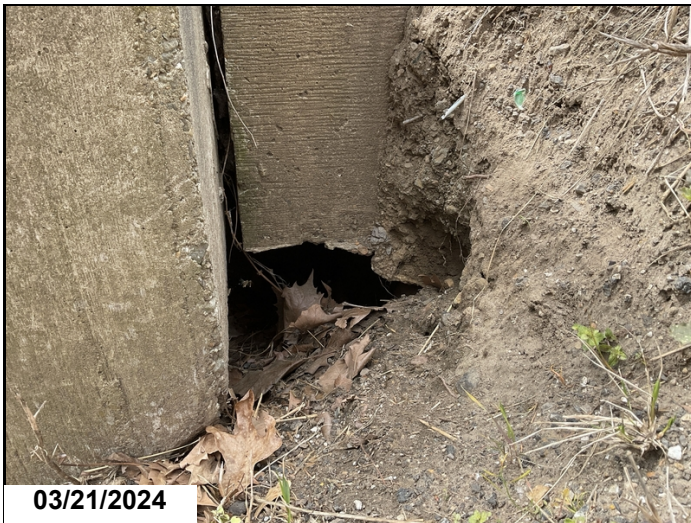
2'x3' erosion behind Lt wing @ abutment 1.

Type of Work: Repair (General)

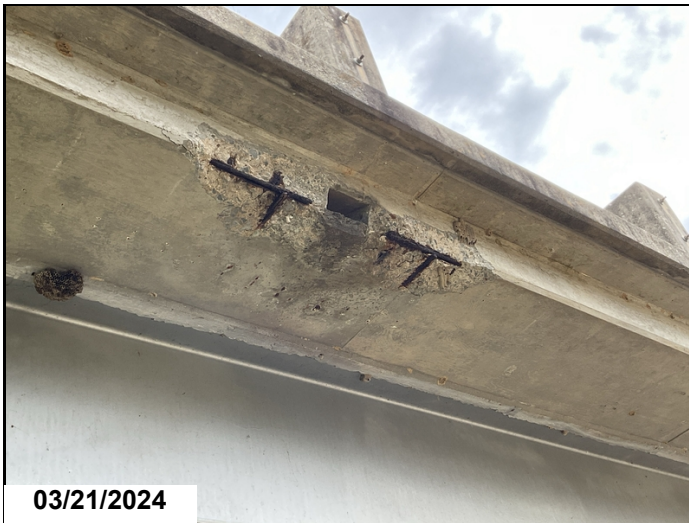
Span 1 has spall with 2' rebar exposed to soffit @ 2nd drain opening on Right.

Type of Work: Deck Repair

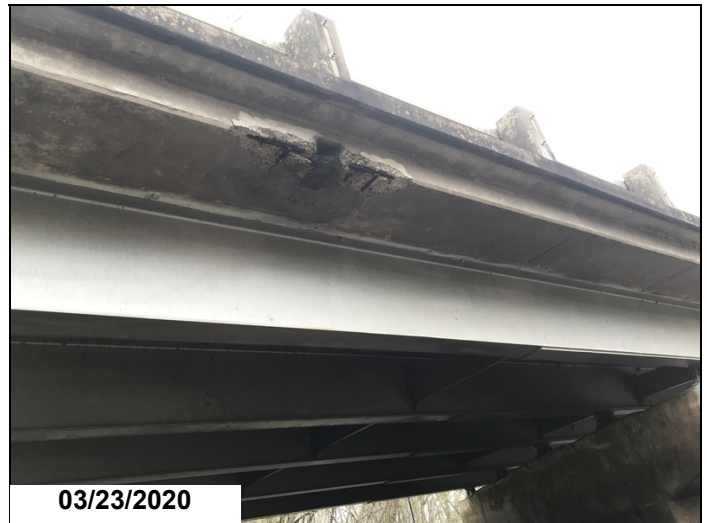
Span 1 has spall with 2' rebar exposed to soffit @ 2nd drain opening on Right.

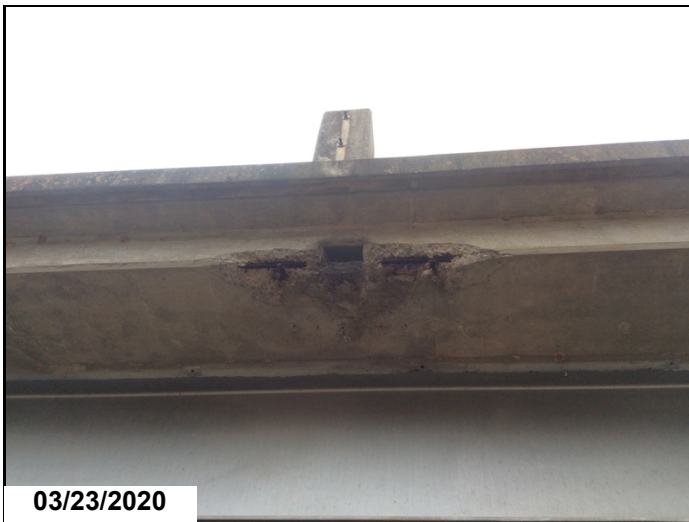
Span 1 has spall with 2' rebar exposed to soffit @ 2nd drain opening on Right.

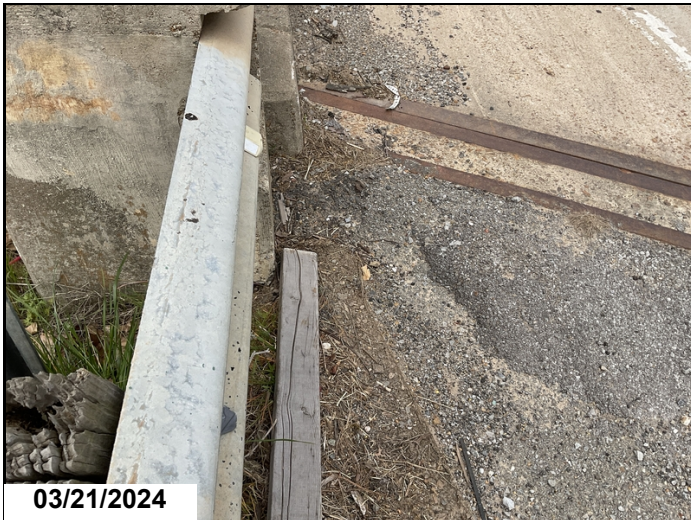
Eroded area 1' deep @ roadway & ±4' long under Right approach at Abutment 2.
Repaired

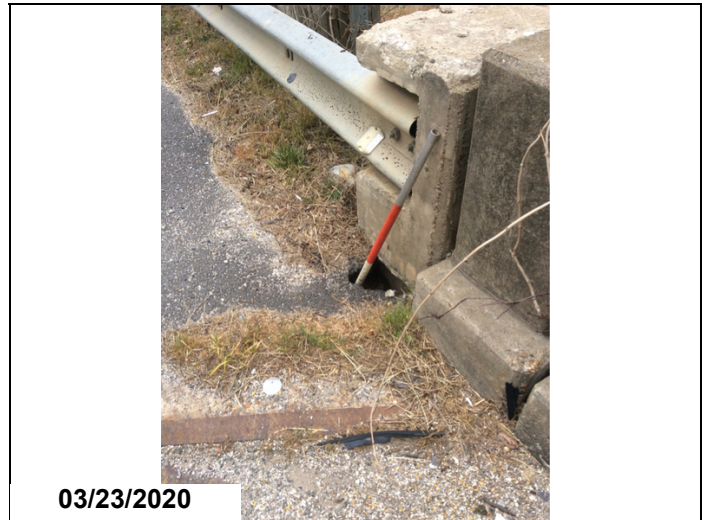
Eroded area 1' deep @ roadway & ±4' long under Right approach at Abutment 2.

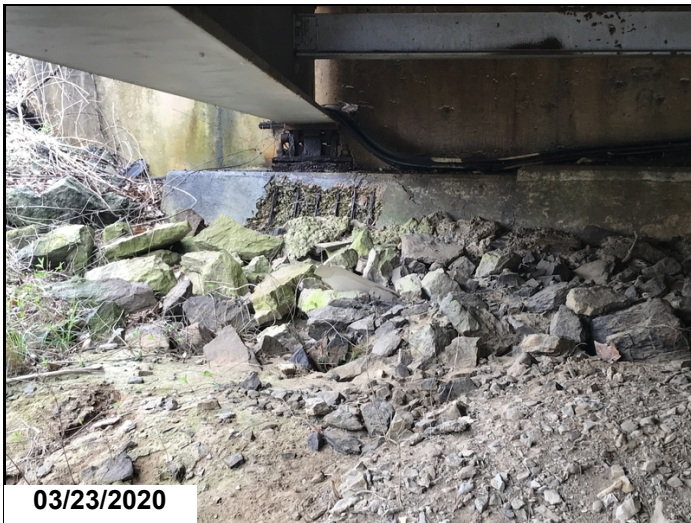
Spall with 6' rebar exposed to left end of Abutment 2.

Type of Work: Substructure Repair

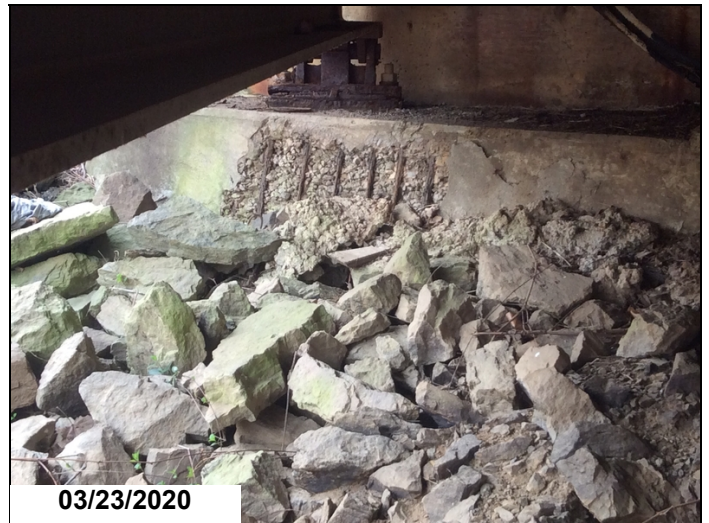
Spall with 6' rebar exposed to left end of Abutment 2.
