Asset #M0453(Routine)

SH 16 White County over CREEK

Location: S OUTSKIRTS OF PANGBURN

Team Lead: Kerry Little Inspection Date: 06/13/2023

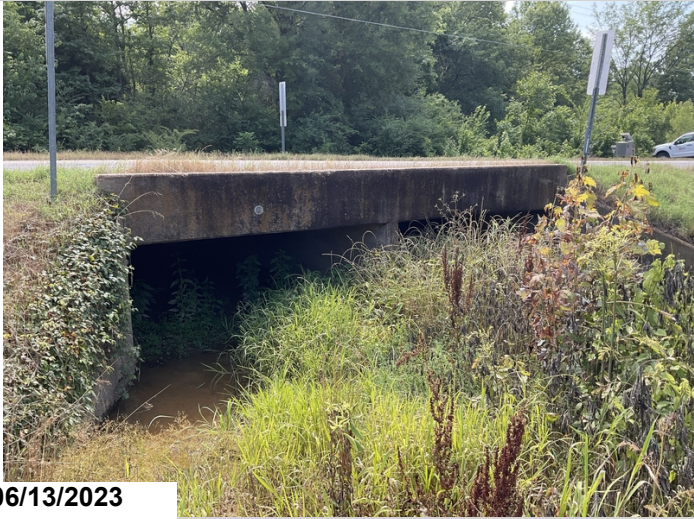
Elevation with log mile going right.

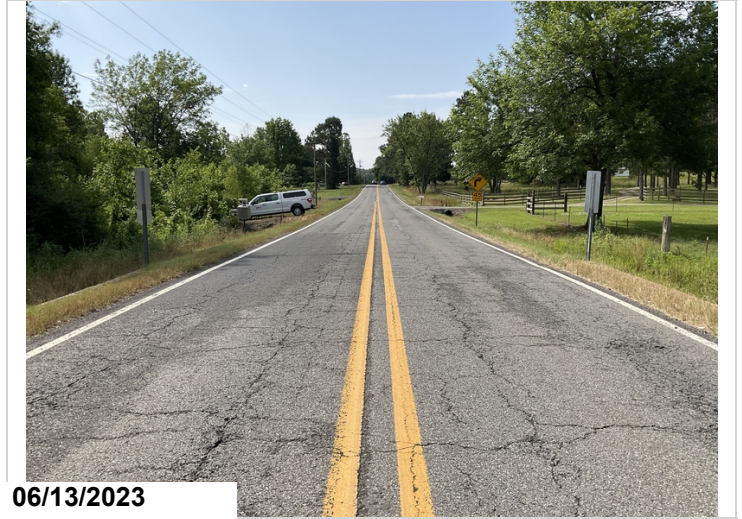
Roadway with log mile looking south.

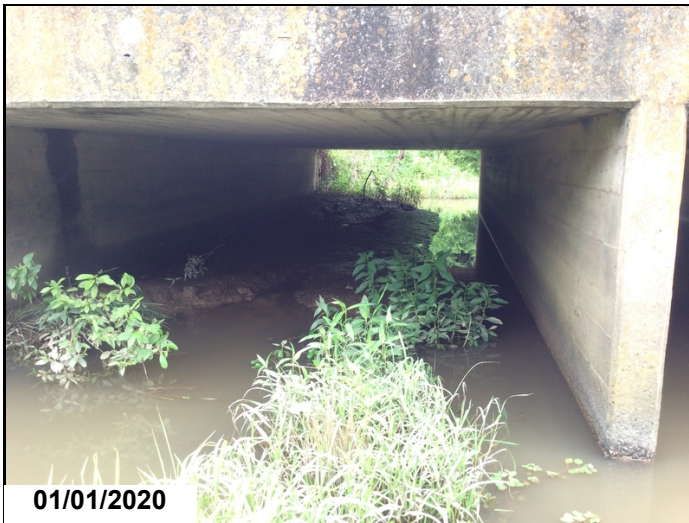
1' - 1.5' of Sediment in Barrel 1 is restricting flow.

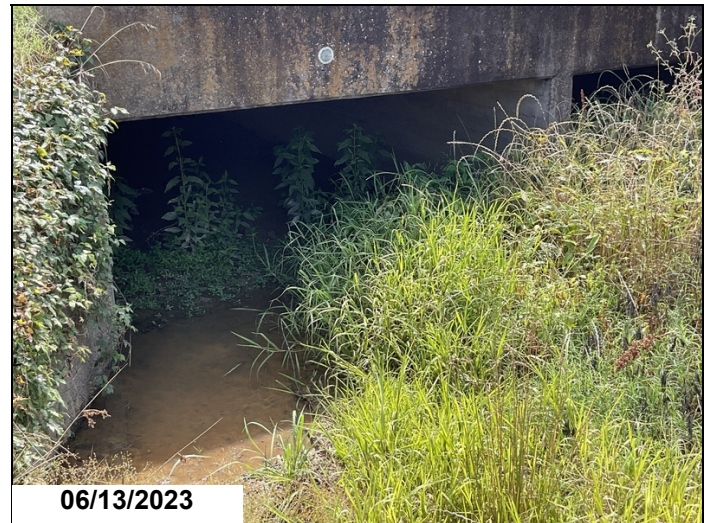
1' - 1.5' of Sediment in Barrel 1 is restricting flow.

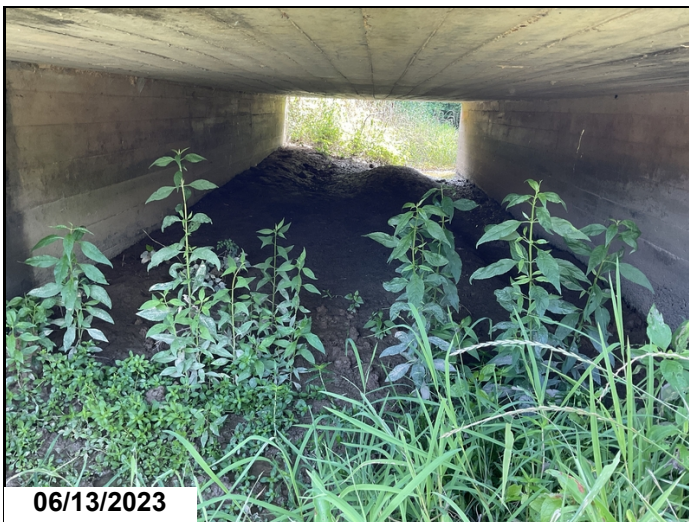
1' - 1.5' of Sediment in Barrel 1 is restricting flow.
