Route:16 Section:13 Log:6.39

(4) Place Code	0
(6) Features Intersected	BIG CREEK RELIEF
(7) Facility Carried	SH 16 White County
(9) Location	.50 MI N JCT SH 310
(11) Mile Point	6.39 mi

Asset #M0456(Routine)
SH 16 White County over BIG CREEK RELIEF
Location: .50 MI N JCT SH 310
Team Lead: Floyd Haley Inspection Date: 05/22/2024

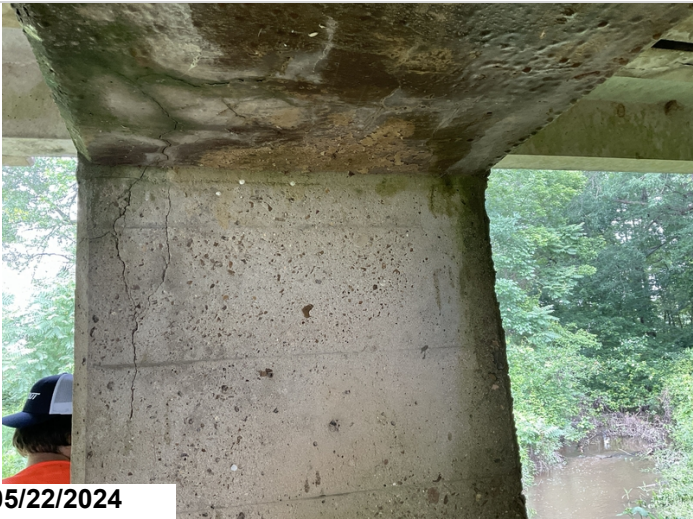
Vertical crack to Lt side of column 2 @ bent 2.

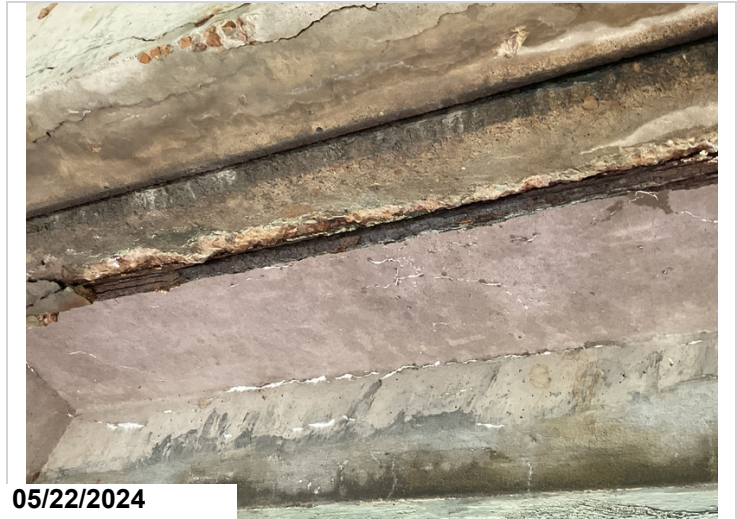
Spall with rebar exposed with 2' of rebar not adhered to unit 4, span 3.

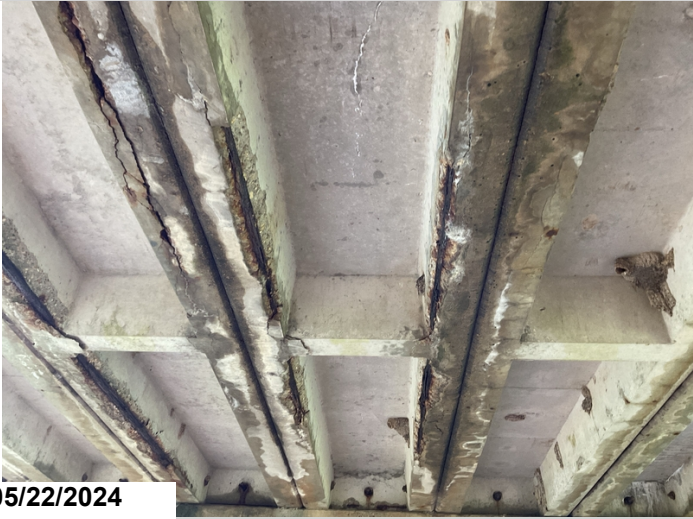
Overall superstructure is in poor condition with spalls with rebar exposed & efflorescent cracks to legs at all spans.

Typical spalls with rebar exposed to units @ all spans

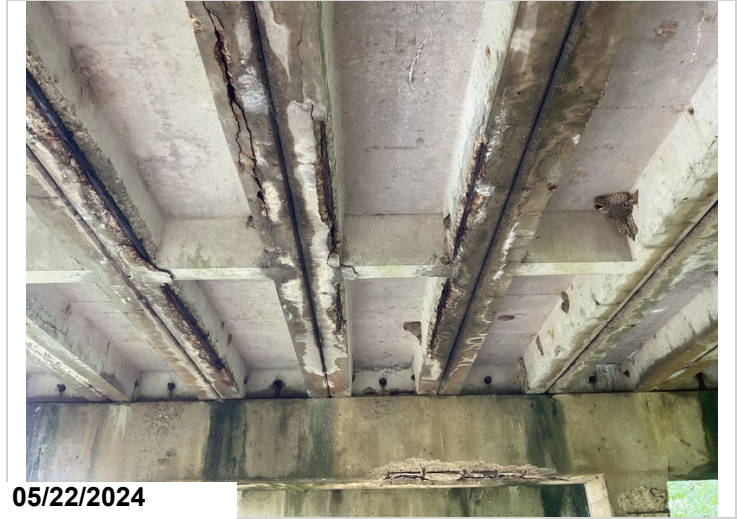
Overall deck is in fair condition with areas of efflorescent cracks to undersurface at all spans.

Undersurface @ span 4

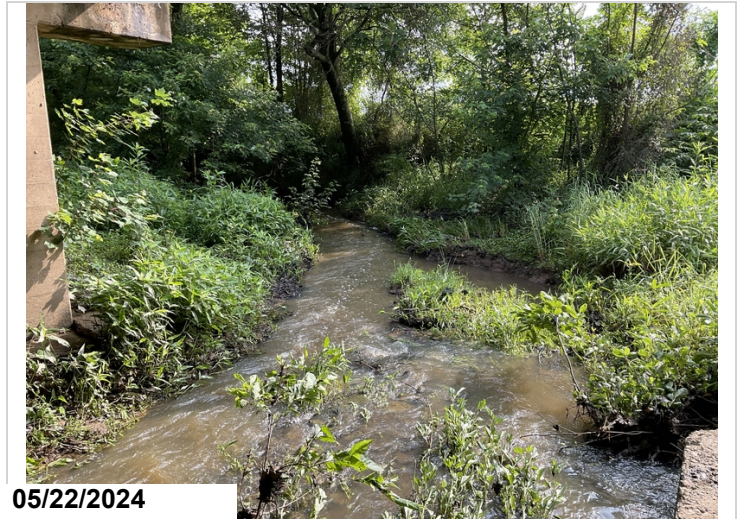
Lt channel

Heavy vegetation at all Spans on Left.

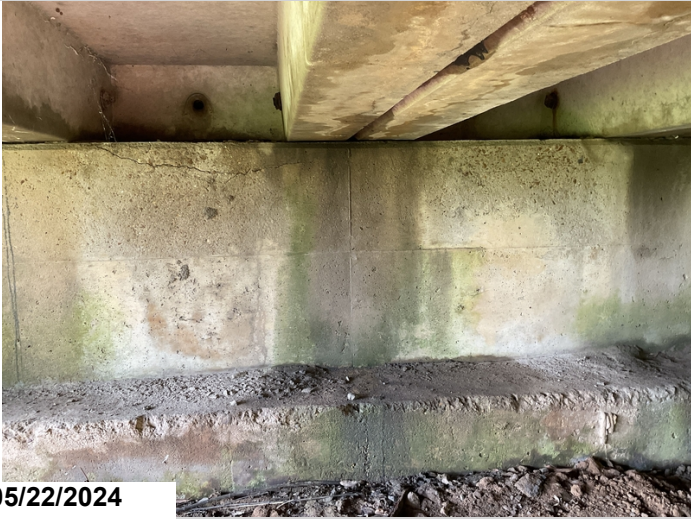
15' of horizontal crack to Abutment 2.

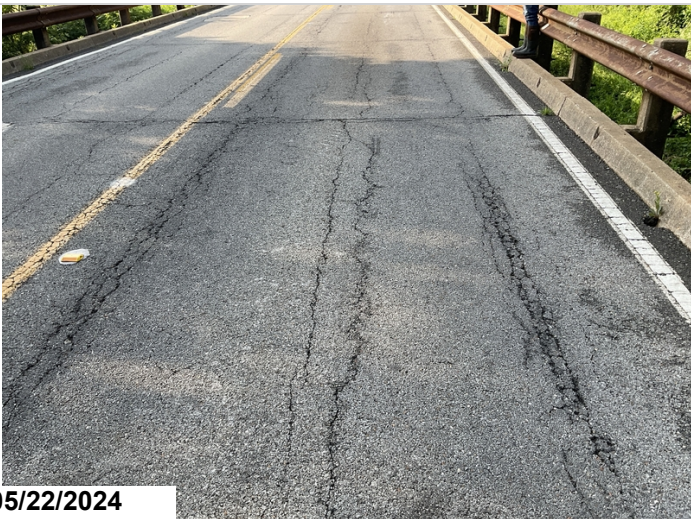
(16) Spans 1 - 7 has areas of efflorescent cracking to top flange undersurface in various locations throughout. 164' CS 2, 38' CS 3							
(510-16) Cracking to asphalt overlay @ all transverse & longitudinal unit joints @ all spans. Potholes forming to asphalt overlay.							
110	Reinforced Concrete Open Girder/Beam	LF	931	515	61	355	0
1080	Delamination/Spall/Patched Area	LF	9	0	3	6	0
1090	Exposed Rebar	LF	135	0	0	135	0
1120	Efflorescence/Rust Staining	LF	123	0	45	78	0
1130	Cracking (RC and Other)	LF	149	0	13	136	0

Typical cracks to wearing surface

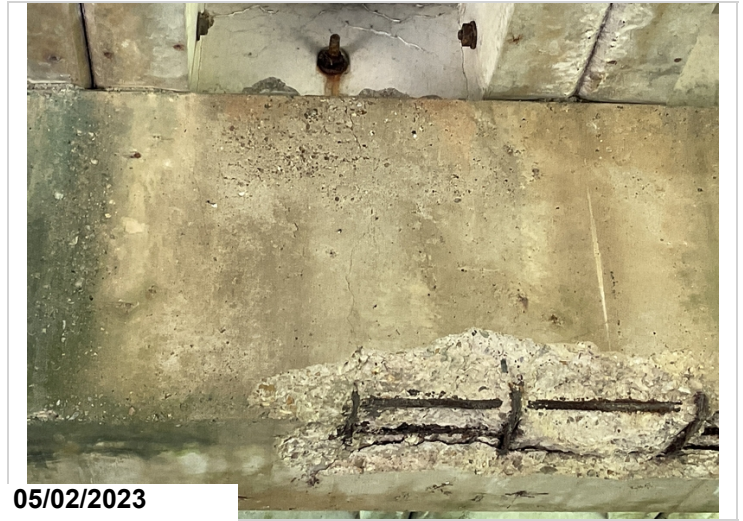
Vertical crack to backside of cap near centerline @ bent 4.

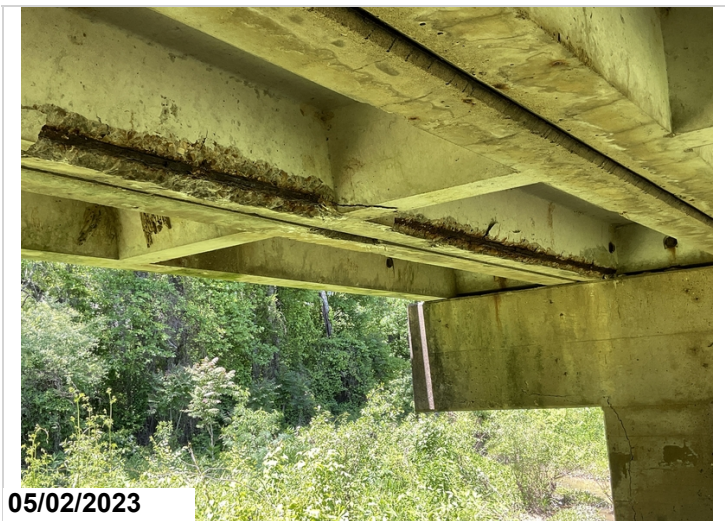
Super Structure - Girders have severe cracking with heavy efflorescence & spalling, most have exposed rebar with section loss. Some areas have lost adhesion to concrete.

Typical spalls with rebar exposed to girders @ all spans.

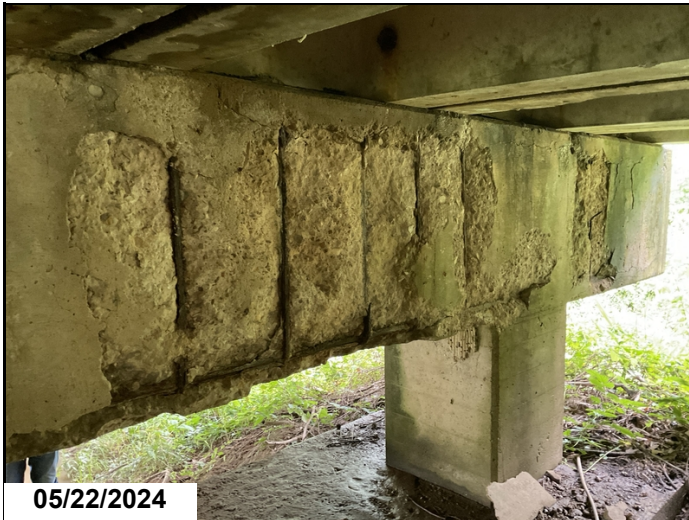
05/22/2024
Bent 1 - Horizontal cracks & spalls with 10' rebar exposed.

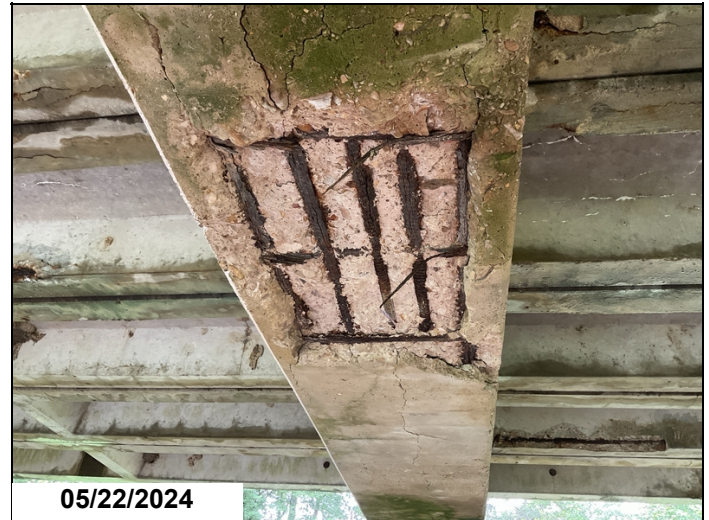
05/22/2024
Bent 3 - Heavy cracking, areas of delaminating & spalls with 8' rebar exposed.

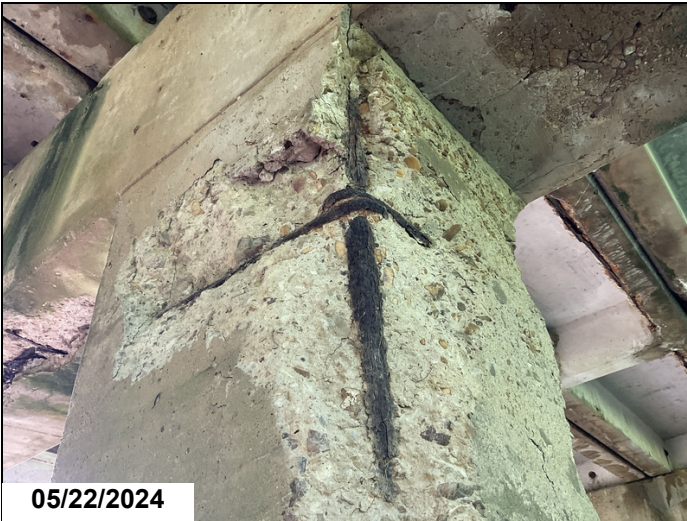
Bent 4 - Column 2 has large deep spalls with 6' of rebar exposed.

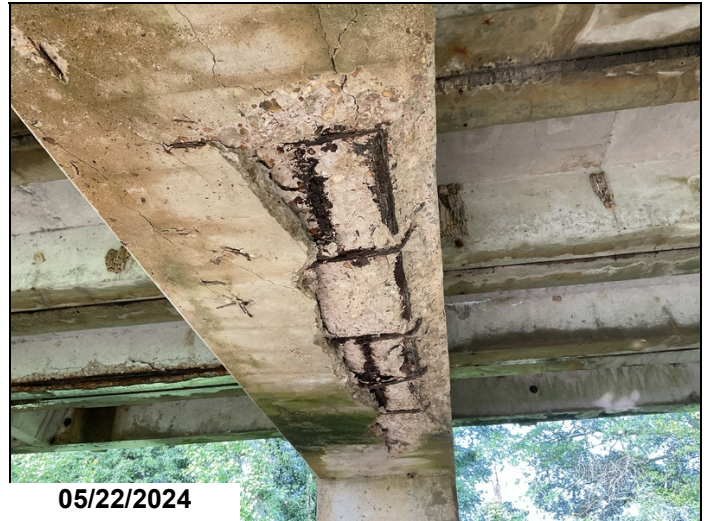
Bent 4 - Areas of delamination & spalls with 13.5' rebar exposed.

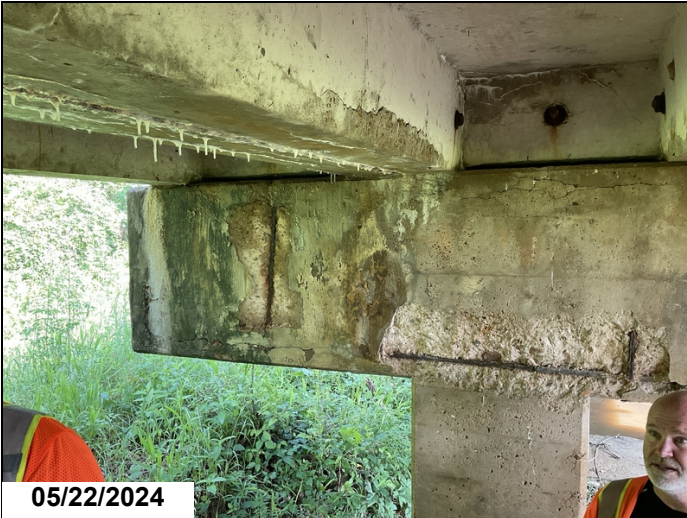
Bent 5 - Large areas of delamination & spalls to ahead side of cap with 5' of rebar exposed.

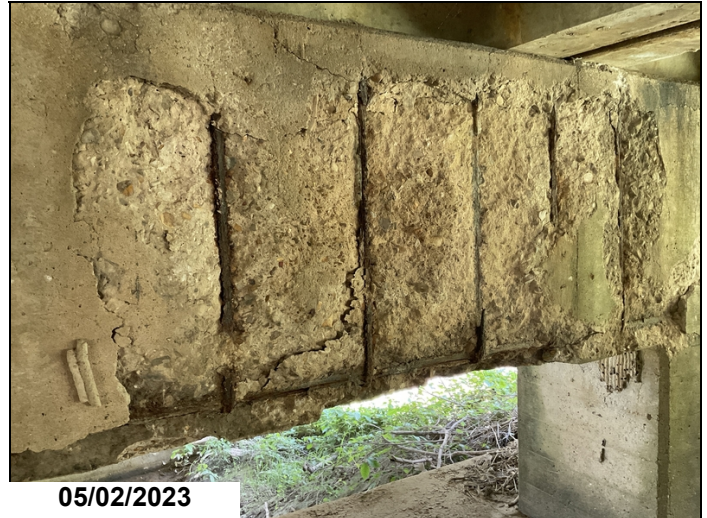
Bent 1 - Horizontal cracks & spalls with 10' rebar exposed.

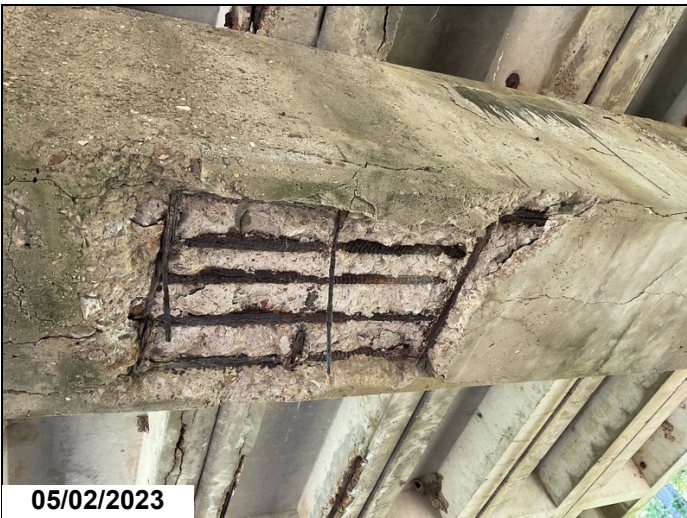
Bent 3 - Heavy cracking, areas of delaminating & spalls with 10' rebar exposed.

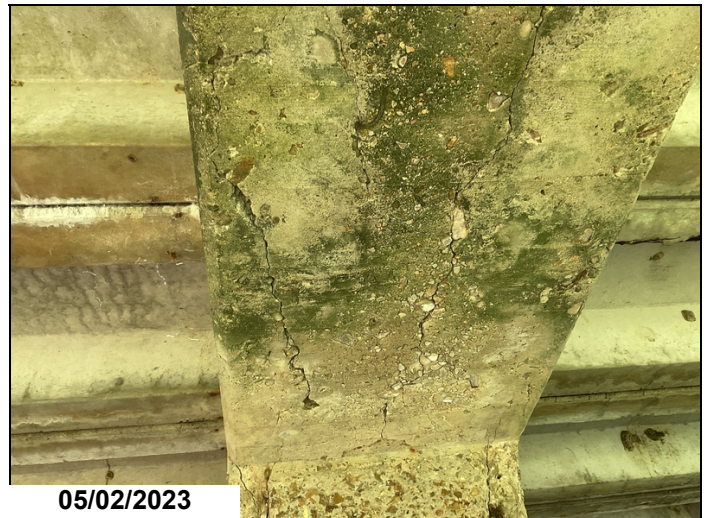
Horizontal cracks to rt side of cap near large spall.

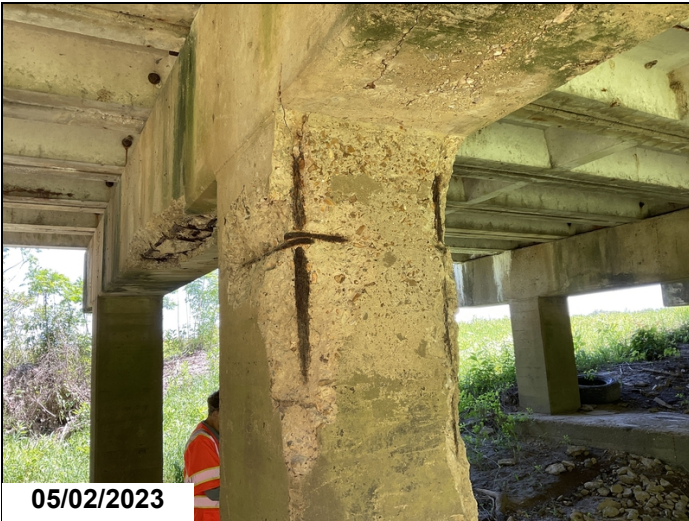
Bent 4 - Column 2 has large deep spalls with 6' of rebar exposed.

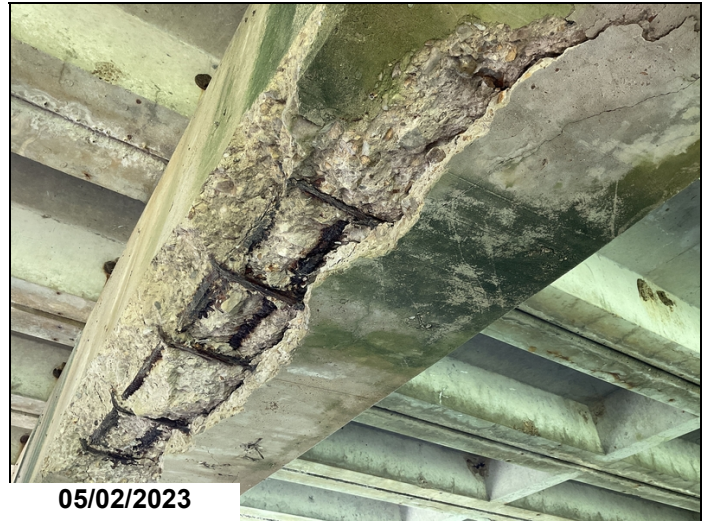
Bent 4 - Areas of delamination & spalls with 13.5' rebar exposed.

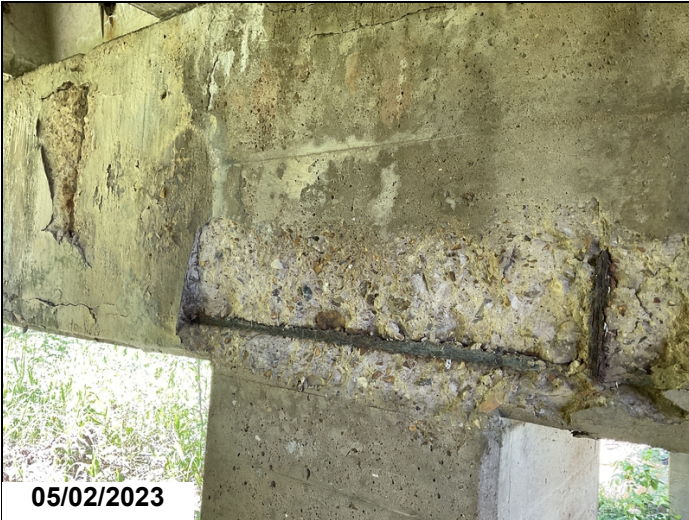
Bent 5 - Large areas of delamination & spalls to ahead side of cap with 5' of rebar exposed.

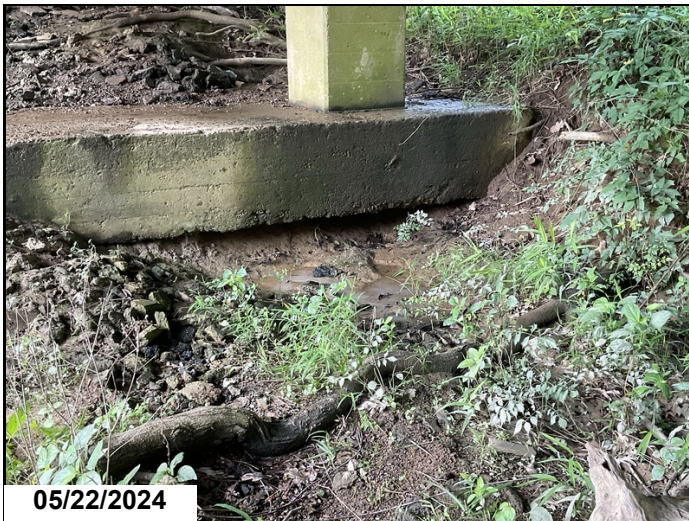
Scoured below bottom and back under footings @ Bents 1, 4 & 5. Bent 5

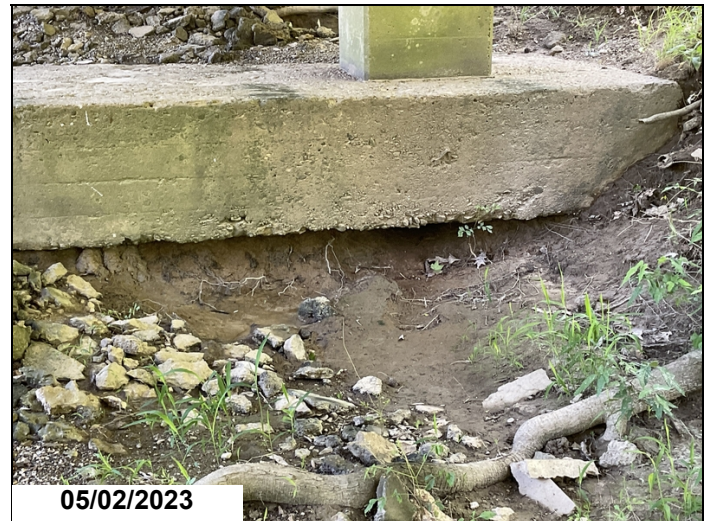
Scoured below bottom and back under footings @ Bents 1, 4 & 5. Rt side of bent 5.

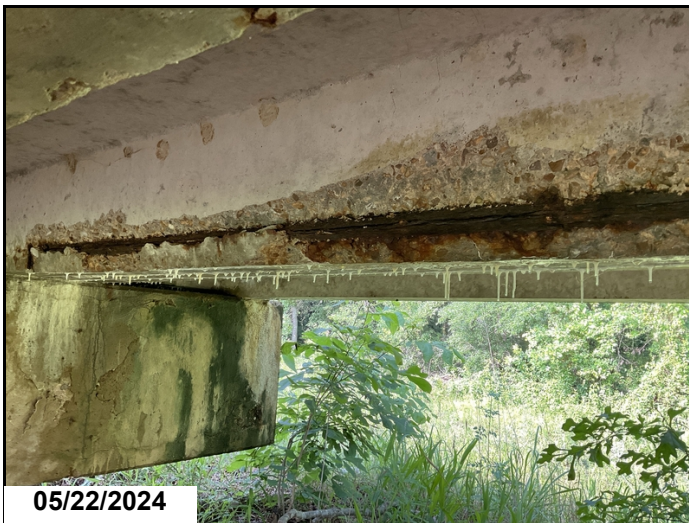
Longitudinal cracking with rebar exposed to Girders at all
Spans Unit 6, Rt leg

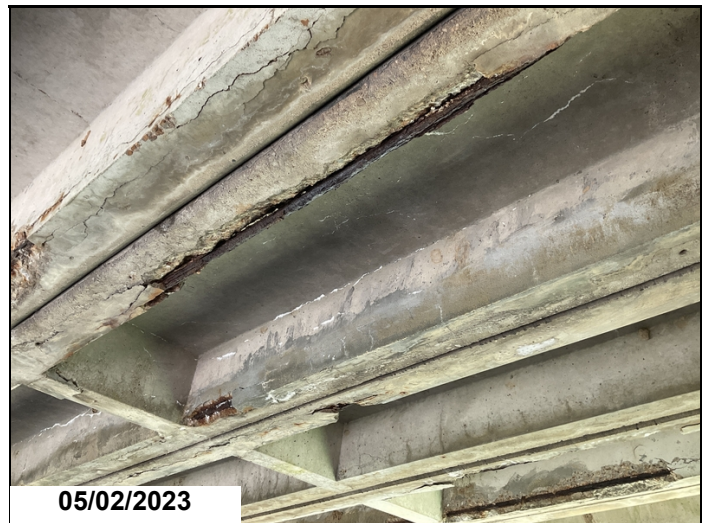
Longitudinal cracking with rebar exposed to Girders at all
Spans
Unit 4, span 3.

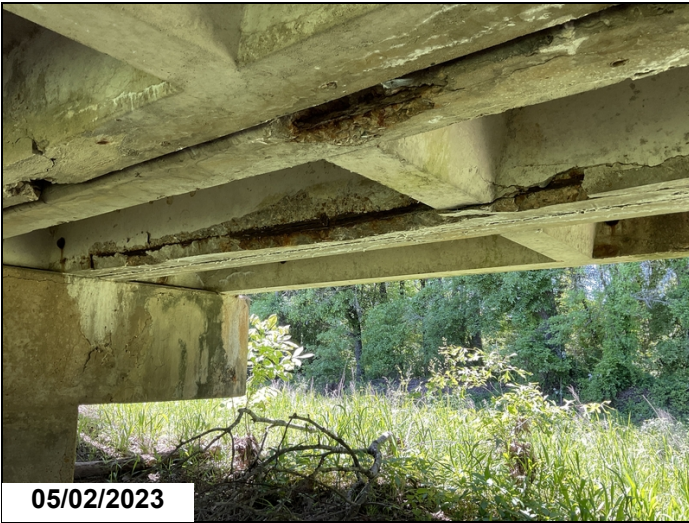
Longitudinal cracking with rebar exposed to Girders at all
SpansUnit 6, span 6.

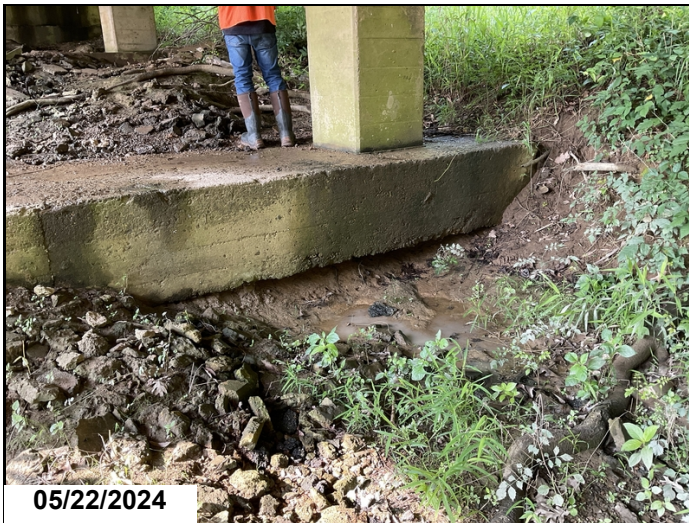
Scour with Footings exposed at Bents 1 - 6 Bent 5

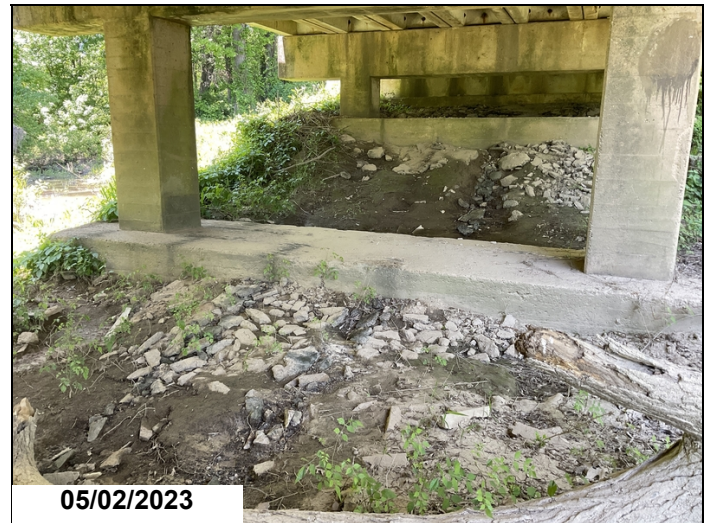
Scour with Footings exposed at Bents 2, 3, & 6. Bent 2.

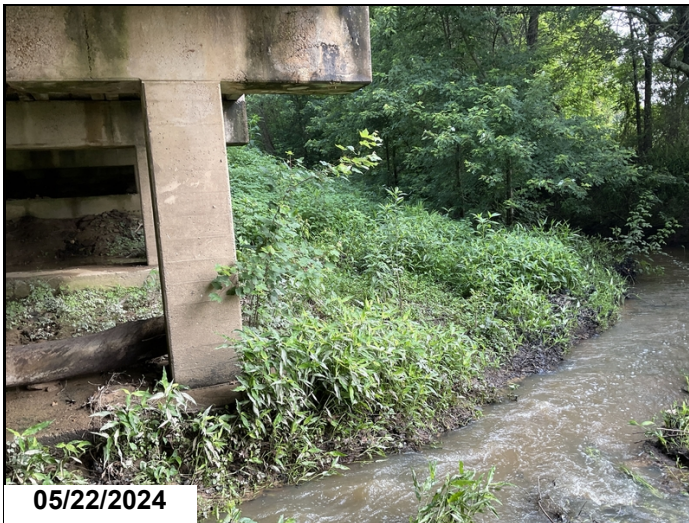
Heavy vegetation at all Spans on Left.

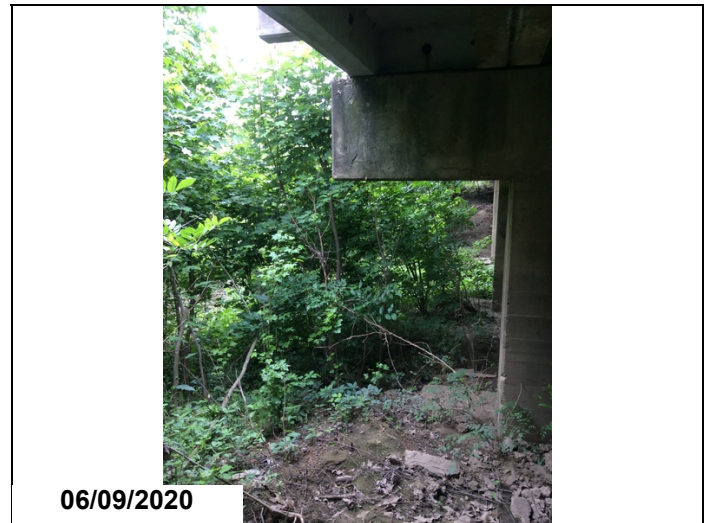
Heavy vegetation to Left side at all Spans.
