Asset #X0575(Routine)
SH 16 WHITE CO. over BRIER CREEK

Location: .25 MI S PANGBURN

Team Lead: Kerry Little Inspection Date: 01/09/2024

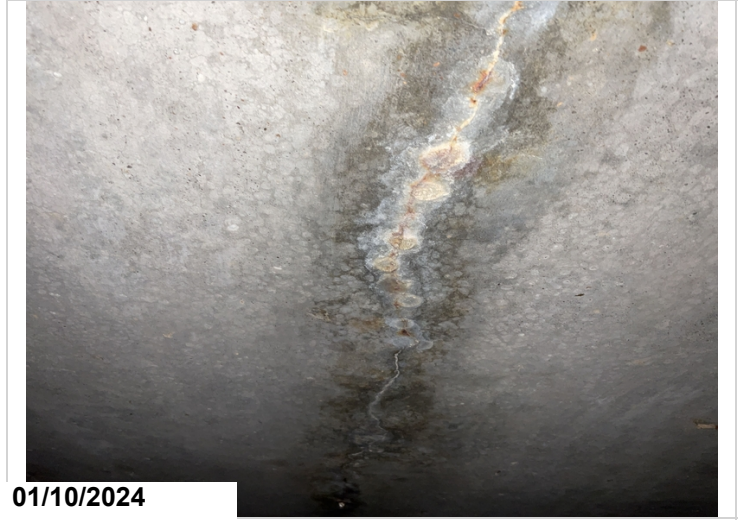
Efflor crack with rust to soffit @ barrel 3.

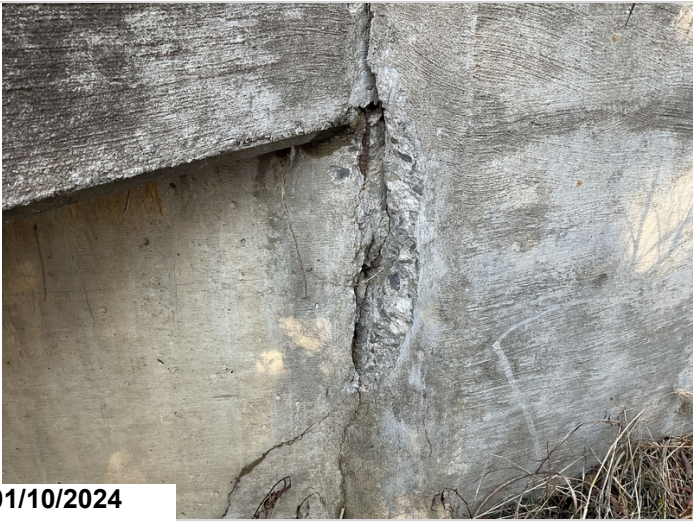
Spall with rebar exposed to Lt side of abutment 1.

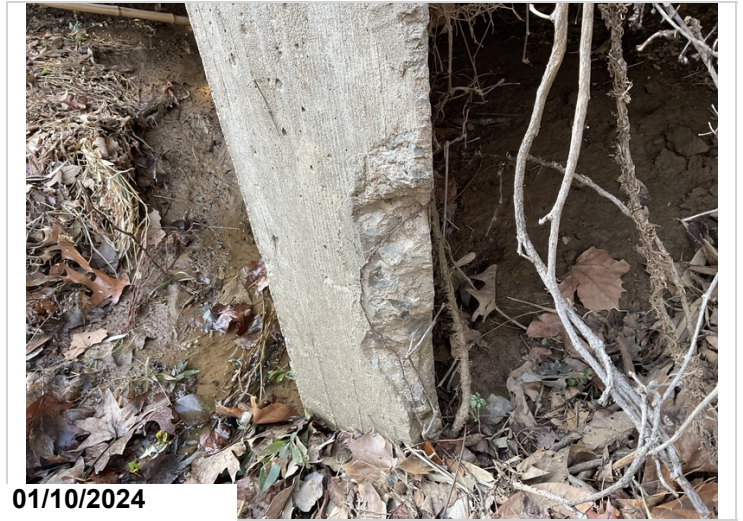
Spalls to Left end of Walls 1 & 2.(#3)(Wall 1)

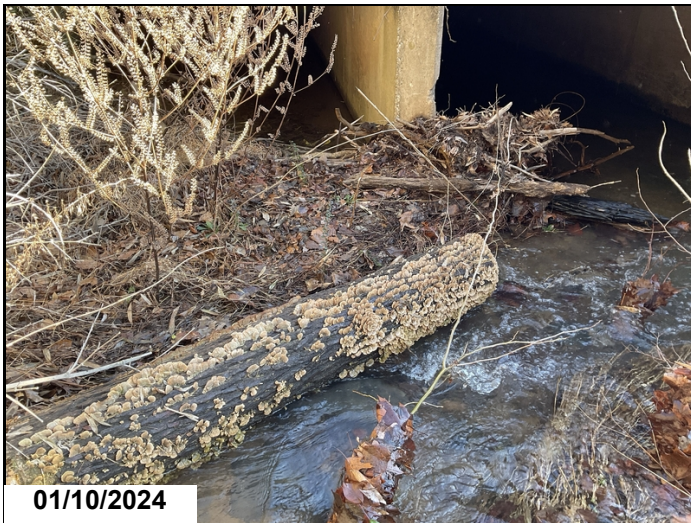
Drift buildup @ barrels 1-3.

Type of Work: Channel Work/Drift Removal

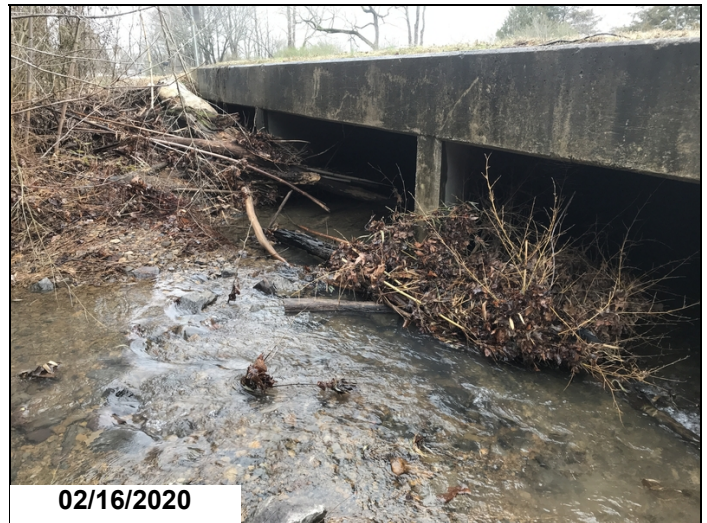
Heavy drift buildup @ barrels 1-3.

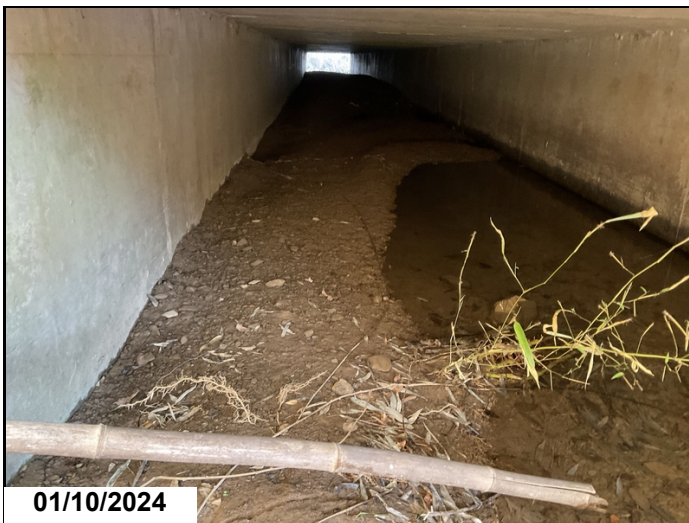
01/10/2024

+/- 2' sediment in Barrel 1.
Minor sediment in Barrel 2.
Barrel 2

Type of Work: Repair (General)

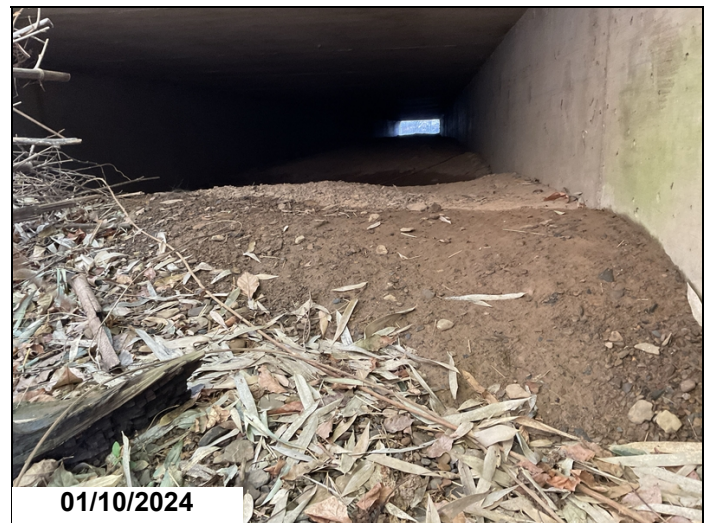
01/10/2024

+/- 2' sediment in Barrel 1.
Minor sediment in Barrel 2.
Barrel 1.

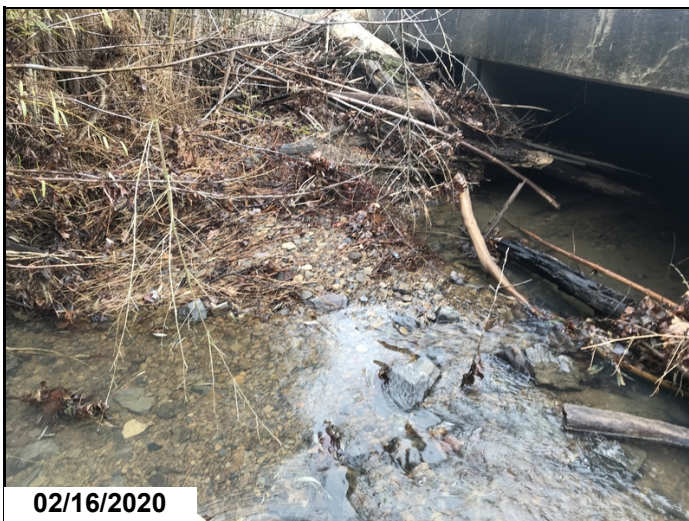
02/16/2020

+/- 2' sediment in Barrel 1.
Minor sediment in Barrel 2.

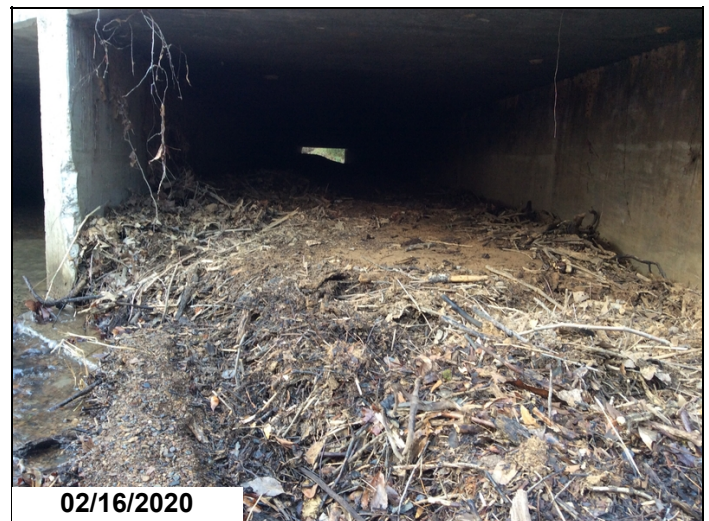
02/16/2020

+/- 2' sediment in Barrel 1.

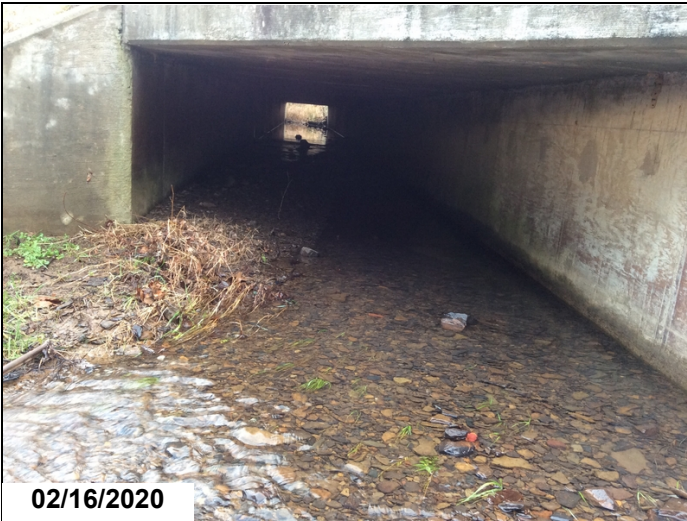
Minor sediment in Barrel 3.

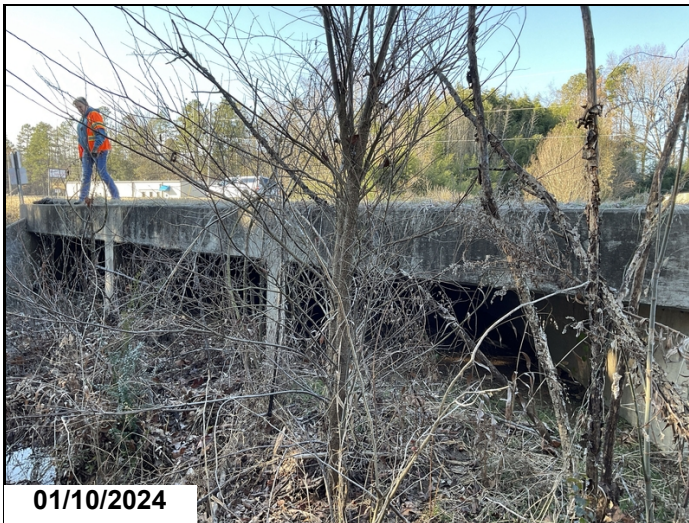
Sediment & vegetation buildup to Right & Left side.

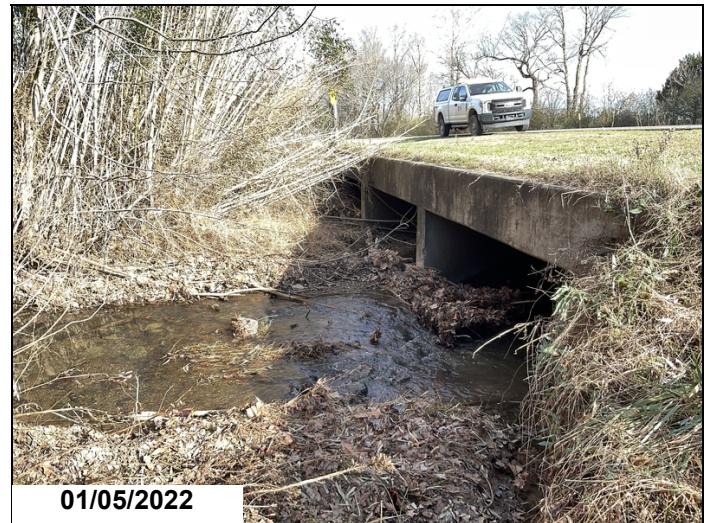
Sediment & vegetation buildup on Right side.
