Asset #X1091(Routine)

SH16 White County over CREEK

Location: SE EDGE OF SUNNY HILL

Team Lead: Kerry Little Inspection Date: 03/20/2023

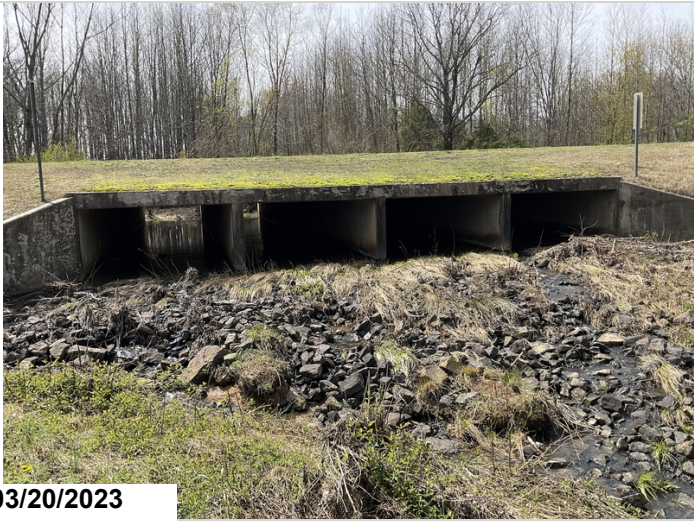
Elevation with log mile going right.

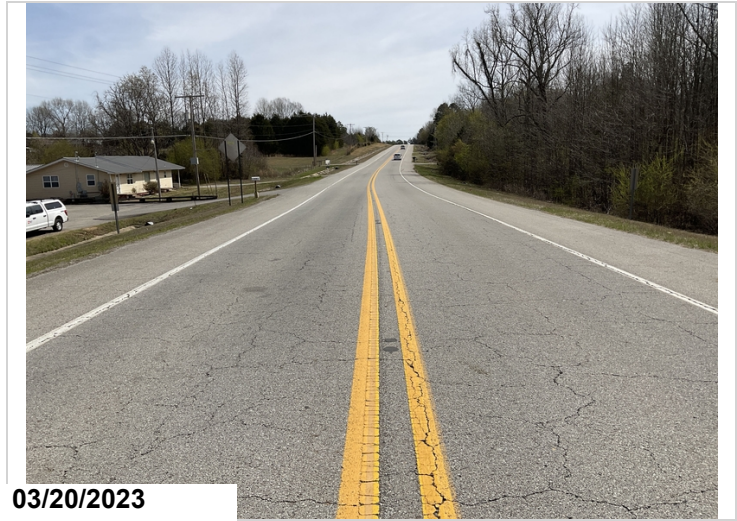
Roadway with log mile looking southeast.

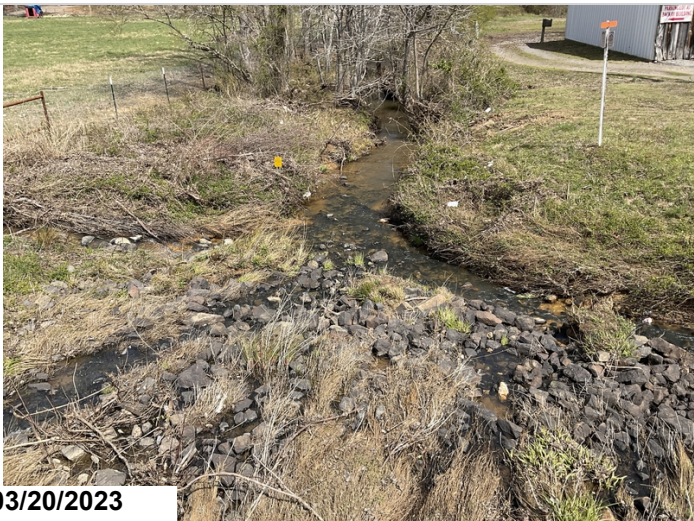
Downstream

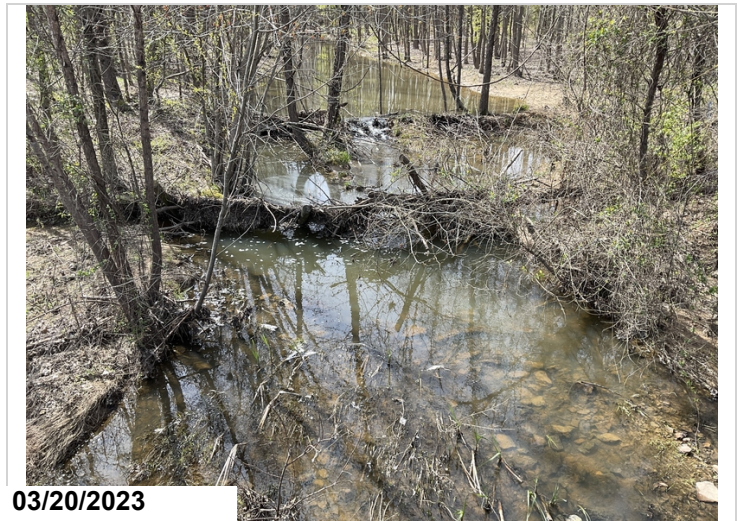
Upstream

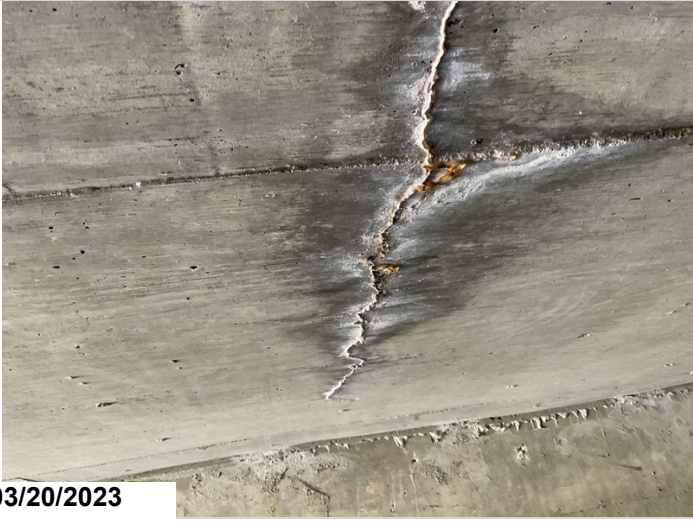
ELEMENTS	DESCRIPTION	UNITS	TOTAL	CS1	CS2	CS3	CS4
241	Reinforced Concrete Culvert	LF	288	223	58	7	0
1120	Efflorescence/Rust Staining	LF	8	0	1	7	0
1130	Cracking (RC and Other)	LF	57	0	57	0	0
(241) Efflorescent cracking with rust stains to soffit all Barrels. Vertical cracking to all walls.

Few efflor cracks with rust to all barrels.
Barrel 3.
