Asset #X1112(Routine)
SH/16 White County over Deener Creek
Location: .98 M N JCT US 67 B
Team Lead: Kerry Little Inspection Date: 03/20/2023

SH/16 White County over Deener Creek

Location: .98 M N JCT US 67 B

Team Lead: Kerry Little Inspection Date: 03/20/2023

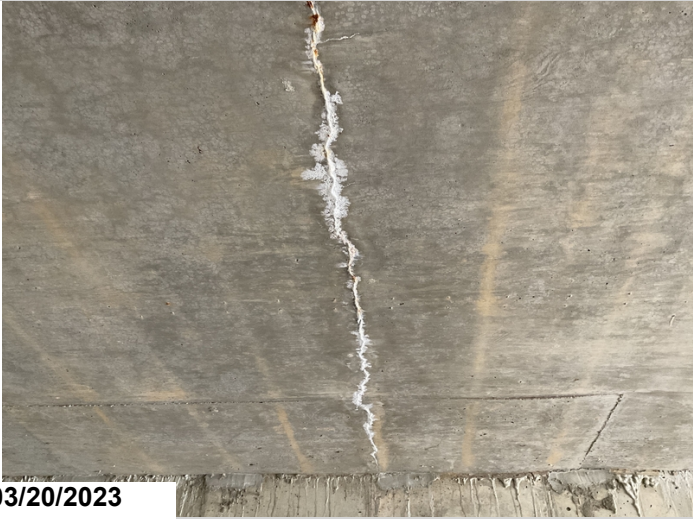
ELEMENTS	DESCRIPTION	UNITS	TOTAL	<div> <div></div> <div></div> <div></div> <div></div> </div>			
				CS1	CS2	CS3	CS4
241	Reinforced Concrete Culvert	LF	390	309	75	6	0
1120	Efflorescence/Rust Staining	LF	41	0	35	6	0
1130	Cracking (RC and Other)	LF	40	0	40	0	0
(241) 2 vertical efflorescent cracks to Abutment 1. 2 vertical efflorescent cracks to Abutment 2. Efflorescent cracking to soffit @ all barrels, some have rust stains. Vertical cracking to all walls. 1.5' to 3' of sediment buildup in Barrels 1, 2 & 3 and at inlet and outlet ends is restricting flow, and realigned main channel flow to Barrel 4. Left & Right wings at Abutments 1 & 2 have separated. Vertical cracking to Left & Right wings @ Abutments 1 & 2, some have efflorescence.

Typical efflor cracks to @ barrels.
Barrel 3.

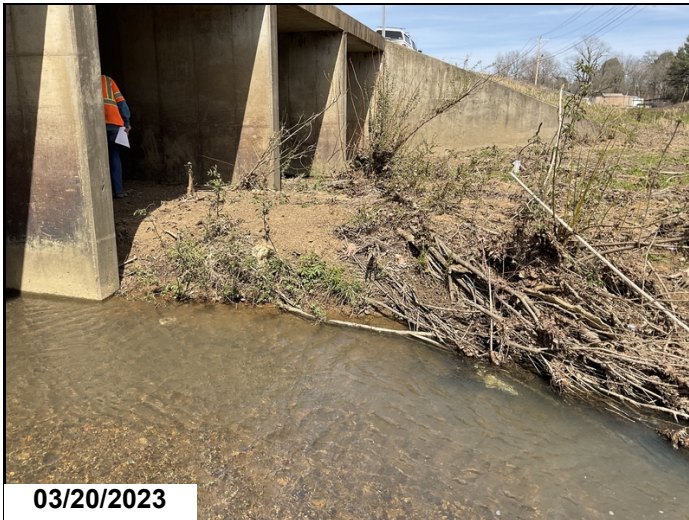
1.5' to 3' of sediment buildup in Barrels 1, 2 & 3 and at inlet and outlet ends is restricting flow, and realigned main channel flow to Barrel 4.

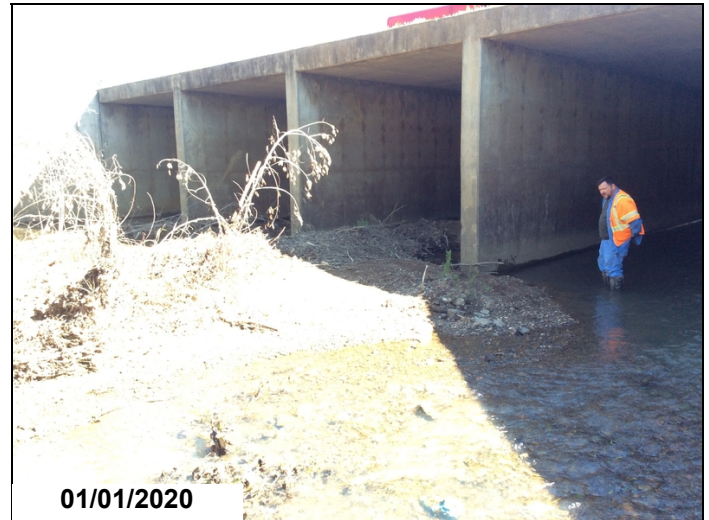
Sediment buildup in Barrels 1, 2 & 3.

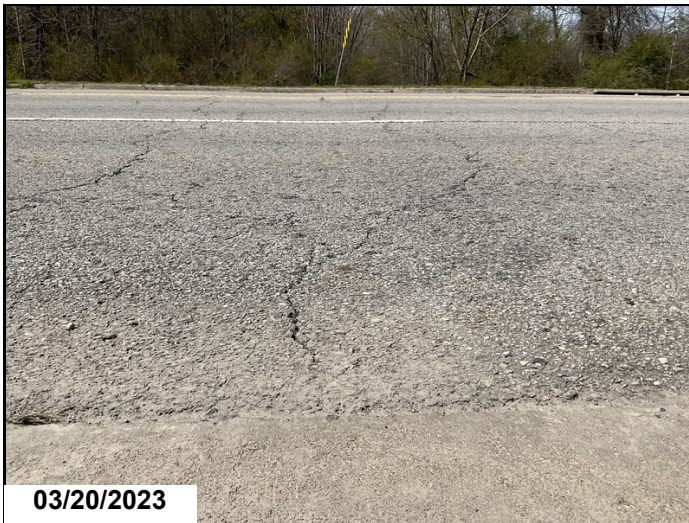
Visible settlement to approach roadways

Visible settlement to approach roadways
Abutment 2.

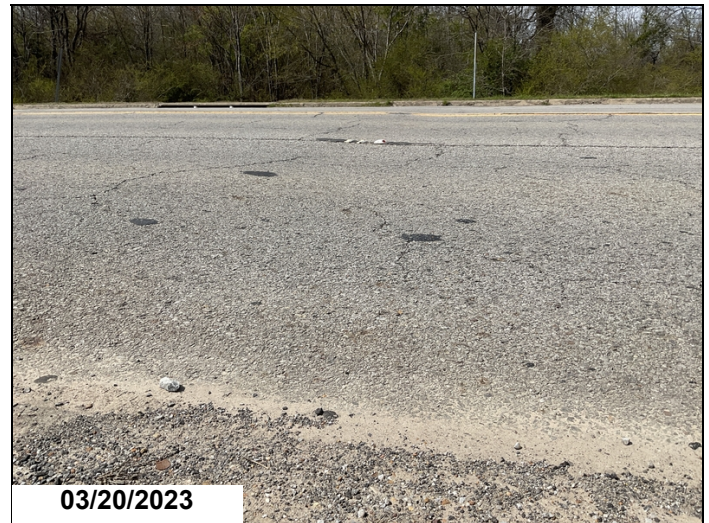
Visible settlement to approach roadways
Abutment 1.

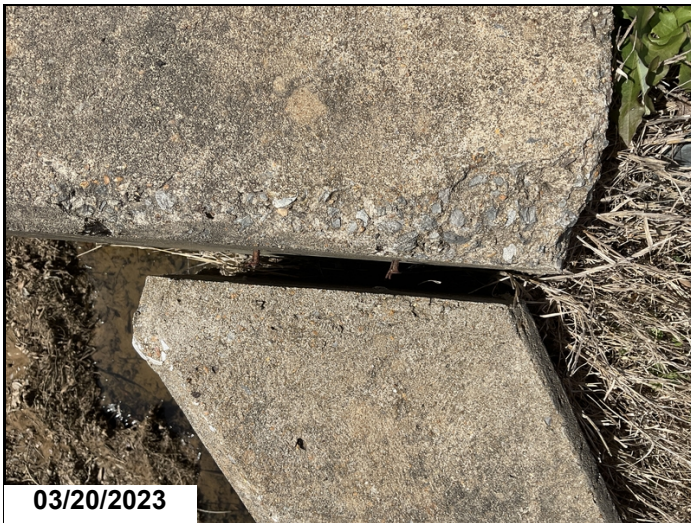
Left & Right wings at Abutments 1 & 2 have separated.

Type of Work: Repair (General)

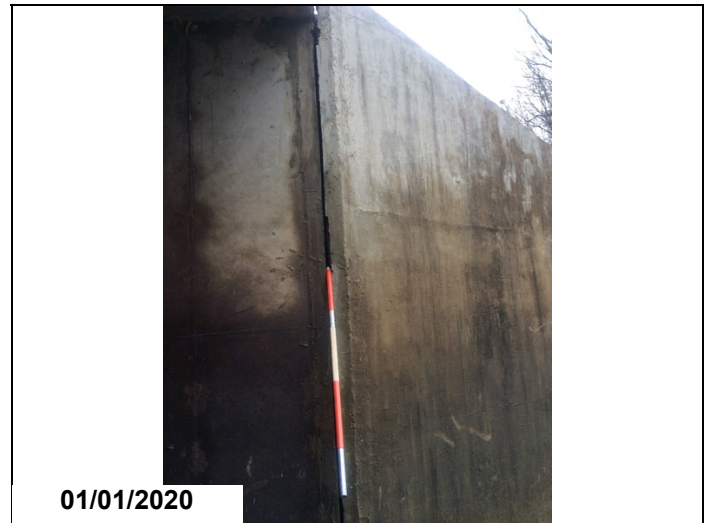
Right & left wings at Abutments #1 & #2 have separated
