Asset #X1113(Routine)
SH/16 White County over Rocky Branch
Location: 1.62 M W US 67B
Team Lead: Kerry Little Inspection Date: 03/20/2023

Asset #X1113(Routine)

SH/16 White County over Rocky Branch

Team Lead: Kerry Little **Inspection Date:** 03/20/2023

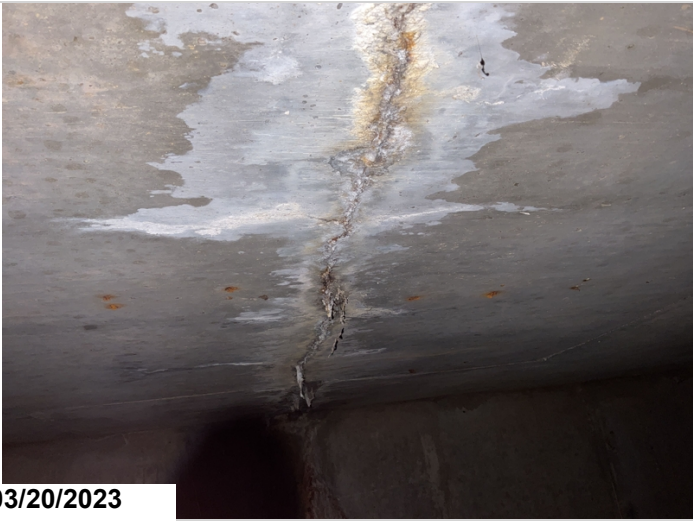
ELEMENTS	DESCRIPTION	UNITS	TOTAL	CS1	CS2	CS3	CS4
241	Reinforced Concrete Culvert	LF	528	423	34	71	0
1120	Efflorescence/Rust Staining	LF	95	0	24	71	0
1130	Cracking (RC and Other)	LF	10	0	10	0	0
(241) 30 efflorescent cracks with rust stains to soffit in Barrel 1. 30 efflorescent cracks with rust stains to soffit in Barrel 2. 17 efflorescent cracks to soffit @ barrels 1 & 2.(#2) Minor vertical efflorescent cracks to Abutments 1 & 2 & Wall 1. Vertical cracking to interior walls. Sediment & vegetation buildup @ inlet & outlet ends of Barrel 1 restricting flow & minor sediment in Barrel 1.

Efflor cracks with rust stain @ barrel 1.

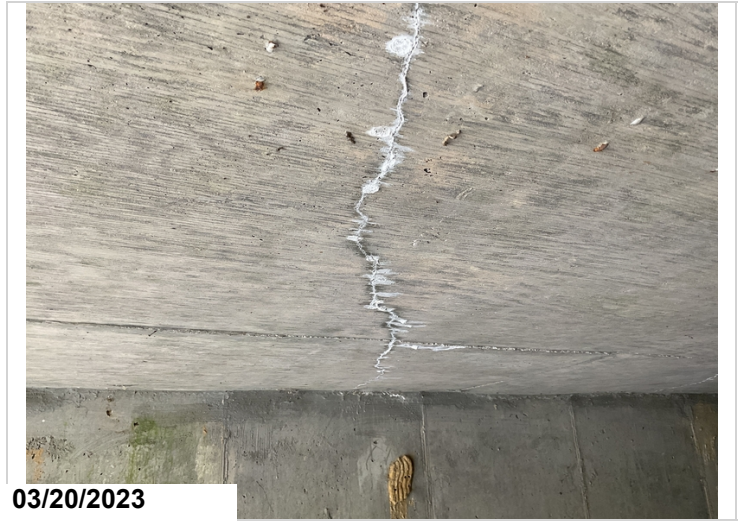
Typical efflor cracks to barrels 1 & 2.

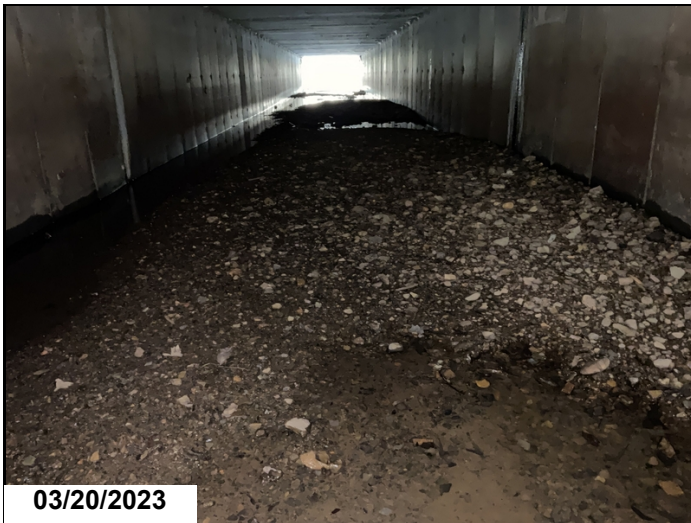
Barrel 1 has 6" of sediment buildup.

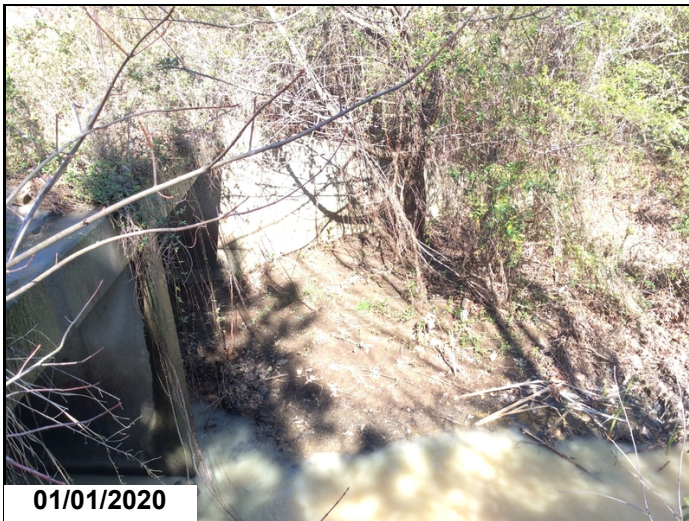
Sediment @ trees restricting flow @ outlet end of Barrel 1.

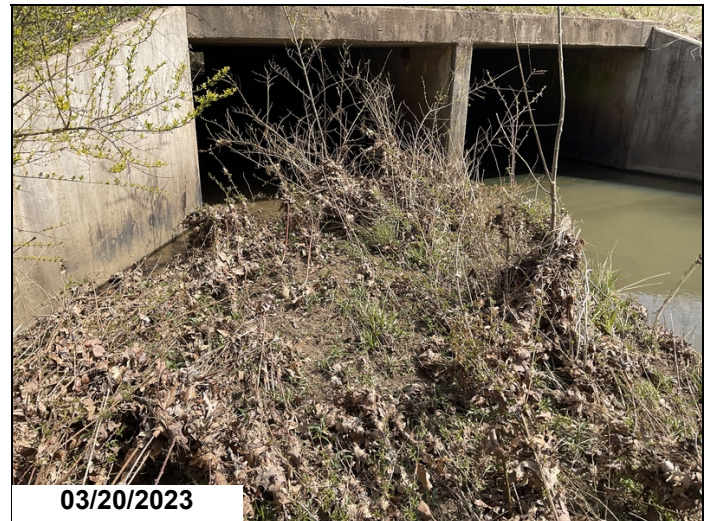
Sediment buildup & vegetation is restricting flow in channel at inlet and outlet ends of Barrel 1
