Asset #02111(Routine)

US 167 White Co. over OVER FLOW CREEK

Location: 2.54 MI N Jct US 67

Team Lead: Floyd Haley Inspection Date: 05/06/2024

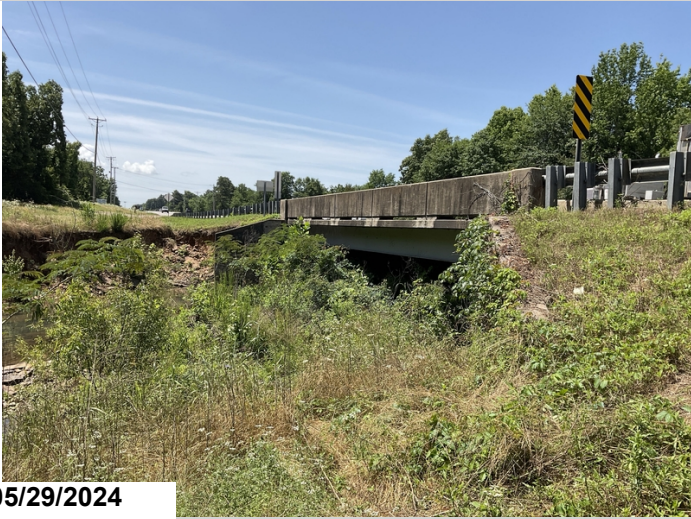
Elevation with log mile going right.

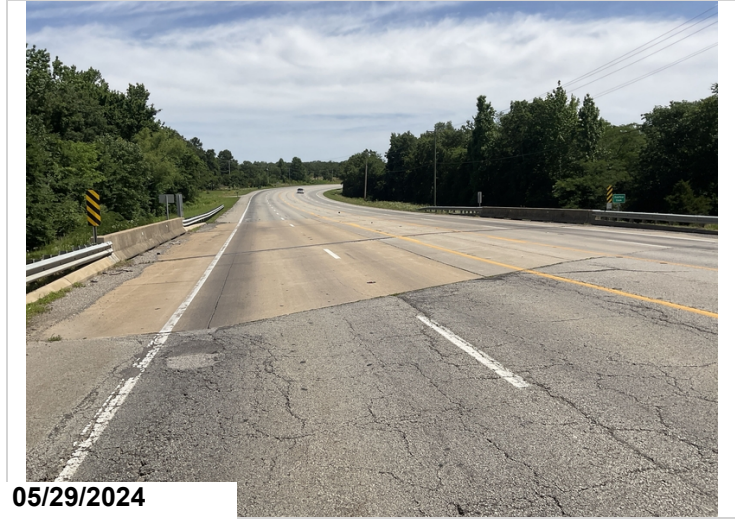
Roadway with log mile going looking north.

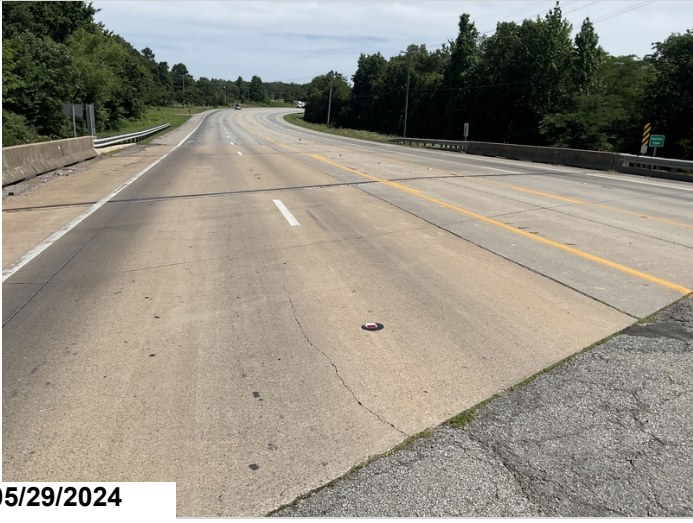
Overall deck is in satisfactory condition with cracks to deck throughout.

Overall deck.

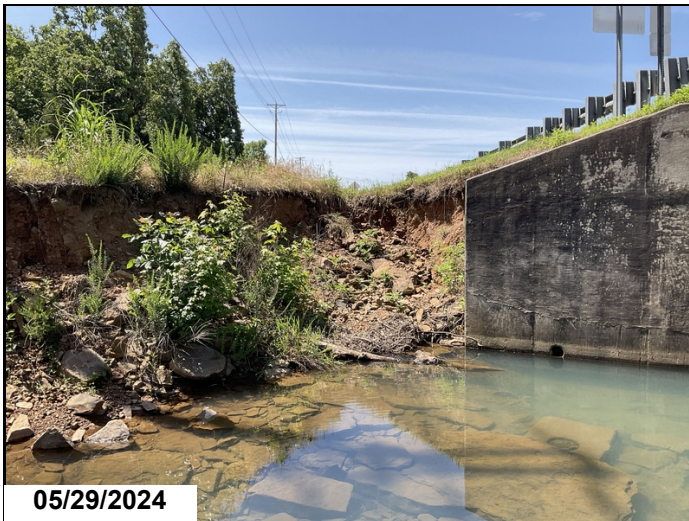
6000	Scour	LF	40	0	0	40	0
(215) Scour to Right end of Abutment 1 .							
Channel has realigned toward Abutment 1.							
Abutment 1: has 6' of efflorescent cracks with rust. 6' CS 3							
12' of vertical & horizontal cracks. 12' CS 3							
2' spall to Lt side of abutment 1. 2' CS 2							
Abutment 2: has 6' of efflorescent cracks with rust. 6' CS 3							
14' of vertical & horizontal cracks. 14' CS 3

Erosion to embankment & behind Right wing at Abutment 1. Scour along footing and Right end of Abutment 1.

**Type of Work:** Repair (General)

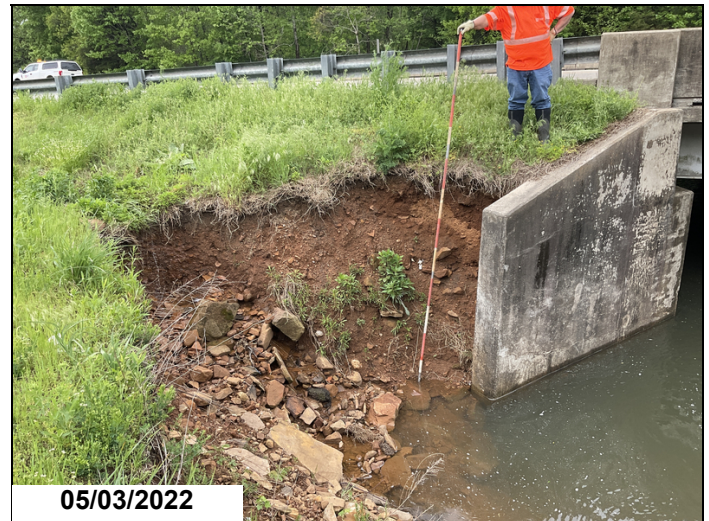
Erosion to embankment & behind Right wing at Abutment 1. Scour along footing and Right end of Abutment 1.
