Asset #06036(Routine)

SH 258 WHITE CO. over OVERFLOW CREEK

Location: 1.54 MI W JCT SH 167

Team Lead: Kerry Little Inspection Date: 02/06/2024

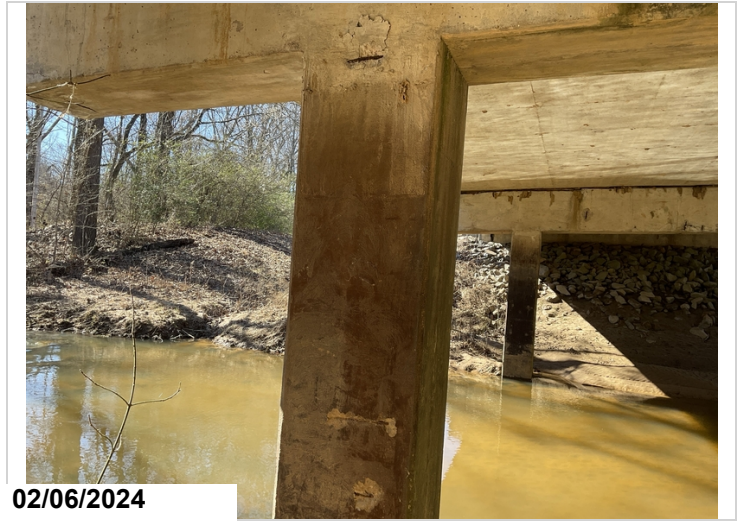
(205) Spall with rebar exposed with s/l to backside of Column 1 @ Bent 1. Spall & Cracking to top of Column 1 @ Bent 2.(#3) Minor spalls to. Column 2 @ Bents 1 & 2. Minor scour @ Col. 1 & 2 @ Bents 1 & 2.							
215	Reinforced Concrete Abutment	LF	94	93	1	0	0
1120	Efflorescence/Rust Staining	LF	1	0	1	0	0

Spalls with rebar exposed to column 1 @ bent 1.

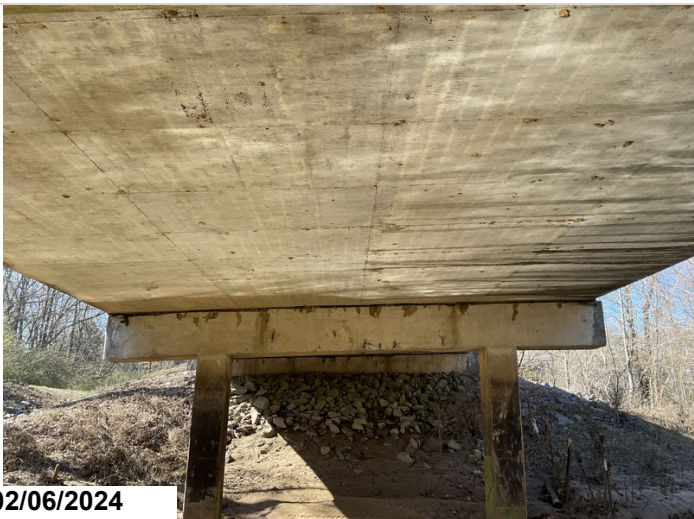
Overall soffit @ span 2.

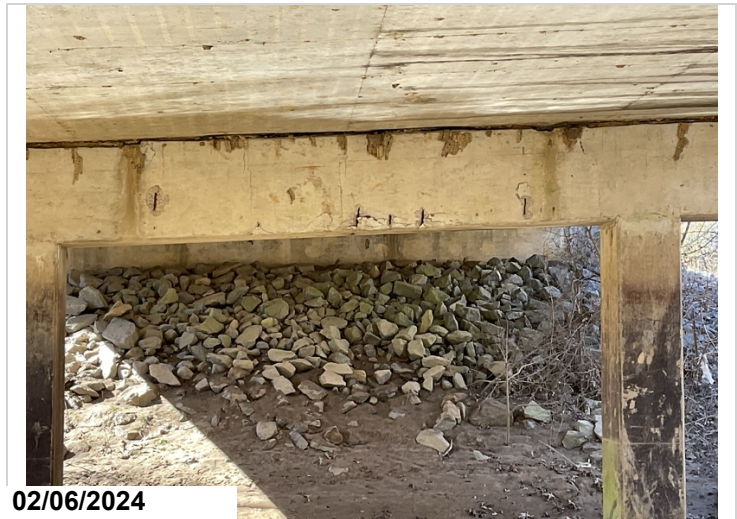
(234) Bent 1 - Spalls with 6" rebar exposed to back side. Bent 2 - Spalls with 5' rebar exposed to cap on backside & 1' to bottom. Minor vertical cracking to caps @ Bents 1 & 2. Efflorescent cracking to caps @ Bents 1 & 2, 1 has rust stains @ Bent 2.							
301	Pourable Joint Seal	LF	66	0	30	36	0
2320	Seal Adhesion	LF	66	0	30	36	0

Spalls with rebar exposed with section loss to backside of cap @ Bent 2.

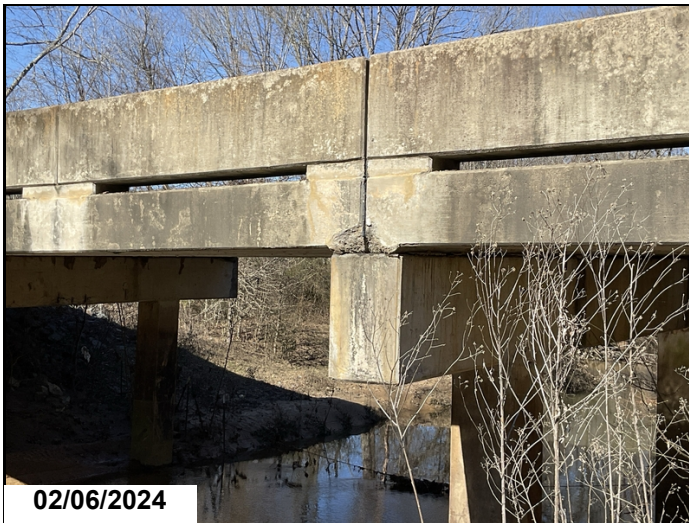
Cracks & spalls to left & right outside edge of deck over Bent 1 & to left and right edge over Bent 2

Cracks & spalls to left & right outside edge of deck over Bent 1 & to right edge over Bent 2
Lt side of bent 1.

Priority: D- Routine

Type of Work: Deck Repair

Status: Monitor

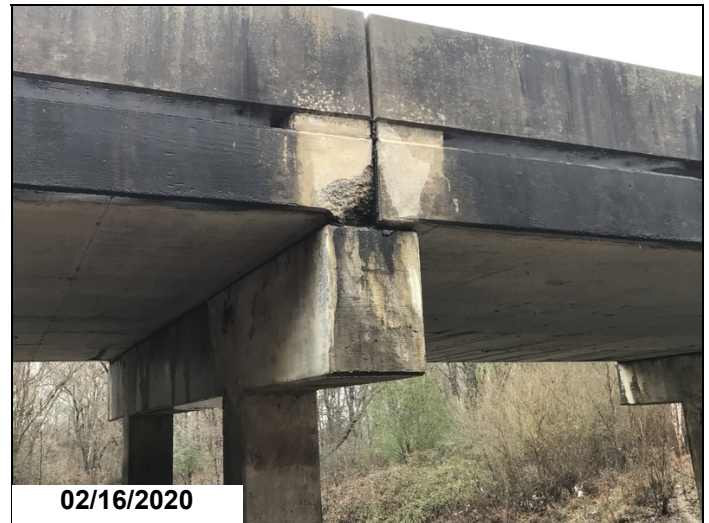
Cracks & spalls to left & right outside edge of deck over Bent 1 & to right edge over Bent 2

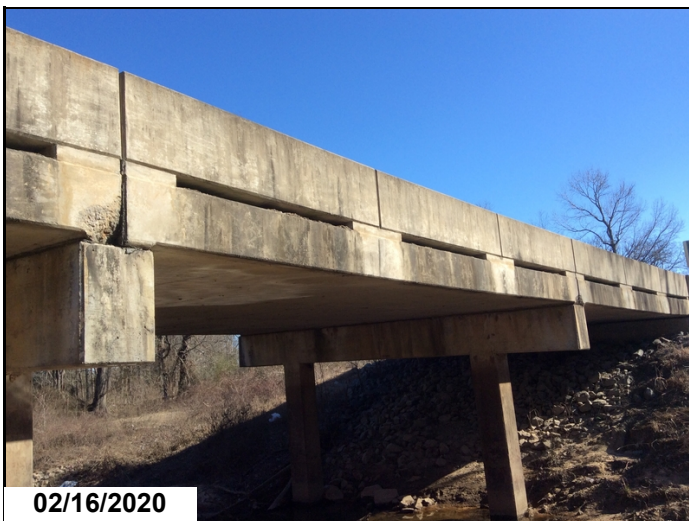
Typical spall to outside edge of deck @ Bent 1 & 2.
