Asset #M2186(Routine)

US 64 White County over DITCH

Location: 0.10 MI N JCT US 67 & 167

Team Lead: Kerry Little Inspection Date: 12/06/2023

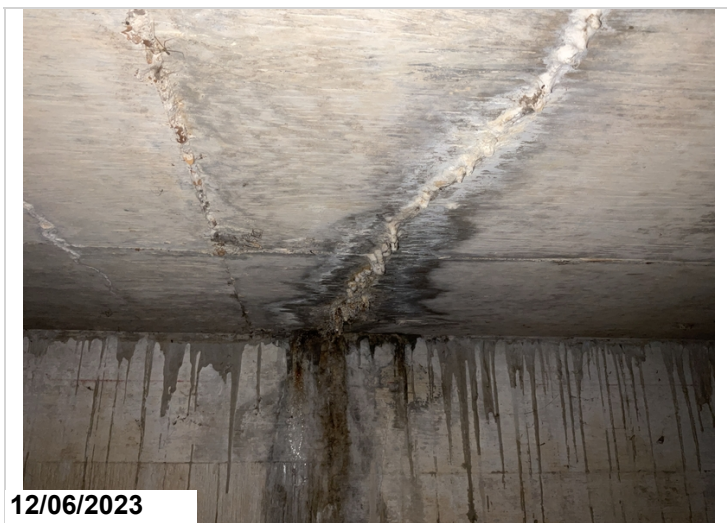
Typical #3 efflor cracks to soffit @ all barrels.

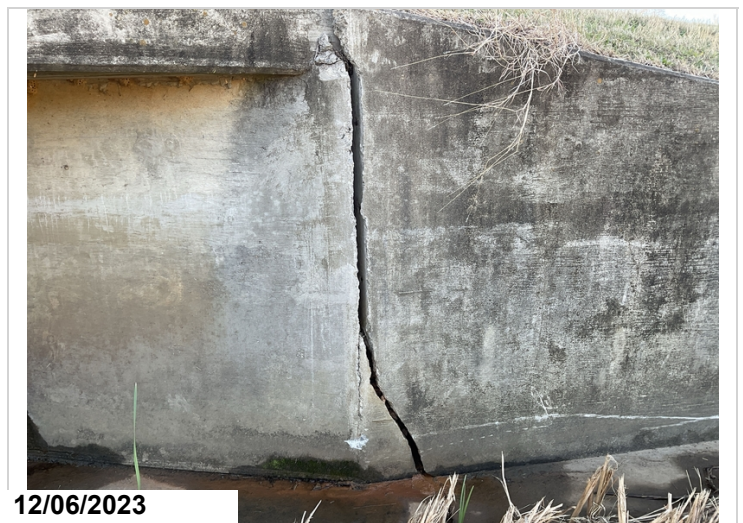
Crack & minor rotation to Left wing @ Abutment 1

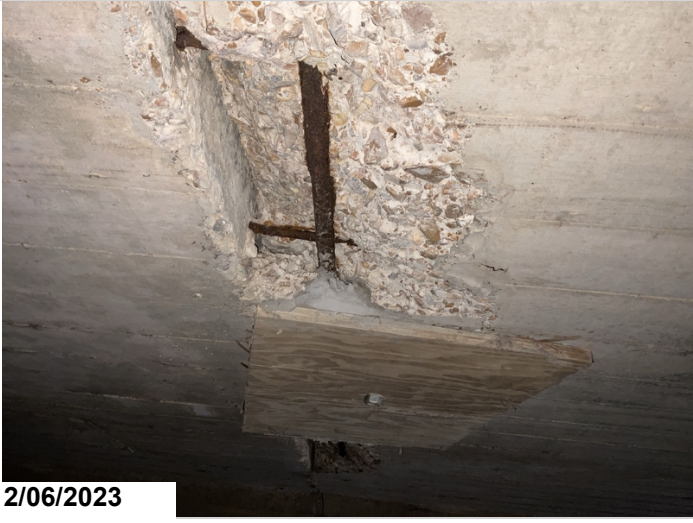
Spalls with rebar exposed with s/l to soffit @ Barrel 3.(#3)

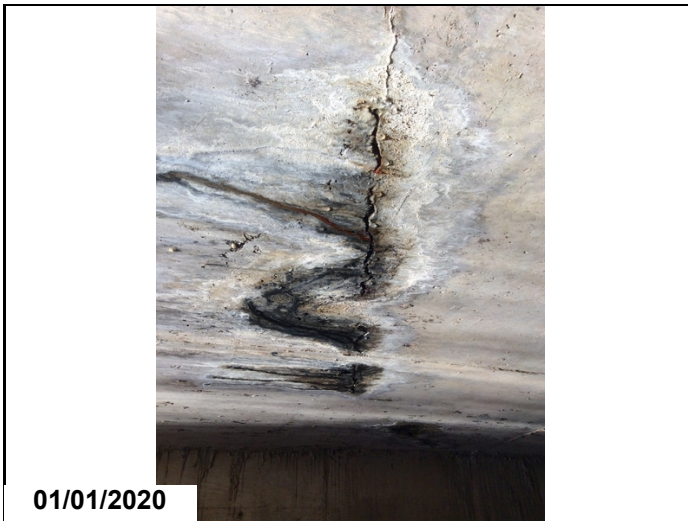
Barrels 3 & 4 has a 1/4" wide Rust Stained longitudinal crack to Deck Below near Outlet end.

01/01/2020
Barrel 3 a has 1/4" wide Rust Stained longitudinal crack to Deck below near Outlet end.

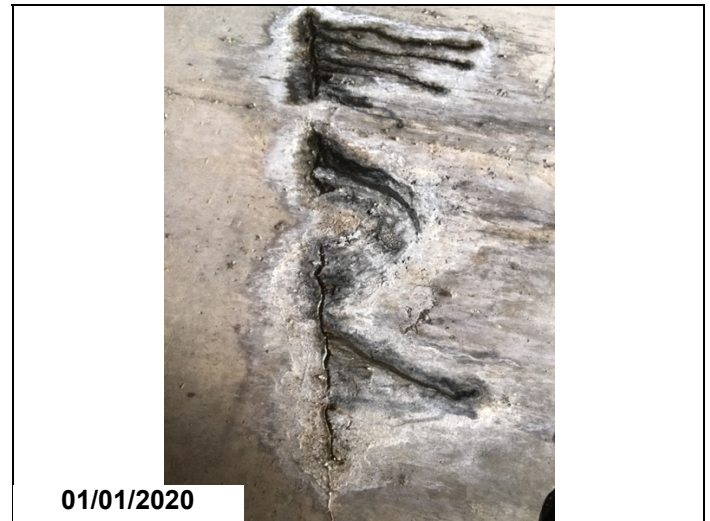
01/01/2020
Barrel 3 & 4 has a 1/4" wide Rust Stained longitudinal crack to Deck Below near Outlet end.

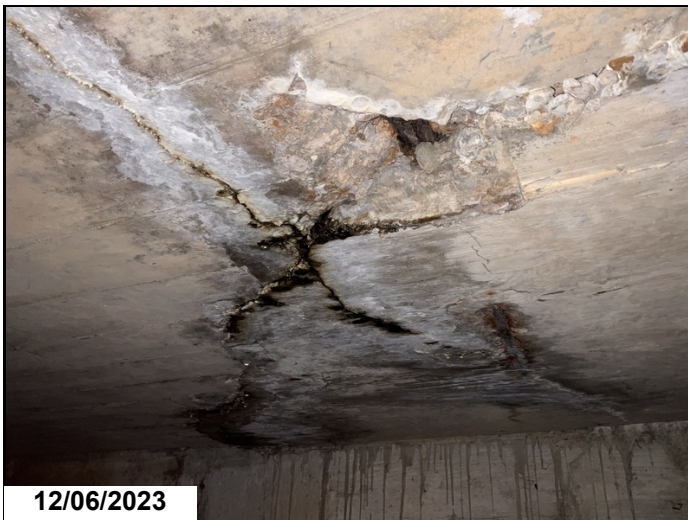
12/06/2023
Barrels 3 & 4 has a 1/4" wide Rust Stained longitudinal crack to Deck Below near Outlet end.

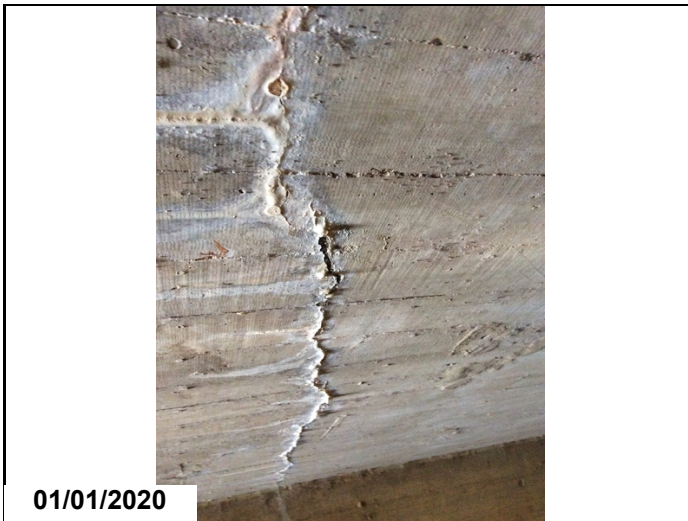
Barrel 1 - 4 has Longitudinal efflorescent cracks to Deck Below.

Barrel 1 - 4 have longitudinal efflorescent cracks to Deck below.

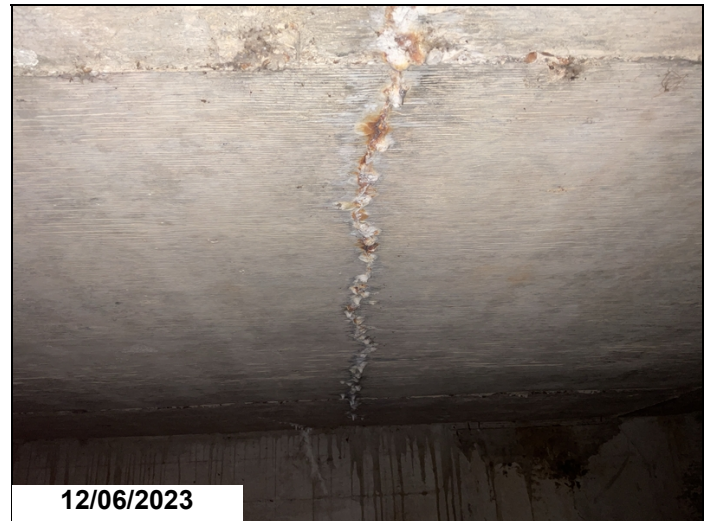
Barrel 1 - 4 has Longitudinal efflorescent cracks to Deck Below.
