Asset #M1275(Routine, Underwater type 2)

State Highway 69B over POLK BAYOU

Location: 0.35 MI SE JCT SH 106 69B

Team Lead: Nathan Edwards Inspection Date: 04/18/2023

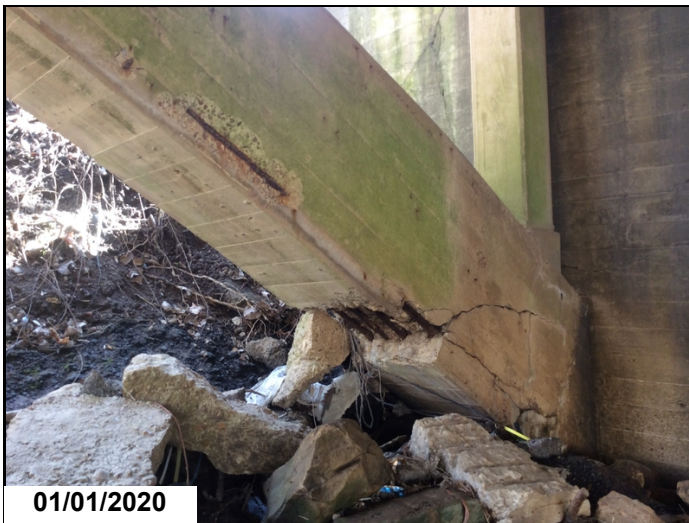
Span 5 - Arch rib 1 has large spall with 5' of rebar exposed at end of span.

Arch Rib 1 at end of Span 5

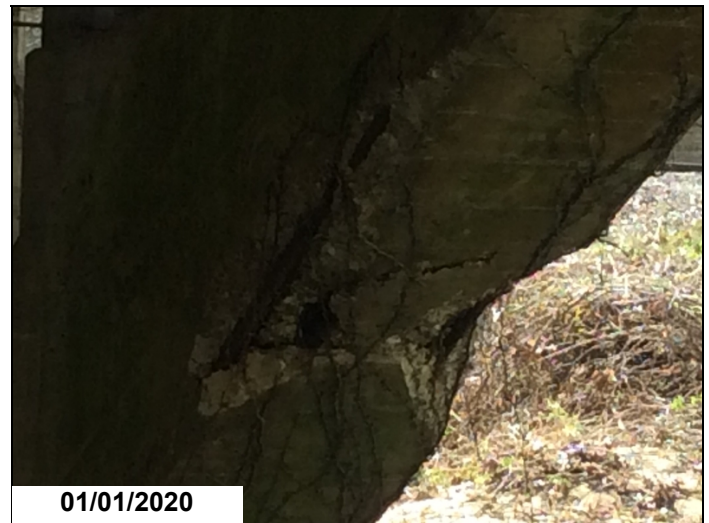
Span 4 - Arch rib 4 has spall with 5' of rebar exposed at end of span.

Arch Rib 4 at end of Span 4

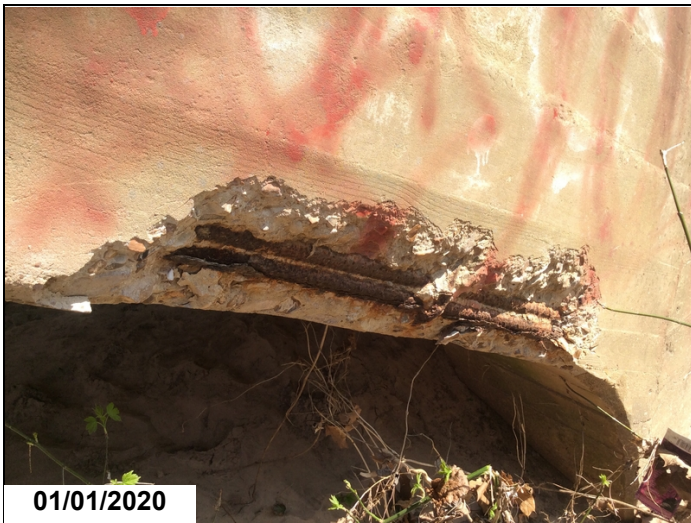
Span 2 - Arch rib 4 has large spall with 4' of rebar exposed near end of span.

Arch Rib 4 at end of Span 2

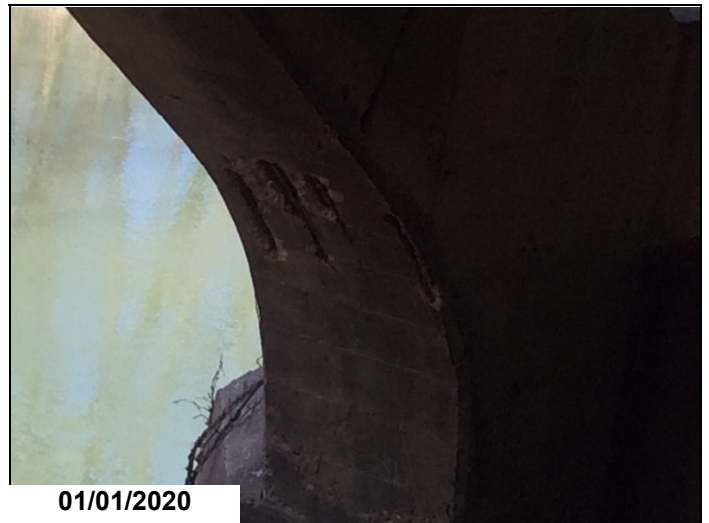
Span 5 - Arch Rib 4 has spall with 4' of rebar exposed at beginning of span.

Arch Rib 4 at beginning of Span 5

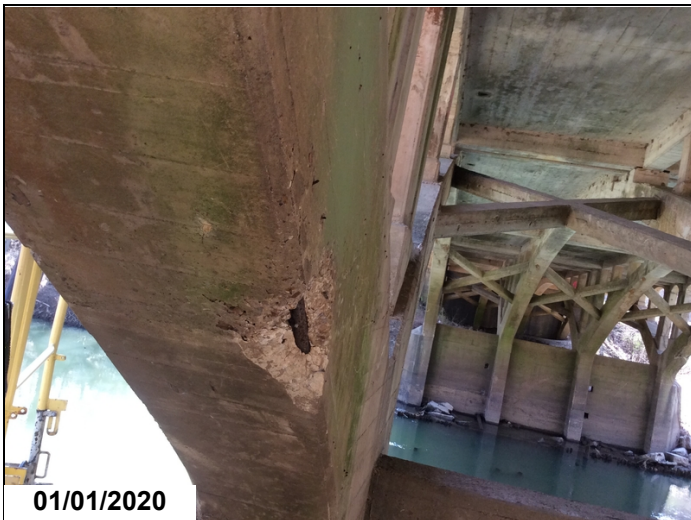
Arch Rib 1 at end of Span 3

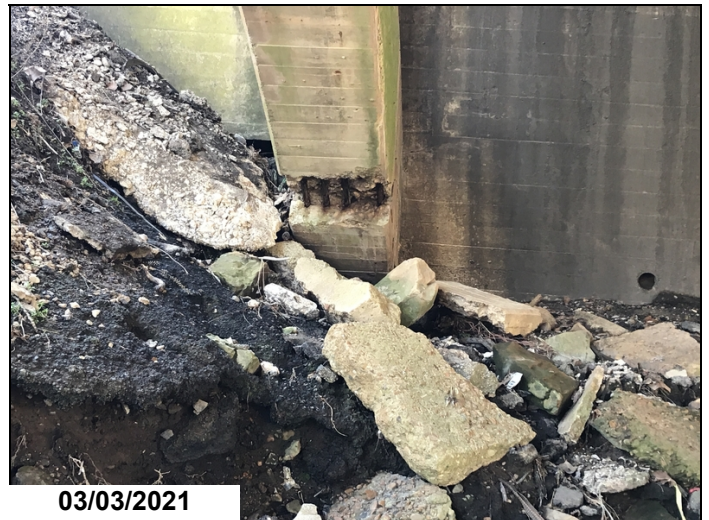
Span 5 - Arch rib 1 has large spall with 5' of rebar exposed at end of span.

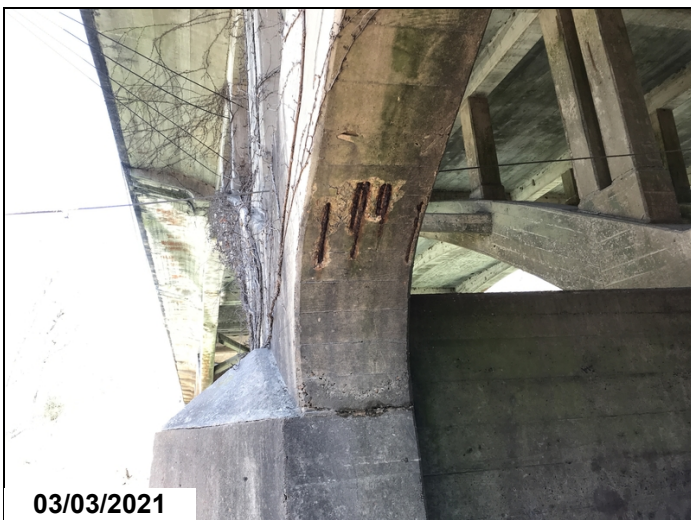
Span 5 - Arch Rib 4 has spall with 4' of rebar exposed at beginning of span.

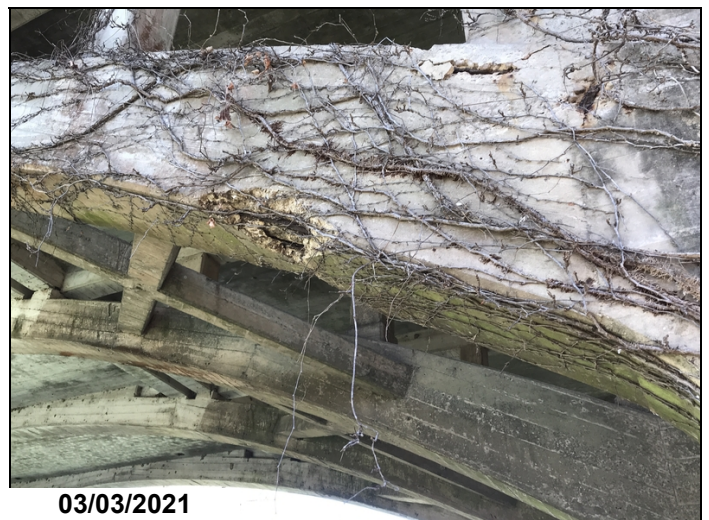
Span 4 - Arch rib 4 has spall with 5' of rebar exposed at end of span.

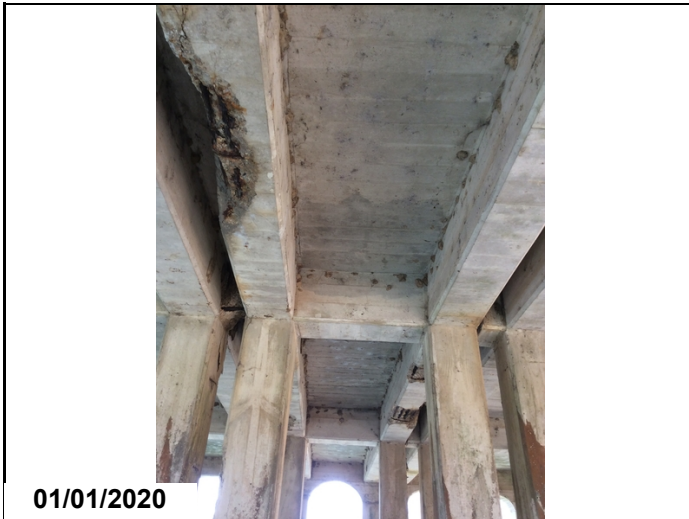
Large spalls with rebar exposed to concrete diaphragms at Bents 1 - 4.

Concrete Diaphragms at Bent 3

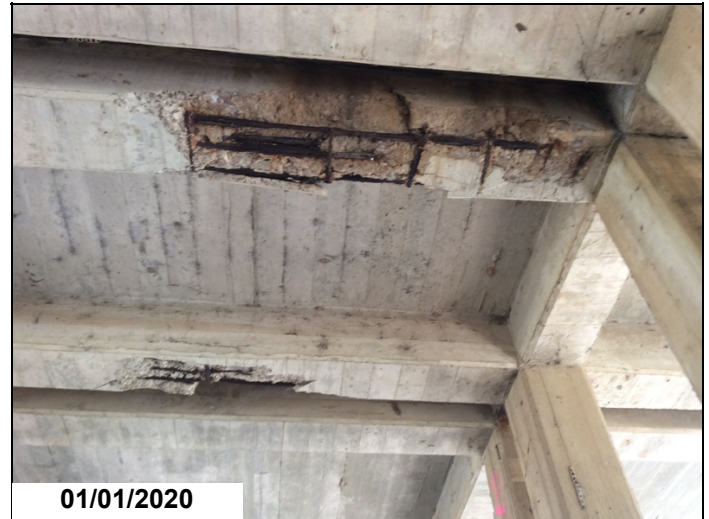
Concrete Diaphragms at Bent 1

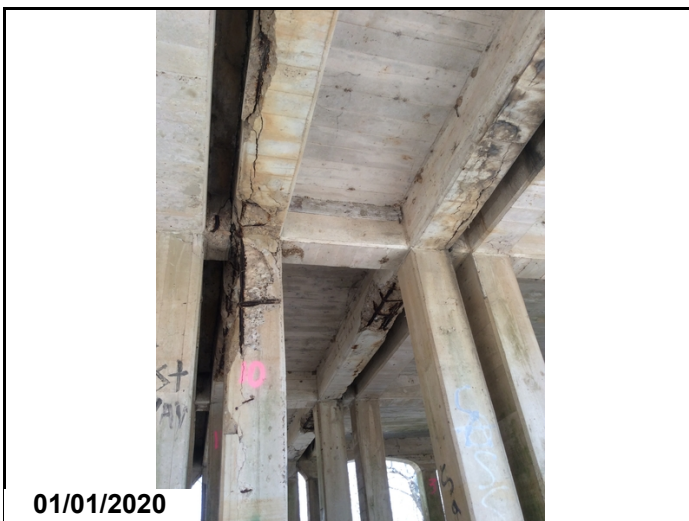
Concrete Diaphragms at Bent 2

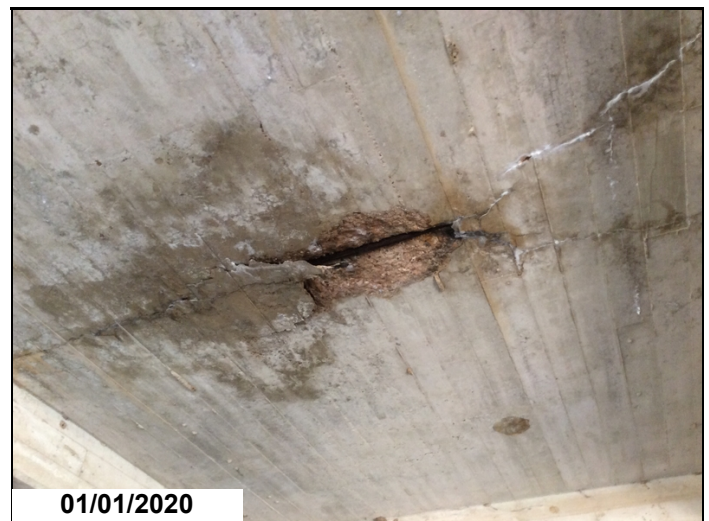
Spall with exposed rebar to soffit between Arch Rib 2 & 3 near end of Span 5.

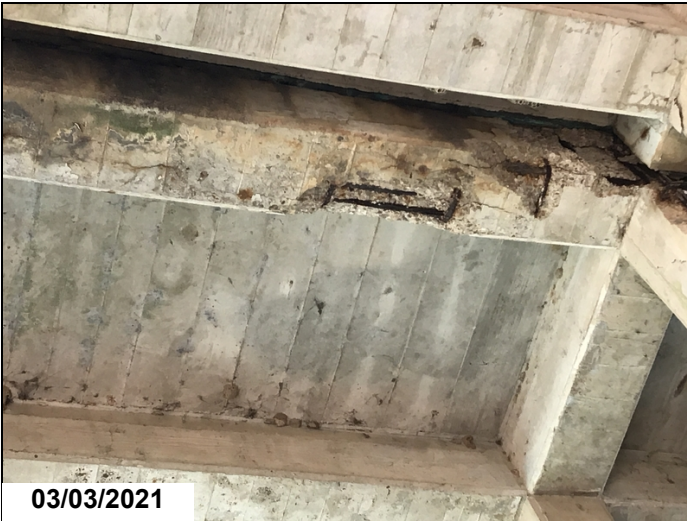
Large spalls with rebar exposed to concrete diaphragms
at Bents 1 - 4.

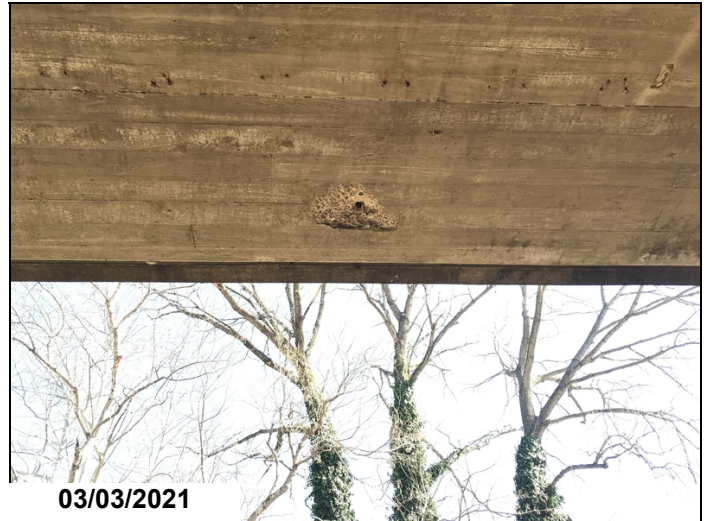
Spalls with rebar exposed to soffit and overhangs.

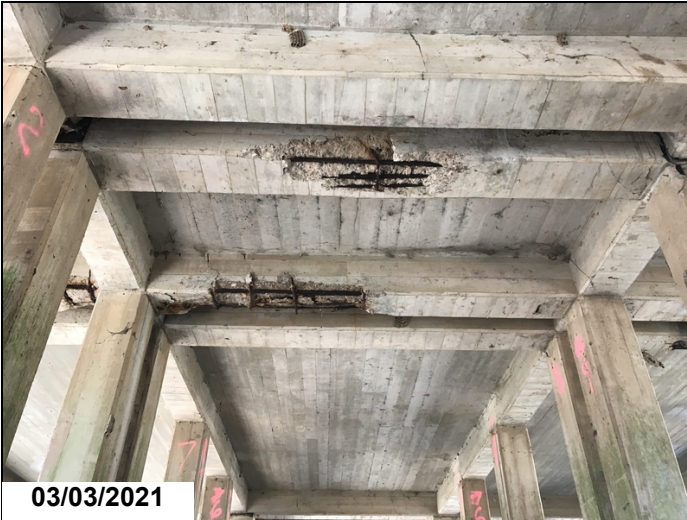
Large spalls with rebar exposed to concrete diaphragms
at Bents 1 - 4.
Span 1.

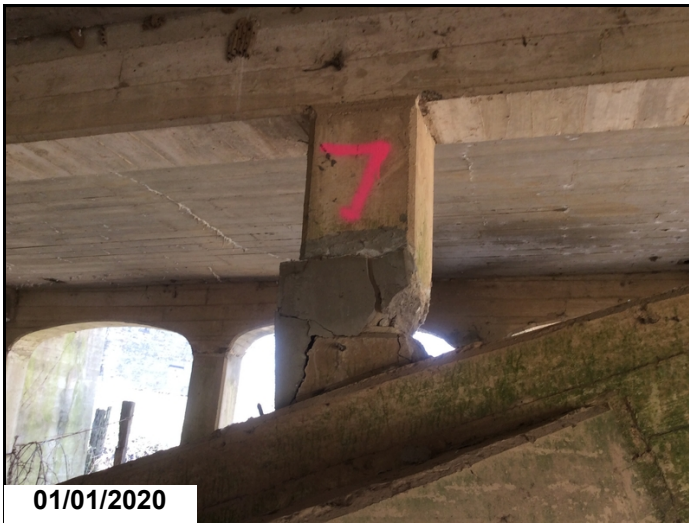
Cracked and delaminated areas, and spalls with rebar exposed to spandrel columns at all spans.

Spandrel Column 7 at Arch Rib 3 Span 5

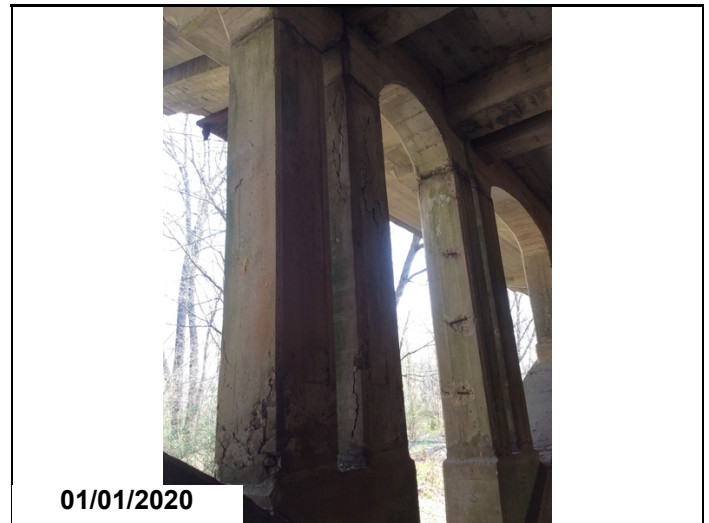
Spandrel Columns 8 & 9 at Arch Rib 1

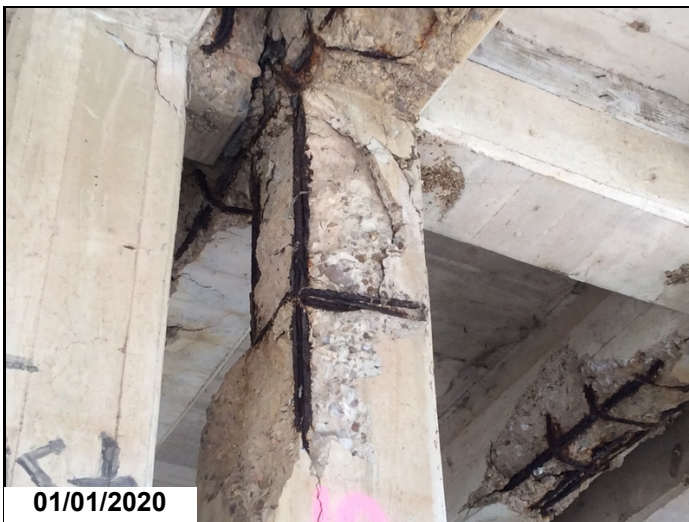
Spandrel Column 10 at Arch Rib 3 at Span 2

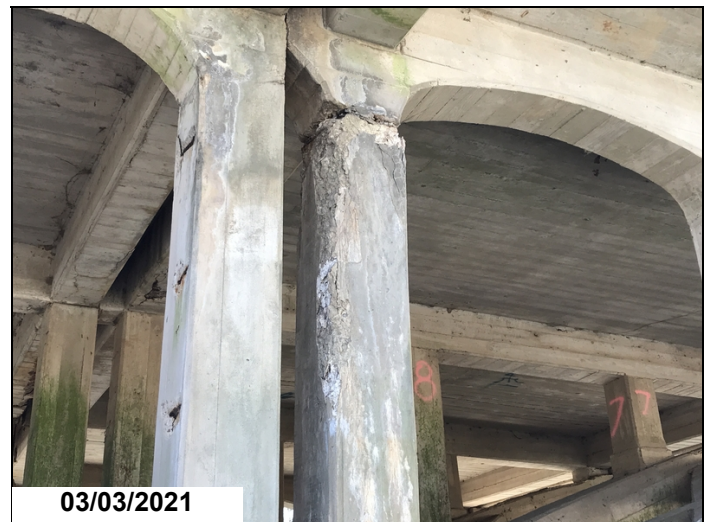
Cracked and delaminated areas, and spalls with rebar exposed to spandrel columns at all spans.

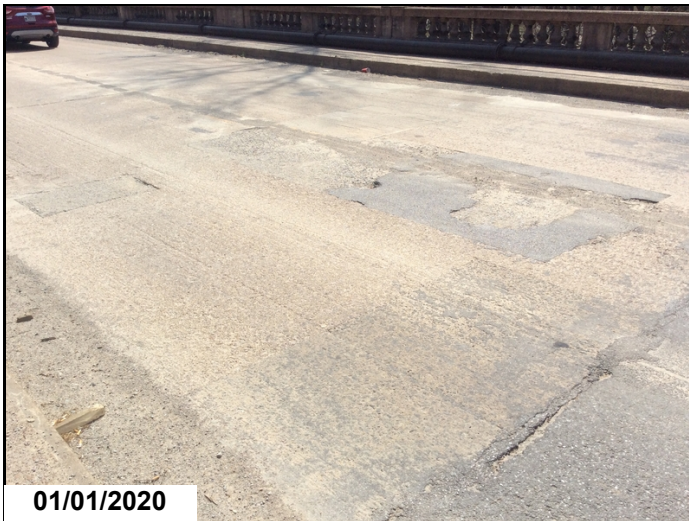
Span 1 left lane

Spalls with rebar exposed to deck at Span 3 & 4
Unsealed cracks, areas of scaling, and spalls to deck at all spans.
Spalls and deterioration to curbs / sidewalks.
Poured joint seals are deteriorated, filled with debris and drain openings are plugged.

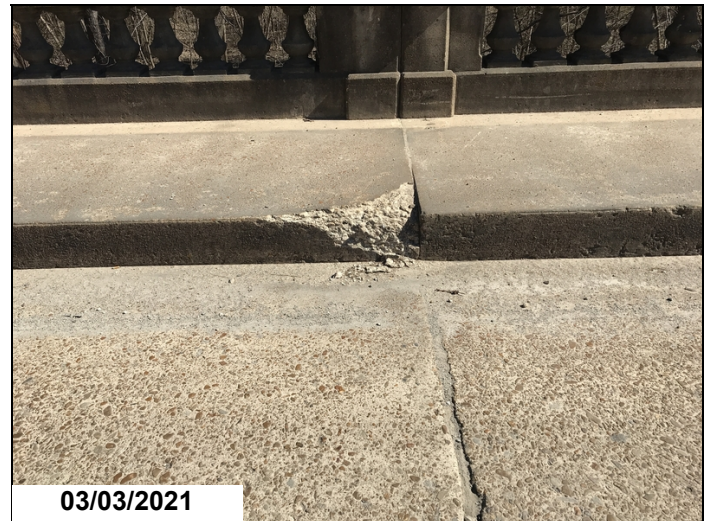
Spalls and deterioration to curbs / sidewalks.

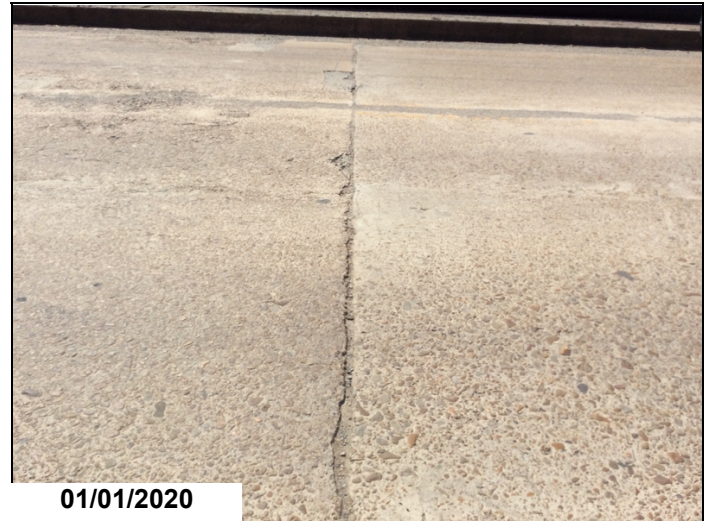
Typical poured joint.

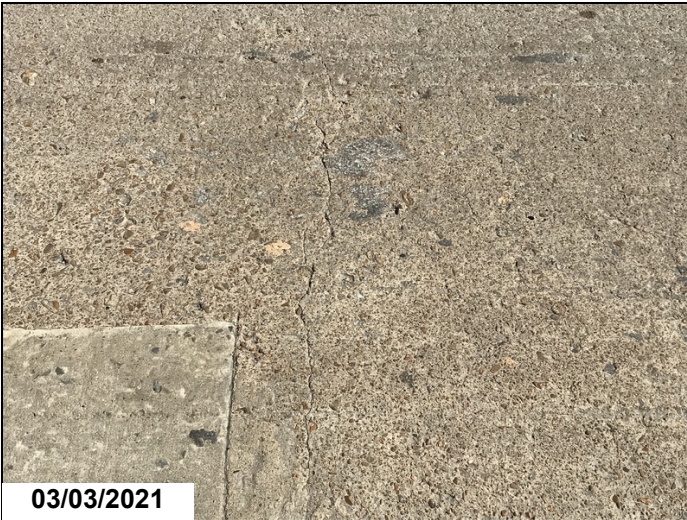
Unsealed cracks, areas of scaling, and spalls to deck at all spans.

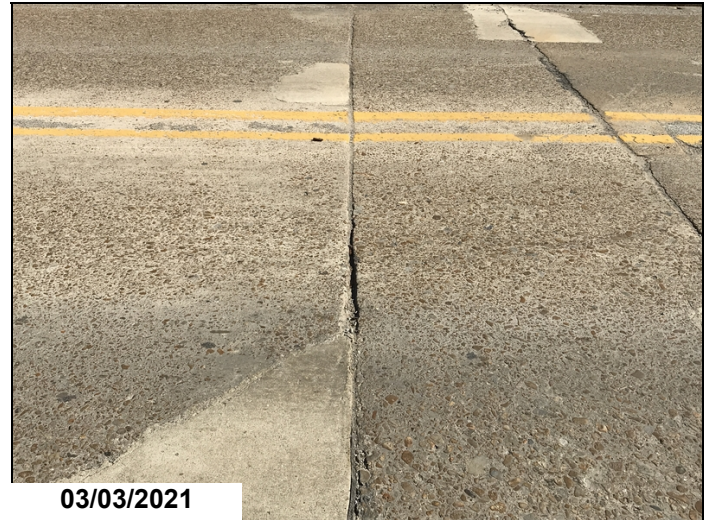
Poured joint seals are deteriorated, filled with debris and drain openings are plugged.

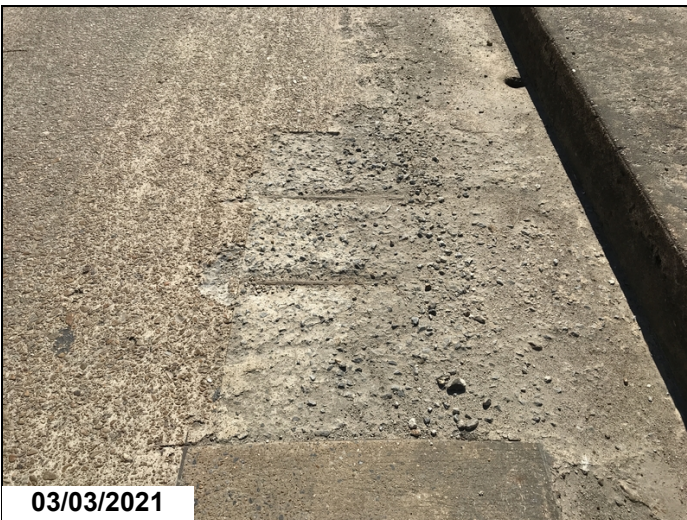
Spalls with rebar exposed to deck at Span 3 & 4
Span 3.

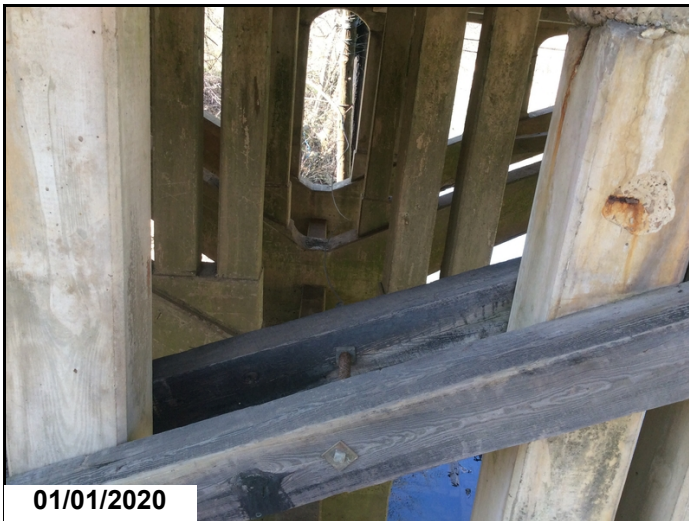
Cable at Bent 4

Cable attached to bridge at Bent 4 and spandrel columns at Span 4.

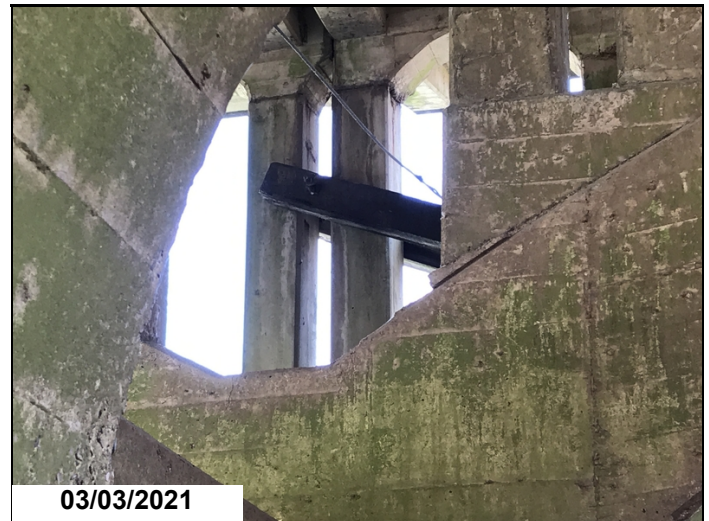
Cable attached to bridge at Bent 4 and spandrel columns at Span 4.
