Route:106 Section:01 Log:2.41

Arnold Road ID:32x106x1xA, Arnold Log mile:2.41

Asset #06180(Routine)
SH 106/Independ.Co over SPRING CREEK/MO.&N.AR RR
Location: 2.43 MI W JCT SH 69
Team Lead: Kerry Little Inspection Date: 10/26/2021

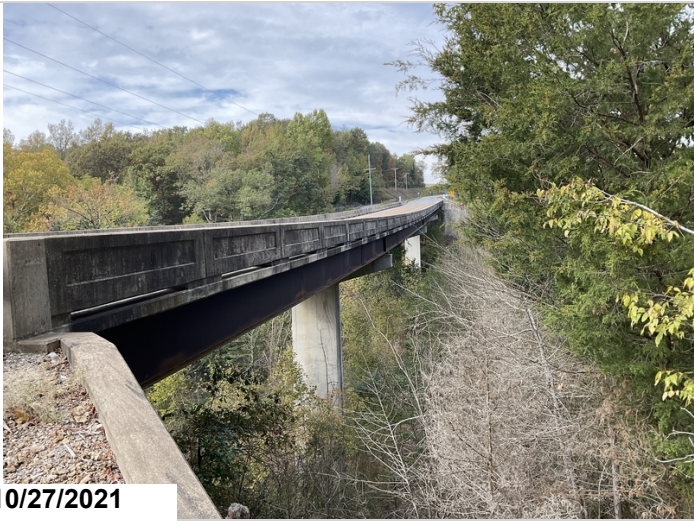
Elevation with log mile going right.

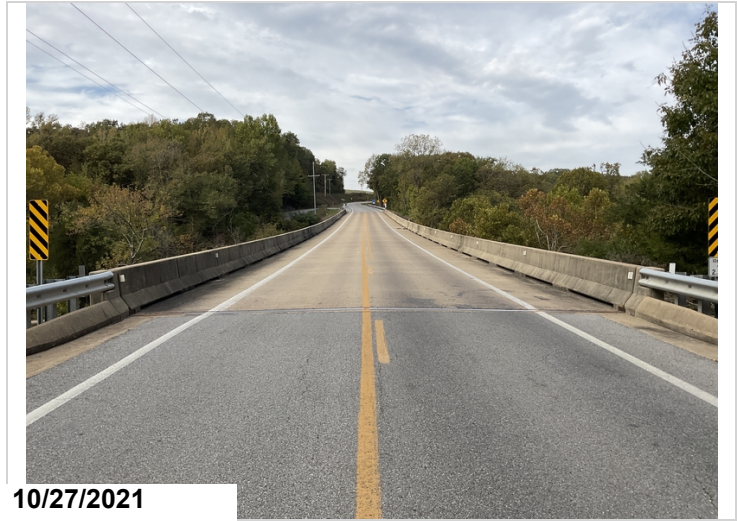
Roadway with log mile looking west.

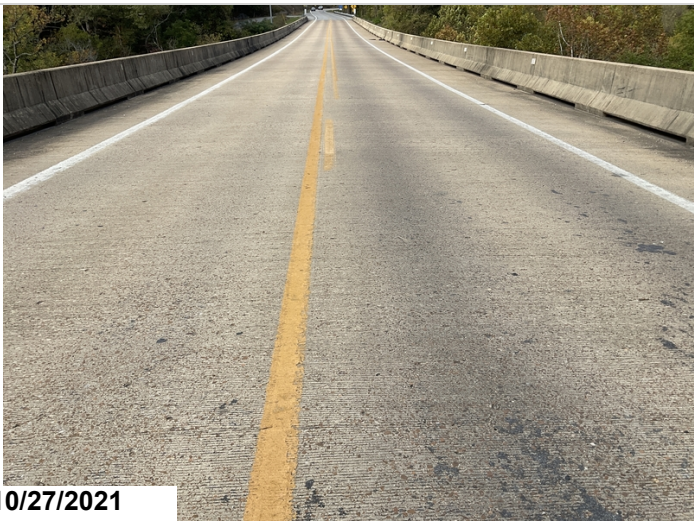
Overall deck @ span 1.

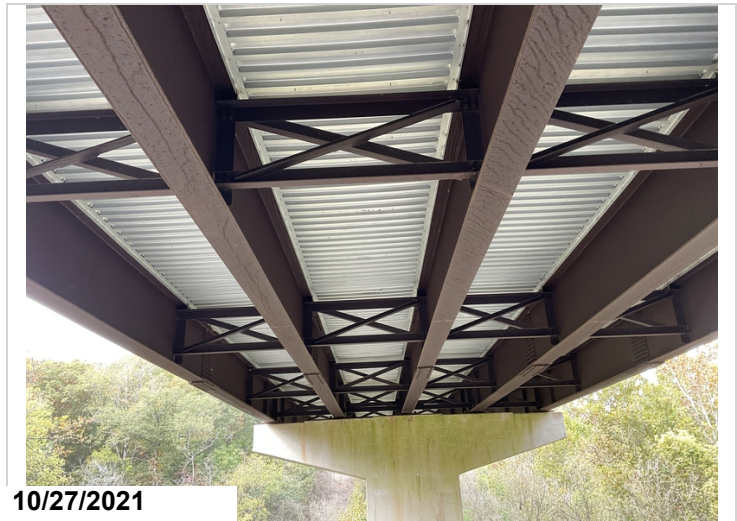
Overall deck below @ span 1.

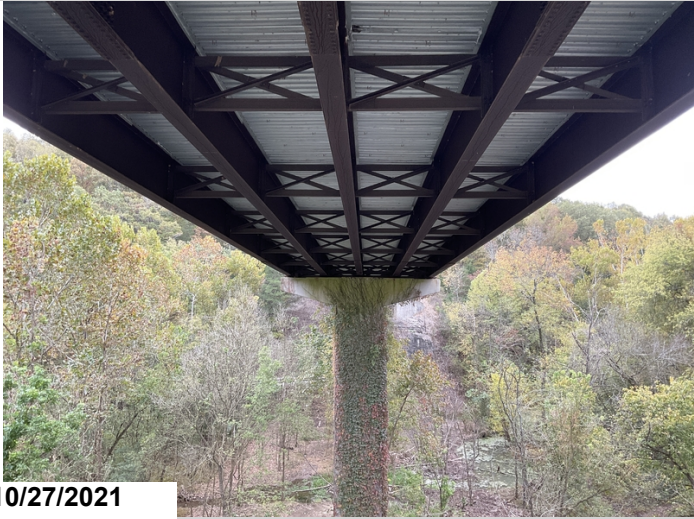
Overall deck below @ span 3.

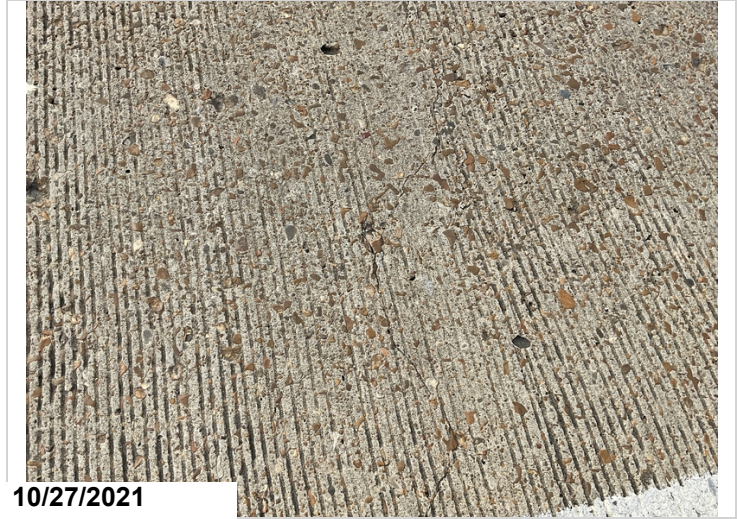
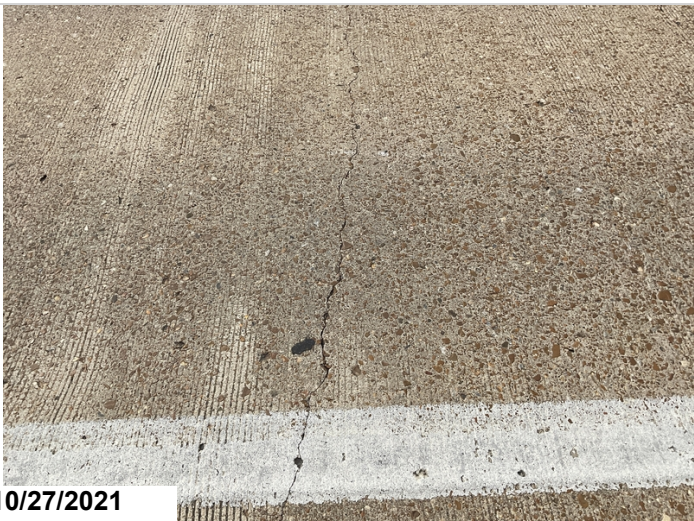
(12) Efflorescent cracks to the Left and Right overhangs. Unsealed cracks to all spans.							
107	Steel Open Girder/Beam	LF	2150	2135	15	0	0
1000	Corrosion	LF	14	0	14	0	0
1020	Connection	LF	1	0	1	0	0
515	Steel Protective Coating	SF	22726	22726	0	0	0

Typical cracks to deck @ all spans.

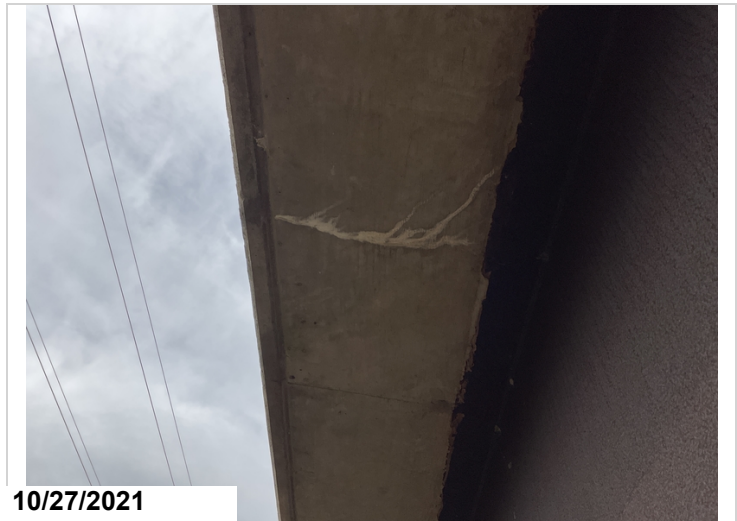
Typical efflor cracks to Lt & Rt overhangs.

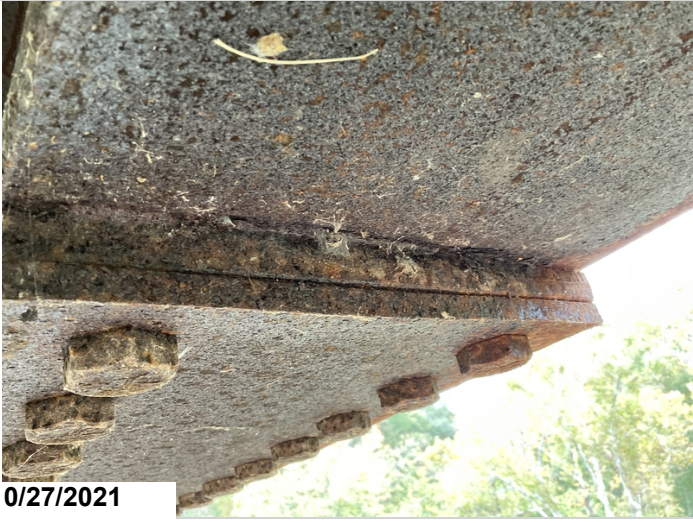
(107) 1 loose bolt at first splice plate in web of Girder 1 @ Span 3. Few areas of flaking rust to bottom flange of Girders 1 & 5. Span 2, girders 1 & 5 has pack rust to first & second splice plate. Span 3, girders 1 & 5 has pack rust to first & second place plate. Span 4, girders 1 & 5 has pack rust to first & second place plate.							
205	Reinforced Concrete Column	EA	3	2	1	0	0
6000	Scour	EA	1	0	1	0	0

Span 2, girders 1 & 5 has pack rust to first splice plate.

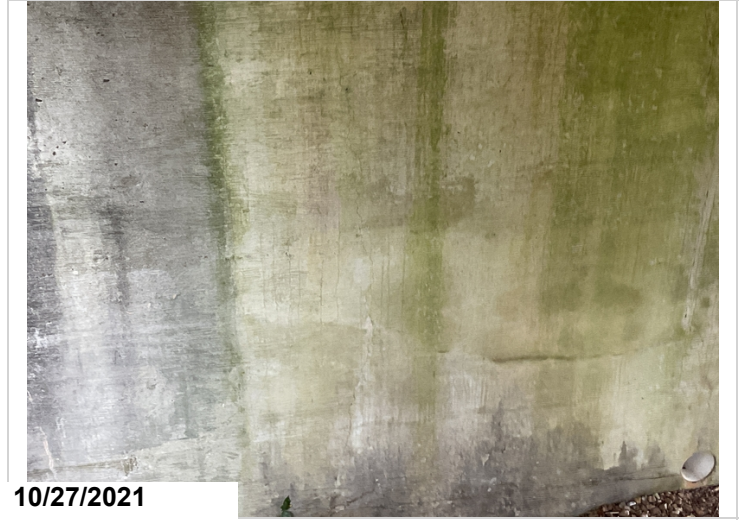
(215) 3 FH 1/16" vertical cracks to Abutment1 with 5 FH vertical efflorescent cracks to backwall. 3 FH 1/16" vertical cracks to Abutment 2 with 9 FH vertical efflorescent cracks to backwall. 3 FH vertical crack to Left wingwall @ Abutment 2 3' efflorescent cracking to Right wing @ Abutment 2.							
220	Reinforced Concrete Pile Cap/Footing	LF	10	10	0	0	0

Full height vertical crack @ abutment 1.

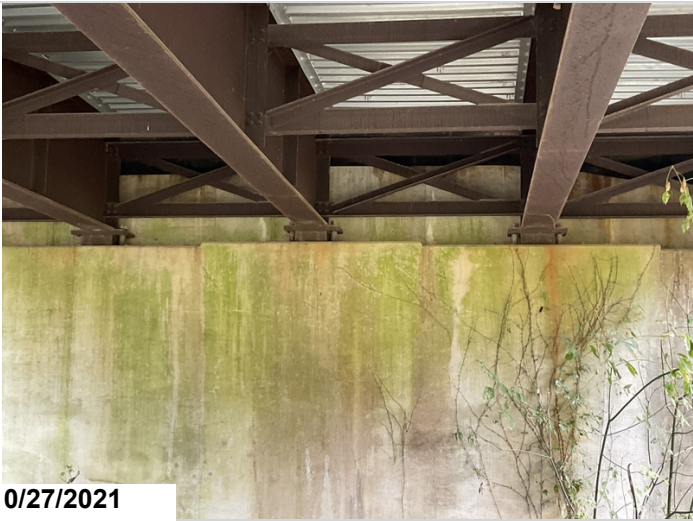
Typical efflor cracks to back wall @ abutment 1.

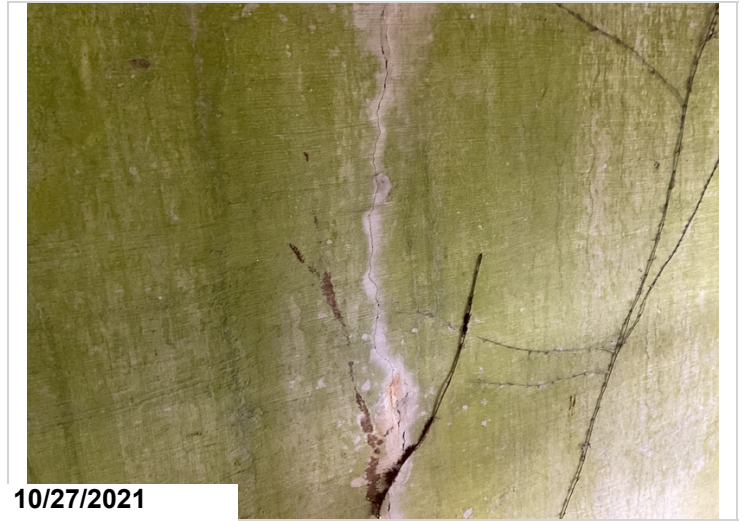
Full height vertical efflor crack @ abutment 2.

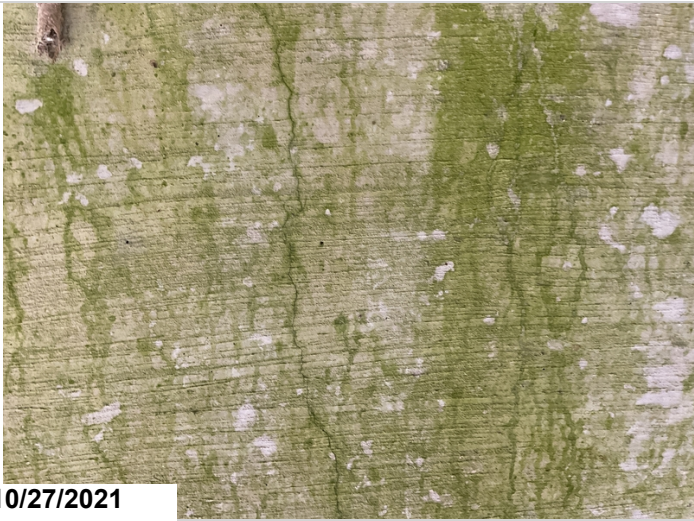
(220) 10' of footing exposed @ Bent 3.							
234	Reinforced Concrete Pier Cap	LF	93	82	11	0	0
1130	Cracking (RC and Other)	LF	11	0	11	0	0
(234) Minor vertical hairline cracks to all Caps.							
303	Assembly Joint with Seal	LF	60	60	0	0	0
310	Elastomeric Bearing	EA	25	18	7	0	0
2220	Alignment	EA	7	0	7	0	0
515	Steel Protective Coating	SF	50	50	0	0	0

Typical vertical cracks to all caps.

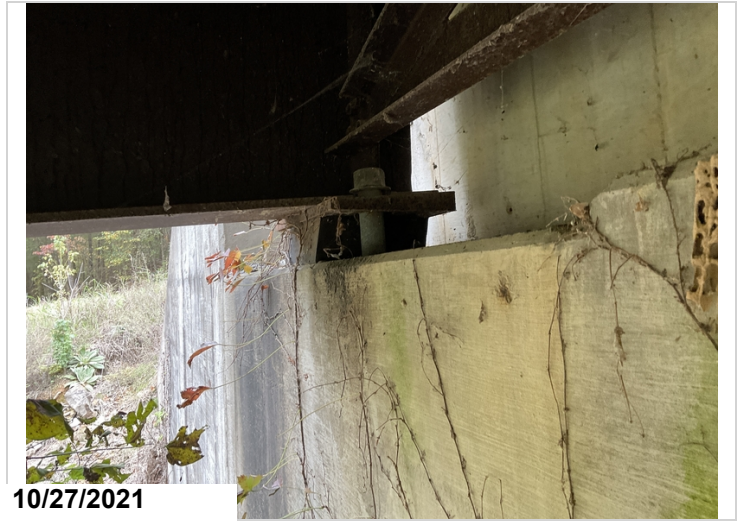
(310) Elastomeric bearings 1-5 @ Abutment 2 are misaligned. Elastomeric bearings 1 & 5 @ Abutment 1 are slightly misaligned.

Elastomeric bearings 1-5 @ Abutment 2 are misaligned.
Bearing 1.

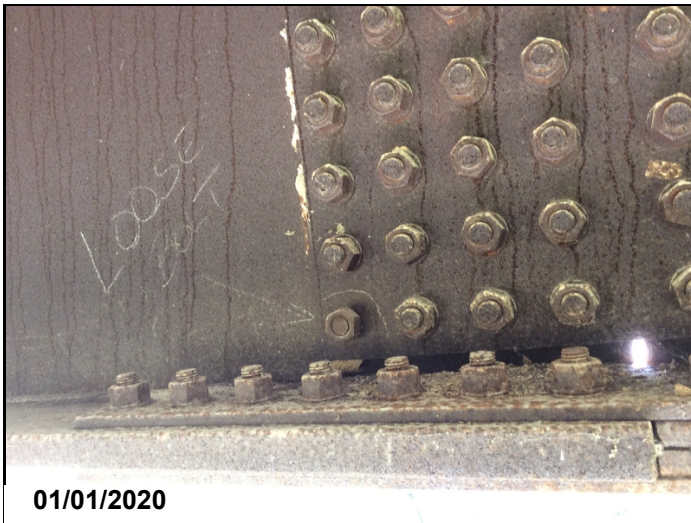
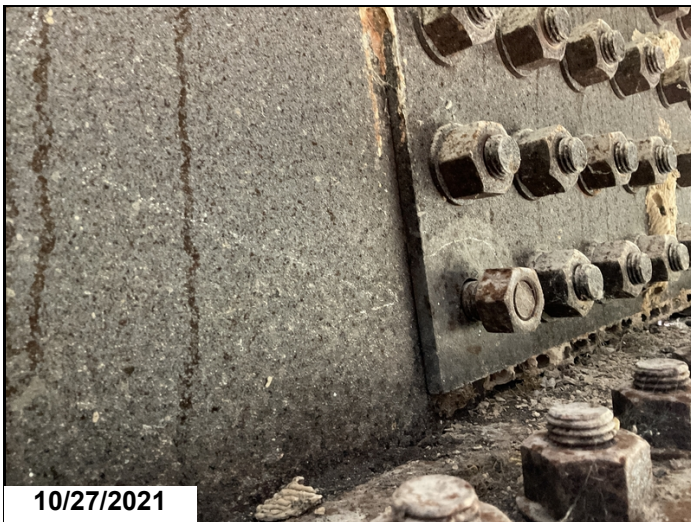
Span 3 - Girder 1 has 1 loose bolt at first splice plate in web.

Span 3 has 1 loose bolt at first splice plate in web of Girder 1.

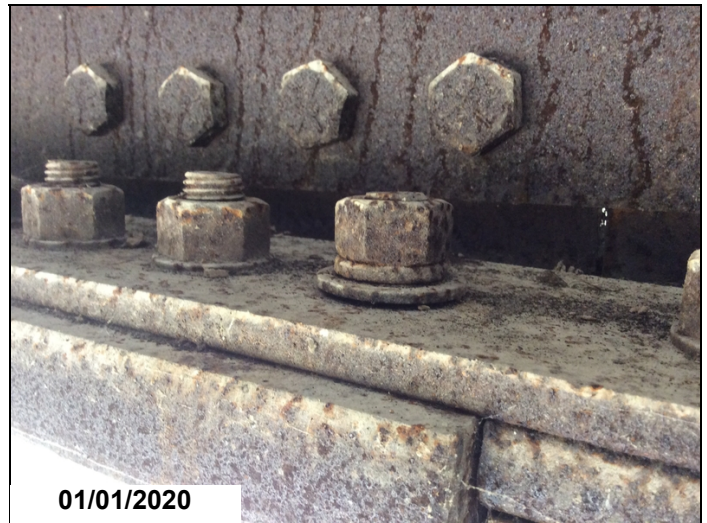
Span 3 has 1 loose bolt at first splice plate in bottom flange of Girder 4

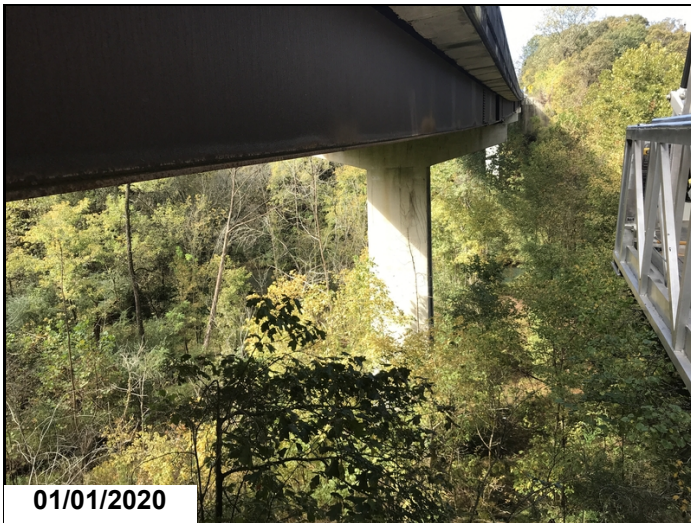
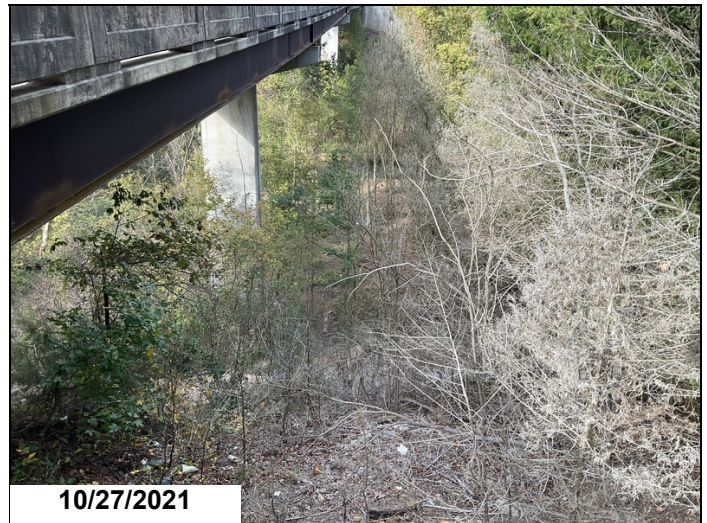
Trees & vegetation @ all spans.

A-64 - Vegetation Removal Requested

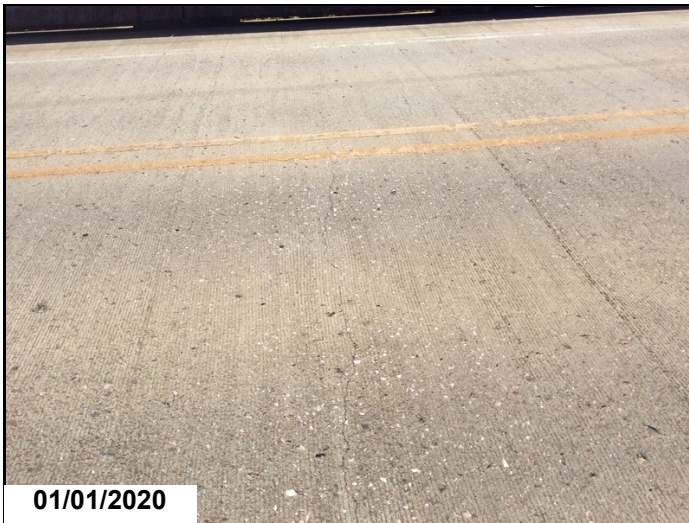
Unsealed transverse cracks to deck @ all Spans.

Span 2 Deck cracks.

A-54 - Sealable Deck Cracks

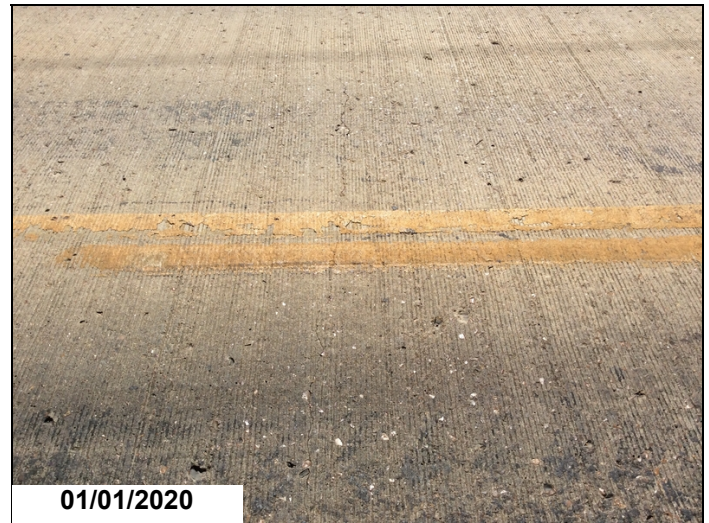
Span 1 Deck cracks.

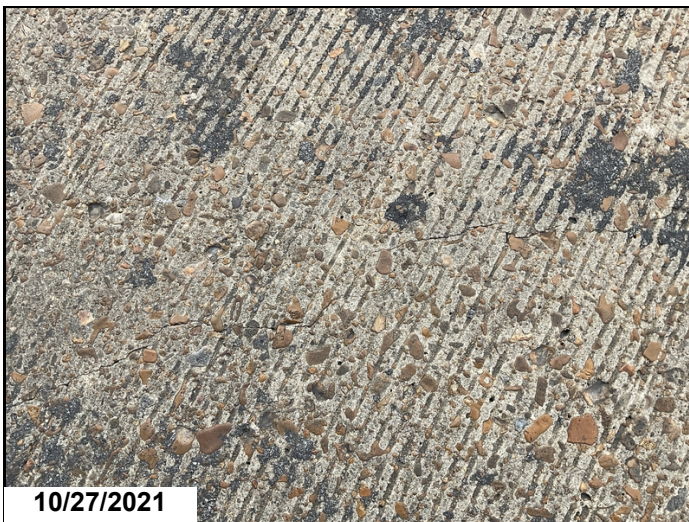
Unsealed transverse cracks to deck @ all Spans.

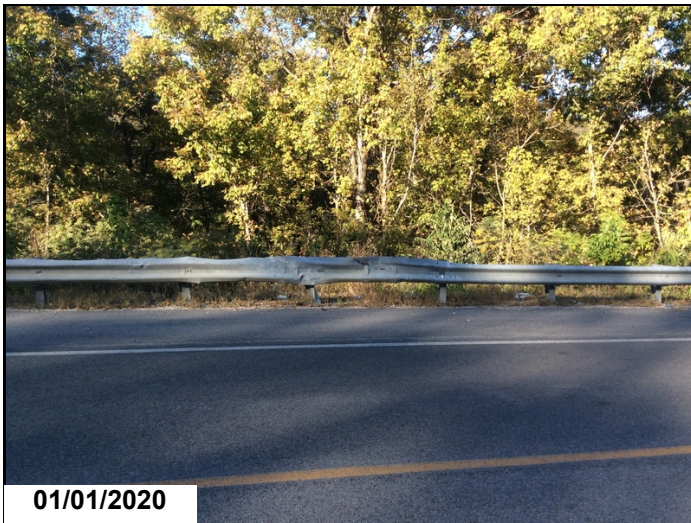
Approach guardrail has minor collision damage at Abutment 2 Left and Right.

Right approach guard rail @ Abutment 2.

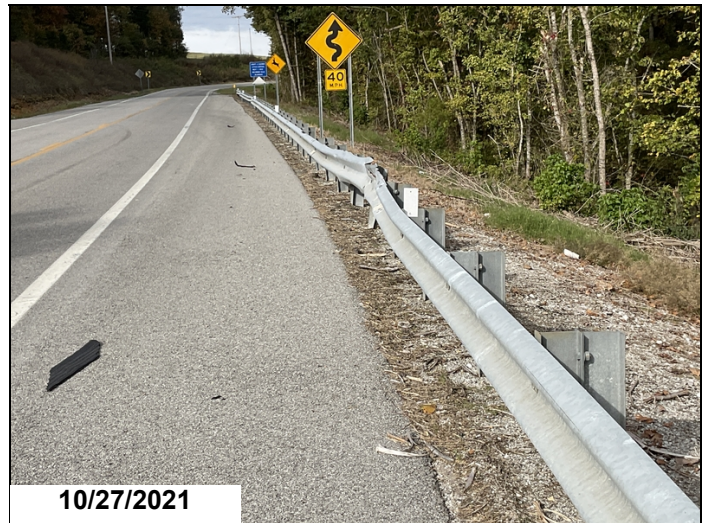
Approach guardrail has minor collision damage at
Abutment 2 Left and Right.
Lt approach guard rail.

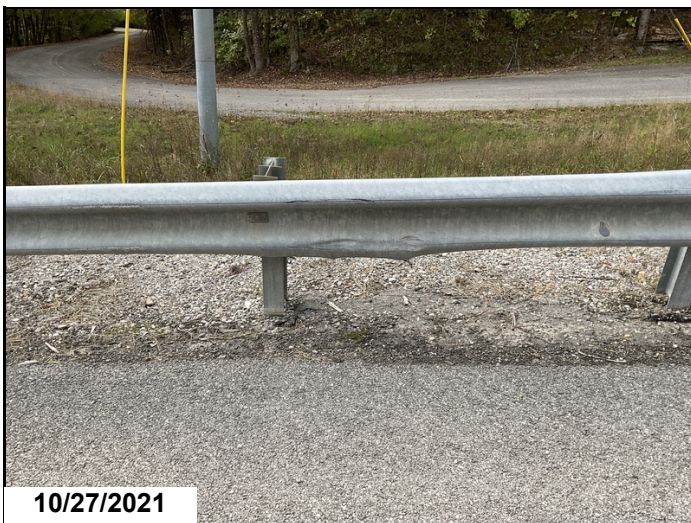
Approach guardrail has minor collision damage at
Abutment 2 Left and Right.
