Asset #06180(SNBI Collection)
SH 106/Independ.Co over SPRING CREEK/MO.&N.AR RR
Location: 2.43 MI W JCT SH 69
Team Lead: Nathan Edwards Inspection Date: 10/17/2023

General Observation

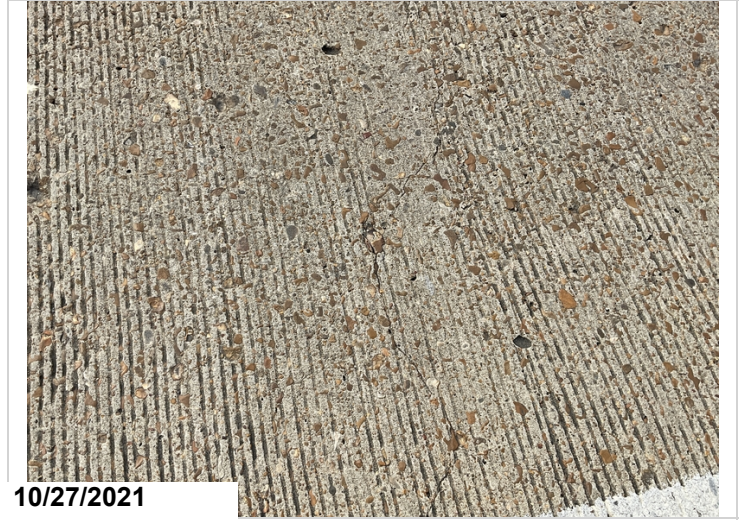
(12) Efflorescent cracks to the Left and Right overhangs. Unsealed cracks to all spans.							
107	Steel Open Girder/Beam	LF	2150	2135	15	0	0
1000	Corrosion	LF	14	0	14	0	0
1020	Connection	LF	1	0	1	0	0
515	Steel Protective Coating	SF	22726	22726	0	0	0

Typical cracks to deck @ all spans.

Unsealed transverse cracks to deck @ all Spans.

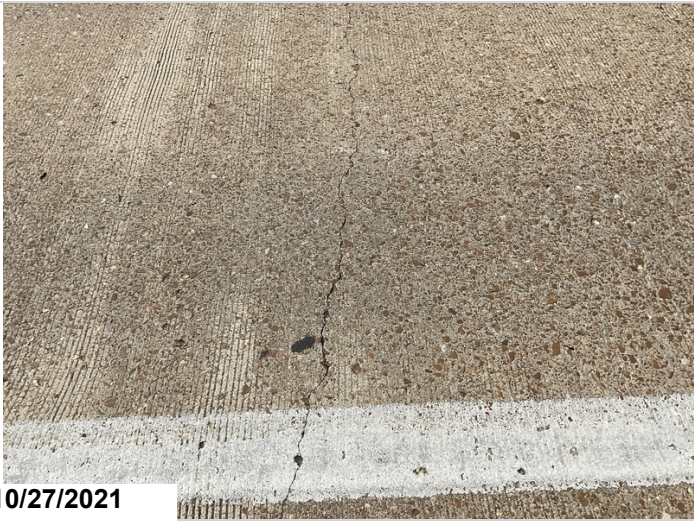
Typical cracks to deck @ all spans.

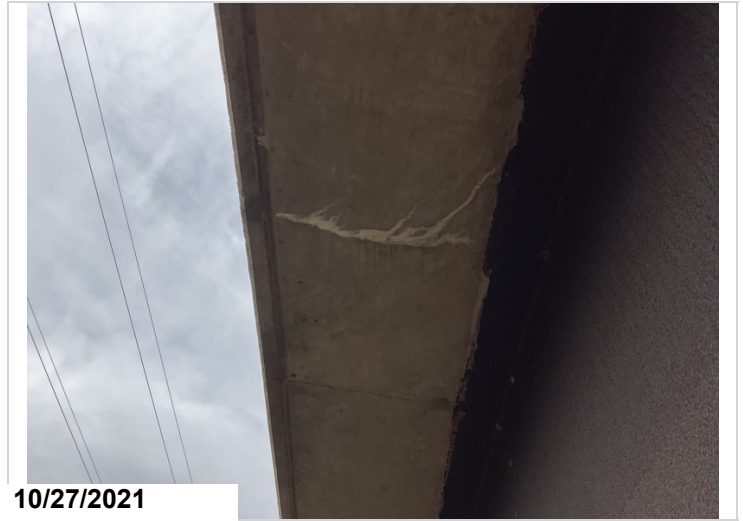
Typical efflor cracks to Lt & Rt overhangs.

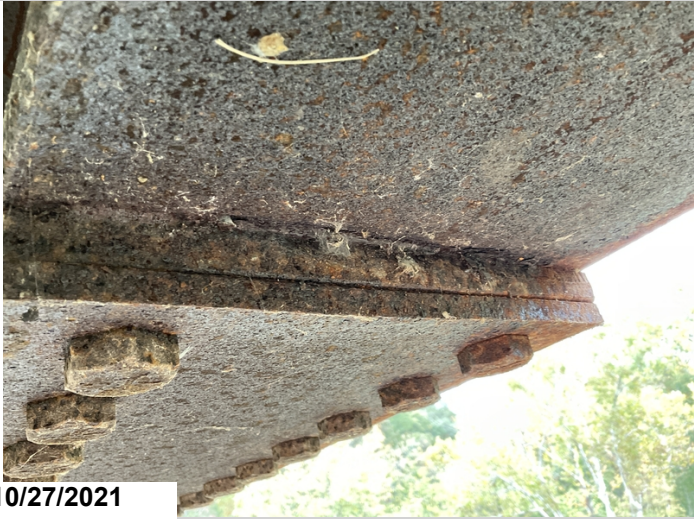
(107) 1 loose bolt at first splice plate in web of Girder 1 @ Span 3. Few areas of flaking rust to bottom flange of Girders 1 & 5. Span 2, girders 1 & 5 has pack rust to first & second splice plate. Span 3, girders 1 & 5 has pack rust to first & second place plate. Span 4, girders 1 & 5 has pack rust to first & second place plate.							
205	Reinforced Concrete Column	EA	3	2	1	0	0
6000	Scour	EA	1	0	1	0	0

Span 2, girders 1 & 5 has pack rust to first splice plate.

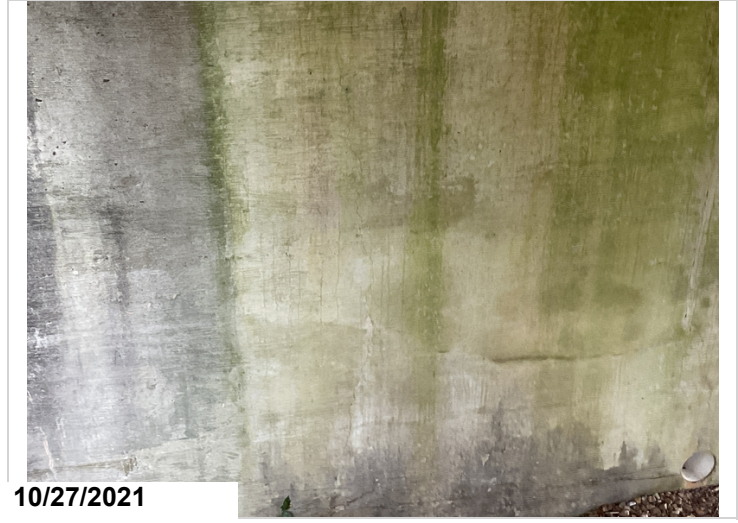
(215) 3 FH 1/16" vertical cracks to Abutment1 with 5 FH vertical efflorescent cracks to backwall. 3 FH 1/16" vertical cracks to Abutment 2 with 9 FH vertical efflorescent cracks to backwall. 3 FH vertical crack to Left wingwall @ Abutment 2 3' efflorescent cracking to Right wing @ Abutment 2.							
220	Reinforced Concrete Pile Cap/Footing	LF	10	10	0	0	0

Full height vertical crack @ abutment 1.

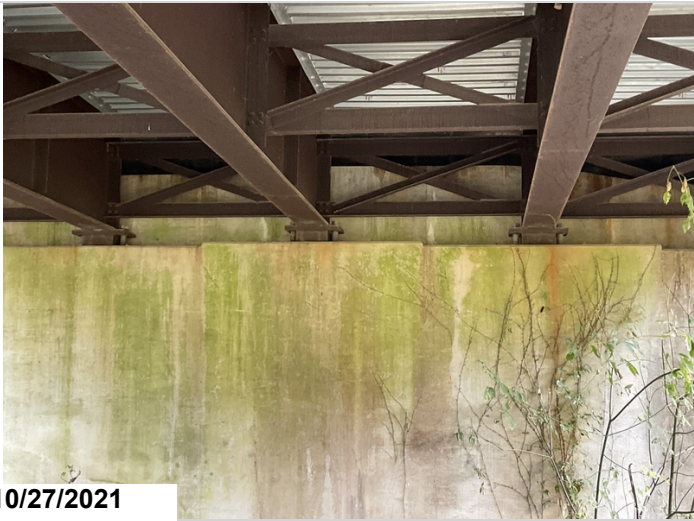
Typical efflor cracks to back wall @ abutment 1.

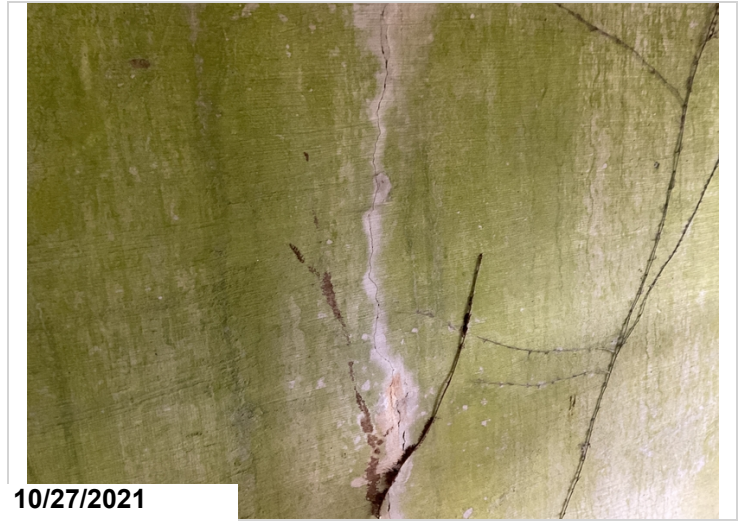
Full height vertical efflor crack @ abutment 2.

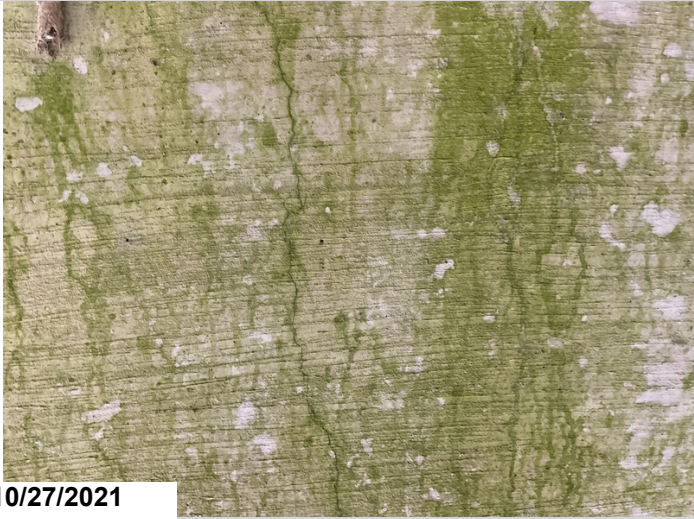
(220) 10' of footing exposed @ Bent 3.							
234	Reinforced Concrete Pier Cap	LF	93	82	11	0	0
1130	Cracking (RC and Other)	LF	11	0	11	0	0
(234) Minor vertical hairline cracks to all Caps.							
303	Assembly Joint with Seal	LF	60	60	0	0	0
310	Elastomeric Bearing	EA	25	18	7	0	0
2220	Alignment	EA	7	0	7	0	0
515	Steel Protective Coating	SF	50	50	0	0	0

Typical vertical cracks to all caps.

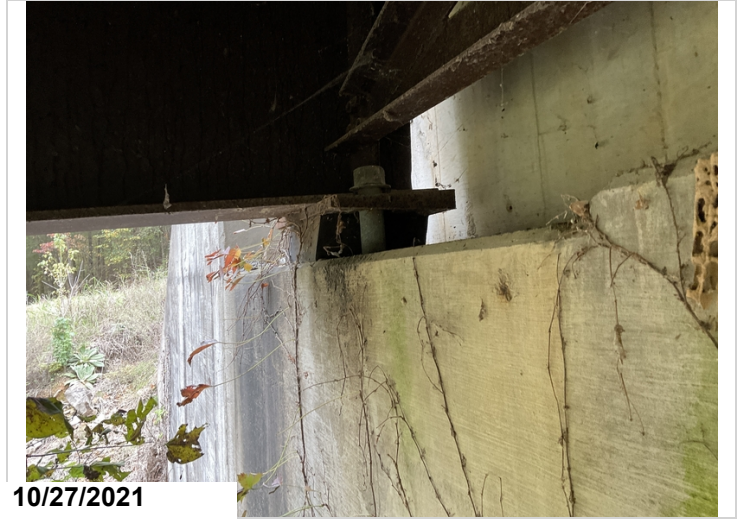
(310) Elastomeric bearings 1-5 @ Abutment 2 are misaligned. Elastomeric bearings 1 & 5 @ Abutment 1 are slightly misaligned.

Elastomeric bearings 1-5 @ Abutment 2 are misaligned.
Bearing 1.

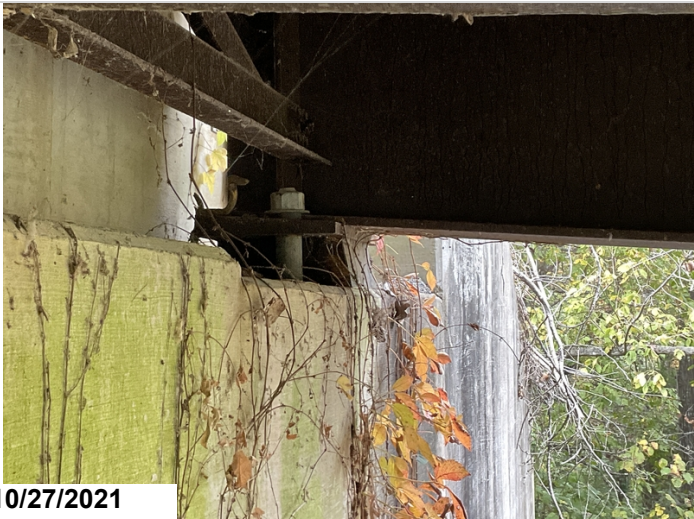
Elastomeric bearings 1-5 @ Abutment 2 are misaligned.
Bearing 5.

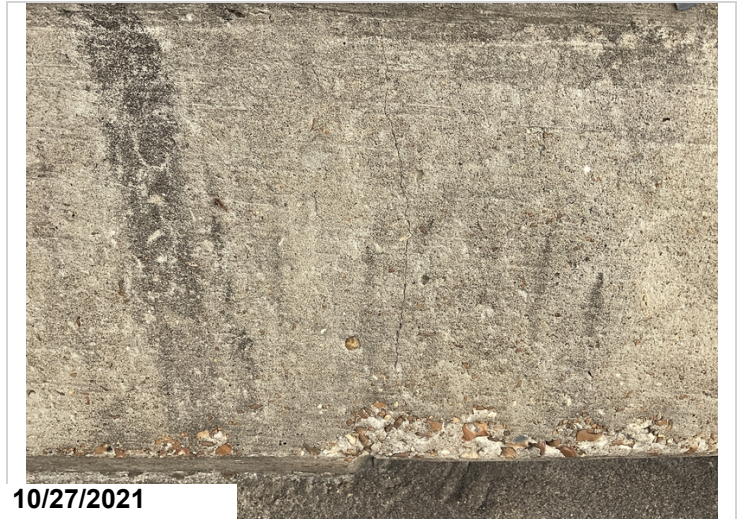
ELEMENTS	DESCRIPTION	UNITS	TOTAL	CS1	CS2	CS3	CS4
331	Reinforced Concrete Bridge Railing	LF	864	757	107	0	0
1130	Cracking (RC and Other)	LF	107	0	107	0	0
(331) Vertical cracking to Left & Right parapets.

Typical cracks to Lt & Rt parapet wall.
