Asset #07142(Routine)

SH 106/Indepen. Co over US Lime Haul Prvt Rd

Location: 1.5 mi E of Jct 106/106S

Team Lead: Nathan Edwards Inspection Date: 04/05/2023

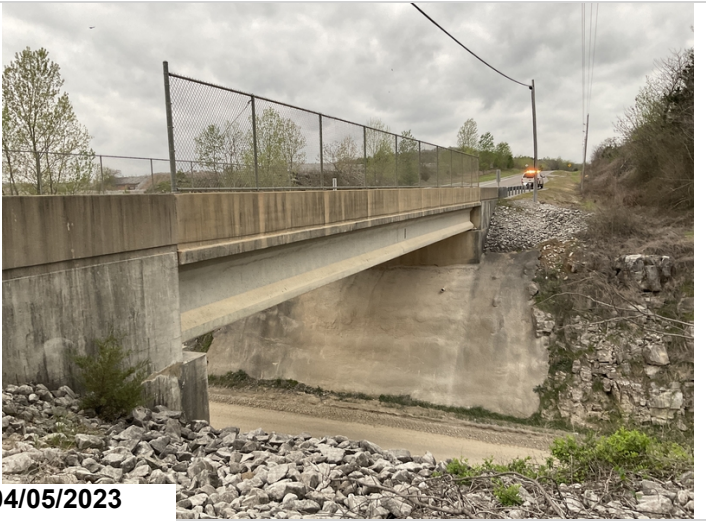
Elevation with Log Mile running to the Right.

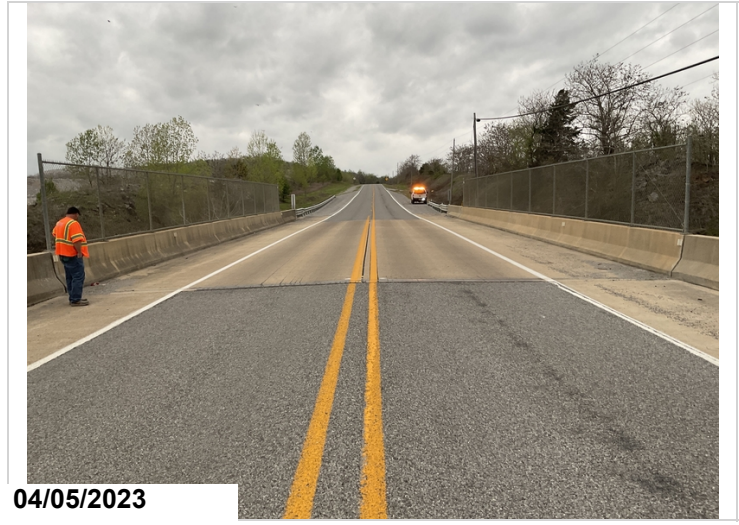
Roadway with Log Mile running East to West.
