## Bridge 01899 Inspection Report

Route:5 Section:16 Log:24.61

District 05, 137 - Stone County

Asset #01899(Routine, NSTM)  
SH 5/Stone County over SYLAMORE CREEK  
Location: .3 MI N JCT SH 14 W  
Team Lead: Seth Foreman Inspection Date: 09/17/2025

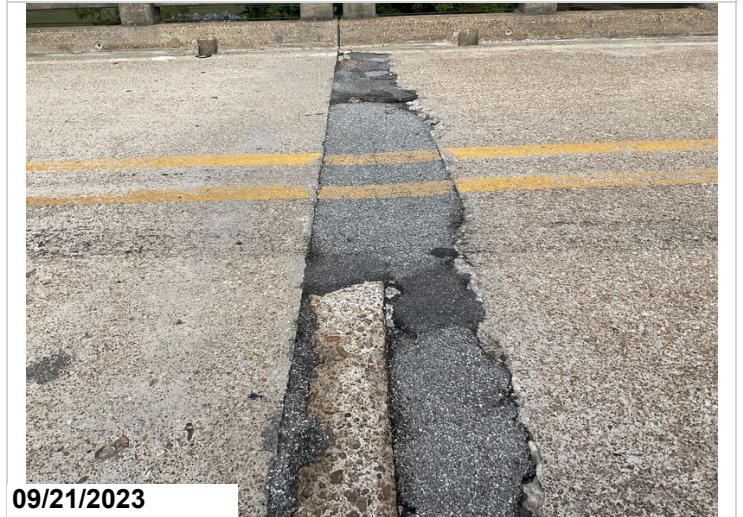
Spalls/patched areas to deck @ beginning of Span 4.(#3)

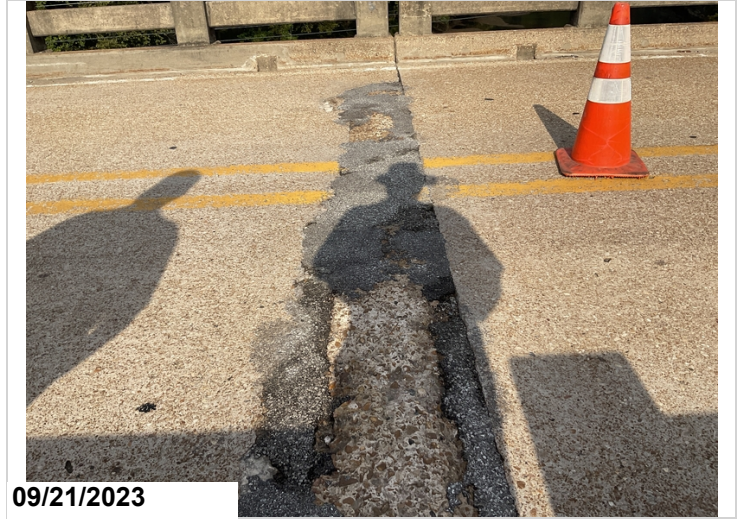
Spalls/patched areas to deck @ end of Span 4.(#3)

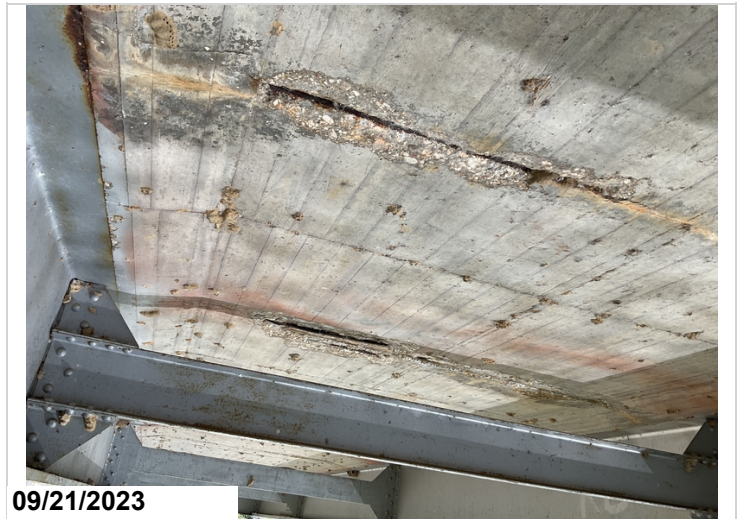
Spalls with rebar exposed with s/l to soffit @ Span 4.(#3)  
(typical)

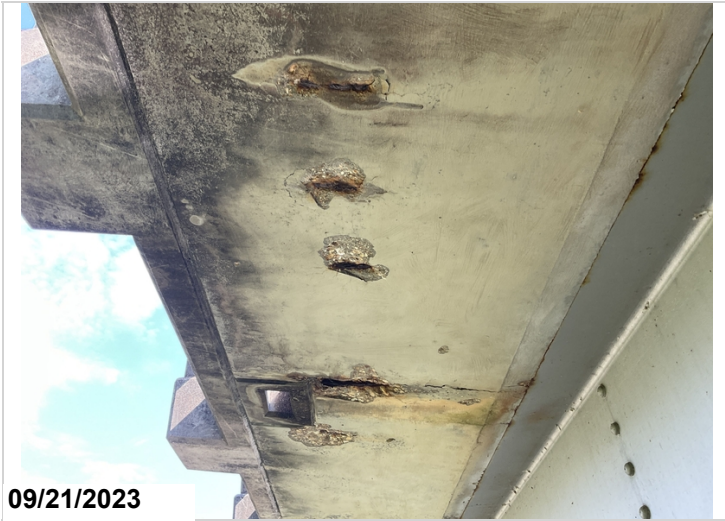
Typical spalls with rebar exposed to overhangs.(#3)(Left overhang @ Span 3)

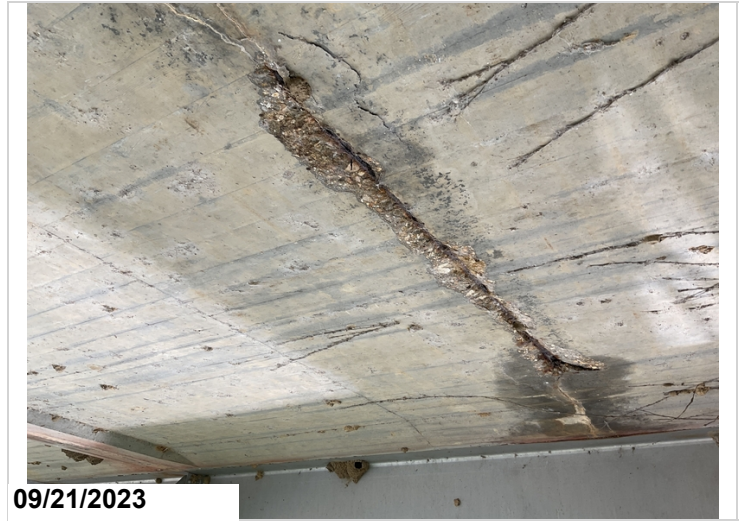
Spalls with rebar exposed with s/l to soffit @ Span 3.(#3) (typical)

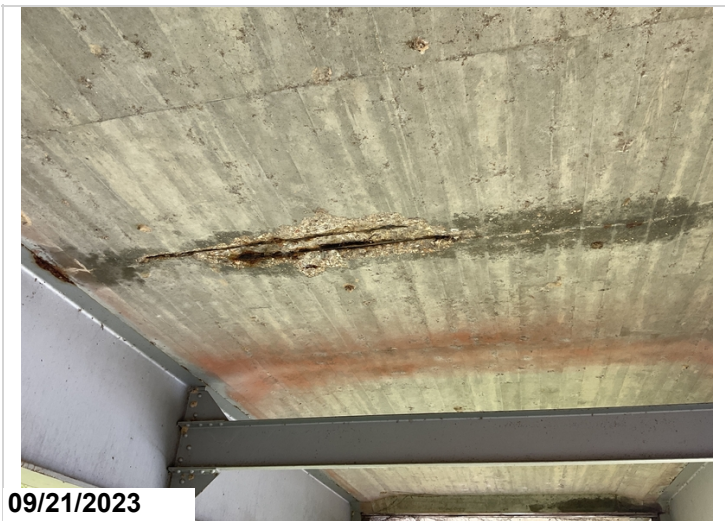
Spalls with rebar exposed with s/l to soffit @ Span 2.(#3) (typical)

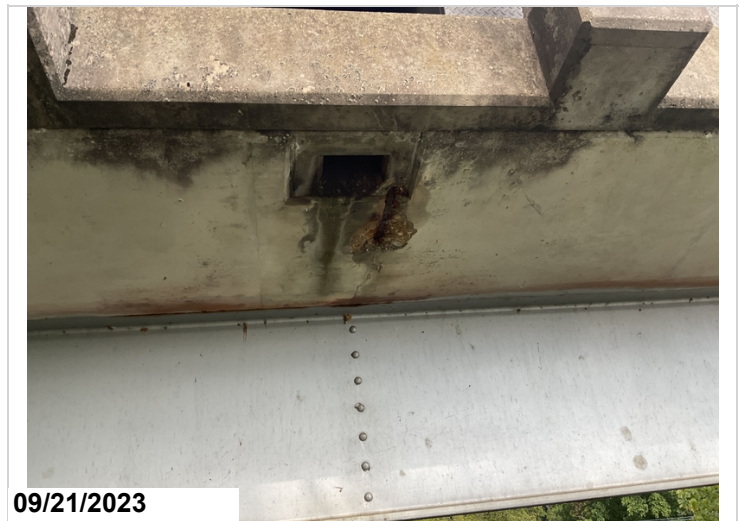
Typical spalls with rebar exposed with s/l to overhangs.(#3)

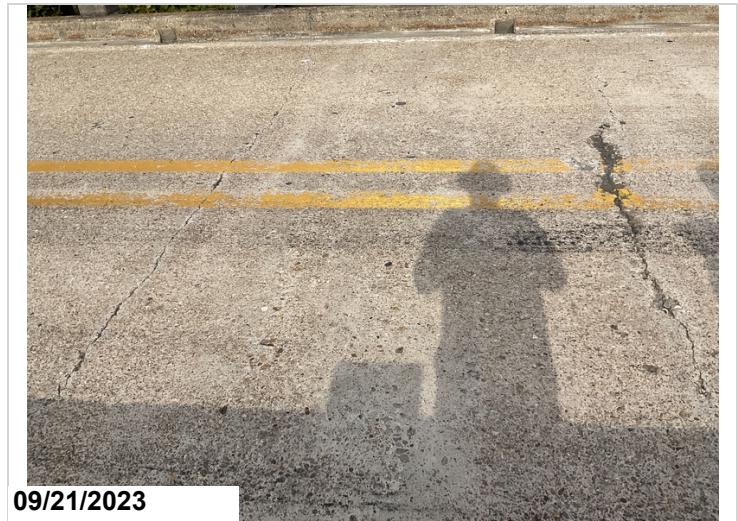
Transverse cracking to deck @ Span 3.(#3)(typical)

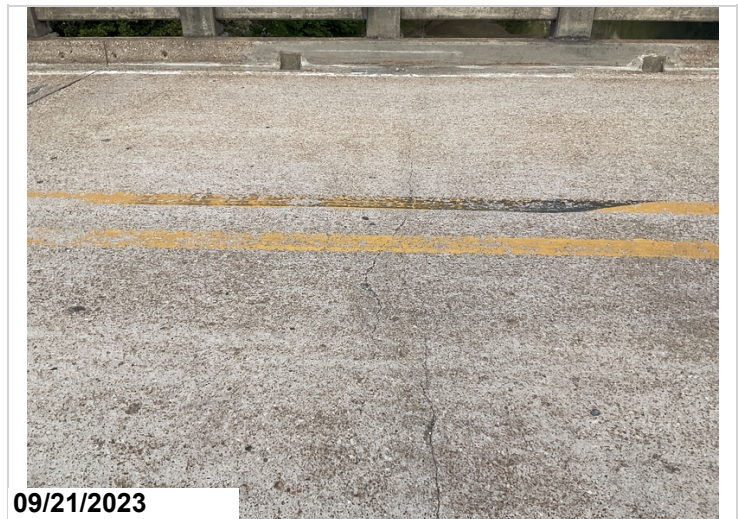
Typical transverse cracking to deck.(#3)(typical)

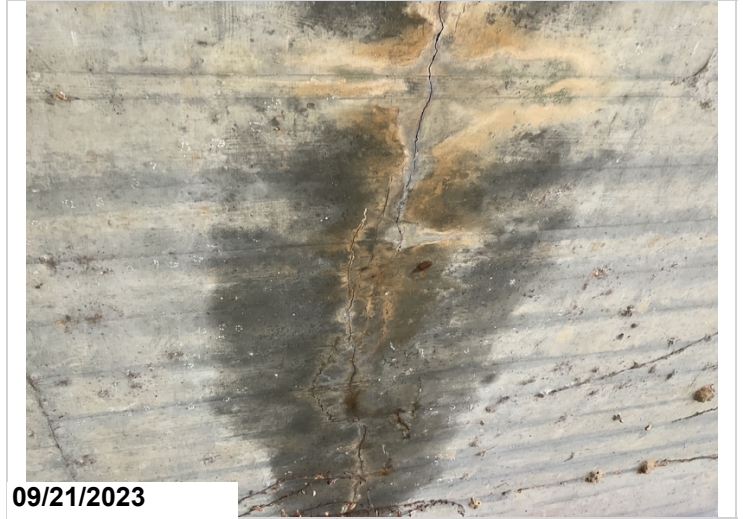
Efflorescent cracking with rust stains to soffit @ Span 3.(#3)  
(typical)

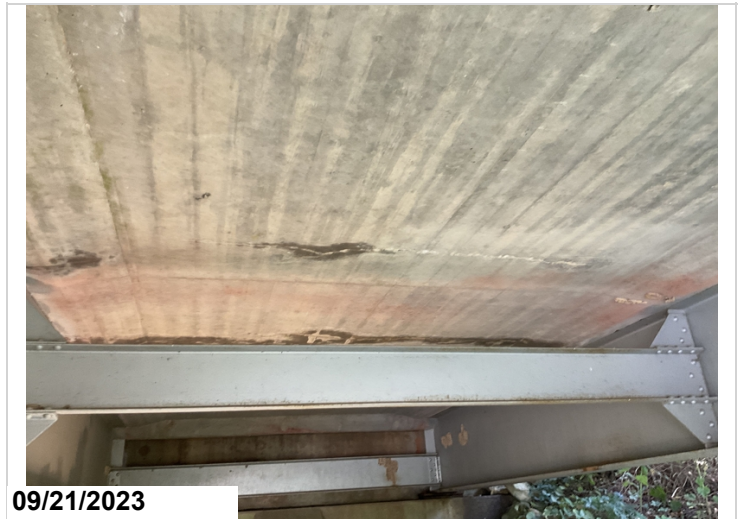
Efflorescent cracking to soffit @ Span 1.(#2)(typical)

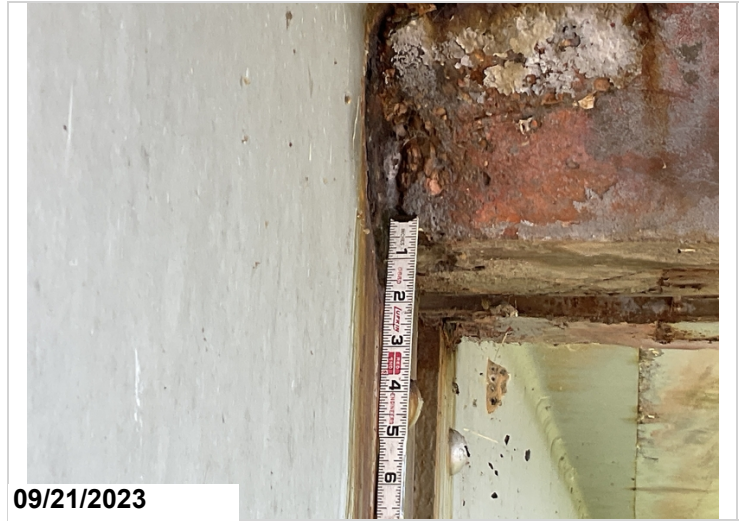
Rust with 1/2" s/l to web below haunch @ Girder 2 @ end of Span 6.(#3)

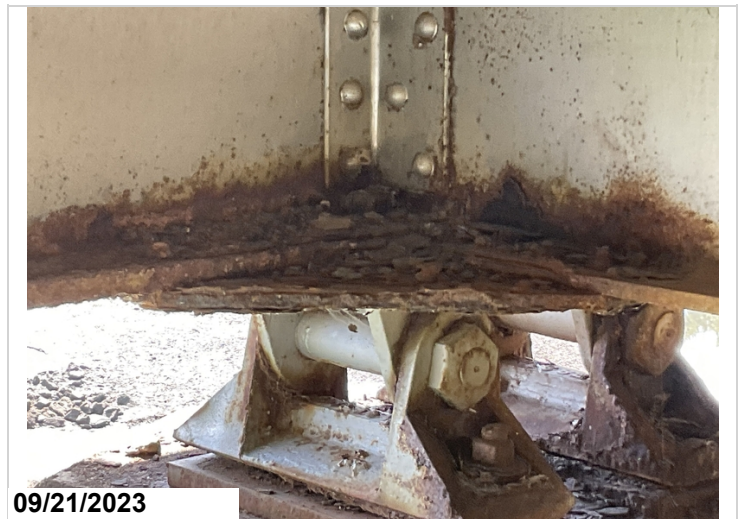
Rust with pack rust & s/l to diaphragm, bottom flange & connecting plate @ Girder 2 @ beginning of Span 6.(#3)

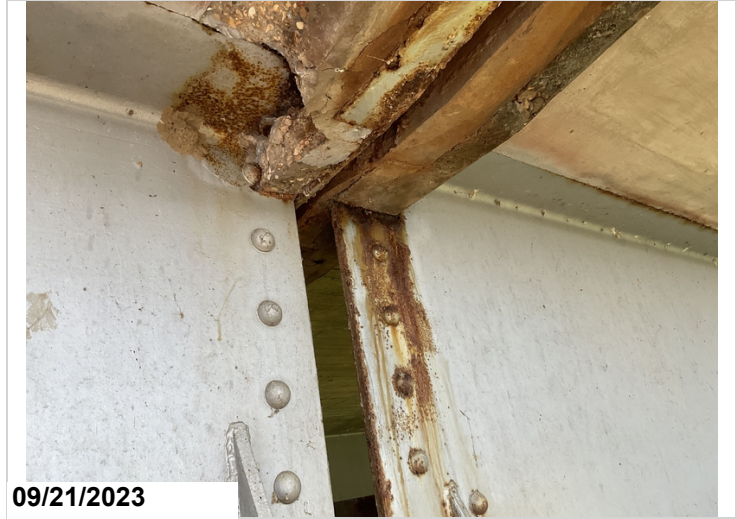
Rust with 1/8" s/l to web below haunch @ Girder 2 @ beginning of Span 6.(#3)

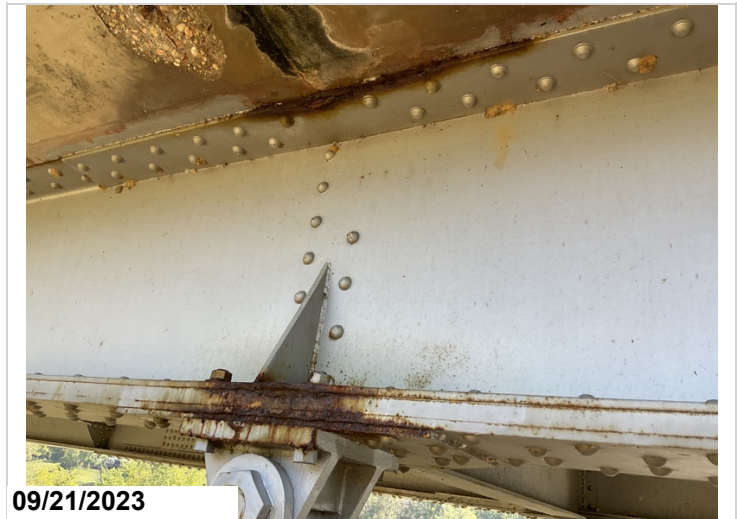
Rust with pack rust to top flange & between cover plates & bottom flange @ Girder 1 @ Bent 4.(#3)

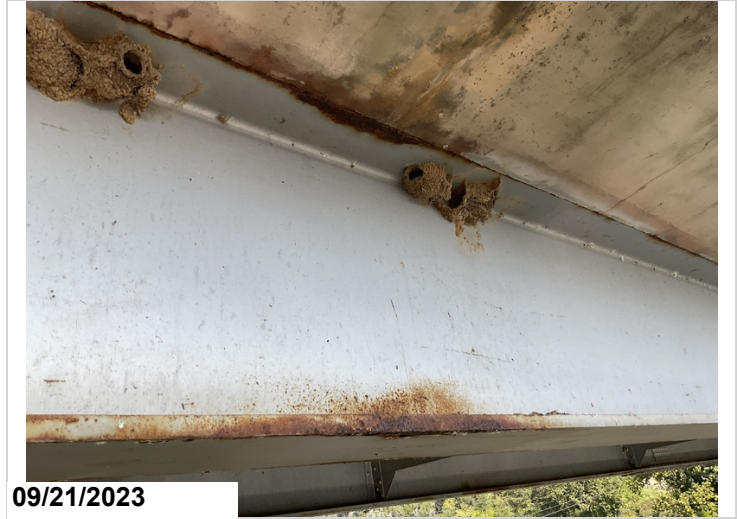
Rust to Girder 2 @ 3rd drain opening @ Span 3.(#3)

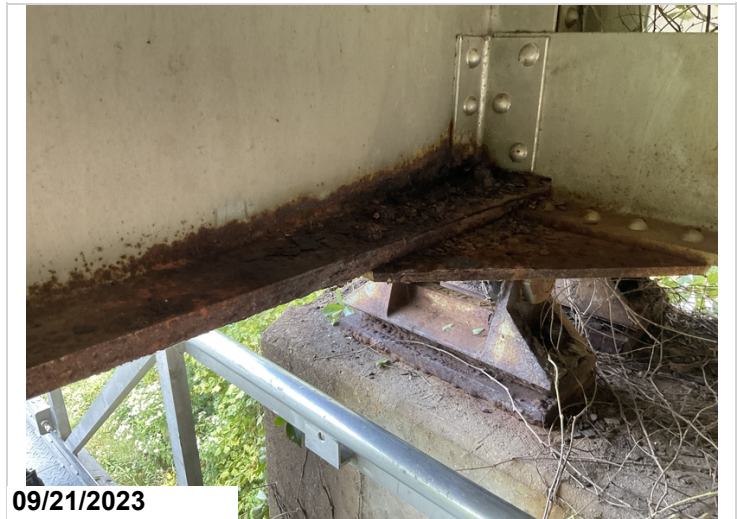
Rust with pack rust with s/l to bottom flange & connecting plate @ Girder 1 @ end of Span 2.(#3)

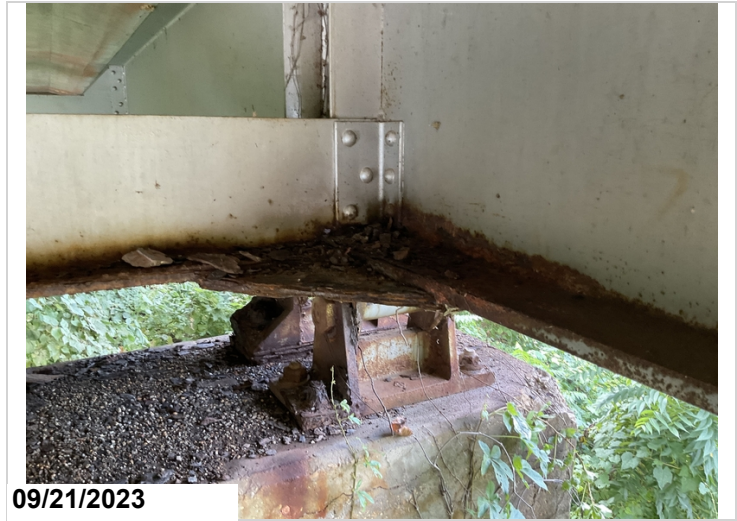
Rust with pack rust & s/l to diaphragm, bottom flange & connecting plate @ Girder 1 @ beginning of Span 2.(#3)

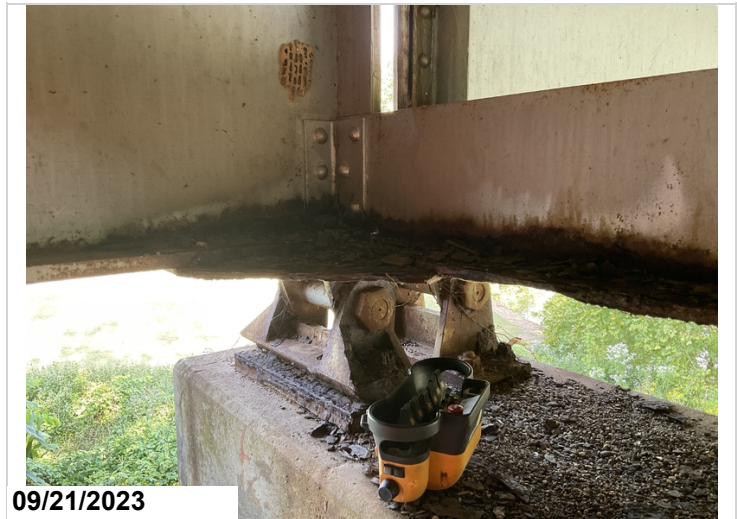
Rust with pack rust & s/l to diaphragm, bottom flange & connecting plate @ Girder 1 @ end of Span 1.(#3)

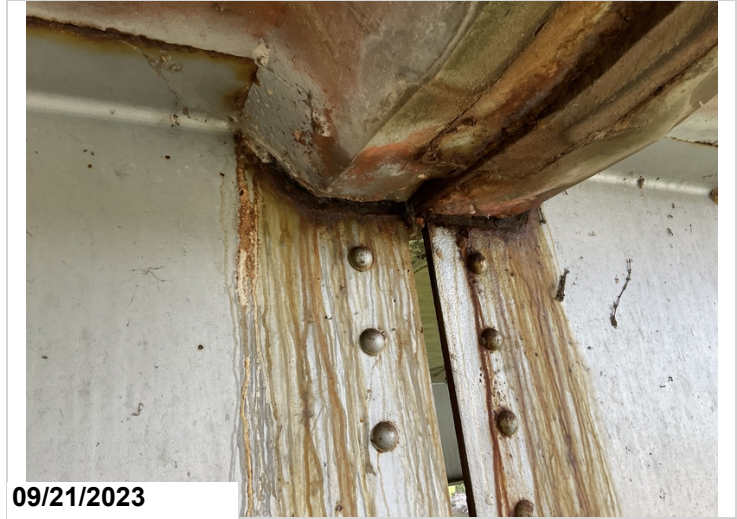
Rust with 3/16" s/l to web below haunch @ Girder 2 @ end of Span 1 & beginning of Span 2.(#3)

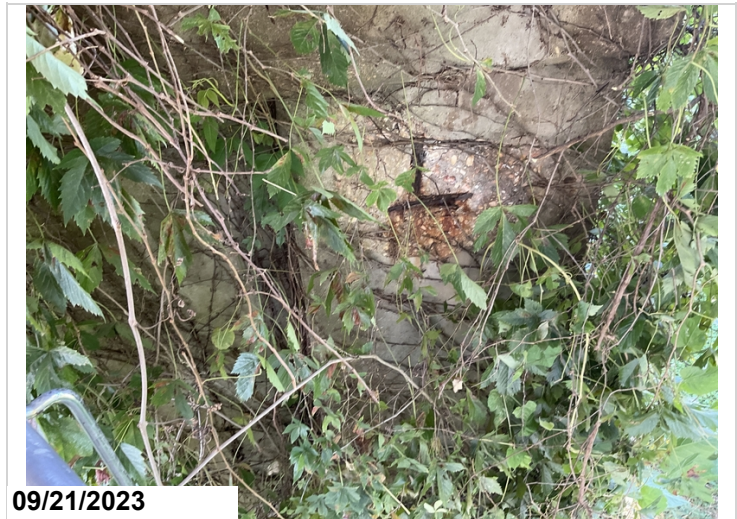
Spall with rebar exposed with s/l to ahead side of Column 1 @ Bent 2.(#3)

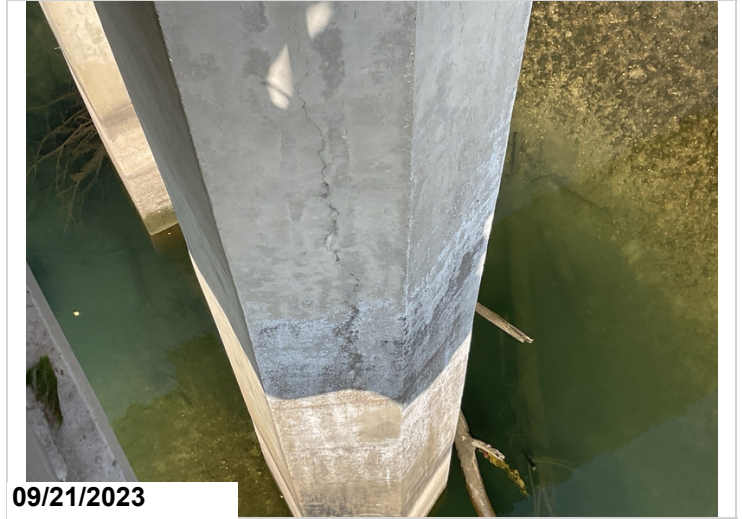
Vertical cracking to Column 2 @ Bent 3.(#2)

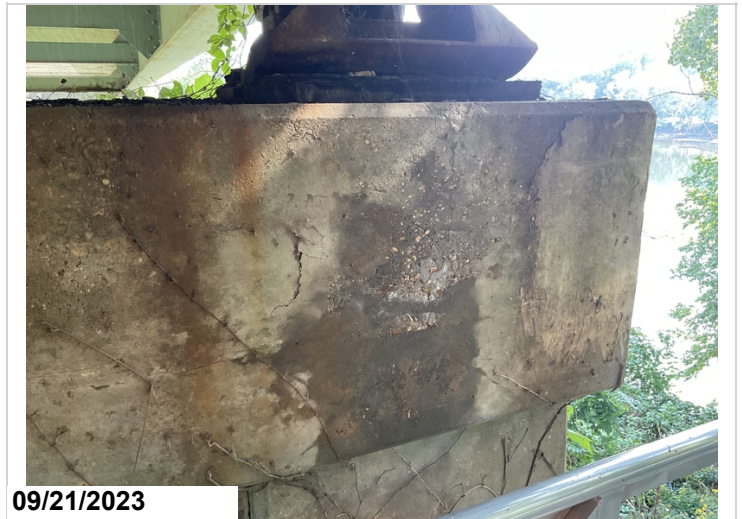
Delaminated areas to Right end of cap @ Bent 1.(#3)

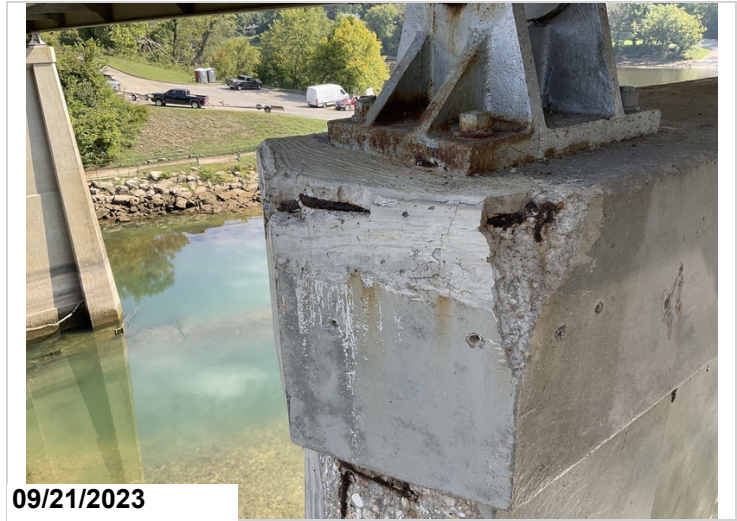
Spall with rebar exposed with s/l to Left end of cap @ Bent 3.(#3)

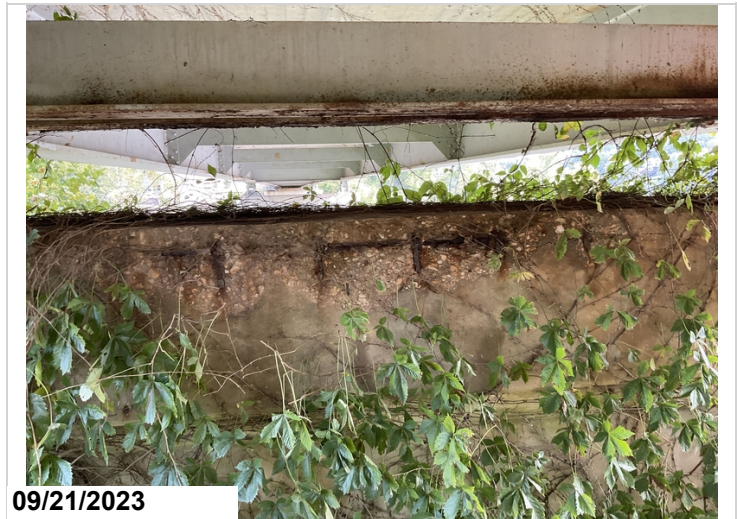
Spalls with rebar exposed with s/l to backside of cap @ Bent 2.(#3)

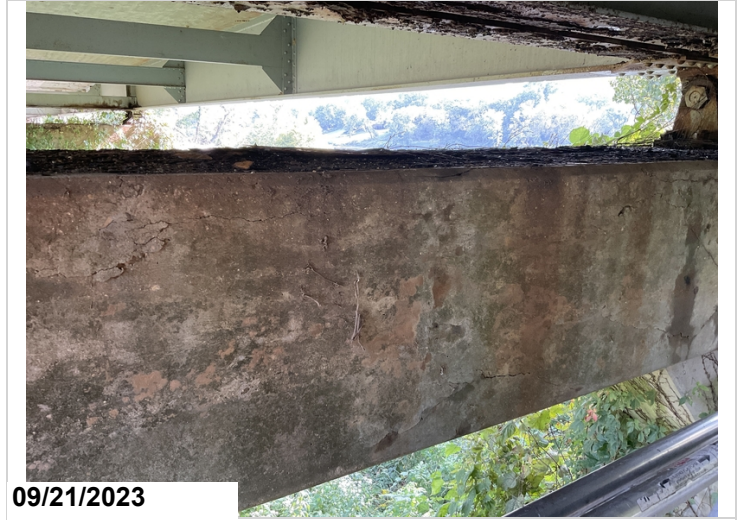
Horizontal cracking to backside of cap @ Bent 1.(#3)

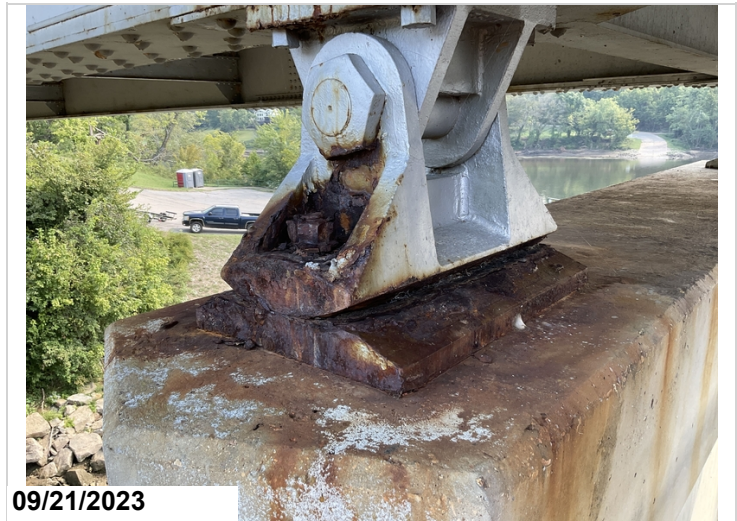
Rust with pack rust to Moveable Bearing 1 @ Bent 4.(#3)  
(typical)

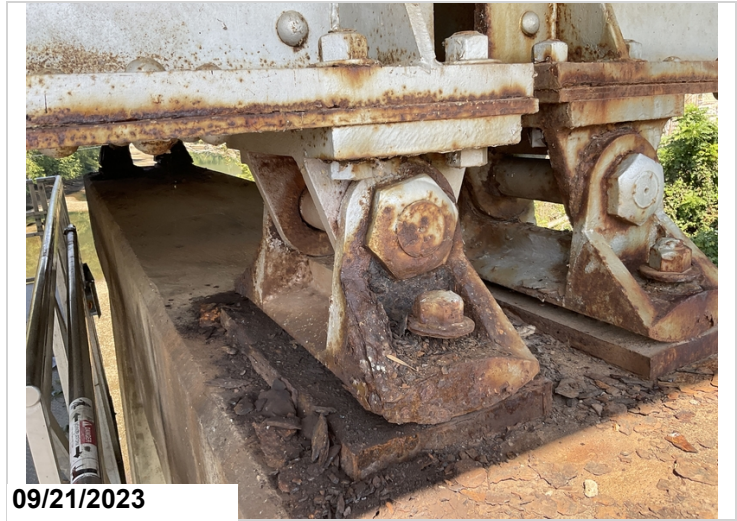
Exterior nut on rocker pin @ Moveable Bearing 2 @ backside of Bent 5 is cracked.(#3)

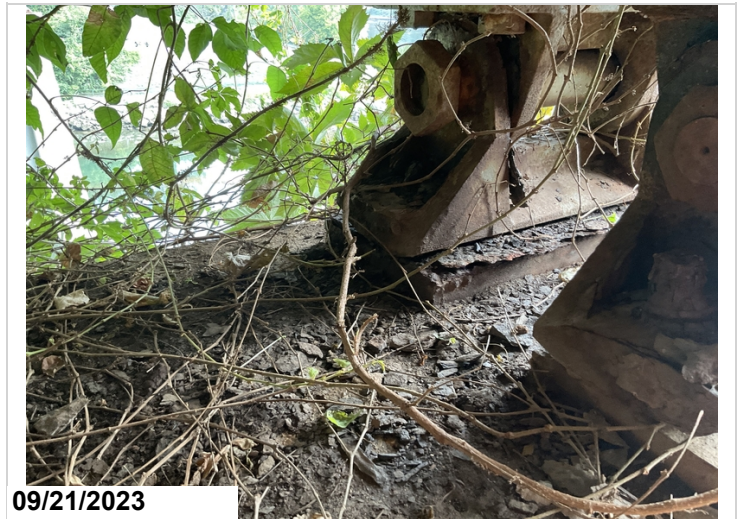
Anchor bolt is missing @ Moveable Bearing 2 on ahead side @ Bent 2.

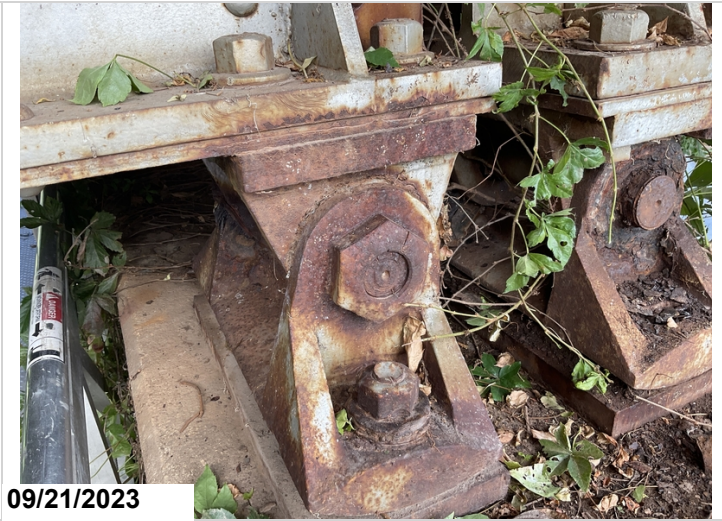
Exterior nut on rocker pin @ Moveable Bearing 2 @ backside of Bent 2 is cracked.(#3)

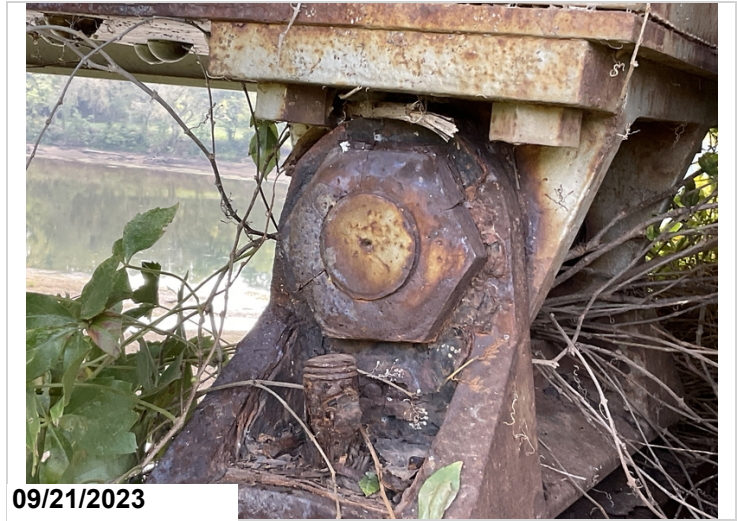
Exterior nut on rocker pin @ Moveable Bearing 1 on ahead side of Bent 2 has 2 cracks.(#3) Anchor bolt nut is also missing due to heavy corrosion.(#3)

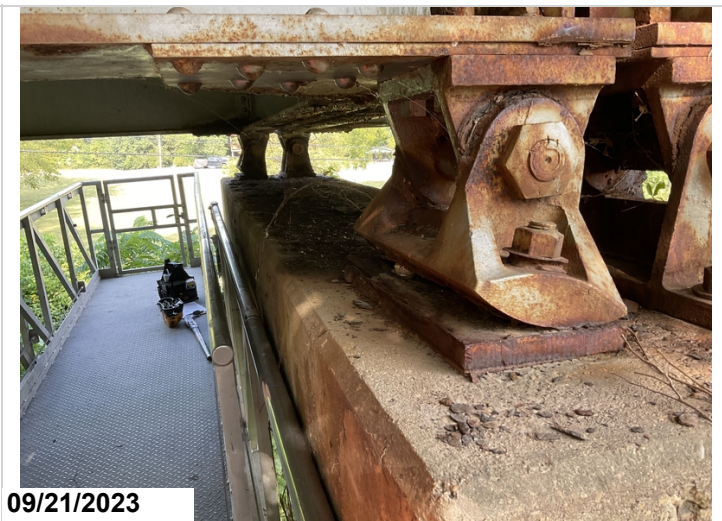
Moveable Bearings @ Bent 1 have rotated ahead to the max.(#4)

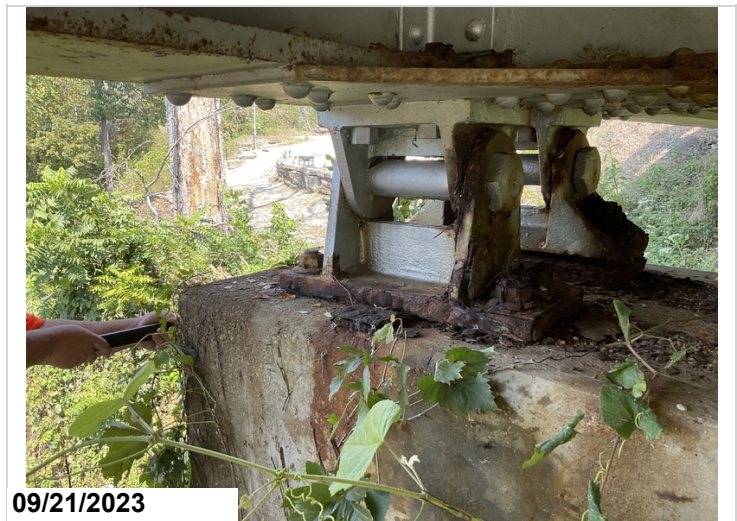
Rust with pack rust to Fixed Bearing 1 @ Bent 7.(#3)

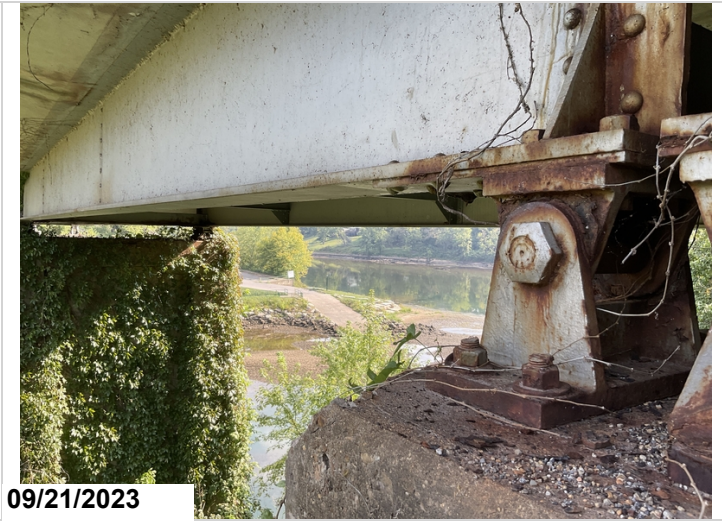
Rust with pack rust to Fixed Bearing 1 @ Bent 1.(#3)

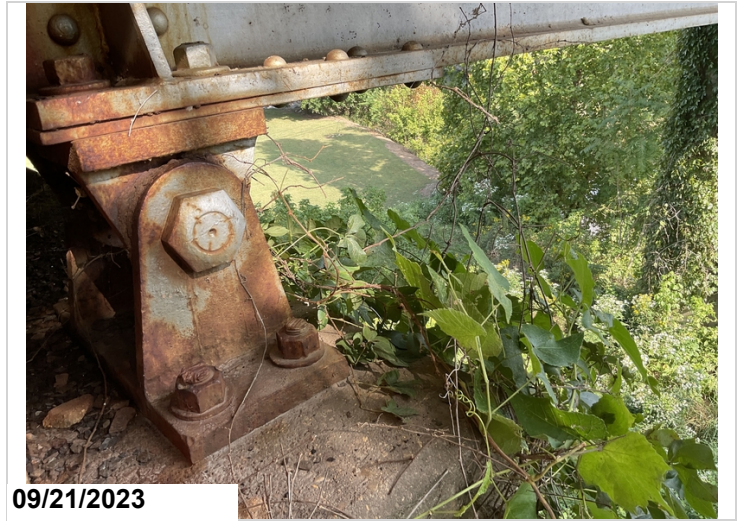
Typical rust to Fixed Bearings.(#2 Bent 1)

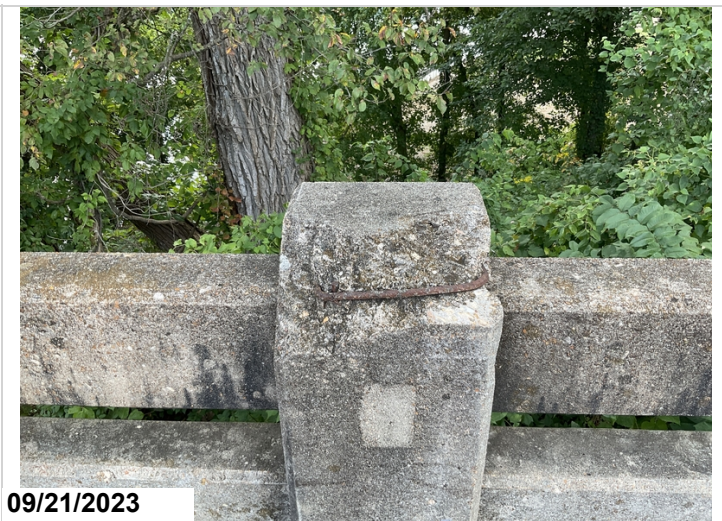
Typical spalls with rebar exposed to concrete bridge rail posts.#2)

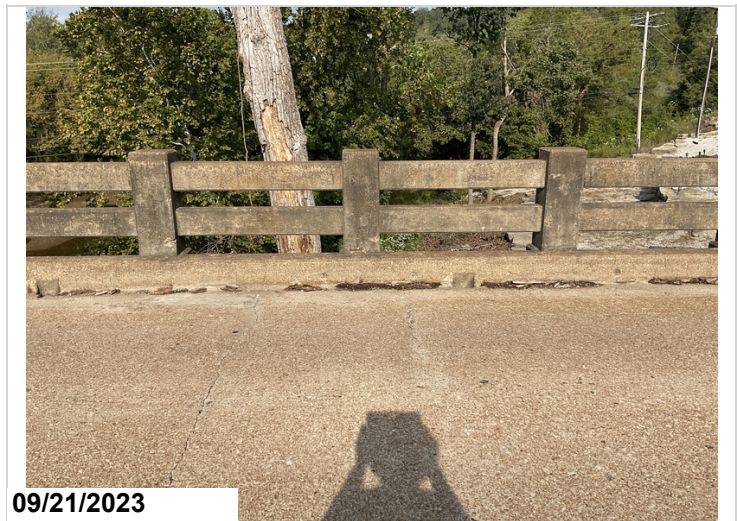
Typical spalls with rebar exposed to concrete bridge rail posts.#2)

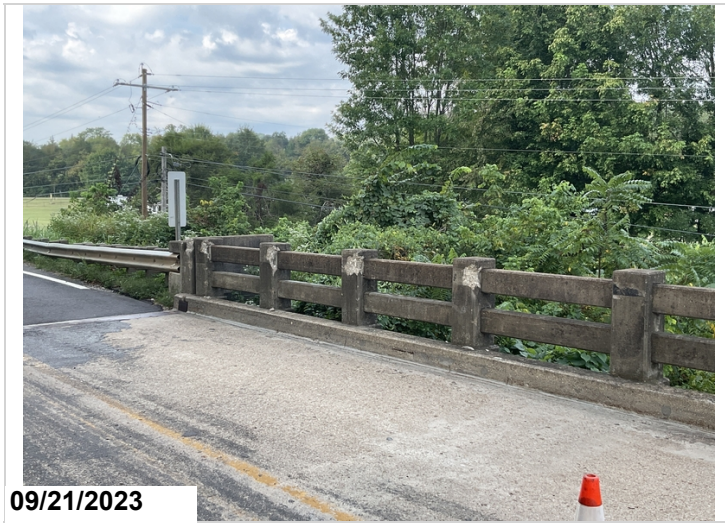
Typical spalling to concrete bridge rail posts.

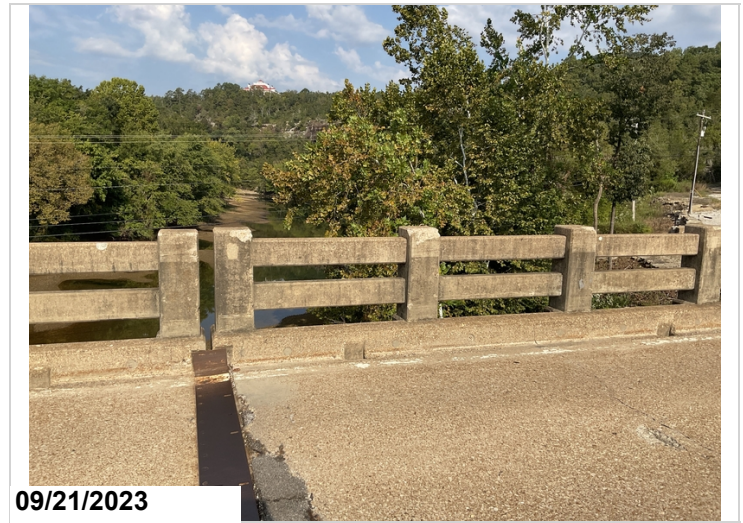
Typical spalling to concrete bridge rail posts.

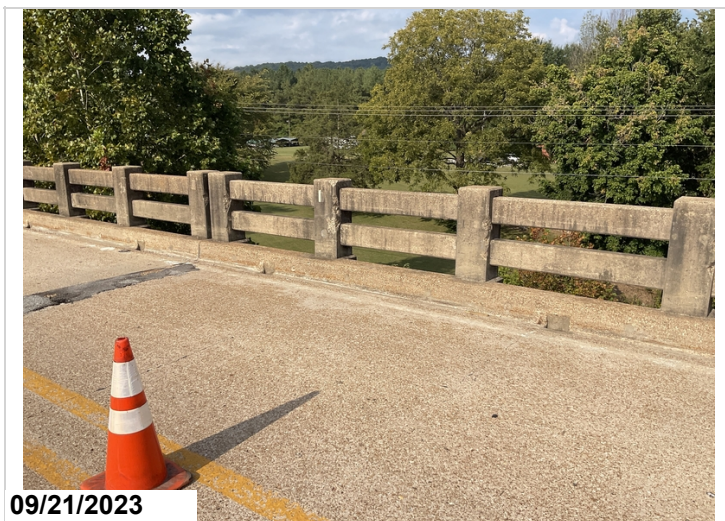
Typical spalling to concrete bridge rail posts.

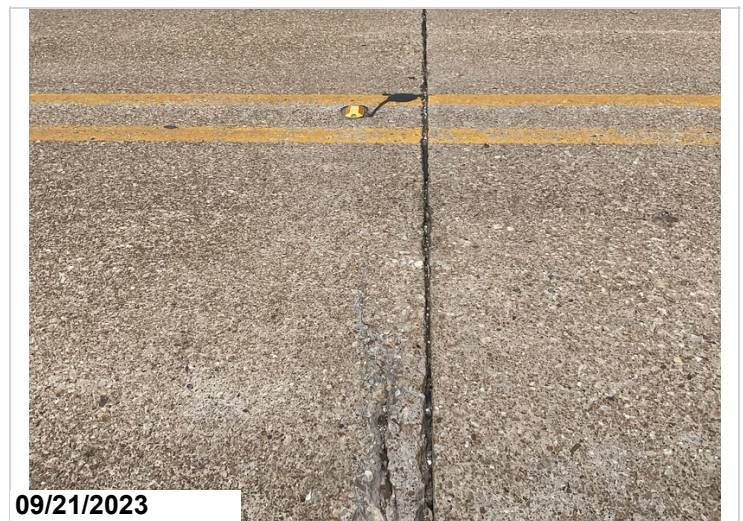
Pourable joint seal is losing adhesion @ Span 5.(#3)

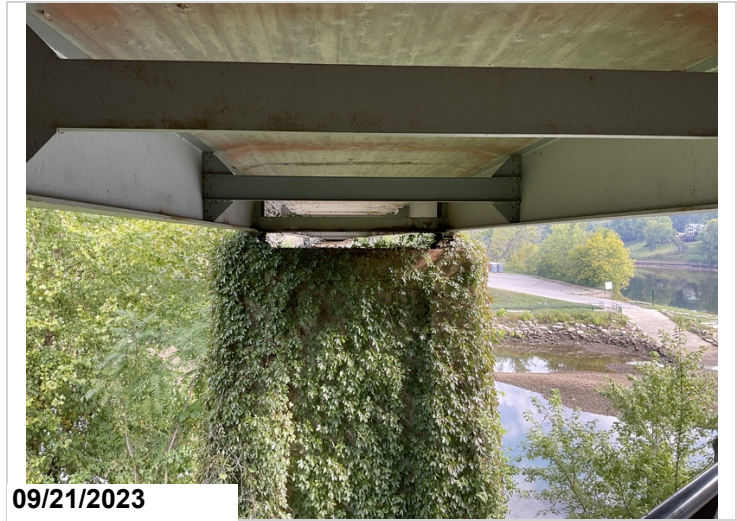
Typical paint condition of girders.

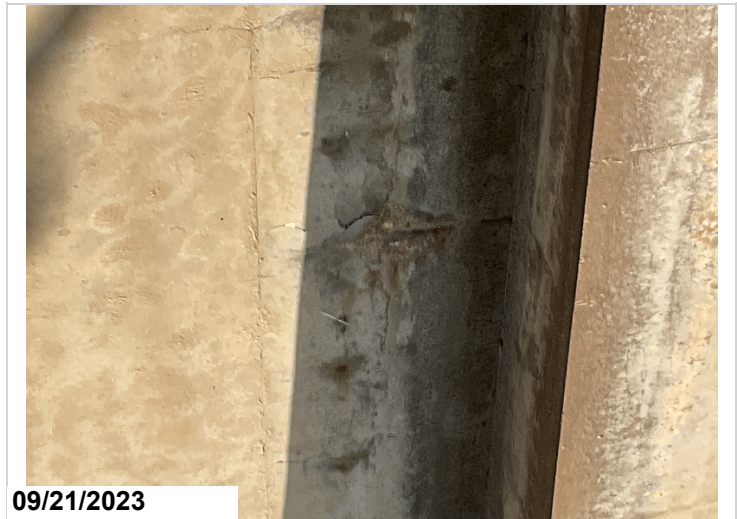
Spall with rebar exposed with s/l to Concrete Pier Wall @ Bent 5.(#3)

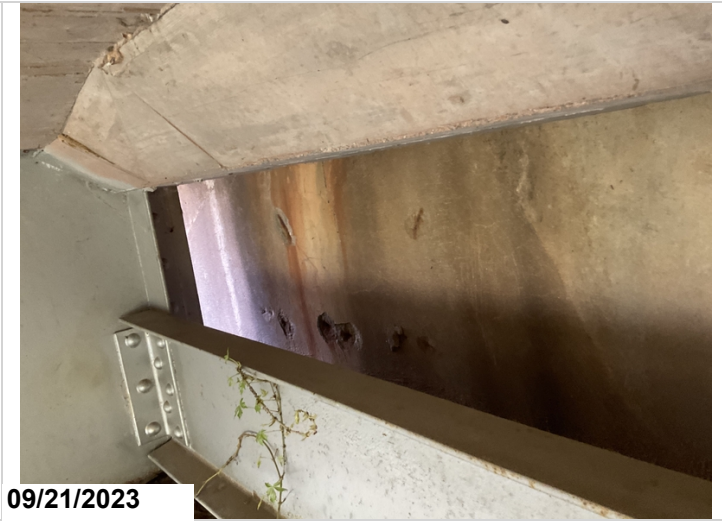
Spalls with rebar exposed to Abutment 2.(#3)

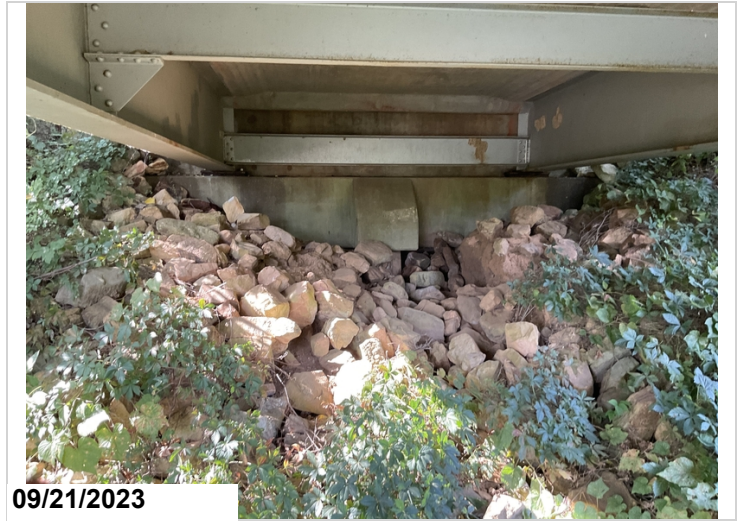
Erosion to slope exposing 1 pile @ Abutment 1.(#3)

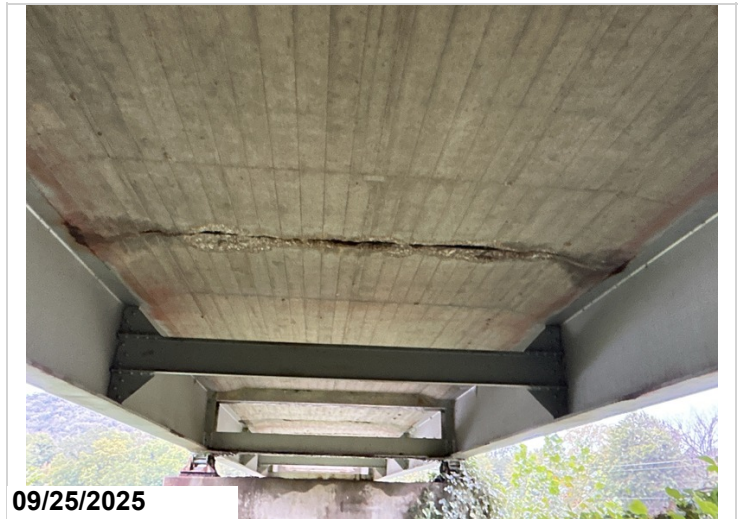
NSTM photo span 7.

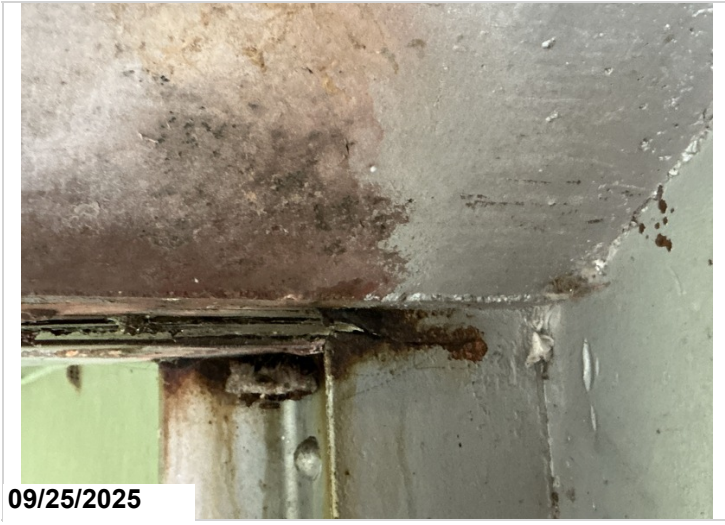
Overall, the NSTMs were found to be in poor condition with widespread corrosion over the bents at the girder ends. An isolated crack was identified in the stiffener of girder 2 on the back side of bent 6. The crack is not currently in the girder and should be monitored closely for future propagation. Other areas of CS3 corrosion were also identified throughout the structure, and the steel girders comprising the NSTMs were therefore rated a 4.

Crack to stiffener on girder 2 end of span 6.

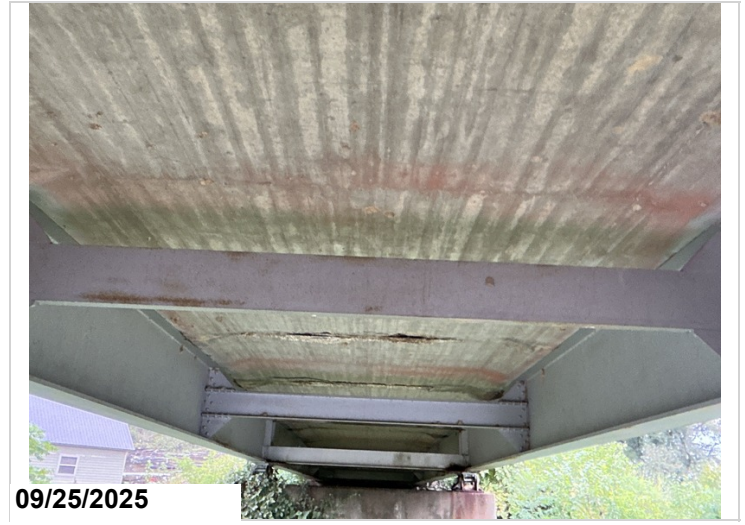
NSTM photo span 6.

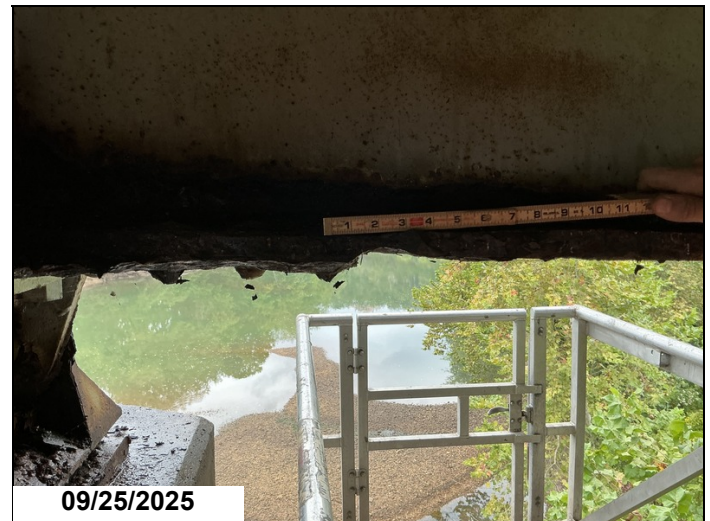
Rust with section loss to girder 1 beginning of span 6.

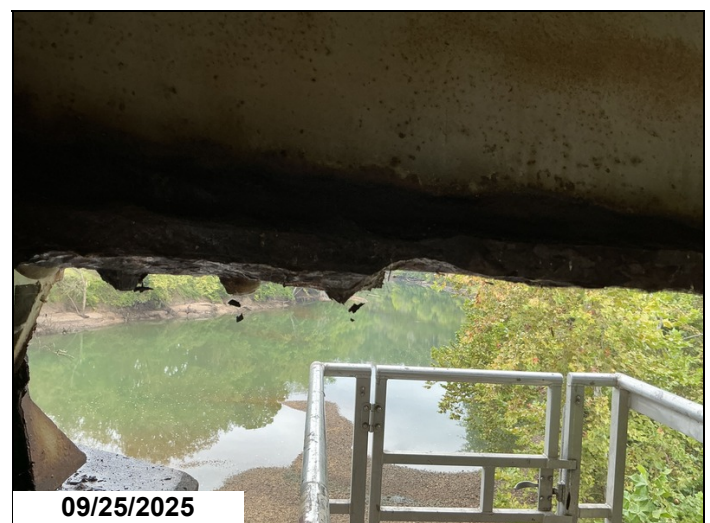
Rust with section loss to girder 1 beginning of span 6.

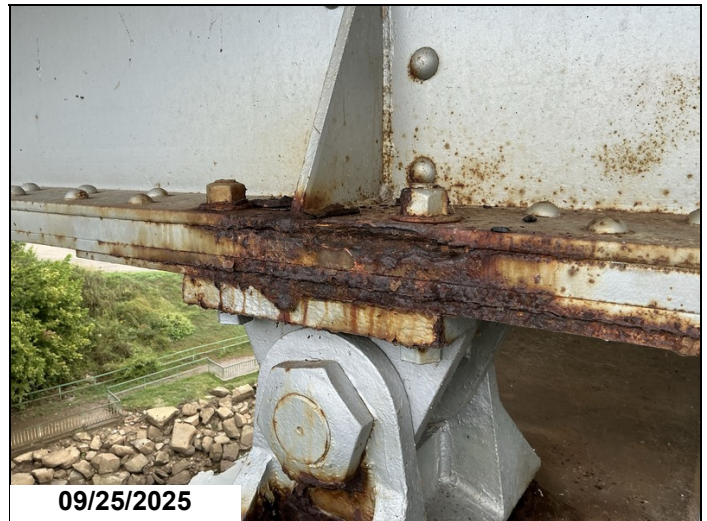
Rust with section loss to girder 1 beginning of span 6.

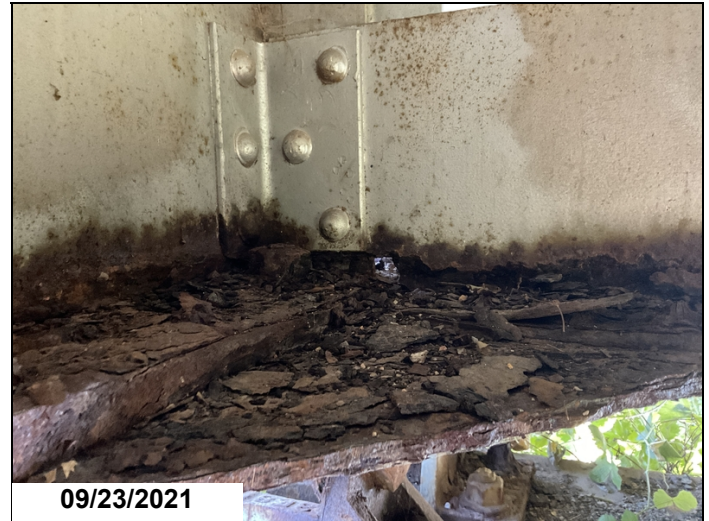
Girders 1 & 2 above Bents 1, 2, 5 have rust with section loss to Girders, diaphragms, and connection plates.

Girders 1 & 2 above Bents 1, 2, 5 have rust with section loss to Girders, diaphragms, and connection plates.  
Girder 1 @ bent 1.

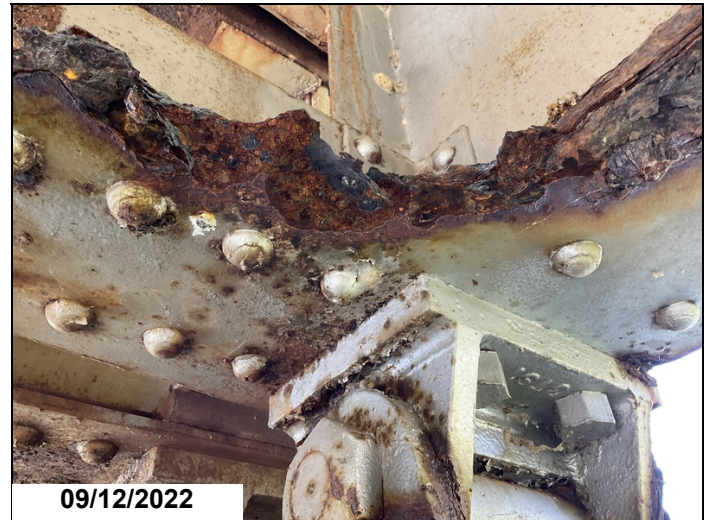
Span 6 - Girder 1 has heavy section loss with part of the gusset plate at bottom flange missing at beginning of span.

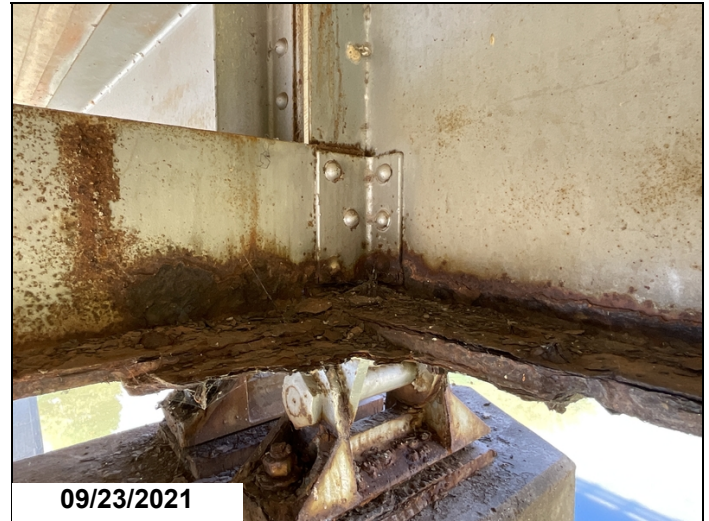
Span 6 - Girder 1 has heavy section loss with part of the gusset plate at bottom flange missing at beginning of span.

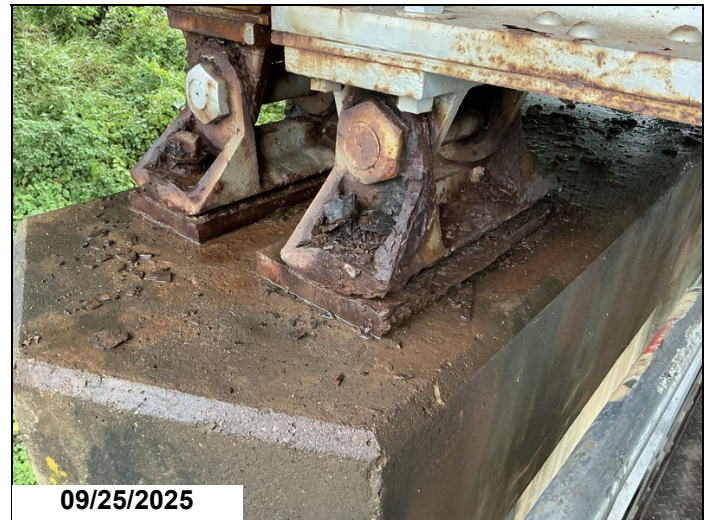
Rust with heavy section loss to anchor bolt nuts to bearing 2 on back and ahead side of bent 6.

Rust with pack rust and anchor bolt missing to bearing 1 back side of bent 5.

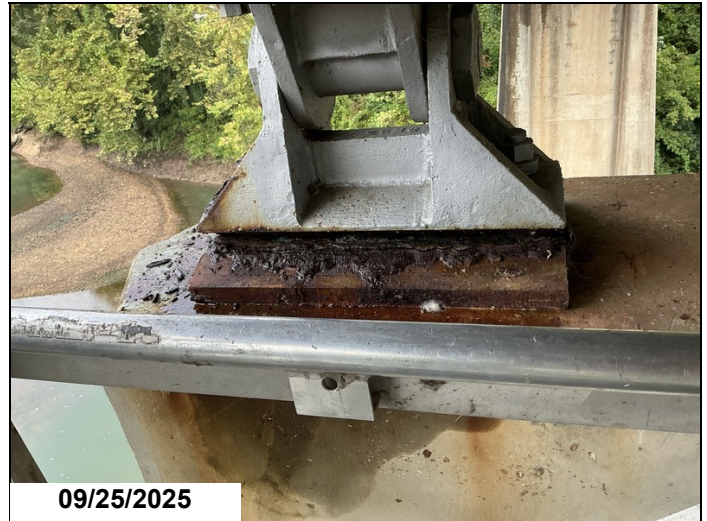
Rust with pack rust and anchor bolt missing to bearing 2 back side of bent 5.

Rust with pack rust to bearing 1 bent 4.

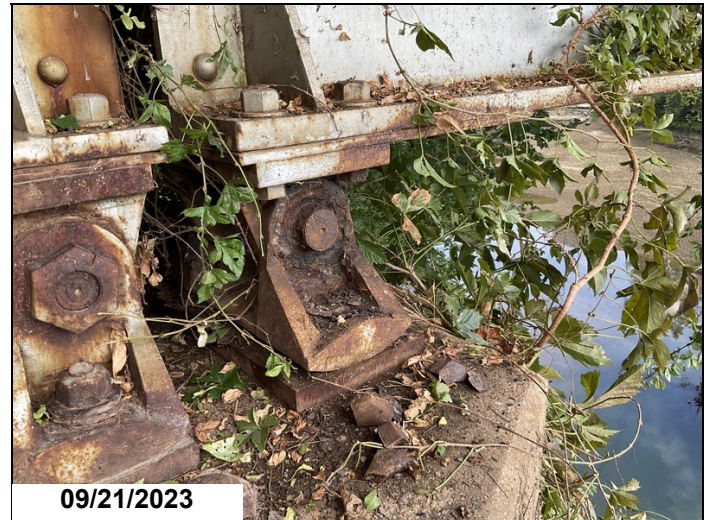
Bent 2, ahead, bearing 1: is missing the exterior nut.

Exterior nut on rocker pin @ Moveable Bearing 2 on ahead side of Bent 2 is missing & Anchor bolt is also missing due to heavy corrosion.(#4)
