## Bridge 01899 Inspection Report

Route:5 Section:16 Log:24.61

District 05, 137 - Stone County

Asset #01899(Routine, NSTM)  
SH 5/Stone County over SYLAMORE CREEK  
Location: .3 MI N JCT SH 14 W  
Team Lead: Seth Foreman Inspection Date: 09/17/2025

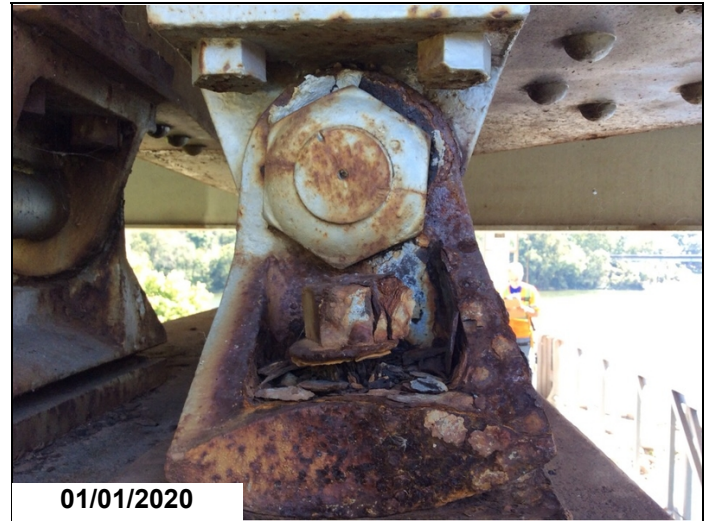
Exterior anchor bolt nut is cracked @ Girder 1 Bent 2 ahead.

Section loss to anchor bolt & cracked nut @ Girder 1 Bent 5.

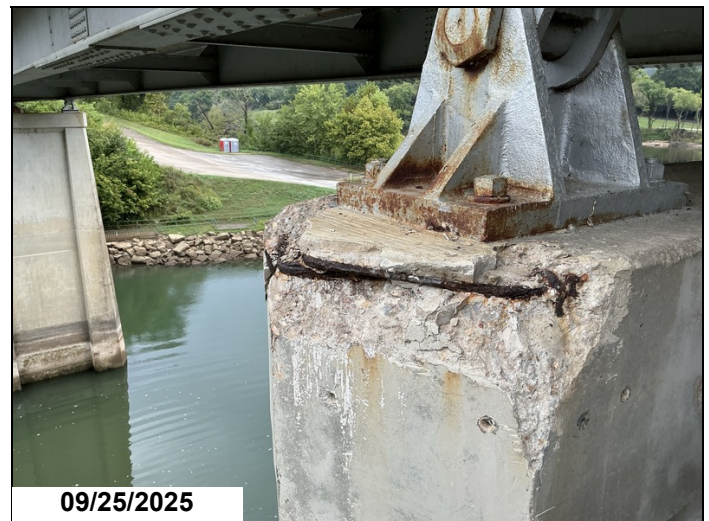
Vertical crack to column 2 at bent 3.

Spall with exposed rebar to left end of cap at bent 3.

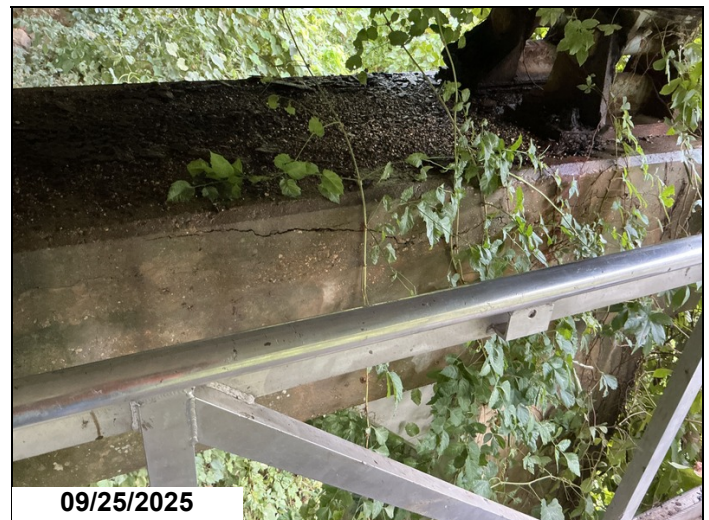
Large spall with exposed rebar to back side of bent 2.

Horizontal crack to ahead side of cap at bent 1.

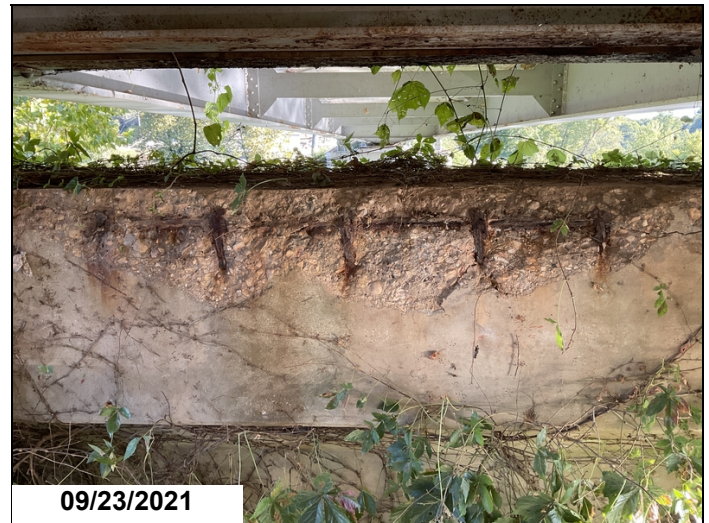
Caps and columns at Bents 1 thru 5.  
Spalls with rebar exposed and delaminated areas.  
Column 1 @ bent 3.

Caps and columns at Bents 1 thru 5.  
Spalls with rebar exposed and delaminated areas.  
Backside of bent 2.

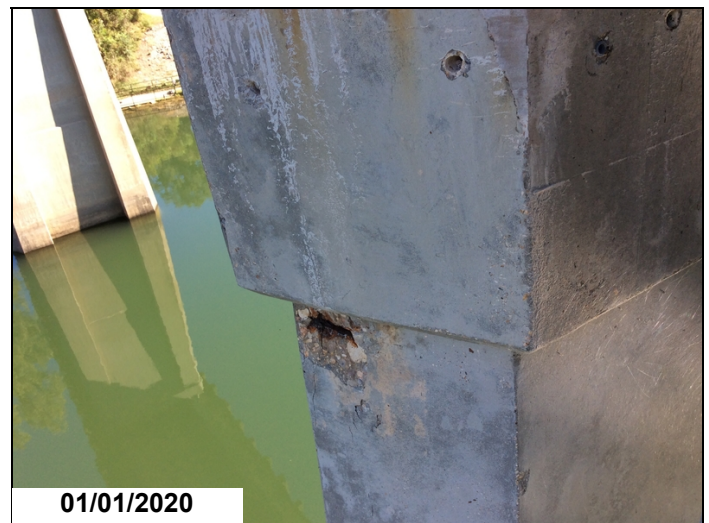
Large delaminated area, Spalls with exposed rebar at  
Bent 2 back side of cap.

Top of Column 1 at Bent 3.

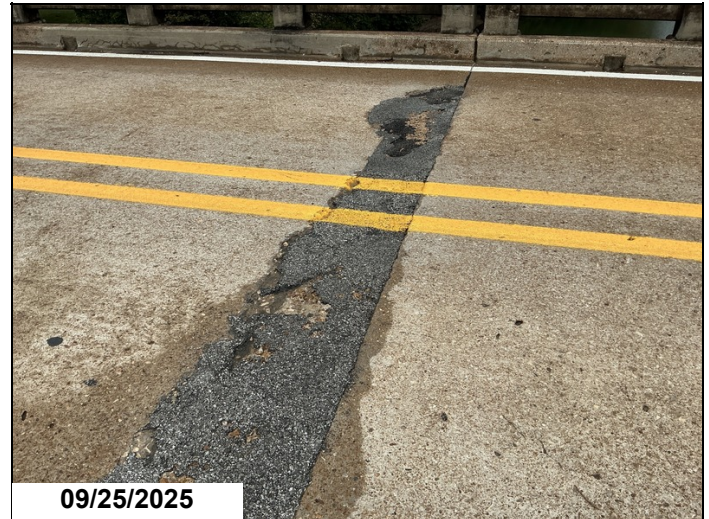
Deep spalls and delaminated areas to deck with some exposed rebar.(covered with asphalt).

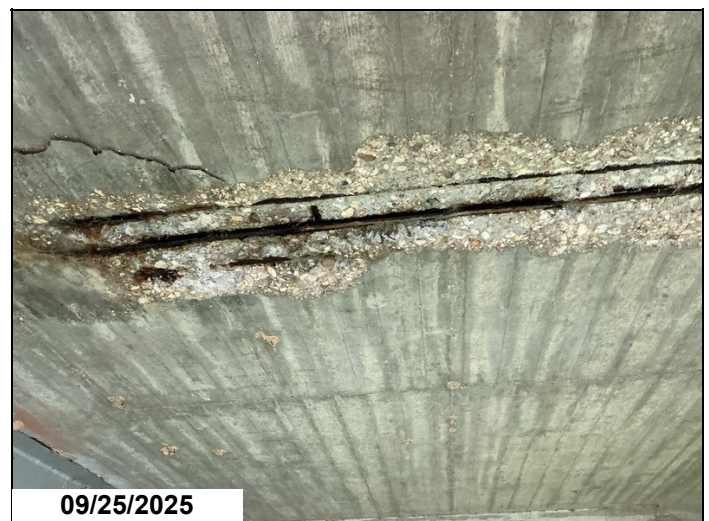
Deep spalls and delaminated areas to deck with some exposed rebar.(covered with asphalt).

Spall with exposed rebar to undersurface of span 6.

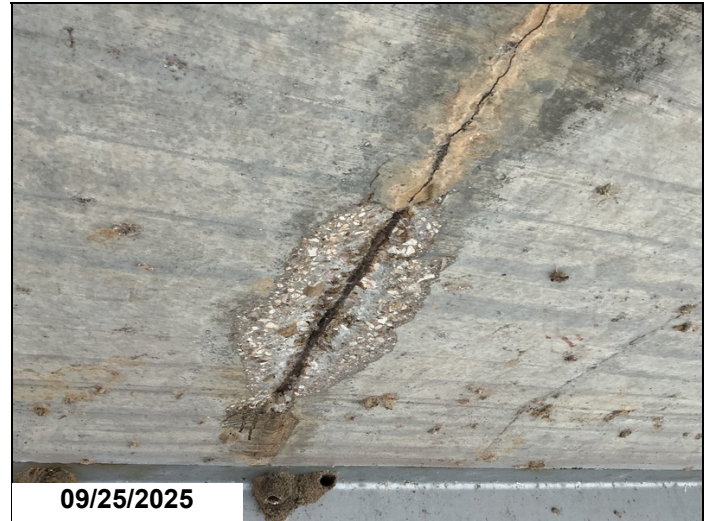
Spall with exposed rebar to undersurface of span 5.

Spall with exposed rebar to undersurface of span 4.

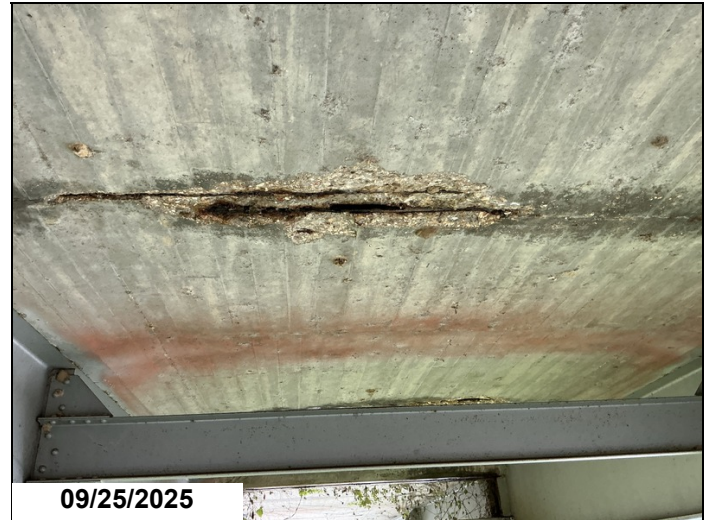
Spall with exposed rebar to undersurface of span 3.

Spall with exposed rebar to undersurface of span 2

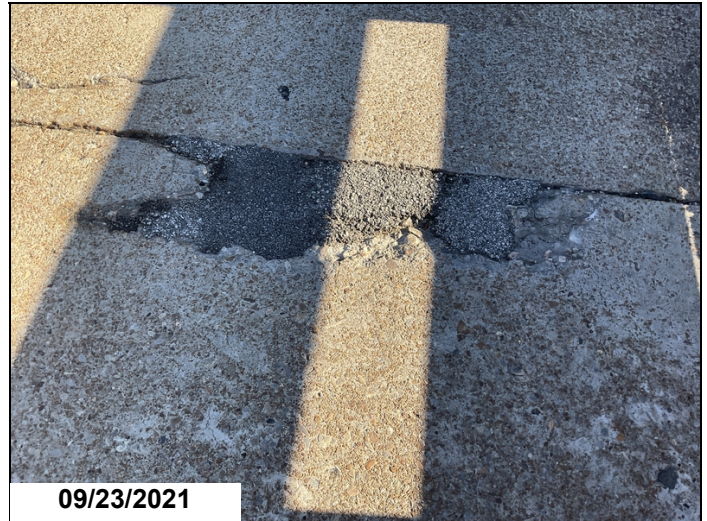
Spalls with rebar exposed to deck below. (Some exposed rebar has been painted) at Spans 2 thru 7.  
Span 2.

Deep spalls and delaminated areas to deck with some exposed rebar.(covered with asphalt).

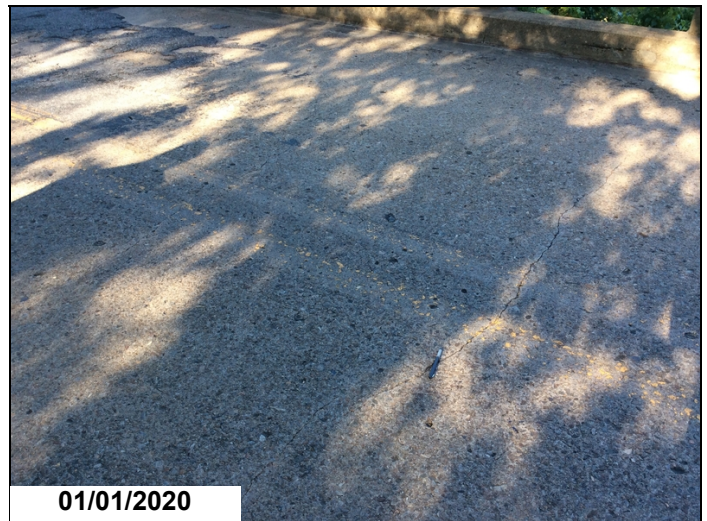
Unsealed transverse cracks to deck at all Spans.

Span 1 Deck cracks(typical)

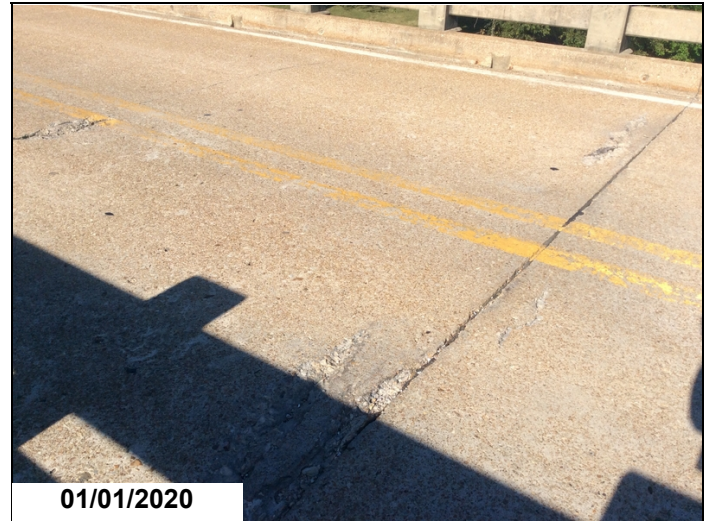
Span 5 Deck cracks and spalls.

Spalls to deck at Span 4.
