Bridge 06404 Inspection Report

Asset #06404(Routine, Underwater type 2)

SH 5/Stone County over COVE PRONG

Team Lead: Floyd Haley Inspection Date: 11/20/2024

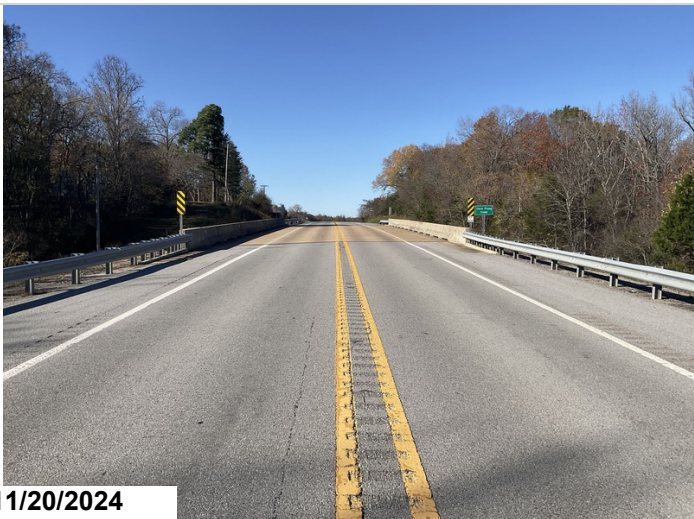
Roadway with Log Mile running Southeast to Northwest.

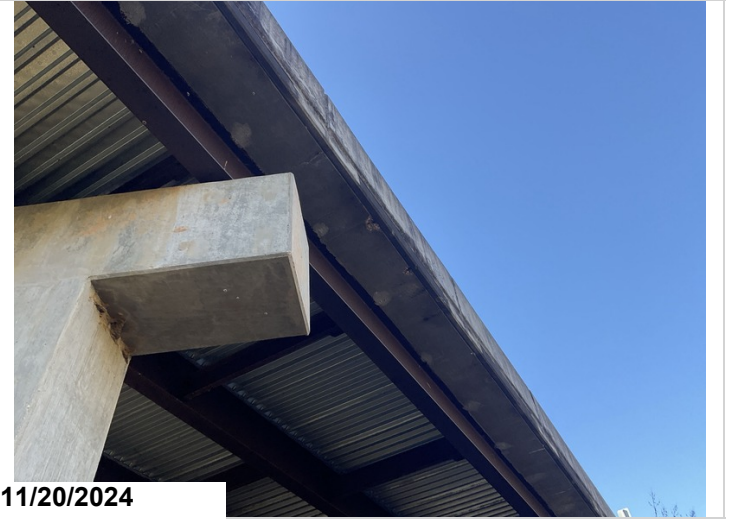
(12) Minor transverse cracks to deck in gutter lines. 25' CS2 Minor efflorescent cracking to Left & Right overhangs. 48' CS2 Abutment 2: Spall to Right outside edge of deck.1' CS3 Span 3: Right overhang: Spalls with corroded reinforcing steel exposed. 2' CS3							
107	Steel Open Girder/Beam	LF	720	720	0	0	0
515	Steel Protective Coating	SF	4442	4442	0	0	0

Span 3, right: has 2 spalls with exposed rebar. 2' CS3

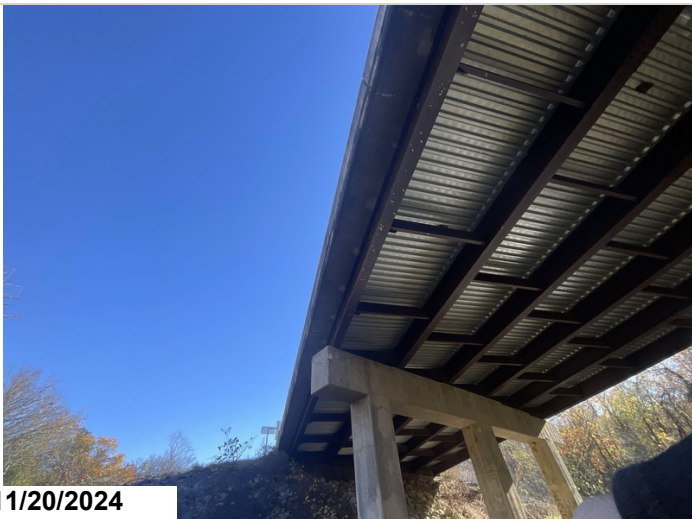
Typical overhangs have 8SF CS2 PER side per span. 48SF CS2

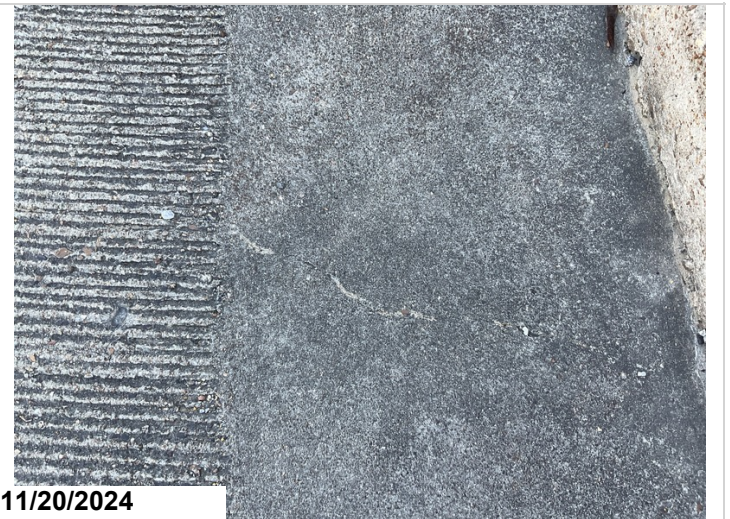
Minor transverse cracks on gutters. 25SF CS2

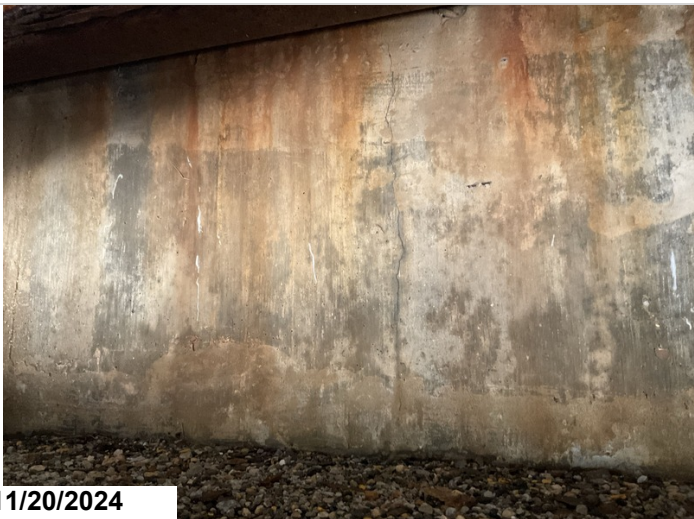
(215) Abutment 1: 4 vertical efflorescent cracks to backwall. 4' CS2 Abutment 2: 4 vertical efflorescent cracks to backwall. 4' CS2 Abutment 2: Right turnback: 3' diagonal efflorescent crack. 3' CS2							
234	Reinforced Concrete Pier Cap	LF	90	90	0	0	0

Typical cracks to backwall.

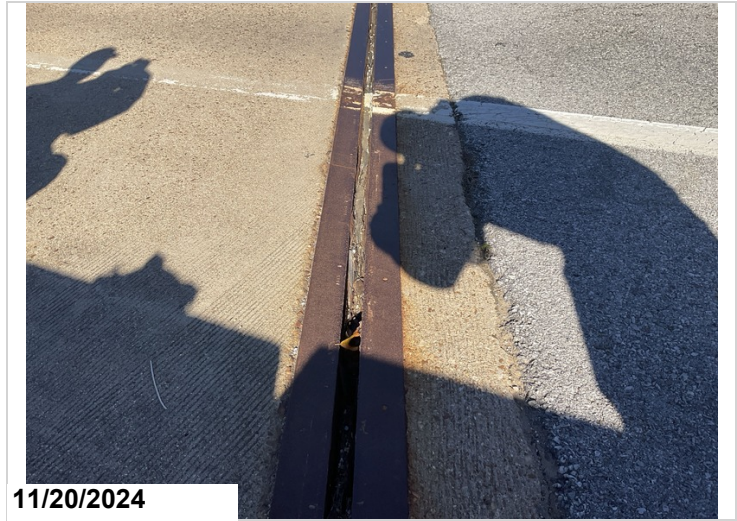
(234) No defects noted.							
301	Pourable Joint Seal	LF	94	0	0	94	0
2310	Leakage	LF	94	0	0	94	0
(301) Pourable joint seal @ Abutments 1 & 2 is losing adhesion and leaking. 94' CS3							
311	Movable Bearing	EA	12	0	0	12	0
1000	Corrosion	EA	12	0	0	12	0
515	Steel Protective Coating	SF	24	0	0	24	0
3440	Effectiveness (Steel Protective Coatings)	SF	24	0	0	24	0

Abutment 1, seal. Both all in CS3. 94' CS3

A-59 - Joint Repair Needed (Yes)

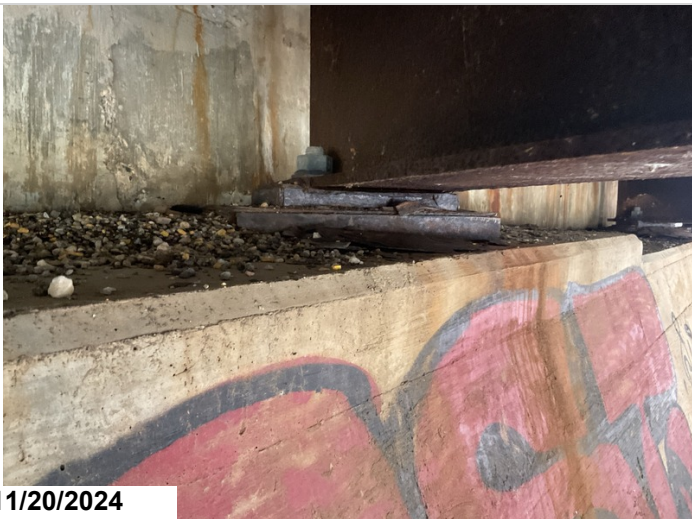
(311) Flaking rust to Moveable Bearings at Abutments. 12EA CS3 (515-311) Flaking rust to Moveable Bearings at Abutments. 24' CS3							
313	Fixed Bearing	EA	12	12	0	0	0

Typical bearings
