Bridge 06405 Inspection Report

Route:5 Section:16 Log:16.24

Team Lead: Jake Norris, Inspection Date: 02/18/2026

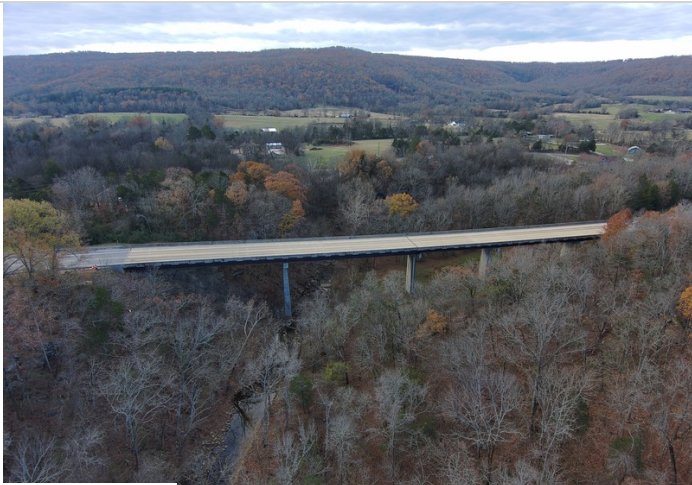
Elevation

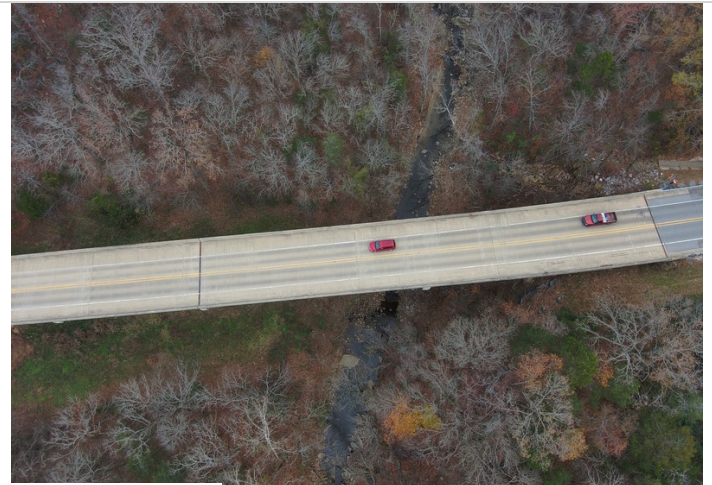
Typical deck

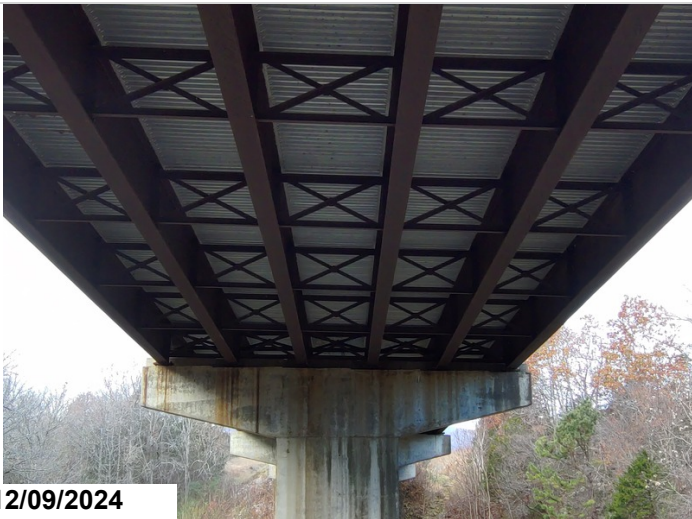
Typical undersurface

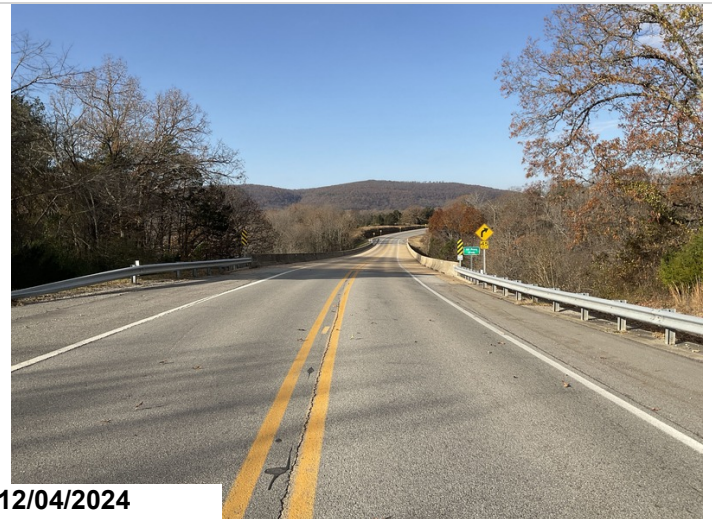
Roadway with Log Mile running Southeast to Northwest.

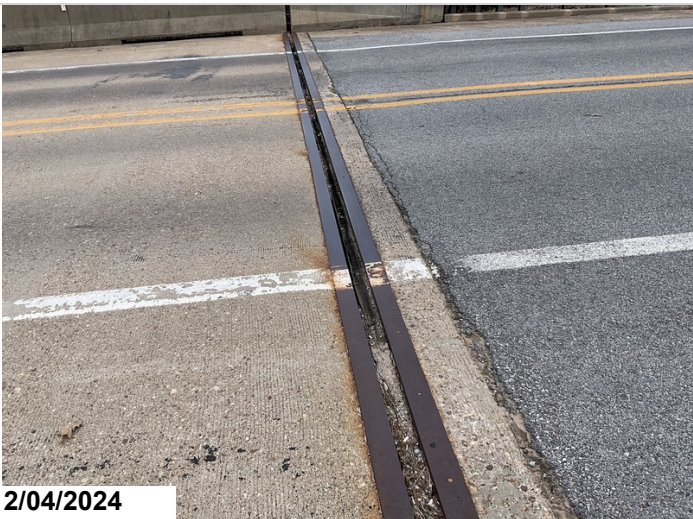
Typical joint condition.

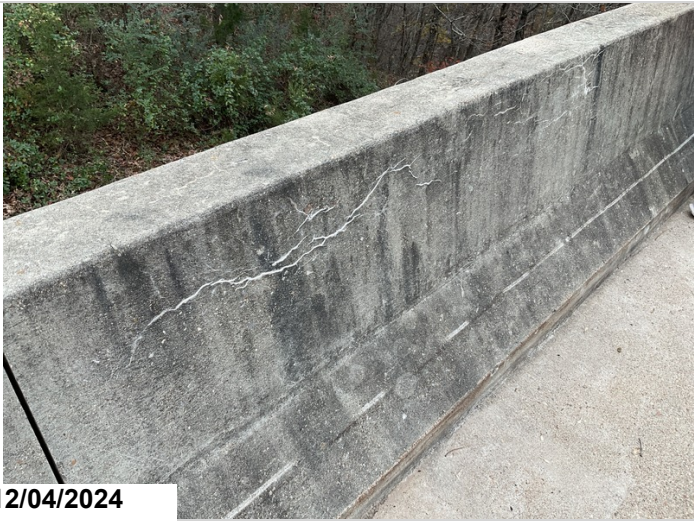
Typical efflorescence

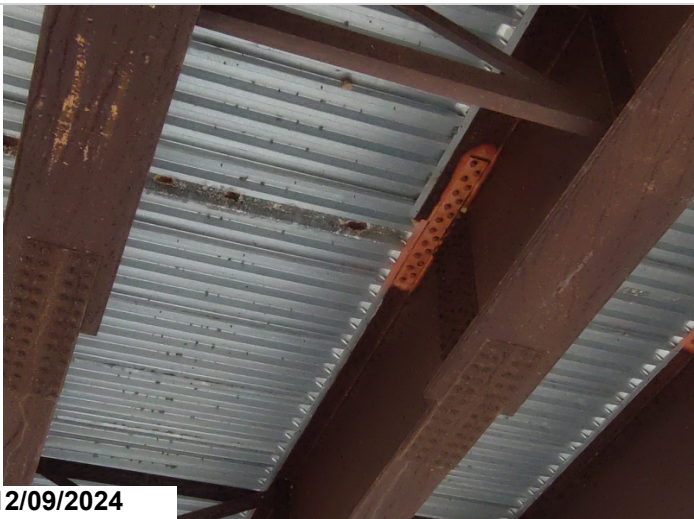
(12) Minor cracking to deck at all spans.(Mostly Span 1) 130SF CS2 80SF CS3 Minor efflorescent cracks to Left and Right overhangs.125SF CS2 Areas of rust to stay in place forms above field splices at all spans.							
107	Steel Open Girder/Beam	LF	3300	3300	0	0	0
515	Steel Protective Coating	SF	30793	30723	50	20	0
3430	Oxide Film Degradation Color/Texture Adherence(Steel Protective Coatings)	SF	70	0	50	20	0

Areas of rust to stay in place forms above field splices at all spans.

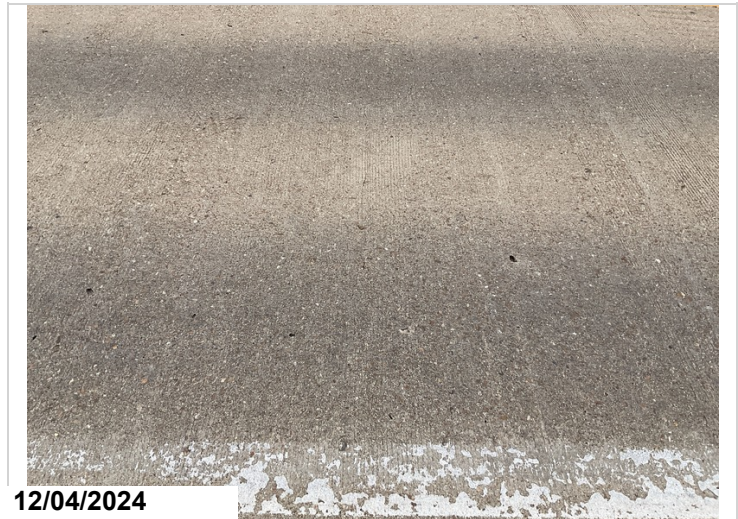
Typical cs2 transverse crack

A-54 - Sealable Deck Cracks (Yes)

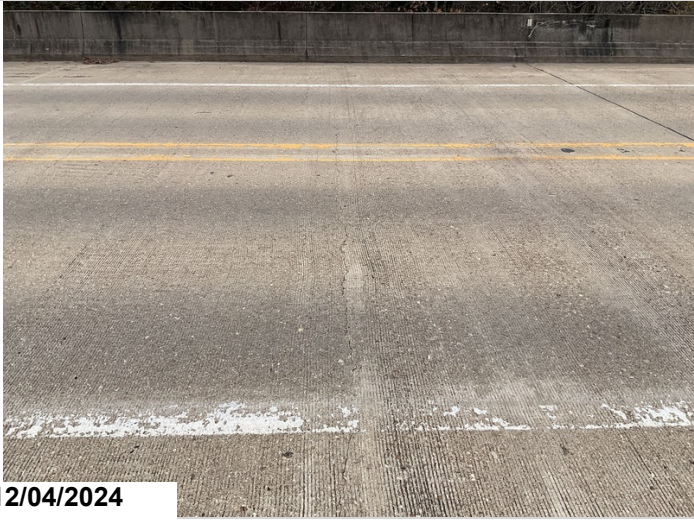
Span 1: transverse cracking. 80LF CS3

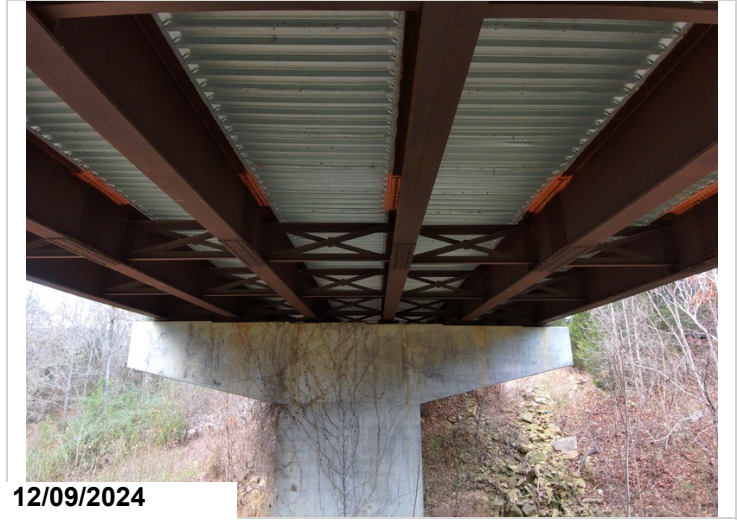
(107) Some minor corrosion developing to girders and random diaphragms between girders.							
210	Reinforced Concrete Pier Wall	LF	52	52	0	0	0
(210) No problems noted.							
215	Reinforced Concrete Abutment	LF	124	112	12	0	0
1120	Efflorescence/Rust Staining	LF	5	0	5	0	0
1130	Cracking (RC and Other)	LF	7	0	7	0	0

Typical girder condition.

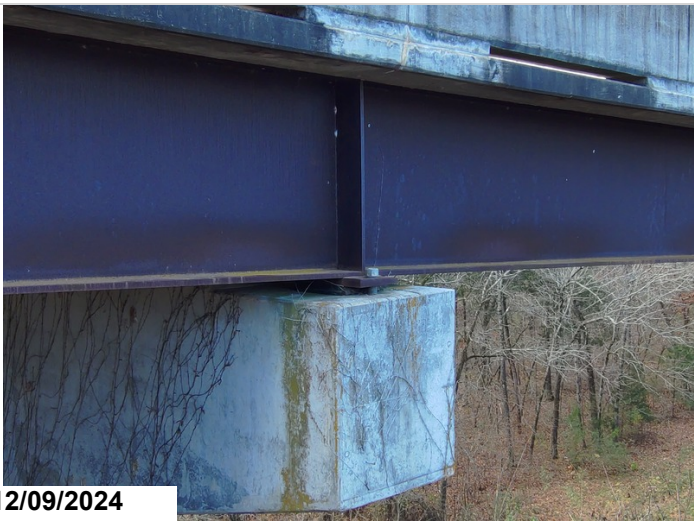
Typical elastomeric bearings.

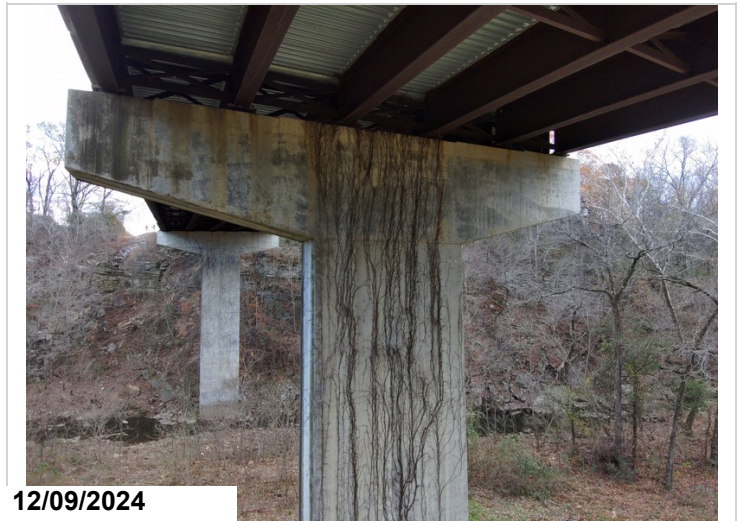
Typical pier wall

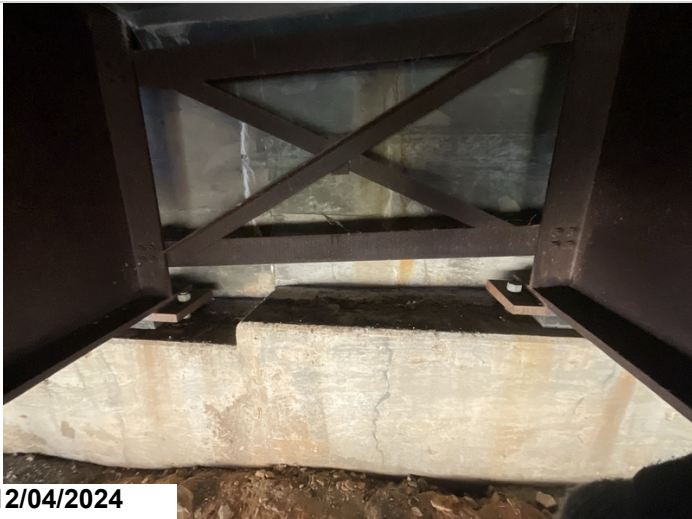
(215) Abutment 1: Backwall: Efflorescent cracking. 4 CS2 Abutment 1: Vertical cracking. 7LF CS2 Abutment 2: Backwall: Efflorescent cracking. 1LF CS2							
234	Reinforced Concrete Pier Cap	LF	168	101	50	17	0
1080	Delamination/Spall/Patched Area	LF	1	0	0	1	0
1120	Efflorescence/Rust Staining	LF	5	0	5	0	0
1130	Cracking (RC and Other)	LF	61	0	45	16	0

Abutment 1: has vertical cracks and efflorescence.

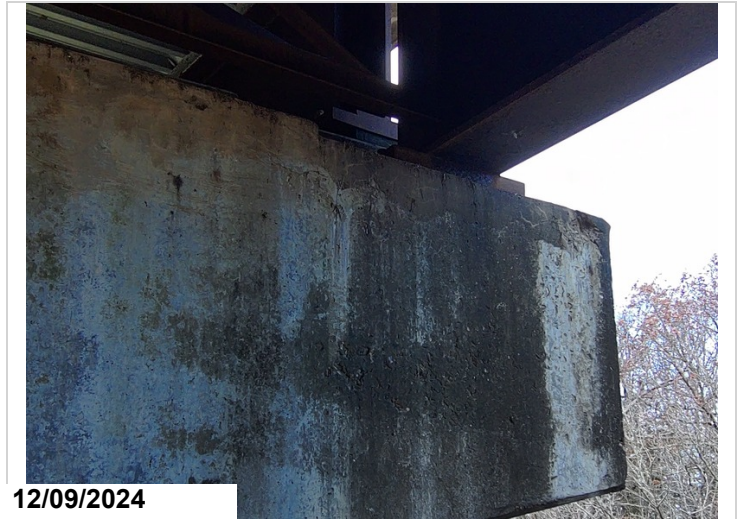
(234) Bent 1: Backside: Minor cracking. 5LF CS2 Bent 2: Backside Right: Spall. 1LF CS3 Bent 2: Backside step up: Minor cracking. 11LF CS2 Bent 2: Backside: Horizontal cracking. 32LF CS2 Bent 2: Backside: Efflorescent cracking.5 LF CS2 Bent 3: Backside: Minor cracking. 9LF CS2 Bent 4: Backside: Minor cracking. 4LF CS2							
301	Pourable Joint Seal	LF	129	0	0	86	43
2310	Leakage	LF	129	0	0	86	43

Bent 2: Backside Right: Spall. 1LF CS3

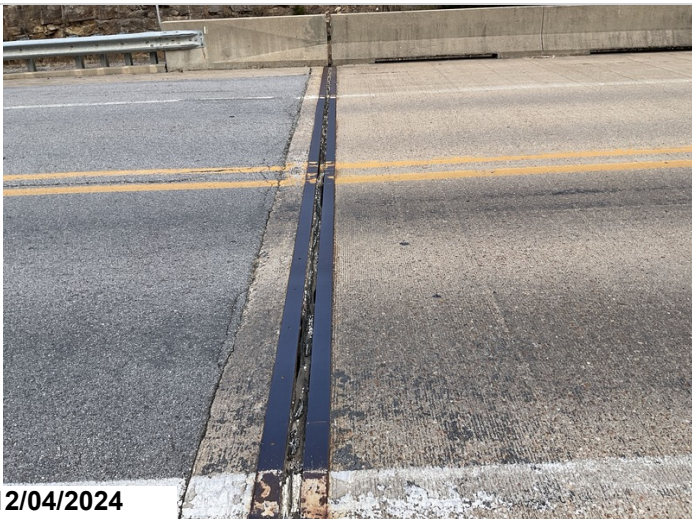
(301) Abutment 1: Adheasion failure/leakage: 43LF CS3 Bent 1: Adhesion failure/leakage. 43LF CS4 Abutment 2: Adheasion failure/leakage: 43LF CS3

Abutment 2: Adhesion failure/leakage: 43LF CS3

A-59 - Joint Repair Needed (Yes)

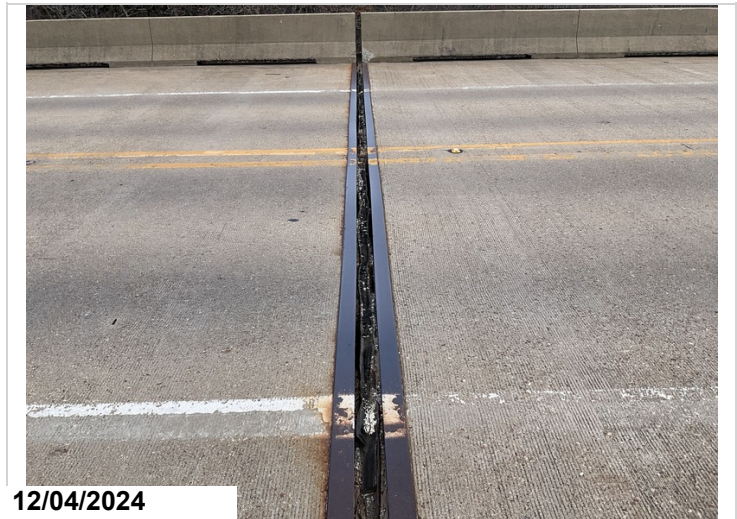
Bent 1: Adhesion failure/leakage. 43LF CS4

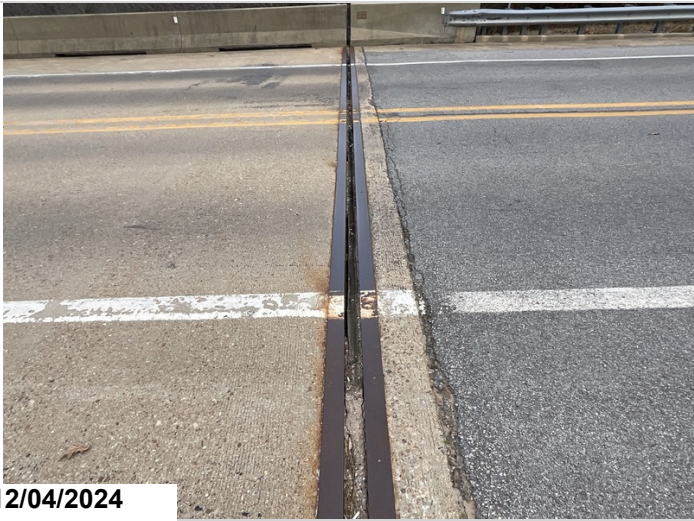
Abutment 1: Adhesion failure/leakage: 43LF CS3

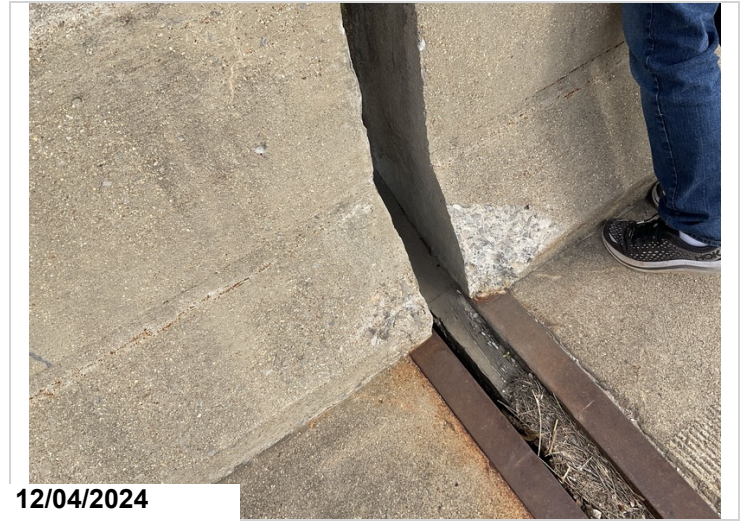
Bent 2, right: has a spall at the joint. 1LF CS3

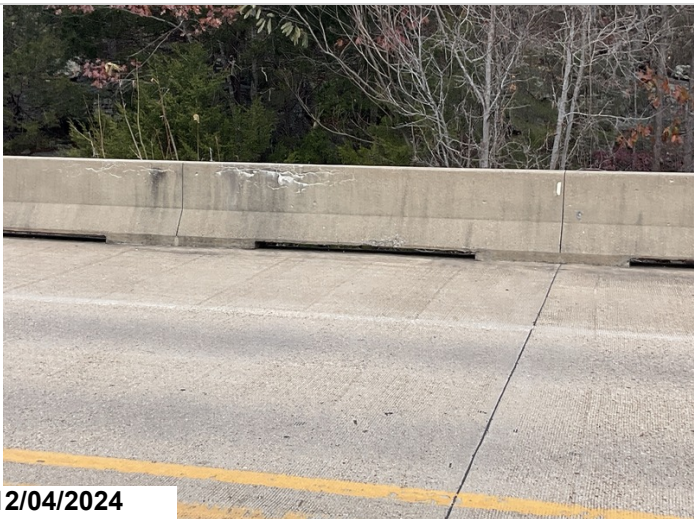
Span 4: Right: Spall. 2LF CS3

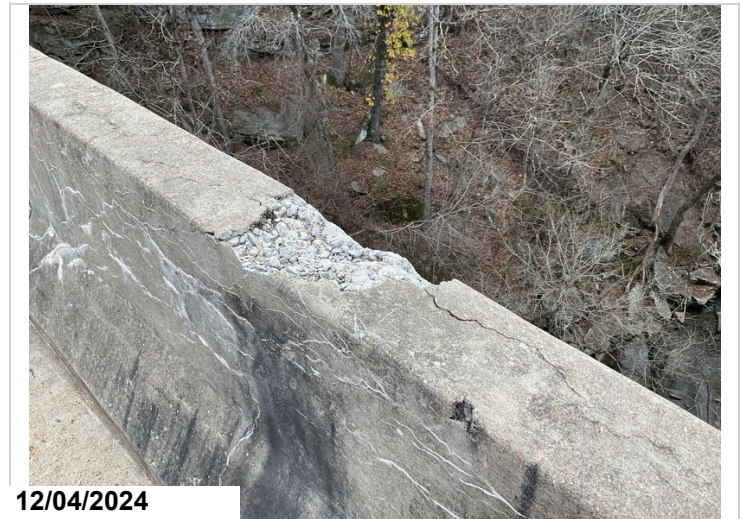
Span 2: Left rail: Spall. 1LF CS3

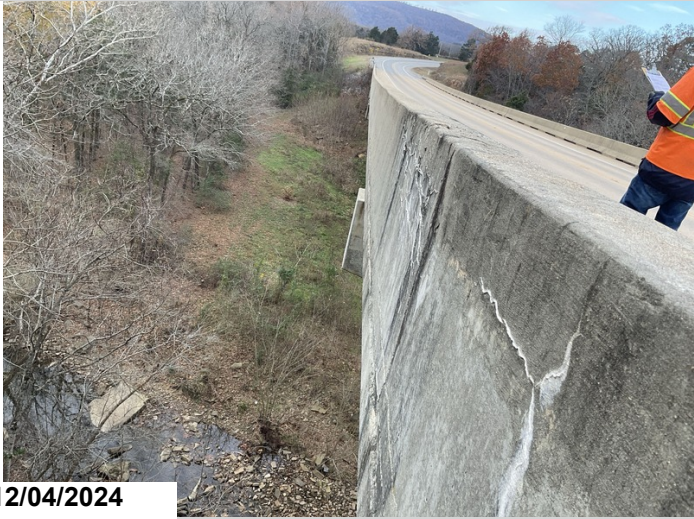
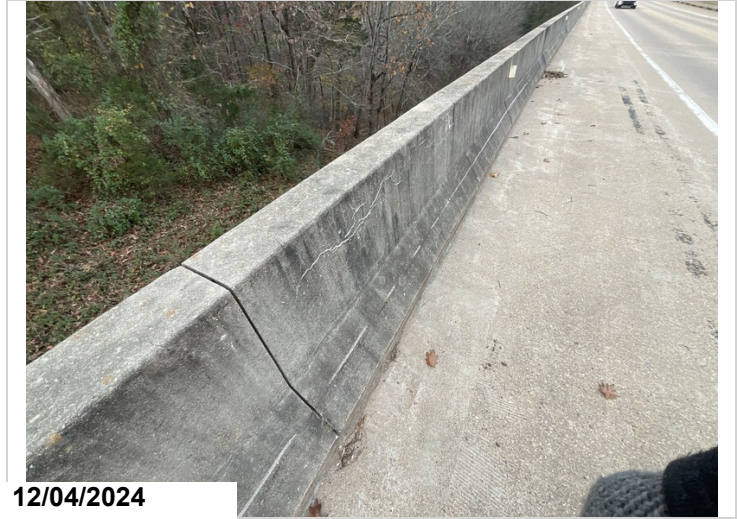
Areas of heavy efflorescent map cracking to Parapet walls
on Left and Right sides.152LF CS3

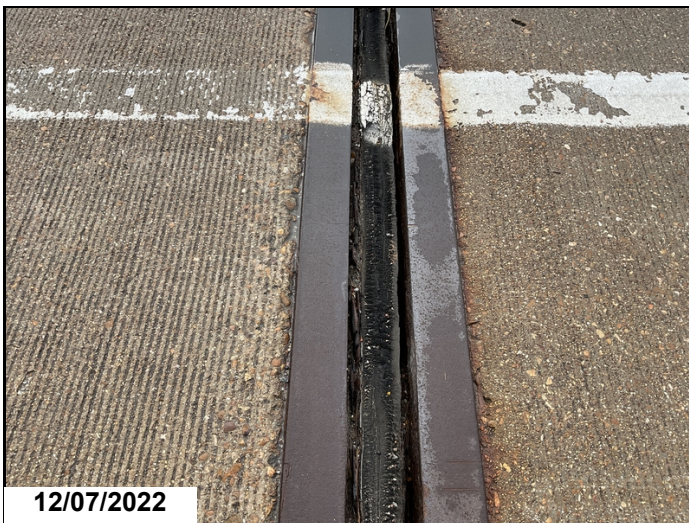
Pourable joint seals are deteriorated and leak.

Type of Work: Joint Repair

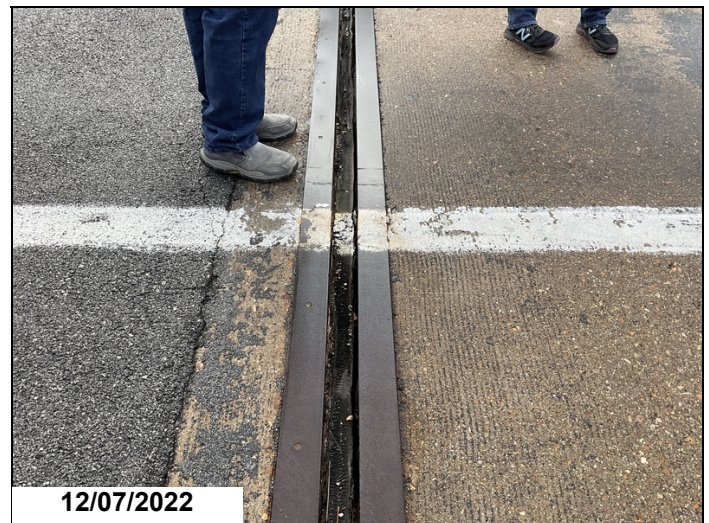
Pourable joint seals are deteriorated and leak.

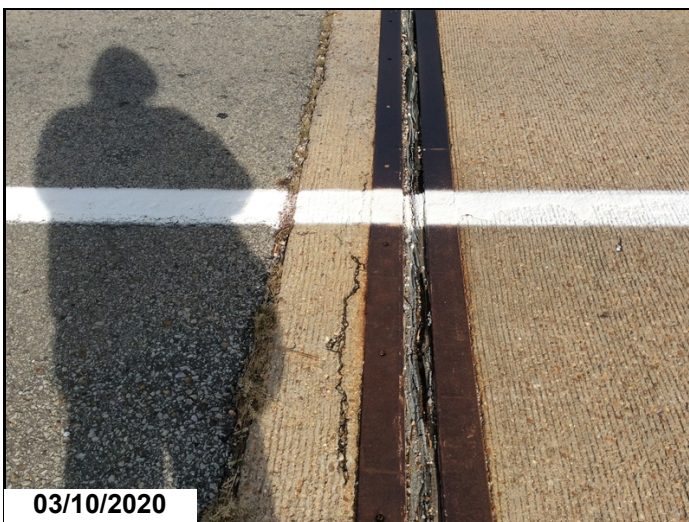
Pourable joint seal is losing adhesion @ Abutment 2.

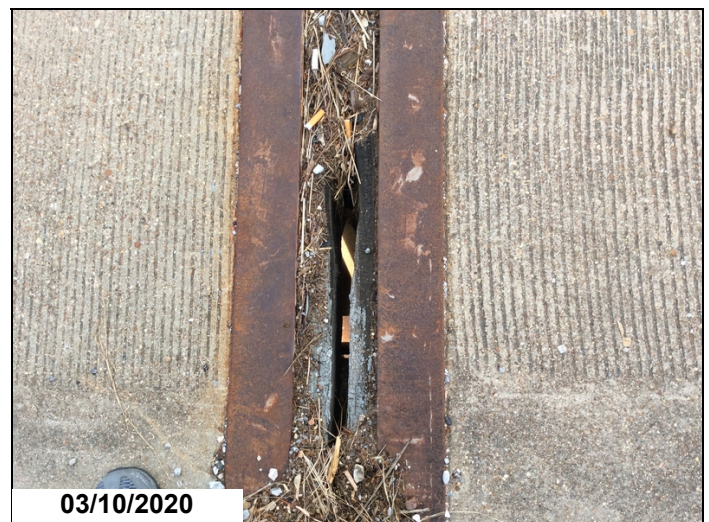
Pourable joint seal is losing adhesion @ Bent 2.

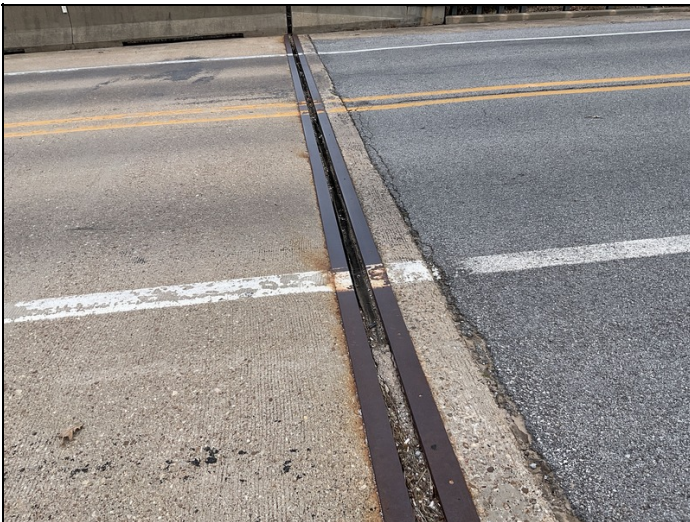
Typical joint condition.
