Bridge 07231 Inspection Report

SH 5/ Stone County over Little Racoon Creek

Location: 8.52 MI NW OF CLEBURNE CO

Team Lead: Floyd Haley Inspection Date: 04/15/2024

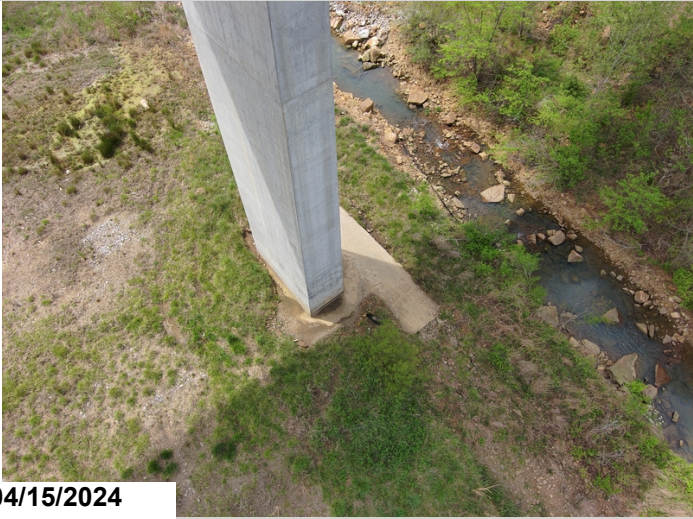
(220) Bents 3 & 6: Top of Footings exposed.							
234	Reinforced Concrete Pier Cap	LF	252	239	13	0	0
1120	Efflorescence/Rust Staining	LF	8	0	8	0	0
1130	Cracking (RC and Other)	LF	5	0	5	0	0

Bent 3: exposed Footing.

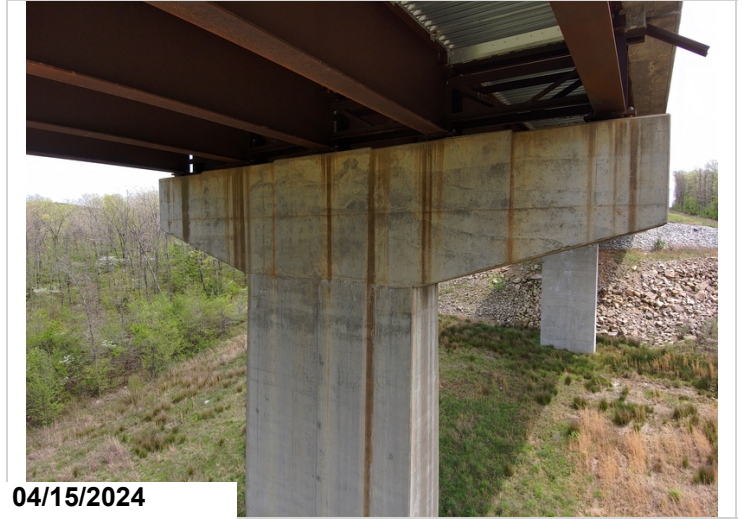
(300) Joints at Abutments 1 & 2: minor debris impaction.							
305	Assembly Joint without Seal	LF	86	86	0	0	0
(305) Bents 2 & 5: rust staining on Pier Cap from Assembly Joints without Seals.

Bents 2 & 5: rust staining on Pier Cap from Assembly Joints without Seals.

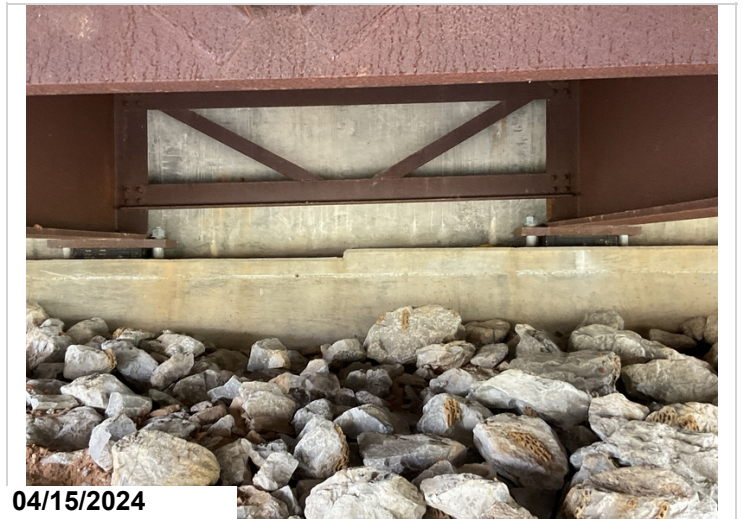
(215) Abutment 1: 5 cracks with efflorescence. Abutment 2: 1 crack with efflorescence adjacent to Girder 4 and 3 vertical cracks adjacent to Girders 2 - 4.							
220	Reinforced Concrete Pile Cap/Footing	LF	46	0	46	0	0
6000	Scour	LF	46	0	46	0	0

Abutment 1: Efflorescent cracking. CS2

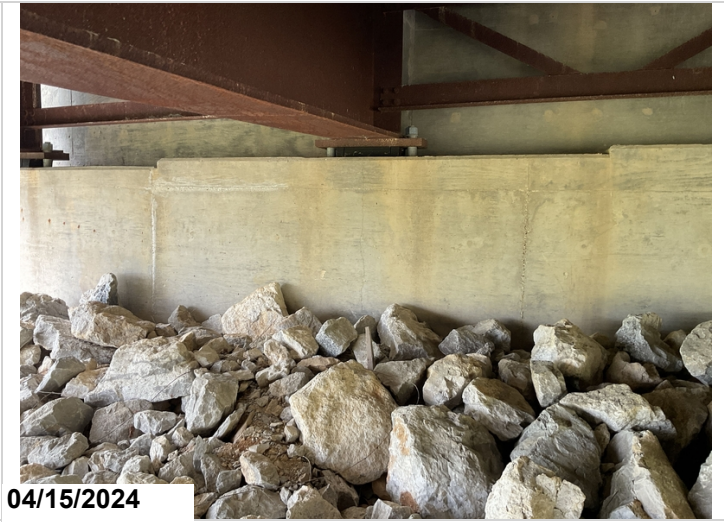
Abutment 2, Girder 2: Vertical crack.

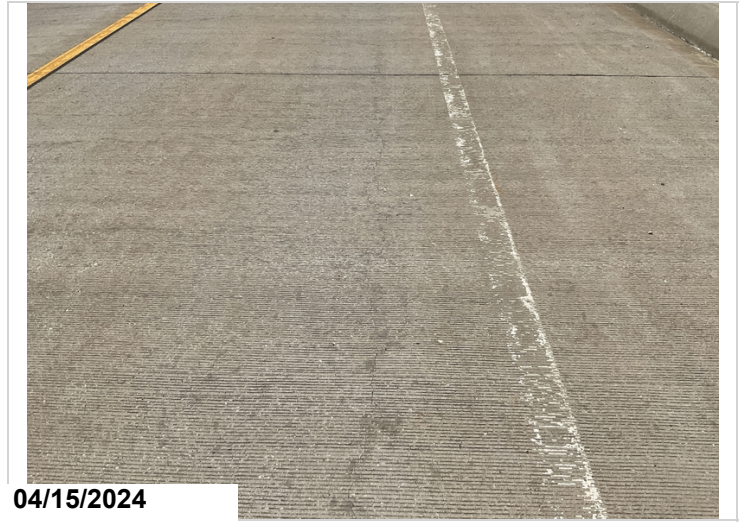
(12) Spans 1 - 7: longitudinal and transverse cracking throughout the structure. Spans 1 - 7, Right & Left Overhangs: cracking with efflorescence.							
107	Steel Open Girder/Beam	LF	4445	4445	0	0	0
515	Steel Protective Coating	SF	58896	58896	0	0	0

Spans 6 & 7: longitudinal cracking. CS2.

A-54 - Sealable Deck Cracks (Yes)

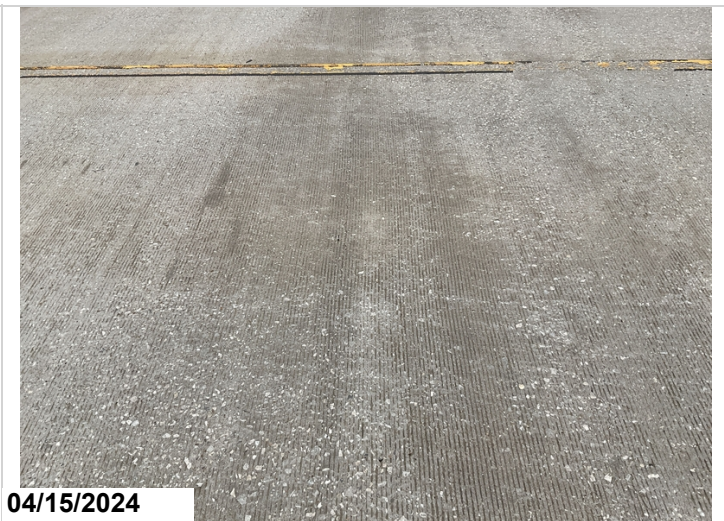
Span 5: transverse cracking. CS2.

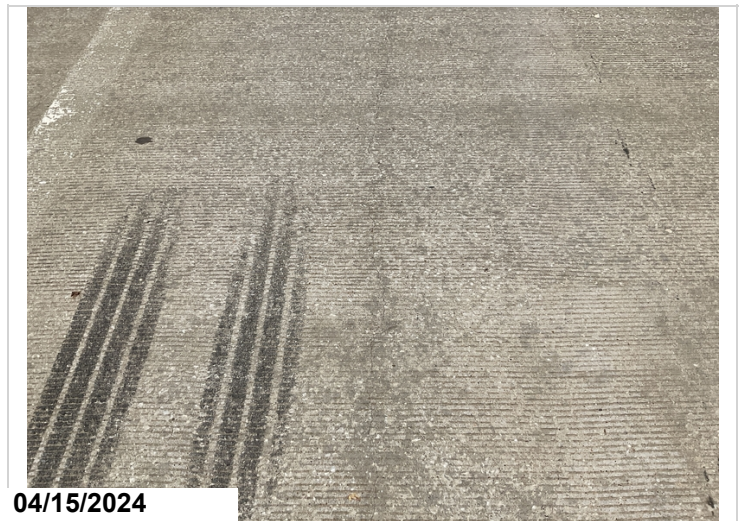
Span 4: longitudinal cracking. CS3.

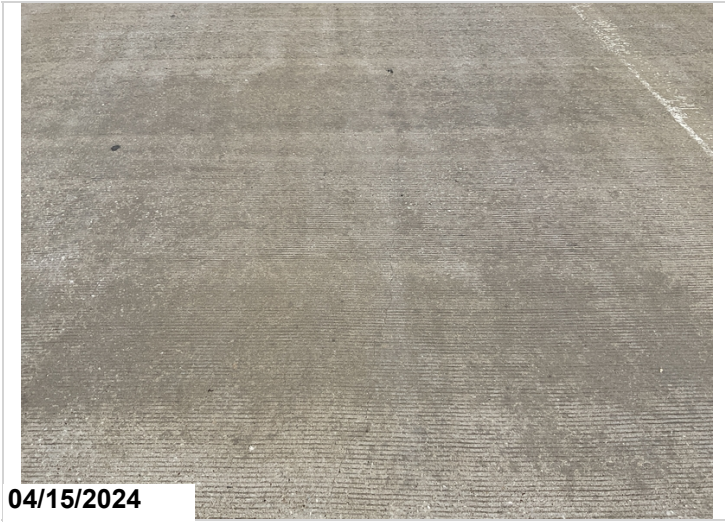
Span 4: longitudinal cracking. CS2.

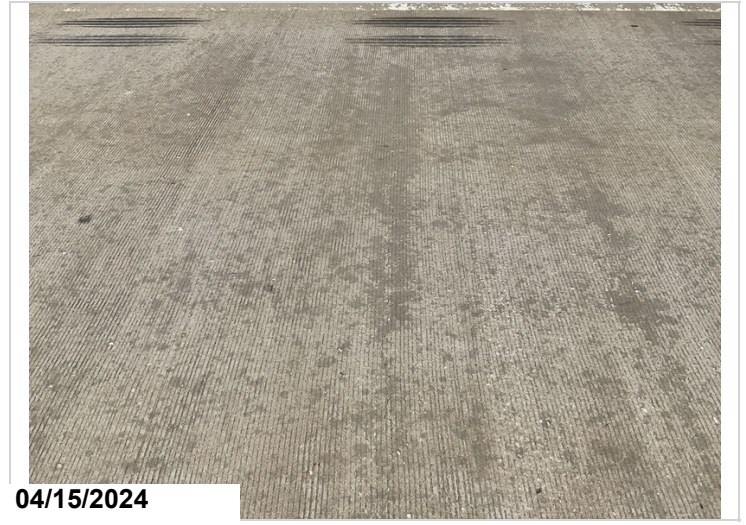
Span 3: transverse cracking. CS2.

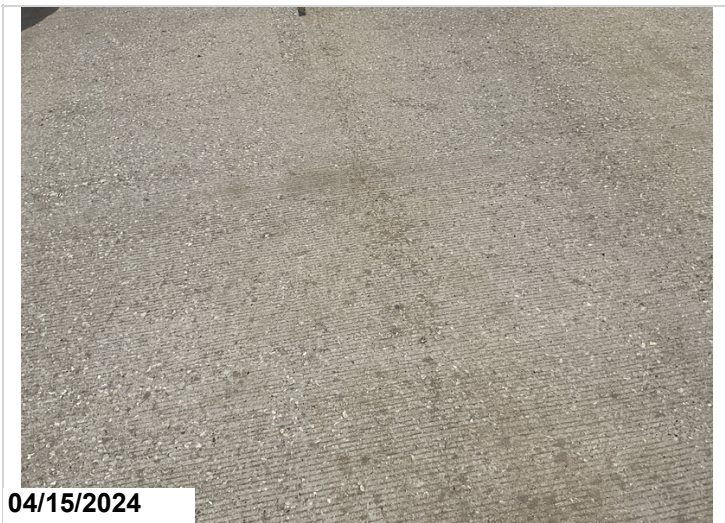
Span 3: longitudinal cracking. CS2.

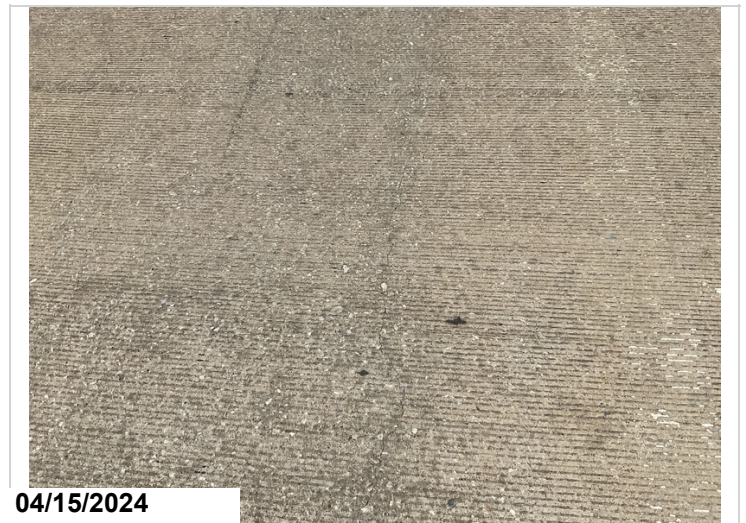
Span 2: longitudinal cracking. CS2.

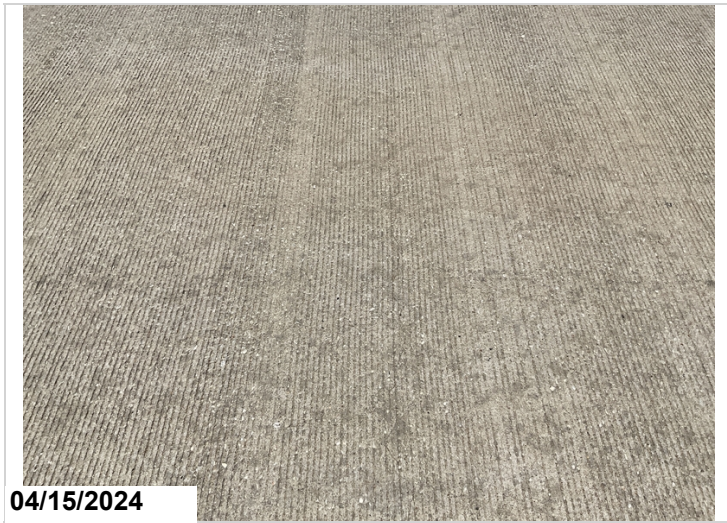
Span 1: transverse cracking. CS2.

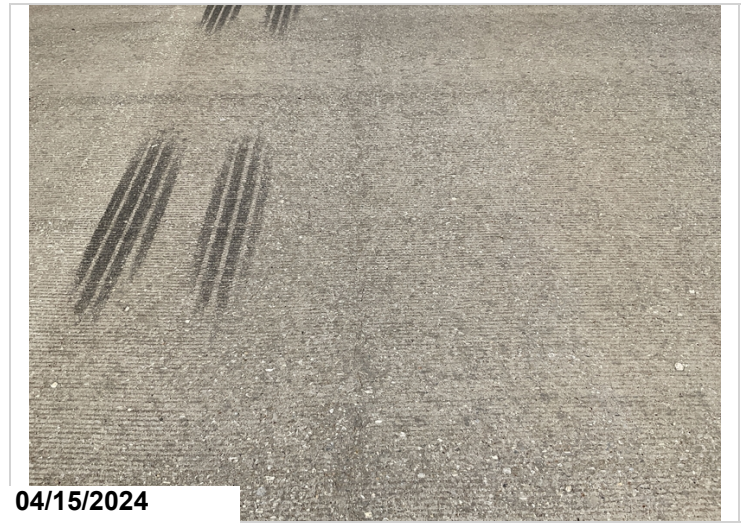
Span 1: longitudinal cracking. CS2.

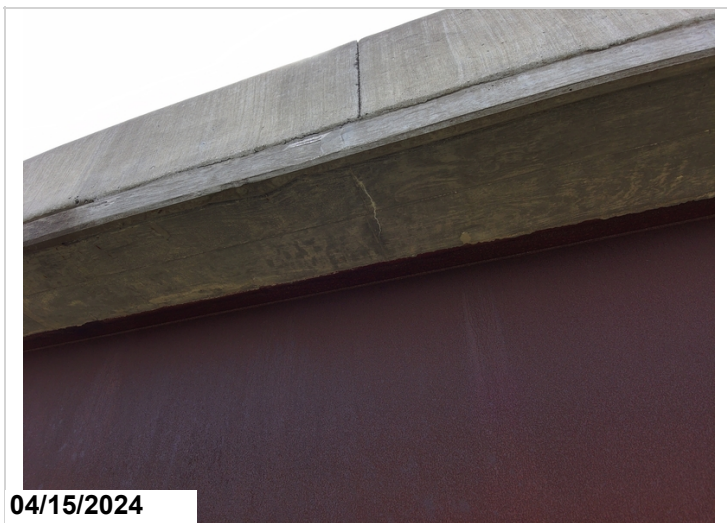
Deck, Right & Left Overhangs: cracking with efflorescence typical throughout the structure. CS2.

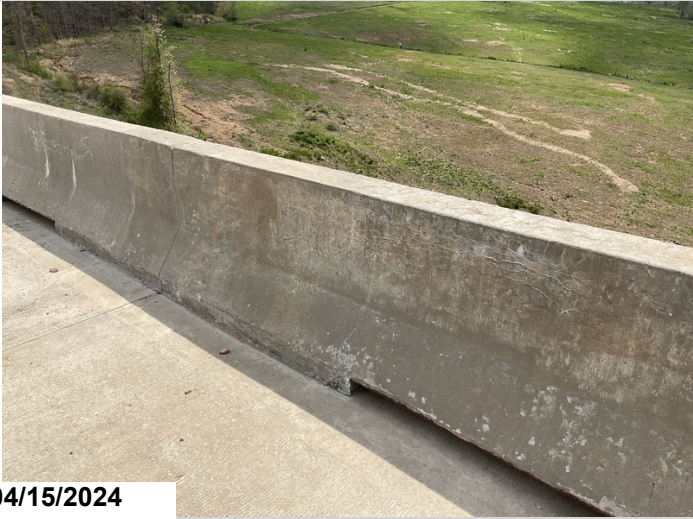
Span 3, Left Bridge Railing: map cracking with efflorescence. CS3.

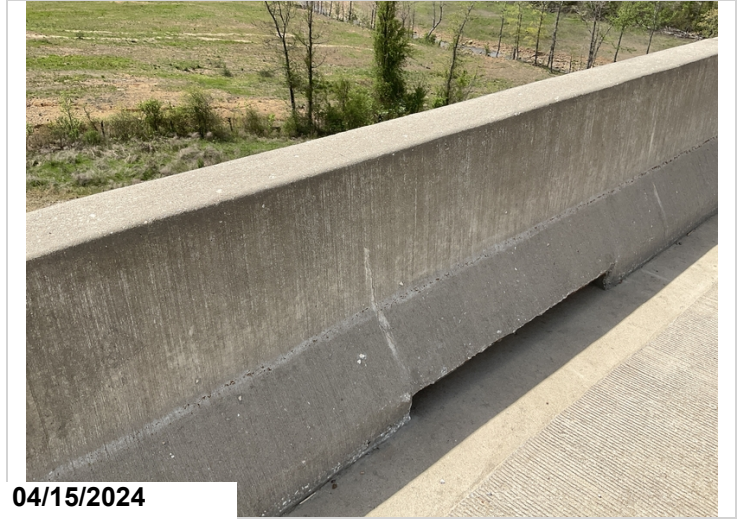
Bridge Railing: typical cracking with efflorescence. CS2.

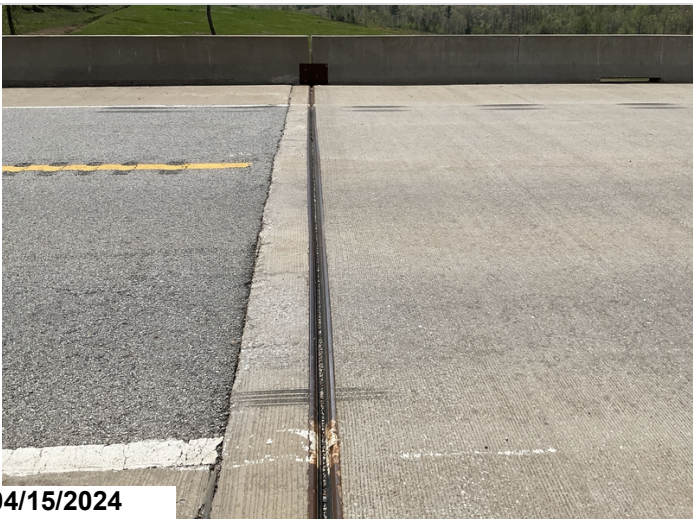
Joint at Abutment 1: Debris impactation. CS2.

A-56 - Joint Cleaning/Flushing Needed (Yes)

A-59 - Joint Repair Needed (Yes)

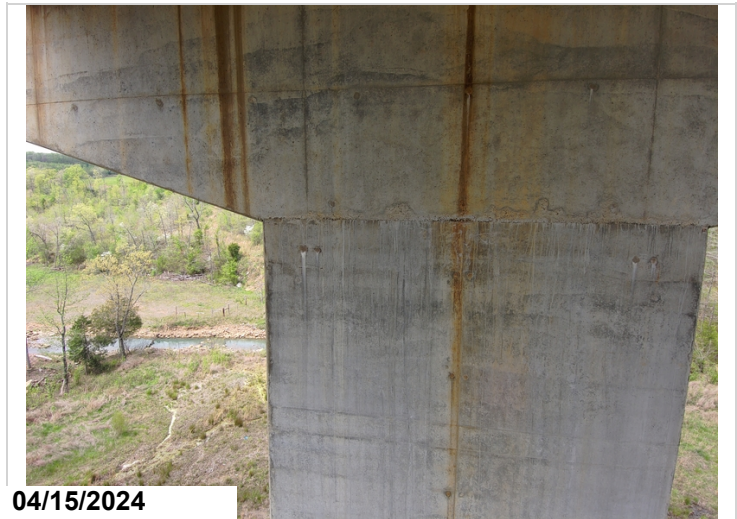
(107) No defects at the time of this inspection.							
210	Reinforced Concrete Pier Wall	LF	96	92	0	4	0
1120	Efflorescence/Rust Staining	LF	4	0	0	4	0
(210) Bent 2, Pier Wall: cracking with efflorescence near the top of the Pier Wall. Bent 4, Pier Wall: cracking with efflorescence near the top of the Pier Wall.							
215	Reinforced Concrete Abutment	LF	86	77	9	0	0
1120	Efflorescence/Rust Staining	LF	6	0	6	0	0
1130	Cracking (RC and Other)	LF	3	0	3	0	0

Bent 2, Back, Top of Pier Wall: cracking with efflorescence.
