## Bridge 05671 Inspection Report

Asset #05671(Routine)

SH 13 White County over CYPRESS CREEK RELIEF

Team Lead: Seth Foreman Inspection Date: 06/18/2024

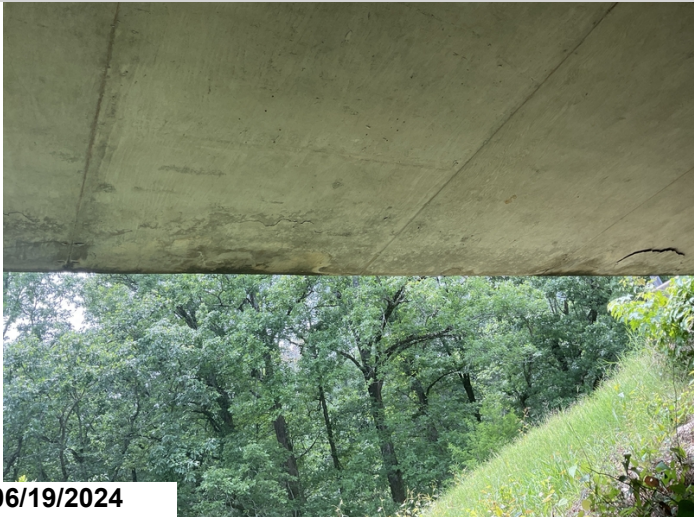
Span 10, Left, Undersurface: 7' of delaminated areas. CS3  
2'. CS2 5'.

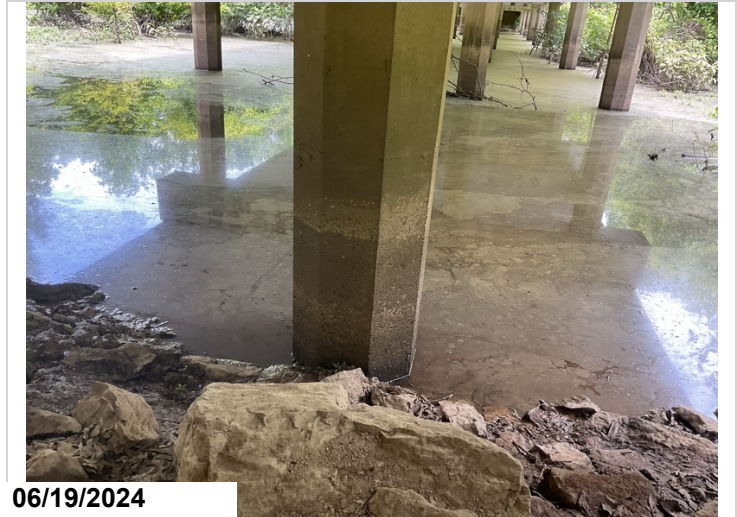
Piles: Minor abrasion throughout the structure. CS2.

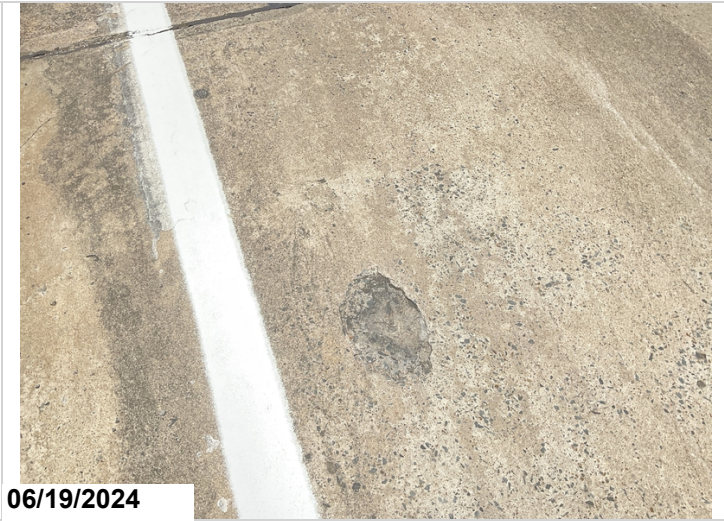
Span 3: Spalling. CS3.

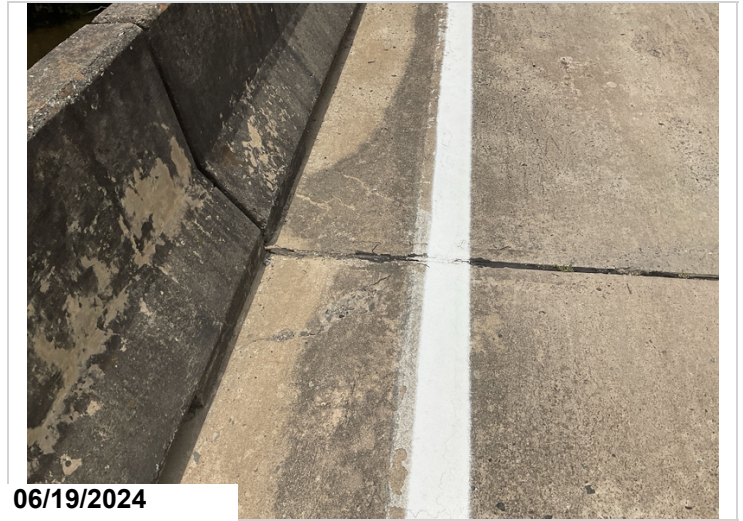
Spans 2 & 3, Left: Diagonal cracking.

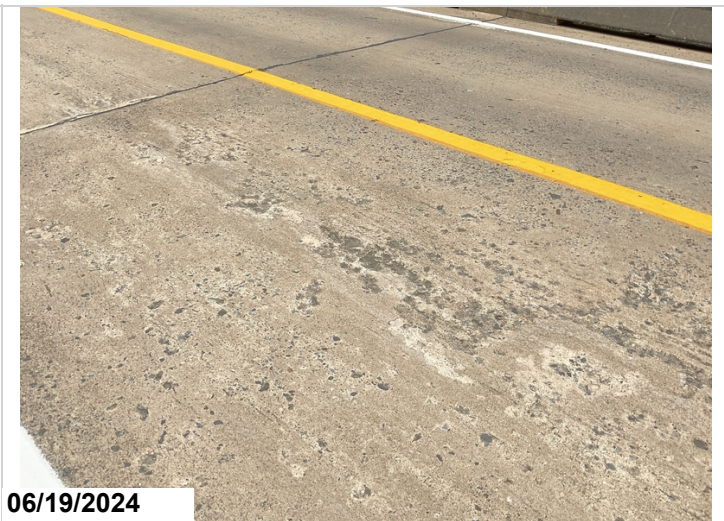
Span 1: Spalling.

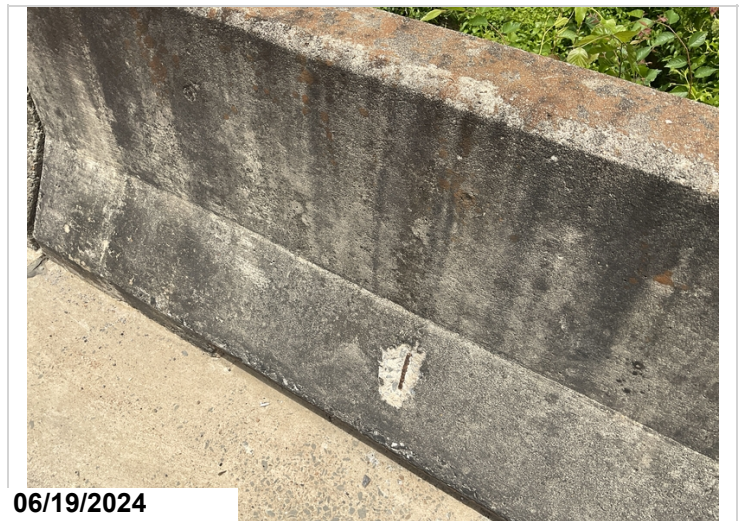
Span 6, Right Bridge Railing: Spalling with exposed reinforcing steel. CS2.

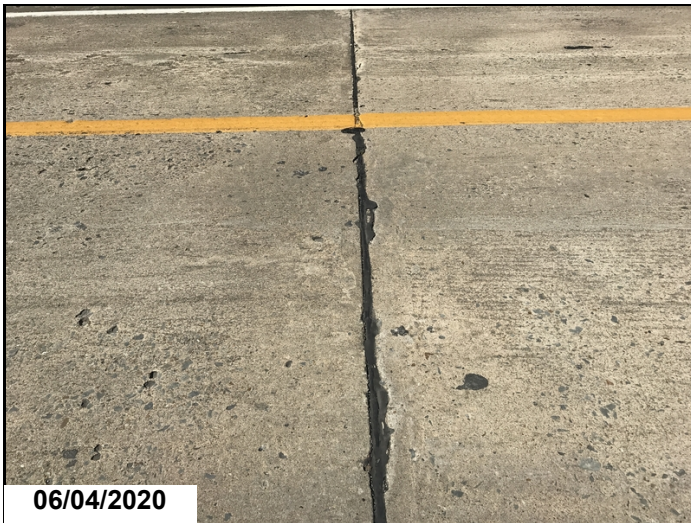
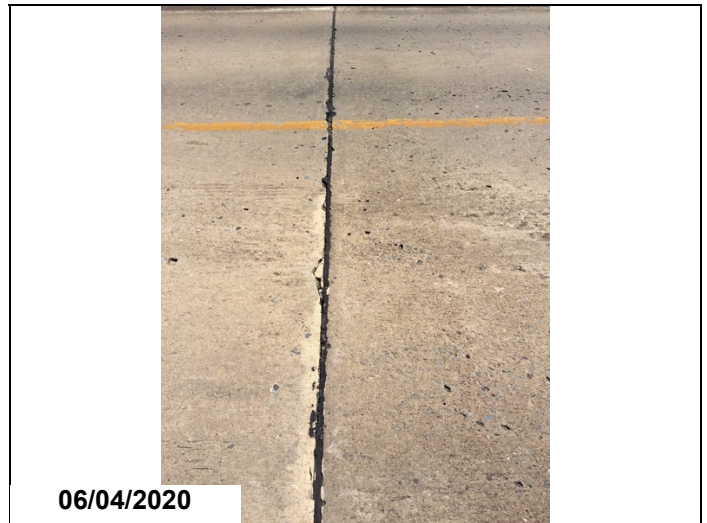
Poured joint seals are cracked, deteriorated & leak.

Type of Work: Joint Repair

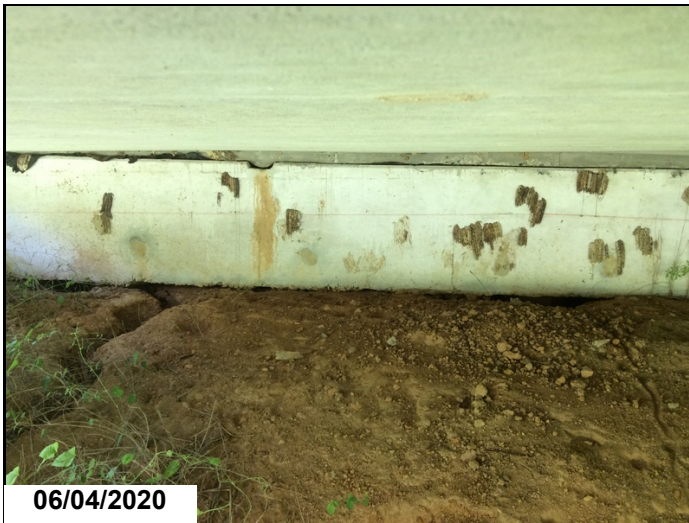
Overall substructure is in good condition with scour to Abutment 1 With 2 piles exposed.

Scour under Abutment 1 with 2 piles exposed.

Settlement under Abutment 1 with 2 piles exposed.

**Type of Work:** Substructure Repair

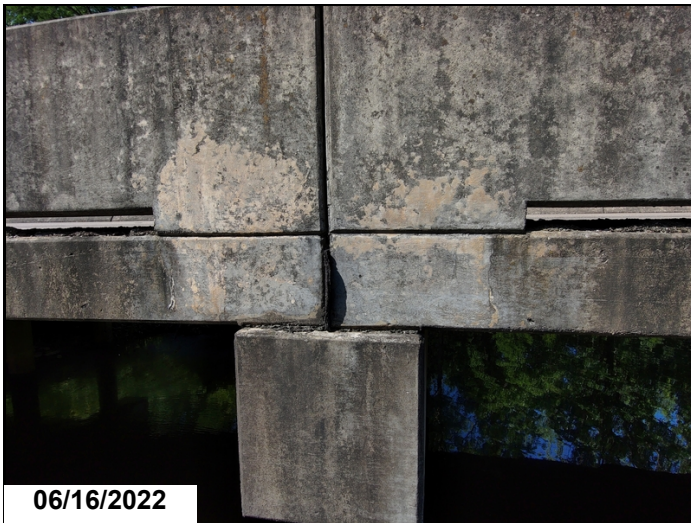
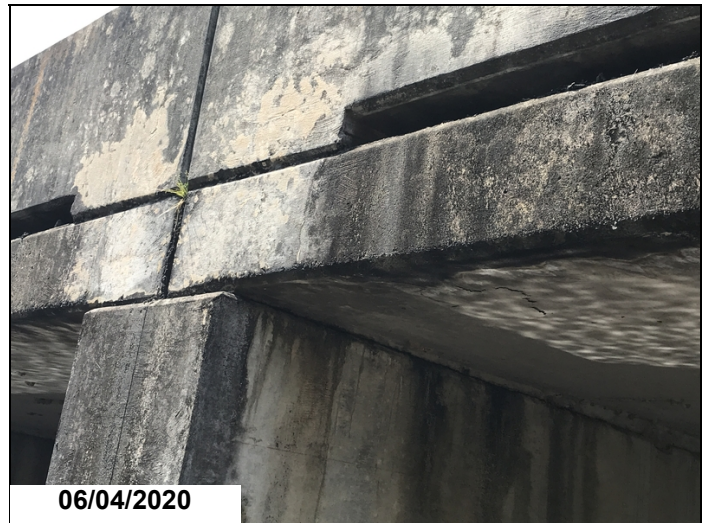
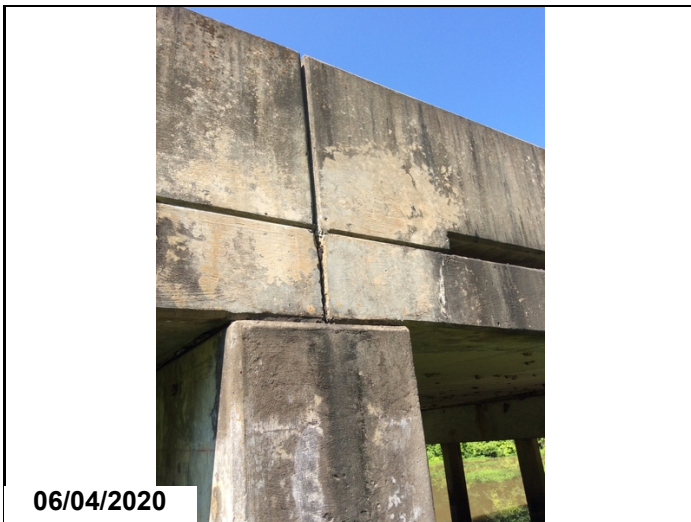
Vertical efflorescent cracks to outside edge of deck at Spans 1, 2, & 3.

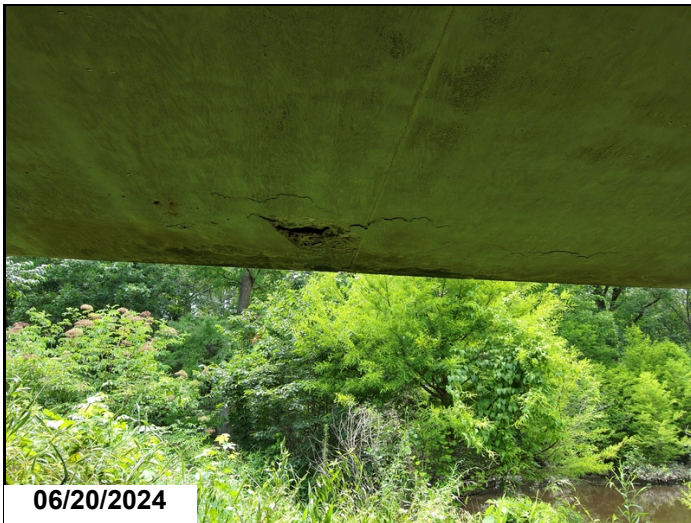
Spall/Areas of delamination to Left & Right edges of soffit at Spans 1-6 & 8-10.

Spall/Areas of delamination to Left & Right edges of soffit at Spans 1-6 & 8-10.  
Lt side, span 1

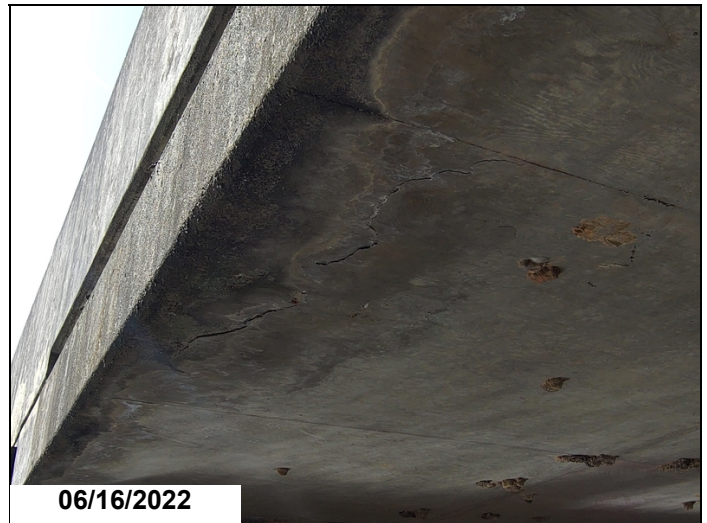
Spall/Areas of delamination to Left & Right edges of soffit at Spans 1-6 & 8-10.  
Span 3

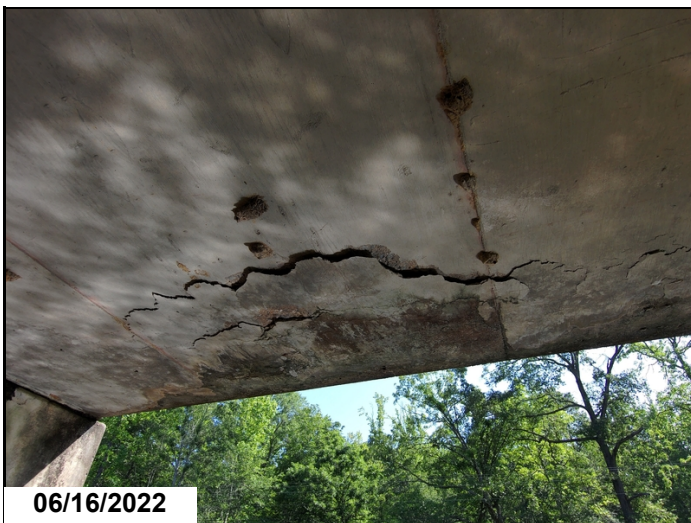
Large delam to rt edge of soffit @ span 2.

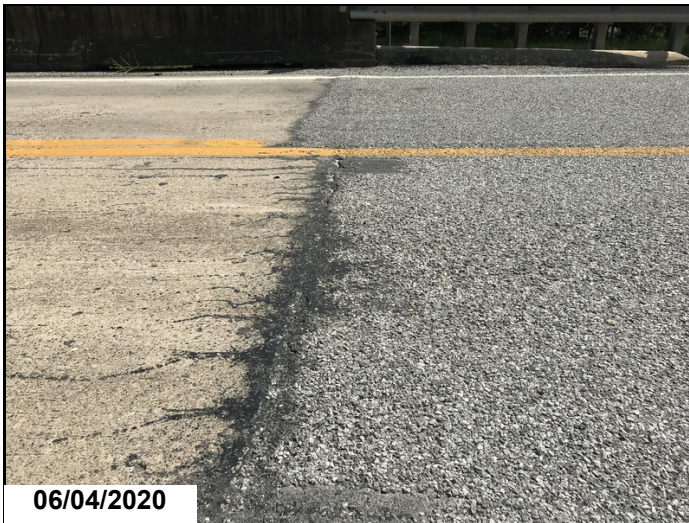
Visible settlement to approach roadway at Abutment 1.

**Type of Work:** Approach Leveling/Maintenance

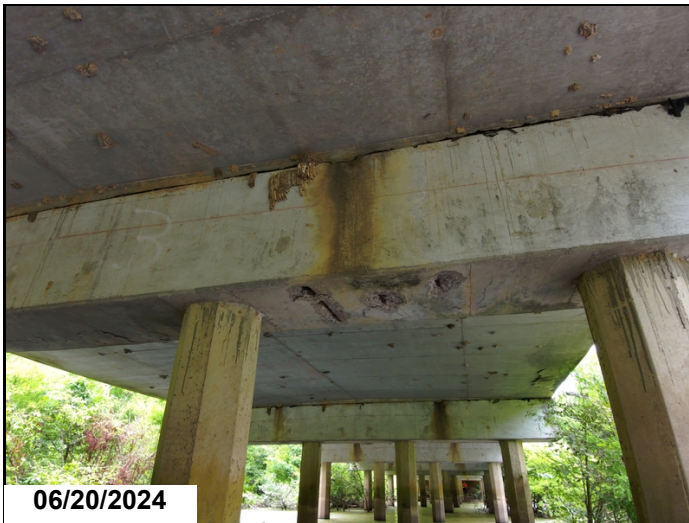
Spalls to cap with rebar exposed at Bents 1, 2, 3, 4, & 5.

Spalls to cap with rebar exposed at Bents 1, 2, 3, 4, & 5.  
Bent 3, between piles 3 & 4

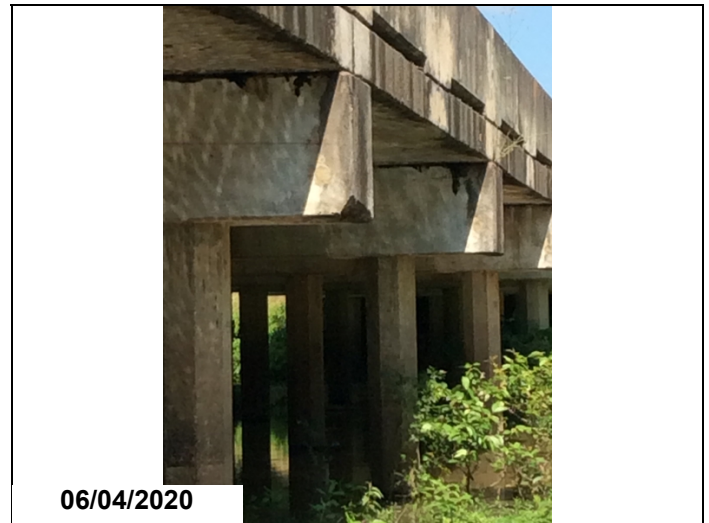
Spalls to cap with rebar exposed at Bents 1, 2, 3, 4, & 5.

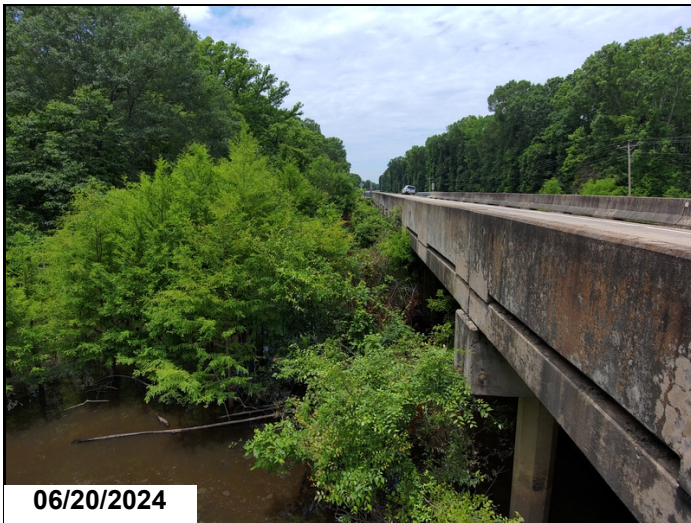
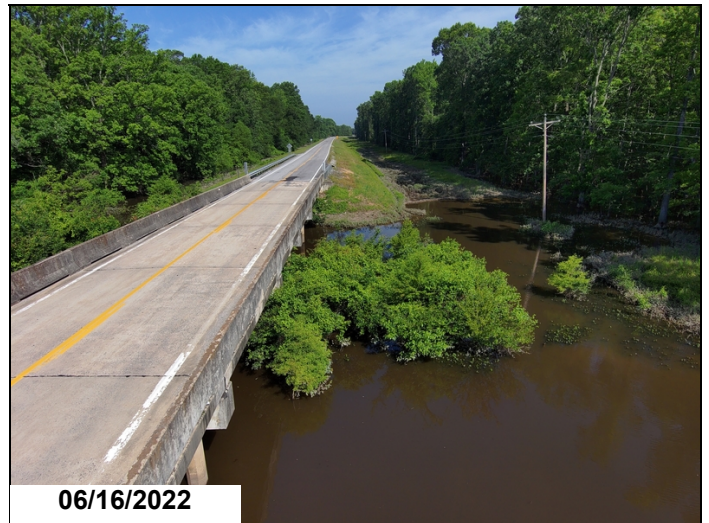
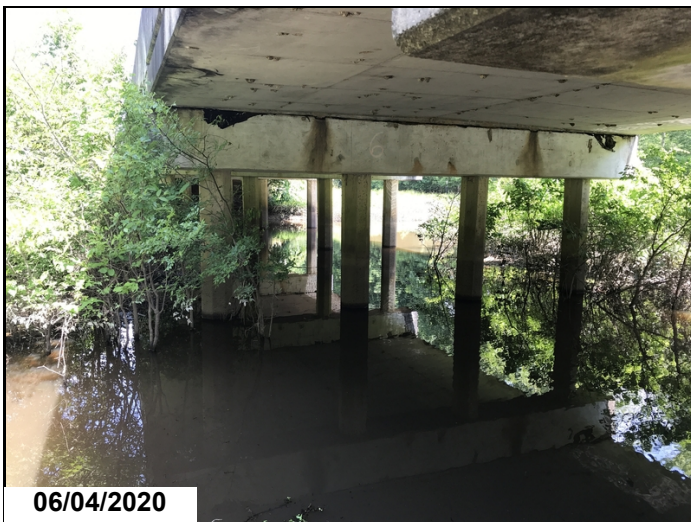
Vegetation to Lt & Rt sides @ spans 4-7.
