## Bridge 05672 Inspection Report

Asset #05672(Routine)  
SH 13 White County over CYPRESS CREEK

Location: 1.7 MI SE SH 267

Team Lead: Seth Foreman Inspection Date: 06/18/2024

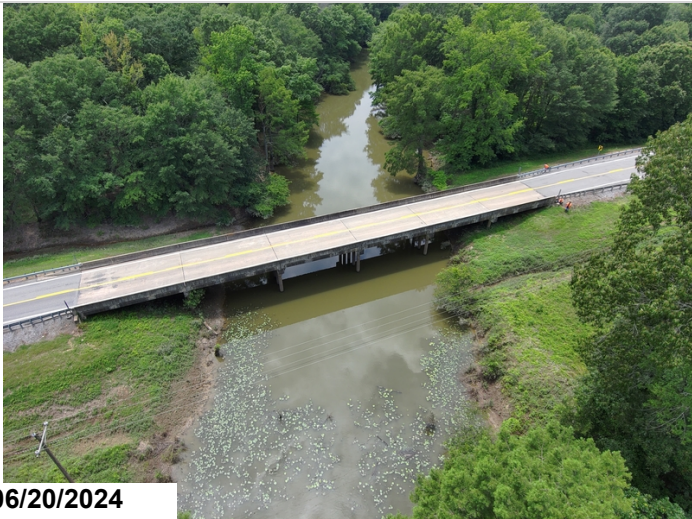
Elevation with Log Mile going to the Right.

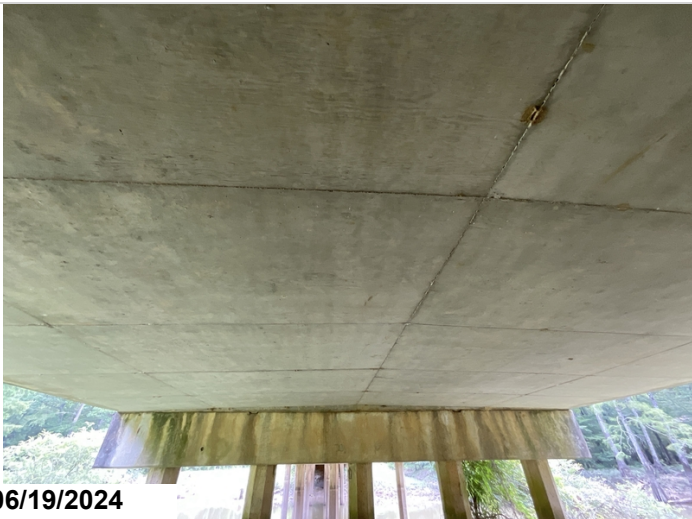
Overall deck is in satisfactory condition with cracks to deck throughout and large delaminated areas to undersurface at all spans.

Typical undersurface.

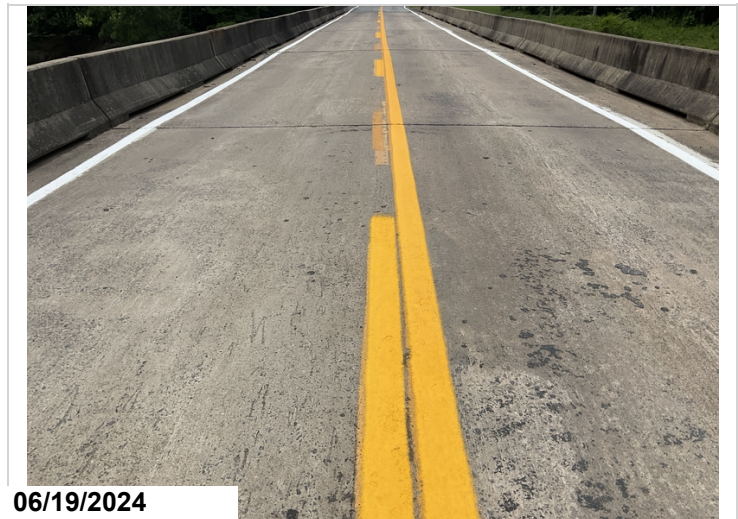
Typical deck.

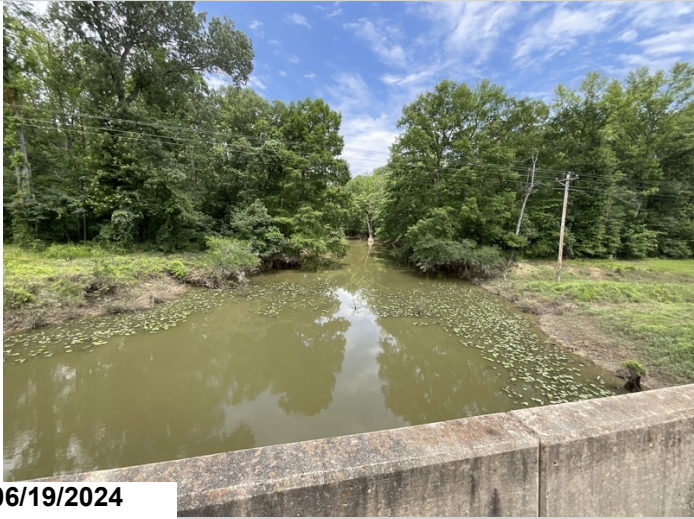
Right side of Bridge: Channel view.

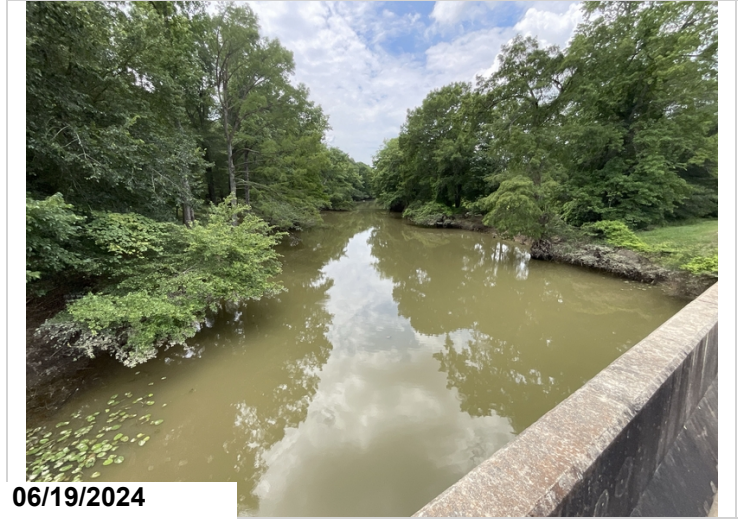
Left side of Bridge: Channel view.

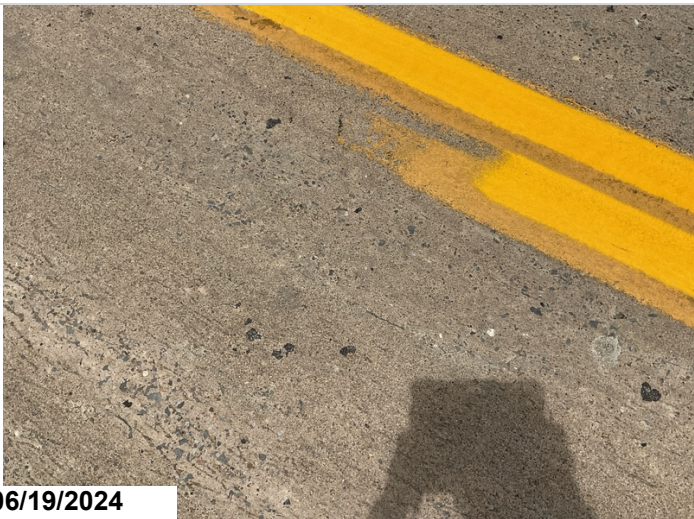
Spans 1 - 6: minor cracking.

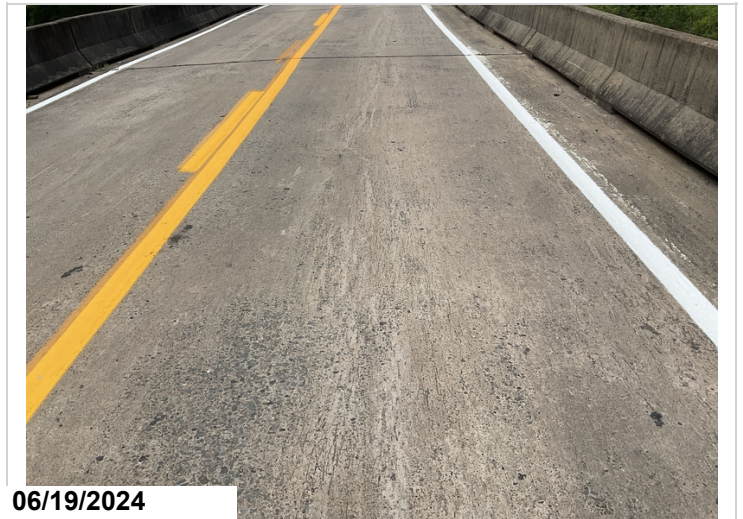
Spans 1 - 5: Minor abrasion.

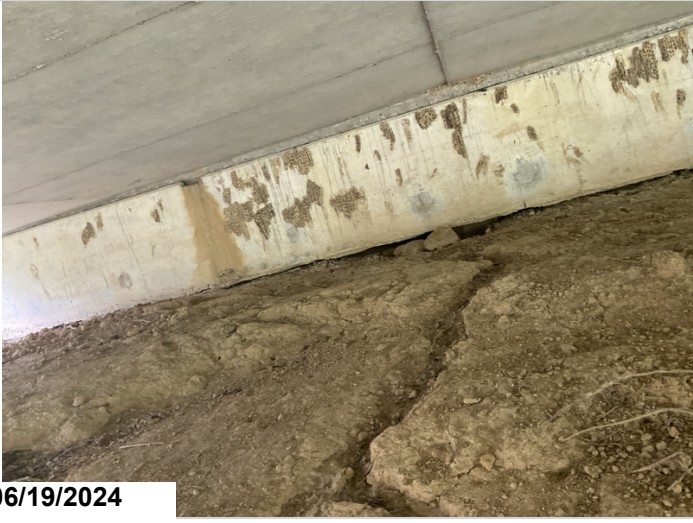
(215) Abutment 1 - Erosion under abutment with 2 piles exposed. 6' CS 2 Abutment 2 - Erosion under abutment with 1 pile exposed. 3' CS 2							
227	Reinforced Concrete Pile	EA	28	12	16	0	0
1080	Delamination/Spall/Patched Area	EA	1	0	1	0	0
1190	Abrasion/Wear (PSC/RC)	EA	15	0	15	0	0

Abutment 2: Minor erosion causing one pile to be exposed.

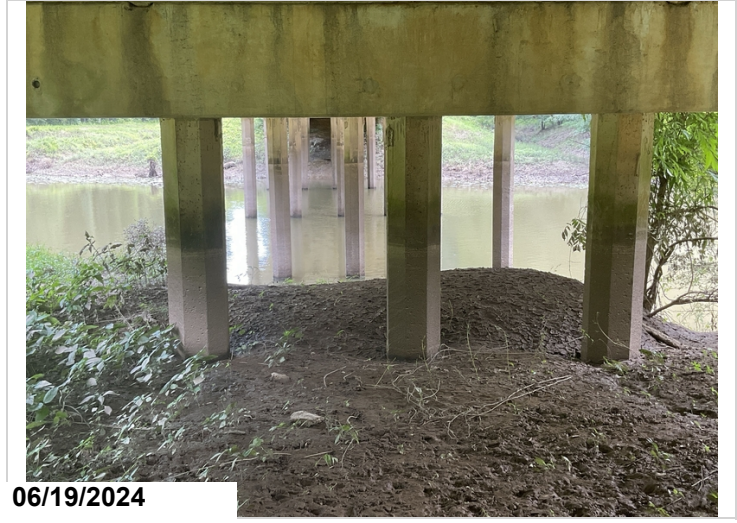
(227) Minor abrasion to piles @ Bents 2, 3 & 4. 15 CS 2 Bent 3, Pile 3 has spall 1' CS 2							
234	Reinforced Concrete Pier Cap	LF	135	129	2	4	0
1080	Delamination/Spall/Patched Area	LF	2	0	2	0	0
1090	Exposed Rebar	LF	3	0	0	3	0
1130	Cracking (RC and Other)	LF	1	0	0	1	0

Piles: Minor abrasion throughout the structure.

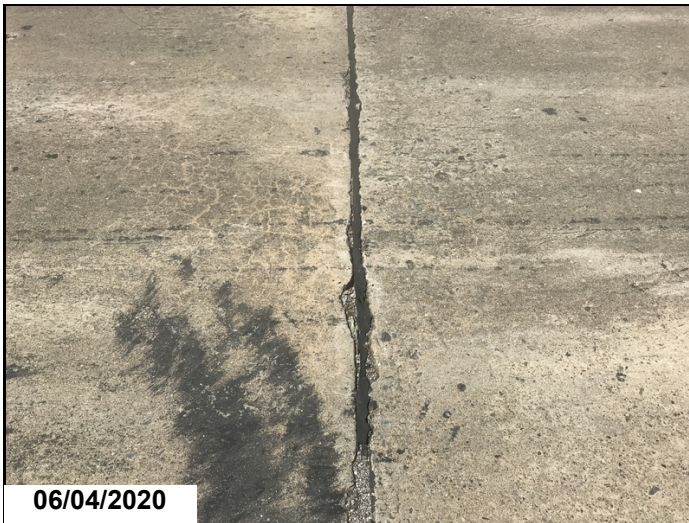
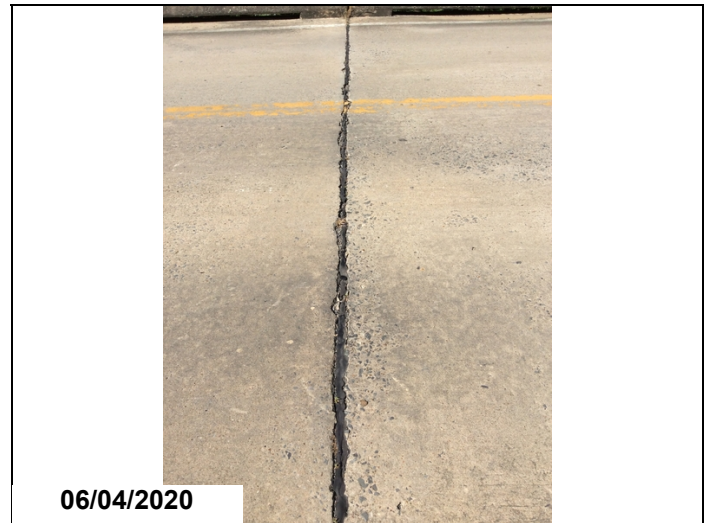
ELEMENTS	DESCRIPTION	UNITS	TOTAL	CS1	CS2	CS3	CS4
301	Pourable Joint Seal	LF	134	0	0	134	0
2320	Seal Adhesion	LF	134	0	0	134	0
(301) Joint seal is losing adhesion. 134' CS 3							
331	Reinforced Concrete Bridge Railing	LF	420	420	0	0	0

Poured joint seals are cracked, deteriorated & leak.

Type of Work: Joint Repair

**A-59 - Joint Repair Needed (Yes)**

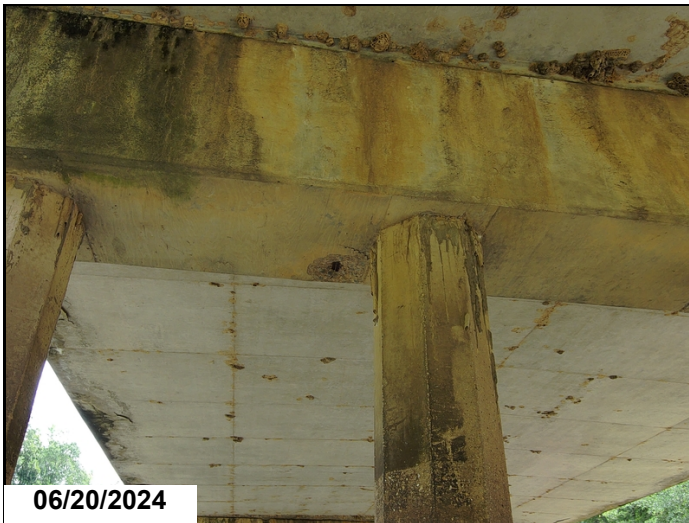
(234) Bent 1 - Crack to left end of cap. 1' CS 3 Bent 2 - Areas of delaminating & spall with 2' rebar exposed to bottom of cap. 2' CS 3 Spall with no rebar exposed to back side of cap near Pile 2. 1' CS 2 Bent 3 - Spall to back face of cap & spall with 2" rebar exposed to bottom of cap. 1' CS 2 spall, 1' CS 3 rebar

Spalls to cap with rebar exposed to Bents 2 & 3.  
Bent 3.

Type of Work: Substructure Repair

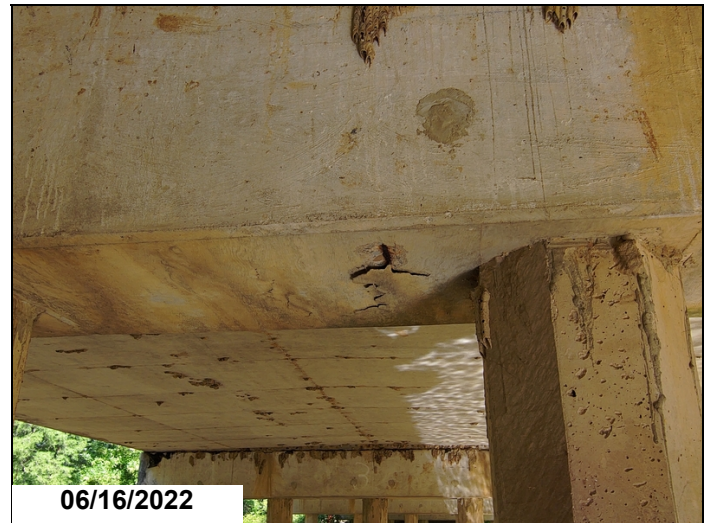
Spalls to cap with rebar exposed to Bents 2 & 3.  
Bottom of cap between piles 3 & 4 @ bent 3.

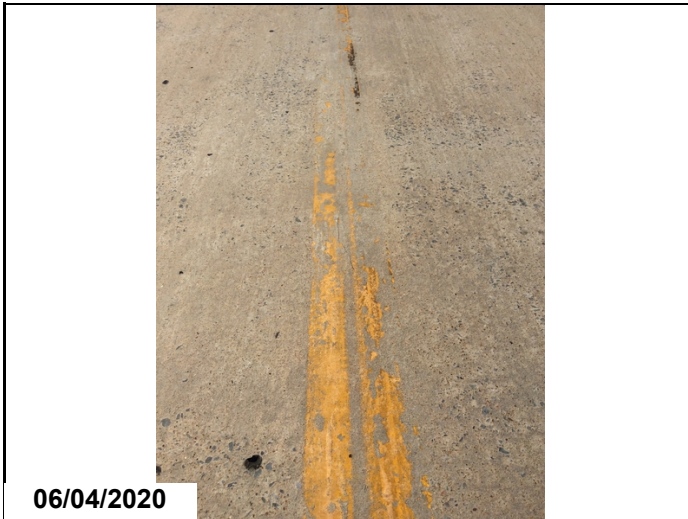
Unsealed cracks to deck.

**Type of Work:** Deck Repair

**A-54 - Sealable Deck Cracks (Yes)**

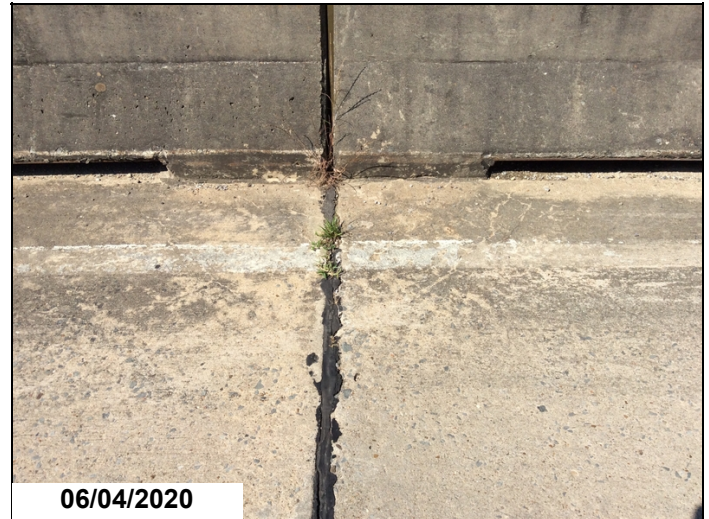
Typical deck cracking on Left & Right edges of deck over Bents.

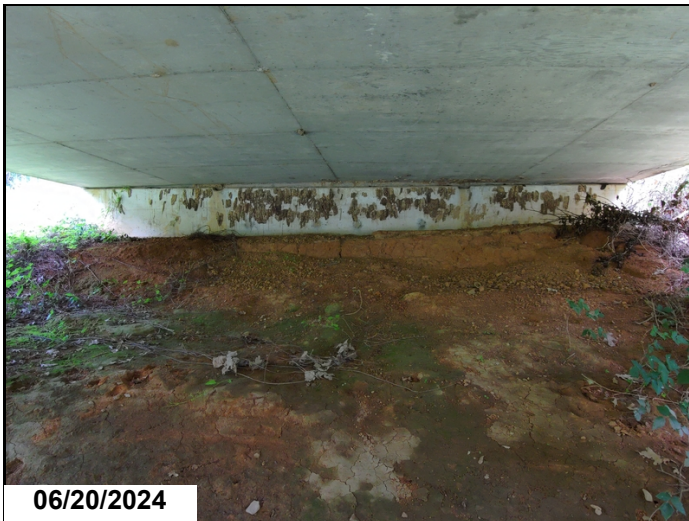
Scour under Abutment 1 with 2 piles exposed & under Abutment 2 with 1 pile exposed.  
Abutment 2.

Type of Work: Substructure Repair

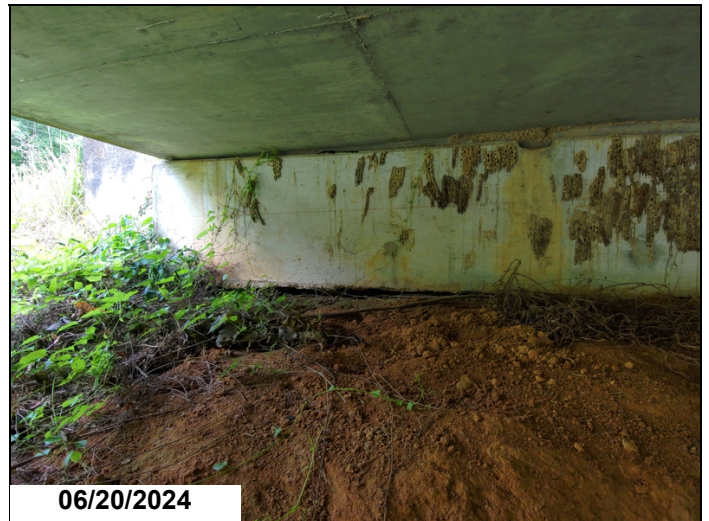
Scour under Abutment 1 with 2 piles exposed & under Abutment 2 with 1 pile exposed.  
Abutment 1.

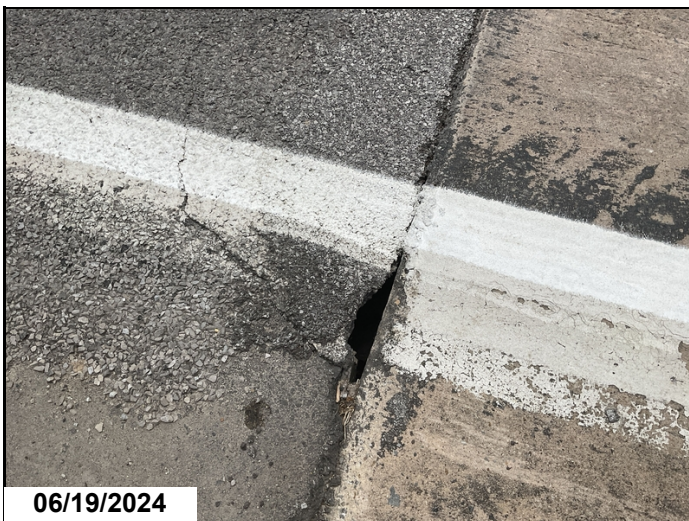
Abutment 1, Right, Approach Roadway: Pothole from erosion.

**A-66 - Approach minor pothole/leveling needed**
