Bridge 07029 Inspection Report

Asset #07029(Routine, Underwater type 2)

SH 25/Indepen Co. over PFEIFER CREEK

Team Lead: Floyd Haley Inspection Date: 10/02/2024

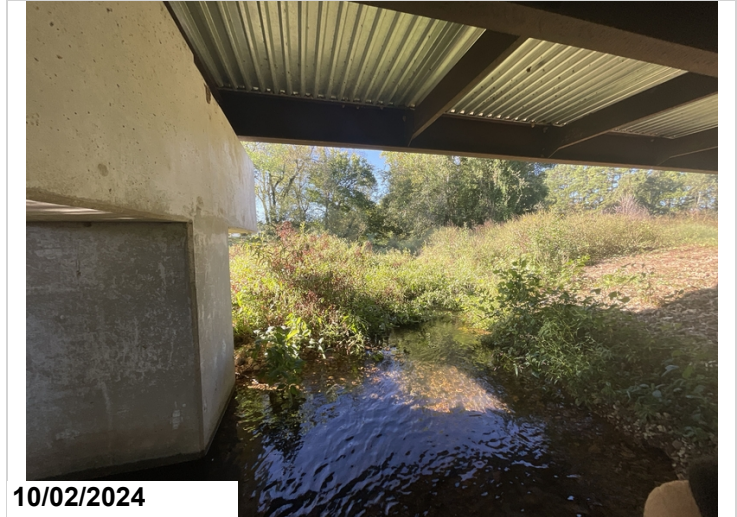
The channel is in good condition with minor defects noted. General scour is present upstream, and downstream vegetation is restricting the channel. Protections consist solely of vegetation and could use improvement, but no local scour or defects affecting the structure are present. This item was rated a 7 as a result.

Downstream. Heavy vegetation restricting flow downstream

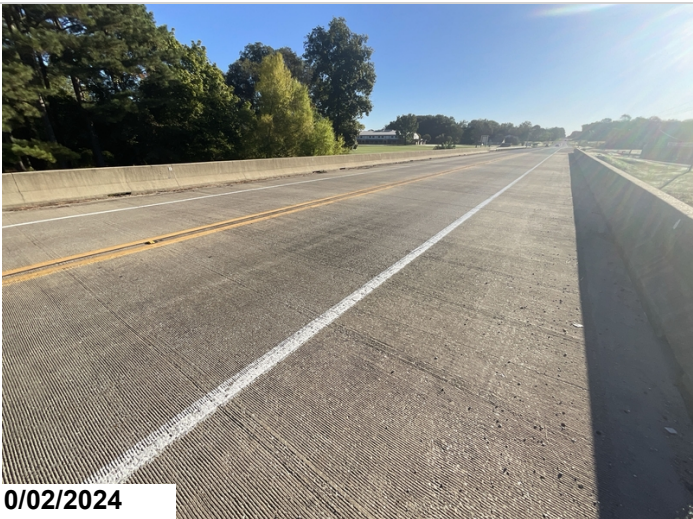
Typical deck

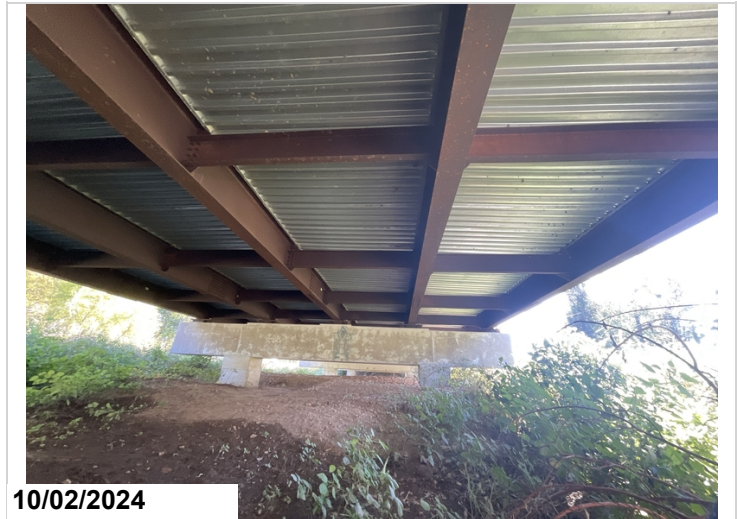
Typical undersurface

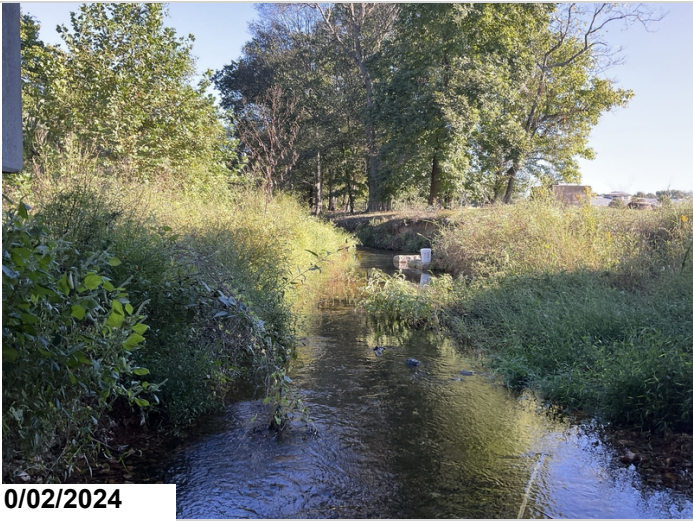
Minor general scour is present upstream, but this item is otherwise in good condition and was rated a 7.

Upstream channel view. The outside bank has minor scour and protection is needed. This has no effect on the structure at present.

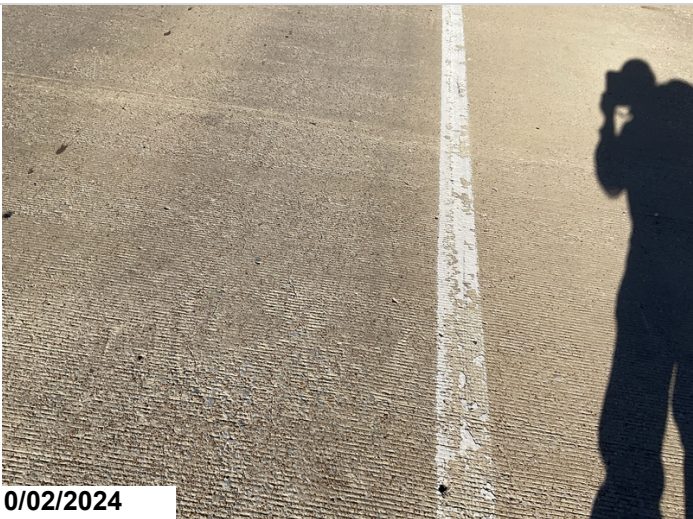
Sealable cracks are present in the deck throughout.

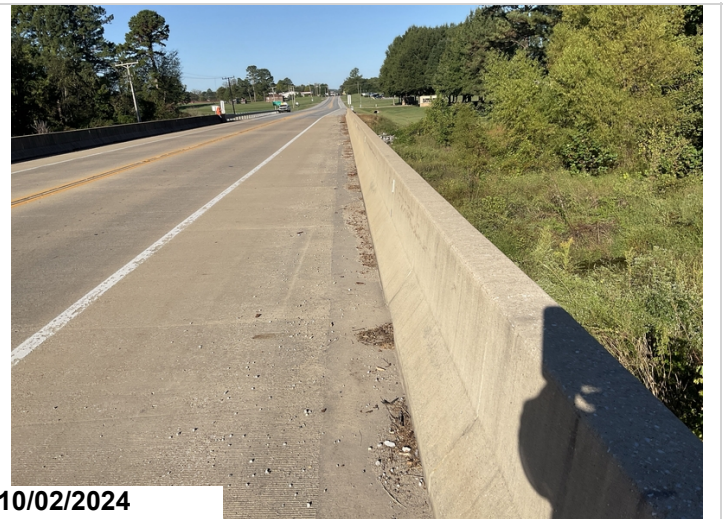
The gutter lines have debris throughout.

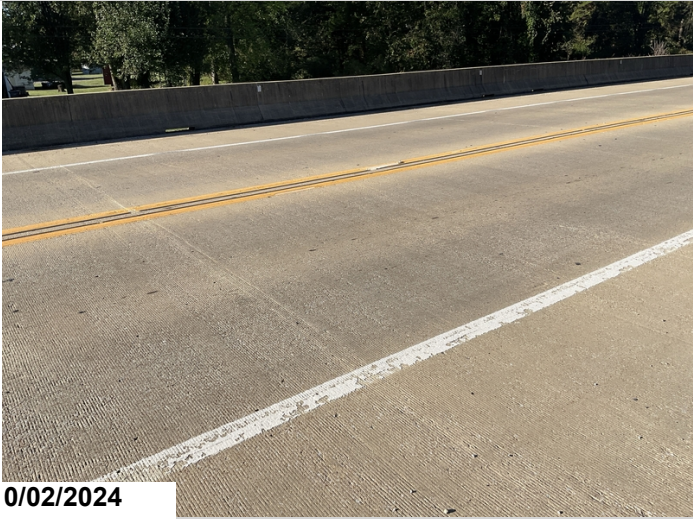
The deck has sealable cracks throughout.

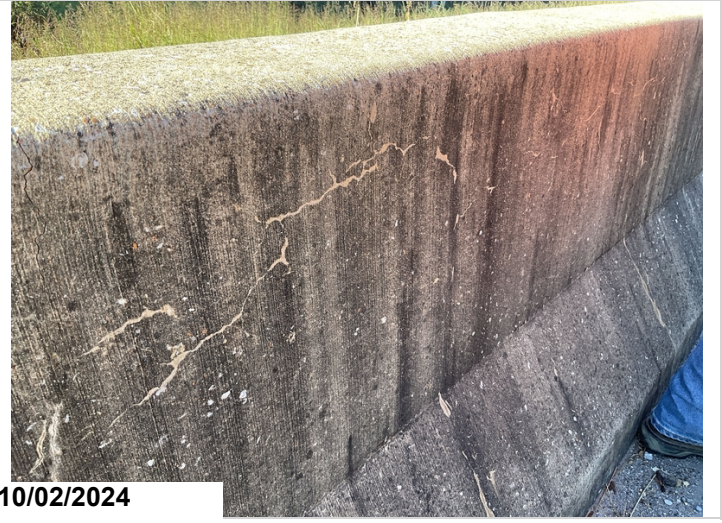
Typical railing has minor cracking, some with efflor, throughout, but is in otherwise good condition.

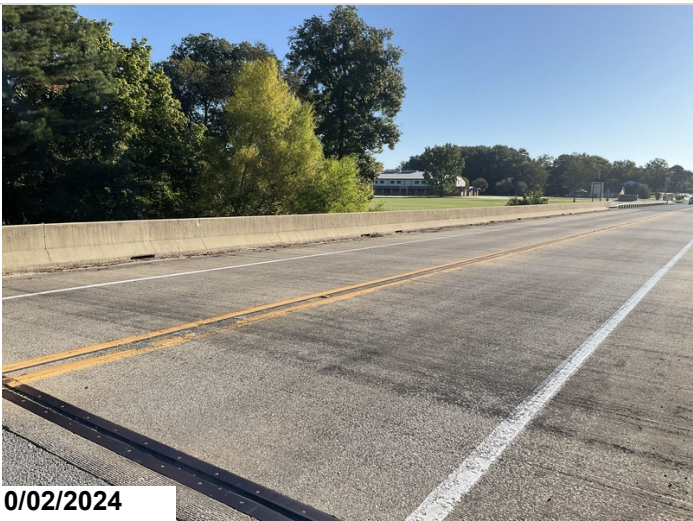
Typical railing condition.

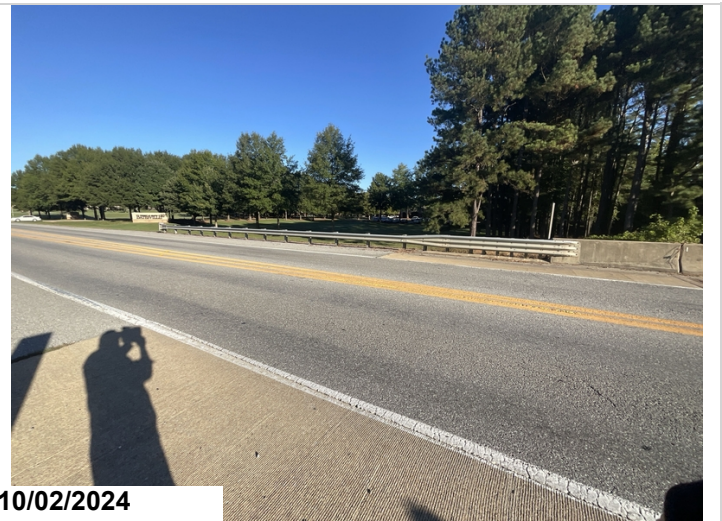
The rail transitions are in good condition throughout.

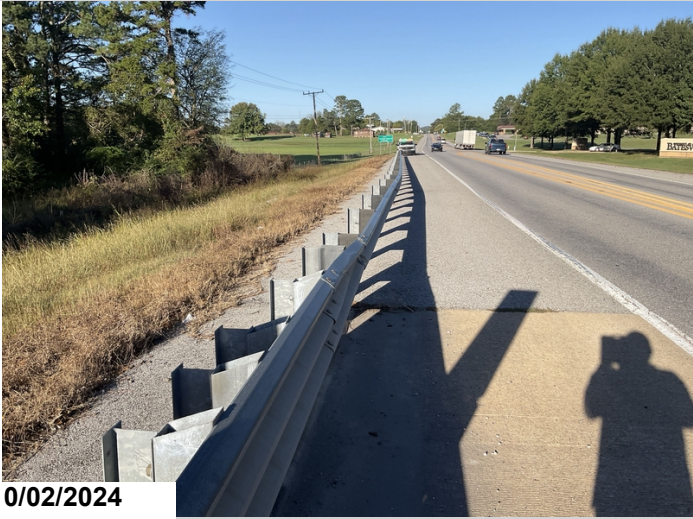
Typical transition condition.

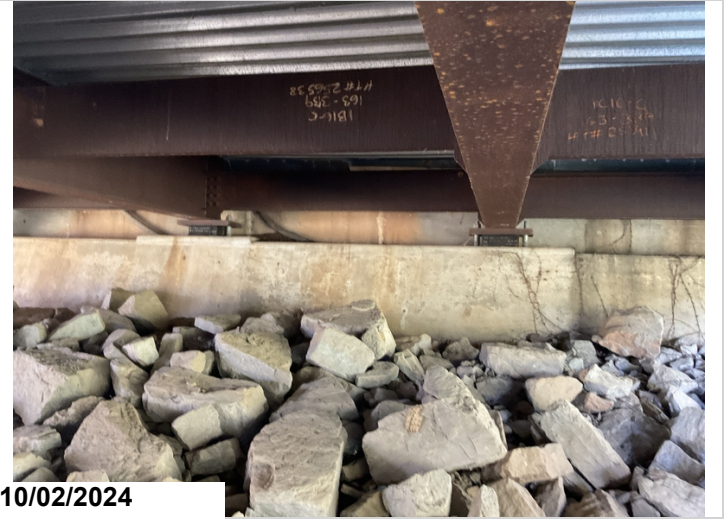
The bearings are in good condition with isolated connection issues.

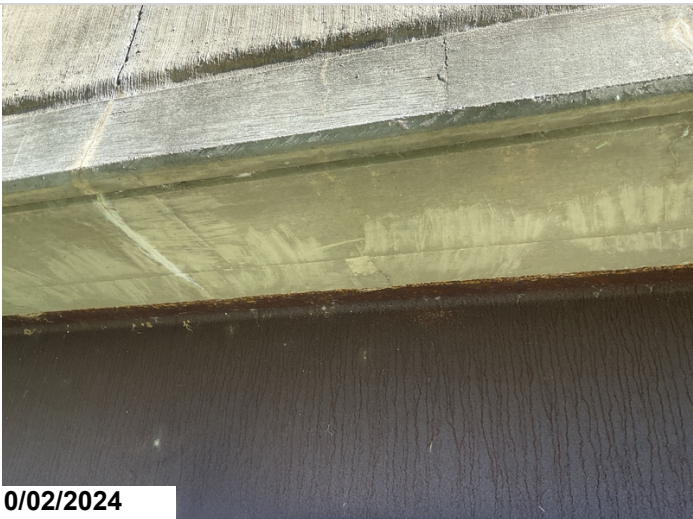
The overhangs have efflorescence throughout. 110SF CS2

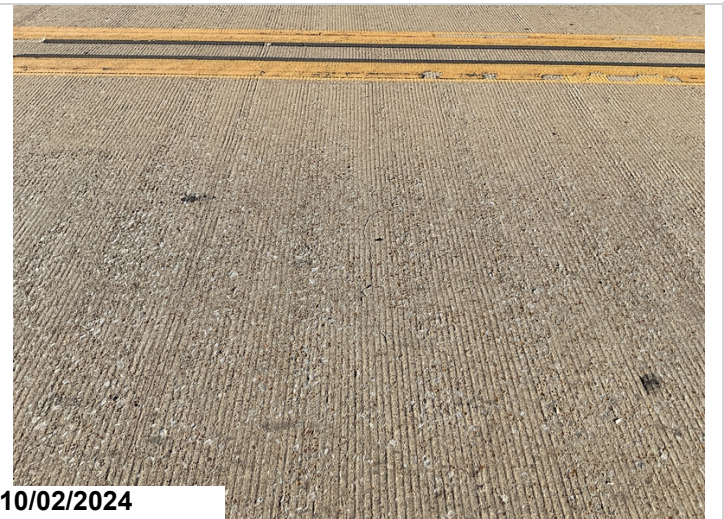
Typical transverse cracks are present throughout. CS3

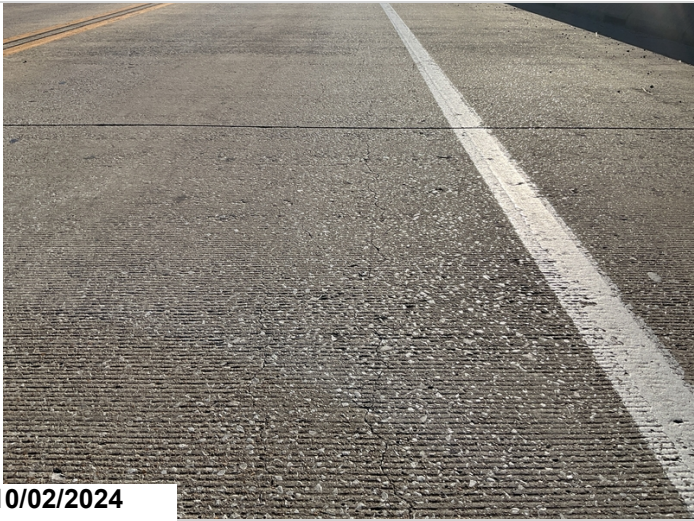
Typical moderate longitudinal cracks are present in the wheel path throughout. CS3

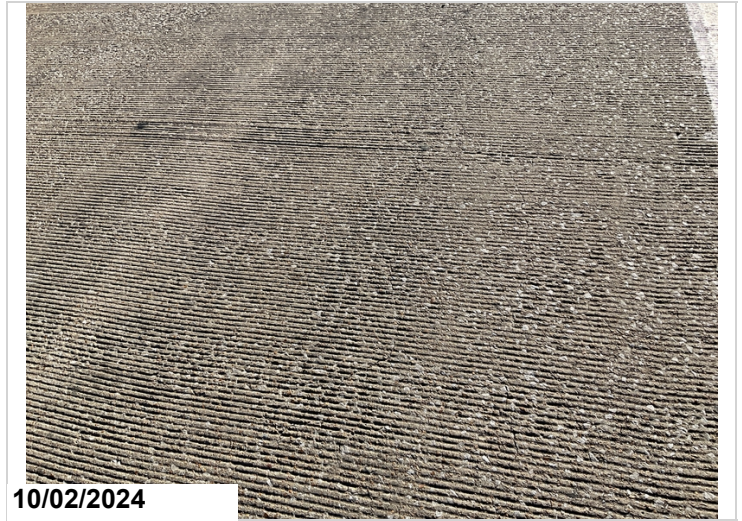
Typical minor cracking to deck throughout. 630SF CS2

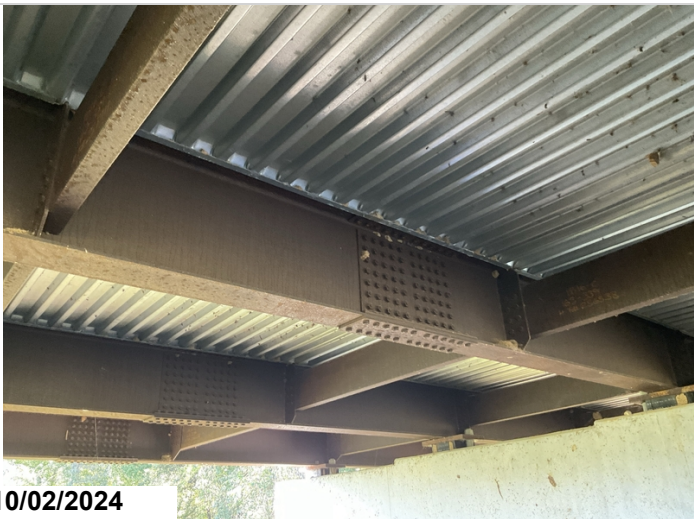
Typical splice connection

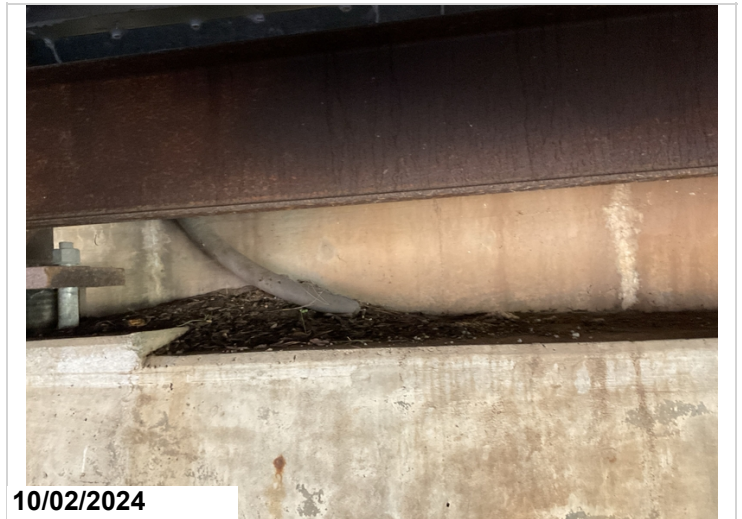
Abutment 1, efflor

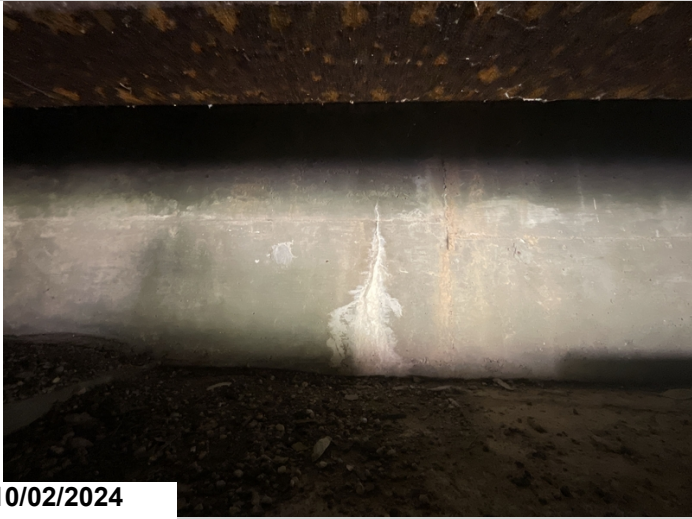
Abutment 2, backwall: has efflor cracks with buildup. 4LF
CS3

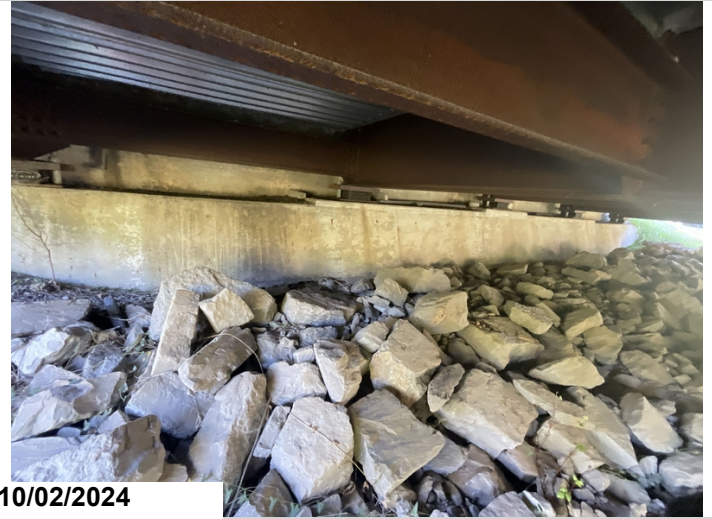
Typical abutment

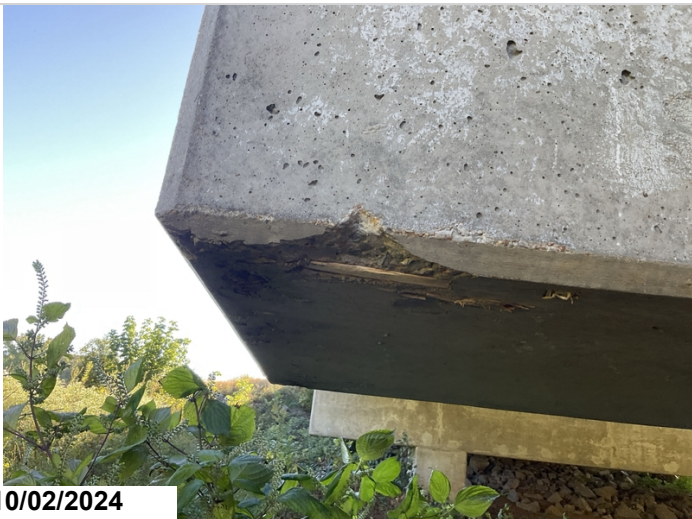
(234) Bent 3, left: spall. 1LF CS2							
301	Pourable Joint Seal	LF	86	58	22	2	4
2320	Seal Adhesion	LF	5	0	0	1	4
2330	Seal Damage	LF	1	0	0	1	0
2350	Debris Impaction	LF	22	0	22	0	0

Bent 3, left: spall. CS2

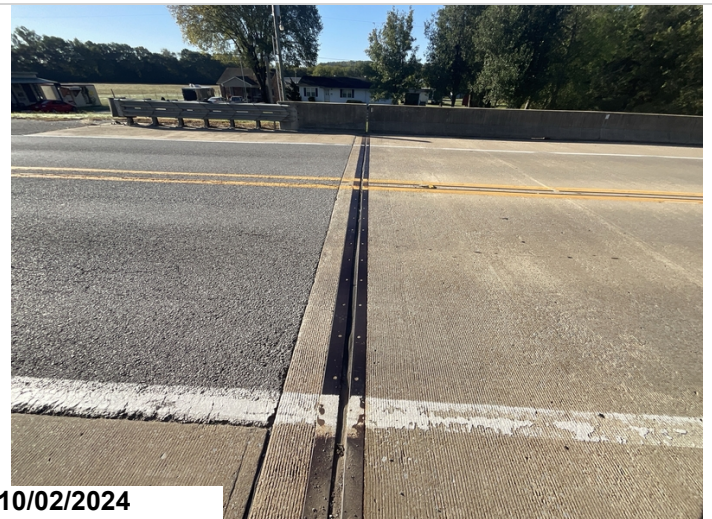
Abutment 2, joint has isolated defects throughout

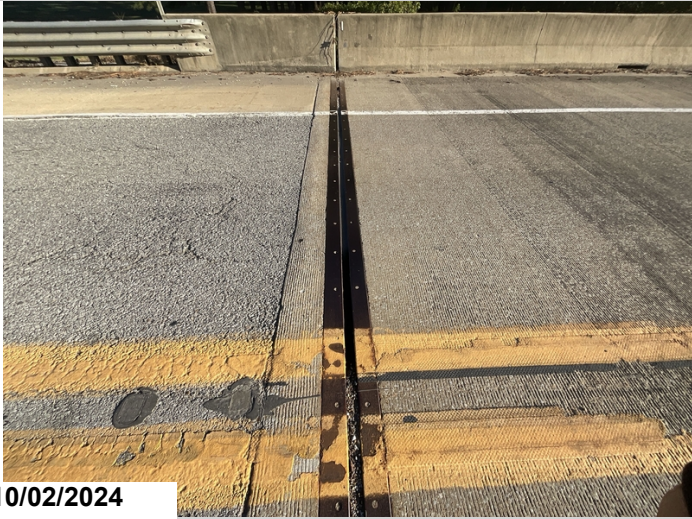
Abutment 1, joint: has adhesion loss for in the center line and left shoulder. 4LF CS4

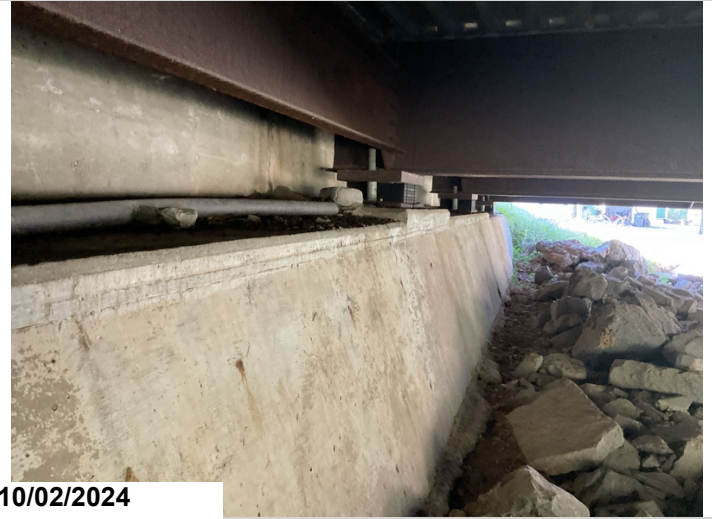
Abutment 2, bearings, are missing anchor nuts. 5EA CS2

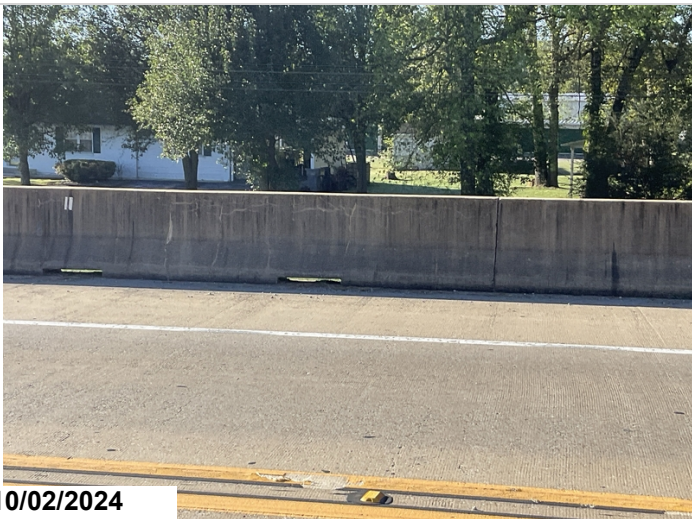
Span 4 right. 20' map cracking with efflor. CS3

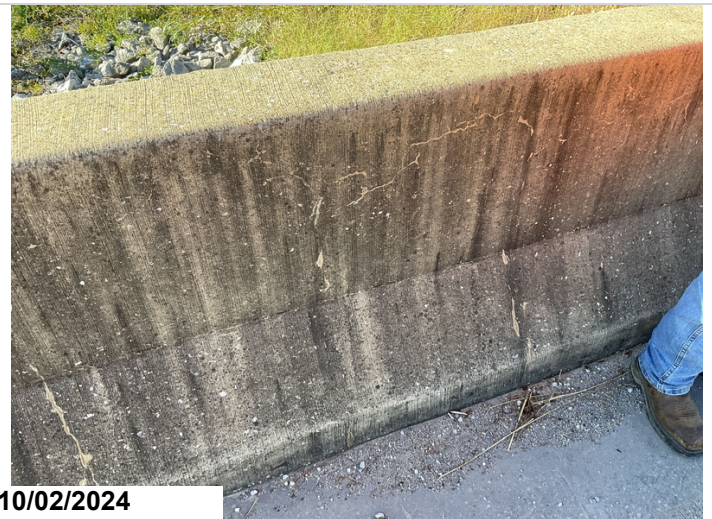
Typical railing cracks

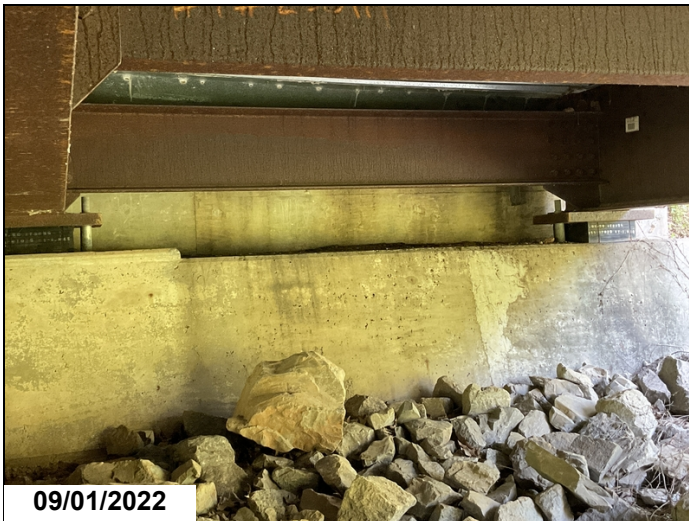
Anchor Bolt Nuts Missing
Abutment 1 at Girders 1 & 2 missing one nut.

Type of Work: Bearing Repair/Replacement

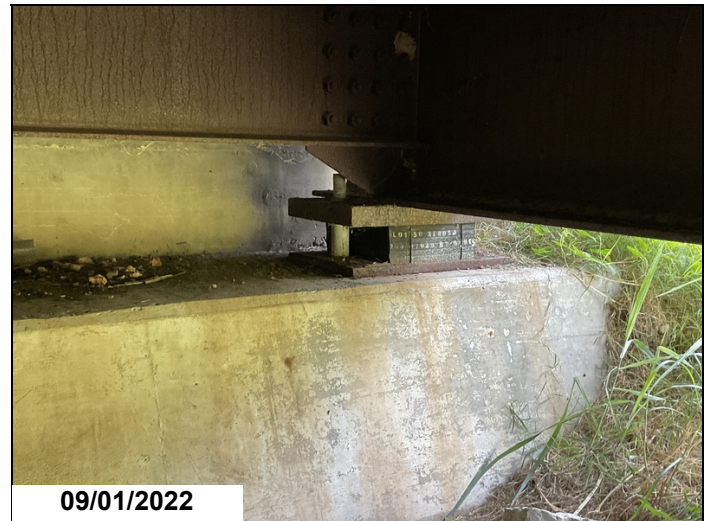
Abutment 2 at Girders 1, 2 & 5 missing one nut, Girders
3 & 4 missing both nuts.
Girder 5.

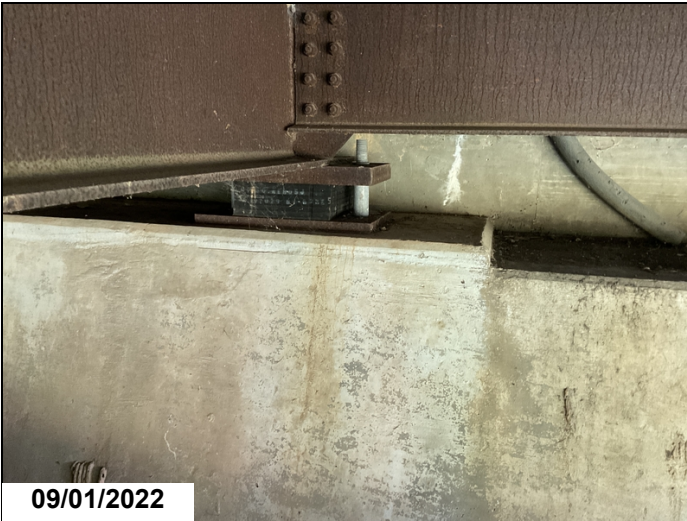
Abutment 2 at Girders 1, 2 & 5 missing one nut, Girders 3 & 4 missing both nuts.
Girder 3.

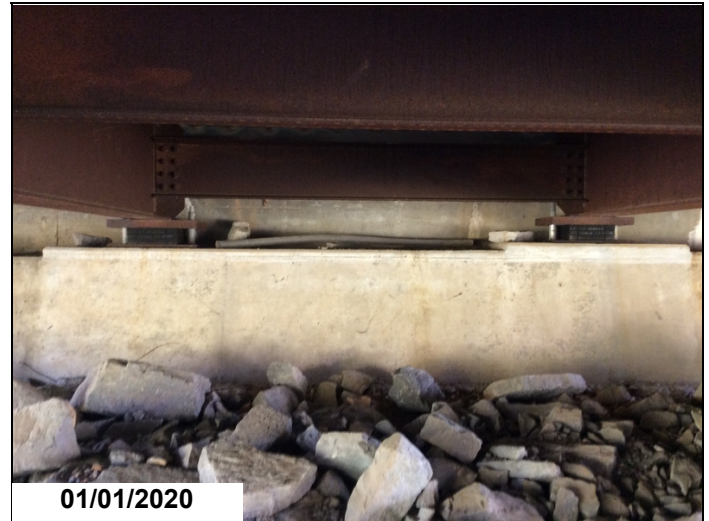
Both anchor bolt nuts are missing from Girders 3 & 4 @
Abutment 2.

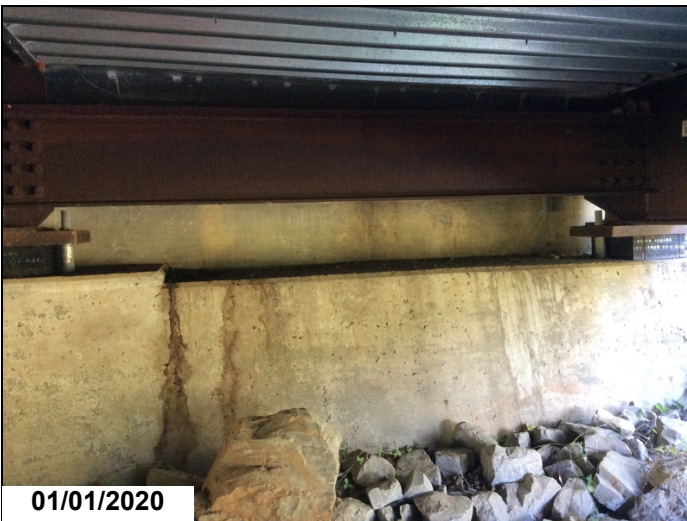
Anchor bolt nuts missing @ Girders 1 & 2 @ Abutment 1.

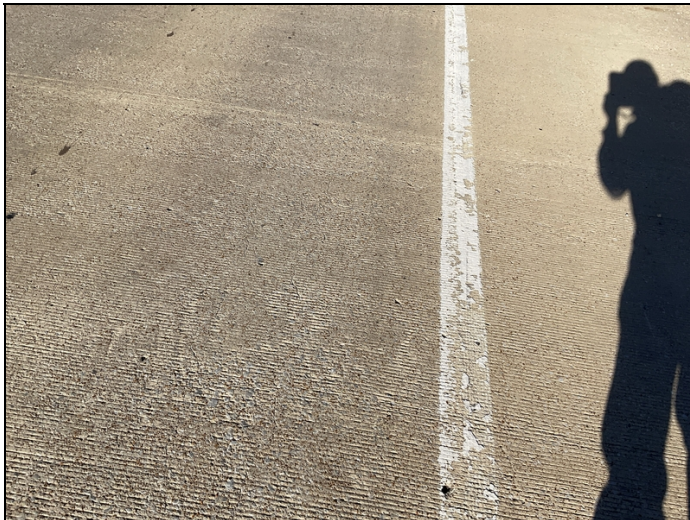
Sealable cracks are present in the deck throughout.

A-54 - Sealable Deck Cracks (Yes)

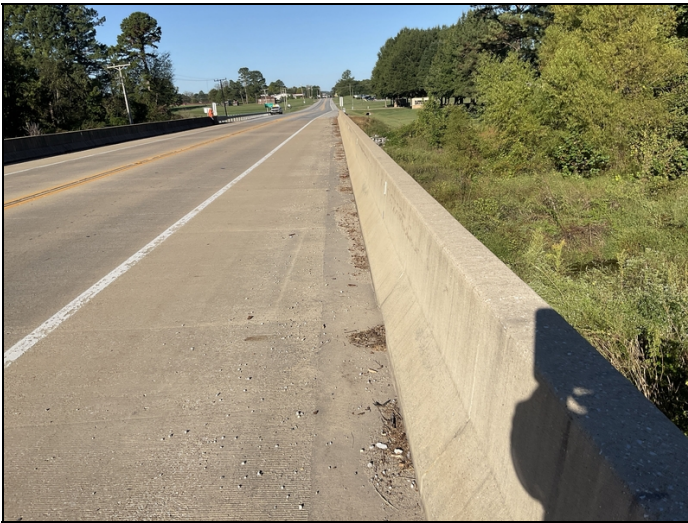
The gutter lines have debris throughout.

A-55 - Deck Washing Needed (Yes)

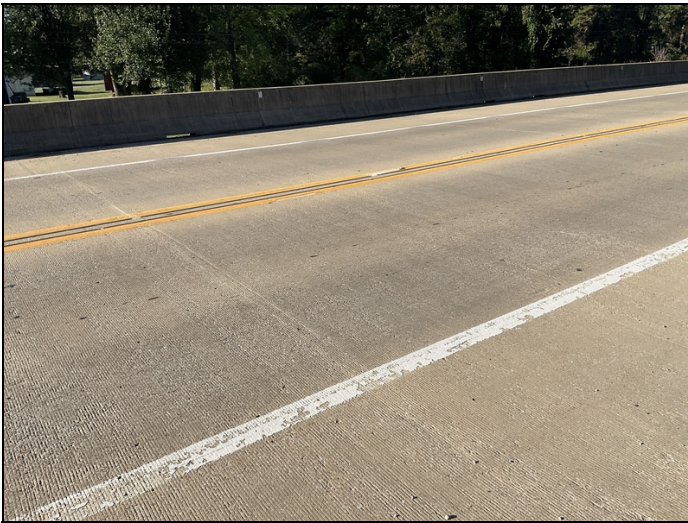
The deck has sealable cracks throughout.

A-61 - Polymer Overlay Advised (Yes)
