Bridge M0591 Inspection Report

Asset #M0591(Record Change)

SH 25/Independ. Co. over BLUE CREEK

Team Lead: Seth Foreman Inspection Date: 08/14/2025

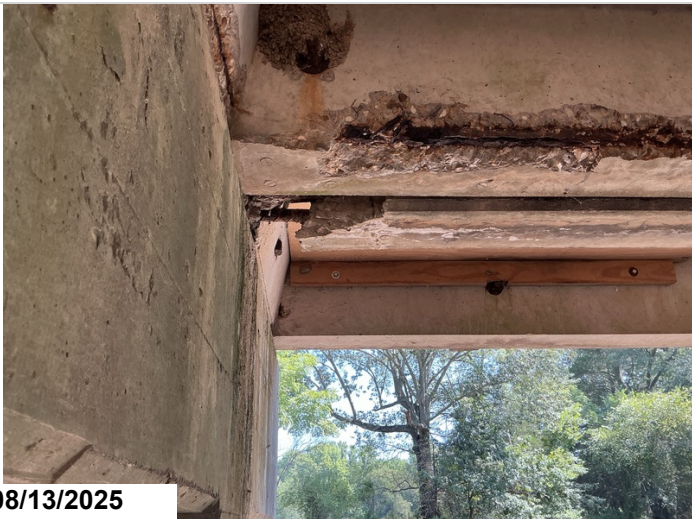
Spall with exposed rebar to right leg of unit 1 beginning of span 6.

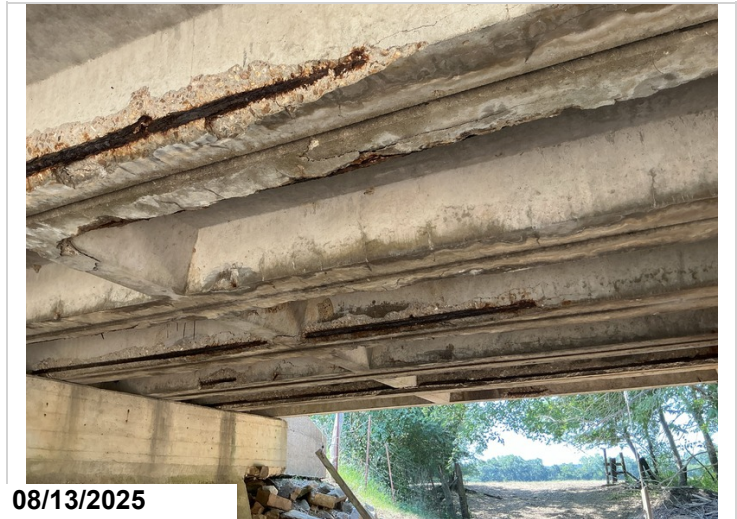
Concrete Precast Units
Spalls w/corroded rebar exposed to units @ all Spans.
Span 6.

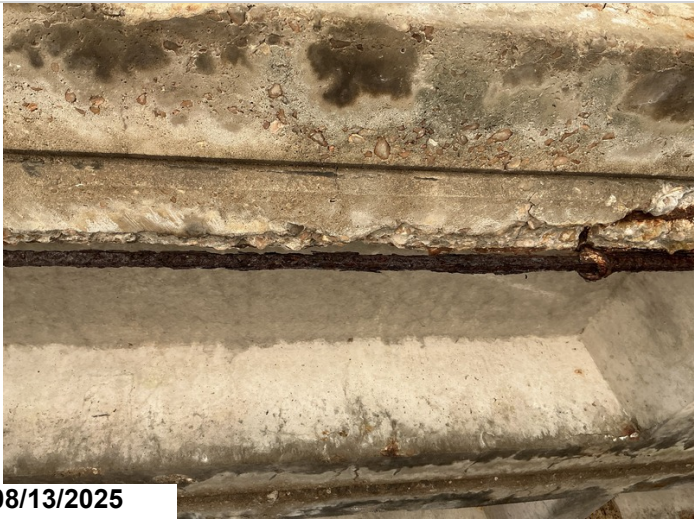
Units that have spalls with rebar exposed that have lost adhesion to concrete: Span 6 unit 6.

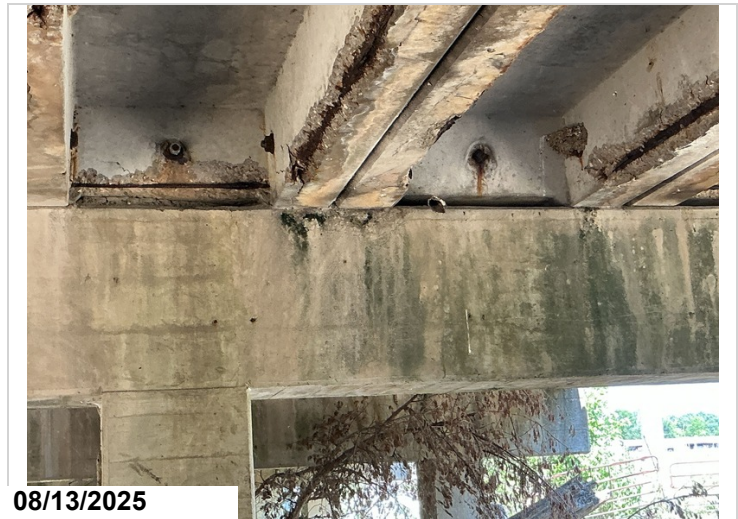
Spalls to caps throughout.

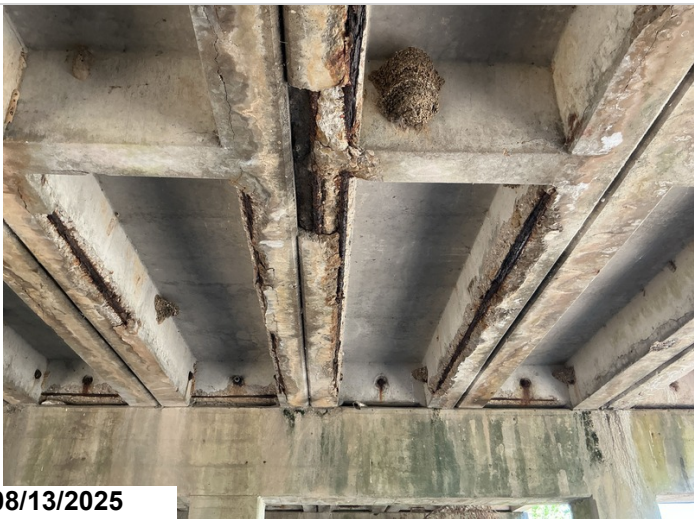
Concrete Precast Units
Spalls w/corroded rebar exposed to units @ all Spans.
Span 5.

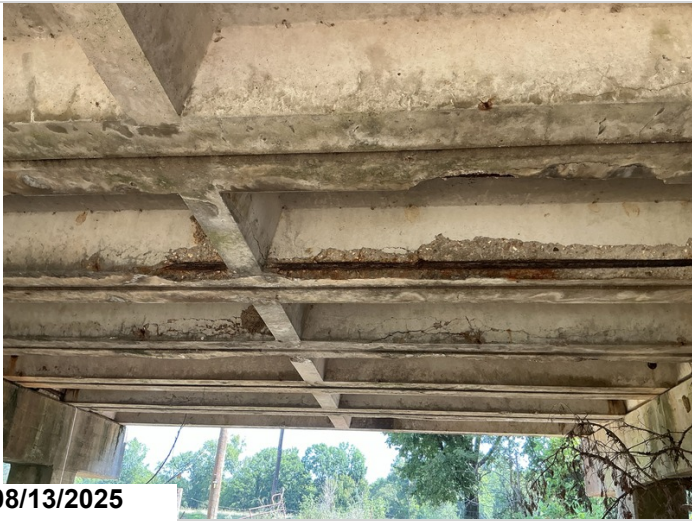
Concrete Precast Units
Spalls w/corroded rebar exposed to units @ all Spans.
Span 3.

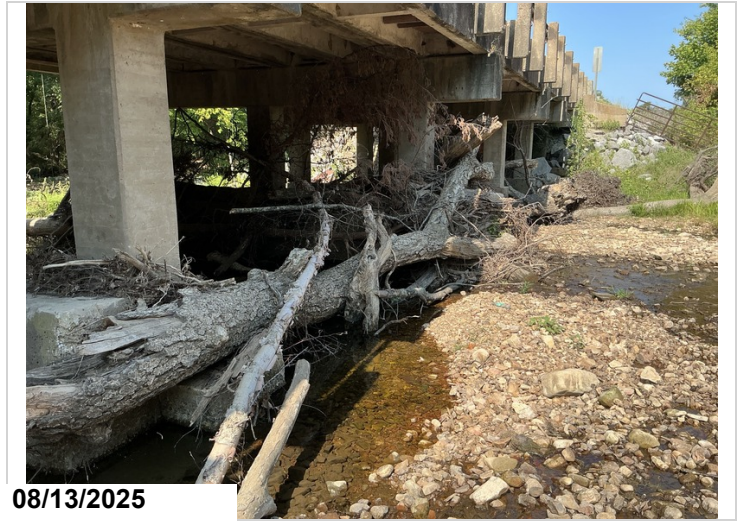
Drift @ Spans 1 - 5. Beginning to cause local scour.

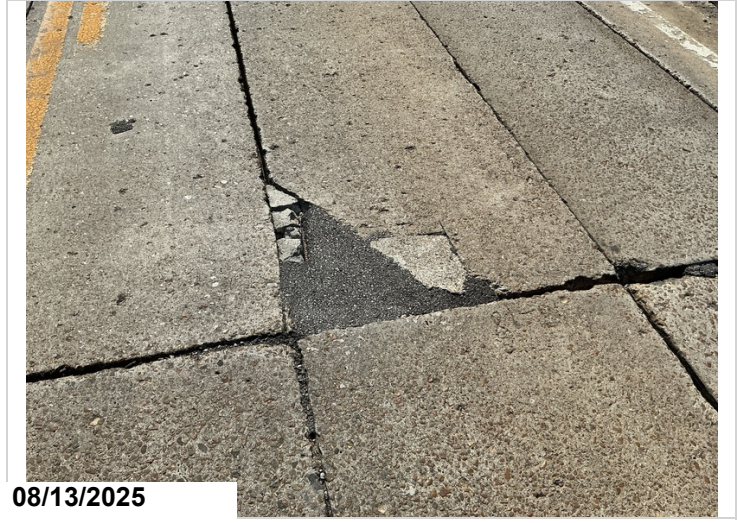
Spall with exposed rebar to unit 5 beginning of span 4.

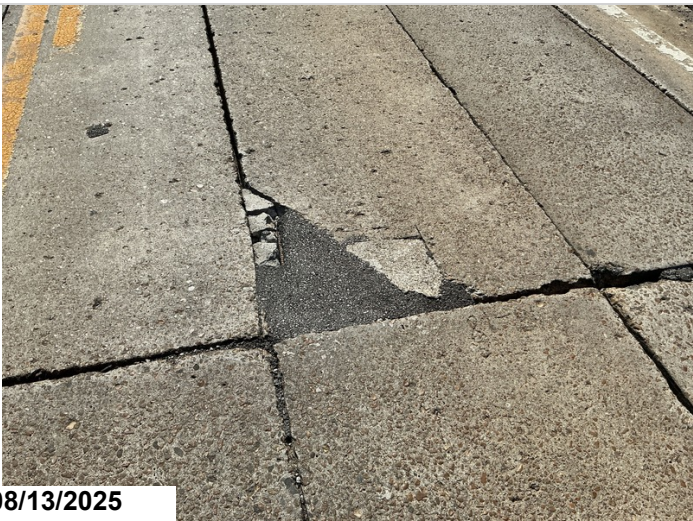
Spall with exposed rebar to unit 5 beginning of span 4.

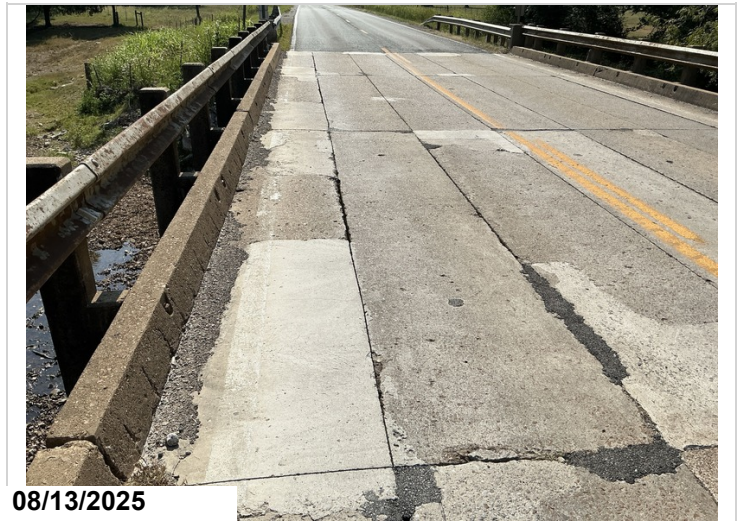
Severe patched concrete areas to units throughout.

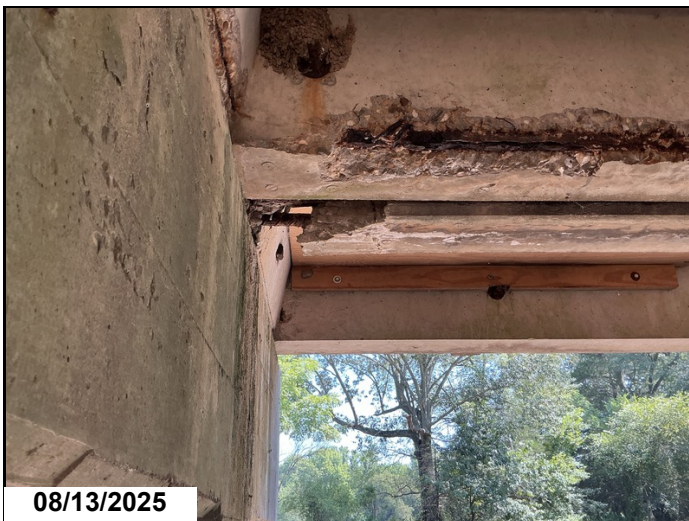
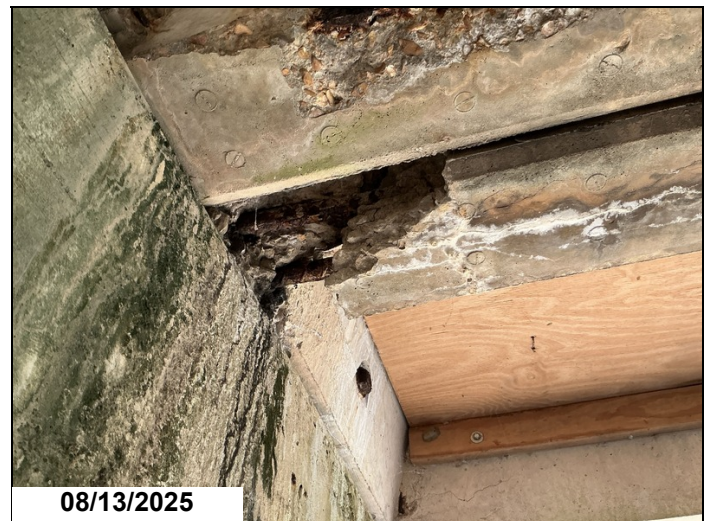
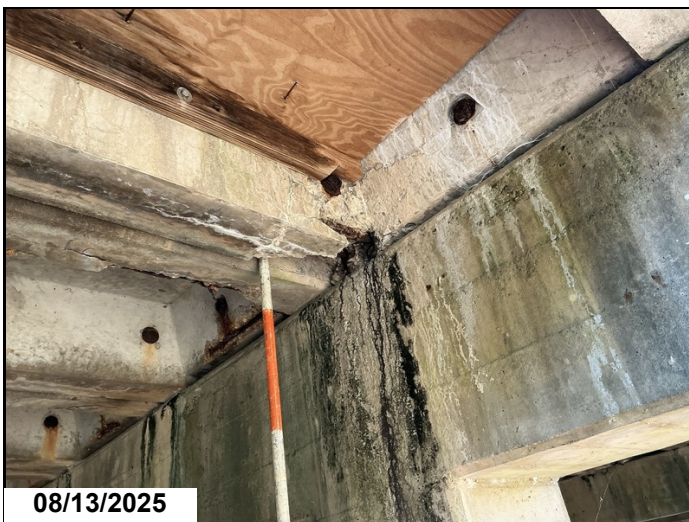
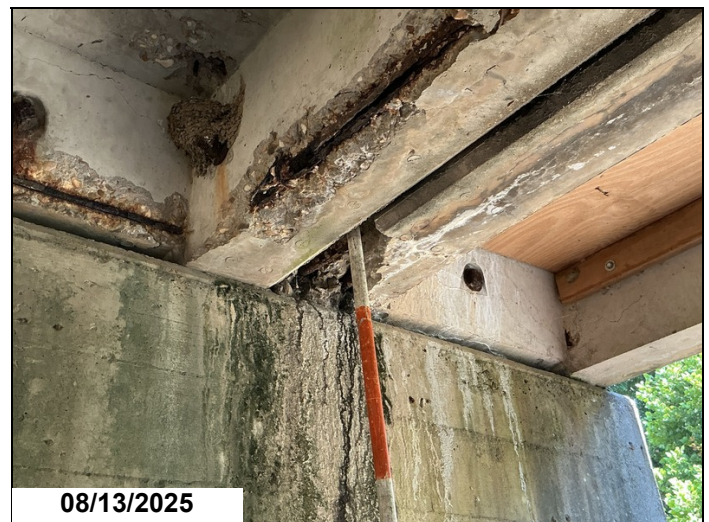
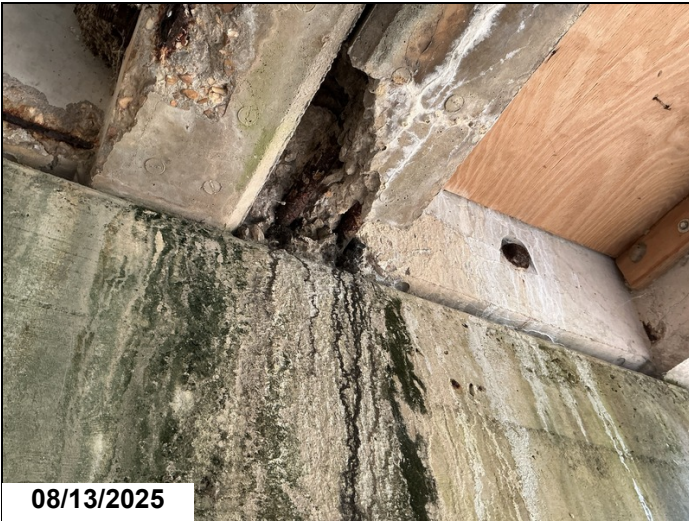
Deep spall with 1' exposed rebar to right leg begging of span 6.
Unit flexes 2" - 3" for the first 3' under heavy traffic load

Spall with exposed rebar to right leg of unit 1 beginning of span 6.

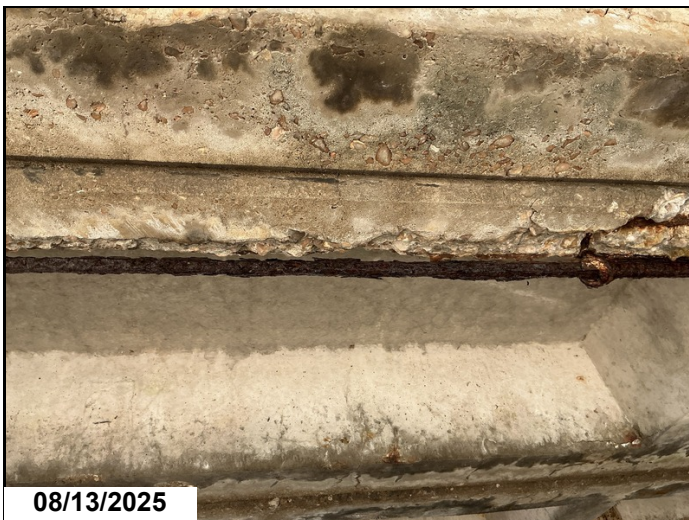
Units that have spalls with rebar exposed that have lost adhesion to concrete: Span 6 unit 6.

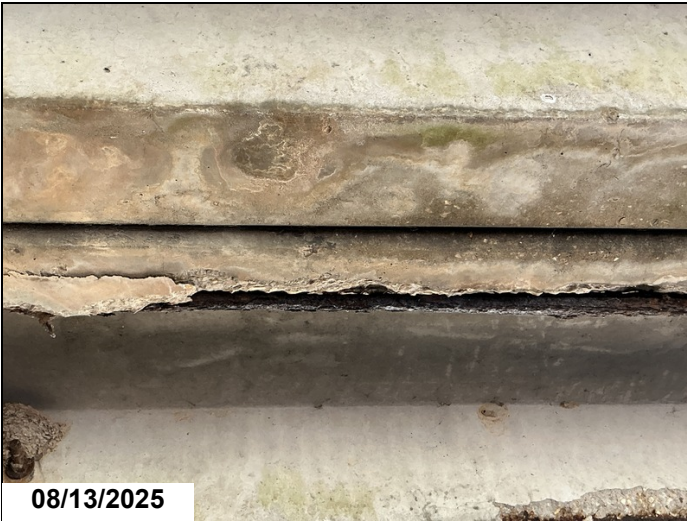
Units that have spalls with rebar exposed that have lost adhesion to concrete: Span 3 Unit 5.

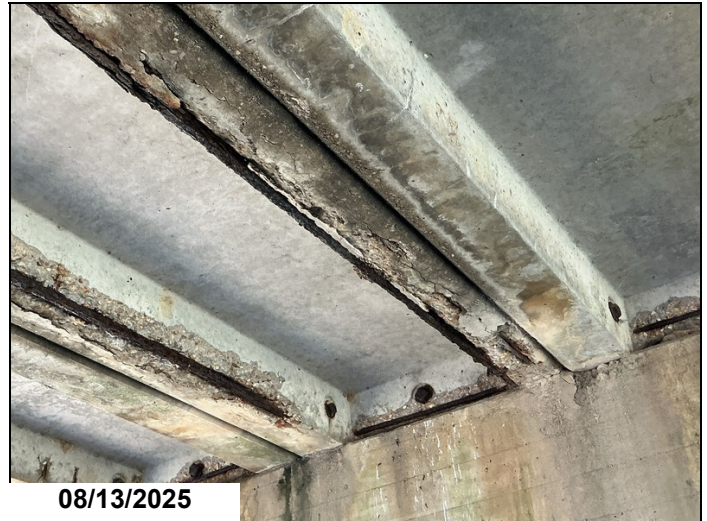
Units that have spalls with rebar exposed that have lost adhesion to concrete: Span 2 Unit 5.

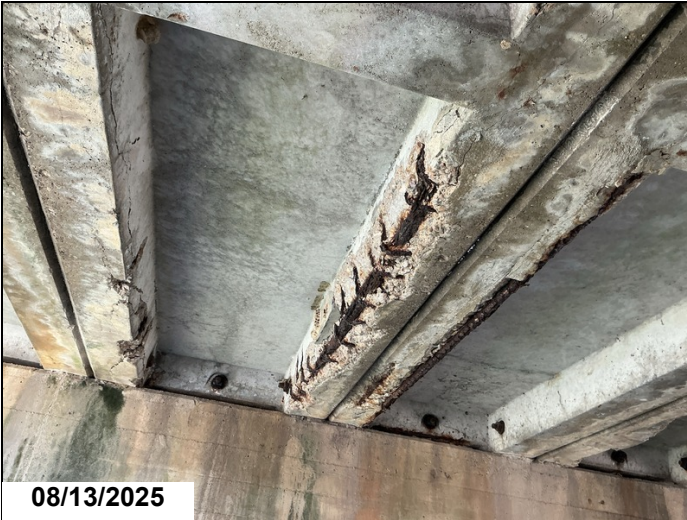
Span 1 - Units 2 & 4 (Precast) have large deep spall with rebar exposed @ beginning of span with 100% s/l to stirrups.

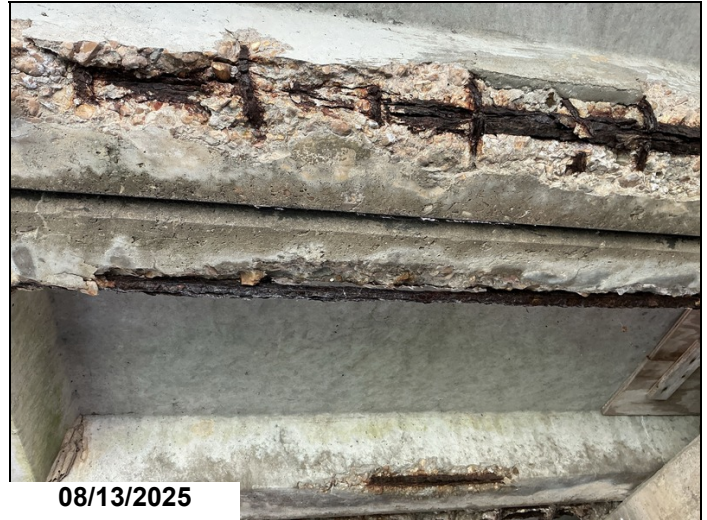
Units that have spalls with rebar exposed that have lost adhesion to concrete: Span 1 Unit 3.

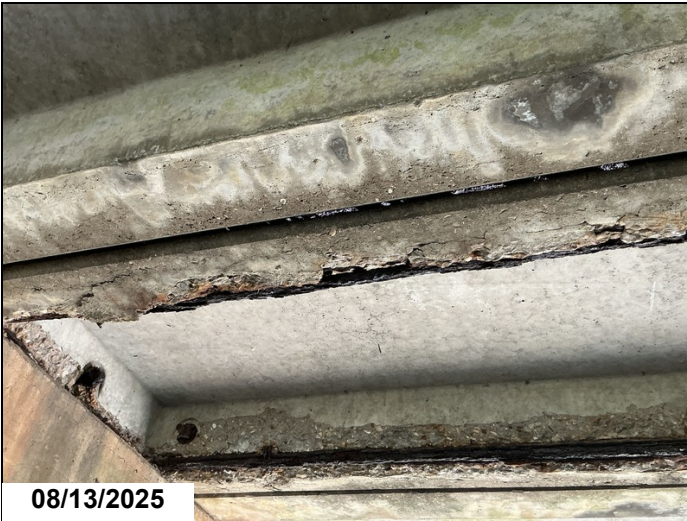
Units that have spalls with rebar exposed that have lost adhesion to concrete: Span 1 Unit 6.

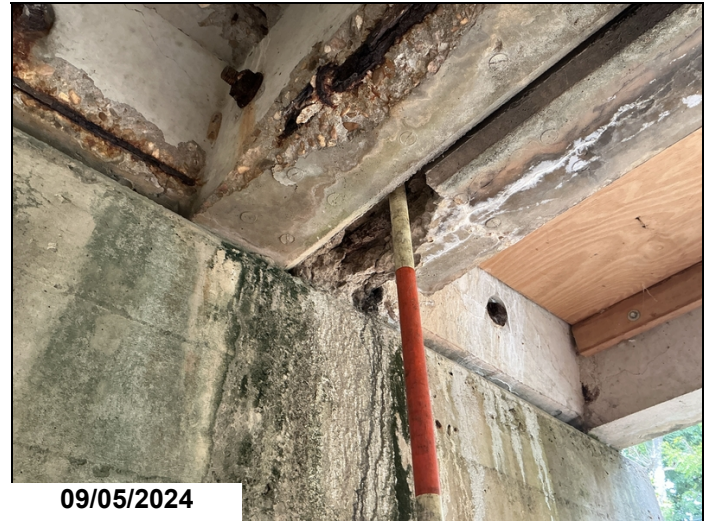
Deep spall right leg unit 1 span 6.

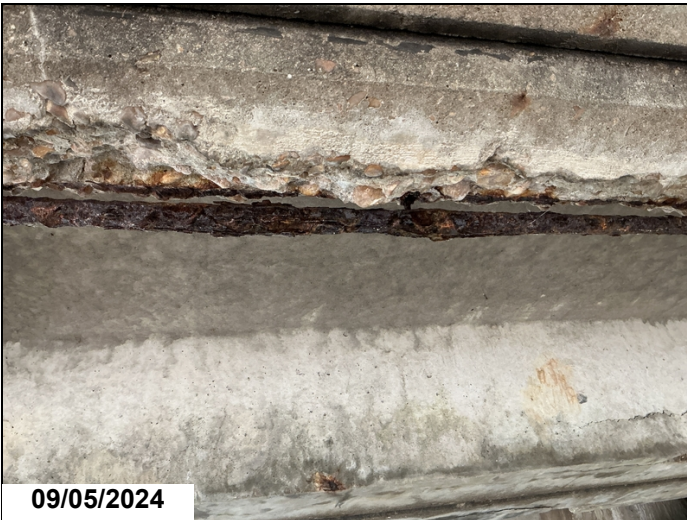
Right leg unit 6 span 6.

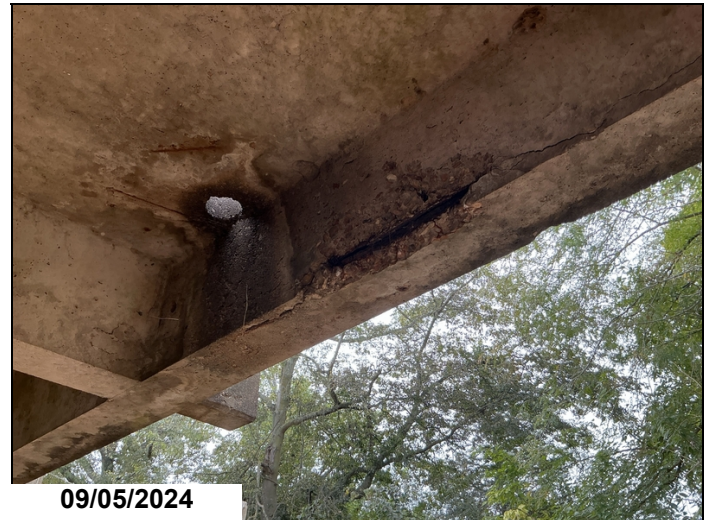
Exposed rebar right leg unit 7 span 6.

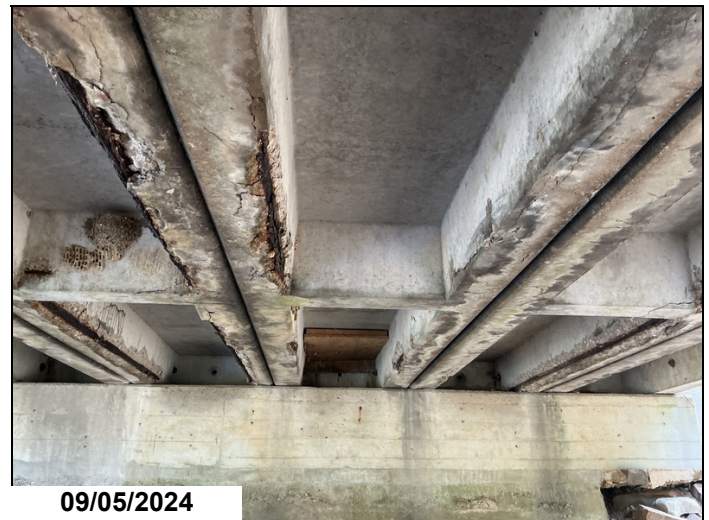
Exposed rebar to left and right leg unit 5 span 6.

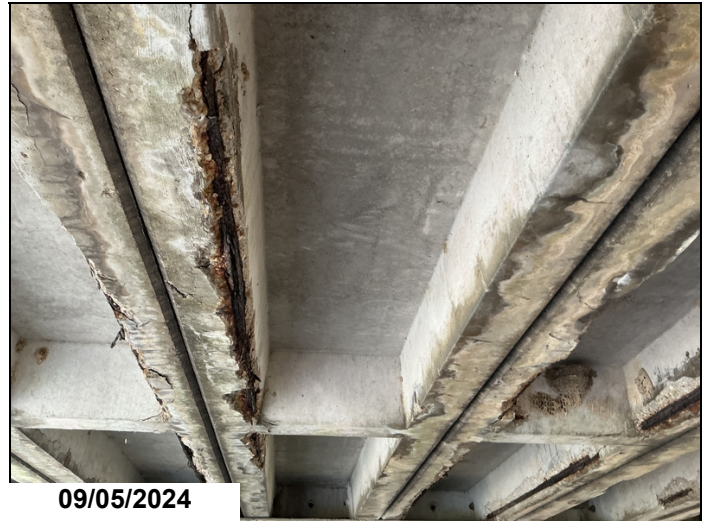
Exposed rebar to left leg unit 3 span 6.

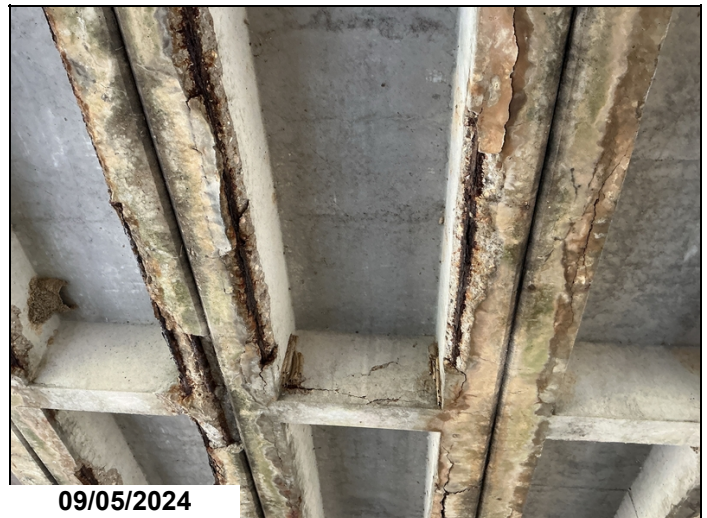
Exposed rebar to left and right leg unit 4 span 5.

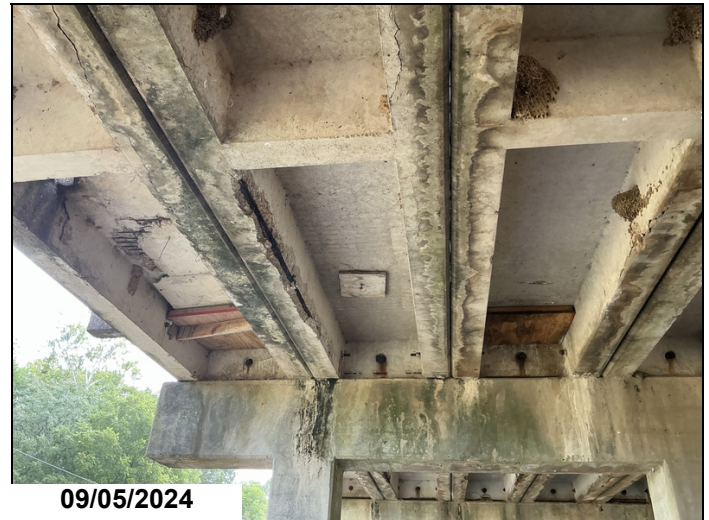
Exposed rebar left leg unit 2 span 4.

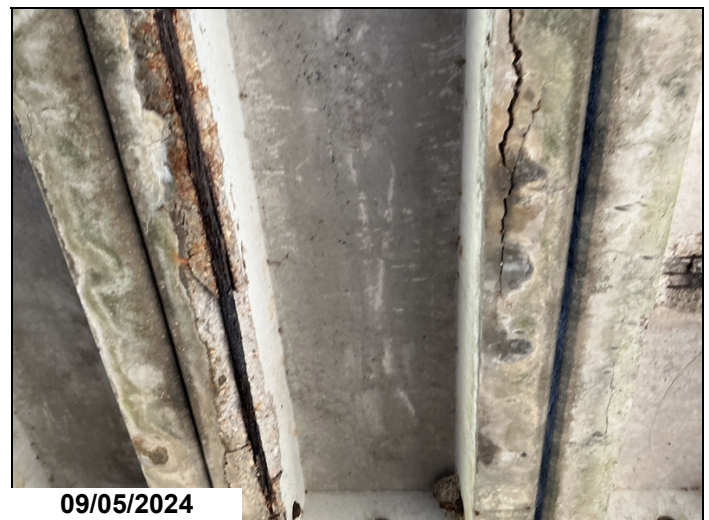
Exposed rebar left leg unit 5 span 3.

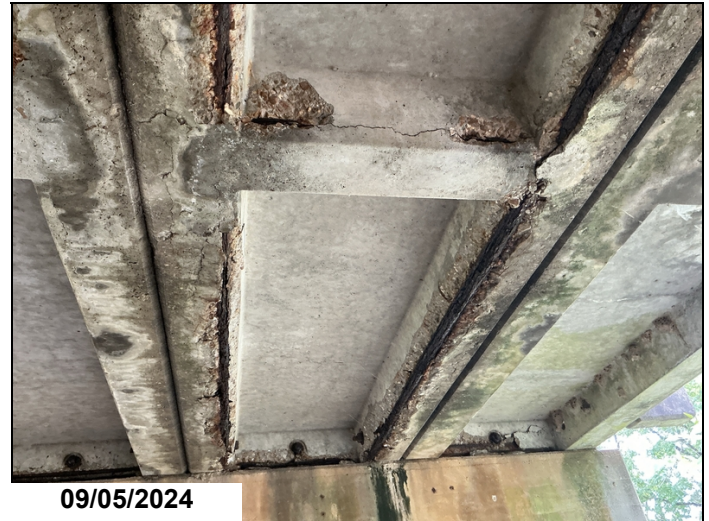
Exposed rebar left and right leg unit 6 span 1.

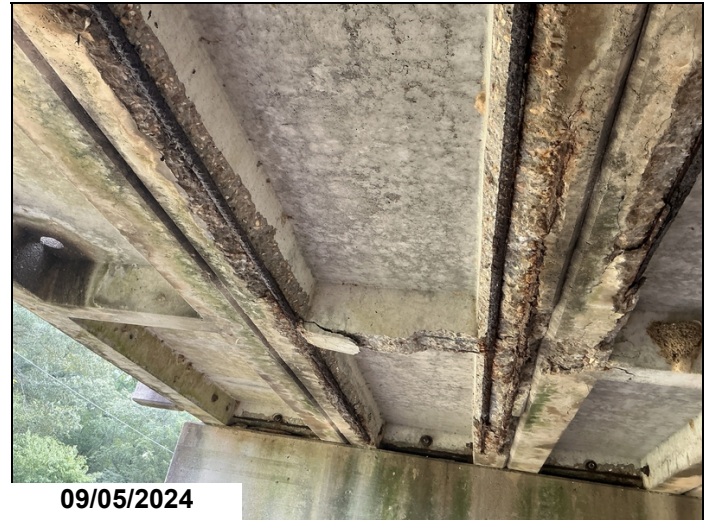
Spalls with rebar exposed with 100% s/l to stirrups @
Girder 2 @ Span 2.

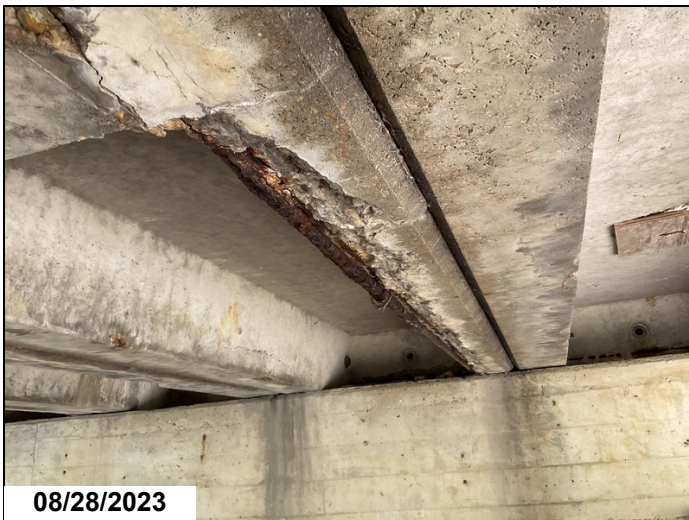
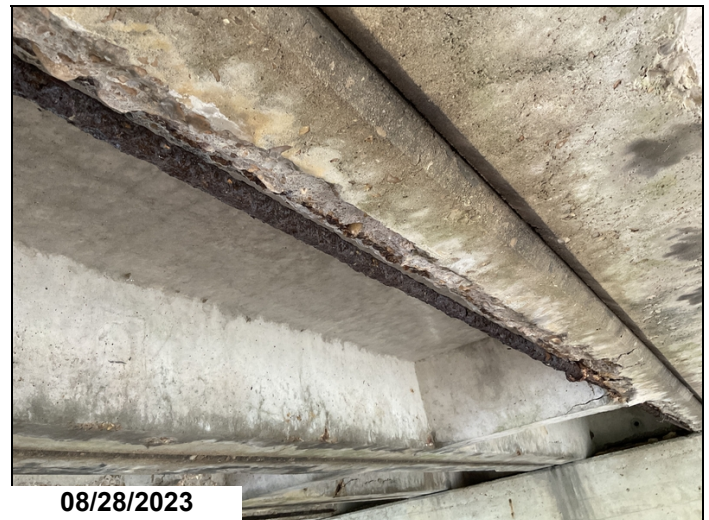
Spalls with rebar exposed with heavy s/l to Girder 7 @
Span 6. 14' of rebar is not adhered to concrete.

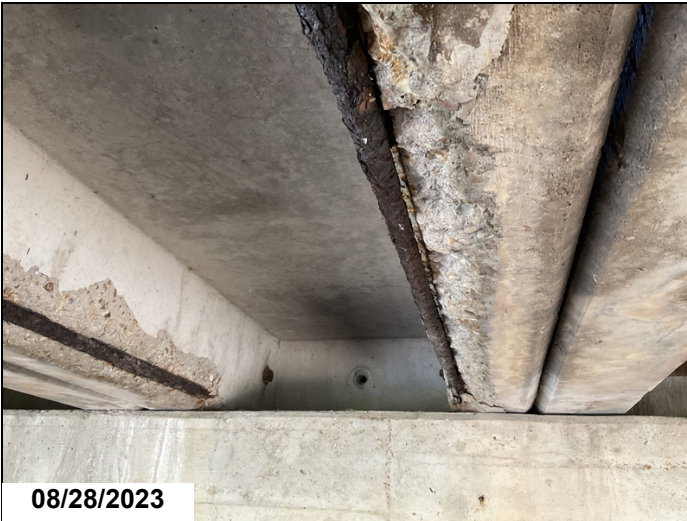
Spalls with rebar exposed with heavy s/l to Girder 4 @ Span 6. 4' of rebar is not adhered to concrete.

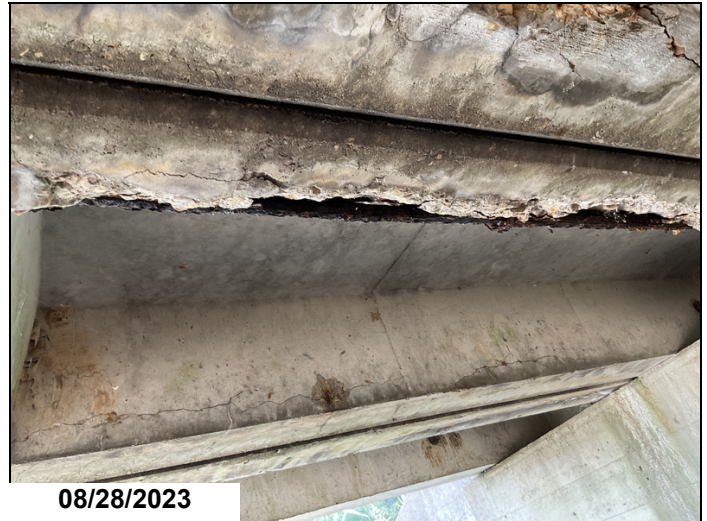
Spalls with rebar exposed with heavy s/l to Girder 2 @ Span 6. 4' of rebar is not adhered to concrete.

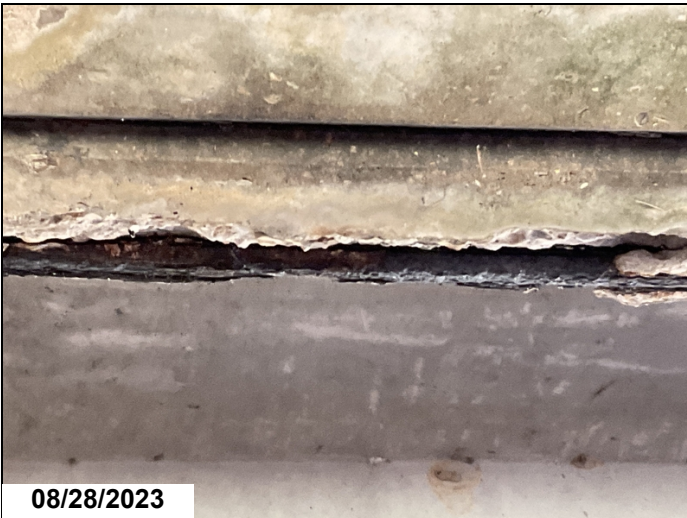
Spalls with rebar exposed with heavy s/l to Girder @ Unit 5 @ Span 3. 3' of rebar is not adhered to concrete.

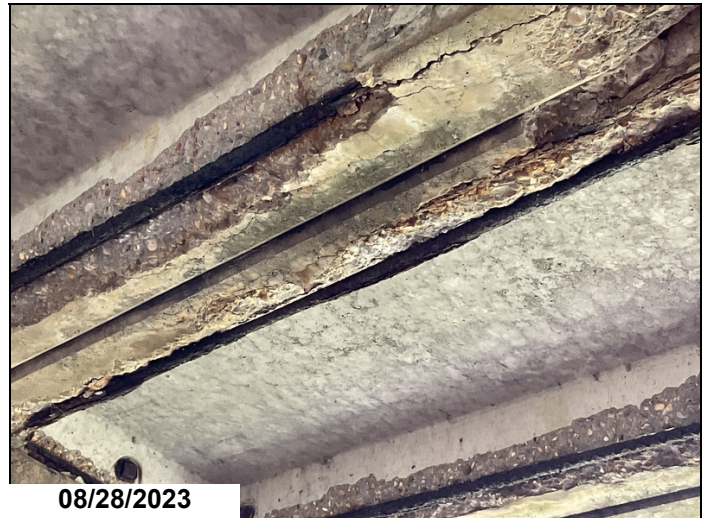
Spalls with rebar exposed with heavy s/l to Girder @ Unit 2 @ Span 2. 7' of rebar is not adhered to concrete.

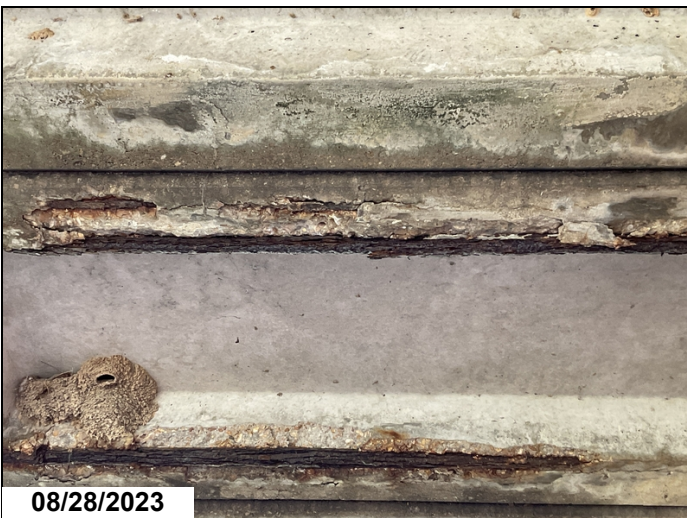
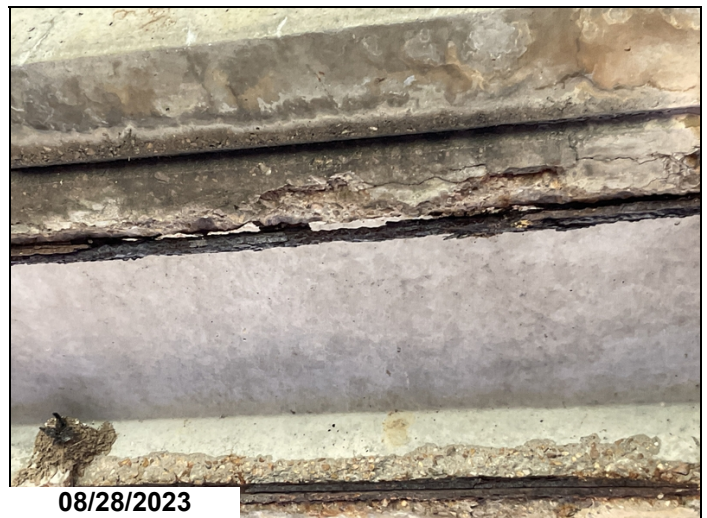
Spalls with rebar exposed with heavy s/l to Girder @ Unit 5 @ Span 2. 10' of rebar is not adhered to concrete.

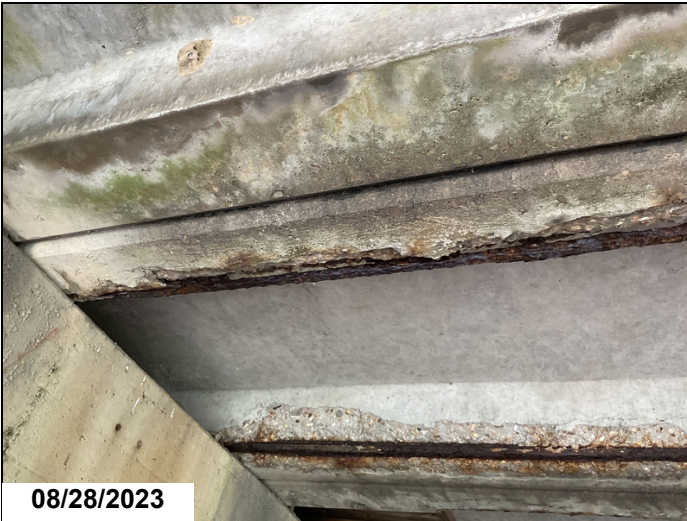
Spalls with rebar exposed with heavy s/l to Girder 6 @ Span 1. 4' of rebar is not adhered to concrete.

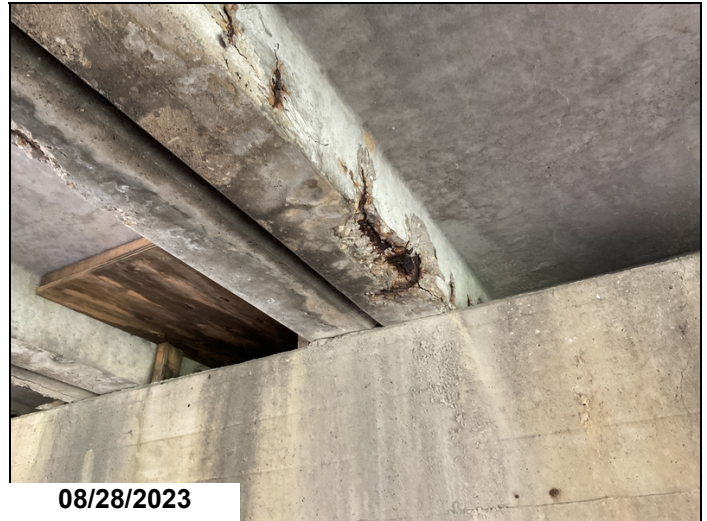
Spall with rebar exposed with 100% s/l to stirrups @ Girder 4 @ Span 1.

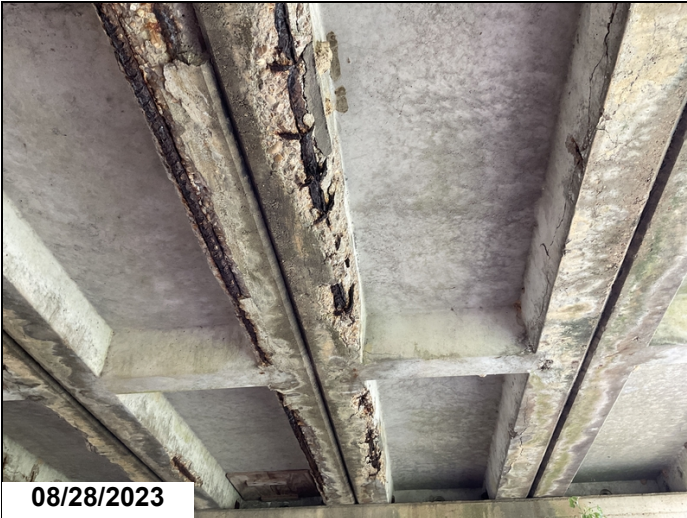
Spalls with rebar exposed with 100% s/l to stirrups @ Girder 2 @ Span 1.

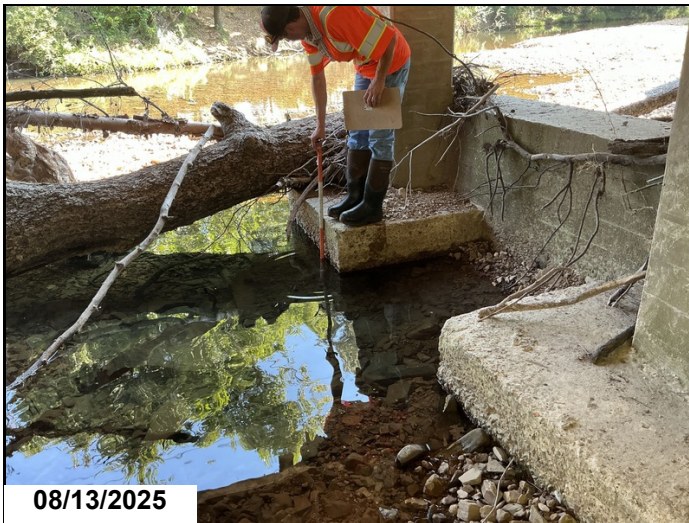
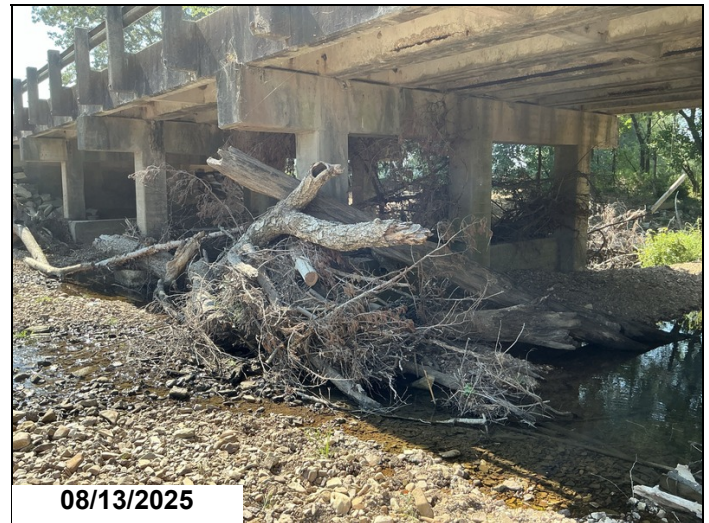
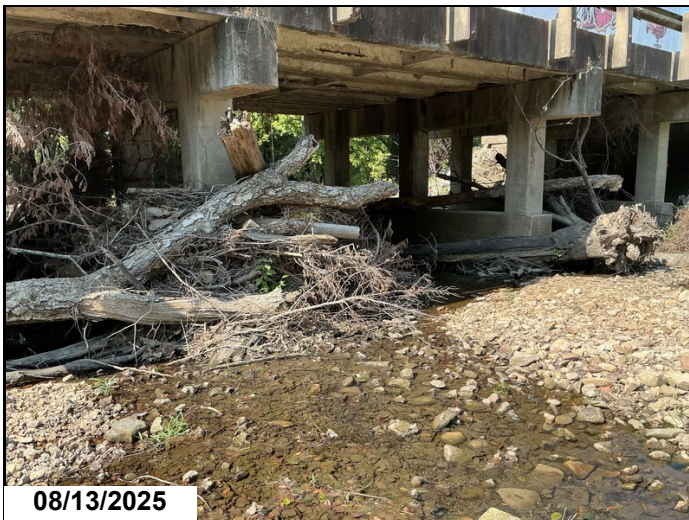
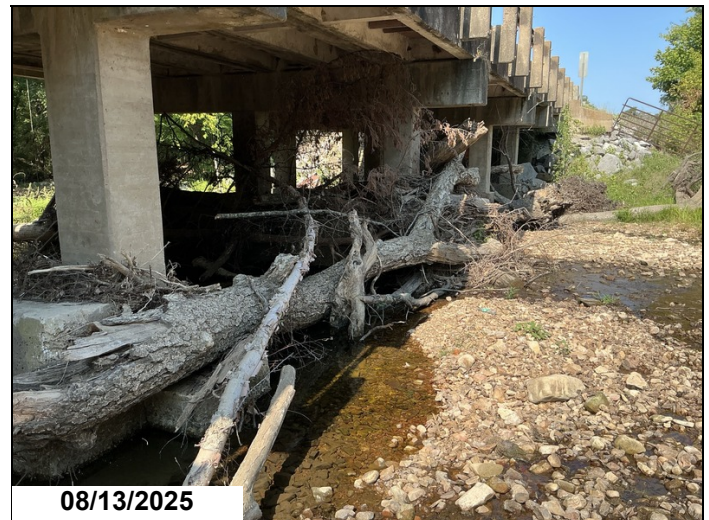
Drift is starting to cause scour at bent 4.

Drift @ Spans 1 - 5. Beginning to cause local scour at bent 4.

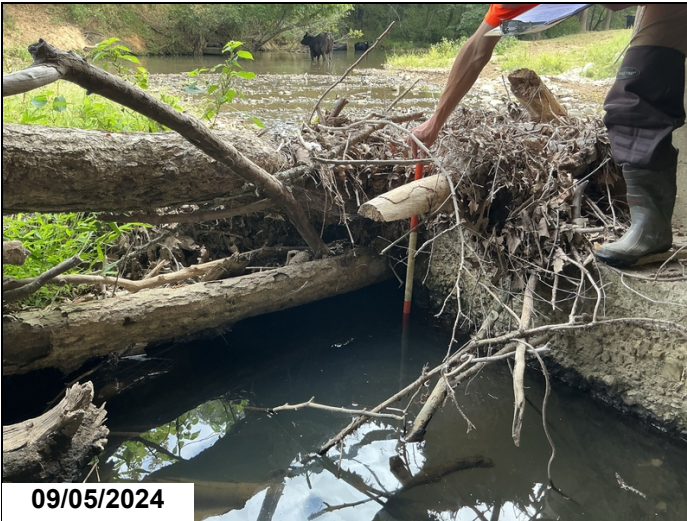
Scour 2' down 1' under bent 4.

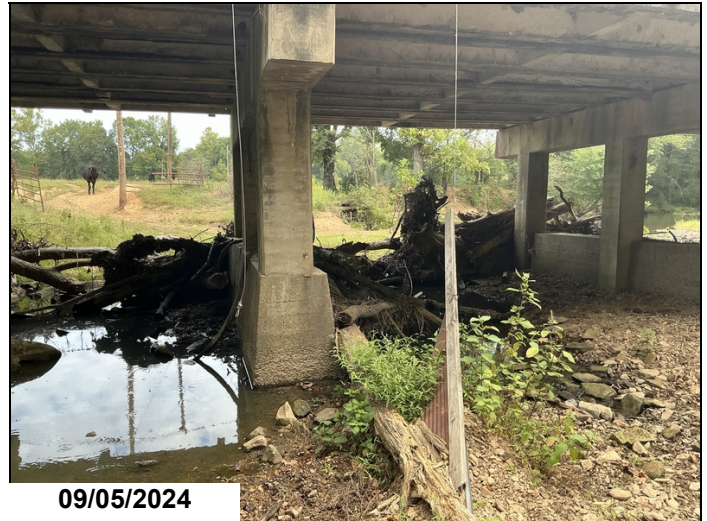
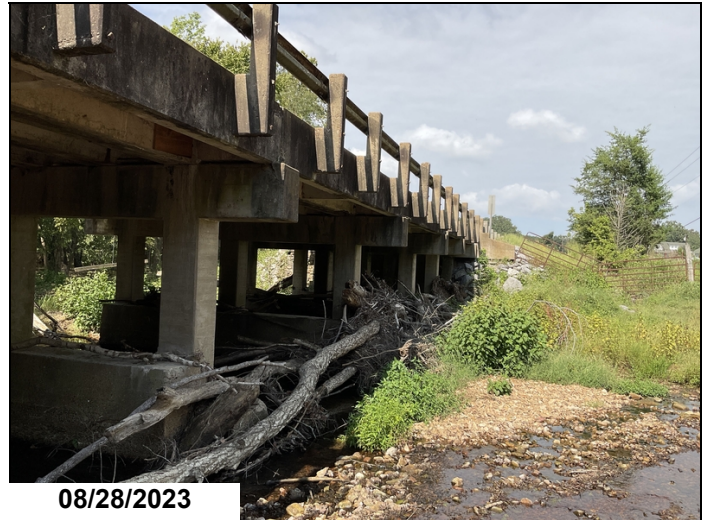
Drift @ Spans 1 - 5.

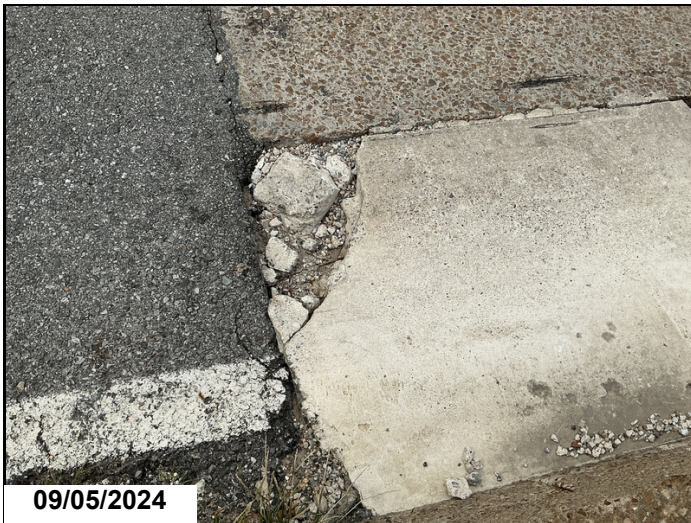
Spall to deck unit 1 end of span 6.

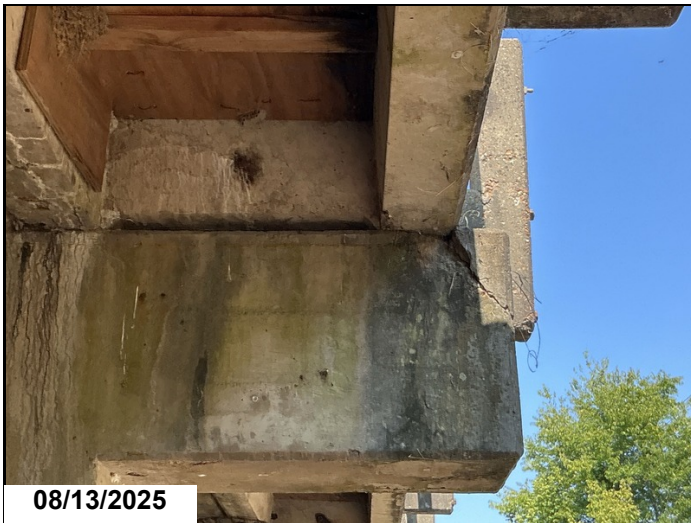
Left side ahead of cap @ Bent 4 has spall with rebar exposed under Girder 1.

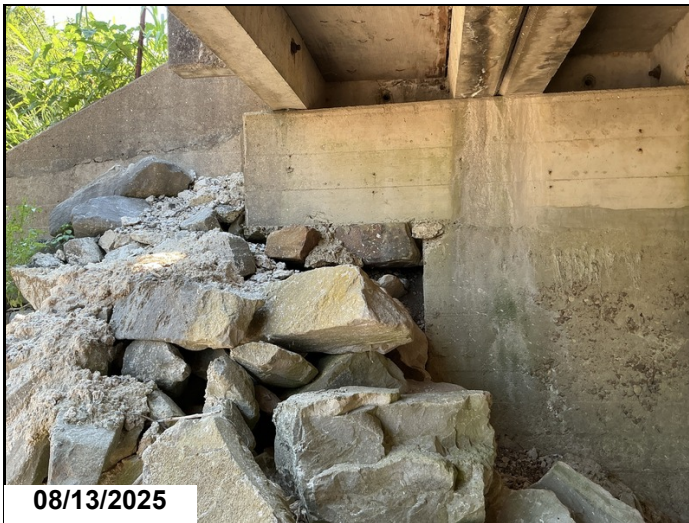
Erosion to wing and left side of abutment 2.

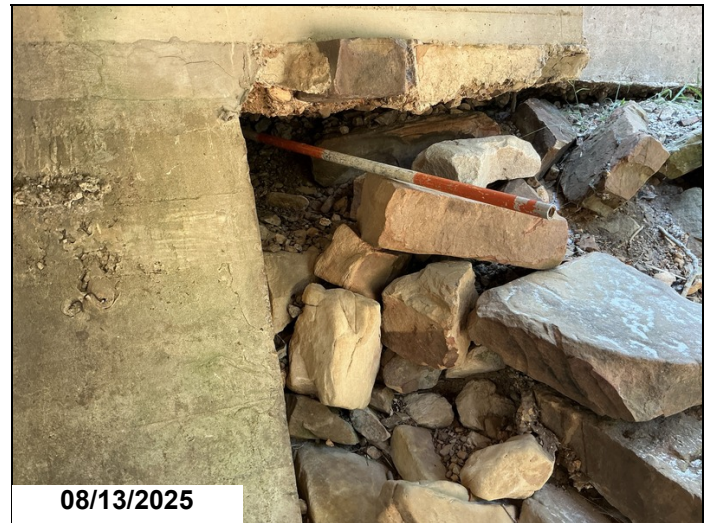
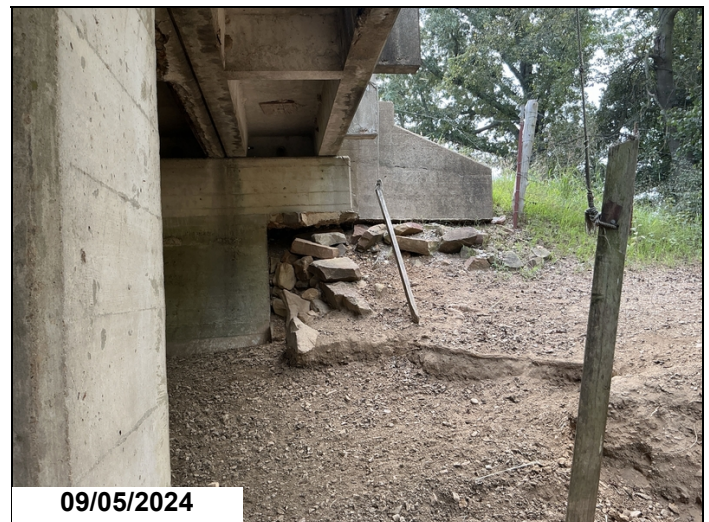
Erosion to wing and right side of abutment 2.

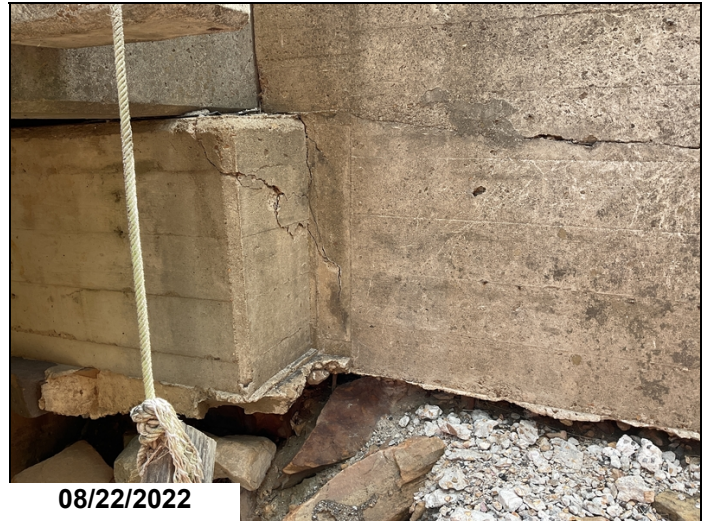
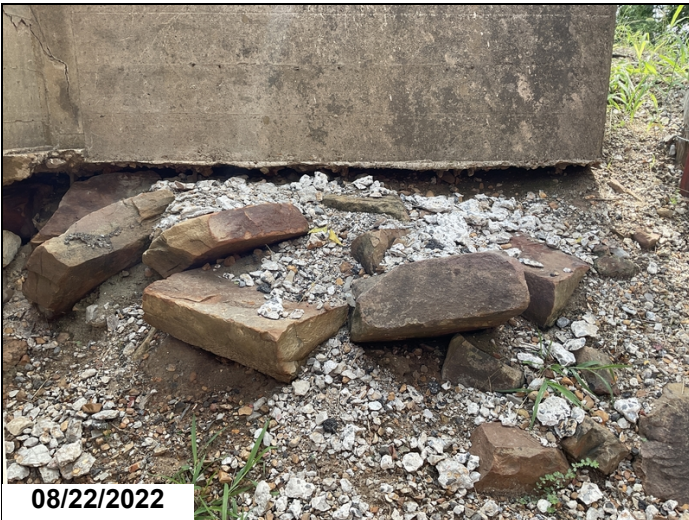
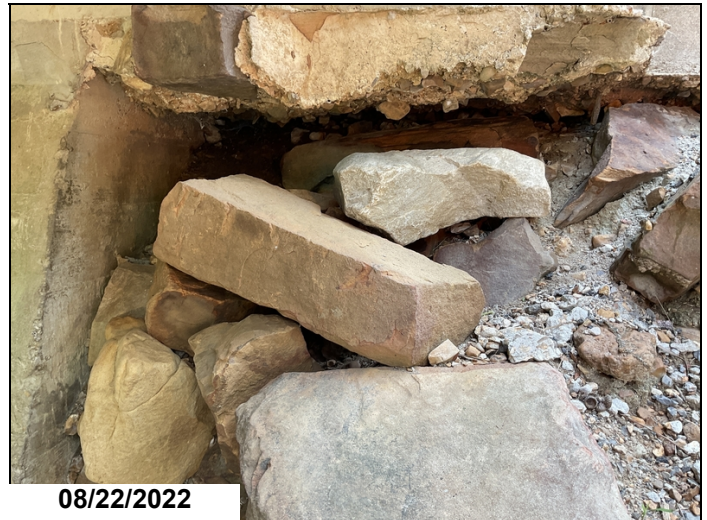
Erosion to Left & Right wings @ Abutment 2 with Left wing starting to crack.
