## Bridge 01878 Inspection Report

## National Bridge Inventory Data Sheet

**Asset #01878**(Routine, Underwater type 2)  
**SH 367/Jackson Co. over WHITE RIVER RELIEF**  
**Location: 5.15 MI SW JCT SH 14**  
**Team Lead:** Kerry Little **Inspection Date:** 01/30/2024

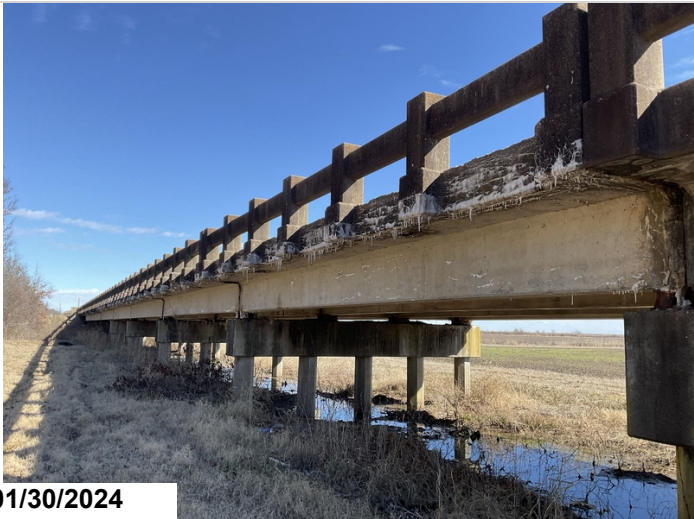
Elevation with Log Mile going Left.

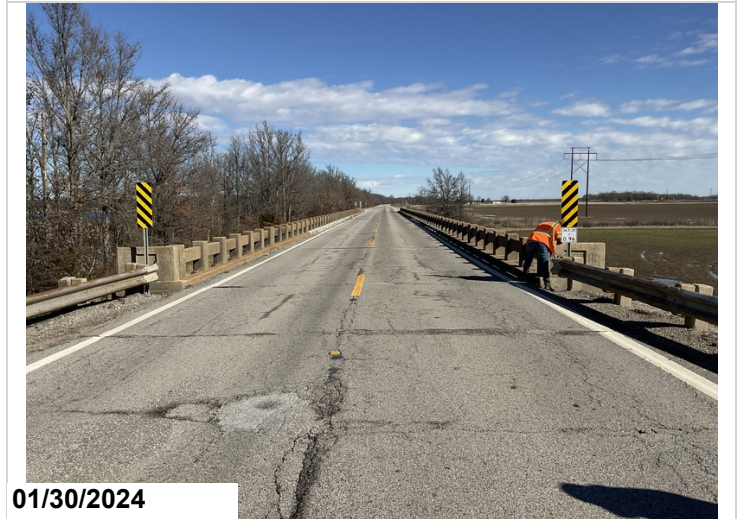
Roadway with Log Mile running Southwest to Northeast.

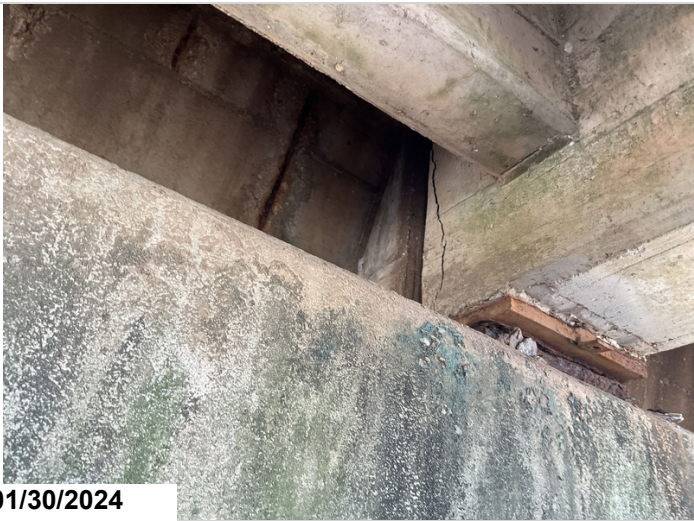
Large crack to end of Girder 3 @ end of Span 7(#3)

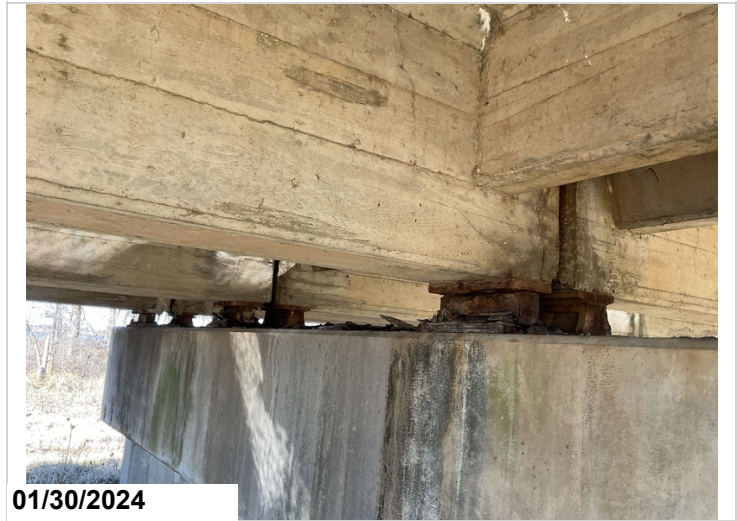
Rust with pack rust to Moveable Bearings 2 & 3 @ Bent 5.  
(#3)

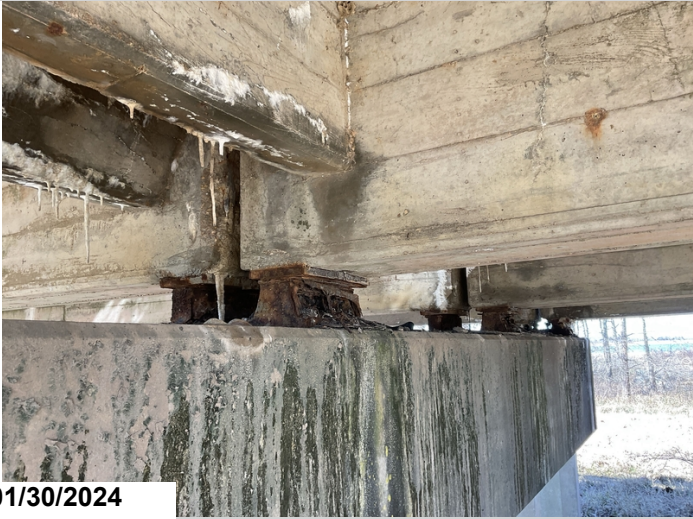
Rust with pack rust to Fixed Bearings @ Bent 4.(#3)

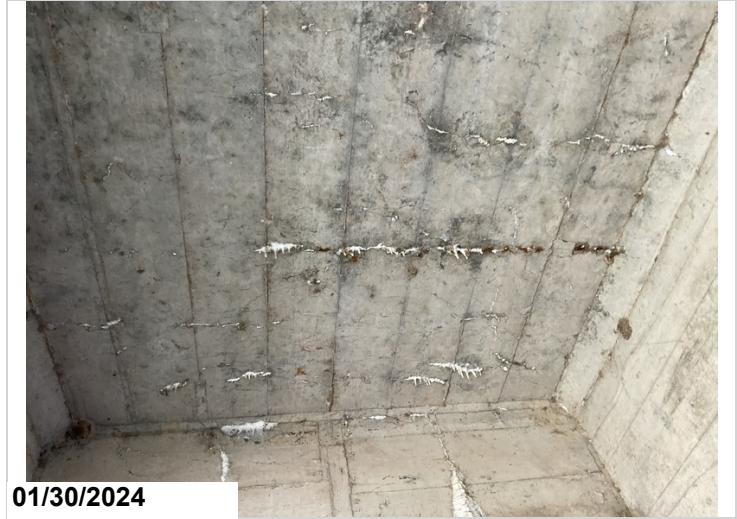
Efflorescent cracking with rust stains to soffit @ Span 5.(#3)

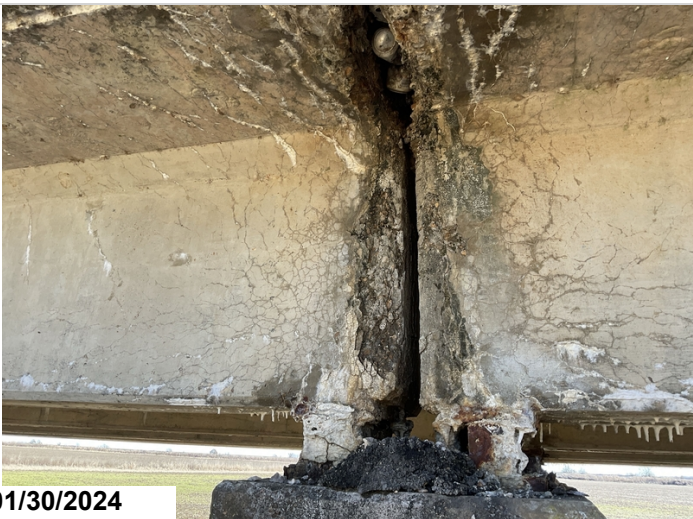
Spalls to Girder 1 @ Bent 4.(#3)

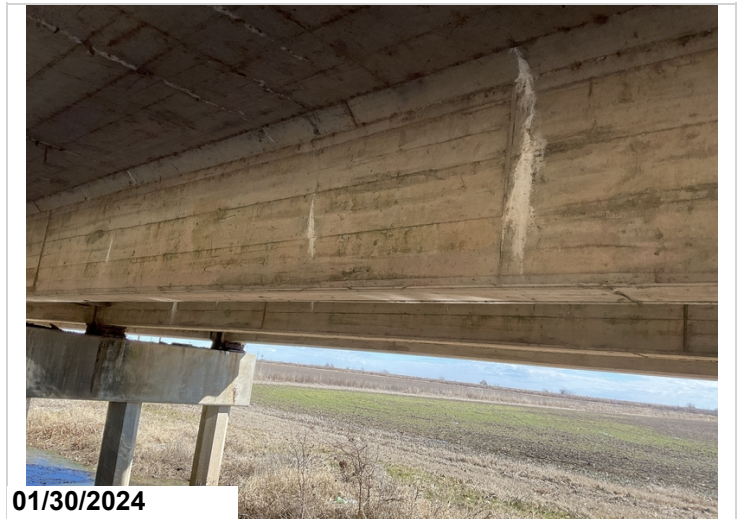
Efflorescent cracking to Girder 2 @ Span 5.(#2)

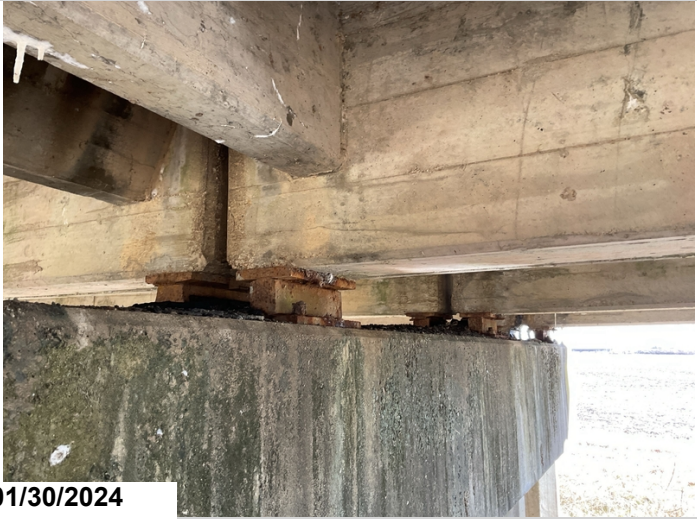
Light rust to Moveable Bearings 2 & 3 @ Bent 3.(#2)

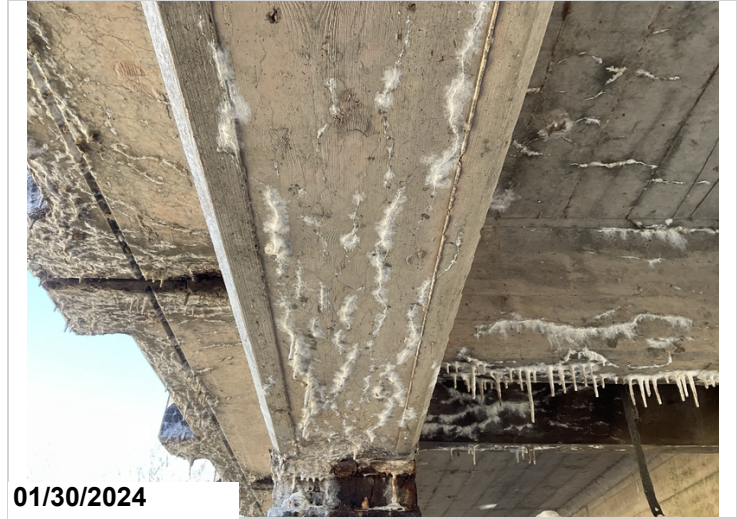
Efflorescent map cracking to bottom of Girder 1 @ Span 3.  
(#3)

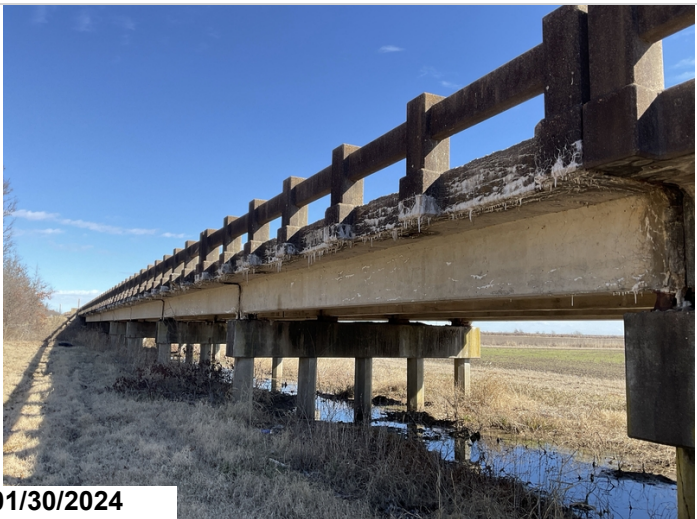
Heavy efflorescent map cracking to Left outside edge of  
deck @ Spans 3 - 7.(#3)

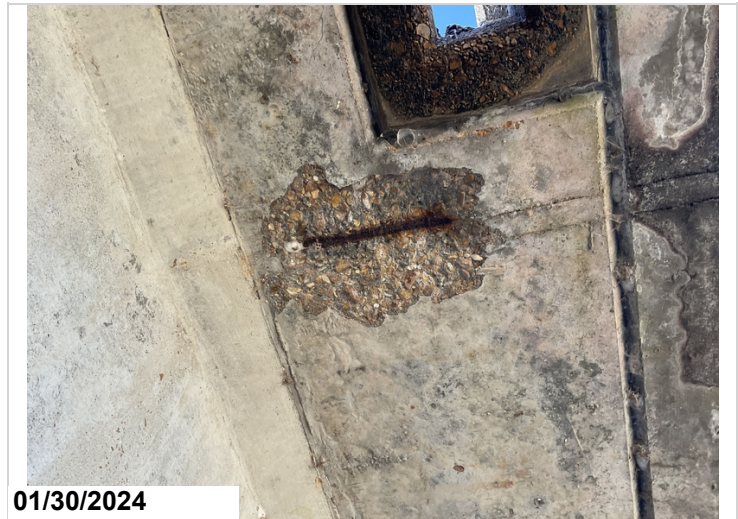
Spall with rebar exposed with s/l to 2nd drain opening on  
Left @ Span 1.(#3 typical)

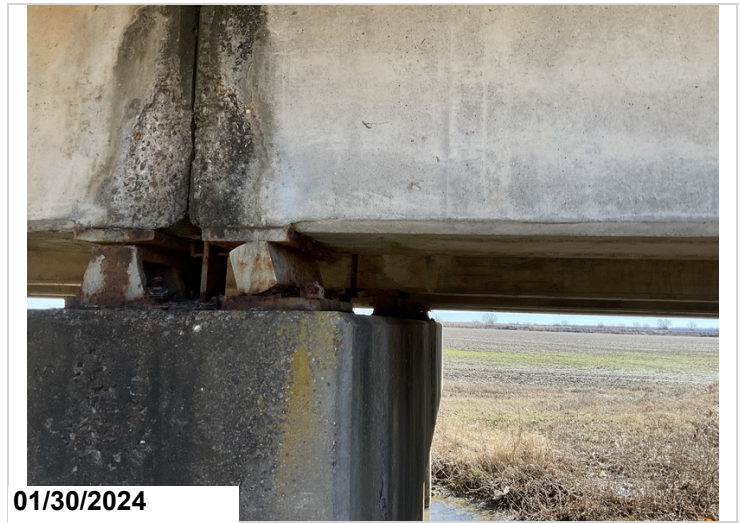
Moveable Bearings @ Bent 1 have rotated ahead.

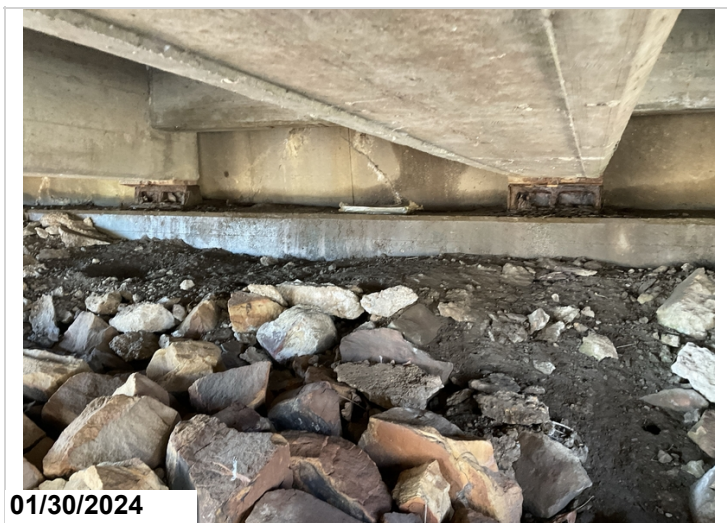
Rust with pack rust to Fixed Bearings @ Abutment 1.(#3 typical)

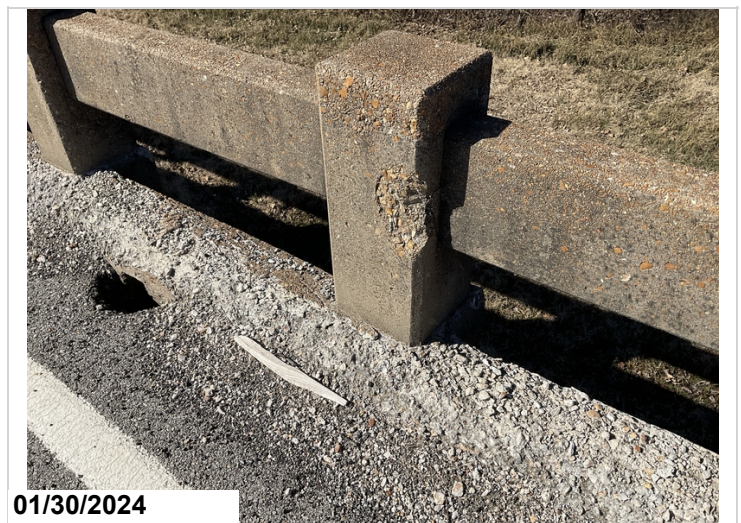
Typical spalling to Right bridge rail.(#3)

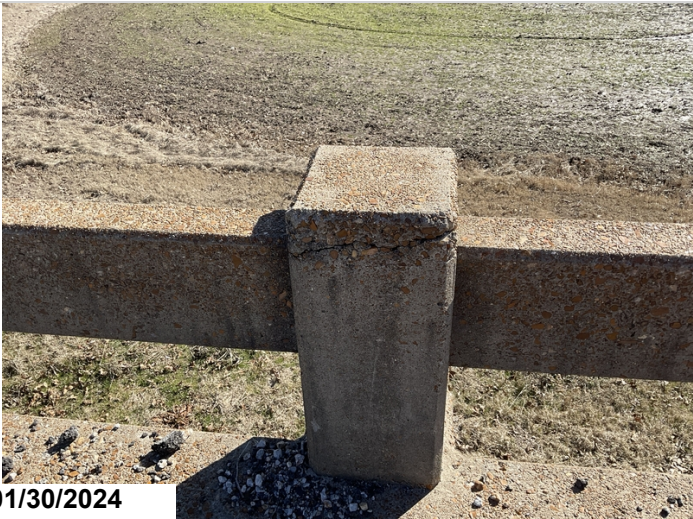
Typical cracking to Concrete Posts.(#3)

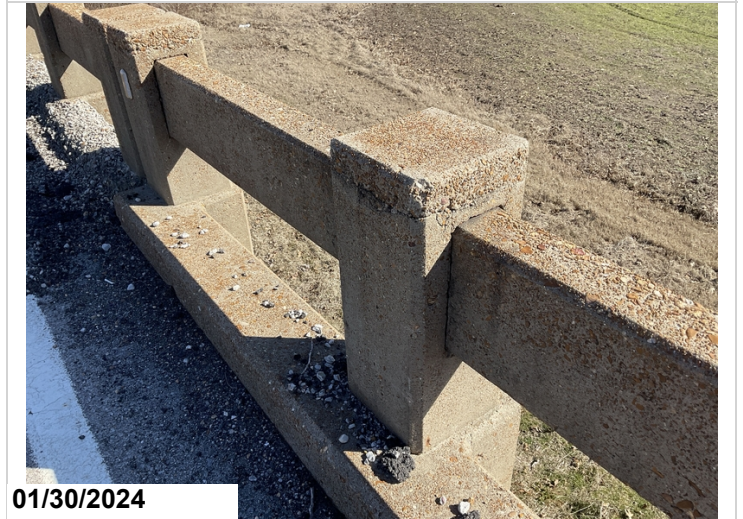
Typical cracking to Concrete Posts.(#3)

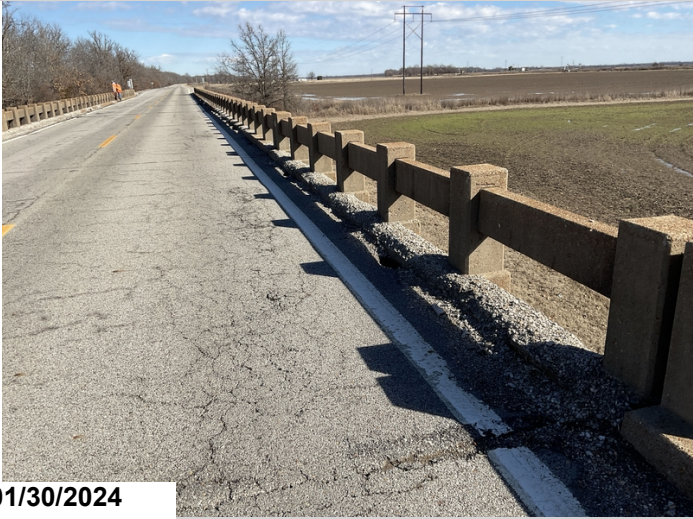
Typical spalling to Right curb.(#3)

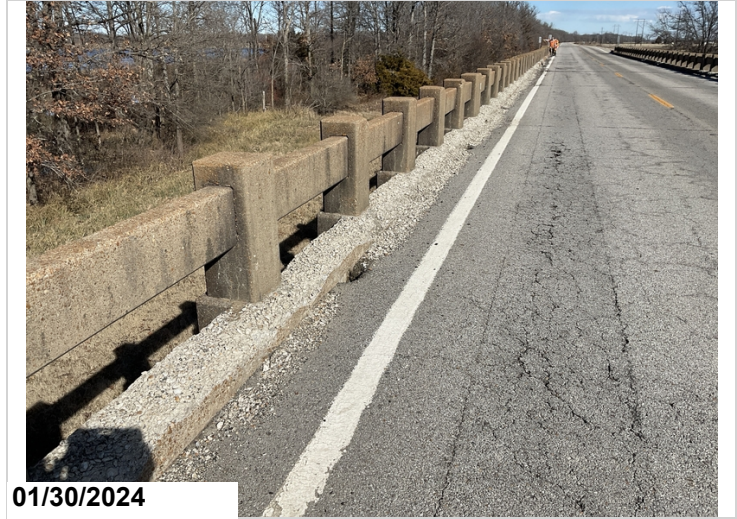
Typical spalling to Left curb.(#3)

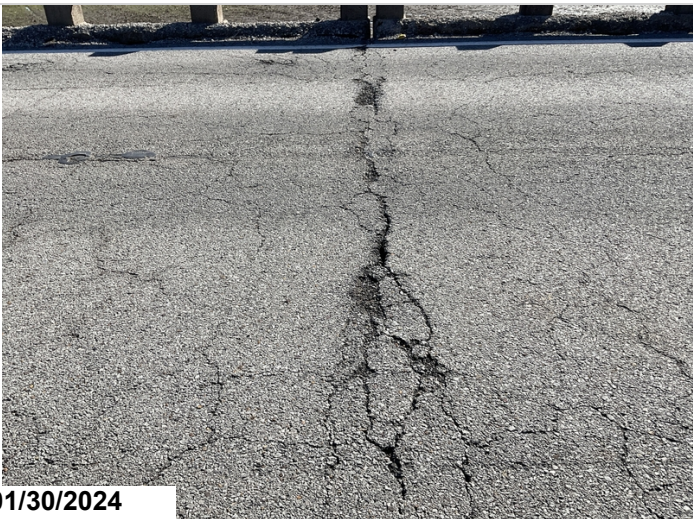
Typical debris impactation to Assembly Joint.(#3)

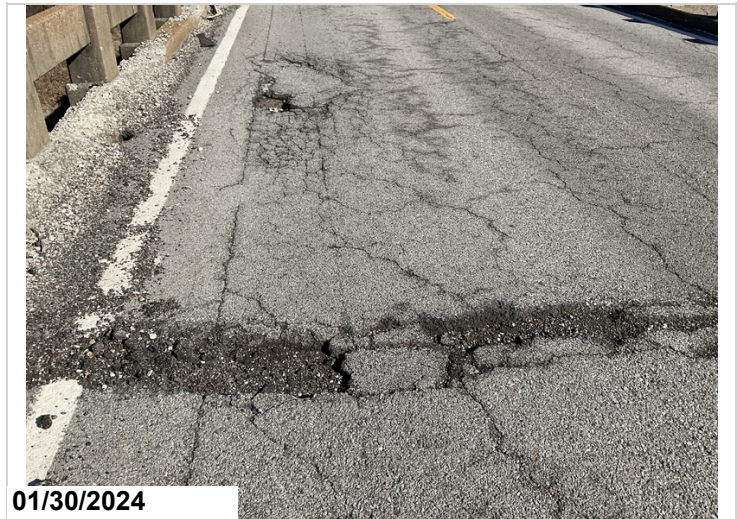
Spalls/potholes in asphalt overlay @ Bent 5 & Span 6.(#3)

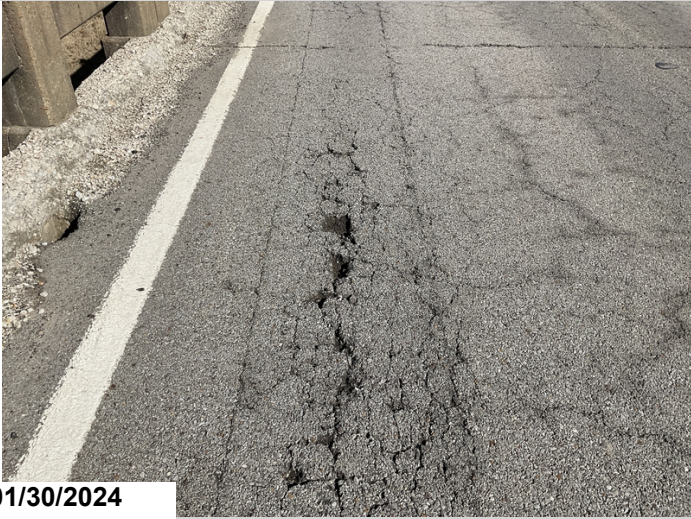
Spalls/potholes in asphalt overlay @ Span 3.(#3)

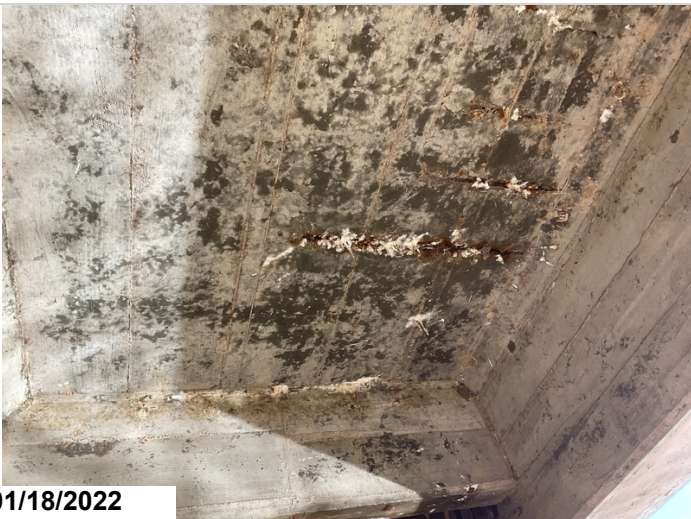
Efflor cracks to soffit between girders 3 & 4 @ end of span 9.

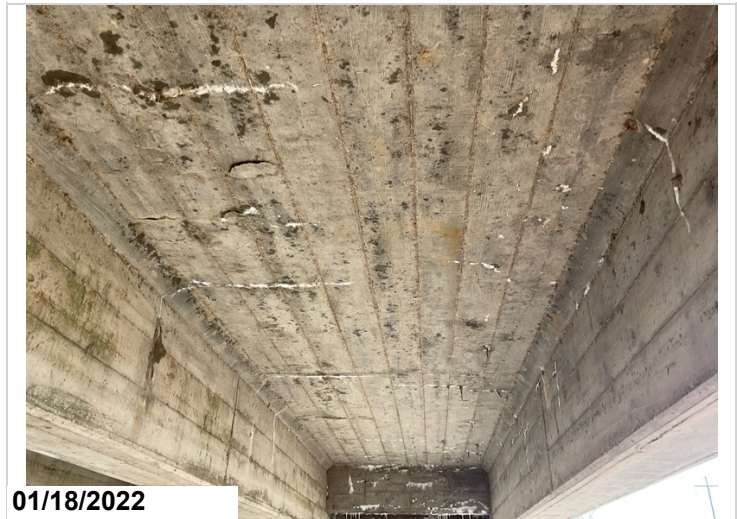
Typical efflor cracks to soffit @ all spans.

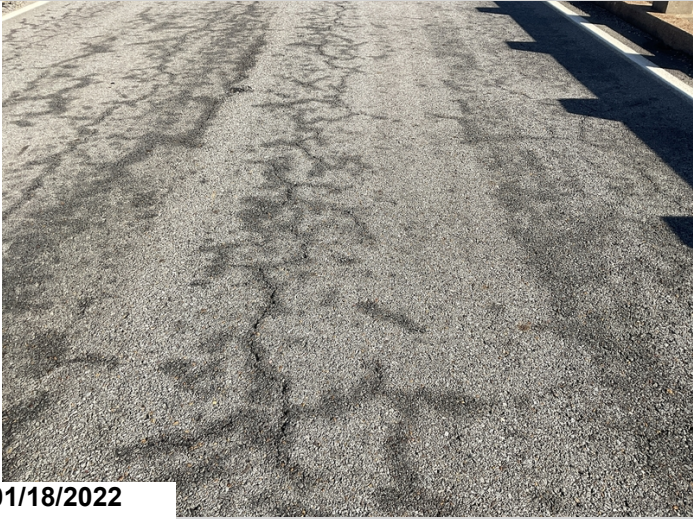
Typical cracks to wearing surface @ all spans.

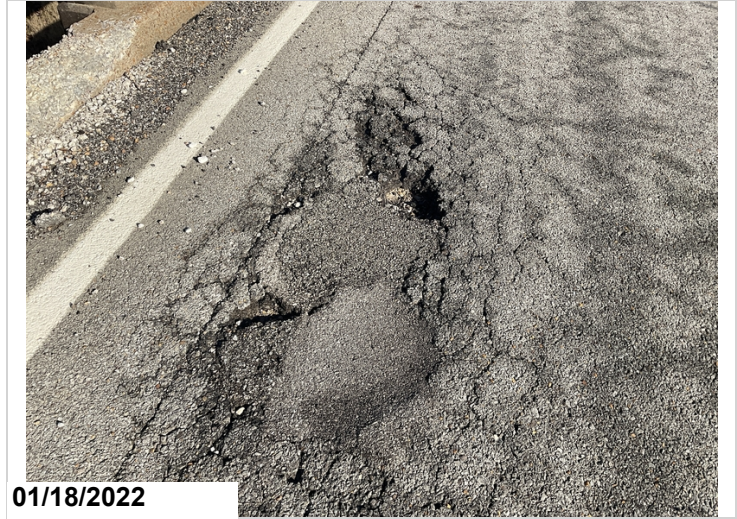
Potholing to joint & asphalt overlay in Left lane @ Span 6.

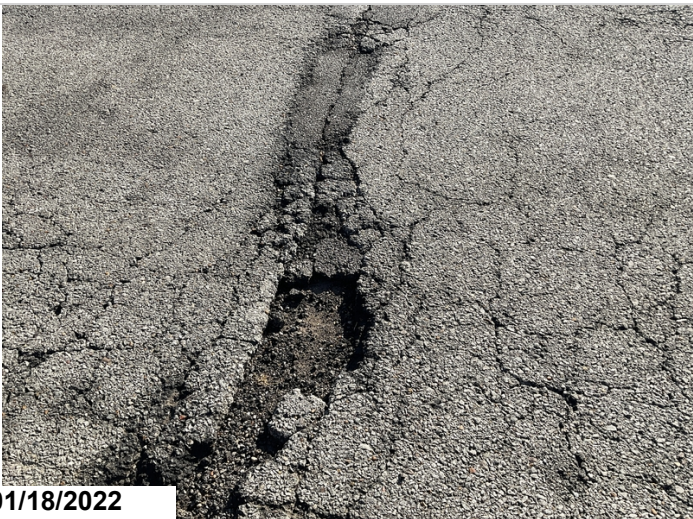
Typical spalls to joints @ all spans.

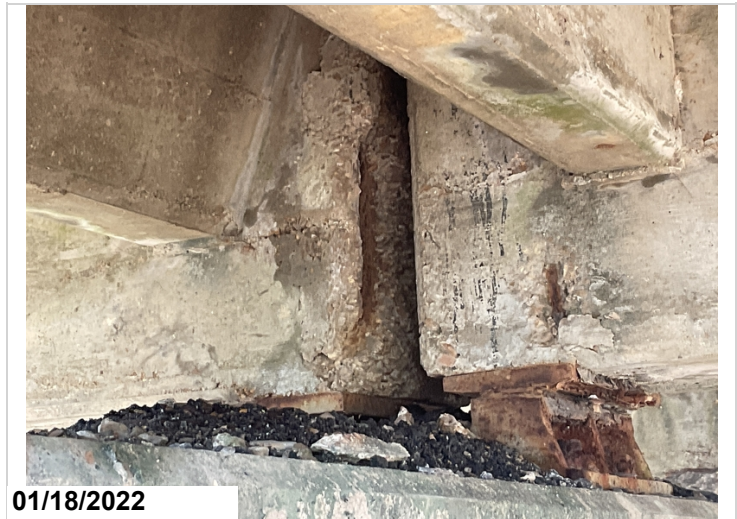
Spall with rebar exposed to back of girder 3 over bent 3.

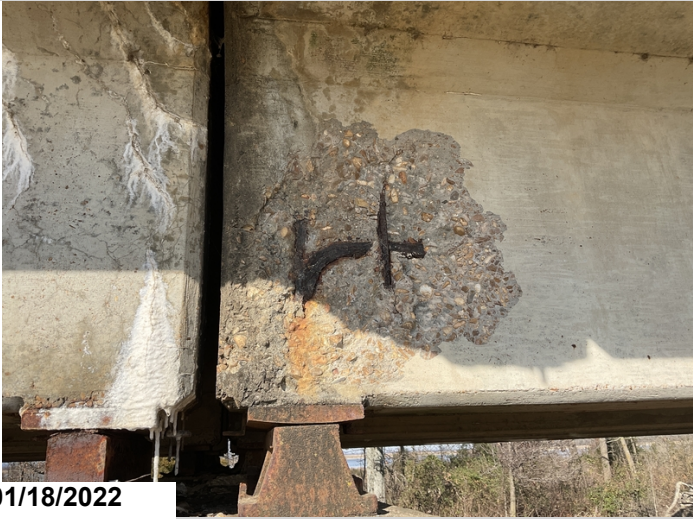
Spall with rebar exposed to girder 4 @ beginning of span 8.

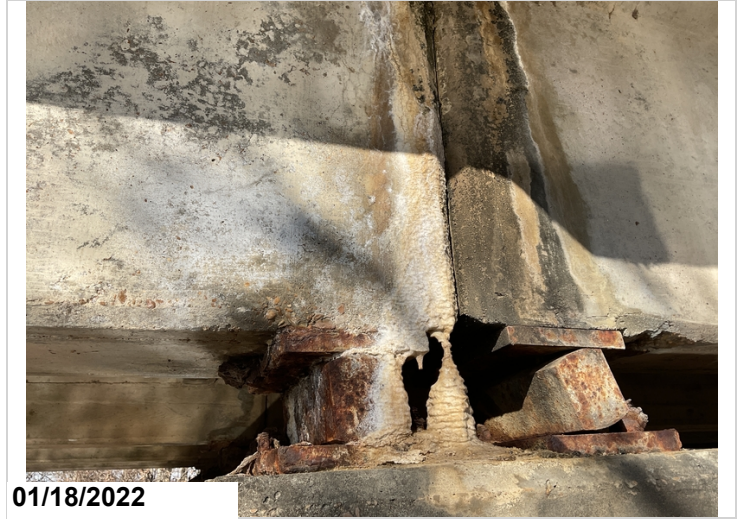
Efflor crack to girder 4 @ end of span 9.

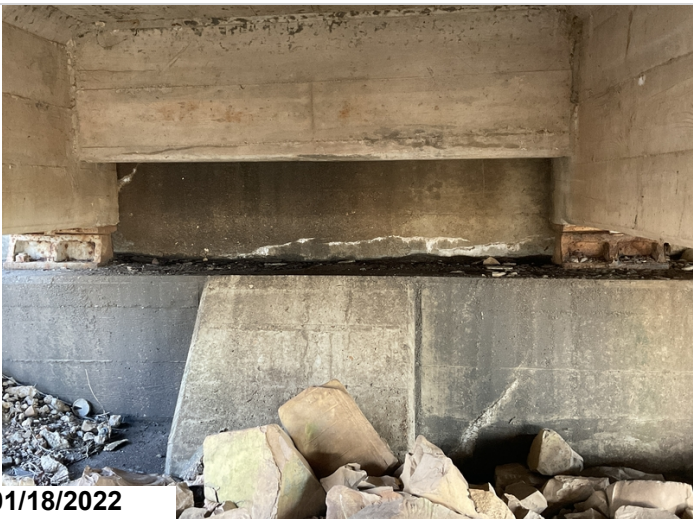
Efflorescent cracks to backwall @ Abutment 2.

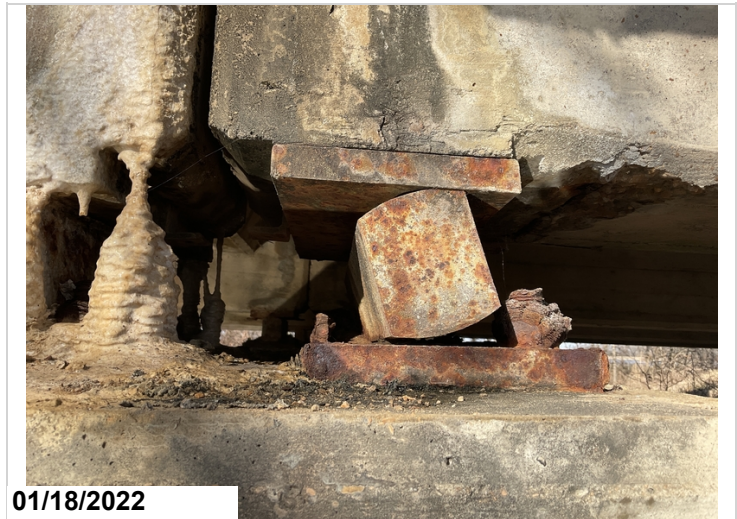
Moveable bearing has rotated back @ Bent 9.

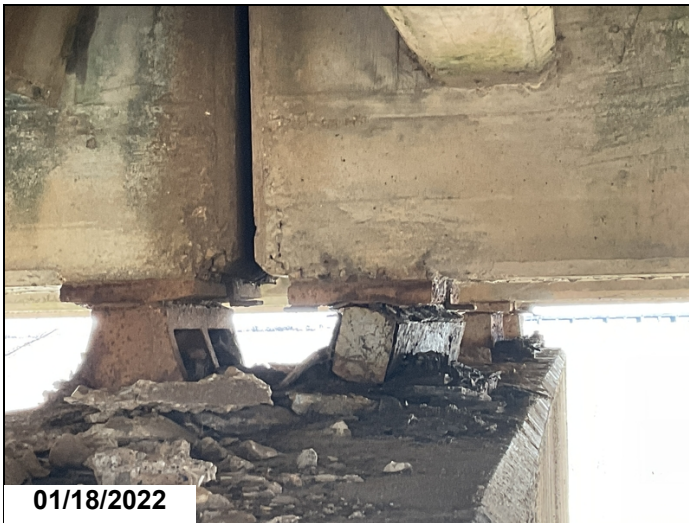
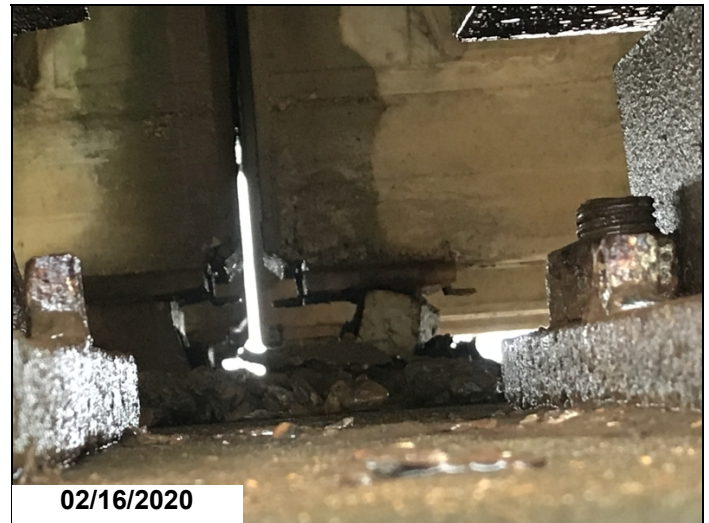
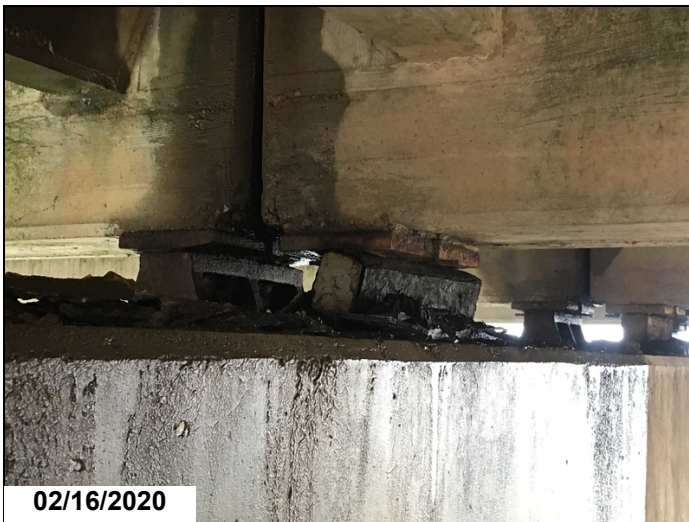
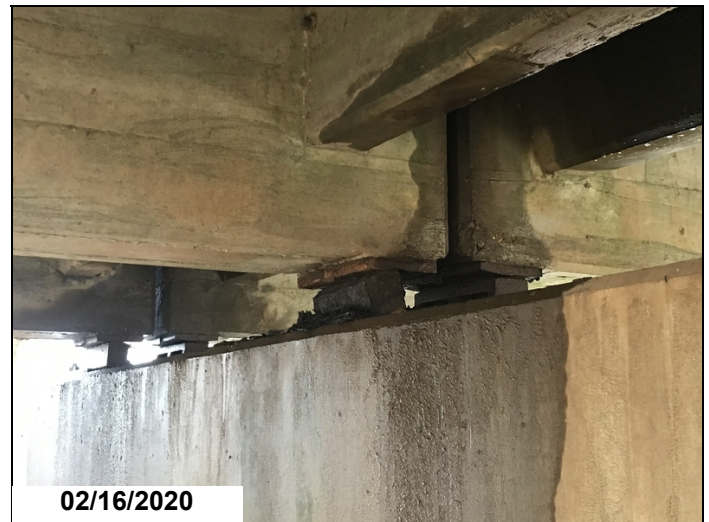
Moveable Bearing 2 @ Bent 8 has rotated back & is twisting out of place.

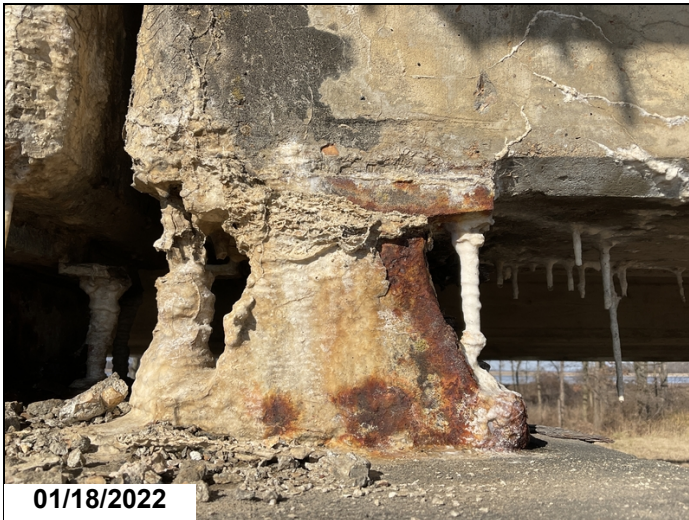
Bents 1 and 9 under all Girders.  
Bearings have rotated to limits and no longer function.

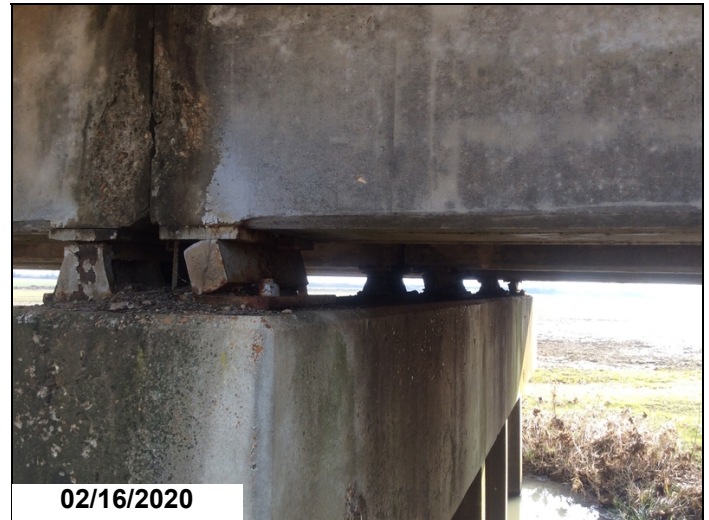
Bearings have rotated to limits and no longer function @  
Bent 1.

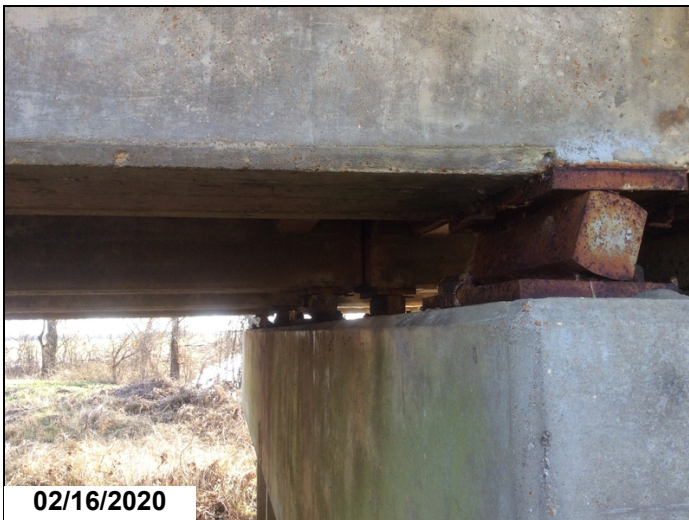
Bearings have rotated to limits and no longer function @  
Bent 9.

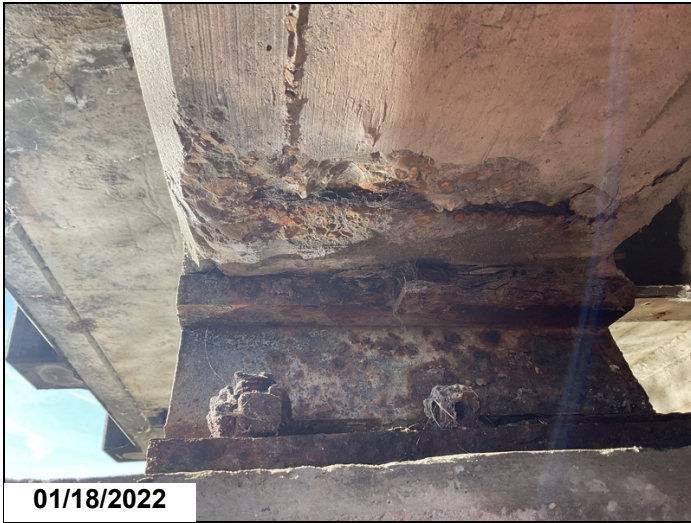
Span 10- Girder 4 has spall with 10" exposed rebar at beginning.

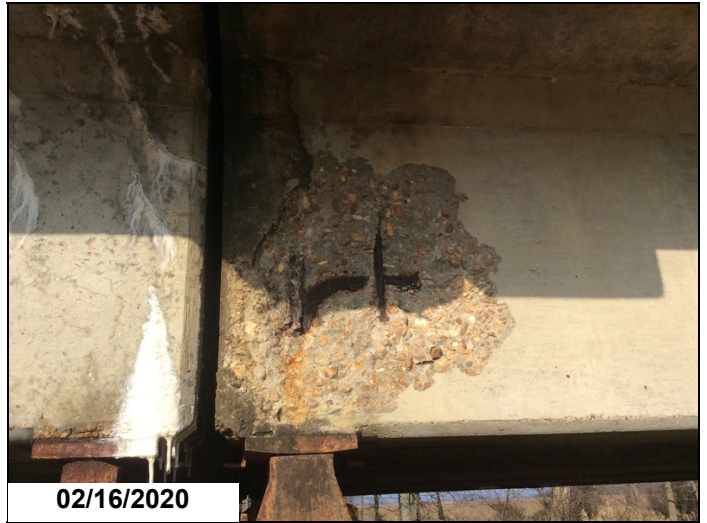
Span 8- Girder 4 has 2' spall with exposed rebar on outside end with section loss

Span 8. Girder 4 has 2' spall with exposed rebar on outside end with section loss.

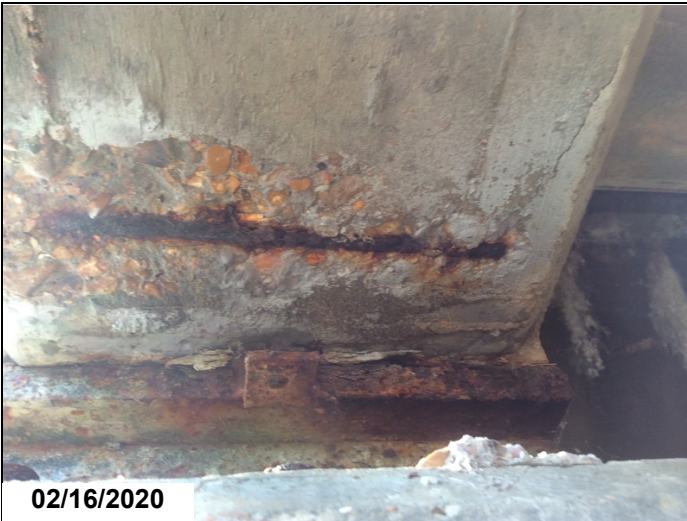
Span 10. Girder 4 has spall with 10" exposed rebar at beginning of span.

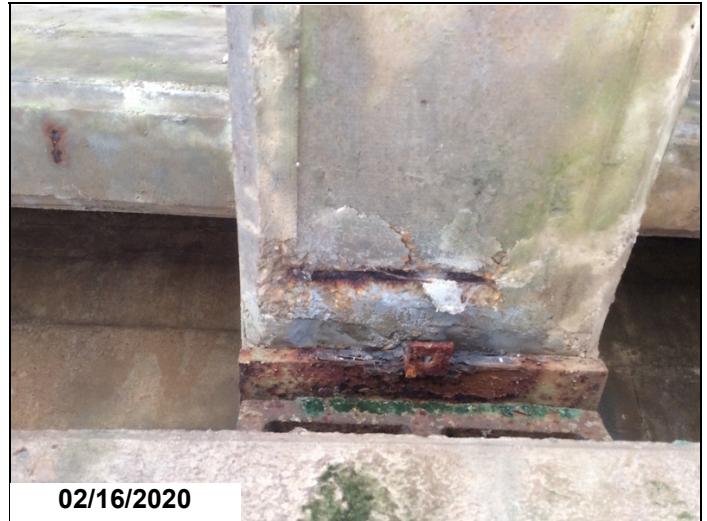
Span 2- Girders 3 & 4 have 6" spall with 6" rebar exposed to bottom at beginning,

Span 2. Girders 3 & 4 have 6" Spall with 6" rebar exposed to bottom at beginning of span.

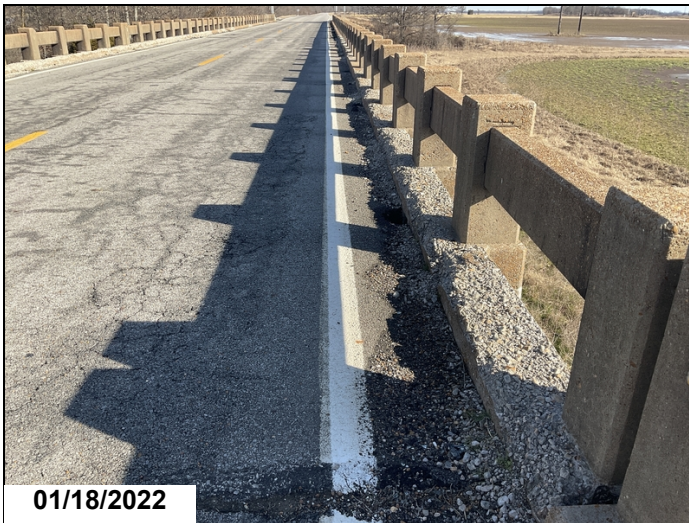
Curb Left and Right Sides of Spans 3 through 9 are deteriorated and spalled.

Curb: Left and Right Sides of Spans 3 through 9 are deteriorated and spalled.

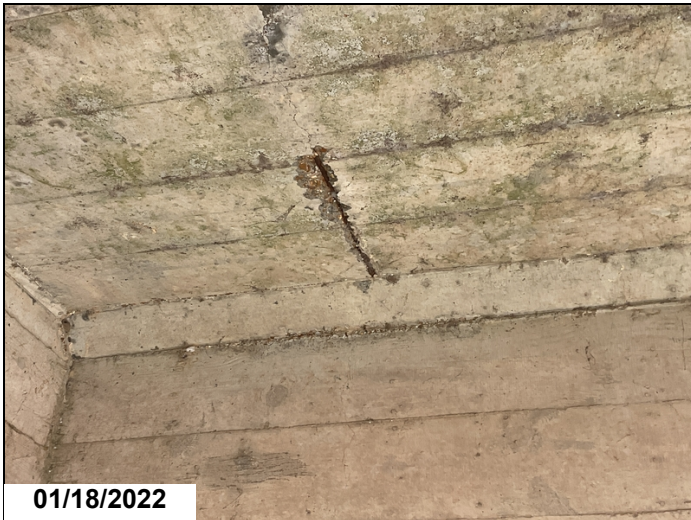
Soffit at Spans 3, 4, 5, 6, 8 & 9  
Spalls with exposed rebar

Soffit at Spans 3, 4, 5, 8 & 9  
Spalls with exposed rebar  
Span 6.

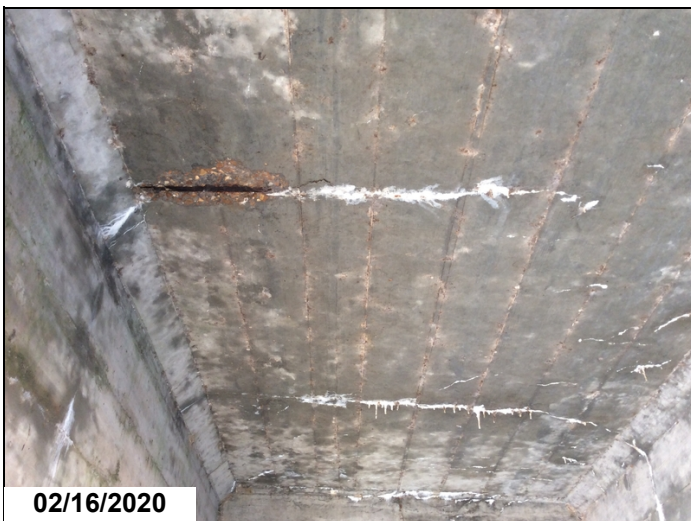
Spall with 12" rebar exposed to soffit @ Span 4 with  
heavy efflorescence.

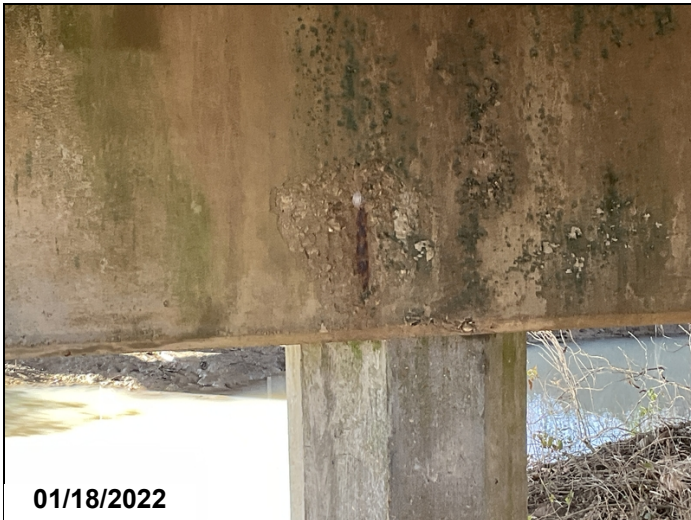
Concrete Caps all Bents  
Spalls with exposed rebar.

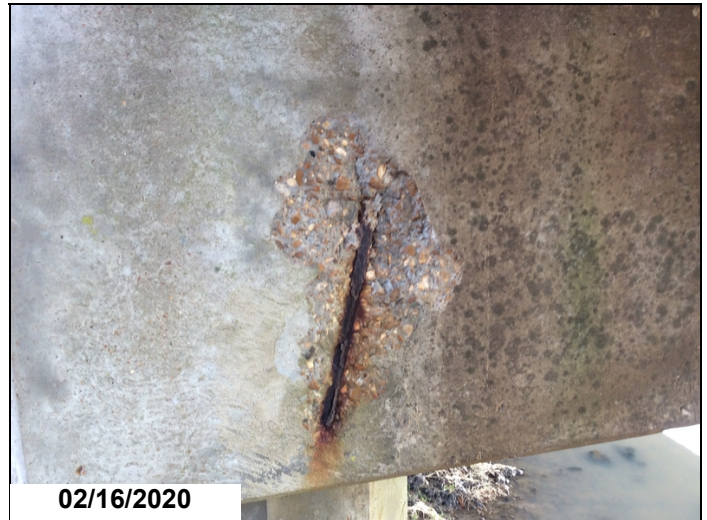
Spall with 12" rebar are exposed to Left side of cap @  
Bent 1.

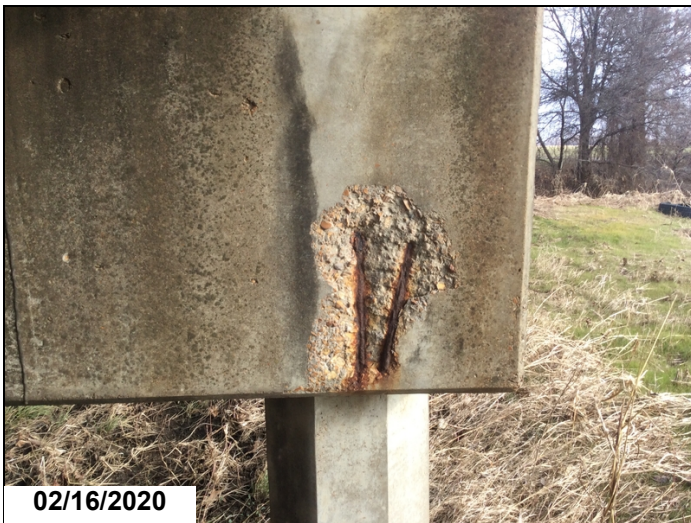
Spall with 24" rebar exposed to Right side of cap @ Bent

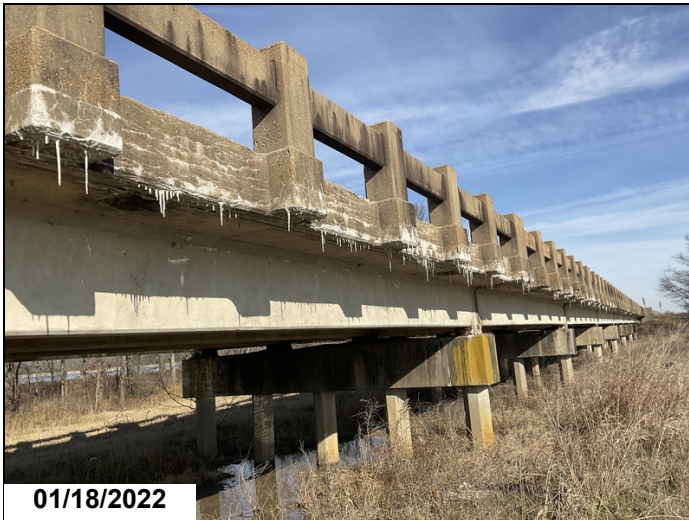
Outside Edge of Deck has Severe Efflorescent Map Cracking.

Spans 1, 3,4,5,6,7,8,&9  
Outside Edge of Deck has Severe Efflorescent Map Cracking.

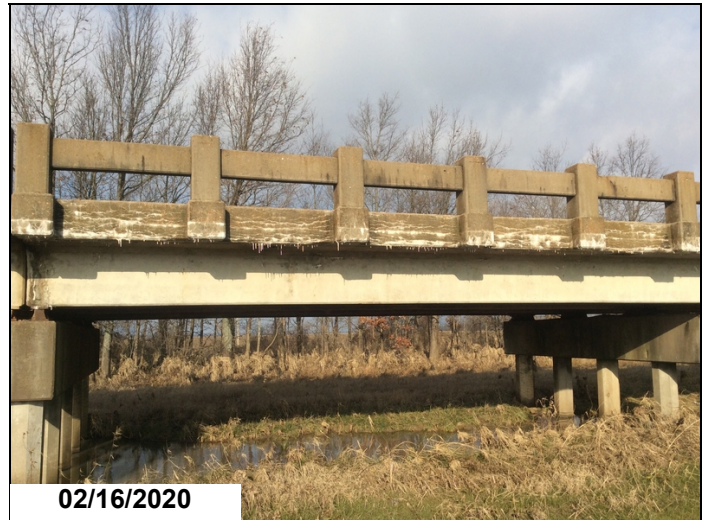
Span 3 Right. Severe map cracking with efflorescence to outside of deck.

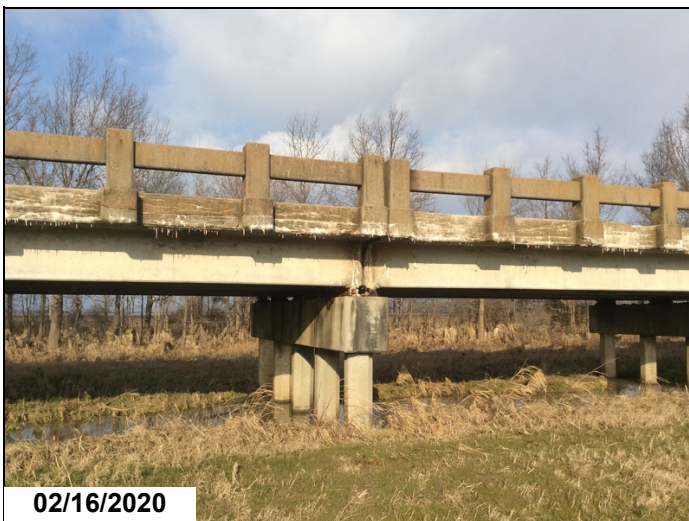
Spans 4 & 5 Right. Severe map cracking with efflorescence to outside edge of deck.
