Bridge 01879 Inspection Report

SH 367/Jackson Co. over WHITE RIVER RELIEF

Location: 4.35 MI SW JCT SH 14

Team Lead: Floyd Haley Inspection Date: 09/03/2024

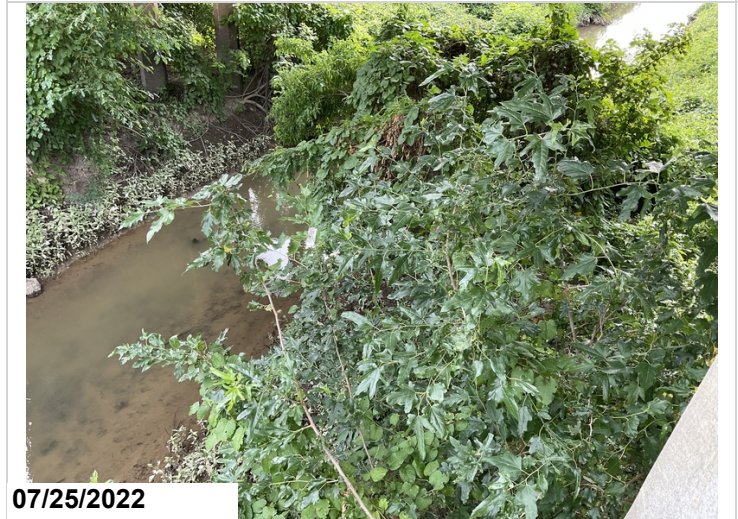
Vegetation @ Spans 4, 11, 12 & 13.
Span 4.

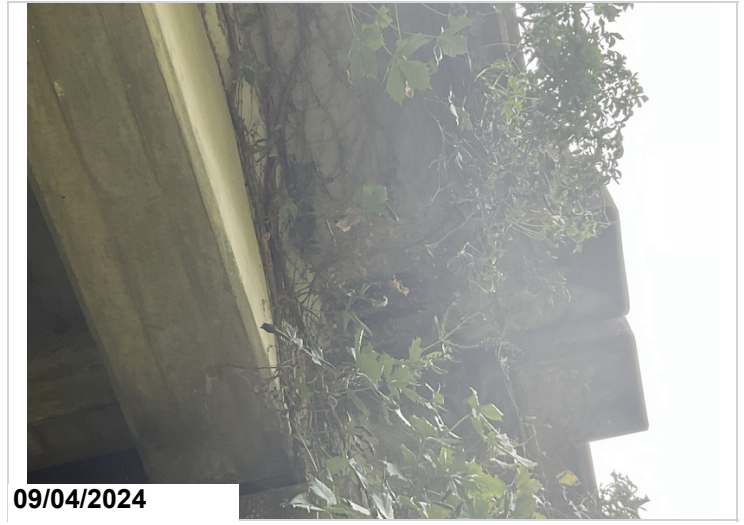
Span 12 left overhang. 1ft rebar 1ft spall

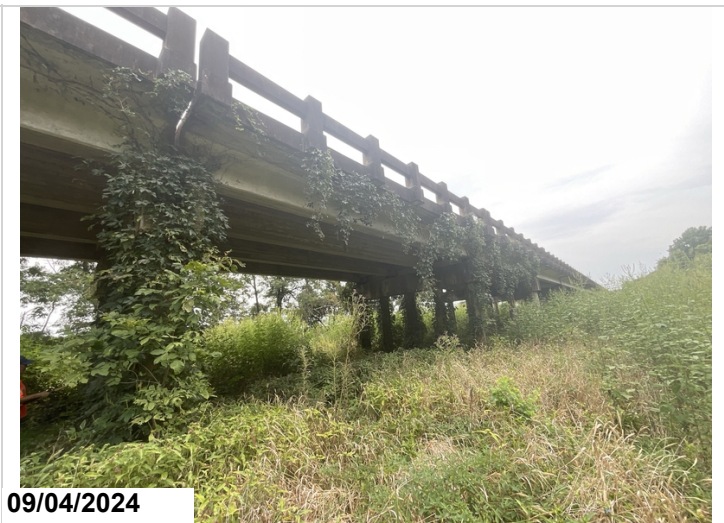
Vegetation span 12

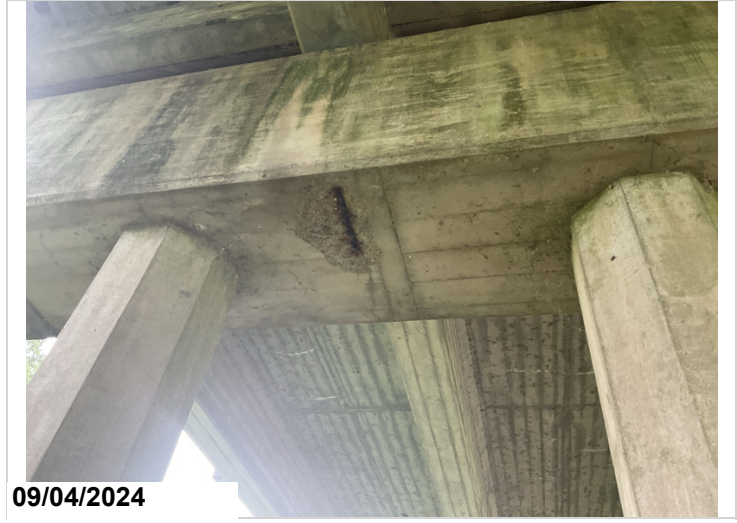
Bent 15 tween piles 3 and 4. 1ft exp rebar

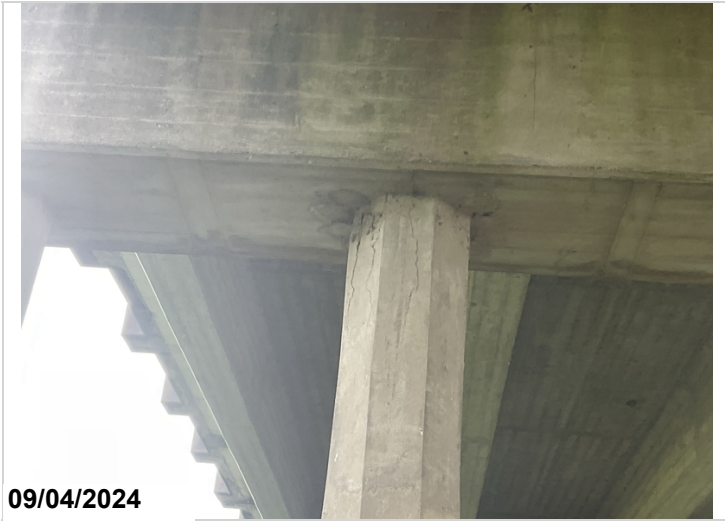
Bent 2, pile 2: heavy vertical cracks

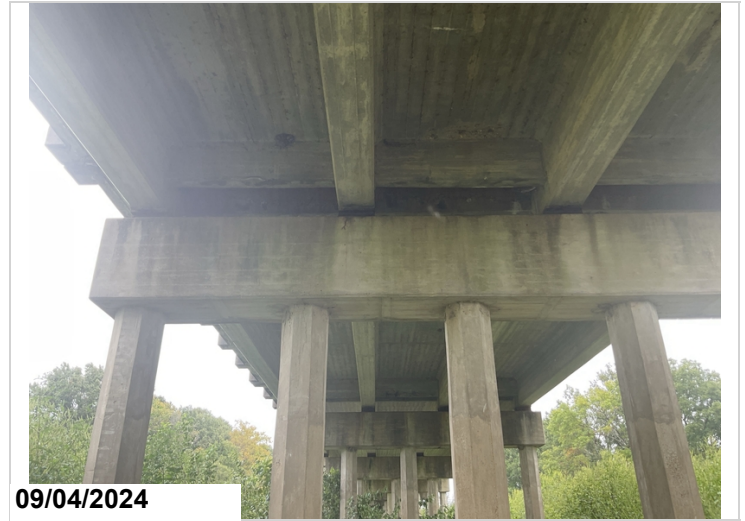
Bent 2, back,g2 crack with rust

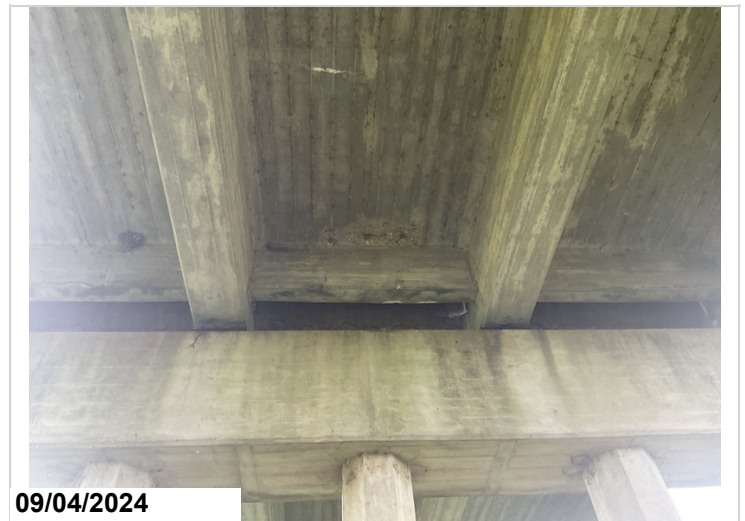
Span 2, bent 2, bay 2: spall

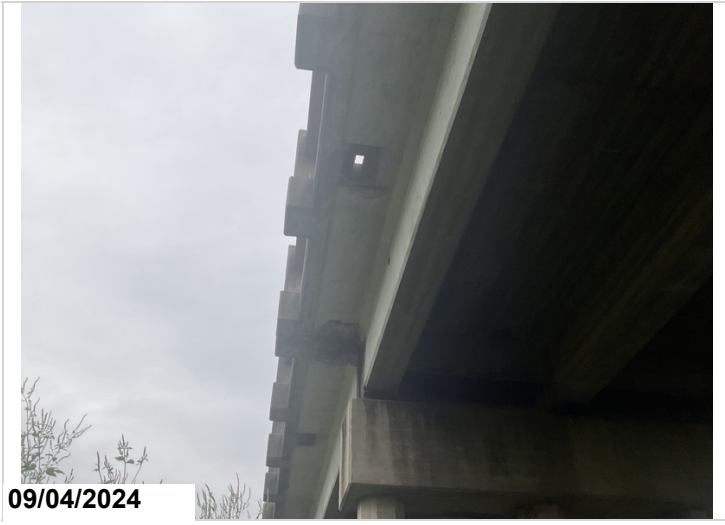
Span 2, left: 2ft rebar

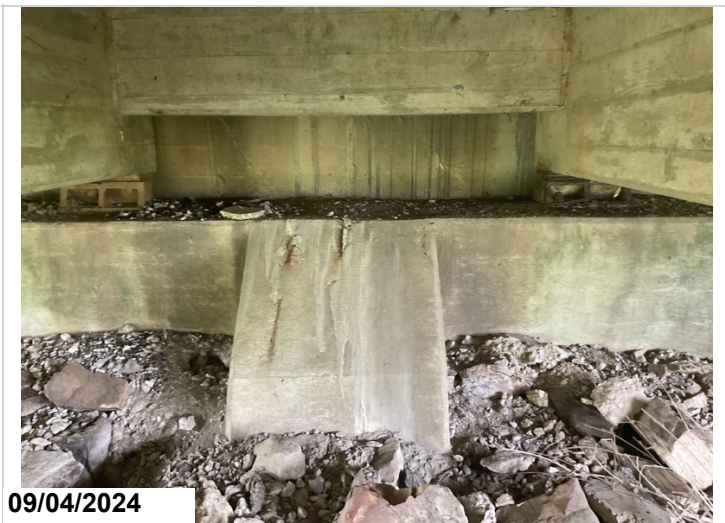
Abutment 1 backwall, center: cracking 4ft exp. Rebar 2'

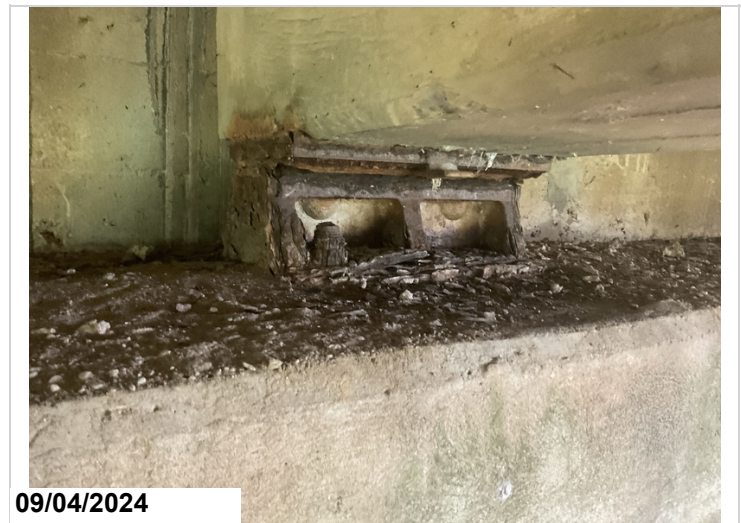
Abutment 1, bearing 2. Heavy corrosion.all have cs3 corrosion. This is worst case

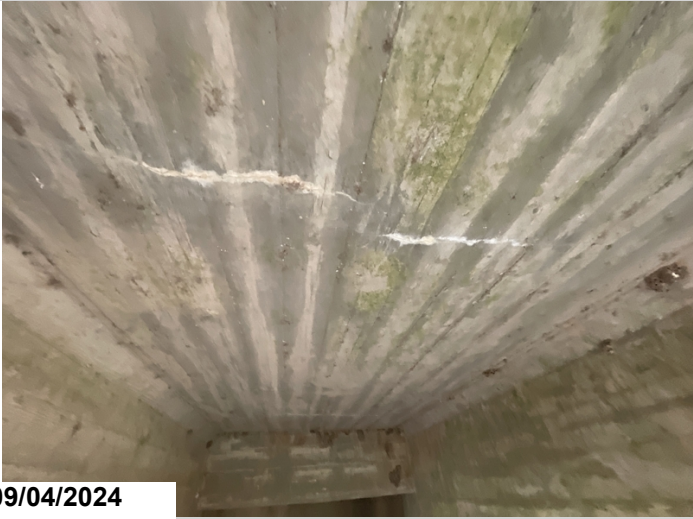
Typical cs3 eff. Undersurface

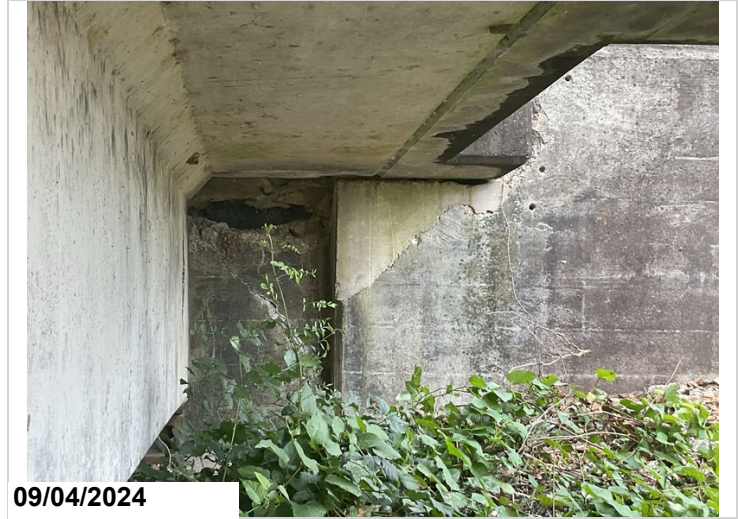
Abutment 1 left. 2ft spall and large crack

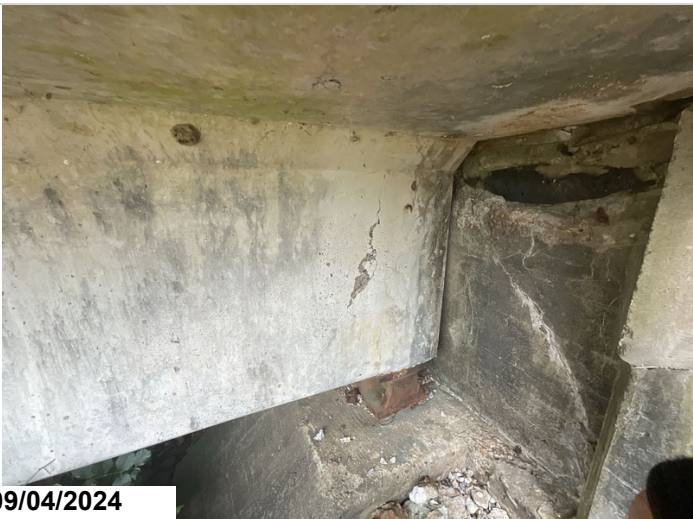
Abutment 1, g1. Spall 1ft

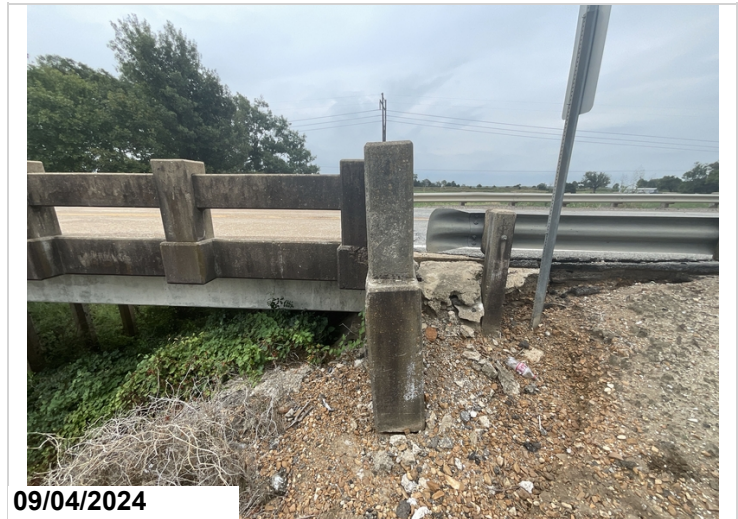
(215) Abutment 1 has rotated ahead closing joint. Abutment 1: Right: Efflorescent cracking. 1' CS3 Abutment 1: Right: Cracking. 4' CS3 Abutment 1: Left: Spalls. 2' CS3 Abutment 1: Column 2: Spalls with corroded reinforcing steel exposed. 1' CS2 Abutment 2 has rotated back closing joint. Abutment 2: Bay 2: Cracking to backwall. 1' CS2							
227	Reinforced Concrete Pile	EA	75	65	6	4	0
1090	Exposed Rebar	EA	2	0	0	2	0
1130	Cracking (RC and Other)	EA	3	0	1	2	0

Abutment 1, rotation

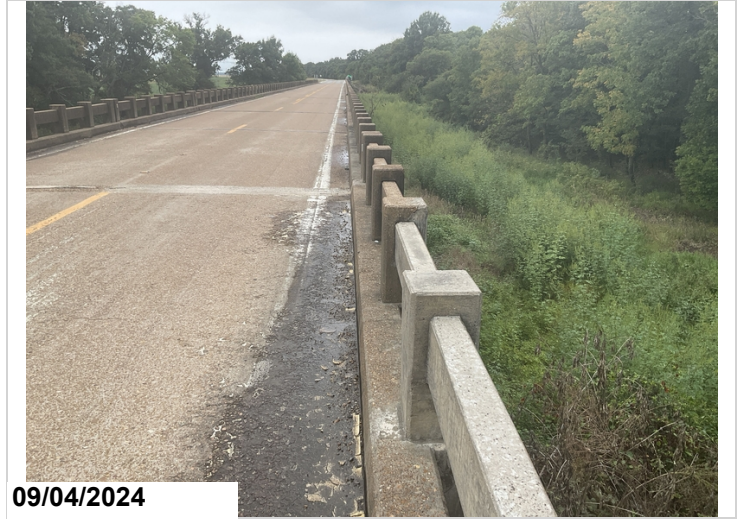
The bridge railing has minor vertical cracks and spalls throughout.

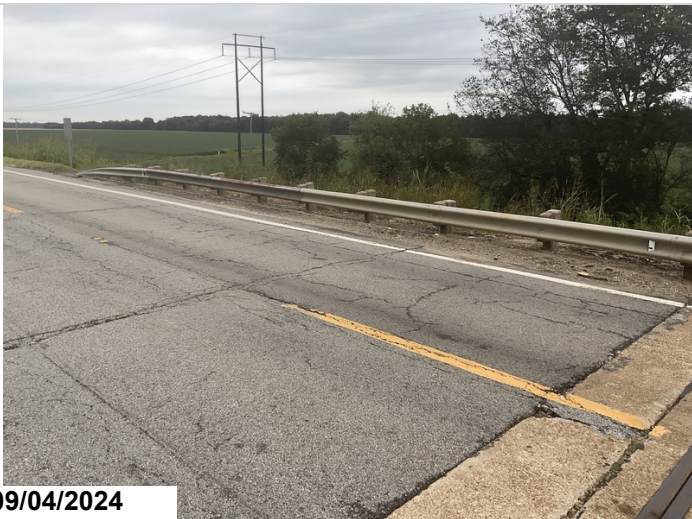
Bridge rail transitions are in good condition with only minor surface corrosion.

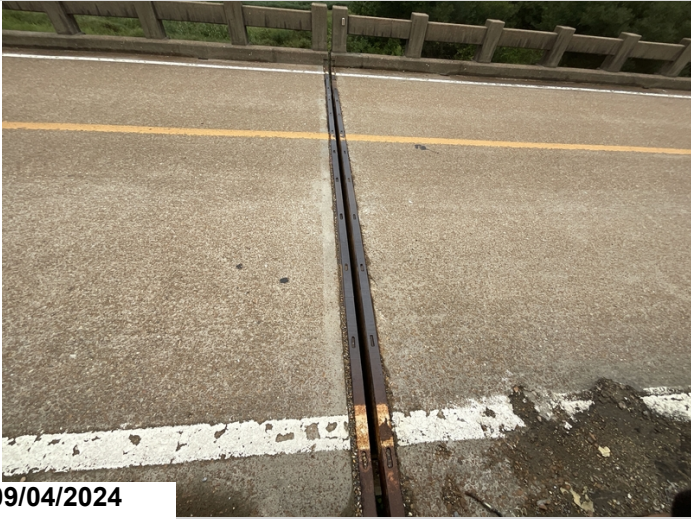
Bent 6, joint armor is cracked and broken in numerous places. Loud when cars pass. Bent 7 similar

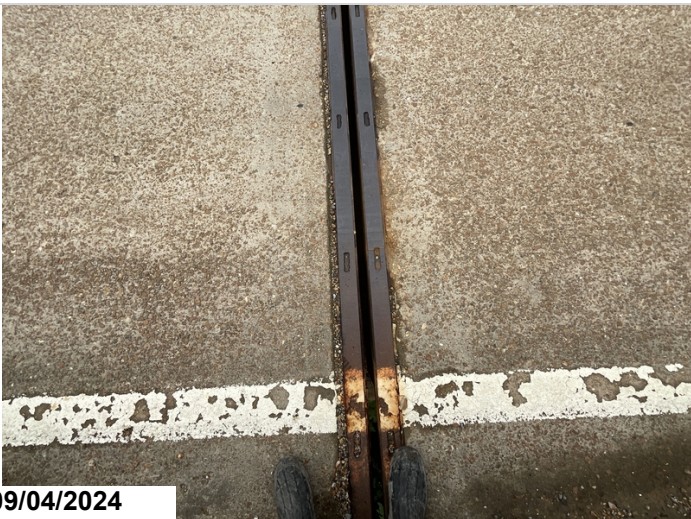
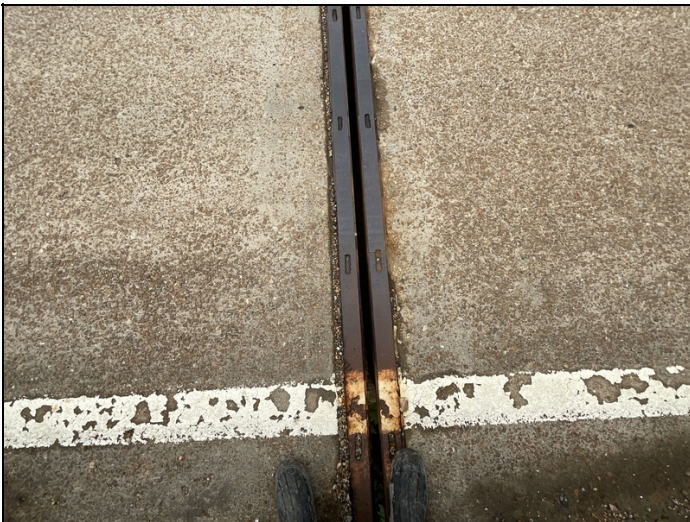
Bent 5 is cracked and sounding when cars pass

A-59 - Joint Repair Needed (Yes)

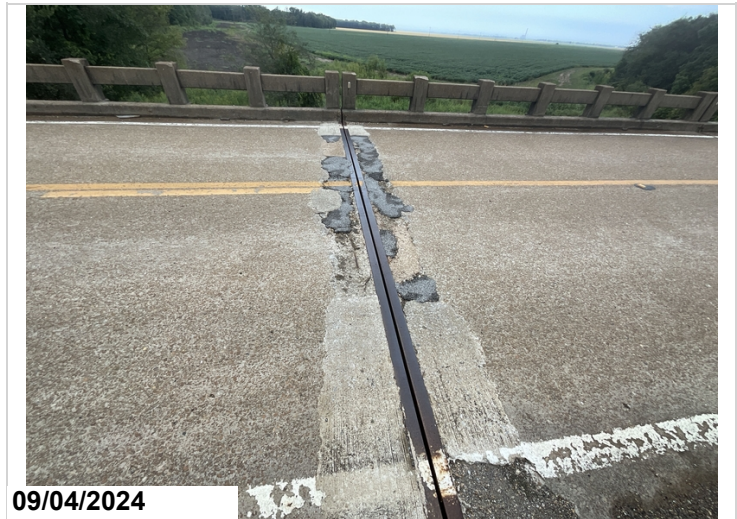
Deck at bent 2 has spalling on both sides of joint with exposed rebar and unsound patches. 2ft cs3 rebar. 2x 15 cs3 spalling/patch. Right gutter has 1x2 spall at bos 3

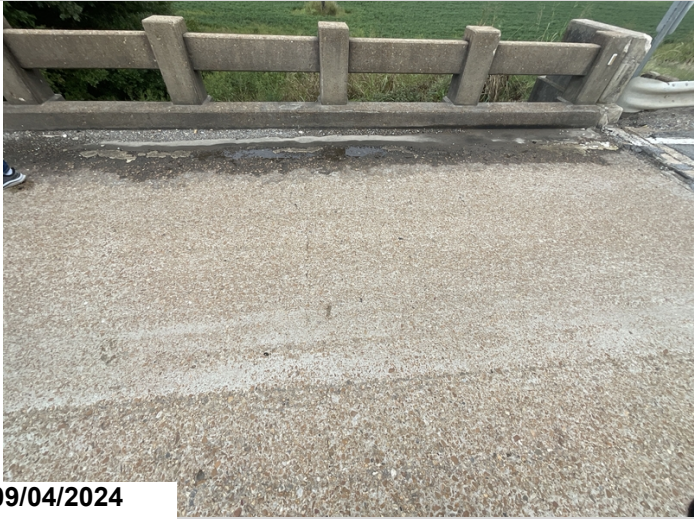
Typical transverse cracks

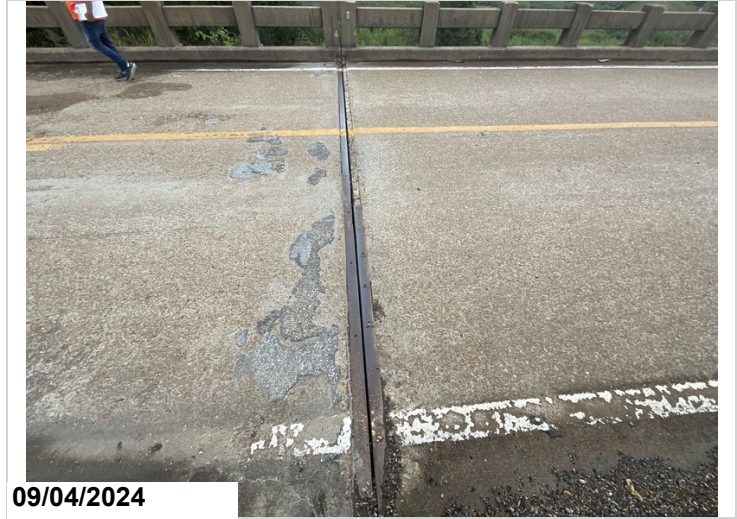
Bent 1. Joint is open, road armor is broken for 15ft

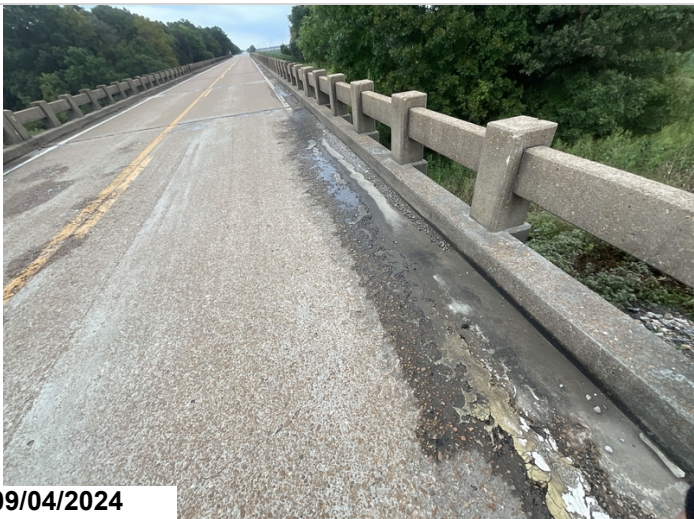
Typical abrasion in gutters

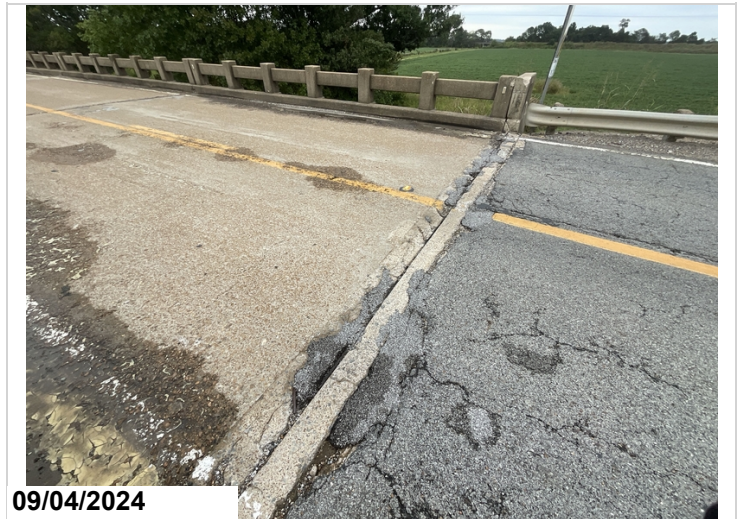
Abutment 1. The deck is spalled adjacent to the headwall with exposed rebar throughout. 9sf rebar. Remaining deck width x1' spalled

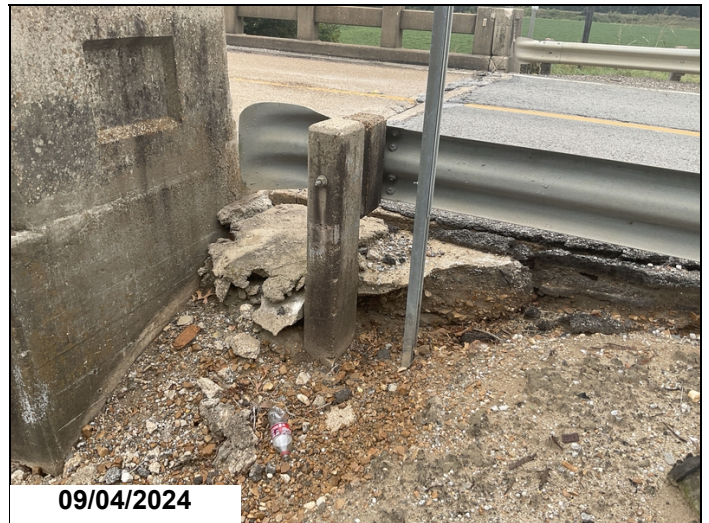
Abutment 1: has rotated ahead with settlement at the approach.

Type of Work: Substructure Repair

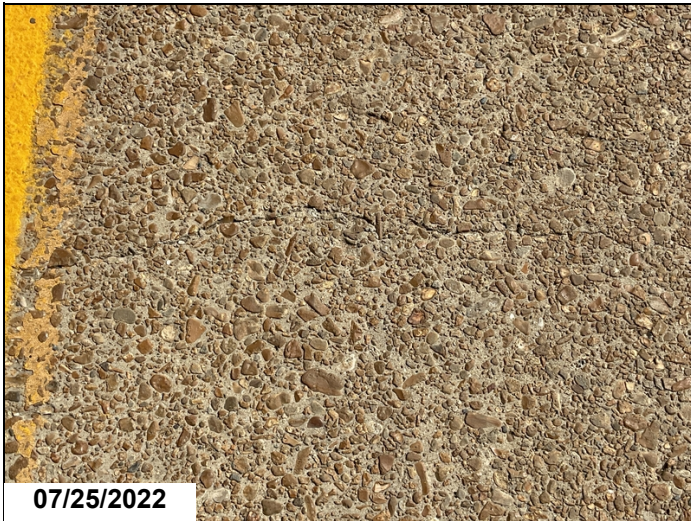
Unsealed transverse cracks to deck @ all spans.

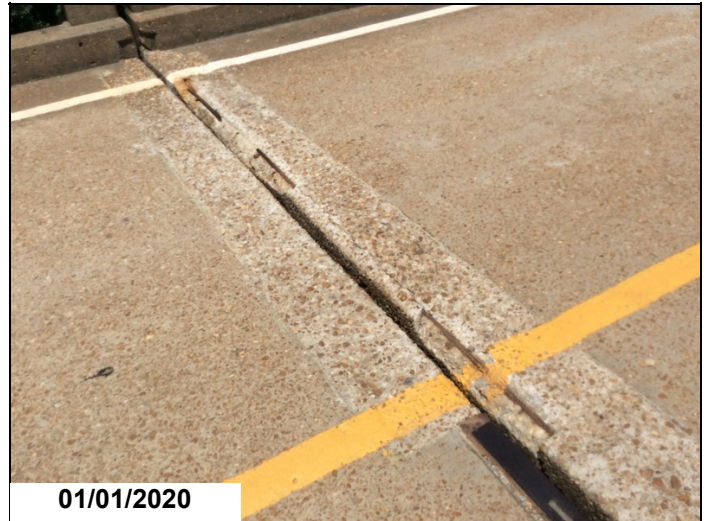
Patched area has spalls with rebar exposed @ BOS 11
Left lane.

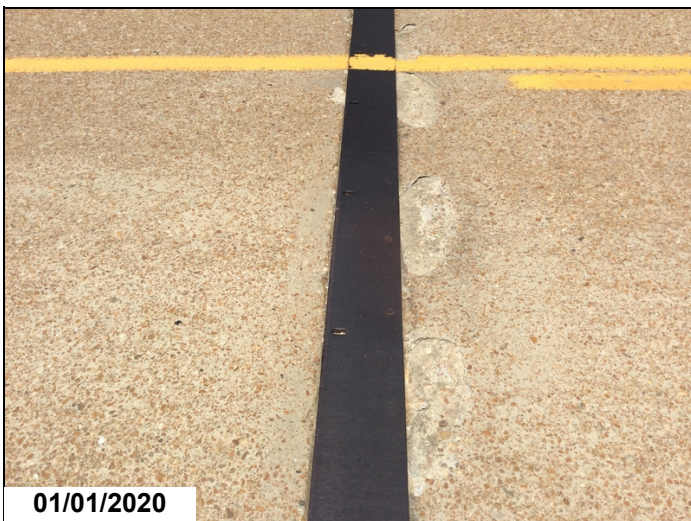
Spalls and delaminated areas along joints @ EOS 4 &
BOS 5

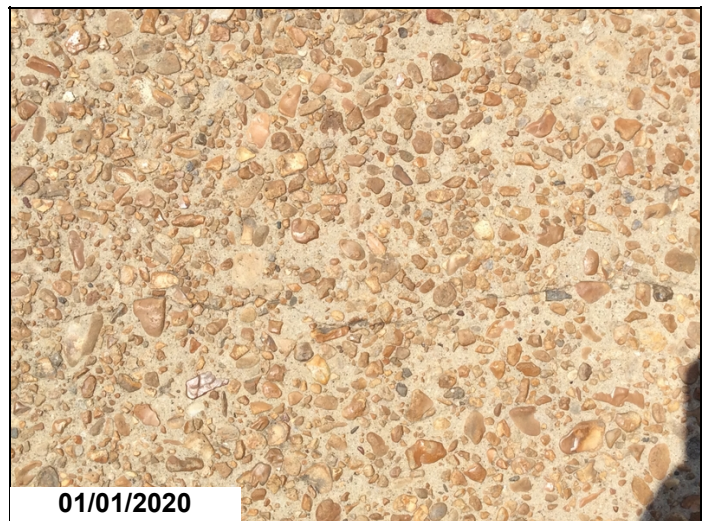
Unsealed transverse cracking to Deck @ Span 5.

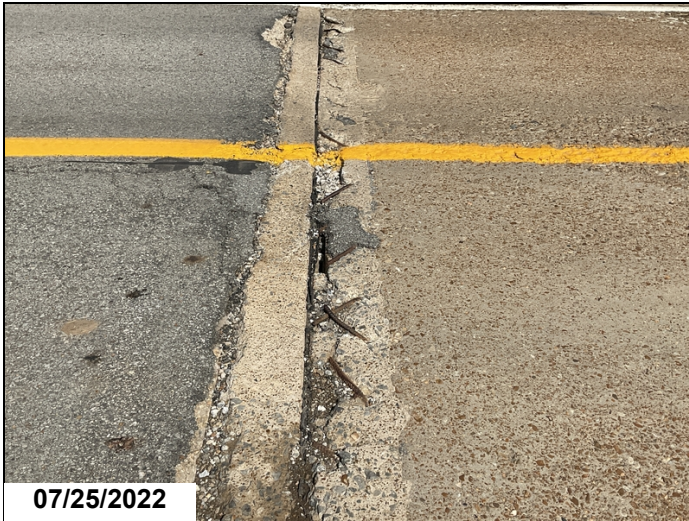
Spalls and delaminated areas along all joints.
Abutment 1.

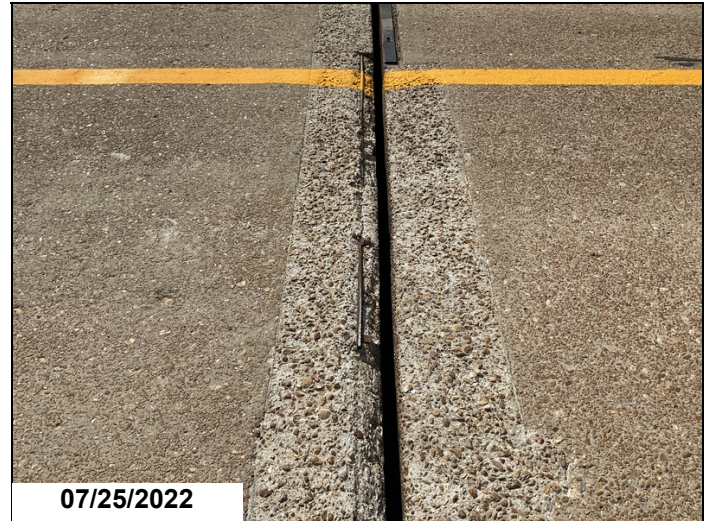
Spalls with rebar exposed to joint @ BOS 11.

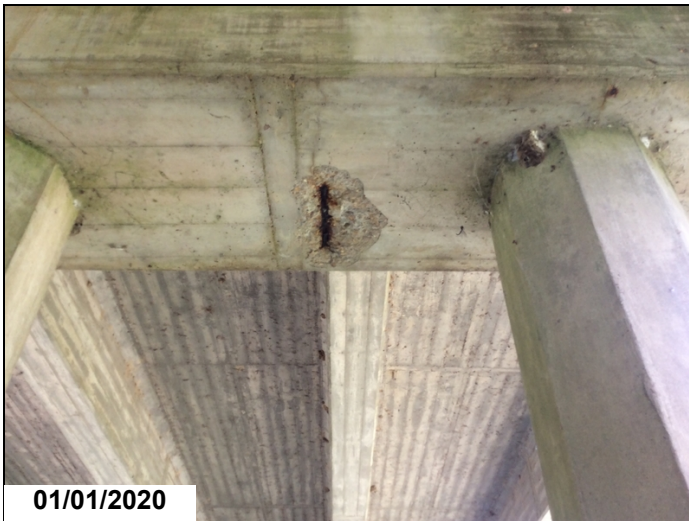
Spall with rebar exposed to bottom of Cap between Piles 3 & 4 @ Bent 14.

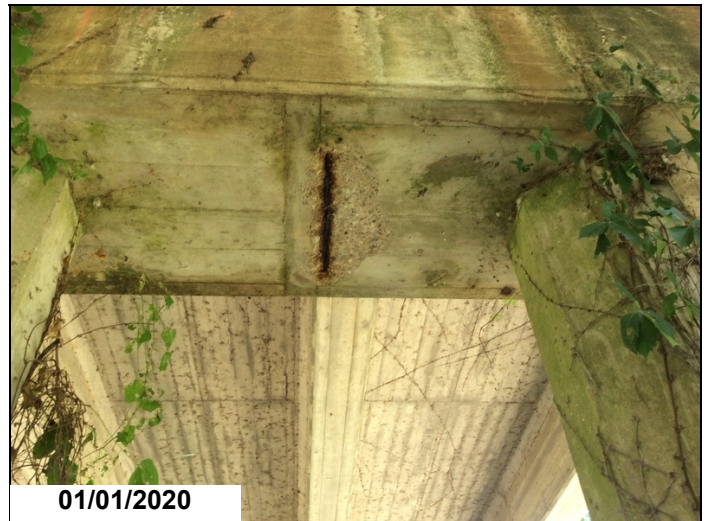
Spall with rebar exposed to bottom of Cap between Piles 3 & 4 @ Bent 12.

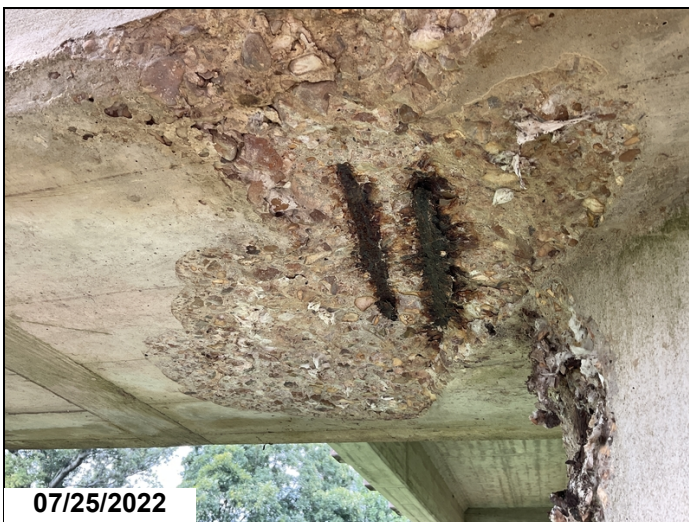
Spalls with rebar exposed to caps at Bents 5, 12 & 14.
Bent 5, between piles 4 & 5.

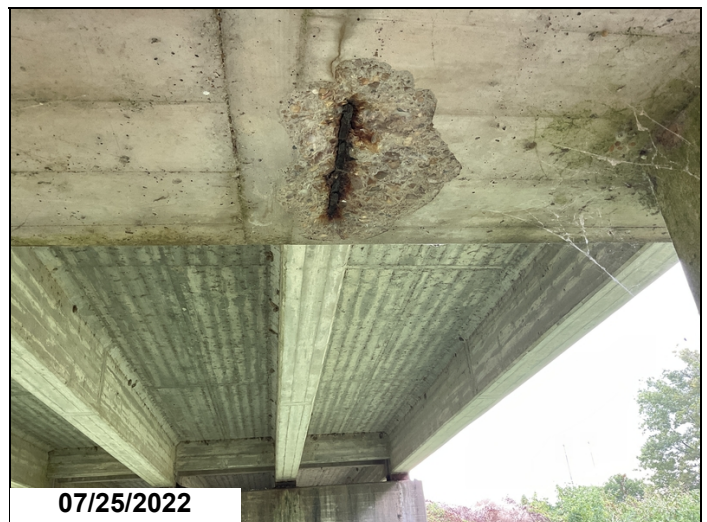
Spalls with rebar exposed to caps at Bents 5, 12 & 14.
Bent 14 between piles 3 & 4.

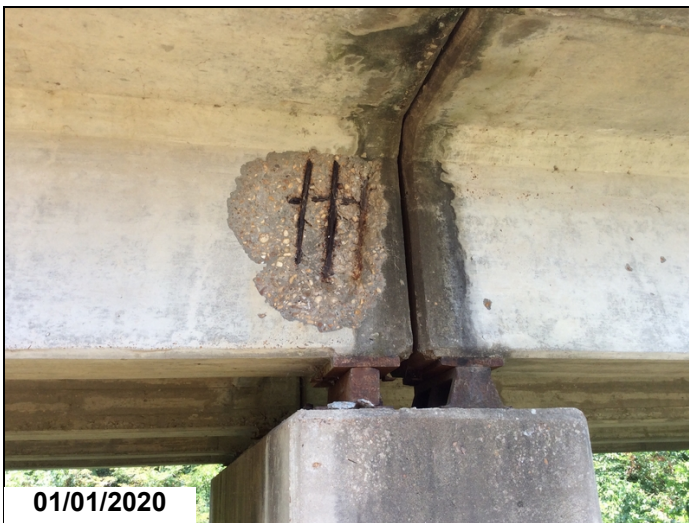
Spalls with rebar exposed to Girder 4 @ EOS 3.

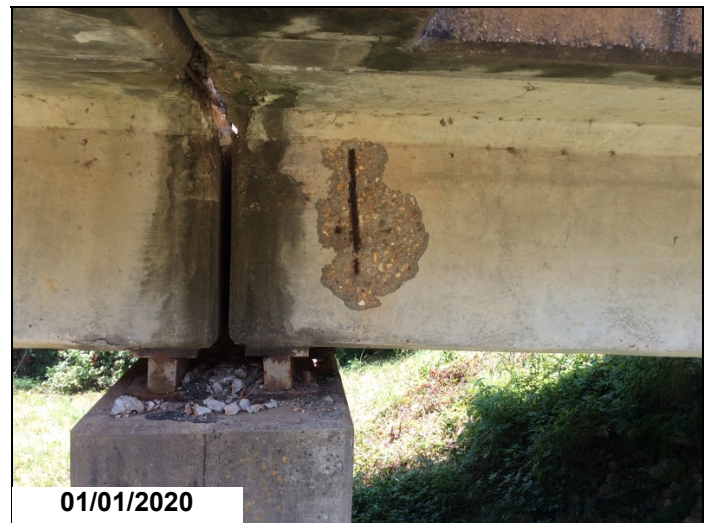
Spall with rebar exposed to Girder 4 @ BOS 16 Right.

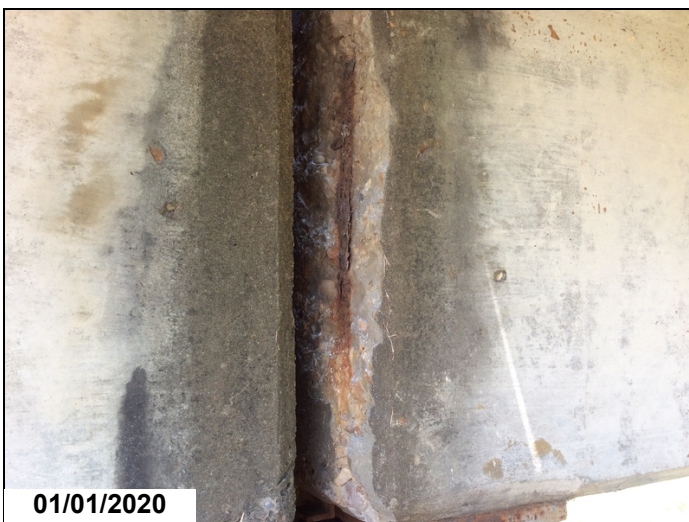
Girder 4 at beginning of Span 9 spalled with 12" of exposed rebar.

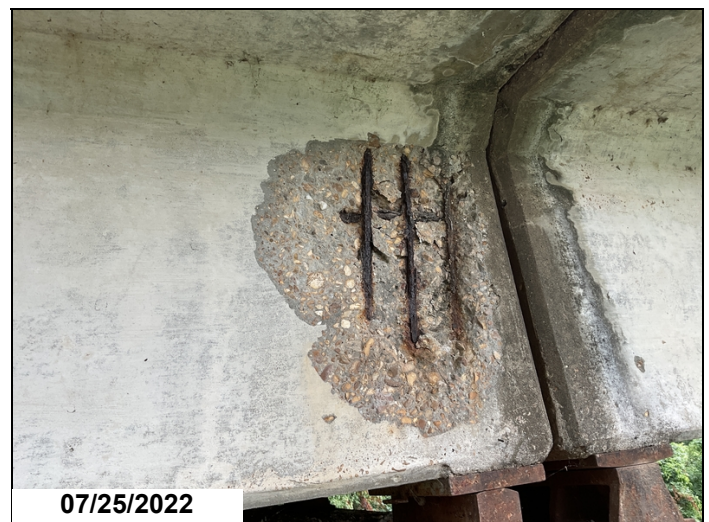
Spalls with rebar exposed to girders at Spans 3, 5, 6, 9, 15 & 16.
Girder 4, end of span 3.

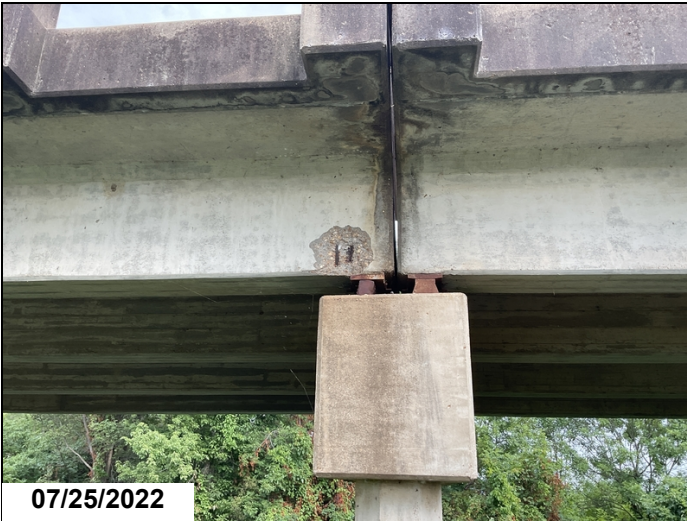
Girder 4, end of span 4.

Spalls with rebar exposed to girders at Spans 3, 4, 5, 6, 9, 15 & 16.

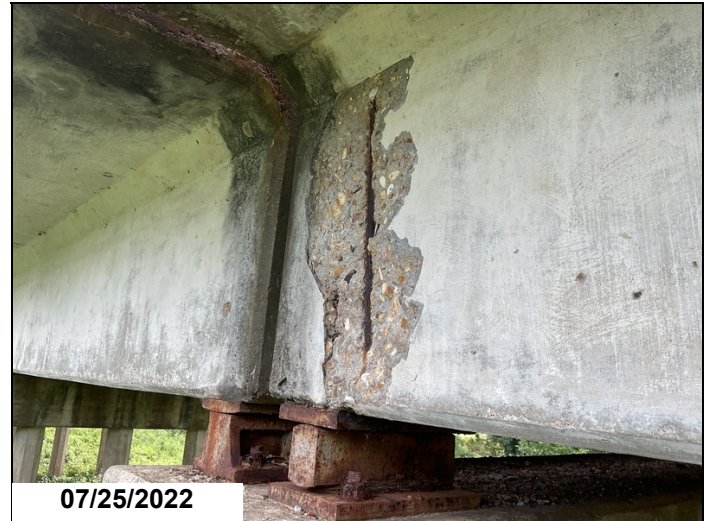
Girder 1, End of span 6.

Spalls with rebar exposed to girders at Spans 3, 4, 5, 6, 9, 15 & 16.

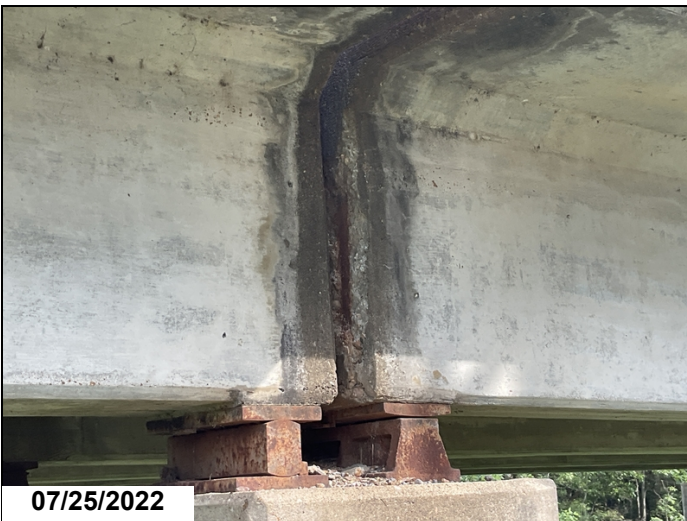
Girder 4, beginning of span 9.

Spalls with rebar exposed to girders at Spans 3, 4, 5, 6, 9, 15 & 16.

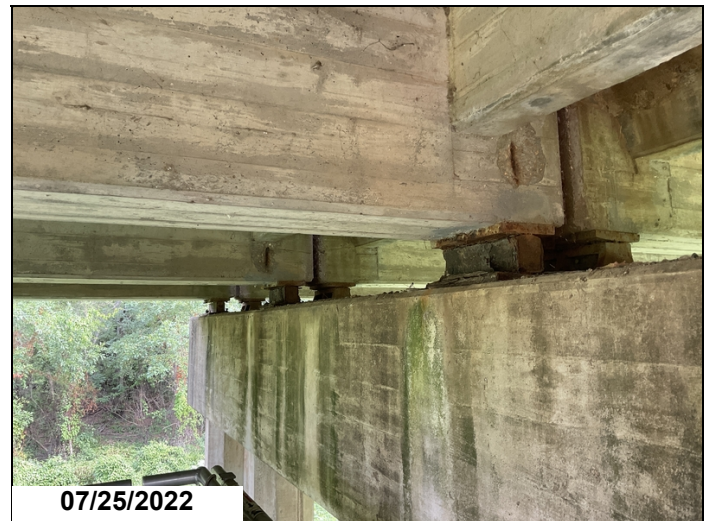
Girders 2 & 3. End of span 9.

Spalls with rebar exposed to girders at Spans 3, 4, 5, 6, 9, 15 & 16.

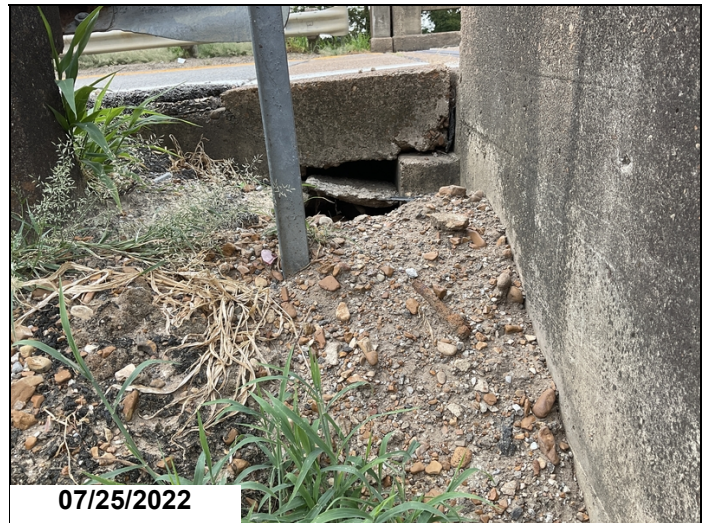
Approach roadway at Abutment 2 has erosion 8" below and 8' back under roadway.

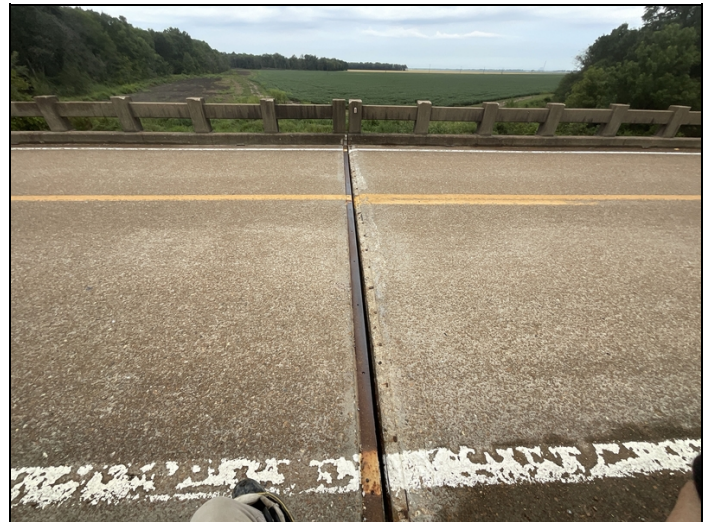
Bent 4, 3 is similar

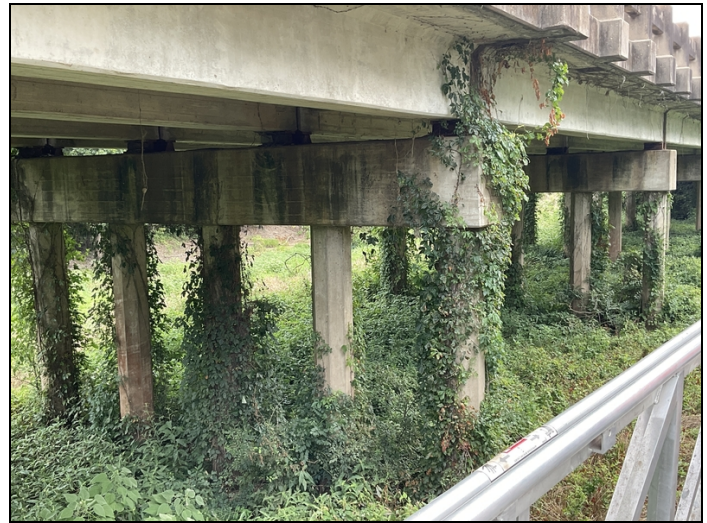
Vegetation @ Spans 11, 12 & 13.
