## Bridge 01880 Inspection Report

Asset #01880(Routine, Underwater type 2)

SH 367/Jackson Co. over WHITE RIVER RELIEF

Team Lead: Kerry Little Inspection Date: 01/30/2024

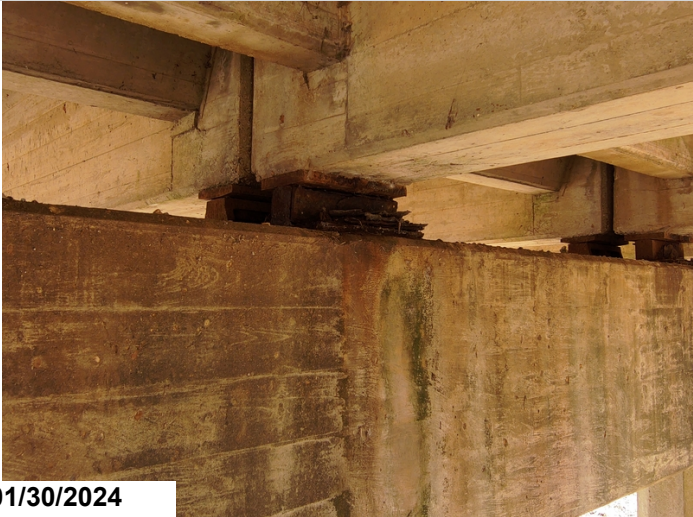
(311) Flaking rust w/ section loss to bearings @ most bents.

Typical rust with section loss to all bearings.

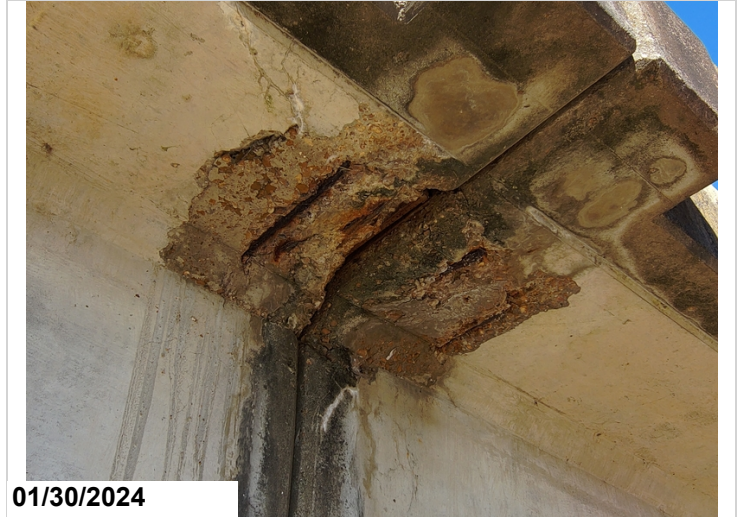
Spalls with rebar exposed with s/l to Right overhang @  
Spans 9 & 10.

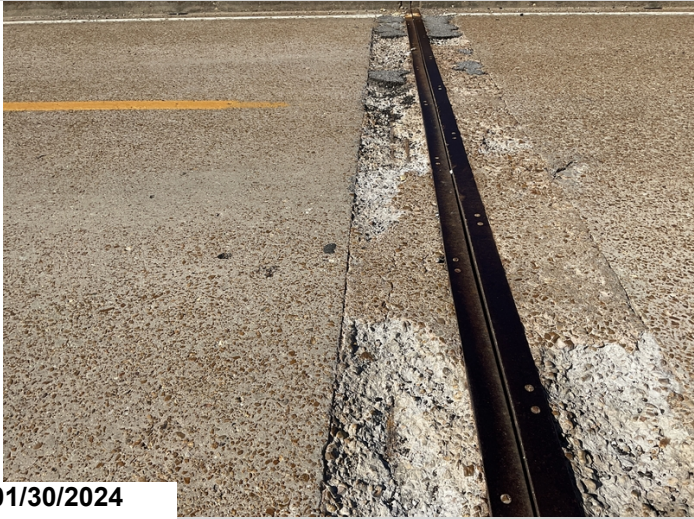
Spalls with rebar exposed with s/l to deck @ end of Span 9.  
(#3)

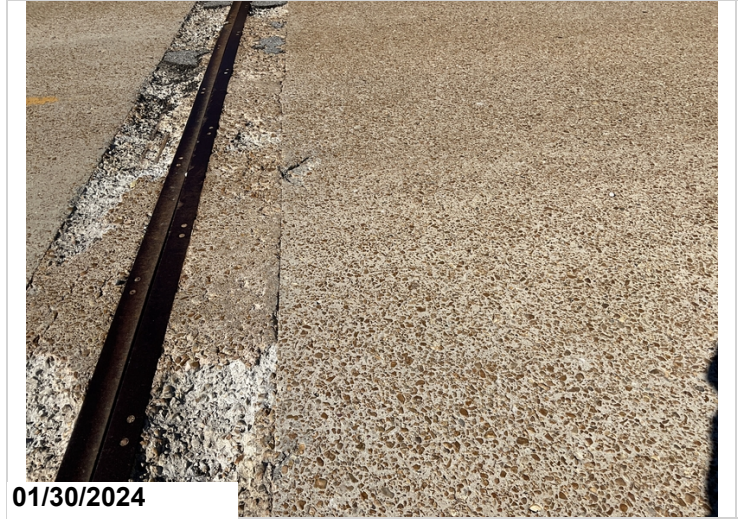
Spalls to deck @ beginning of Span 10.(#3)

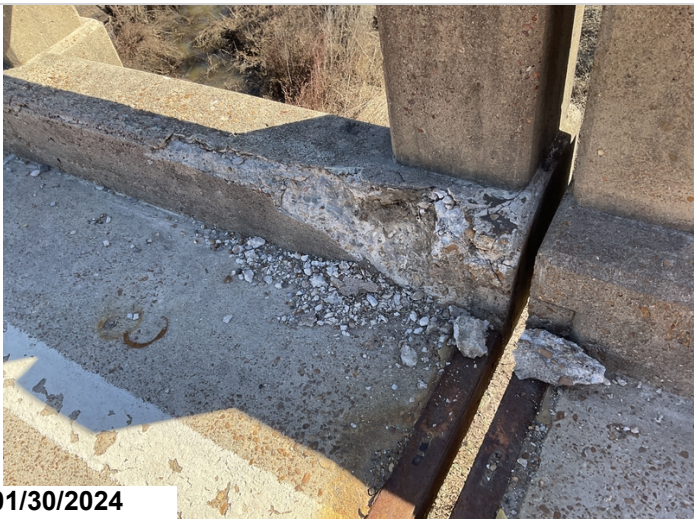
Spalls to Right curb @ beginning of Span 6.(#3)

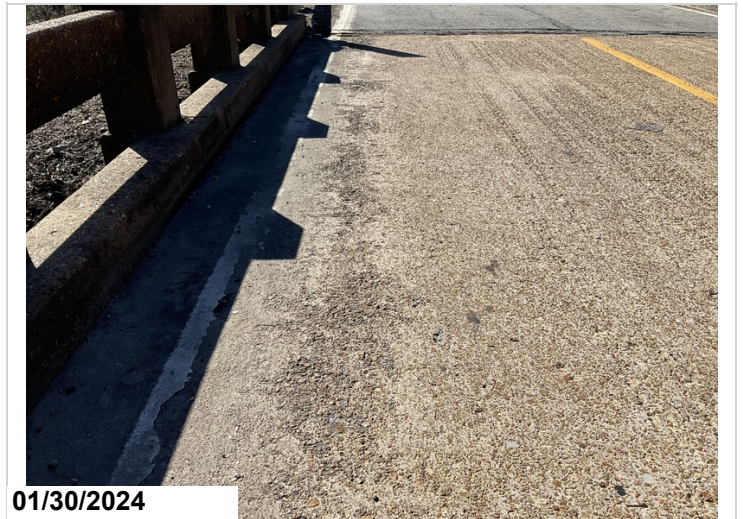
Moderate abrasion to deck in Right lane @ Span 1.(#3)

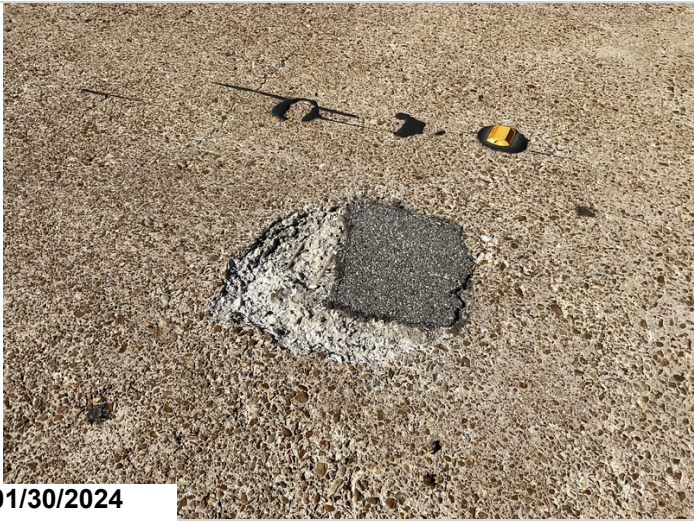
Spall with rebar exposed with s/l to deck @ Span 1.(#3)

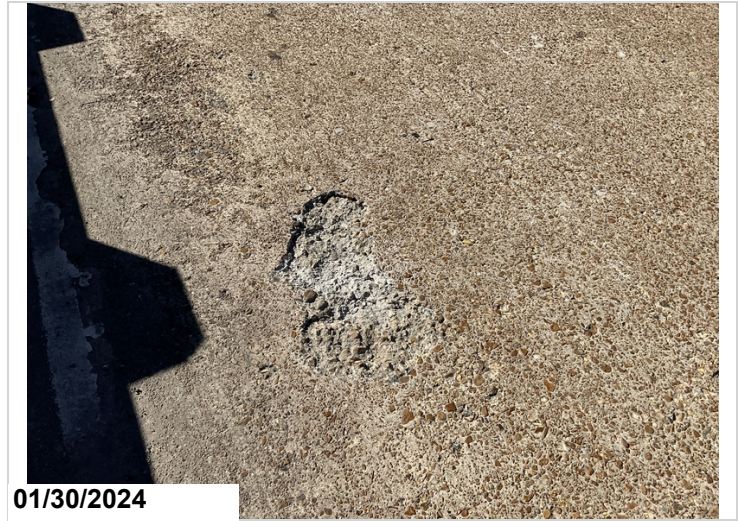
Spalls to deck @ Span 1.(#3)

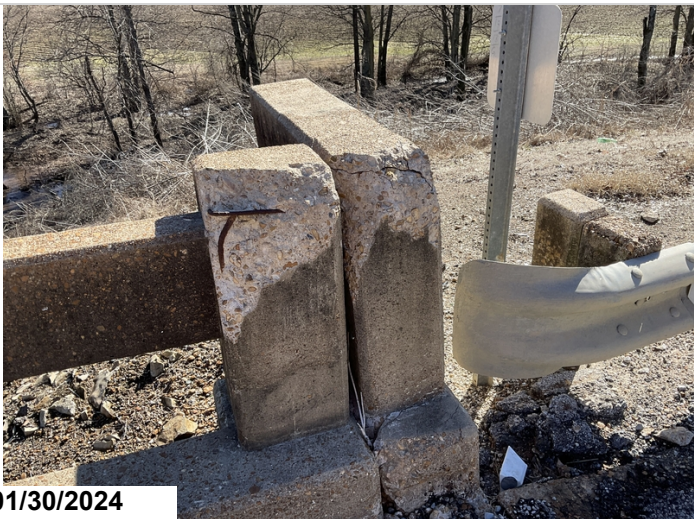
Damage to Right end post & Post 1 on Right @ Abutment 1.  
(#3)

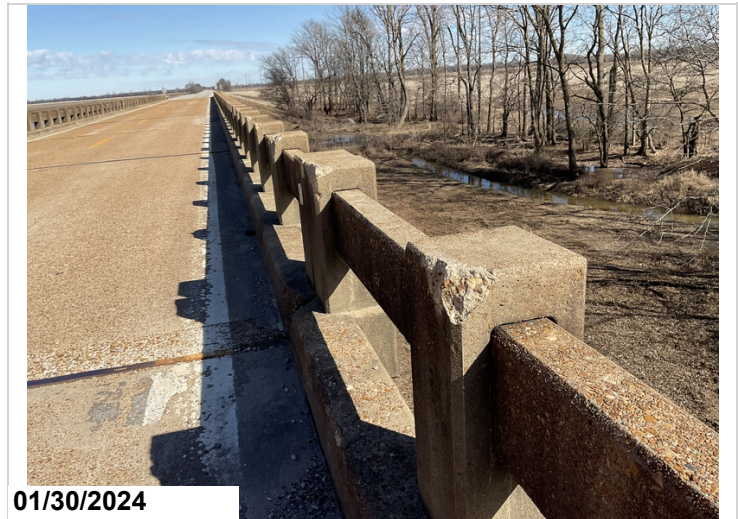
Typical spalls to tops of girders.(#3)

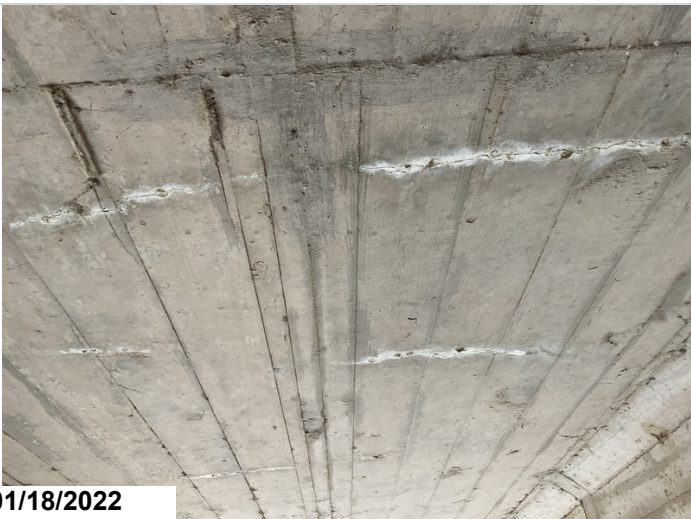
Typical efflor cracks to soffit @ all spans.

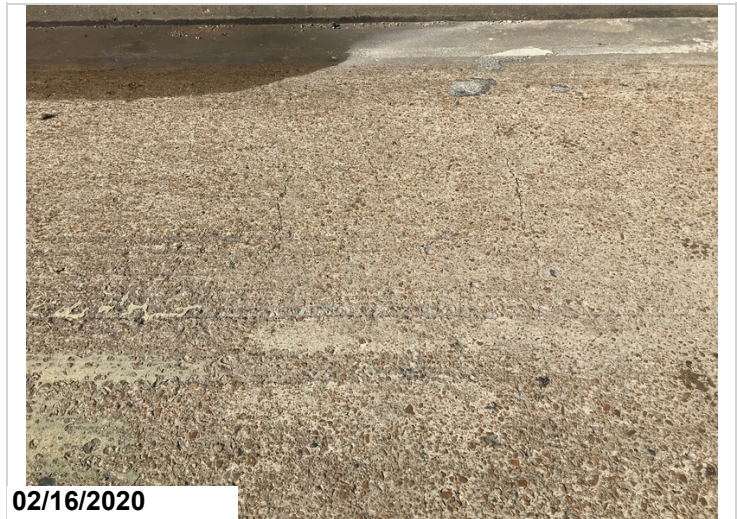
Transverse cracking to deck @ Span 1.(#3)

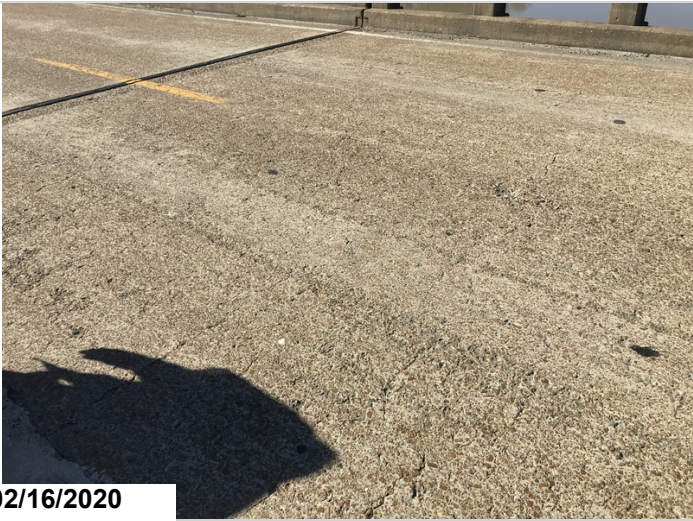
Transverse cracking to deck @ Span 11.(#2 & #3)

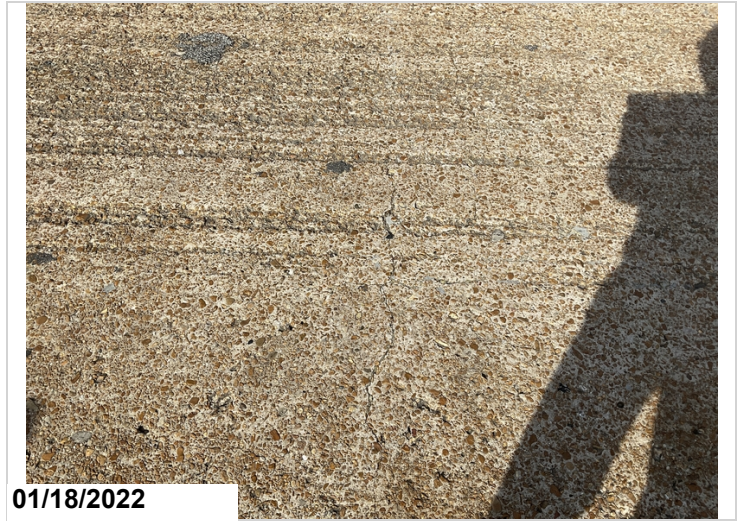
Typical cracks to deck @ all spans.

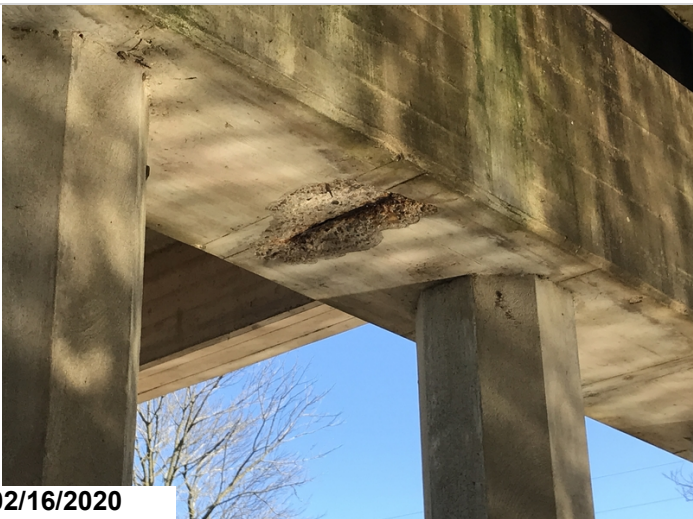
Spall with rebar exposed with s/l to bottom of cap @ Bent 5.  
(#3)

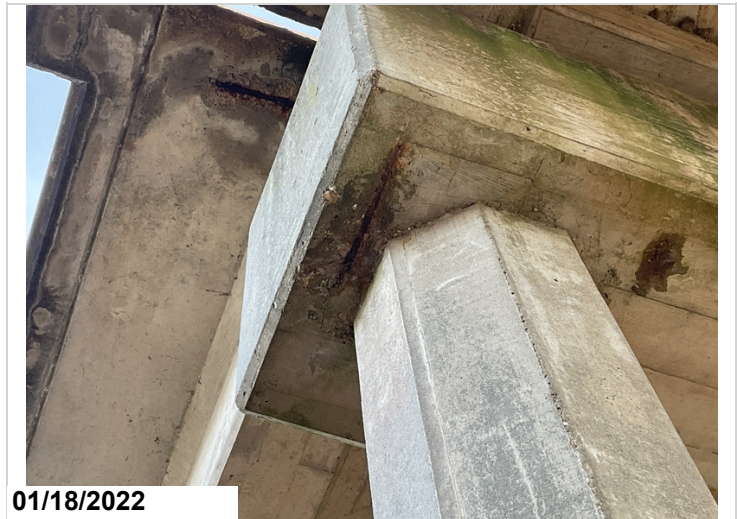
Spall with rebar exposed with s/l to Left end of cap @ Bent  
6.(#3)

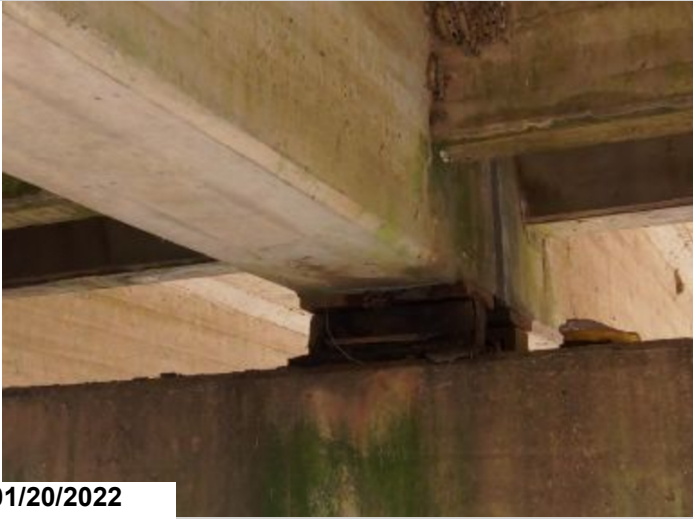
Missing anchor bolt to Girder 1 backside of Bent 1.

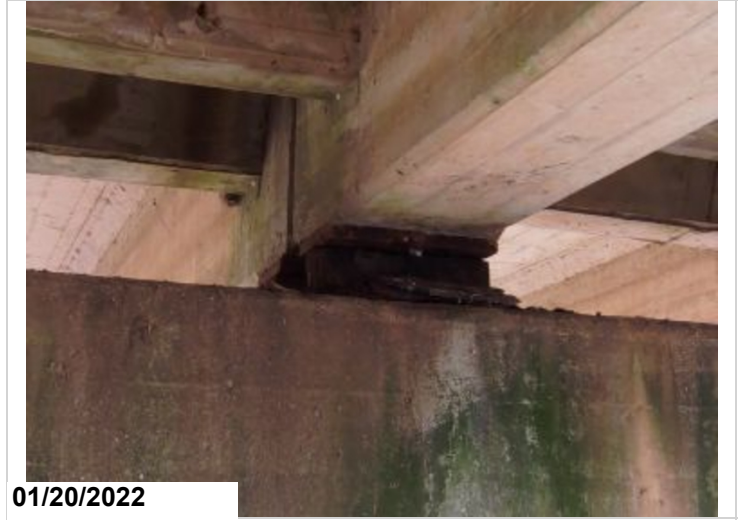
Missing anchor bolt to Girder 3 backside of Bent 1.

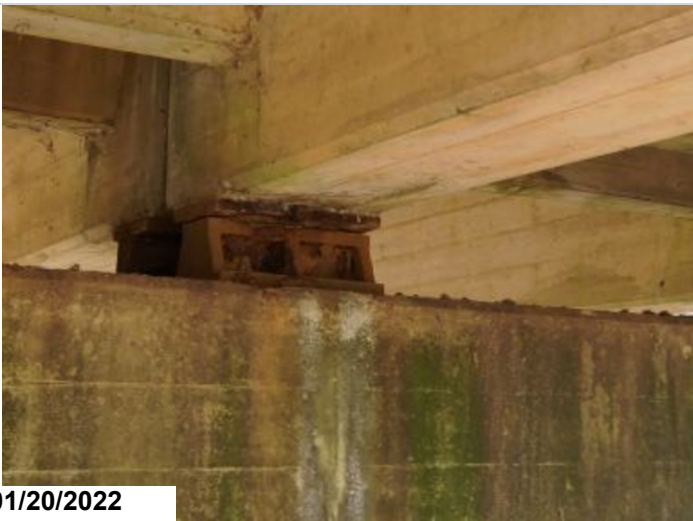
Missing anchor bolt to Girder 2 backside of Bent 2.

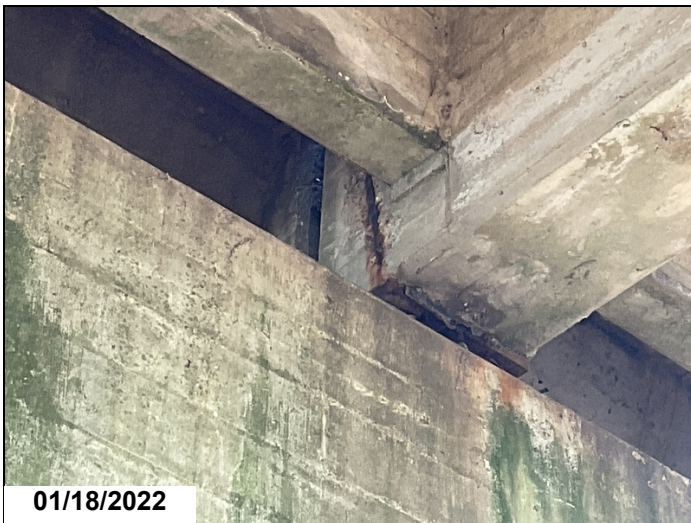
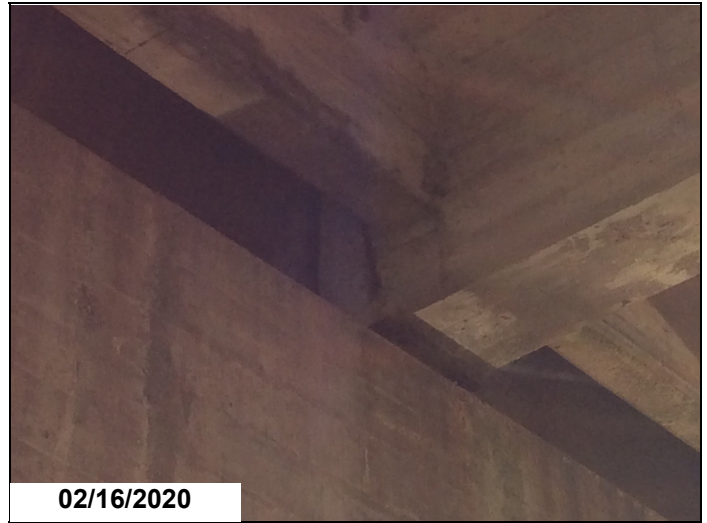
Spall w/ 1' rebar exposed to girder 3 at end of span 5

Spall w/ 1' rebar exposed to Girder 3 at end of Span 5.

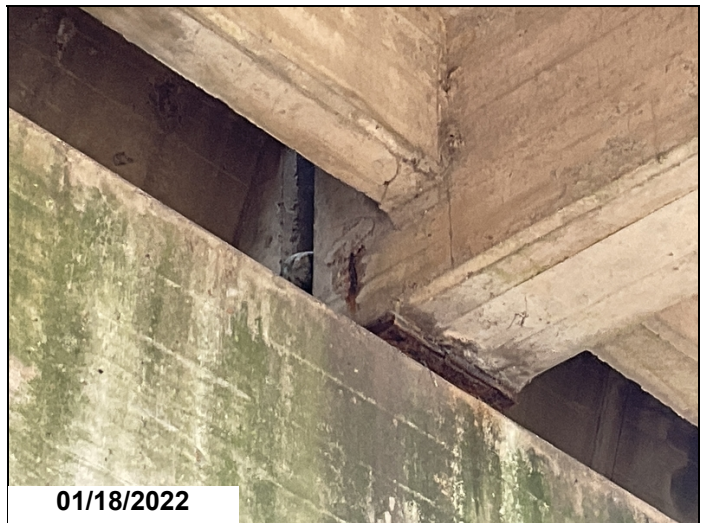
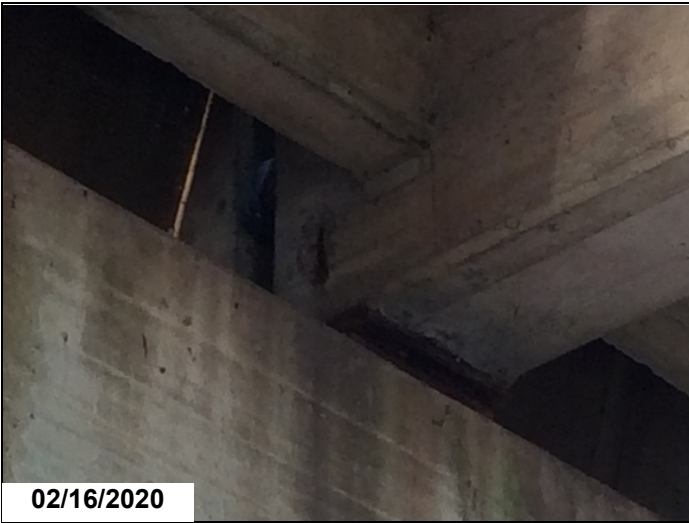
Spall w/ 4" rebar exposed to girder 2 at beginning of span 6

Spall w/ 4" rebar exposed to girder 2 at beginning of span  
6

Spall w/ 4" rebar exposed to Girder 2 at beginning of Span 6

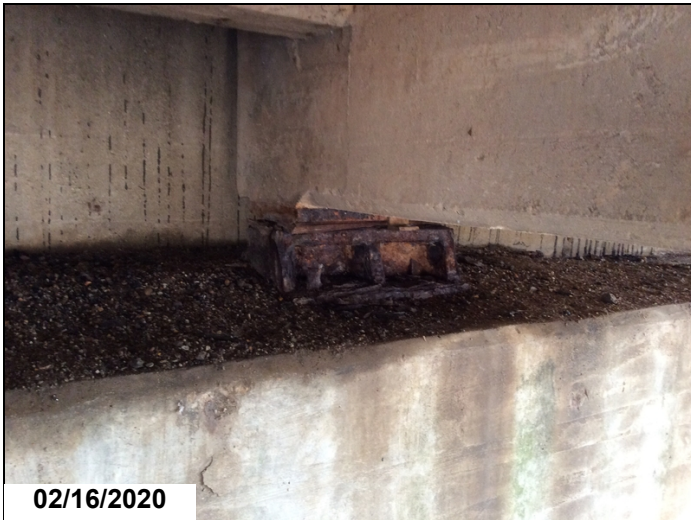
Bearing 3 @ Abutment 2.

Flaking rust w/section loss to bearings at all Bents, and section loss to several anchor bolts

**Type of Work:** Bearing Repair/Replacement

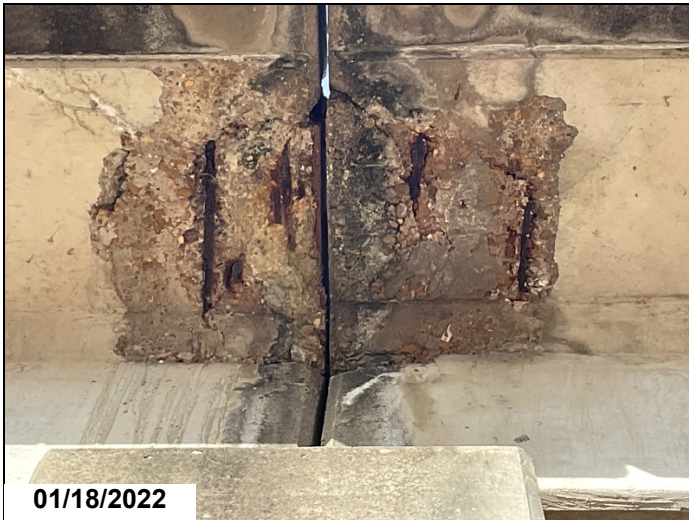
Spans 1 - 3, and 5 - 10  
Spalls with rebar exposed to Left and Right overhangs at joints.

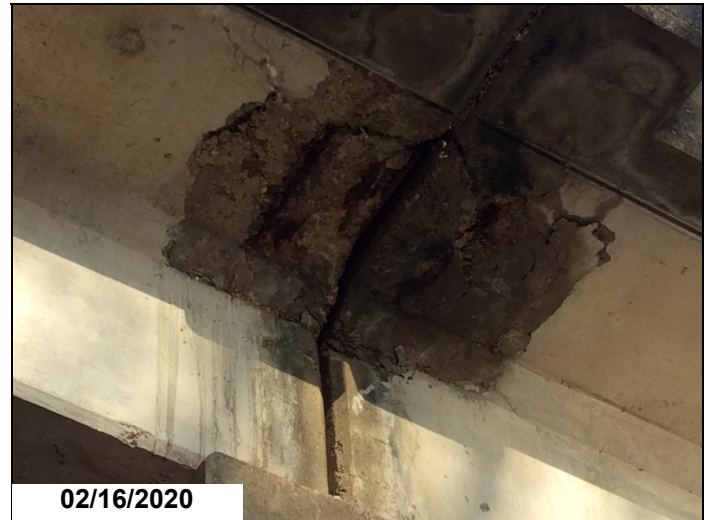
Spalls to Right overhang @ end of Span 9 & beginning of Span 10.

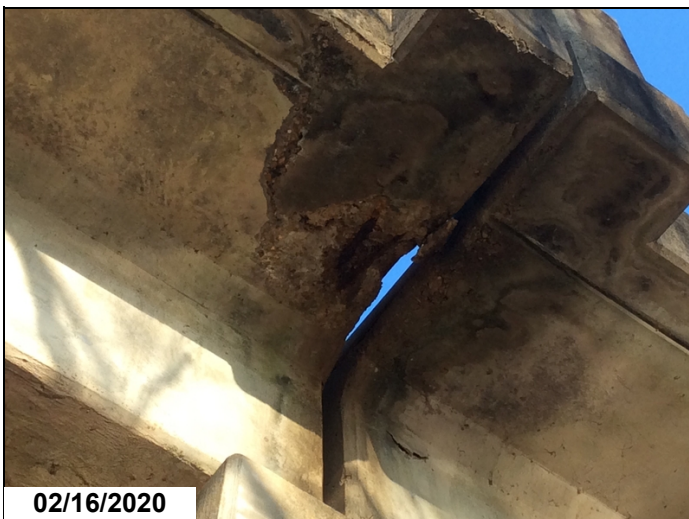
Spall with rebar exposed to Right overhang @ end of Span 5.

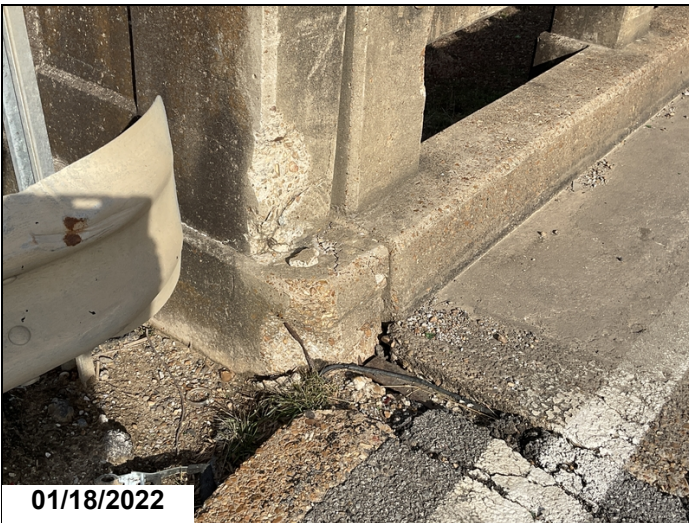
Left bridge rail posts at Spans 1, 8 and 10 have cracks and spalls to posts with rebar exposed.  
Span 1.

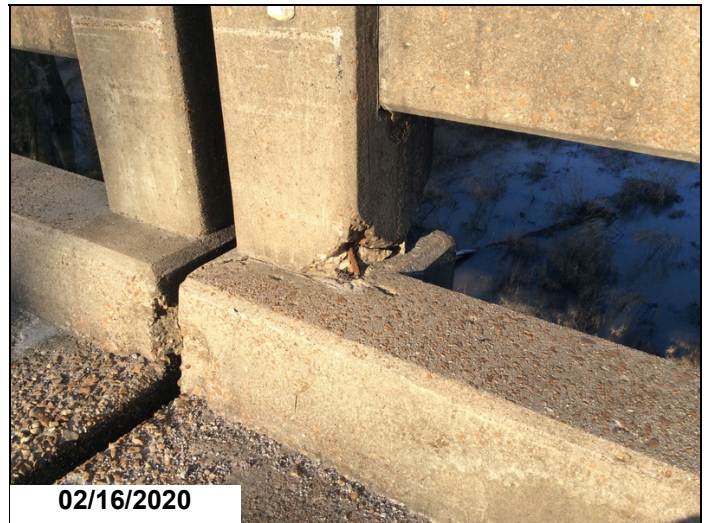
Left bridge rail posts at Spans 1, 2, 8 and 10 have cracks and spalls to posts with rebar exposed.

Left post @ beginning of Span 8.

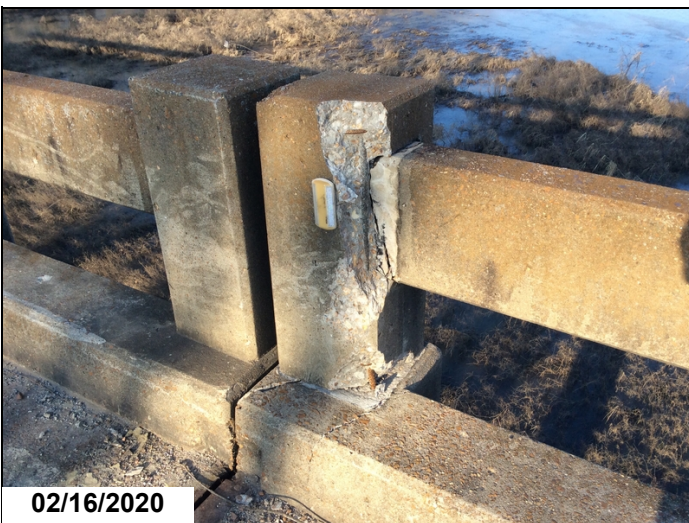
Left bridge rail post @ Beginning of Span 10.

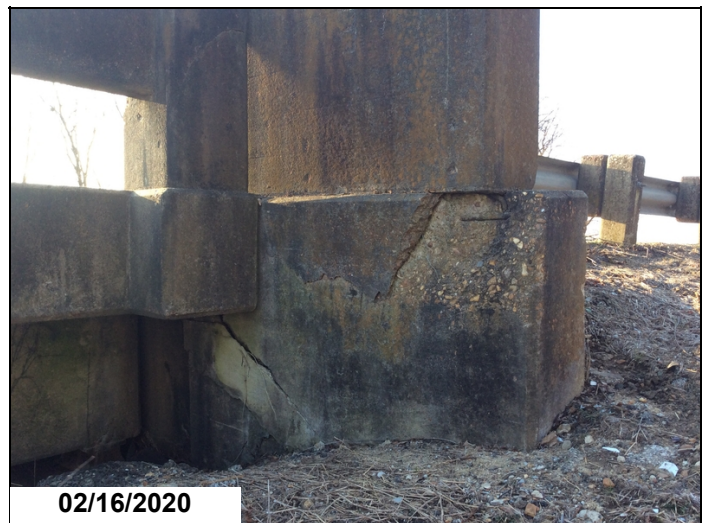
Left end post at Span 1.
