## Bridge 01881 Inspection Report

Asset #01881(Routine)

SH 367/Jackson Co. over WHITE RIVER RELIEF

Team Lead: Floyd Haley Inspection Date: 09/03/2024

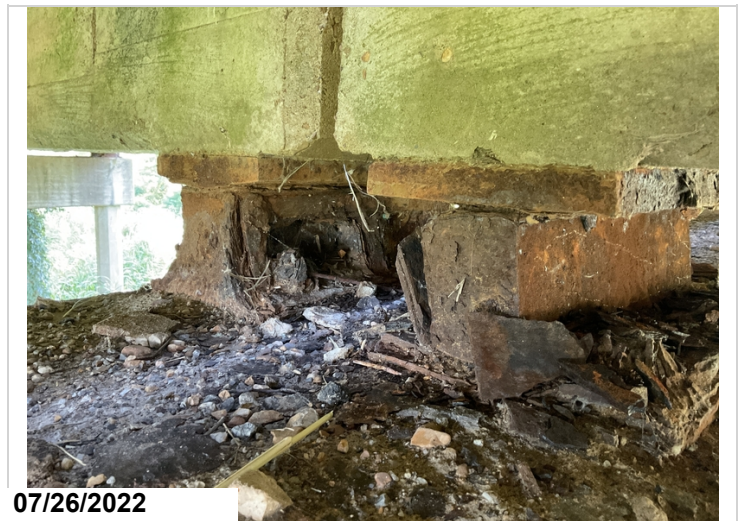
Bearings  
Rust, pack rust, and section loss to all moveable and fixed bearings.

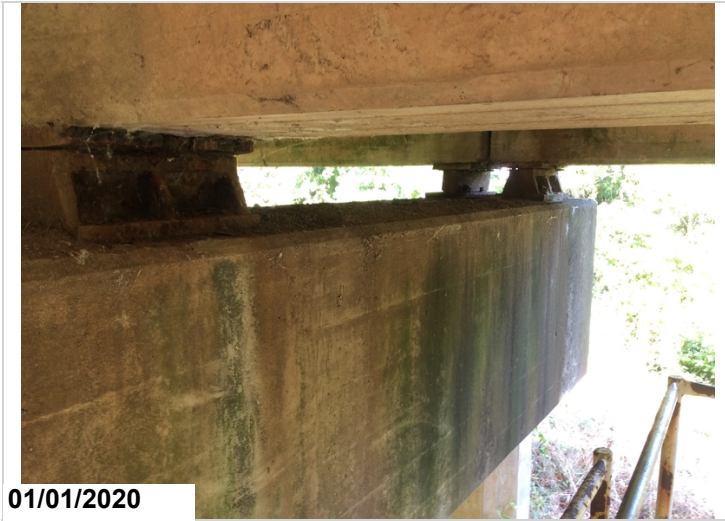
Typical condition of Fixed Bearings.

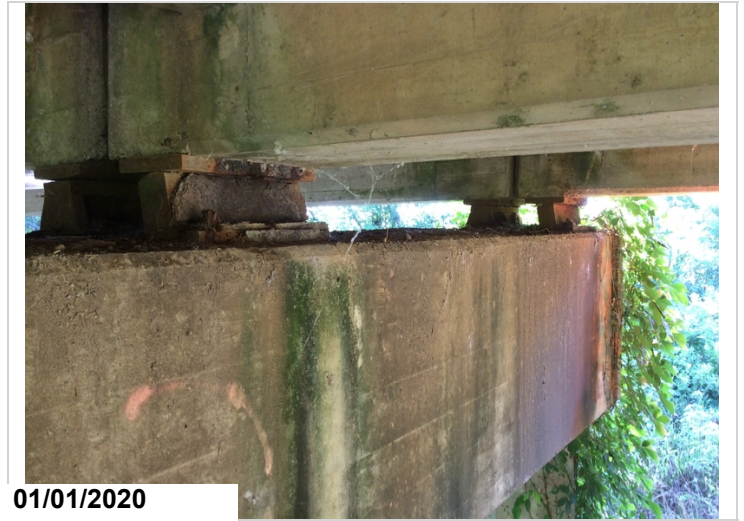
Typical condition of Moveable Bearings.

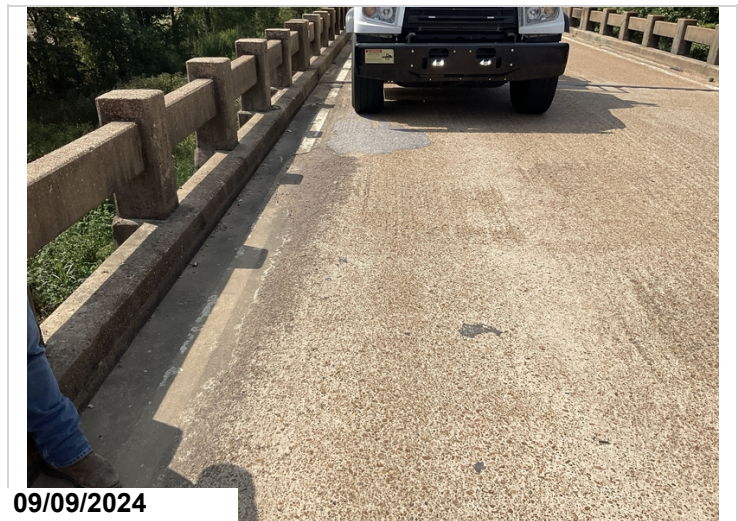
Span 36, right. Large spall

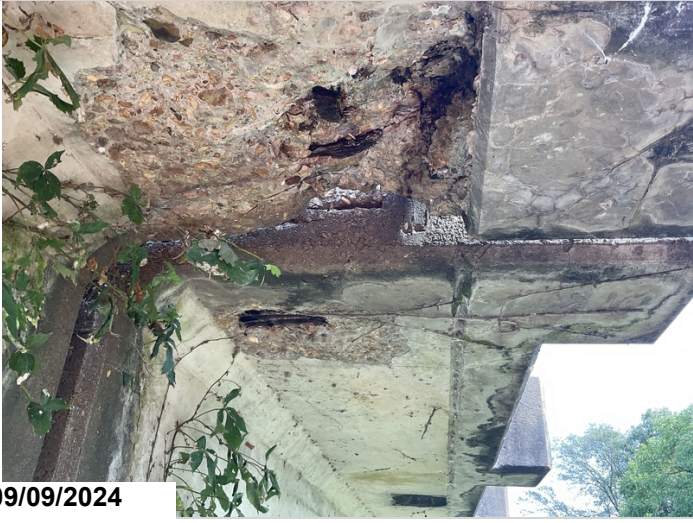
Bent 31, right, back has a large spall that is nearly 8" deep with heavily corroded rebar. 1sf cs3 spall, 1sf cs3 rebar. Ahead this location 1lf cs3 rebar

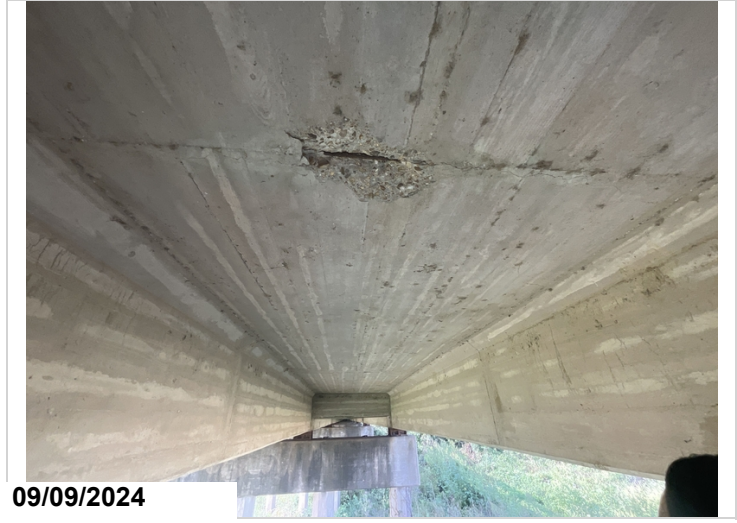
Span 13, bay 1: has exposed rebar. 1sf cs3 rebar

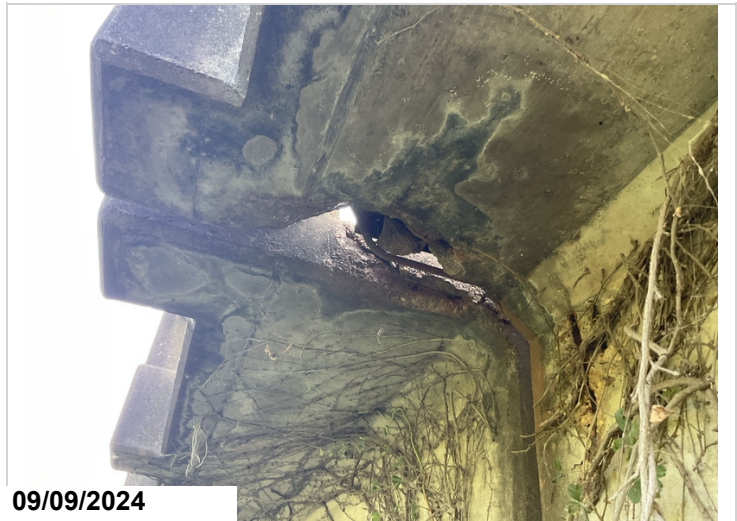
Bent 4, left, back, overhang: large spall at joint armor resulting in exposed rebar. 2sf cs3

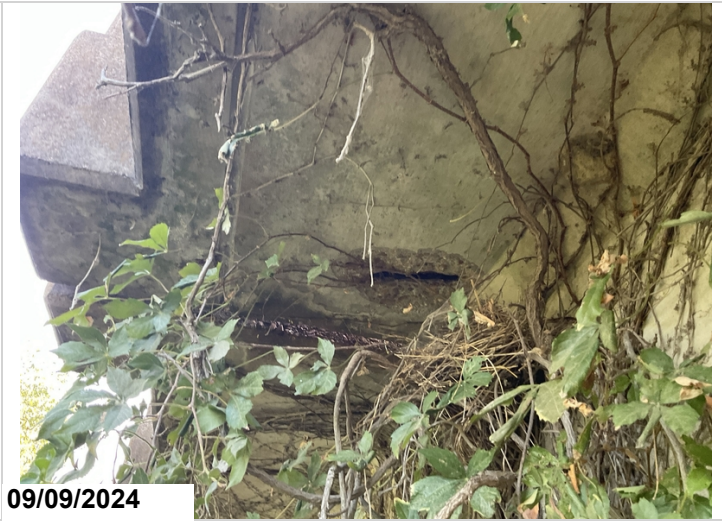
Bent 3, back, left, undersurface. Spall with exposed  
reinforcing steel. 1sf cs3  
Span 5, right: 1sf cs3  
Bent 6 left, back. 1sf cs3

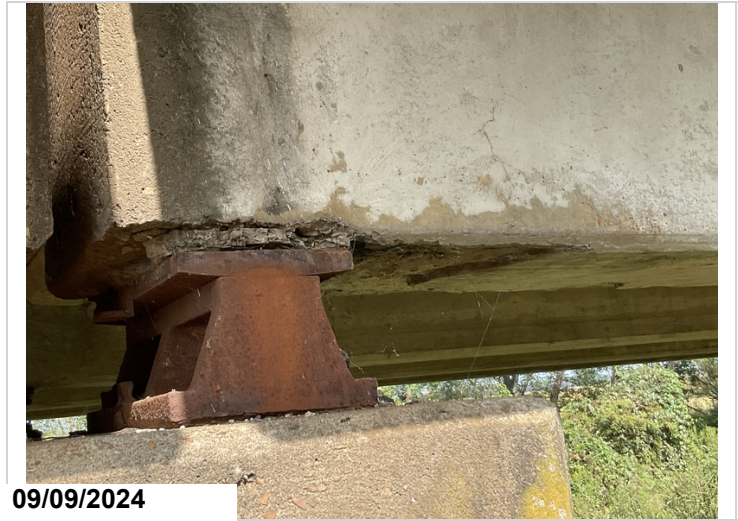
Bent 28, ahead, girder 4. Deterioration to girder end for 3ft.  
3lf cs3

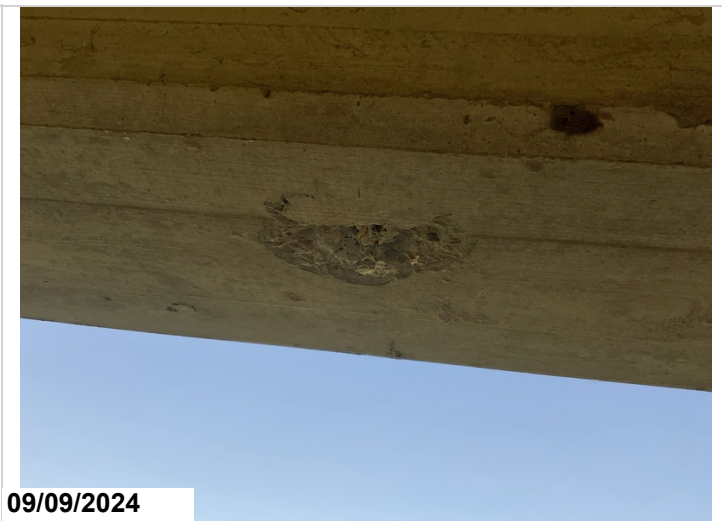
Bent 24, back girder 1: has a spall. 1LF CS3

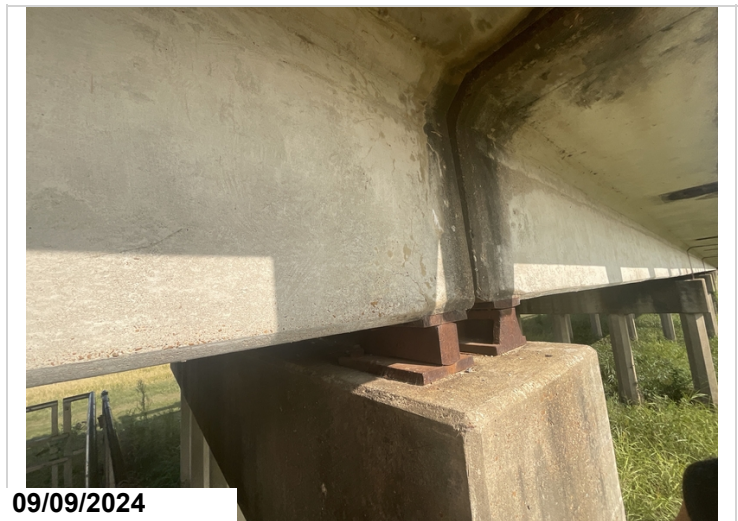
Bent 13, girder 4, back: has a shear crack measuring 6". 1LF  
CS3

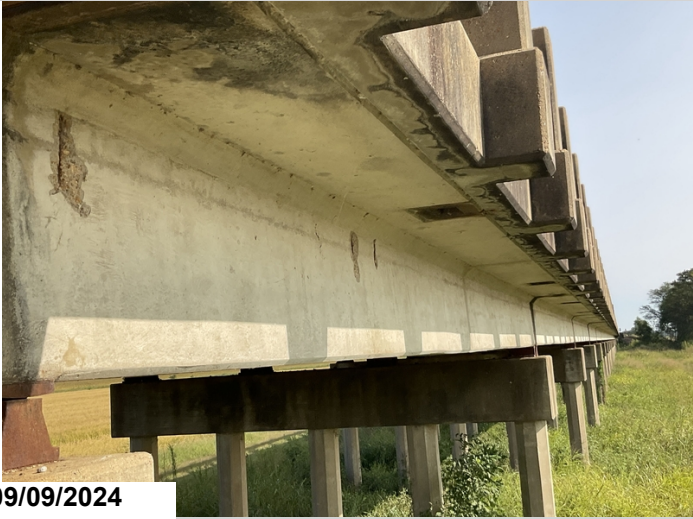
Span 13, girder 4, right: has small spalls with exposed rebar.  
3LF CS3

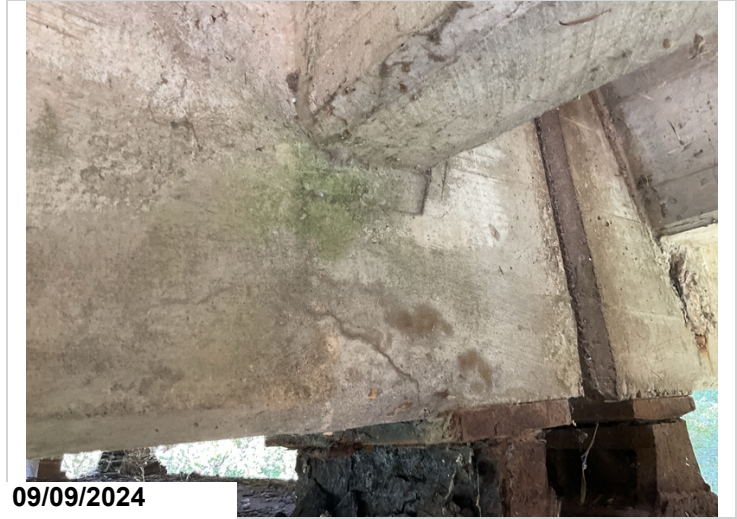
Bent 7, back, girder 2, right. 8" shear crack coming from  
bearing. This crack is mirrored on the left side

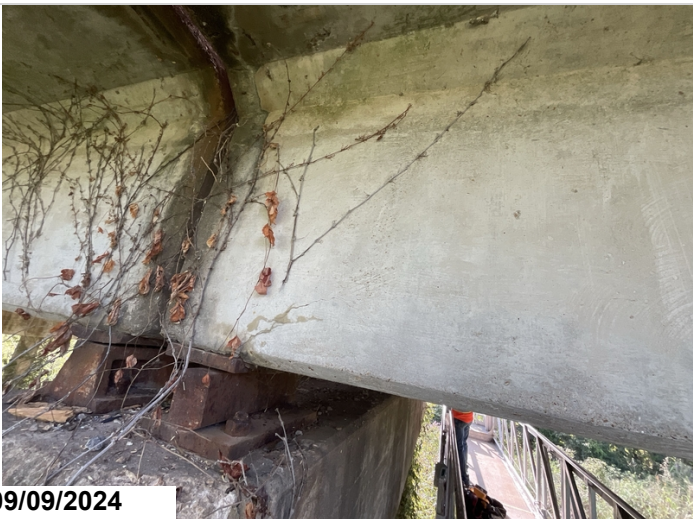
Bent 07, back, girder 1, left: has an 8" shear crack from the  
bearing area. Not mirrored on right. 1LF CS3

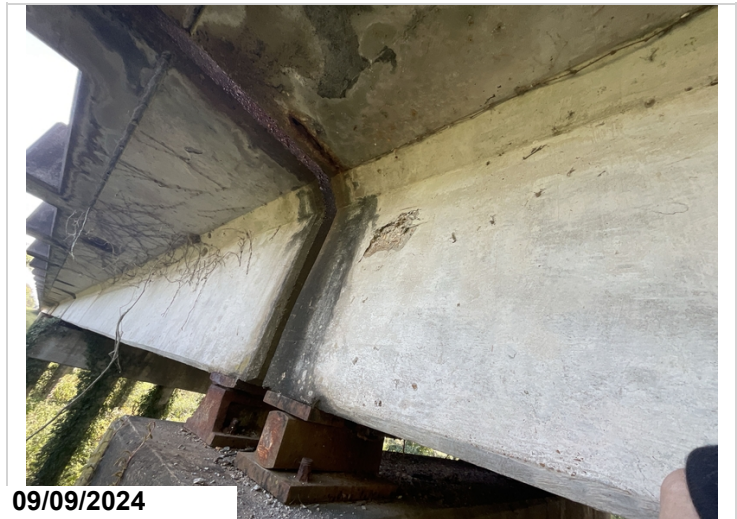
Bent 05, girder 1, left: has a minor spall. 1LF CS3

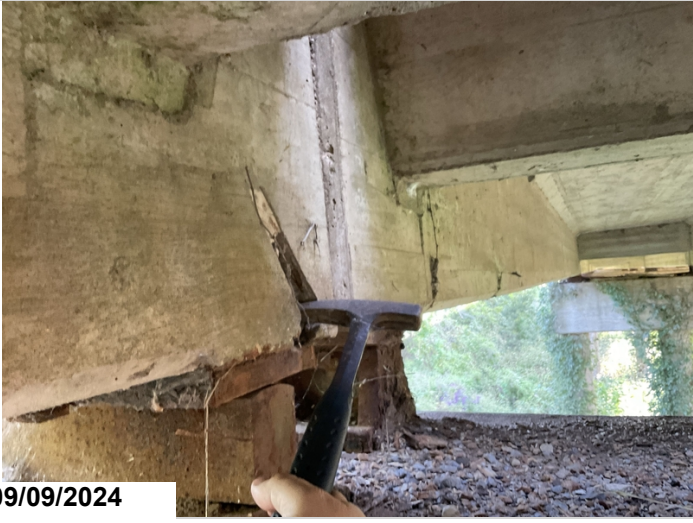
Bent 5, girder 1, right: has a void in the end 1.5" deep and 6" tall above the bearing

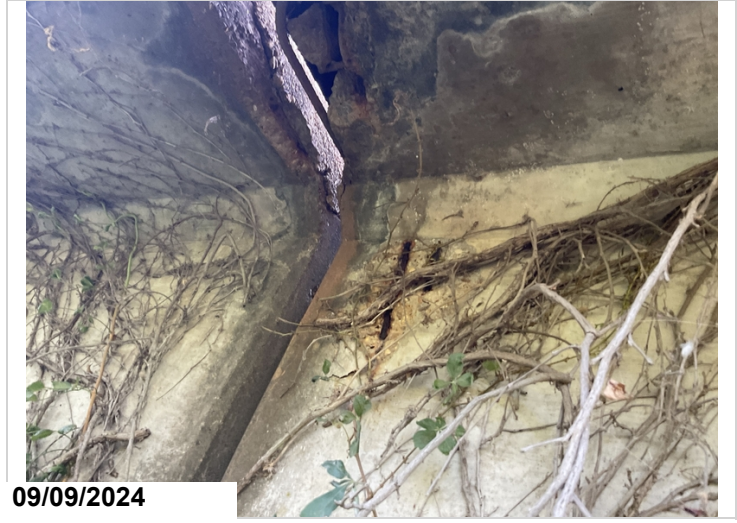
Bent 04, back, girder 1: has a spall with exposed rebar. 1LF CS3

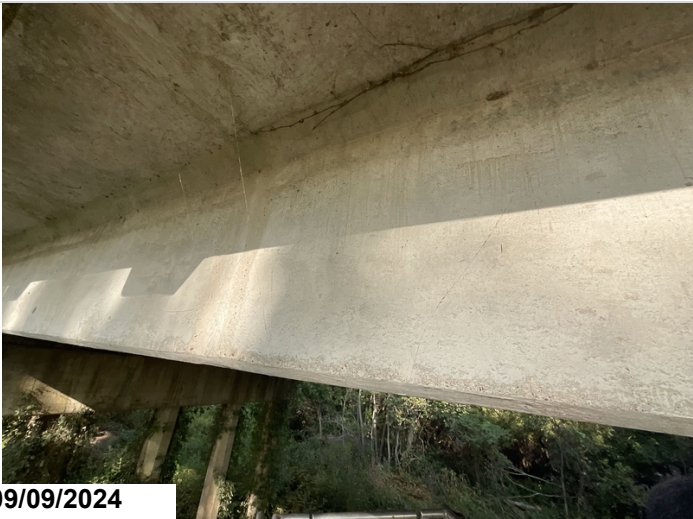
Typical girders have hairline flexure cracks at midspan.

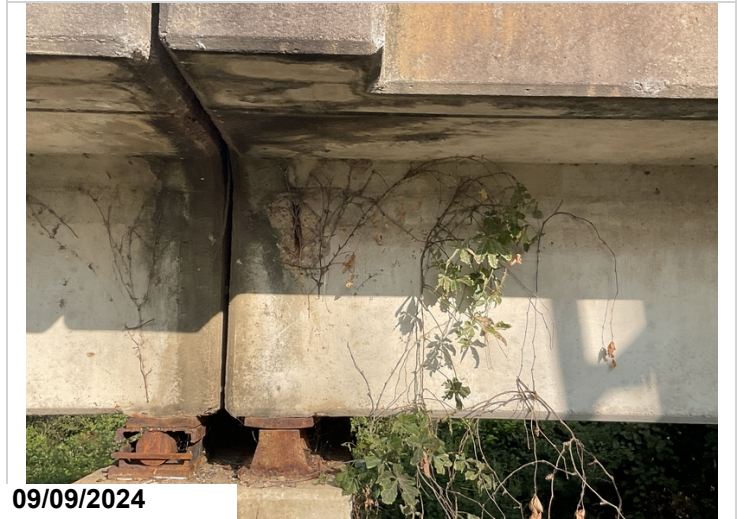
Bent 2, ahead, girder 4: spall with rebar. 1LF CS3

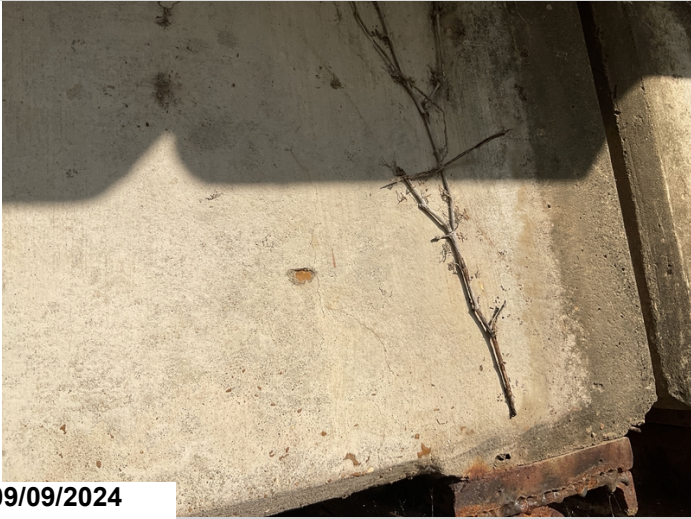
Bent 2, back, girder 4: typical hairline cracks at the girder ends

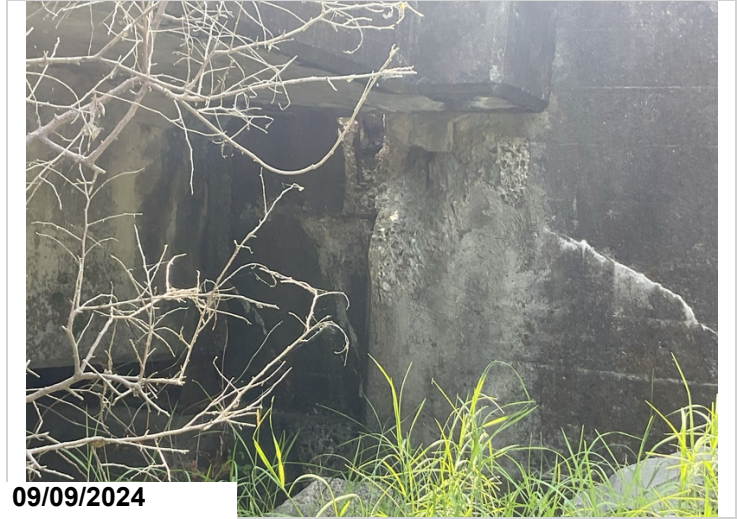
Abutment 1, left:

Abutment 1: has minor scour with 2 piles exposed. 16LF CS2

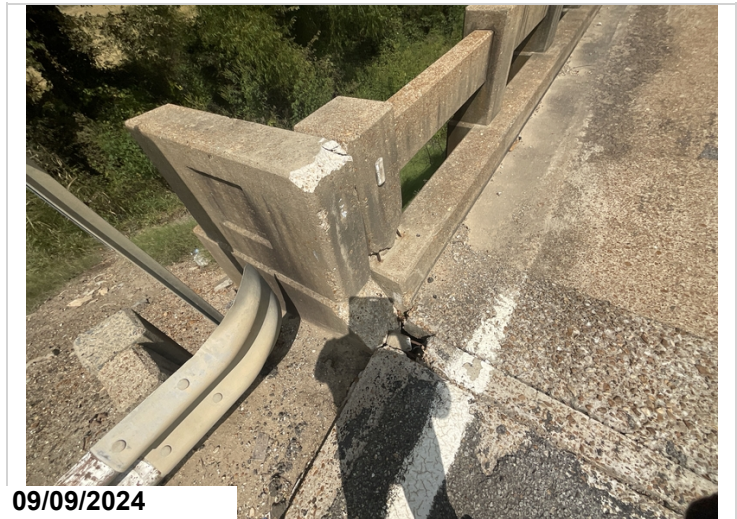
Abutment 1, left: the wing wall has broken away similar to abutment 2.

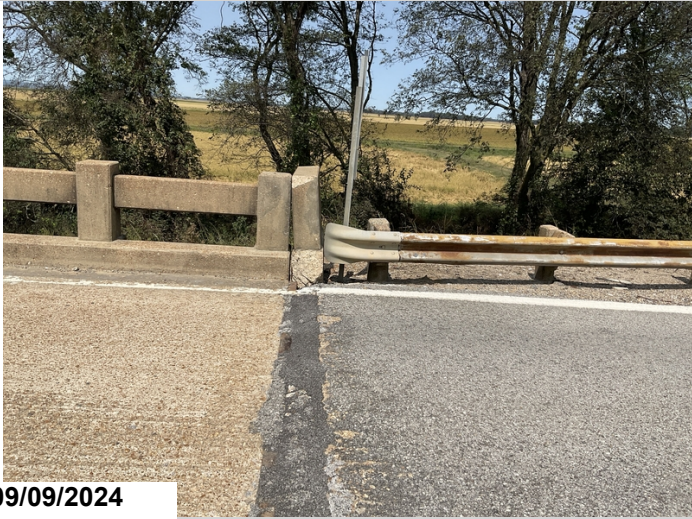
Abutment 2, left, end post at wing wall: has broken away.  
The right end is similar

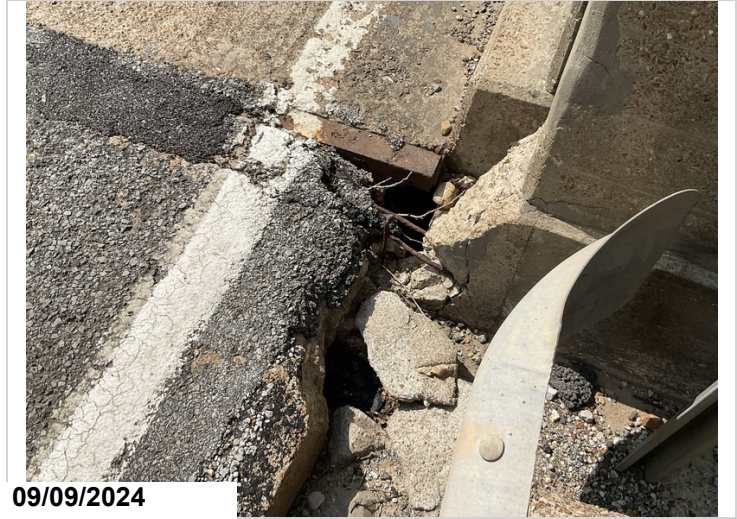
Abutment 2, left: Spalling on the headwall has caused a hole  
in the left shoulder. Right side is similar. 1LF CS3

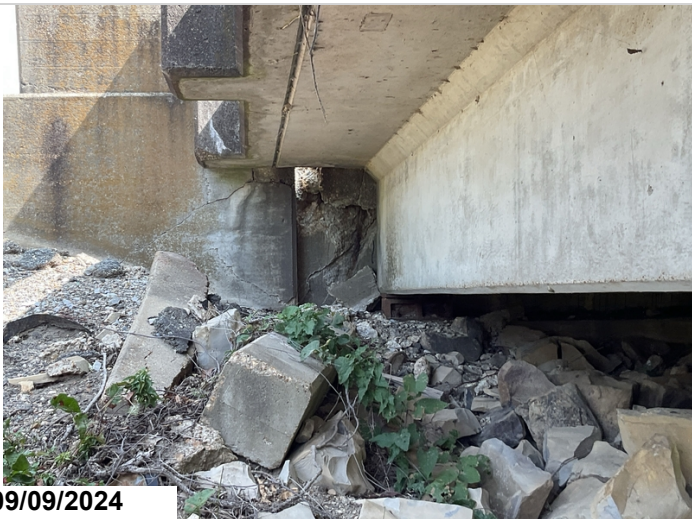
Abutment 1, left: has a large spall where the wingwall end  
post has broken. 2LF CS3 exposed rebar, 4LF CS3 crack

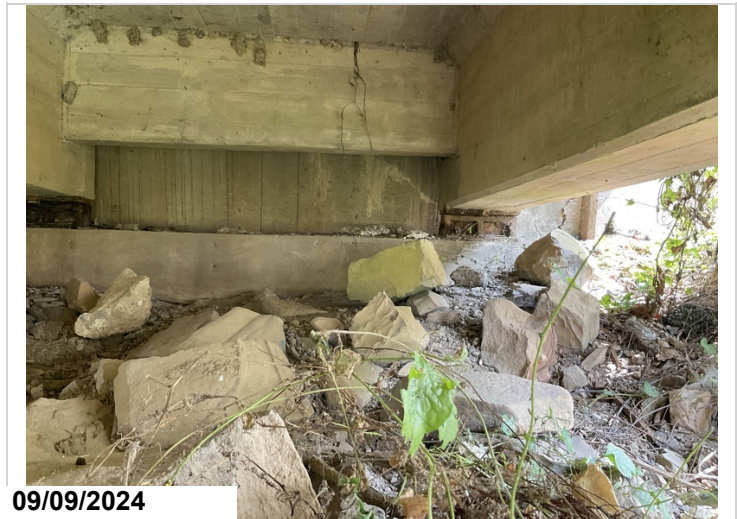
Abutment 2: typical diagonal efflorescent cracks. 8LF CS2

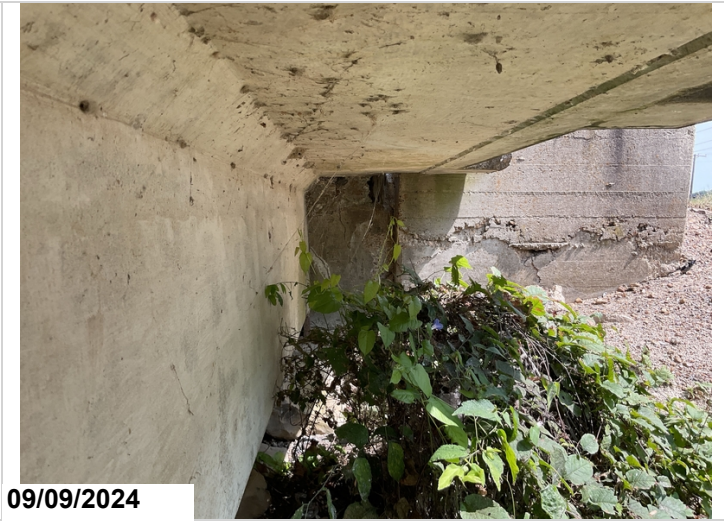
Abutment 2, right: has a large vertical crack. 1LF CS3

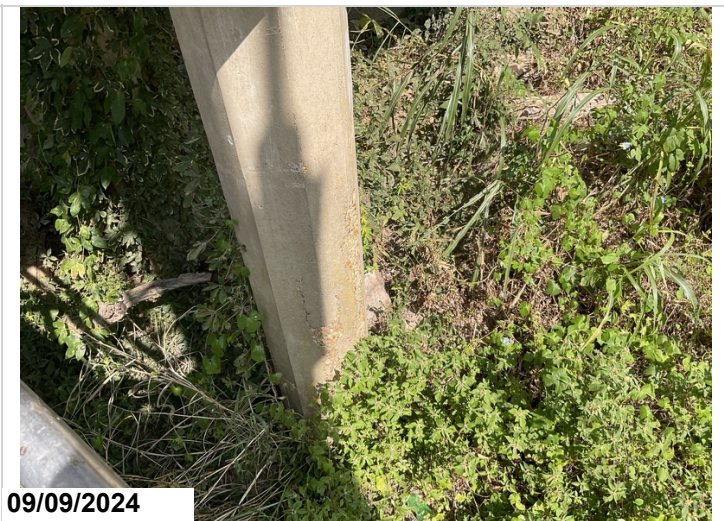
Bent 35, pile 5: has a spall. 1EA CS3

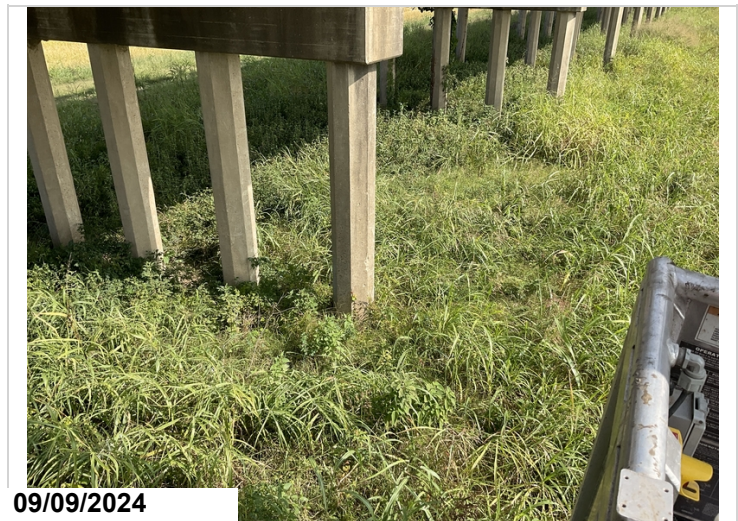
Bent 17, pile 5: has a spall. 1EA CS3

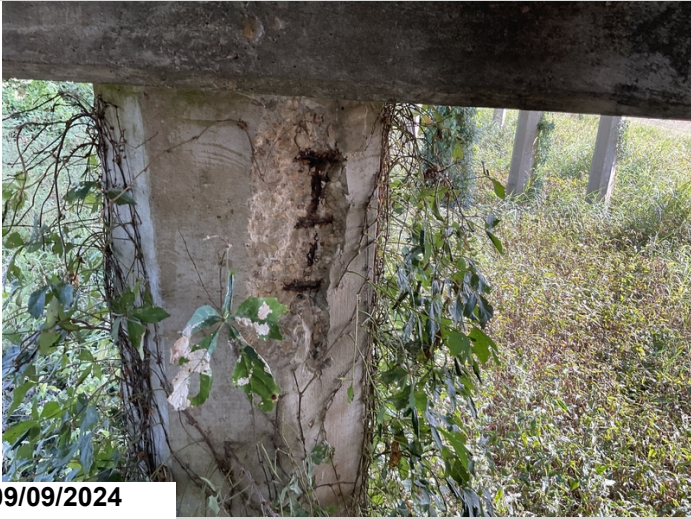
Bent 9, pile 2, back: has a spill with exposed rebar. 1EA CS3

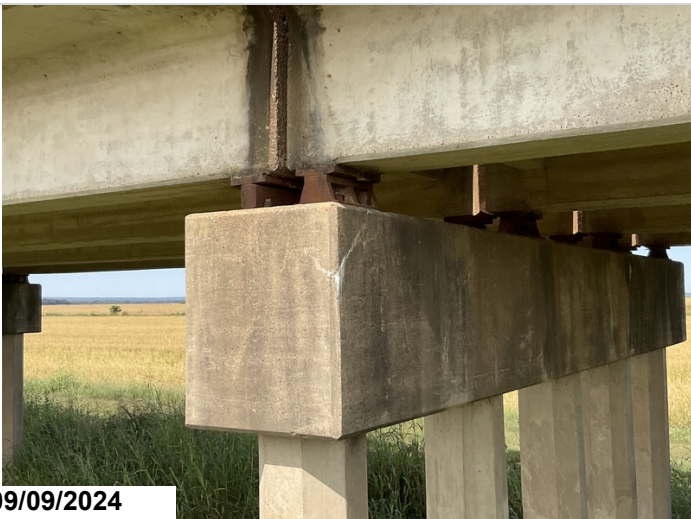
Bent 23, ahead, right, cap: has a diagonal efflorescent crack with buildup. 1LF CS3

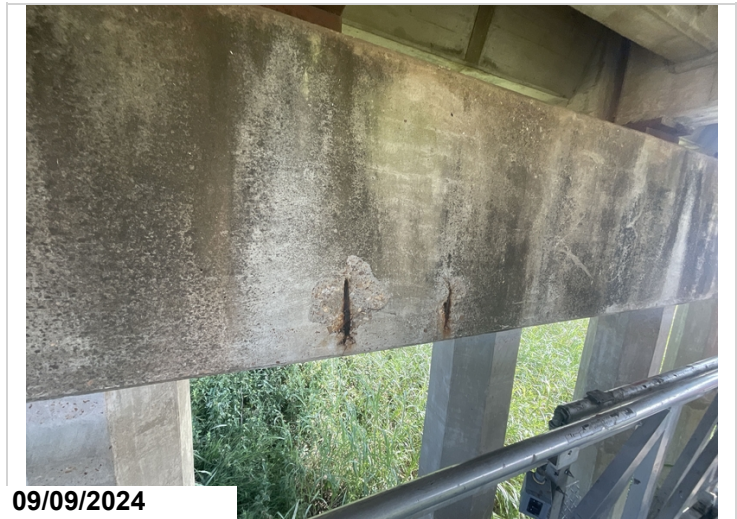
Bent 23, back, cap: has a spill with exposed rebar. 2LF CS3

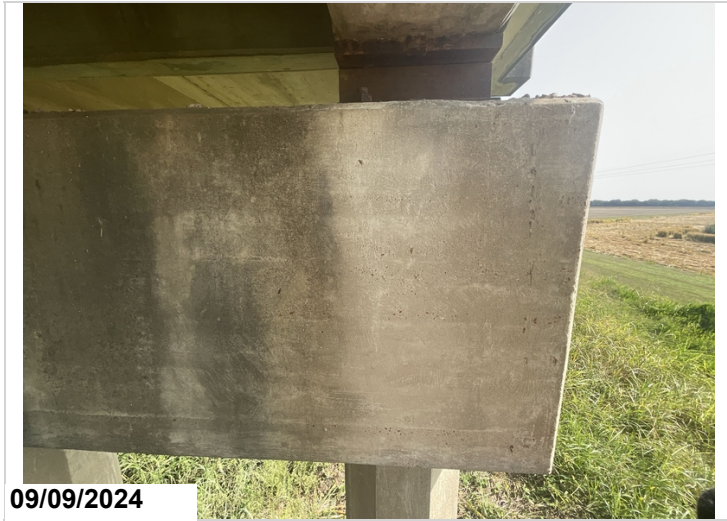
Typical cap crack

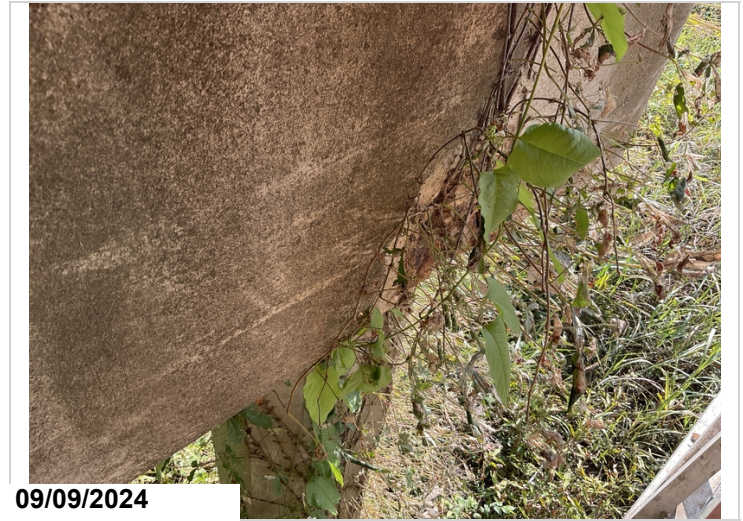
Bent 09, right, back, over pile 5: has a spall with exposed rebar. 1LF CS3

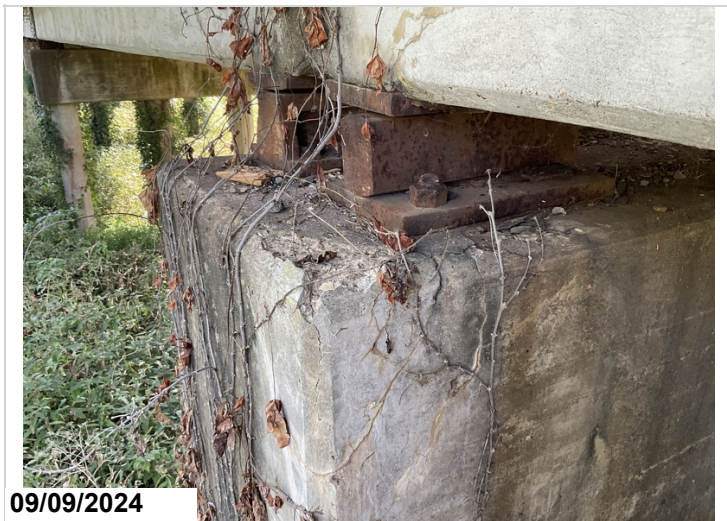
Bent 07, left, back: spall at cap end. 2lf cs3

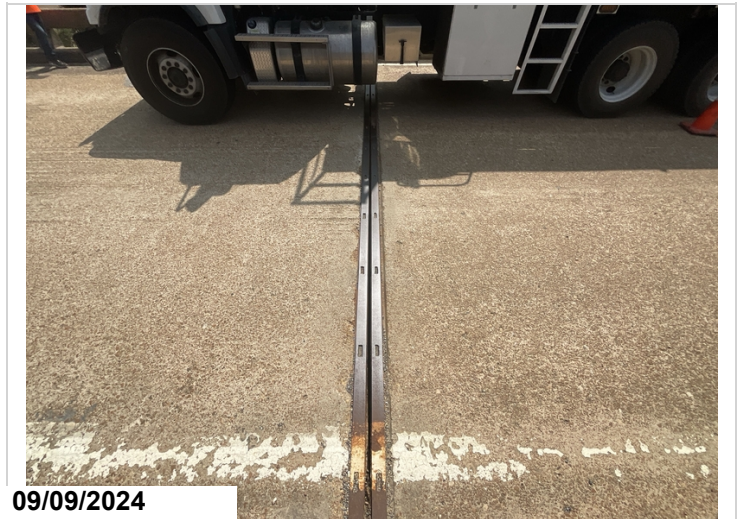
Bent 35: typical broken armor 15LF CS3

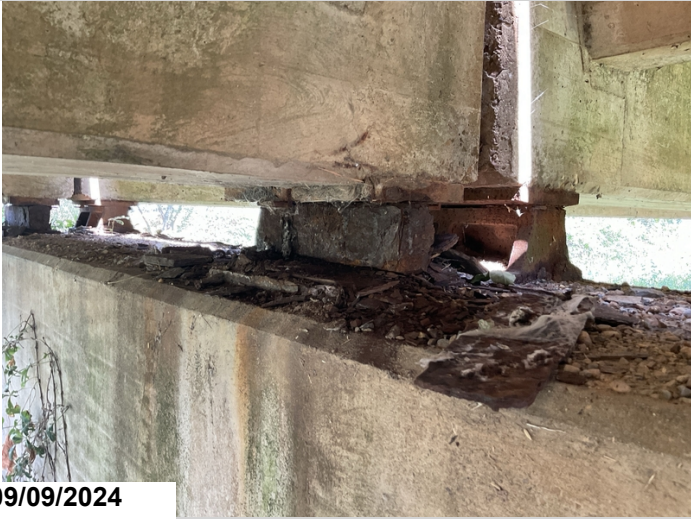
Bent 29, back, bearing 2: is non bearing. 1EA CS3

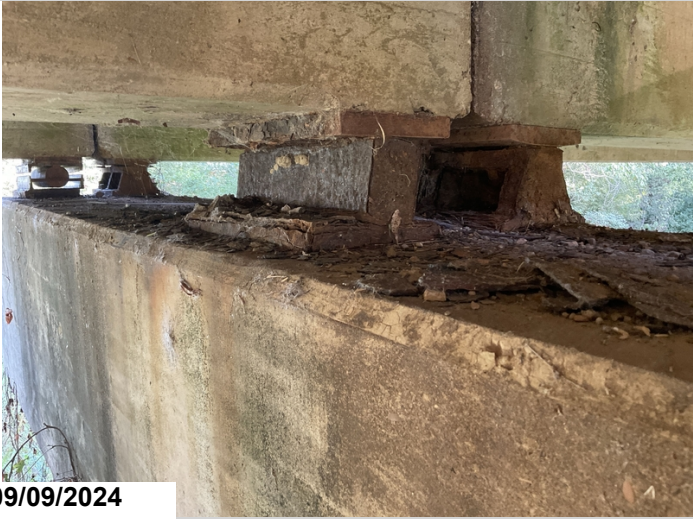
Bent 2, back: typical movable bearings have cs3 corrosion throughout with pack rust and section loss.

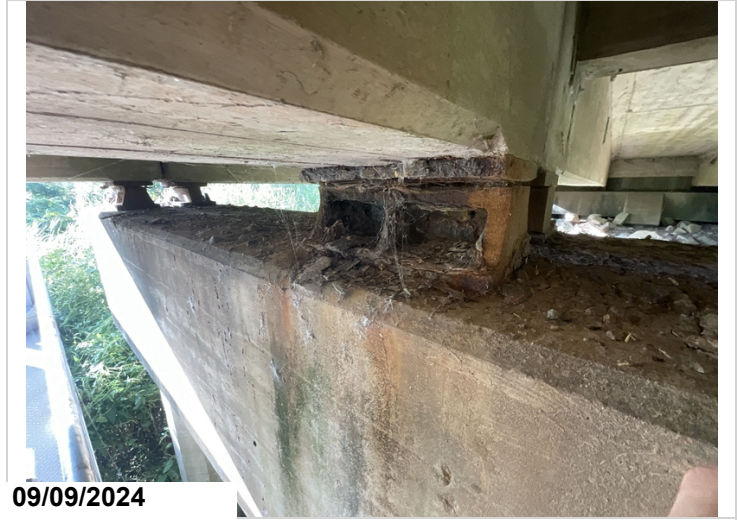
Typical fixed bearings have corrosion with section loss throughout

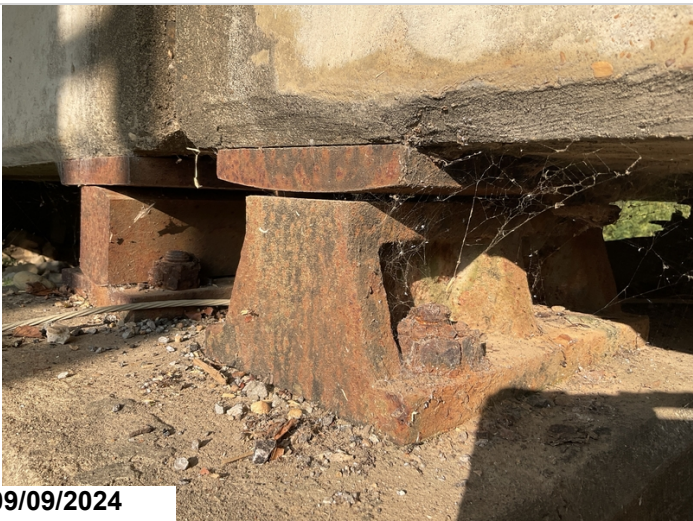
Bent 1, ahead, fixed bearings: pack rust has jacked the bearings up 1/8" all the way across.

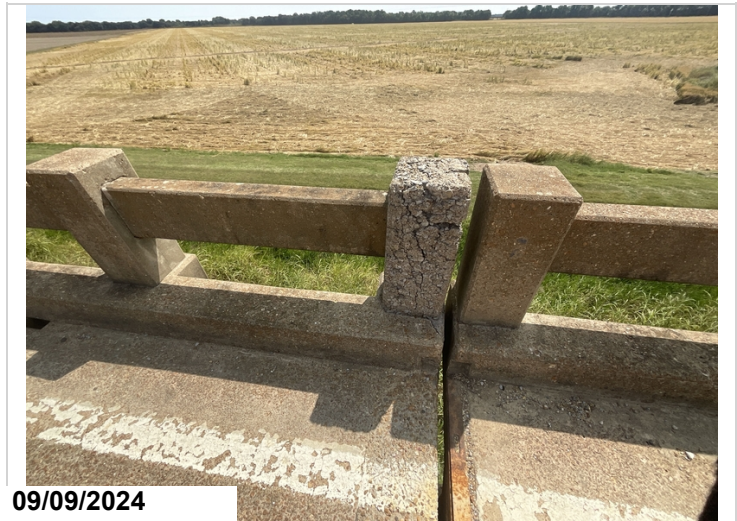
Bent 17, right, ahead: Heavy deterioration to the post. 1LF CS3

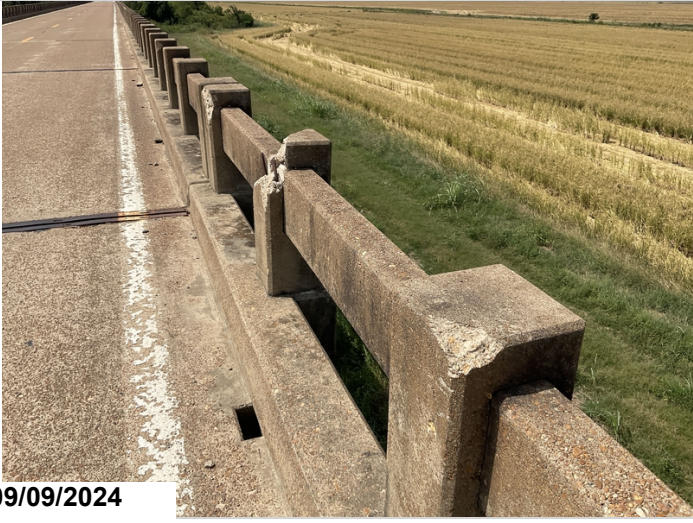
Span 23, left: spalling throughout.

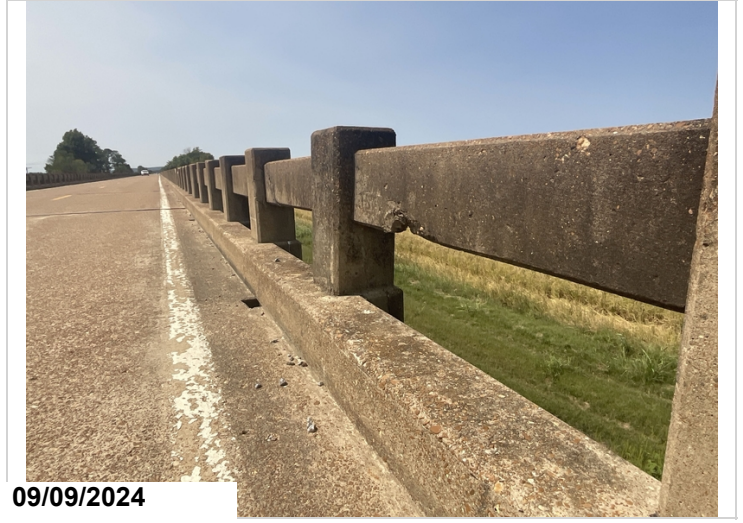
Span 26, left: typical spalling and cracking to guard rail.

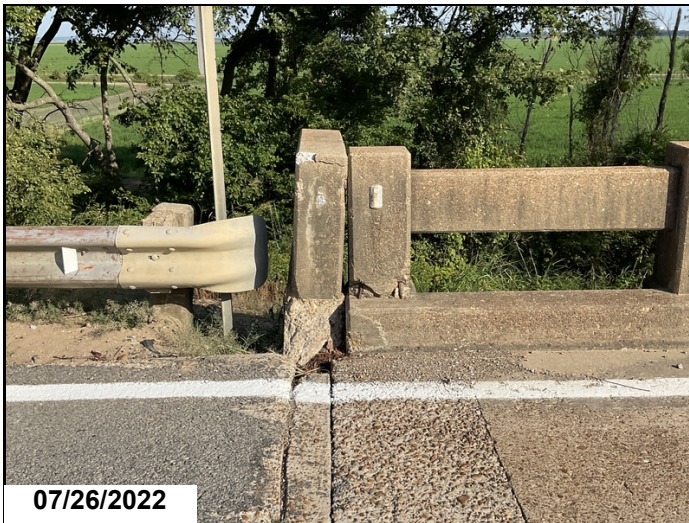
Settlement @ abutment 1.

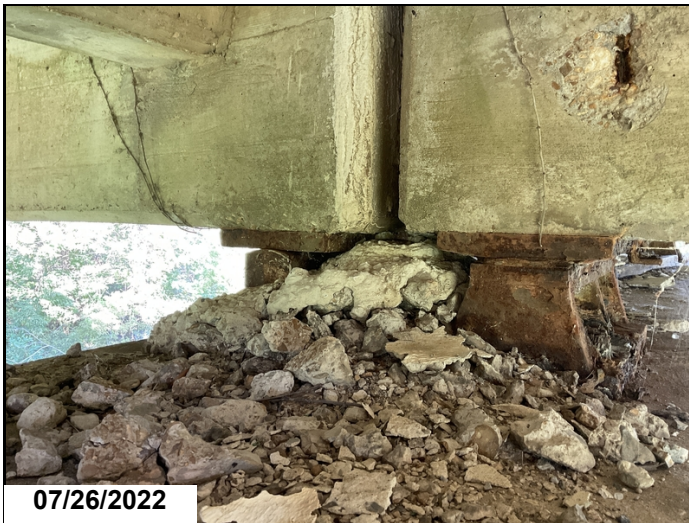
Span 6 - Concrete from Deck repair blowout restricting movement of Moveable Bearing 2 at Bent 6.

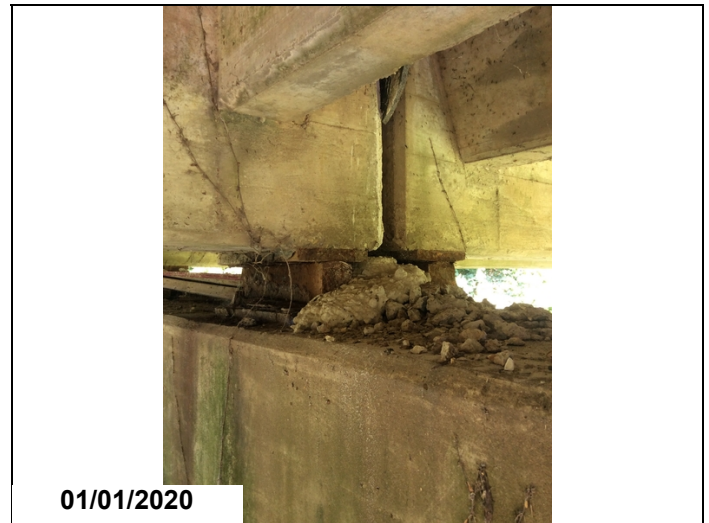
Span 6 - Concrete from deck repair blowout restricting movement of Bearing 2 Bent 6.

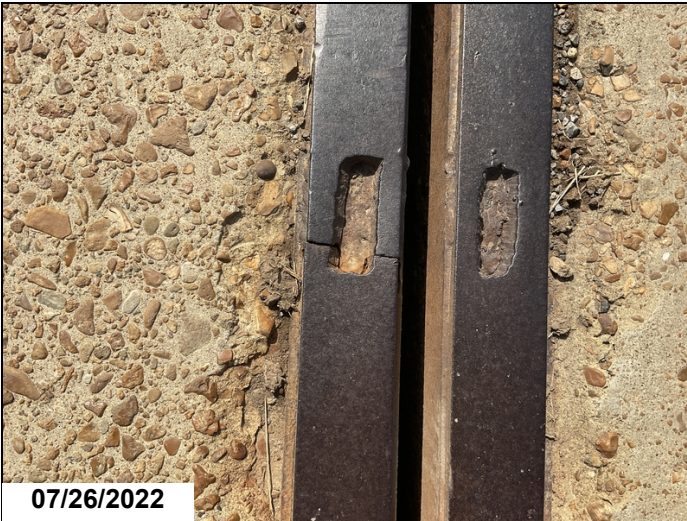
Cracks welds or broken/loose road iron at:  
Span 2 - Beginning of span.

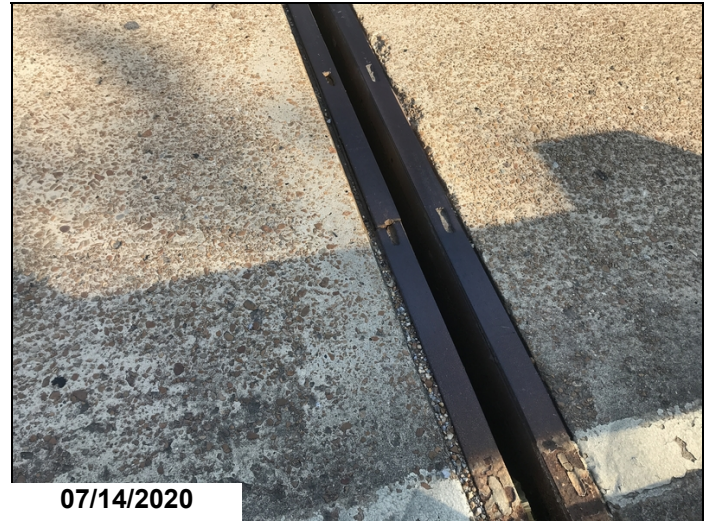
Span 27: Broke road iron at End of span.

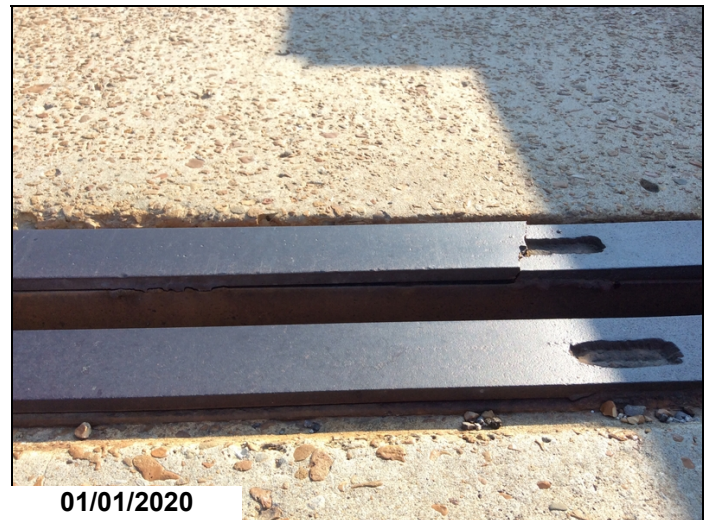
Span 33 - Broke road iron at Beginning of span.

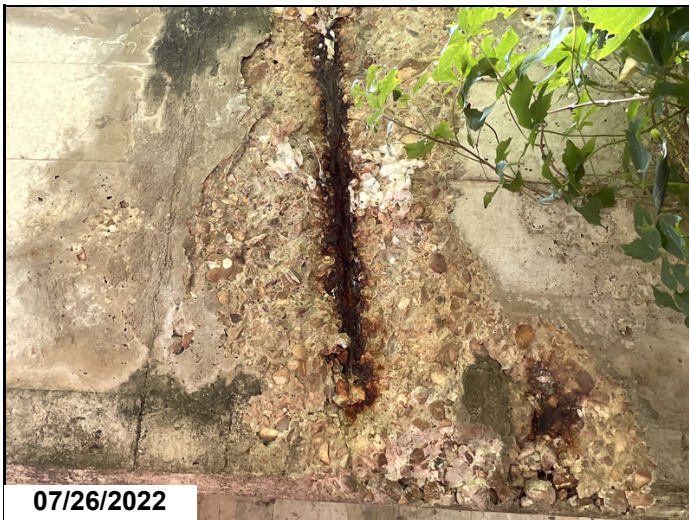
Concrete Caps

Bent 09, between piles 4 and 5, underside, cap: has a spall with exposed rebar. 2LF CS3

Spalls with rebar exposed at Bents 4, 9, 23, 25 & 32.  
Bent 9, between piles 4 & 5.

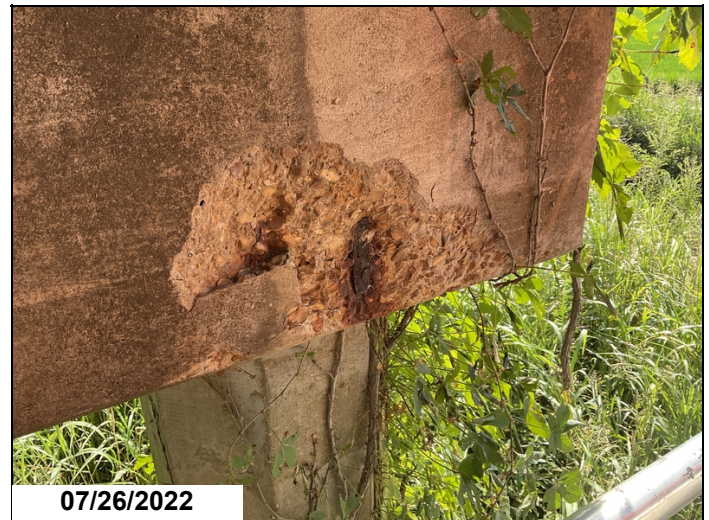
Concrete Caps

Bent 09, right, back, over pile 5: has a spall with exposed rebar. 1LF CS3

Spalls with rebar exposed at Bents 4, 9, 23, 25 & 32.  
Rt side of @ bent 9.

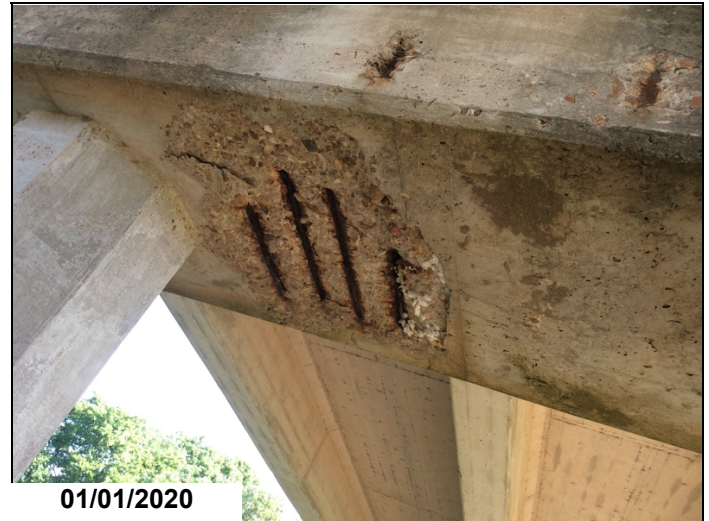
Spalls with rebar exposed to bottom of Cap @ Bent 23.

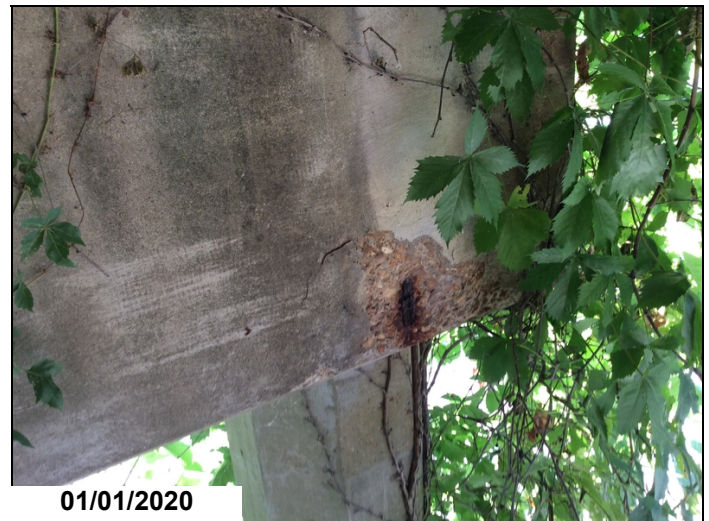
Spall with rebar exposed to cap @ Bent 9 backside  
above Pile 5.

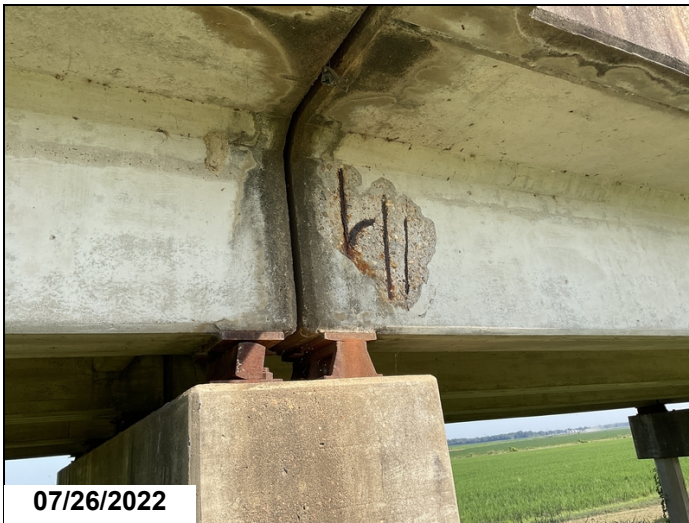
Concrete Girders  
Spalls with rebar exposed at Spans 3 thru 8, 11 thru 13,  
15 thru 17, 20 thru 26, 28, 32.  
Girder 4, beginning of span 12.

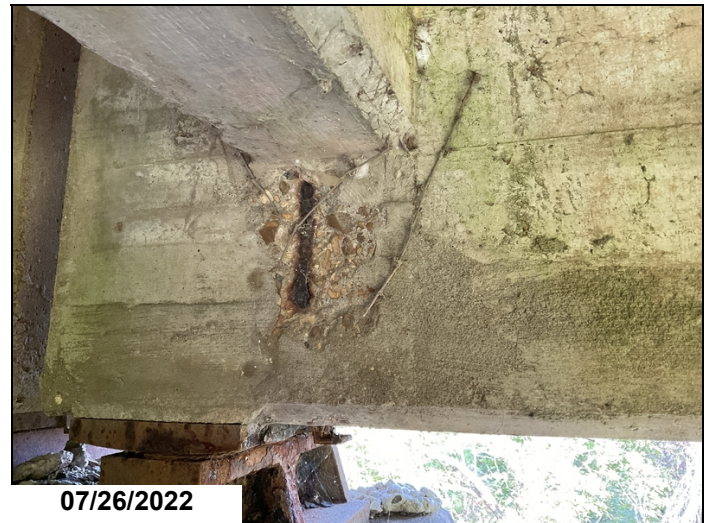
Concrete Girders  
Spalls with rebar exposed at Spans 3 thru 8, 11 thru 13,  
15 thru 17, 20 thru 26, 28, 32.  
Girder 1, Beginning of span 7.

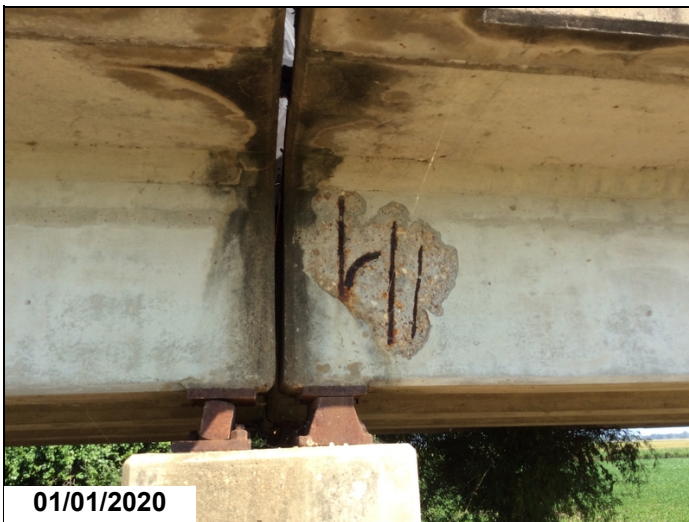
Large spall with rebar exposed to Girder 4 @ BOS 12.

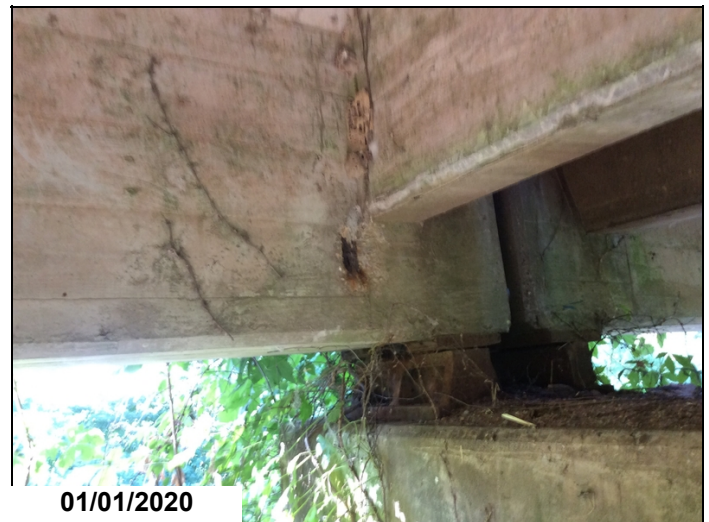
Spalls with rebar exposed to Girder 4 @ BOS 6.

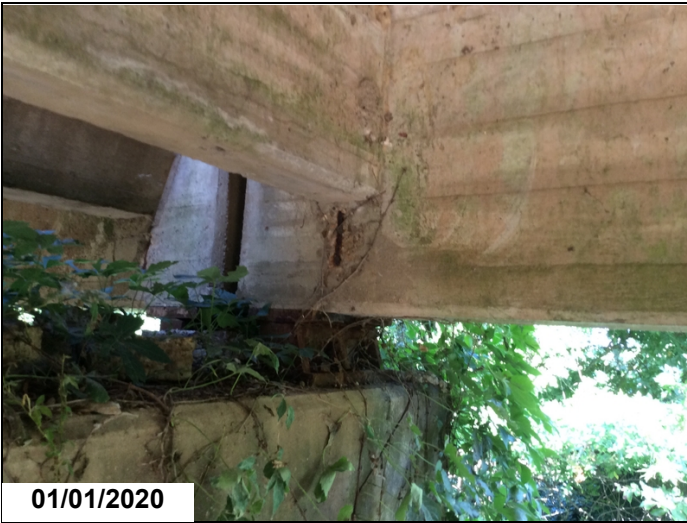
Spalls with rebar exposed to Girder 1 @ BOS 7.

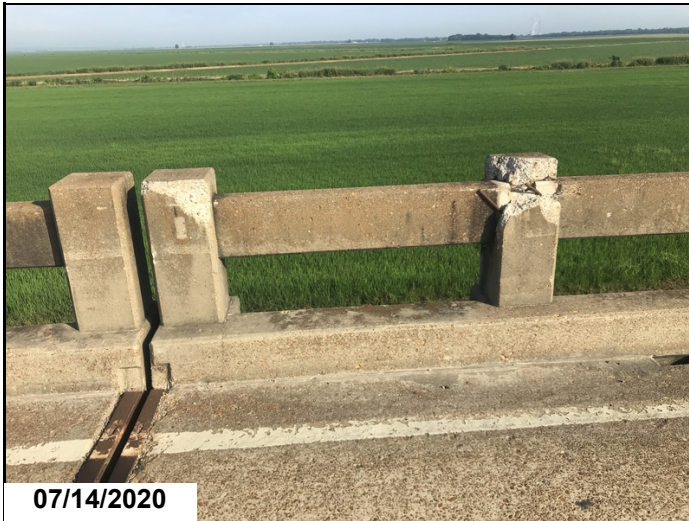
Collision damage to 1st & 2nd concrete post on Left side  
@ Span 23.
