## Bridge 01881 Inspection Report

Asset #01881(Routine)

SH 367/Jackson Co. over WHITE RIVER RELIEF

Team Lead: Floyd Haley Inspection Date: 09/03/2024

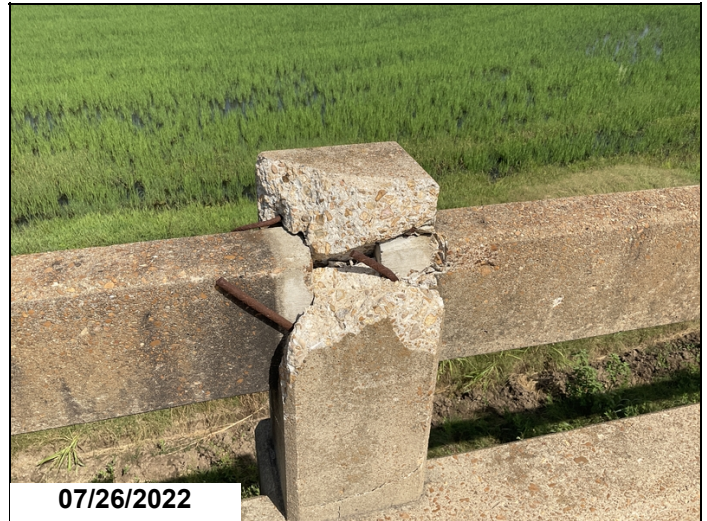
Collision damage to concrete bridge rail post @ Span 23  
Left side.

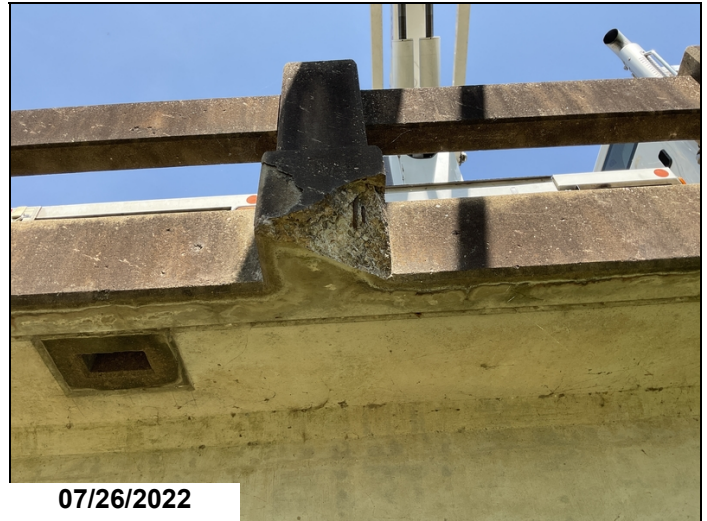
Concrete Bridge Rail  
Cracks and spalls, some with rebar exposed, to rail and or posts at Spans 1, 17 thru 19, 23, 24, 25, 30, 31 & 36  
Span 30, post 6.

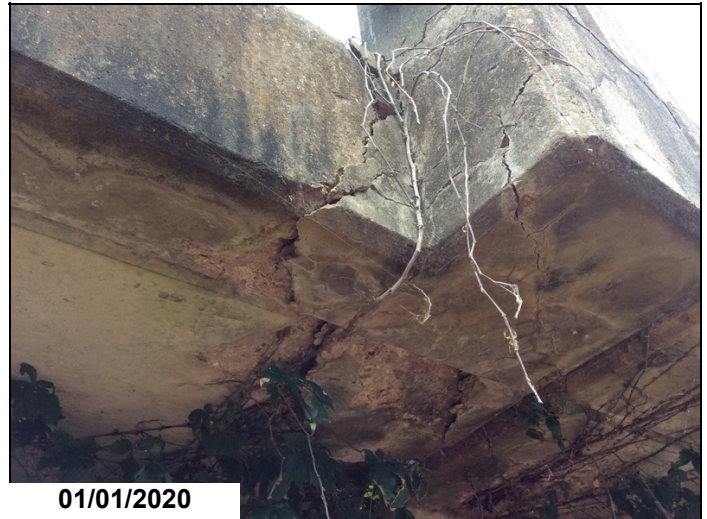
Cracks @ Spalls to bottom of Post 7 @ EOS 31.

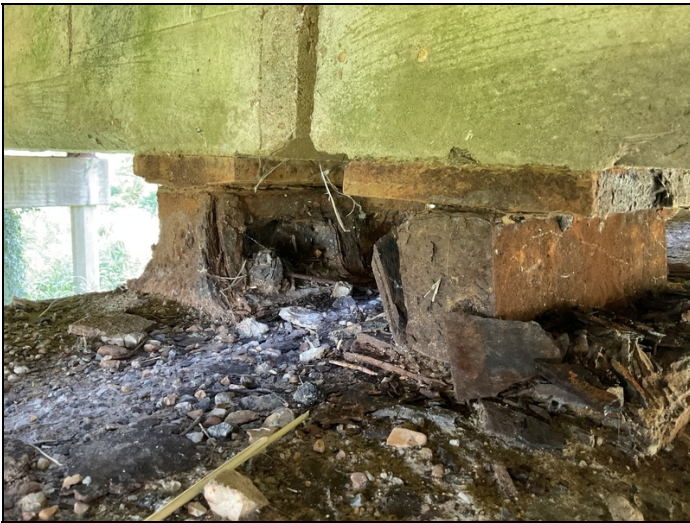
Bearings

Rust, pack rust, and section loss to all moveable and fixed bearings.

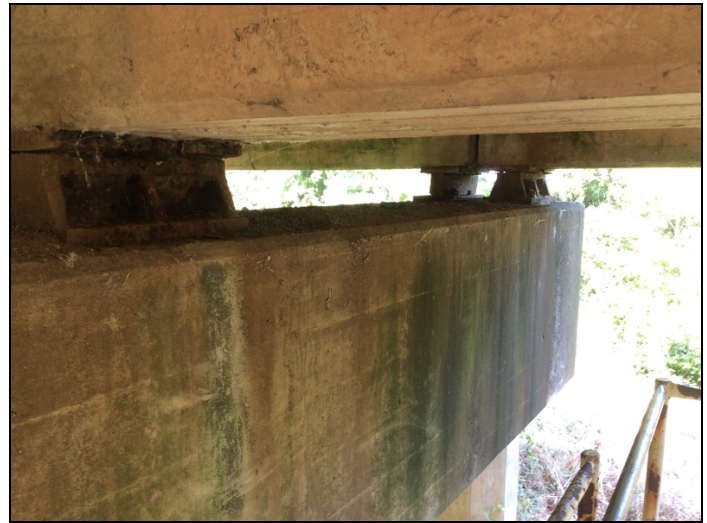
Typical condition of Fixed Bearings.

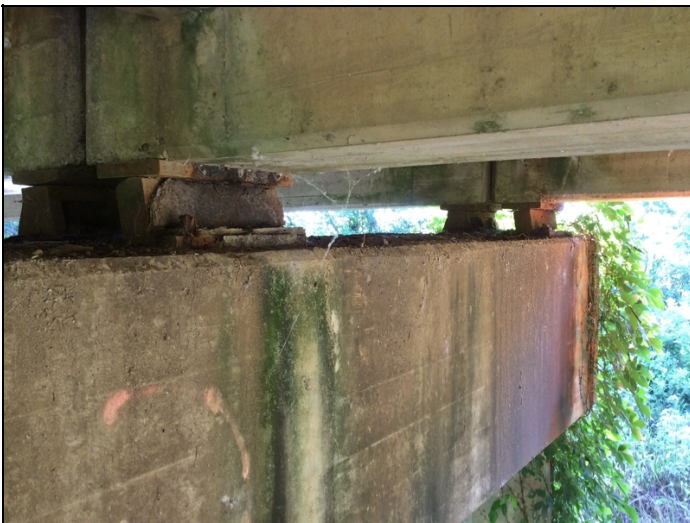
Typical condition of Moveable Bearings.

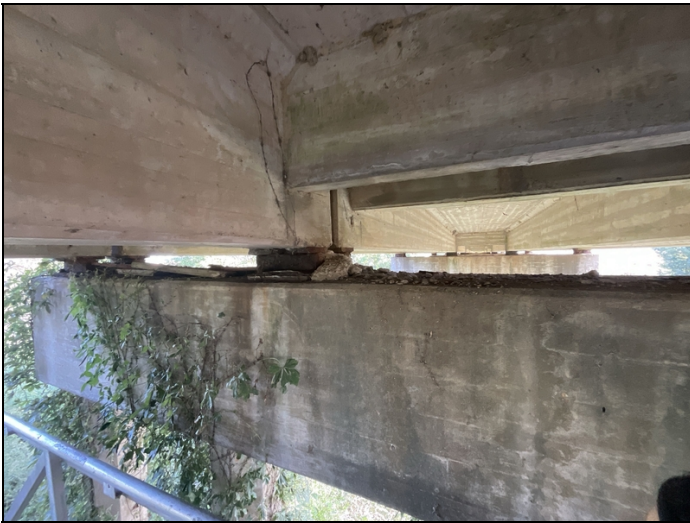
Bent 6

Due to open joints, the caps have debris throughout.
