## Bridge 01882 Inspection Report

**Asset #01882**(Under Record Clearance)  
**SH 367/Jackson Co. over CR 12, WHITE RIVER REL**  
**Location: 2.35 MI SW JCT SH 14**  
**Team Lead: Floyd Haley Inspection Date: 02/13/2025**

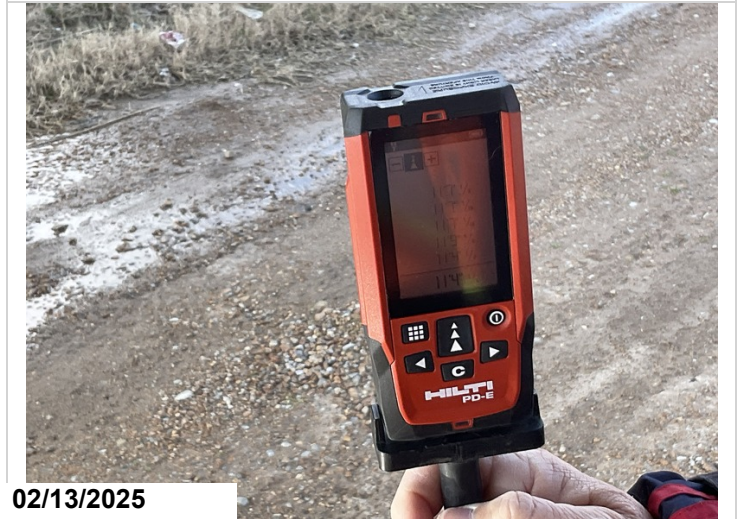
The under-record clearance for the roadway under the structure at span one was verified on this date. No change was noted since the last inspection.

11' 4" verification noted at girder 1, right.

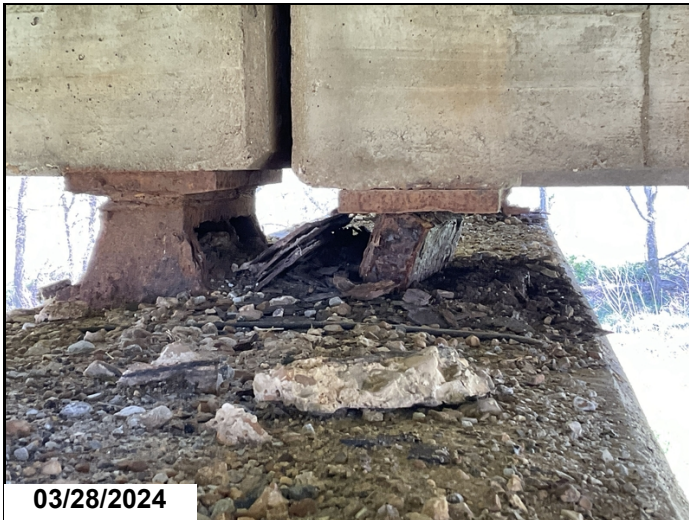
Span 14, Bent 14, Bearing 3.

Span 14, Bent 14, Bearings 2 and 3:

Severe rust with section loss and anchor bolts rusted off. Bearings are also rotated Back to the limits.

**Type of Work:** Bearing Repair/Replacement

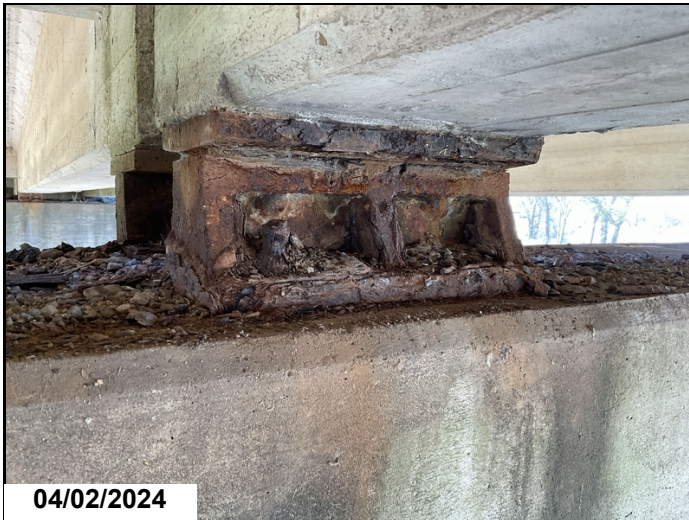
Span 3, Bent 2, Bearings 2 & 3: anchor nuts rusted off.

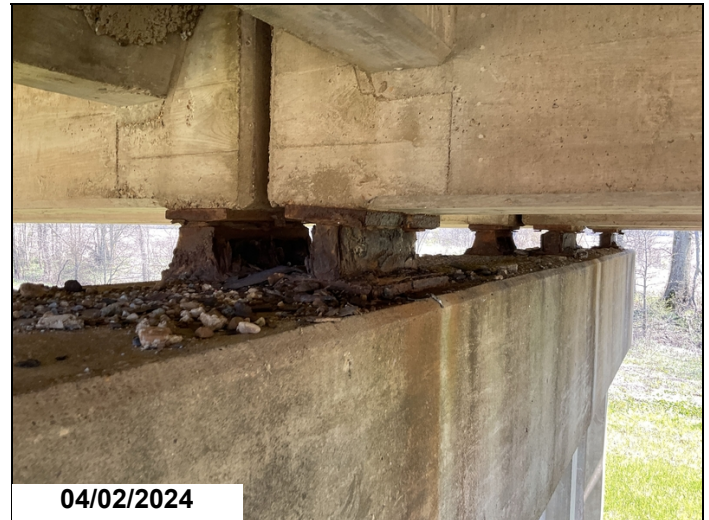
Span 6, Bent 6, Bearings 2 & 3: missing anchor bolts.  
CS3.

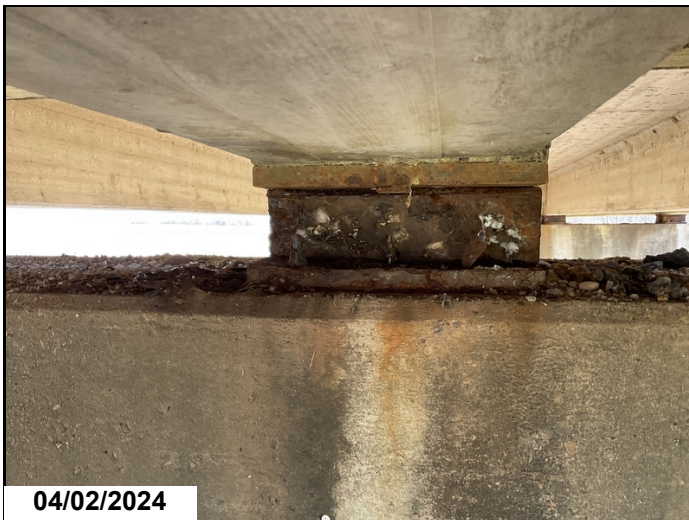
Span 2, Bent 2, Bearings 2 & 3: anchor nuts rusted off.  
Span 3, Bent 3, Bearings 1 - 3: anchor nuts rusted off.

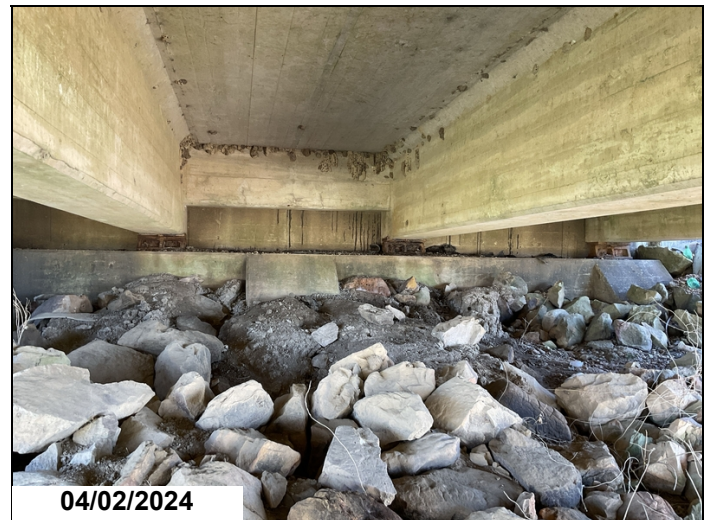
Span 1, Abutment 1, Bearings: active corrosion with pack  
rust.

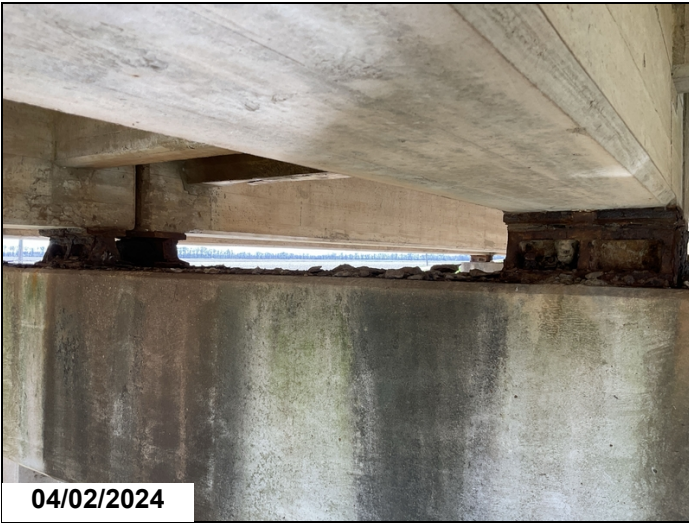
Span 4, Bent 3, Bearings 2 & 3: active corrosion with pack rust.

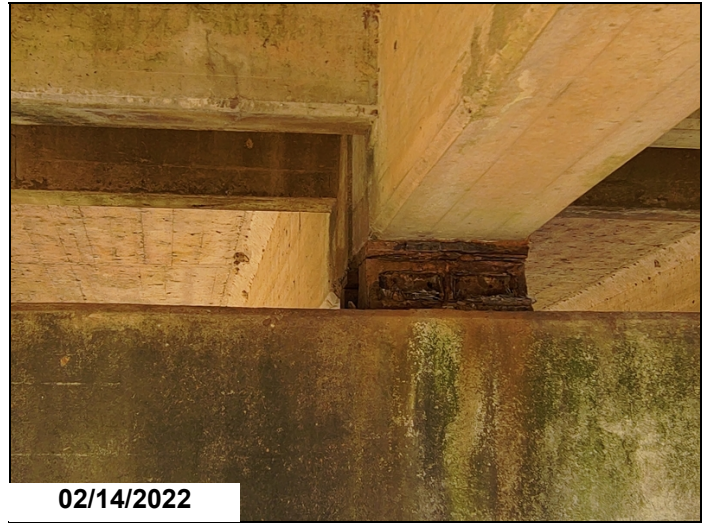
Fixed and Moveable Bearing Assemblies:  
Corrosion with moderate to severe section loss.

Moveable Bearing Assemblies  
Corrosion with moderate to severe section loss  
Typical.

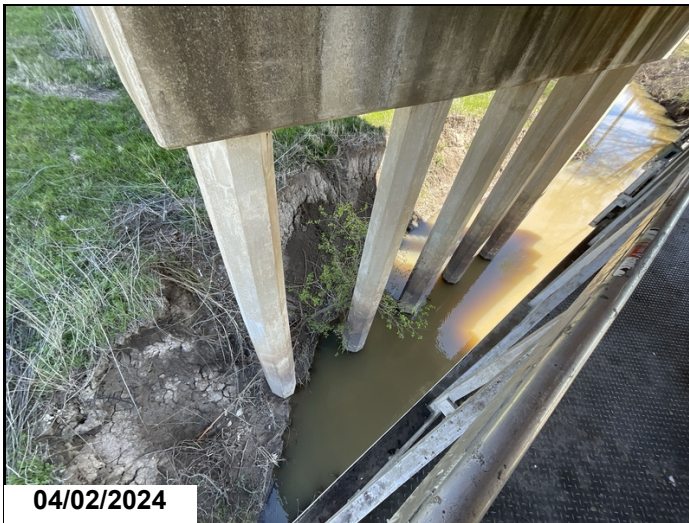
Bent 3, Piles 1 - 5: embankment erosion around all piles causing scour.

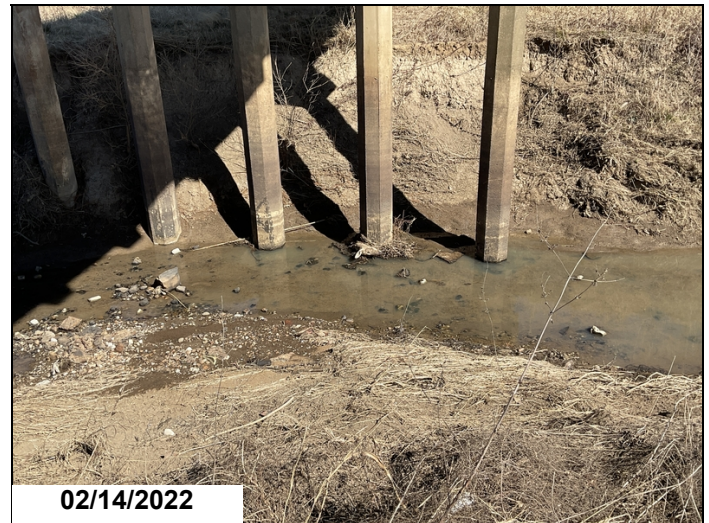
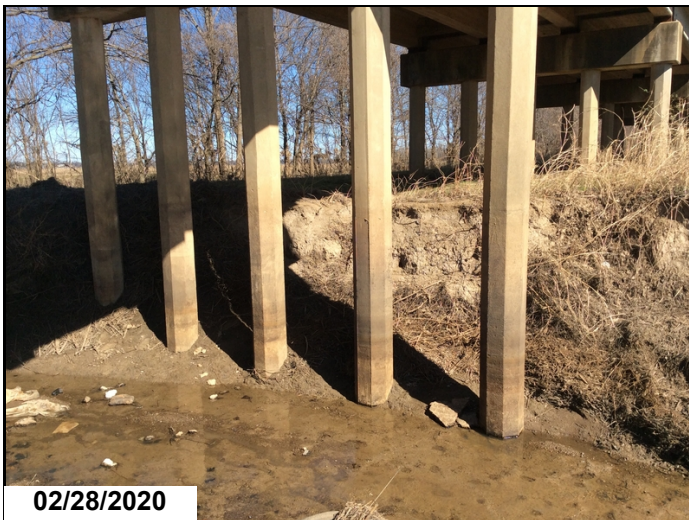
Bent 3, Piles 1 - 5: embankment erosion around all piles causing scour.

Scour to Piles 1 - 5 @ Bent 3.

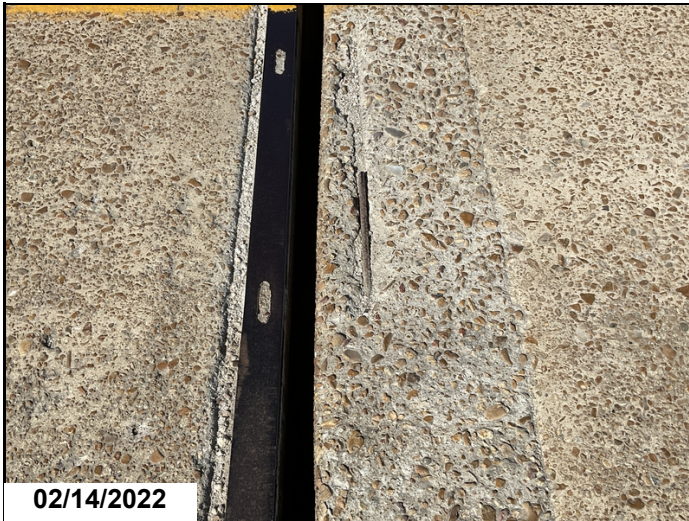
Span 11, Bent 10: exposed reinforcing steel due to shallow cover. CS3.

Spall with rebar exposed in Right lane @ beginning of Span 11, end of span 13 & beginning of Span 15.  
Span 11.

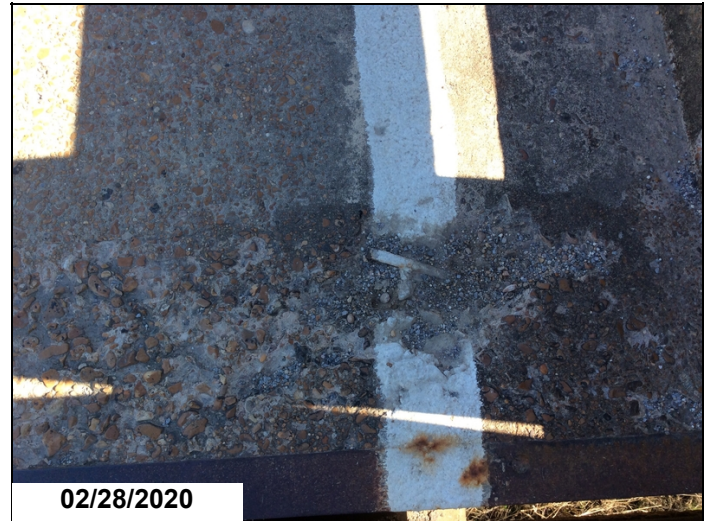
Span 15, Bent 14, Right: exposed reinforcing steel. CS3.

Spall with rebar exposed to Right Gutter line @ beginning of Span 15.

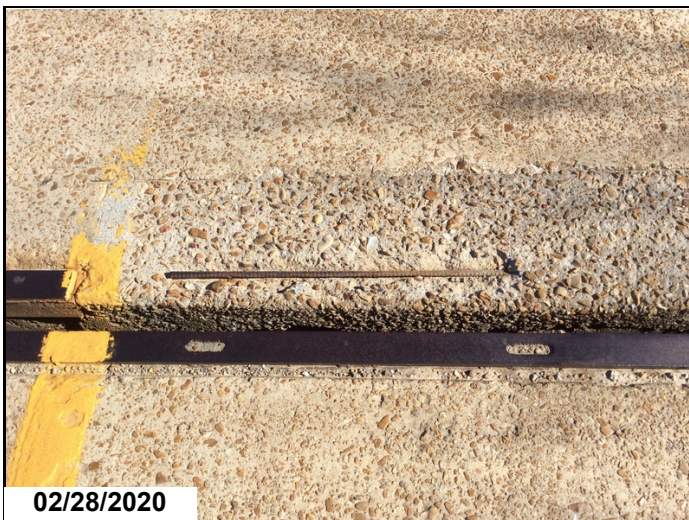
Spall with rebar exposed in Right lane @ Beginning of Span 11.

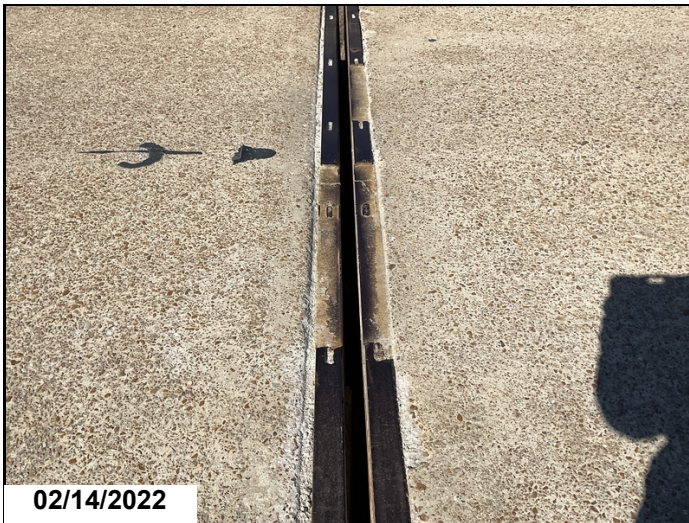
Span 2, 3, 5, 11, 15, 17 has cracked, broke or loose road irons in Lt., Rt. lanes or near centerline.

Broken road iron in Right & Left lanes @ Bents 2 & 4.  
Bent 2.

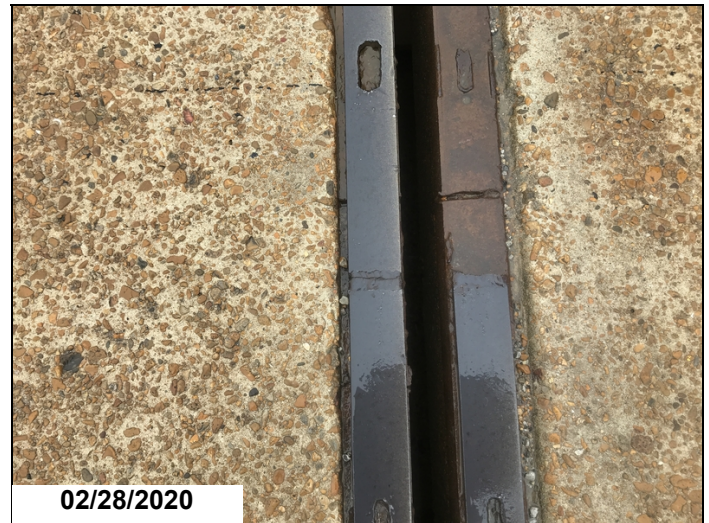
Broken road iron near centerline @ Bent 2.

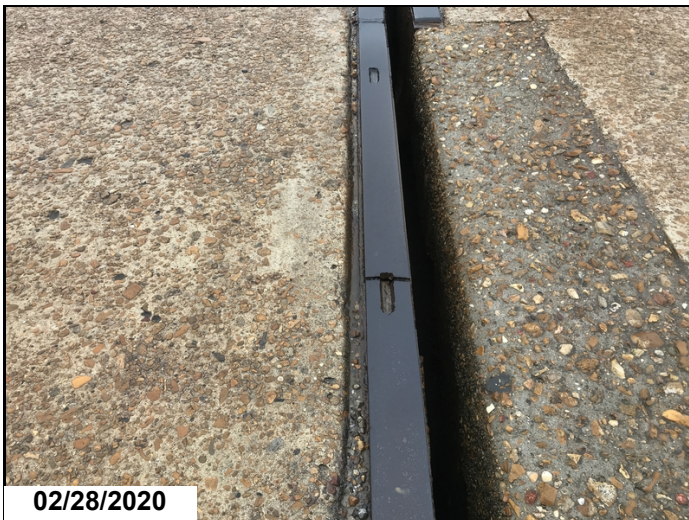
Broken road iron in Right lane @ Bent 4.

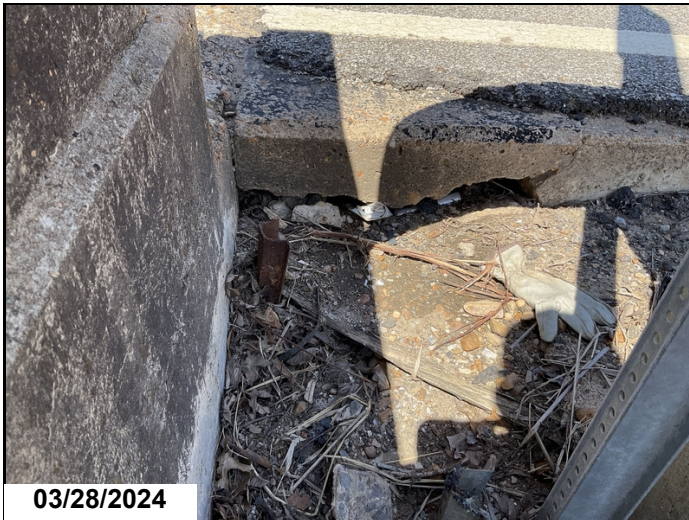
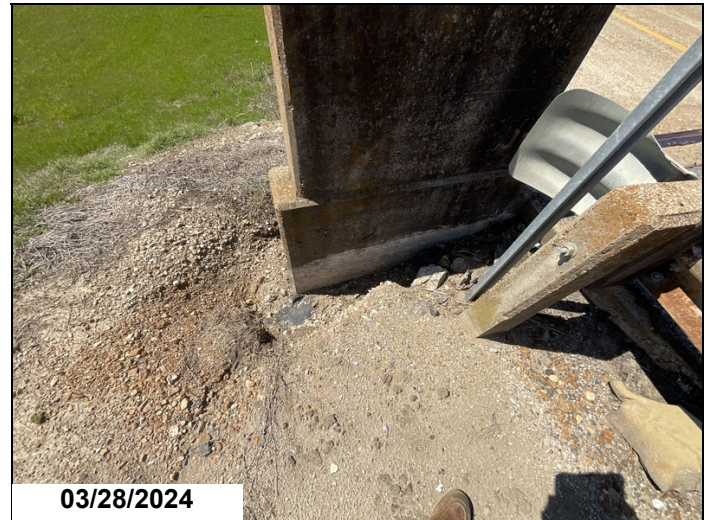
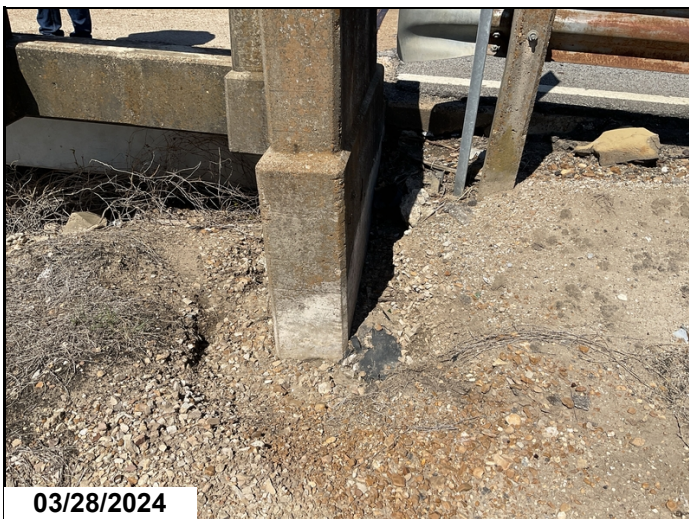
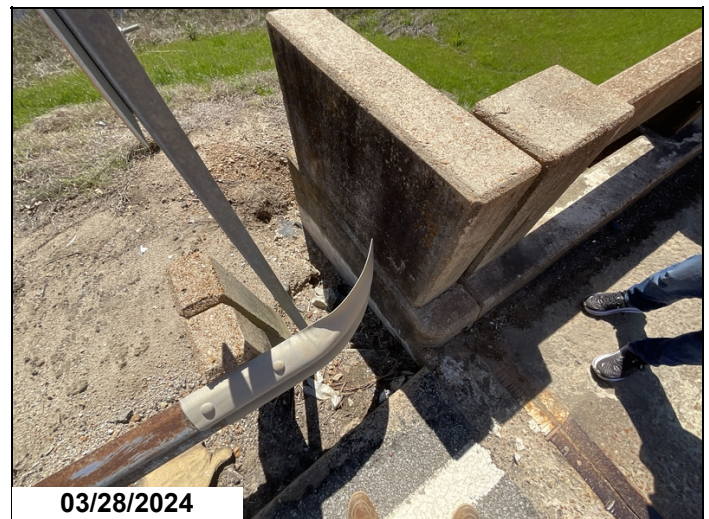
Abutment 2, Right Side: embankment erosion around the Right Wing Wall along with minor undermining to the approach roadway.

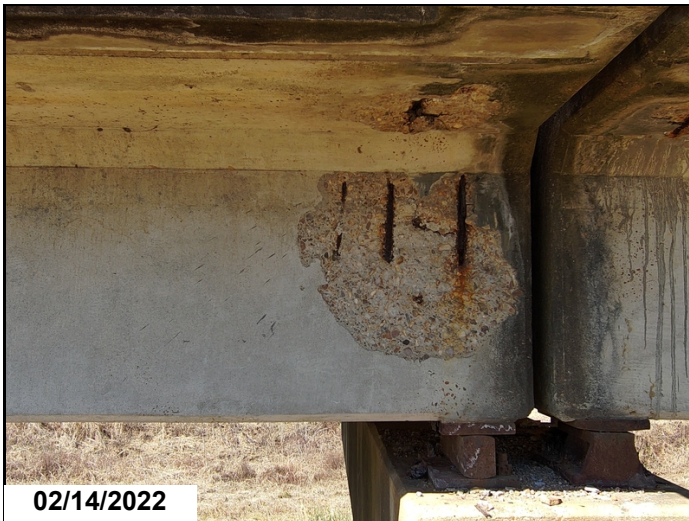
Girders at Spans 1, 2, 4, 7, 8, 9, 10, 11, 12, 13 & 15  
Spalls with rebar exposed to girders.  
Span 7, Girder 4.

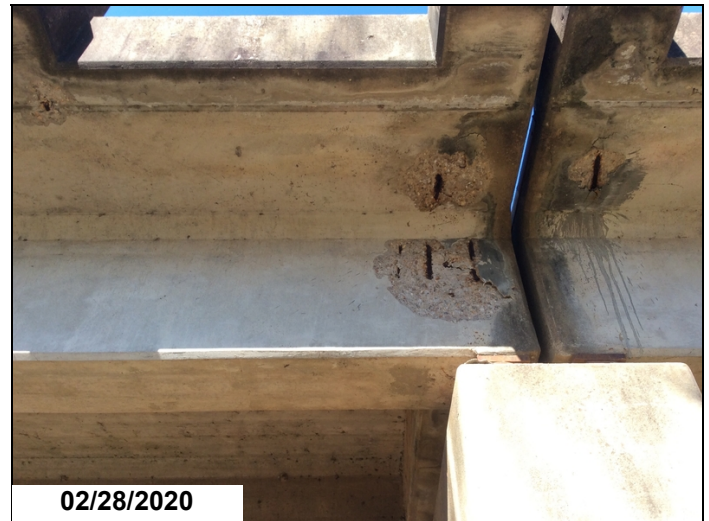
Girder 4 @ Span 7.

Girders at Spans 1, 2, 3, 4, 7, 8, 9, 10, 11, 12, 13 & 15  
Spalls with rebar exposed to girders.

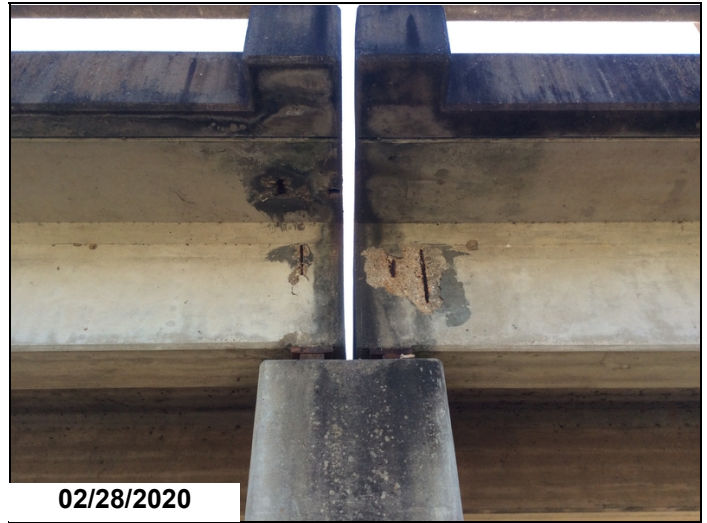
Girder 1 @ end of Span 12 & beginning of Span 13.  
Spalls with rebar exposed.

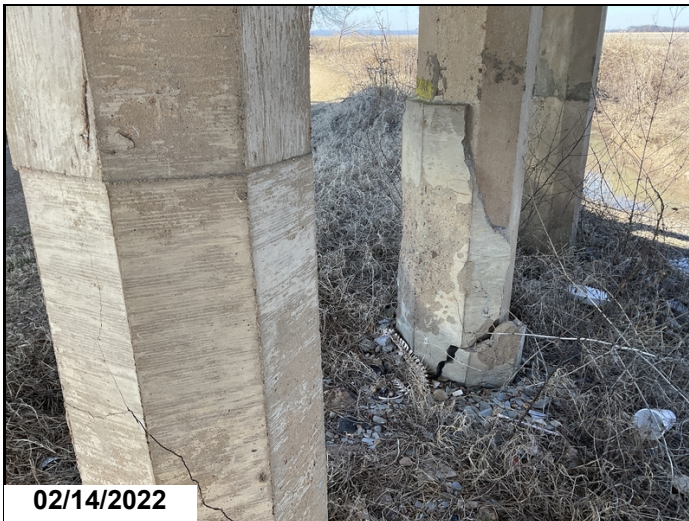
Concrete Pile casing is cracked and spalling @ Piles 2 & 3 @ Bent 2.

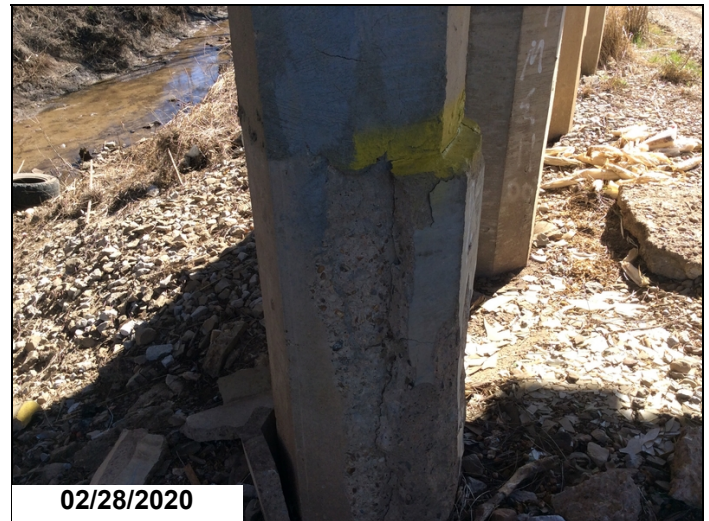
Concrete casing @ Pile 2 Bent 2.

Concrete Pile casing is cracked and spalling @ Piles 2 & 3 @ Bent 2.

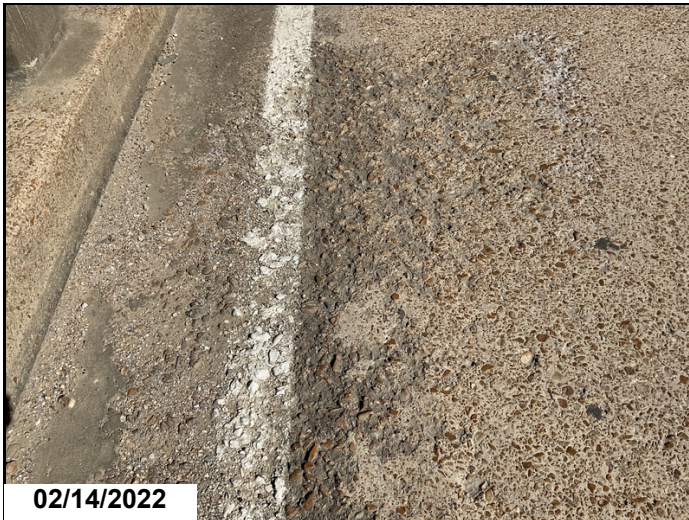
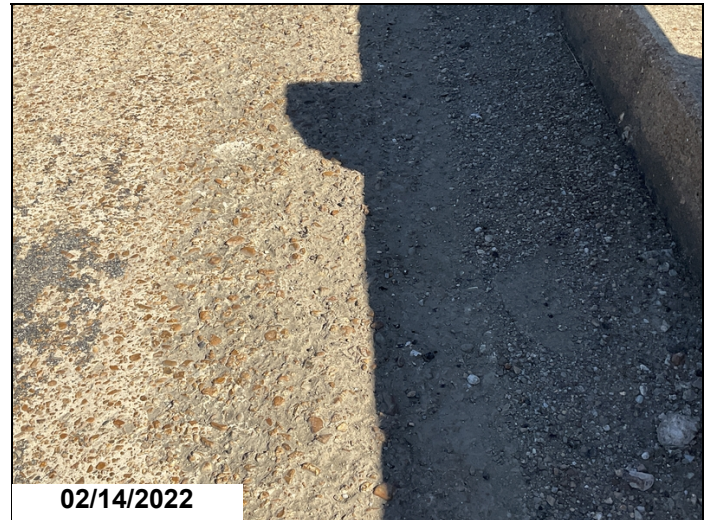
Deck Spans 1, 3, 4, 11, 13, 15, 17 & 18.  
Areas of Heavy Scaling to Left &/or Right Gutter Lines.

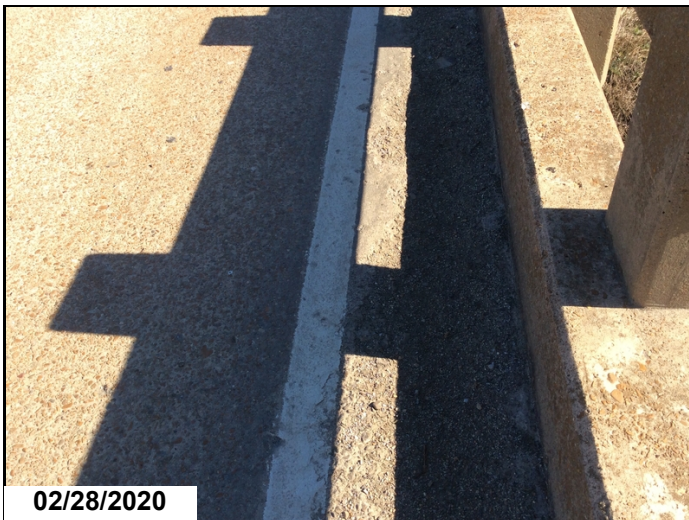
Heavy scaling and Spalls to Right Gutter line @ Span 3.

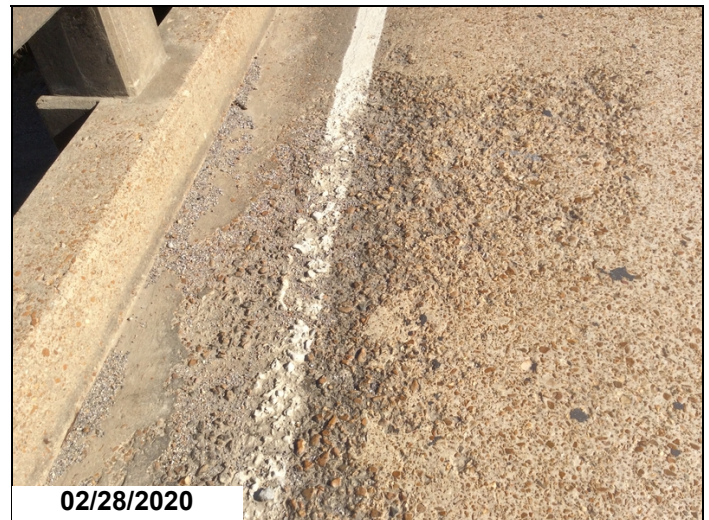
Heavy scaling and spalls to Left Gutter line @ Span 1.
