Bridge 01883 Inspection Report

Route:367 Section:21 Log:4.989

National Bridge Inventory Data Sheet

Asset #01883(Routine, Underwater type 2)
SH 367/Jackson Co. over WHITE RIVER RELIEF
Location: 1.05 MI SW JCT SH 14
Team Lead: Floyd Haley Inspection Date: 08/26/2024

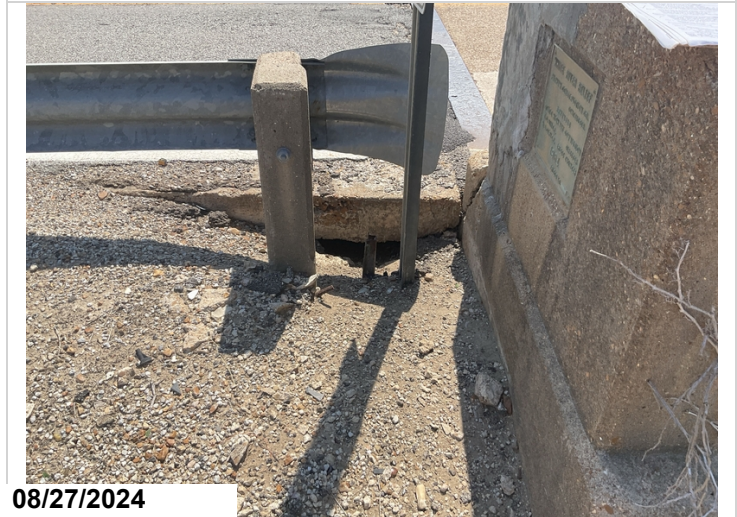
Abutment 2 left: Void under slab. Probing did not produce an end to the void on this side. On the right side, the void was 4' back under the approach slab.

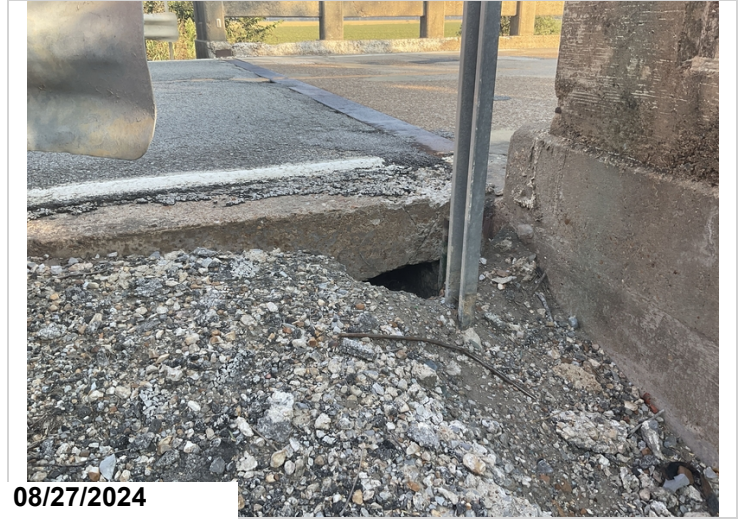
Abutment 1, right: voids under approach slab.

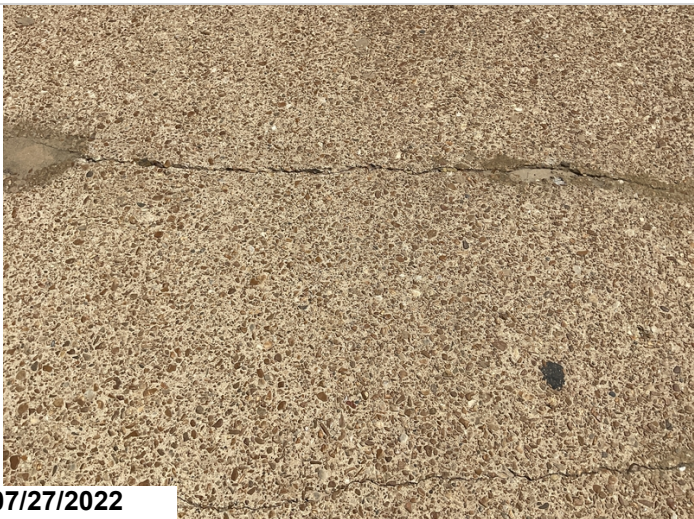
All spans have unsealed cracks.

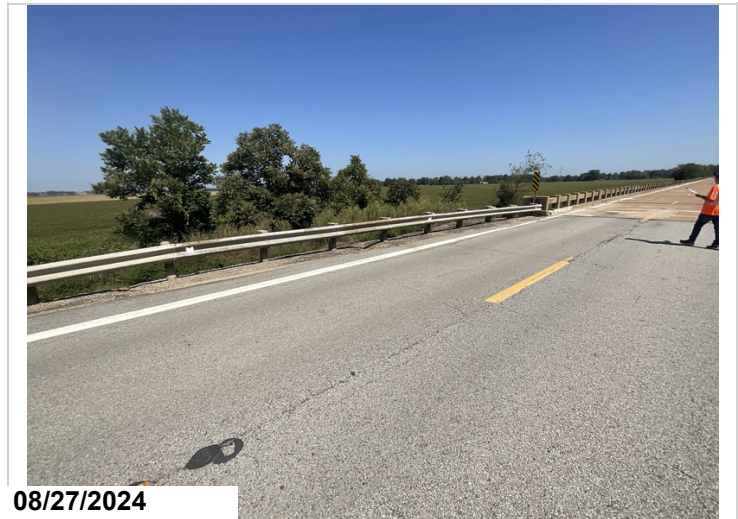
The railing transitions are in good condition with minor surface corrosion throughout.

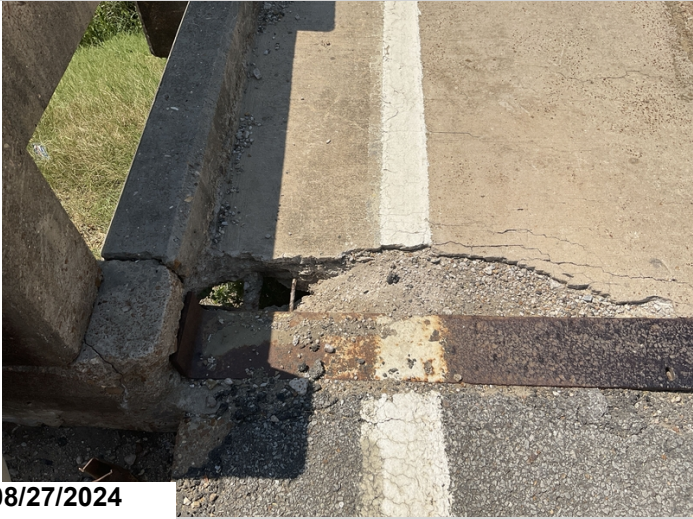
Abutment 2, right: 1'x2' hole in the deck at the shoulder

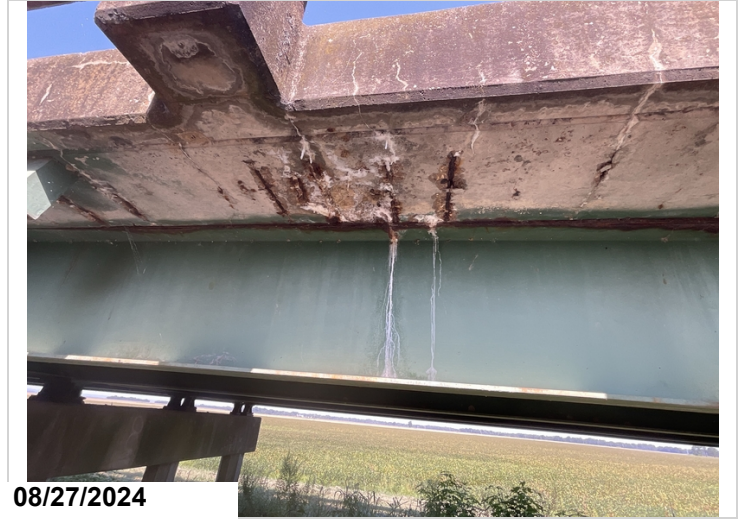
Span 8, right: heavy deterioration typical to curbs and overhangs.

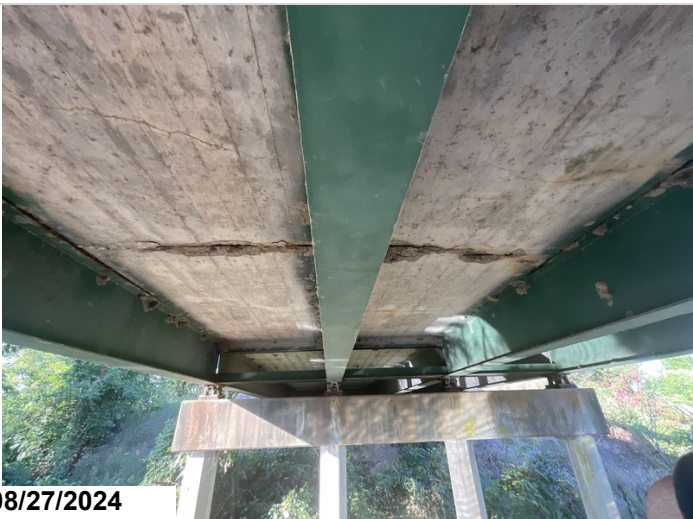
Span 2, bays 1-3: have full-width exposed rebar. 28SF CS3

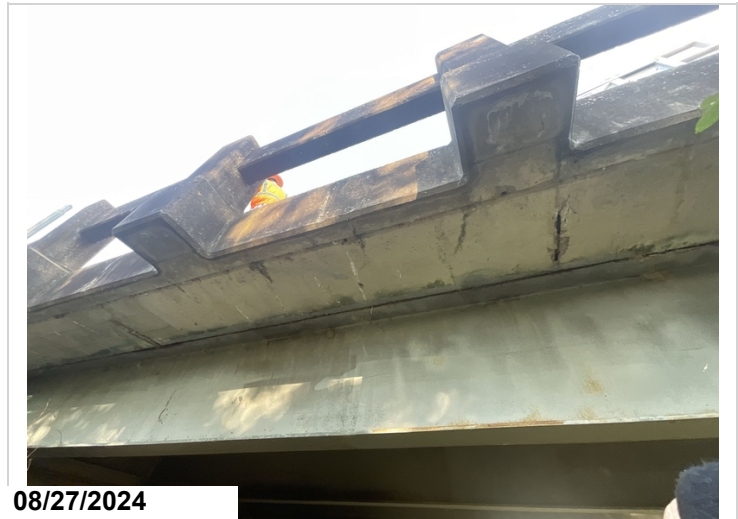
Span 1, right: Typical exposed rebar and efflorescent cracks to overhangs.

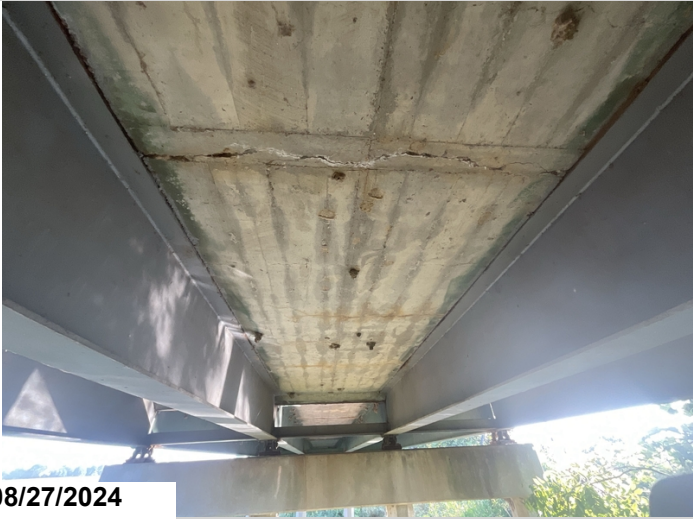
Transverse efflorescent cracks are widespread .

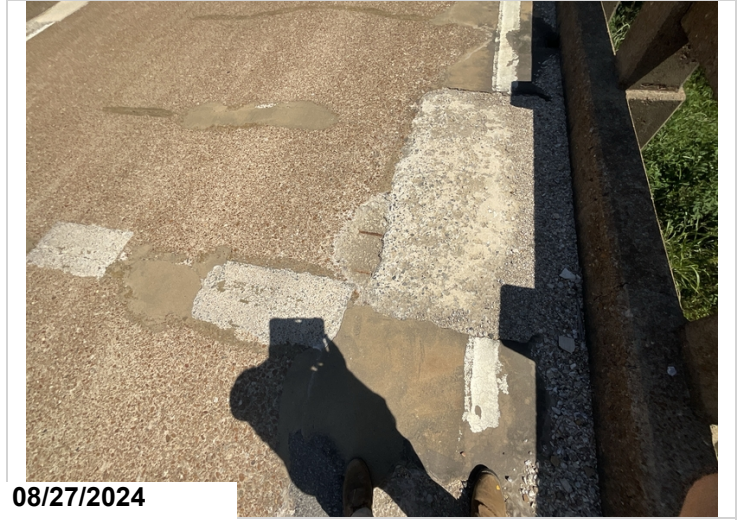
Span 9, right, driving surface: has exposed rebar 2'. 2SF CS3

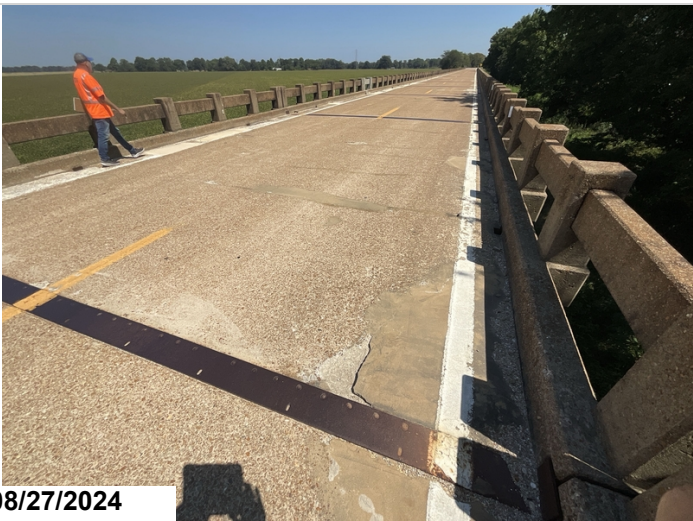
Span 7, left gutter, driving surface: has exposed rebar with corroded reinforcing steel. 2SF CS3

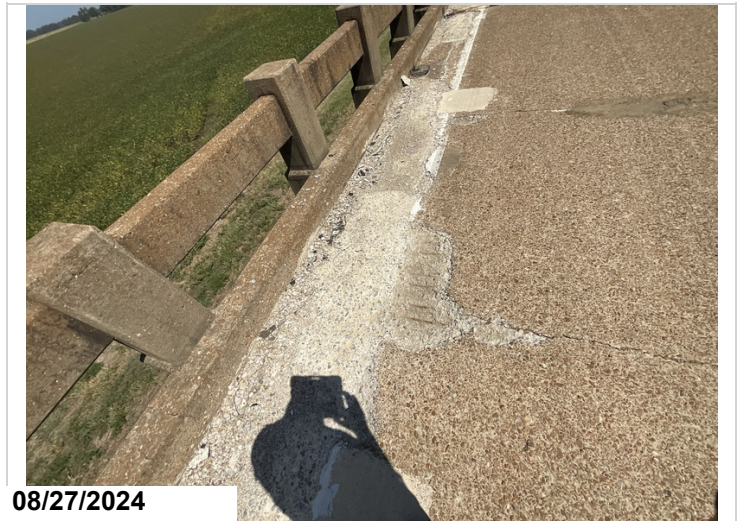
Span 6, left, driving surface: has a spall with exposed rebar. 3SF CS3

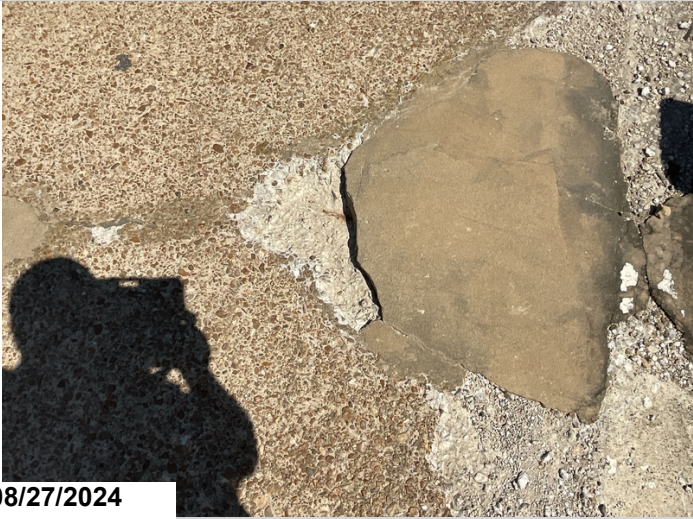
Span 6, left and right lanes, driving surface: have spalls with exposed rebar. 4SF CS3

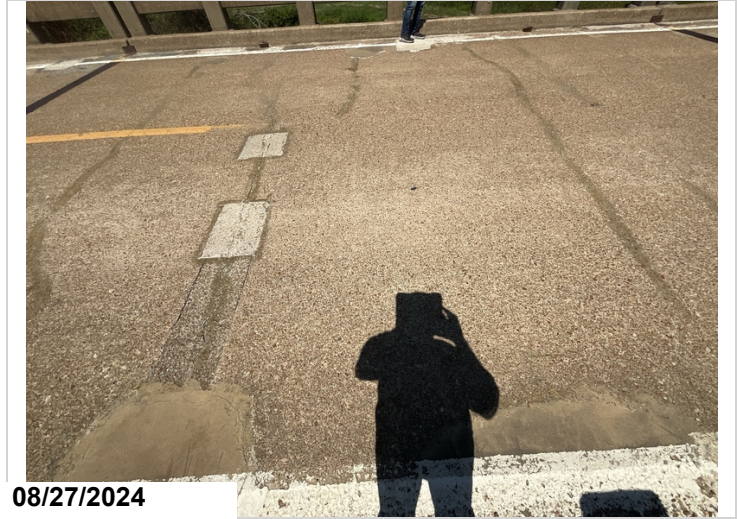
Typical driving surface with patched areas and cracks throughout.

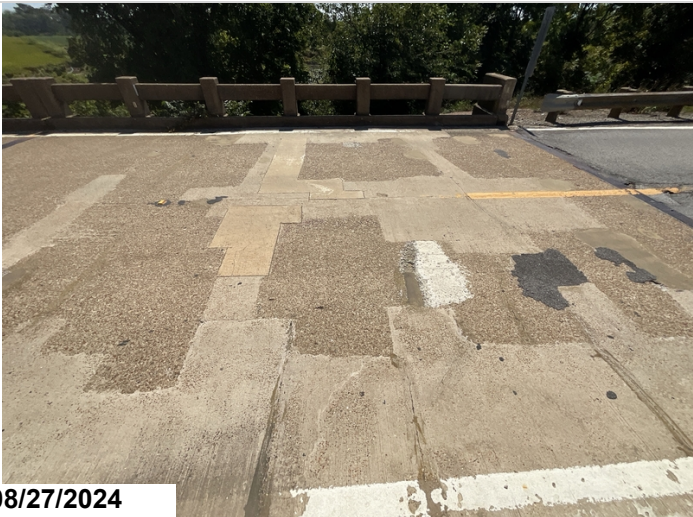
Span 1: has extensive patched areas covering 40% of the driving surface.

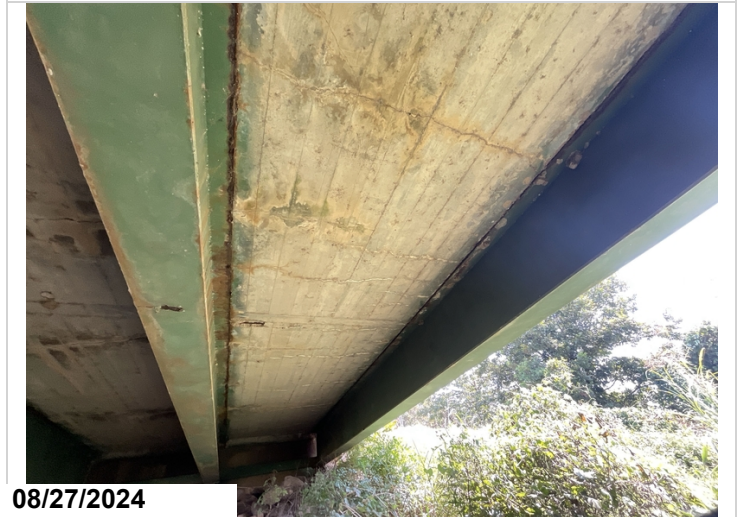
Span 31, girder 4: has a 4"x3" haunch hole. 1LF CS3

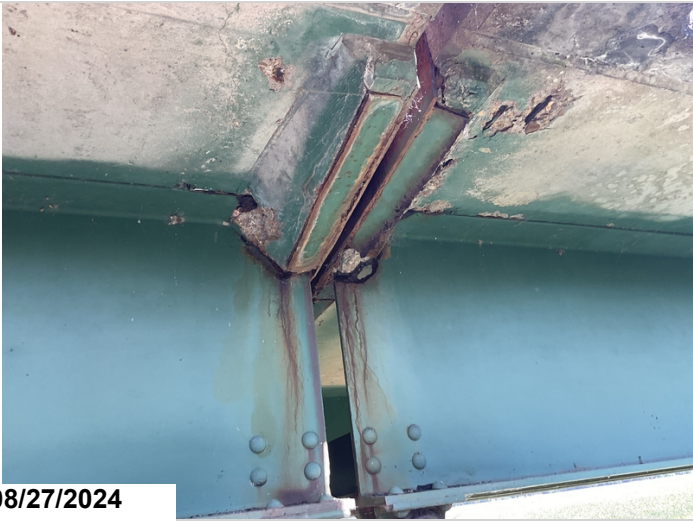
Bent 18, ahead, girder 4: has corrosion with a hole in the haunch area at the beam end measuring 1"x2". 1LF CS3

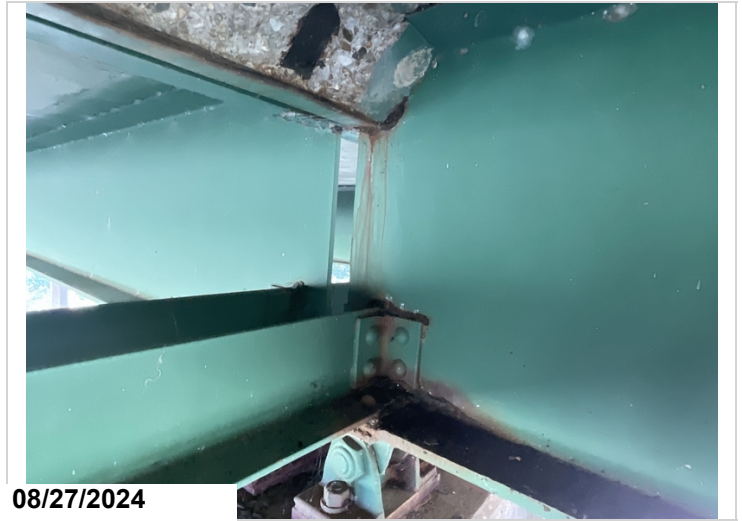
Bent 17, back, girders: have corrosion with section loss in the beam ends. Girder 3 has a 1" diameter hole in the same area and 1/8" section loss at the web to bottom flange connection. 4LF CS3

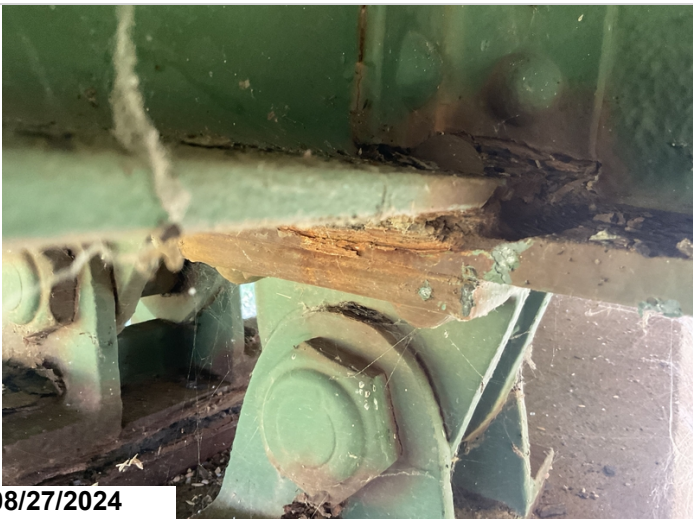
Bent 13, back, girder 3: typical section loss to the bottom flange. 1LF CS3

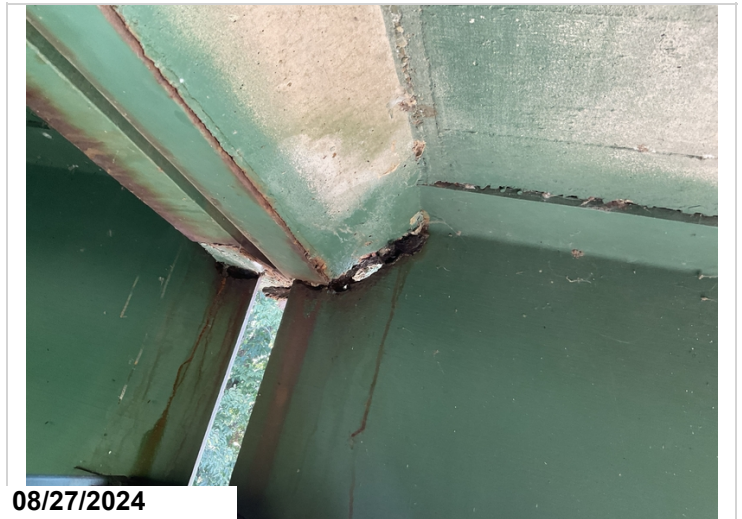
Bent 13, back, girder 4 has a 4"x1" hole in the haunch area. 1LF CS3

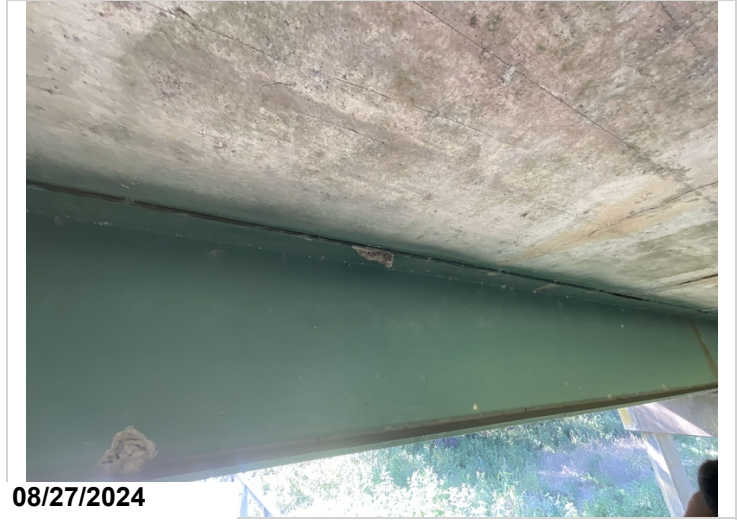
Span 9, midspan, girders 1-3: Typical separation of the deck due to pack rust and corrosion in the top flanges. 60LF CS3

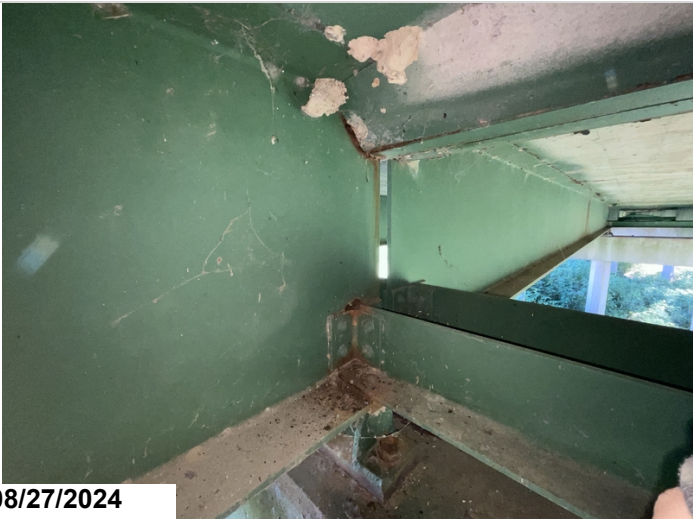
Bent 8, back, girder 2: has a 1"x2" hole at the haunch. 1LF CS3

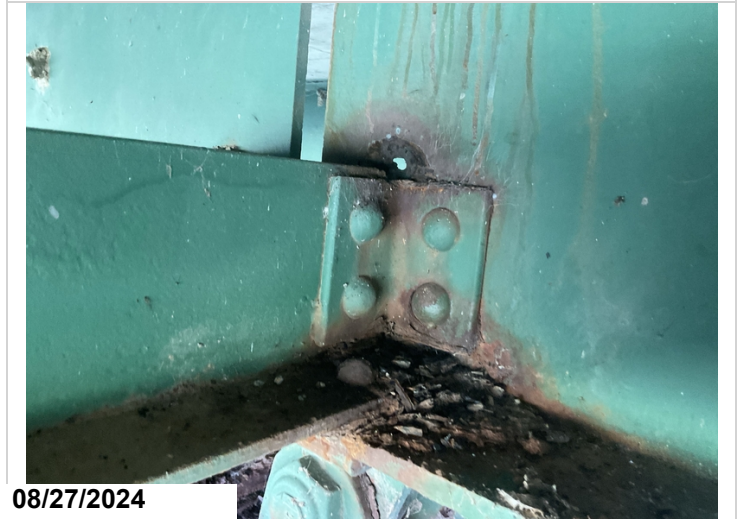
Bent 6, back, girder 3: has a 1" hole in the web above the diaphragm connection. 1LF CS3

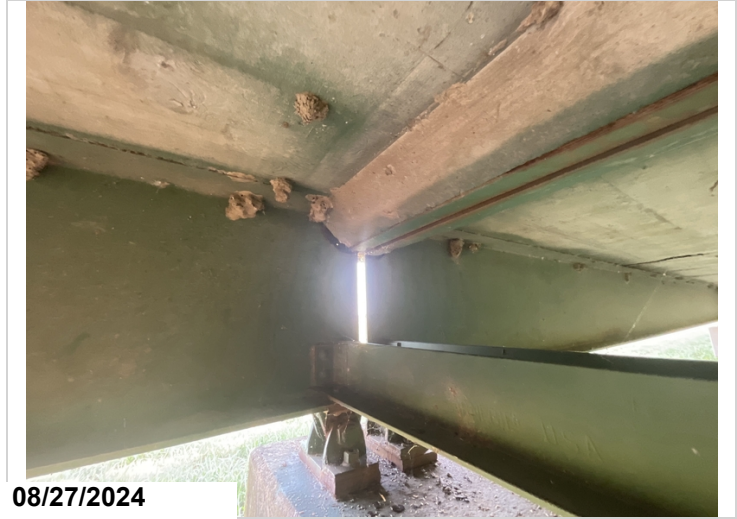
Bent 3, back, girder 1: has a 1/4" diameter haunch hole. 1LF CS3

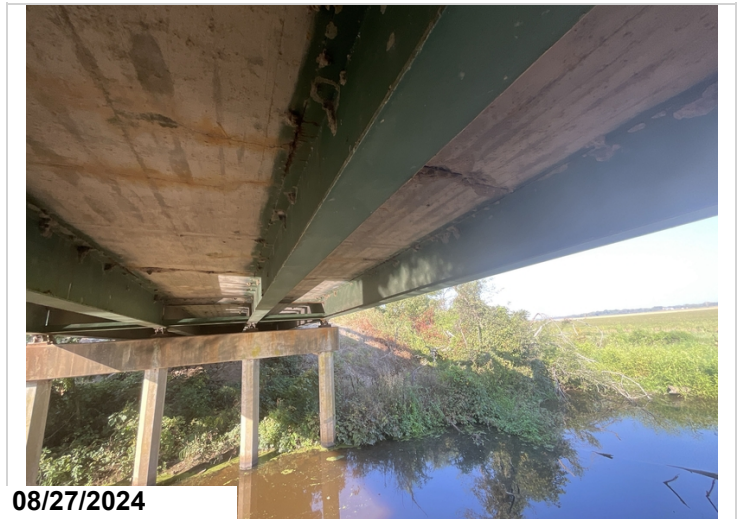
Span 2, midspan, girders 1-4: have corrosion in the top flange at the deck connection. 40LF CS3

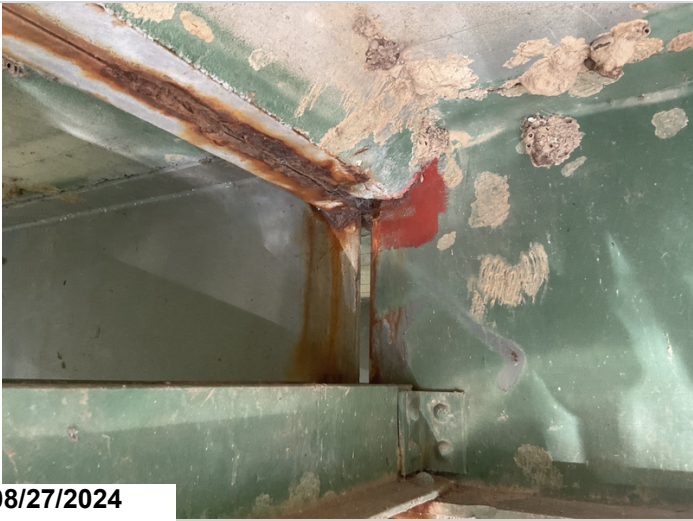
Bent 1, girders: have corrosion with section loss at the haunches. 8LF CS3

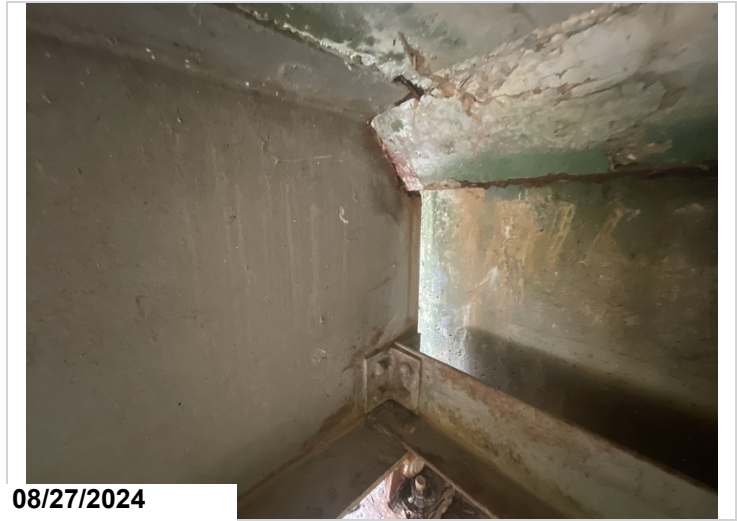
Abutment 1, girder 4: has 3/16" section loss at the haunch. 1LF CS3

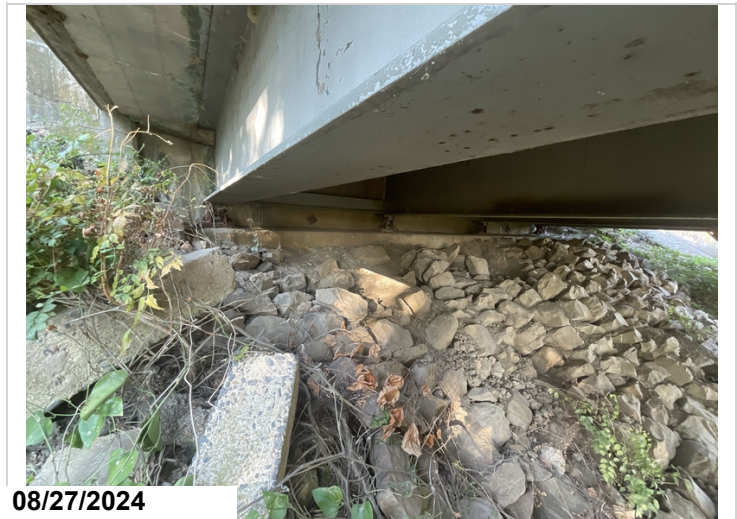
Abutment 1: efflorescent cracks are widespread. 13LF CS3

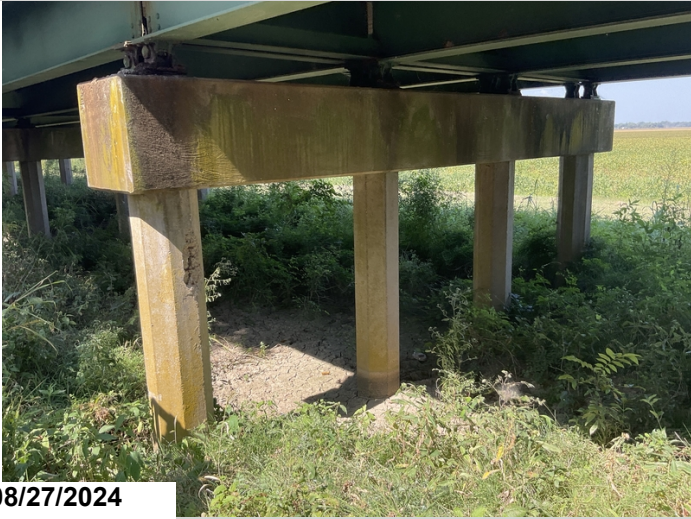
Bent 18, pile 4: has a spall with exposed rebar. 1EA CS3

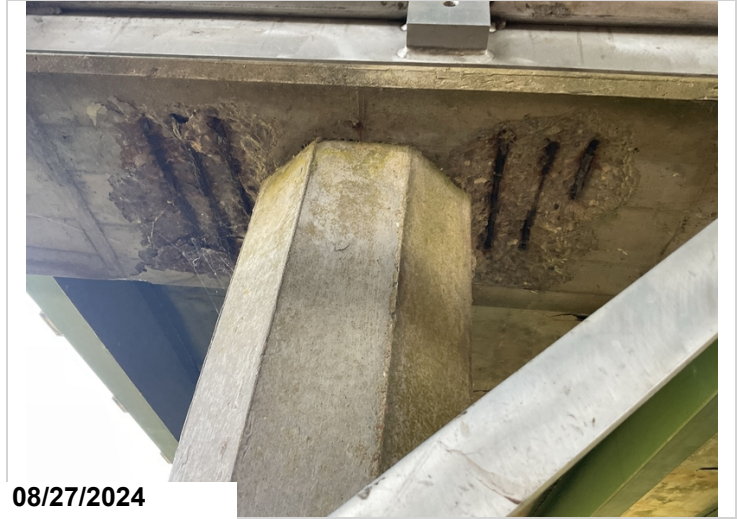
Bent 14, cap, adjacent to pile 2: has a large spall with exposed rebar in the underside. The rebar has completely corroded in two at this location. 6LF CS3

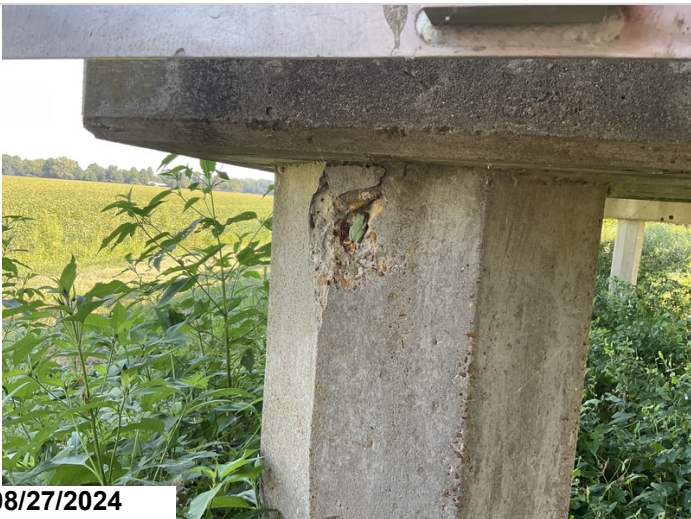
Bent 11, pile 1 spall. Move to pile photos.

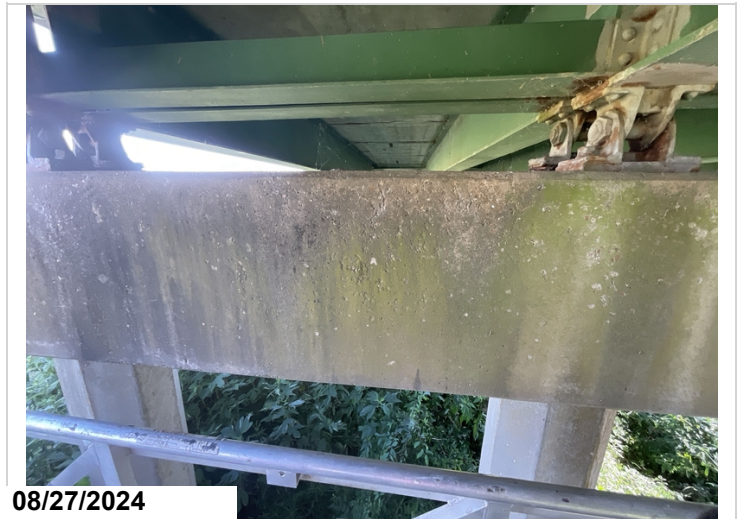
Typical minor cracking to caps.

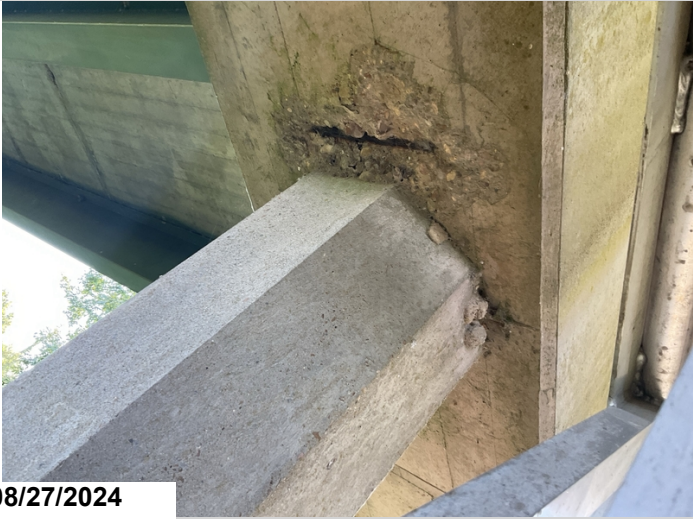
Bent 9, adjacent to pile 3, cap: has a spall with exposed rebar in the underside. 1LF CS3

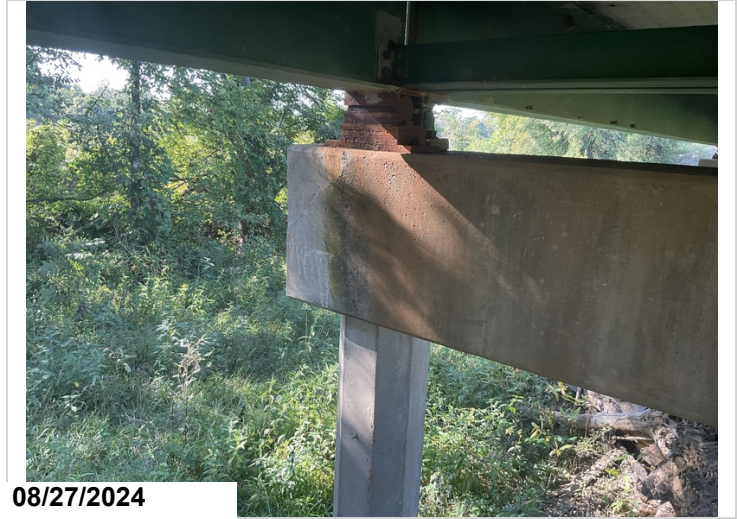
Bent 4, ahead, under bearing 4: there is a moderate diagonal crack. 1LF CS3

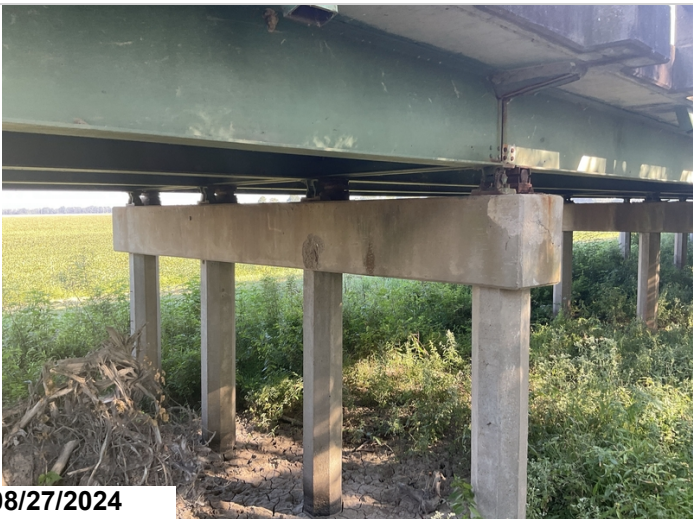
Bent 4, back, over pile 3: has a spall with exposed rebar. 1LF CS3

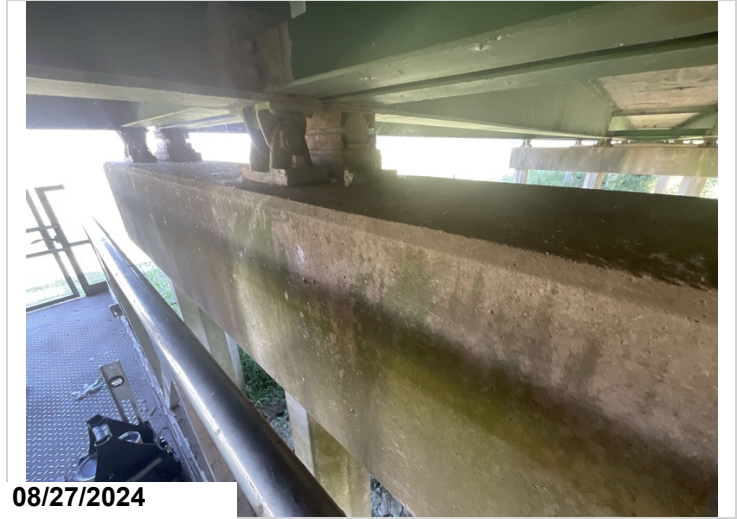
Bent 14, ahead, bearings 1-3 have been replaced and have only minor surface corrosion. 3EA CS2

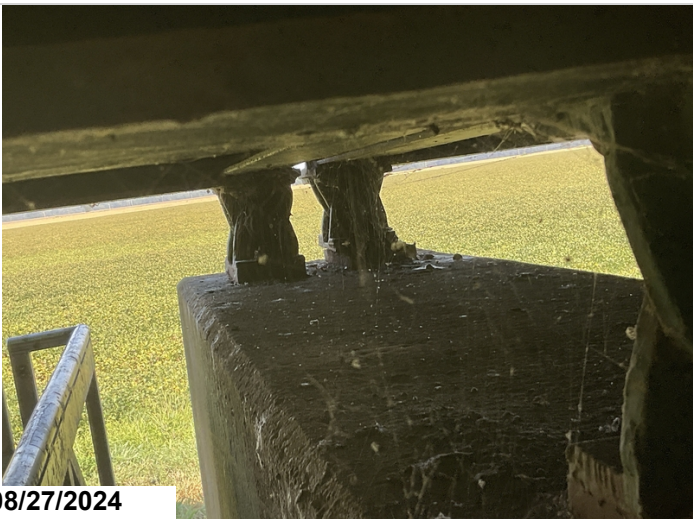
Bent 6, ahead, bearings 1-4: have missing anchor bolts/nuts. Bearing 1 is moving off of the masonry plate. 1EA CS3

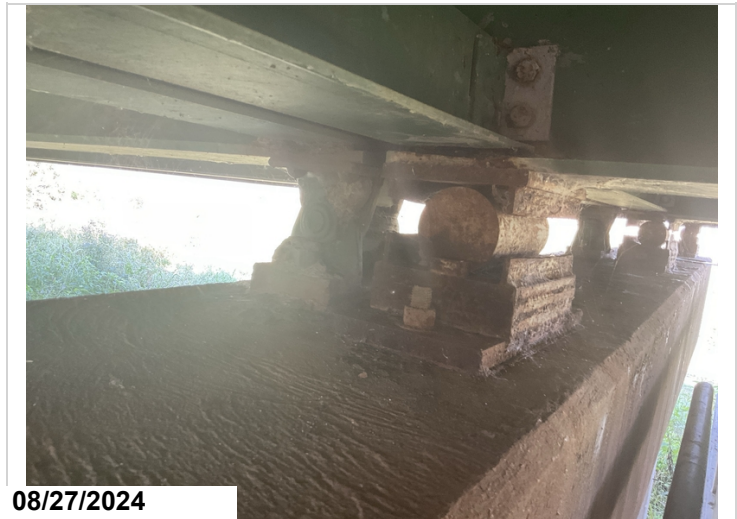
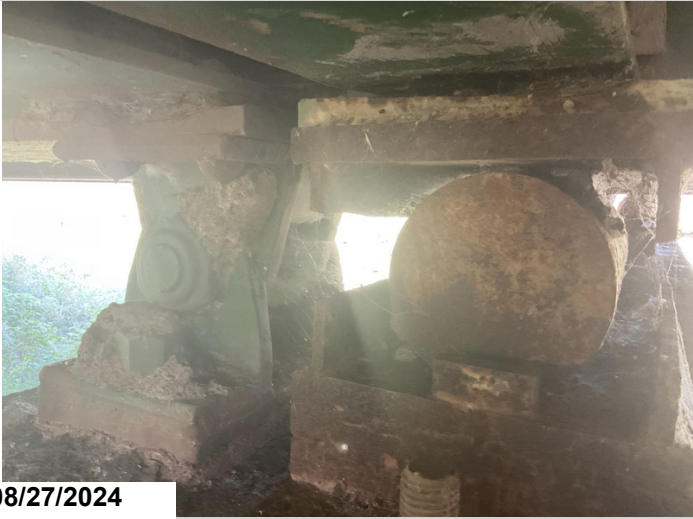
Bent 4, ahead, bearings: have been replaced. Bearings 2 and 3 are non bearing. 2EA CS2 corrosion, 2EA CS3 connection.

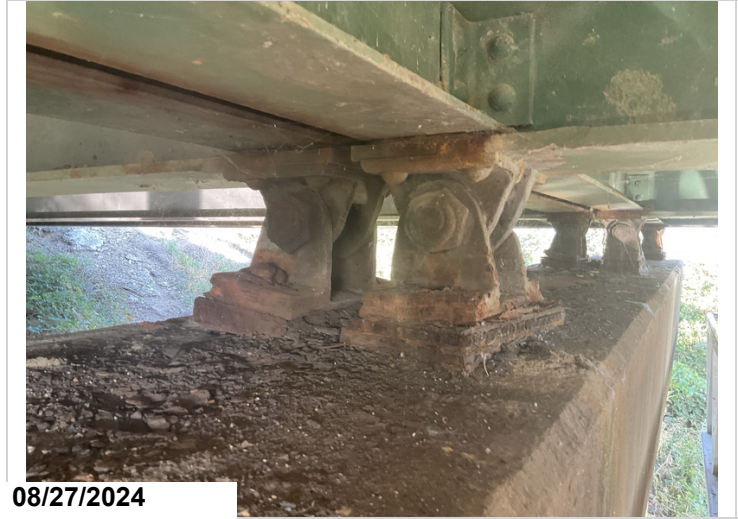
Bent 1, back: all bearings are rotated ahead. 4EA CS3 alignment

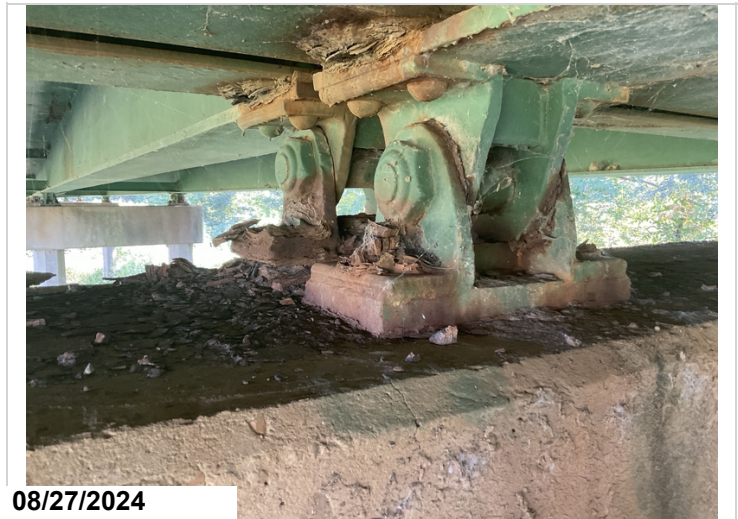
Typical bearings have heavy corrosion

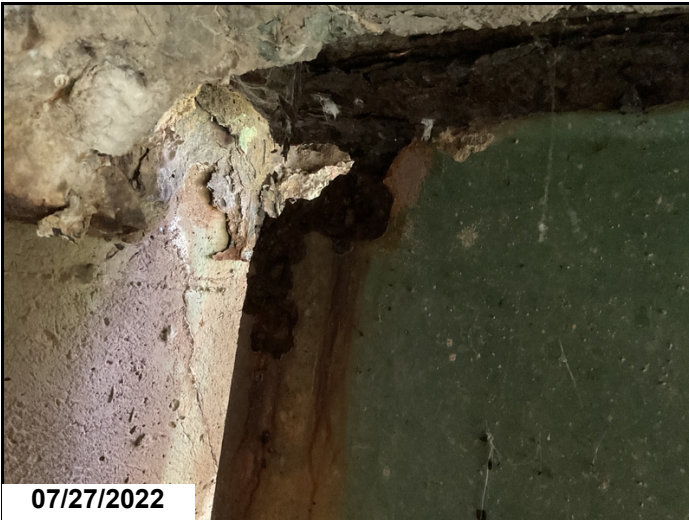
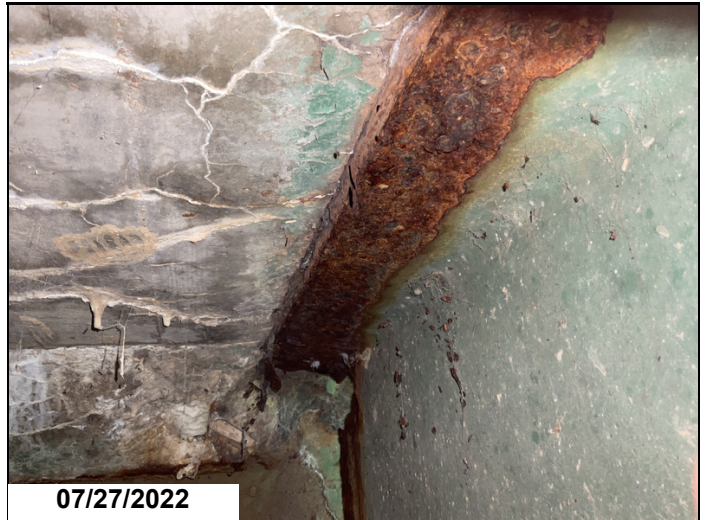
Abutment 2, girder 4 has heavy deterioration and holes at the top flange and web at end of span. Knife edge to the remaining web at the end of girder and to the top flange 1.5' back.

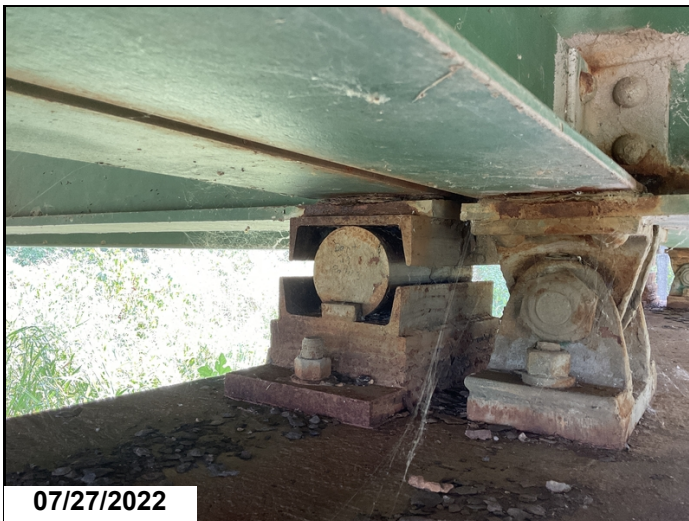
Moveable Bearing 3 @ Bent 29 is non-bearing.

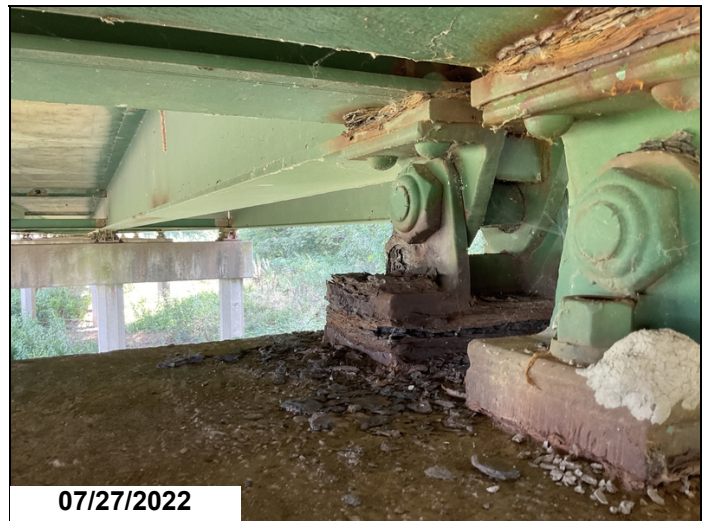
Several Bearing assemblies thru-out are missing Anchor Bolts and/or Nuts.
Bent 18 bearings 2 - 4.

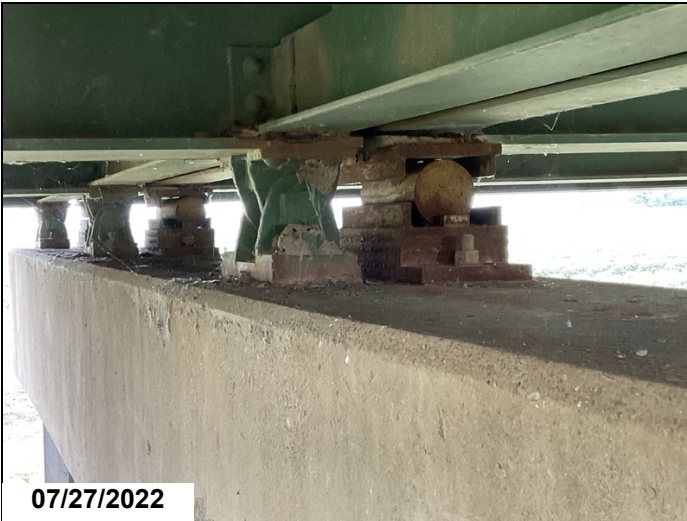
Moveable Bearings 2 & 3 @ Bent 4 are non-bearing.

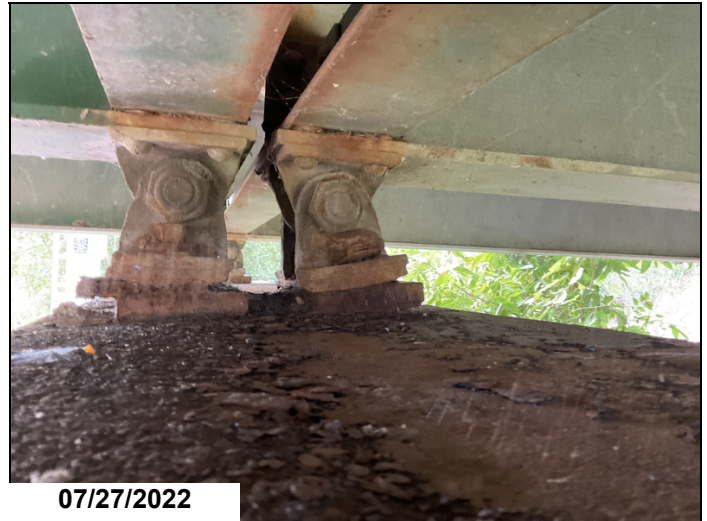
Moveable Bearings at Bents 1 through 7 are all rotated.
Bent 1.

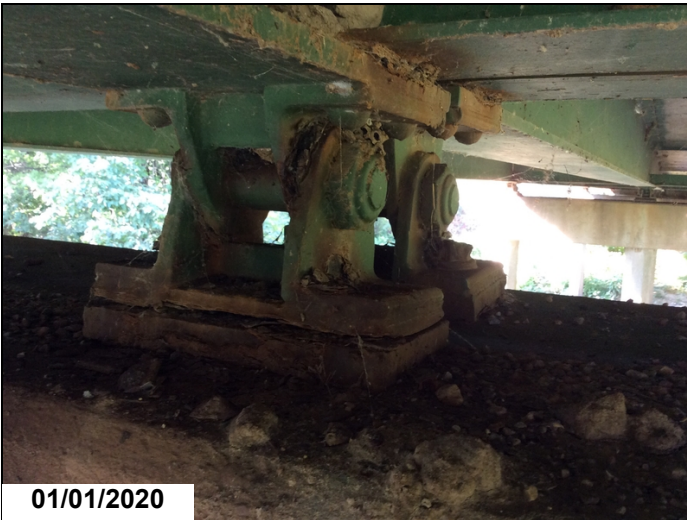
Anchor bolt & nut missing @ Bearing 3 @ Bent 3.

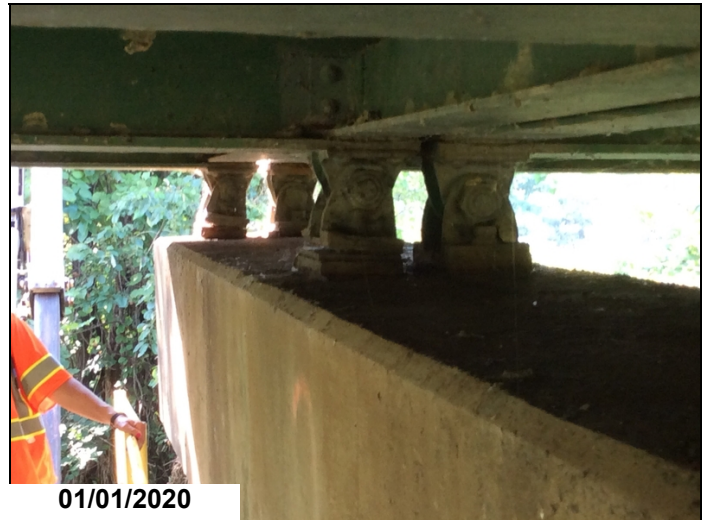
Moveable bearings @ Bent 2 are rotated ahead.

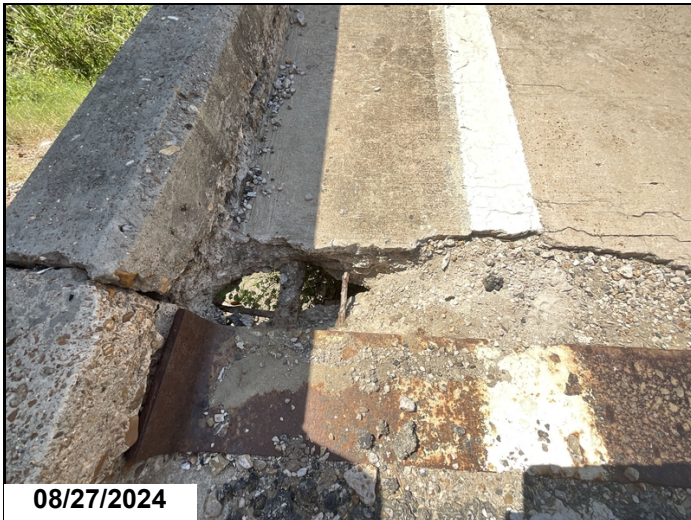
There is a 1x2' hole in the right shoulder span 31
This area is over girder 4 which has an A priority maintenance need for beam end repair.

1x2' hole in the right shoulder span 31

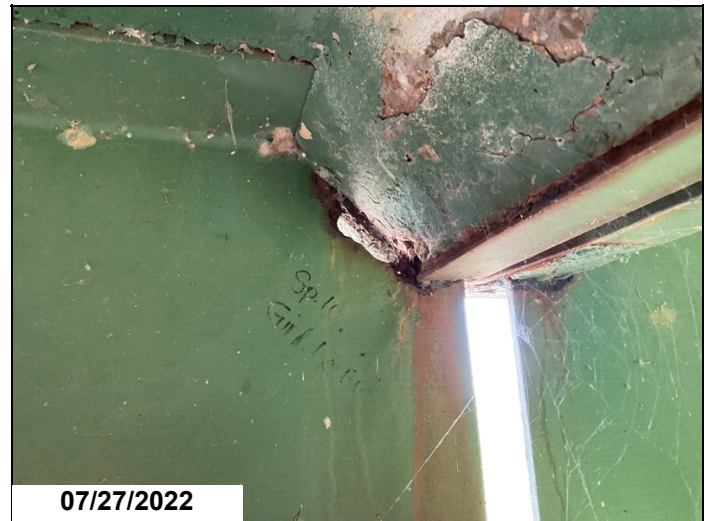
Girder 1 at Span 10

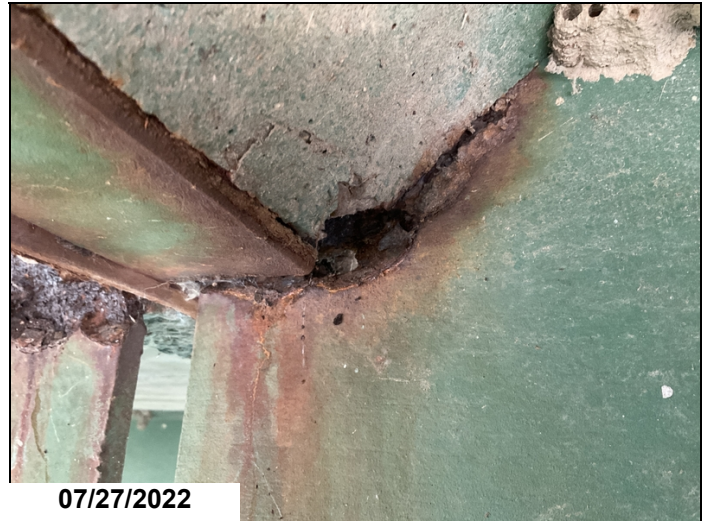
Holes rusted in the webs of Girder Ends under concrete
haunch at End of Span at:
Girder 2 @ bent 3.

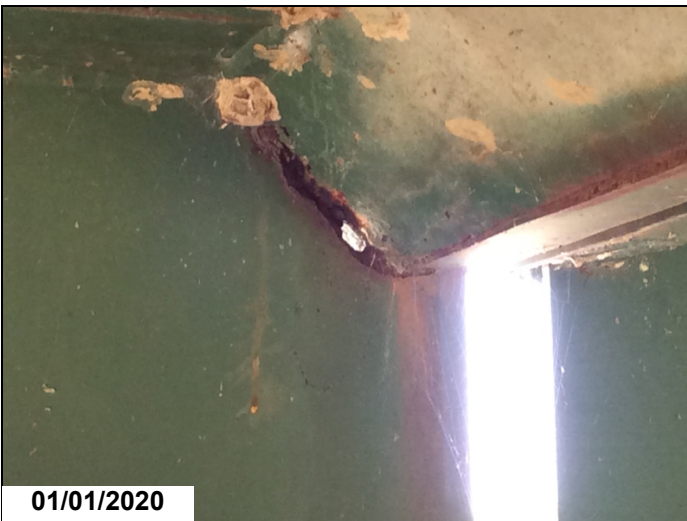
Hole in web below paving haunch @ Girder 1 EOS 16.

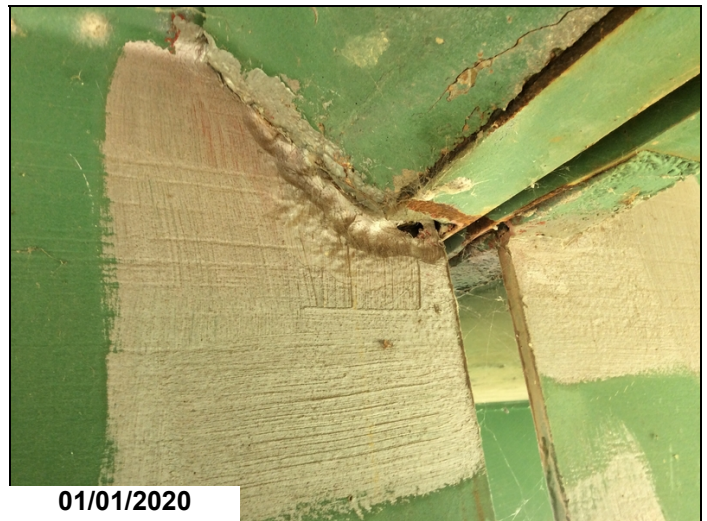
Hole in web below paving haunch of Girder 3 @ EOS 22.

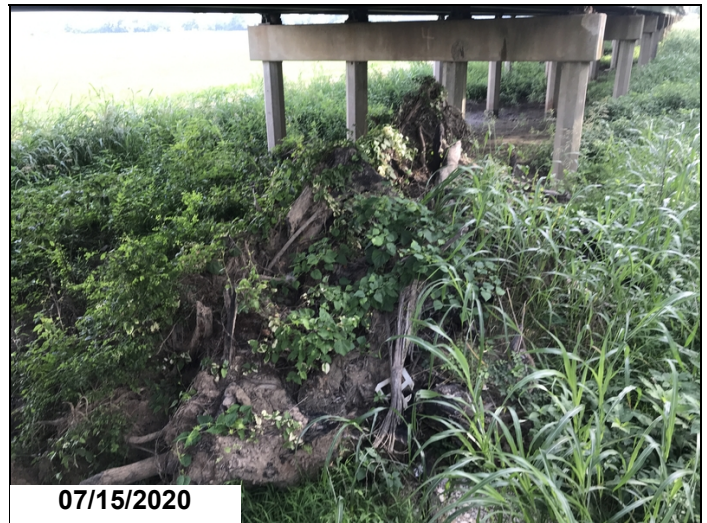
Span 4: Large pile of debris (brush) pushed up in pile under bridge.

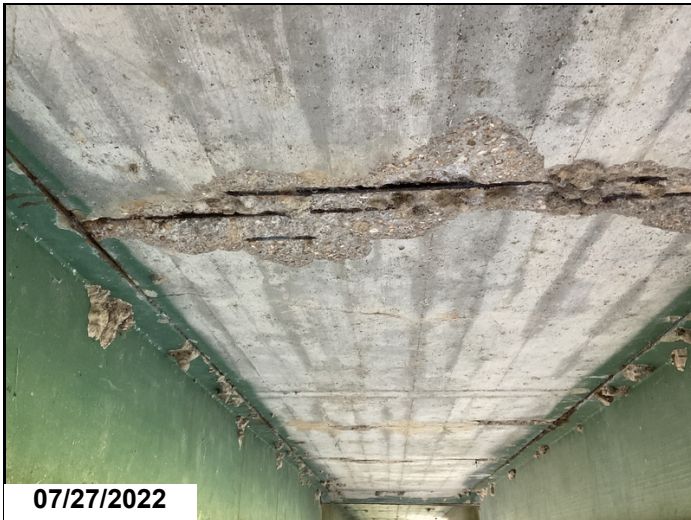
Spalls with rebar exposed at most Spans.

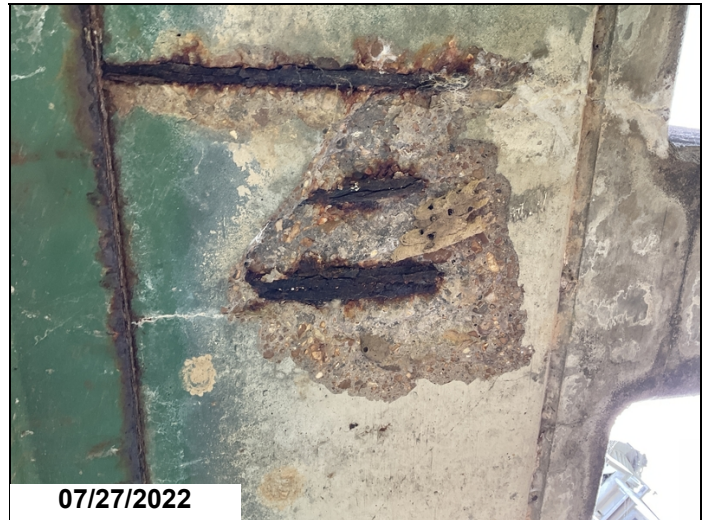
Soffit between Girders and Overhangs.
Spalls with rebar exposed at most Spans.

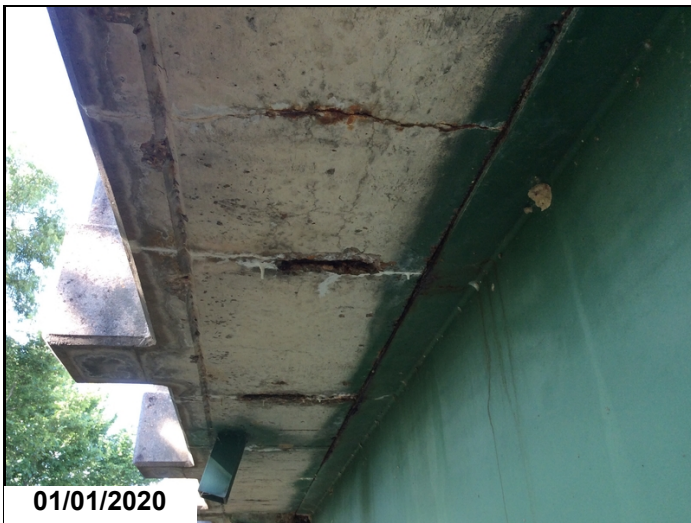
Spalls with rebar exposed & efflorescent cracking to
Right overhang @ Span 6.

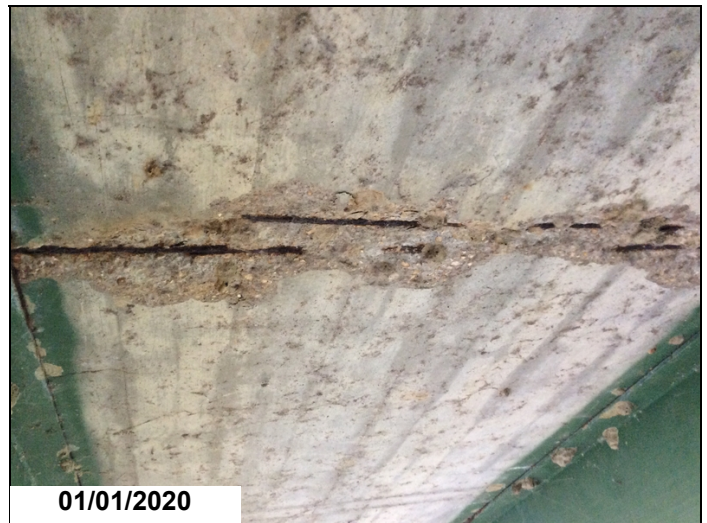
Spalls with rebar exposed to soffit between Girders 1 & 2
@ Span 2
