Bridge 01883 Inspection Report

Route:367 Section:21 Log:4.989

National Bridge Inventory Data Sheet

Asset #01883(Routine, Underwater type 2)
SH 367/Jackson Co. over WHITE RIVER RELIEF
Location: 1.05 MI SW JCT SH 14
Team Lead: Floyd Haley Inspection Date: 08/26/2024

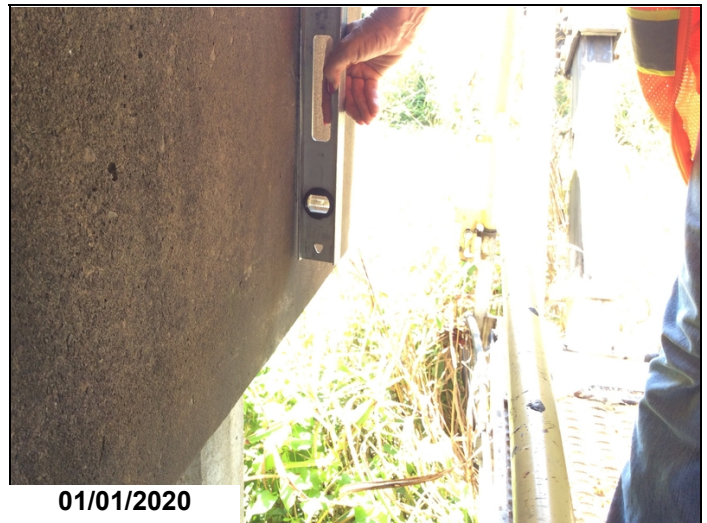
Bent 30 rotated back 1/2" in 18".

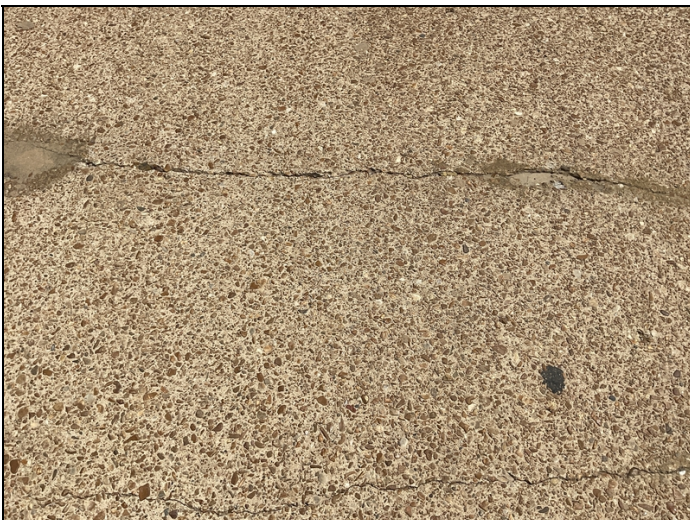
All spans have unsealed cracks.

A-54 - Sealable Deck Cracks (Yes)
