## Bridge 01884 Inspection Report

Asset #01884(Other Special Recurring)

SH 367/Jackson Co. over WHITE RIVER RELIEF

Team Lead: Floyd Haley Inspection Date: 06/23/2025

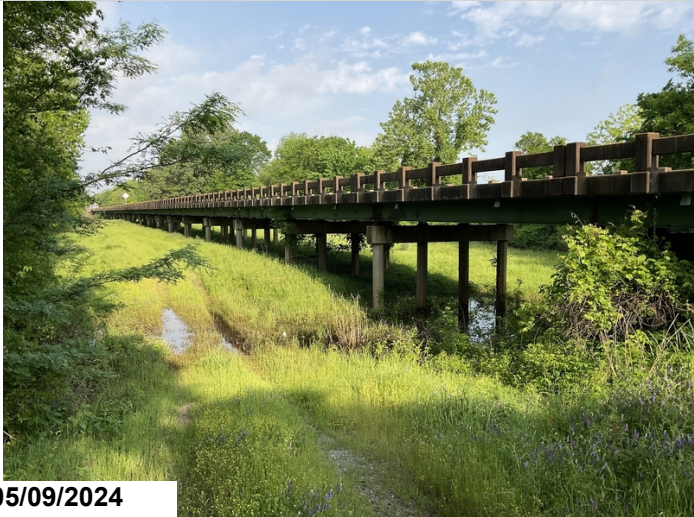
Elevation.

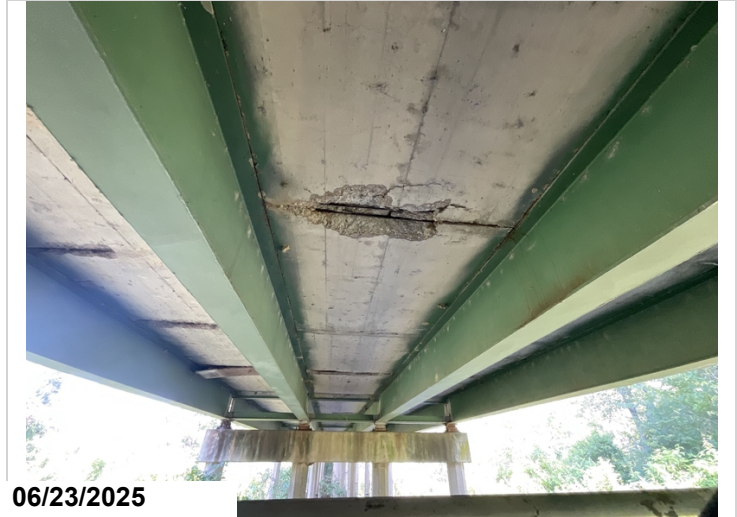
Typical undersurface

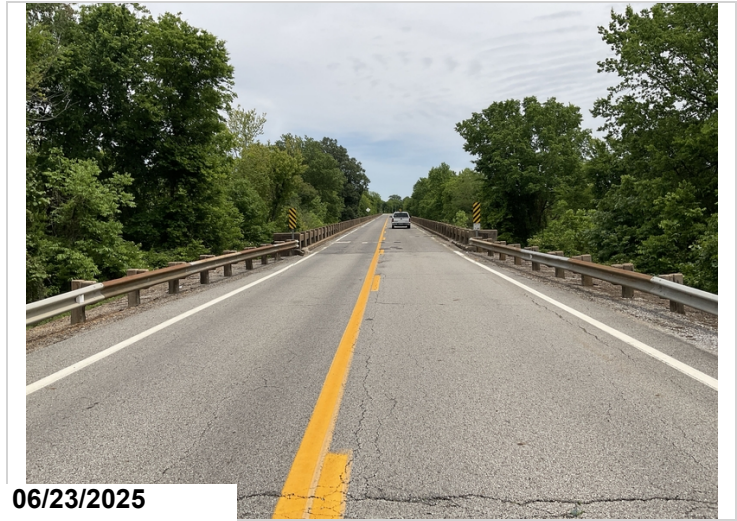
The gutters have widespread debris

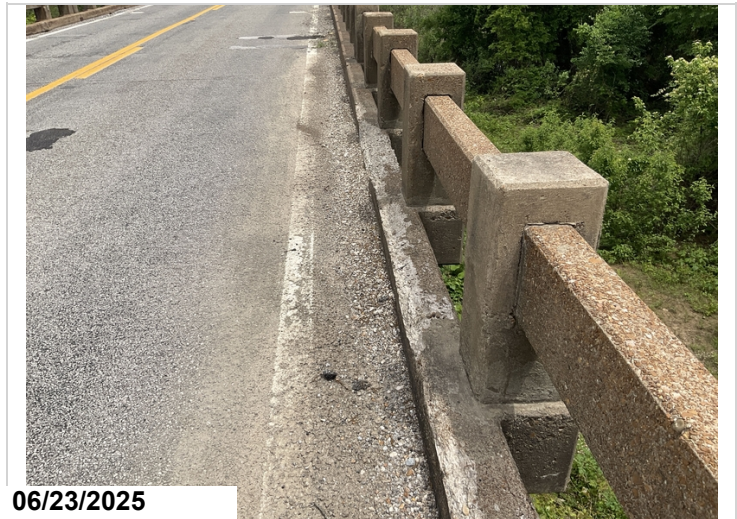
Span 1, right curb: deterioration.

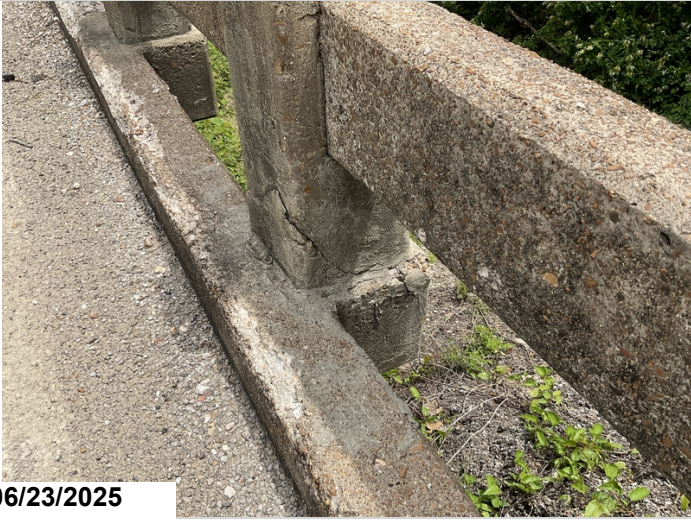
Span 1, right: typical cracking

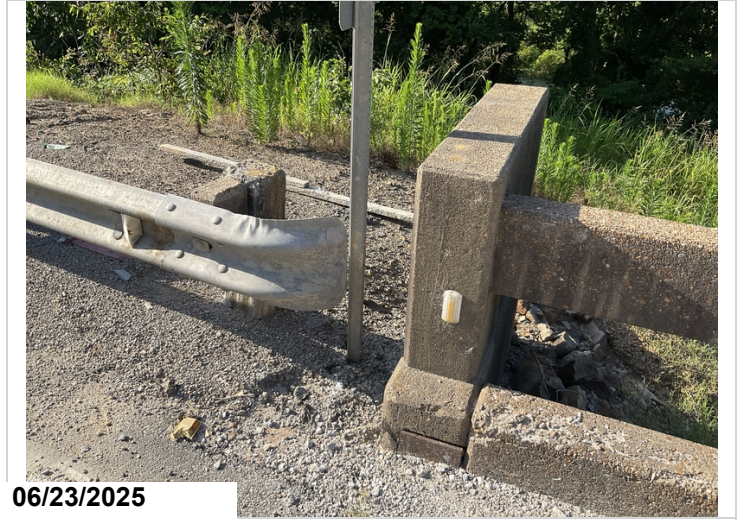
The transitions are not attached to the bridge.

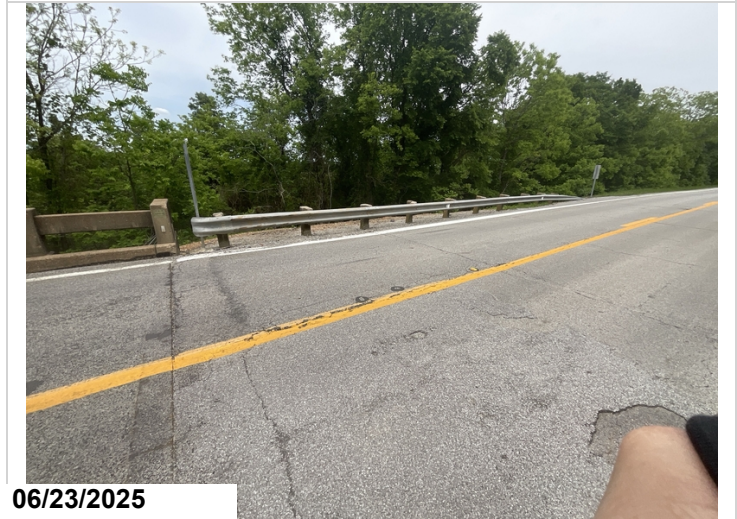
The transitions are not attached to the bridge.

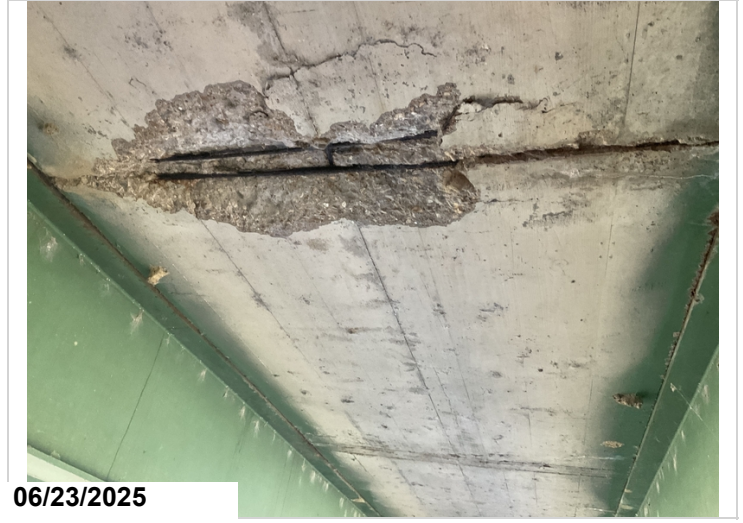
Span 9, bay 2: typical rebar

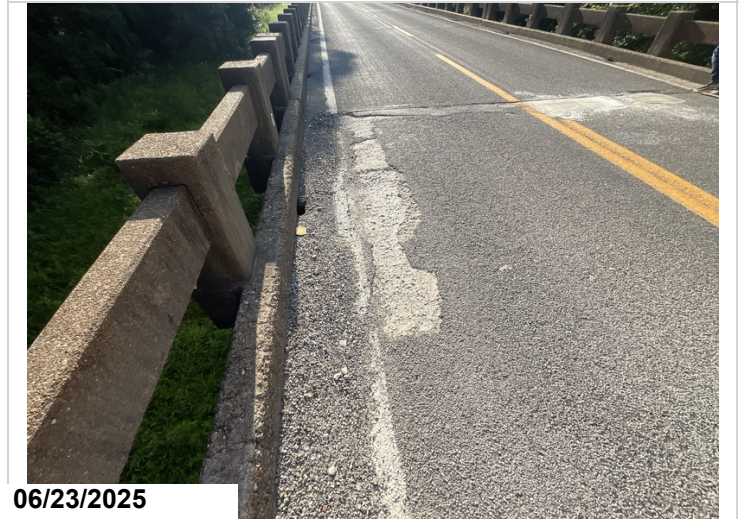
Span 12: Spall with corroded rebar exposed. 1SF CS3

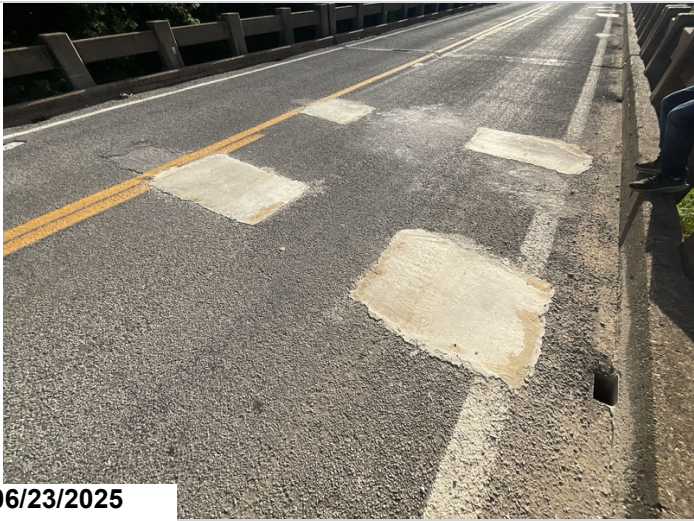
Typical deck patching.

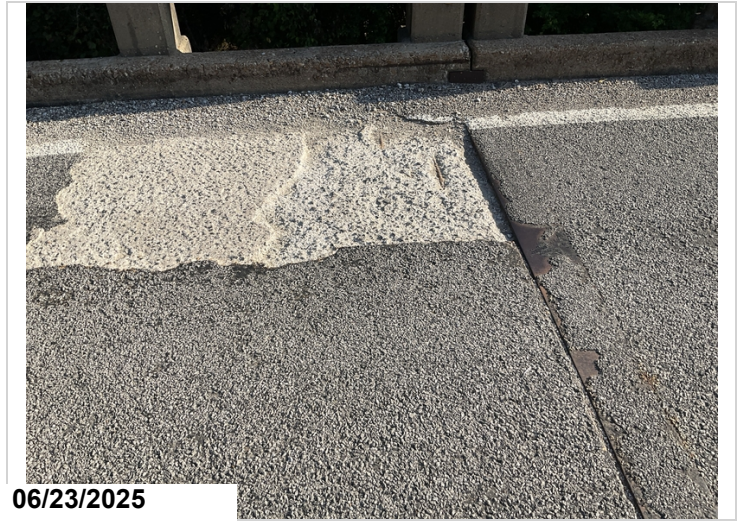
Span 1: Spalls with corroded rebar exposed. 2SF CS3

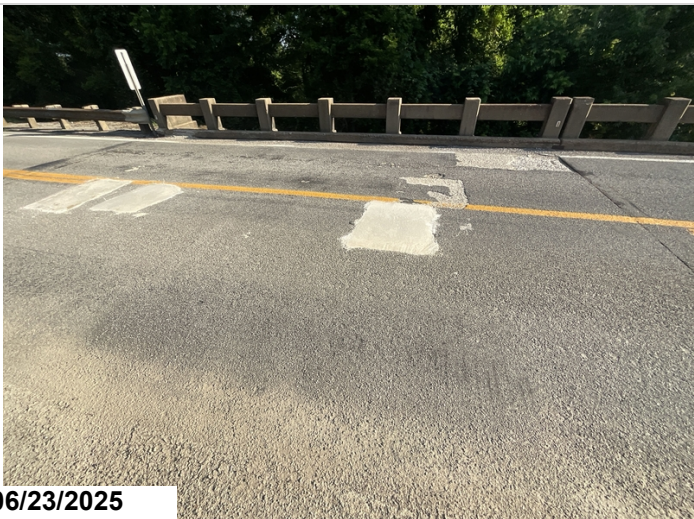
Span 1: Spalls/unsound patches. 33SF CS3

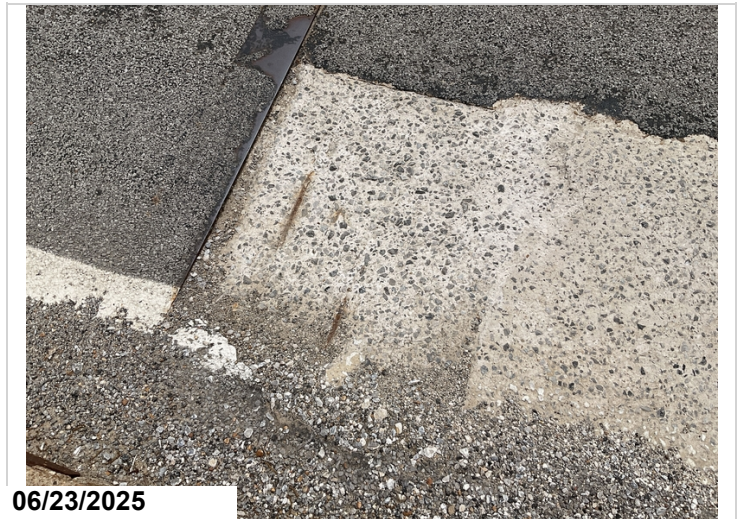
Span 1: Spalls with corroded rebar exposed. 2SF CS3

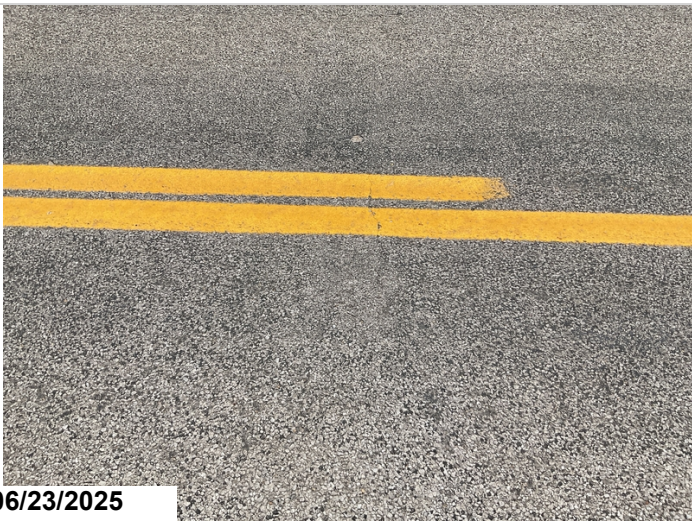
Typical minor crack.

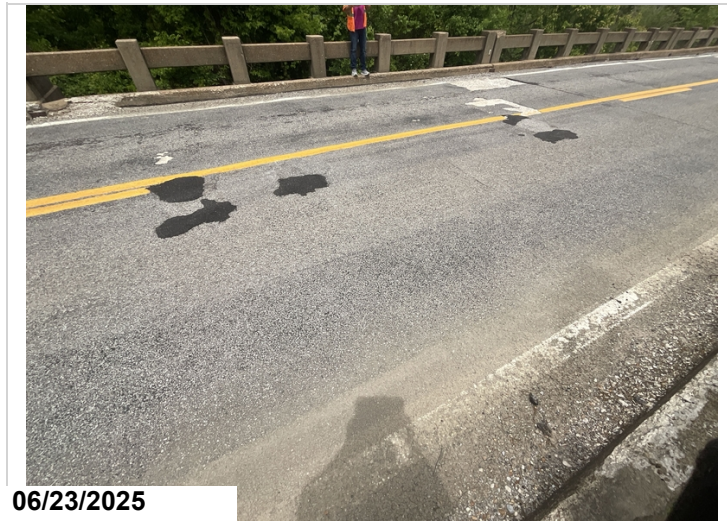
Span 1: typical patches and spalls

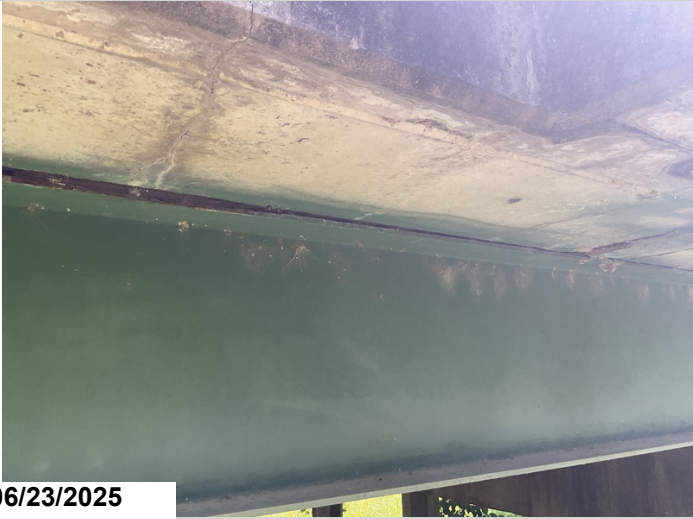
Span 23, girder 4, midspan: has pack rust between the top flange and the deck creating a 1/2" gap. 15LF CS3

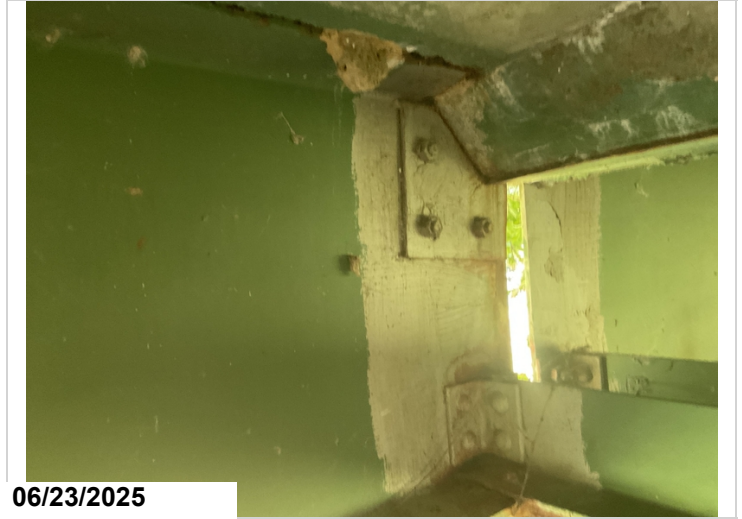
Typical repaired area.

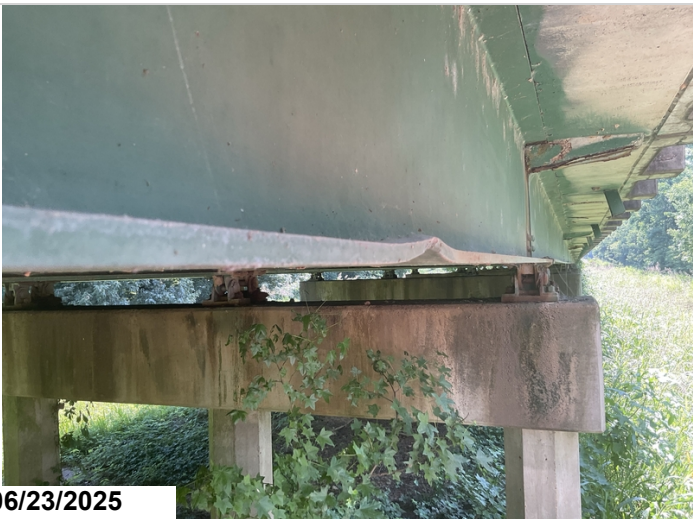
Span 13: Midspan: Girder 4: Bent bottom flange. 1LF CS3

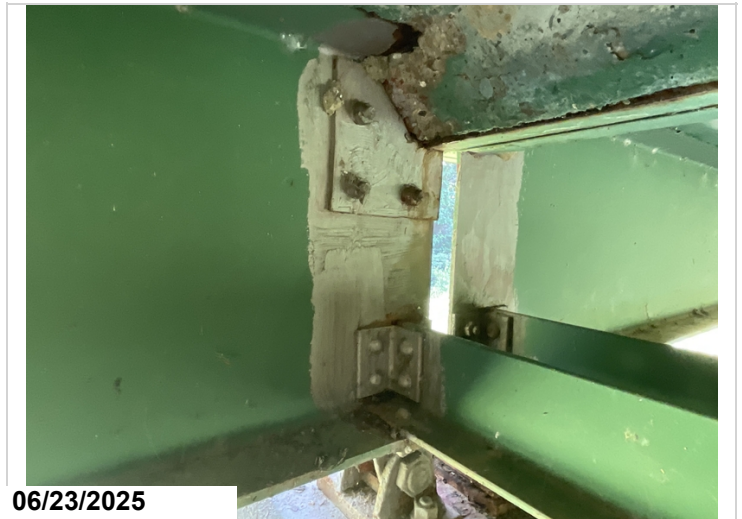
Span 12, bent 12, girder 1: repair

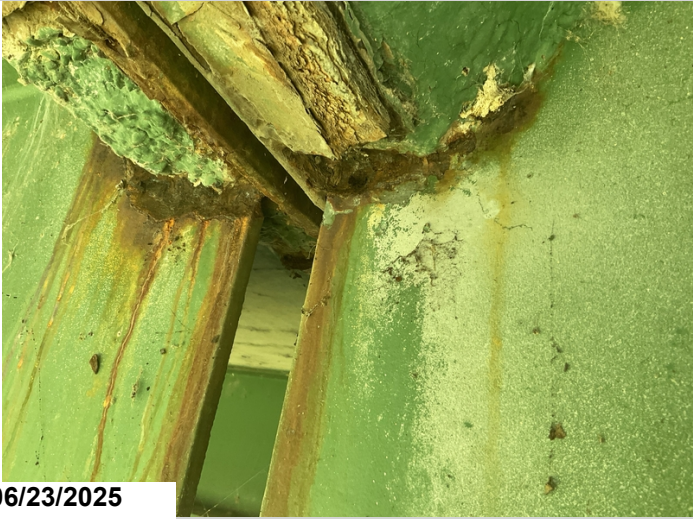
Span 11: EOS: Girder 4: Heavy section loss with 1" x 7 1/2" hole in web below haunch. 1LF CS4

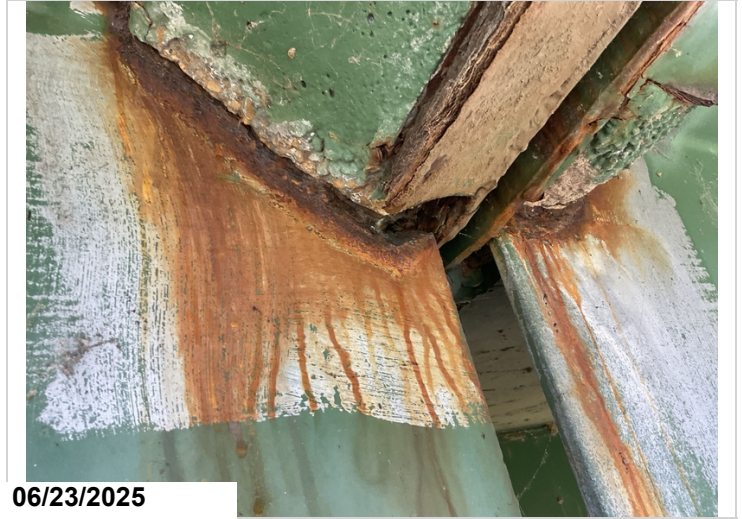
Span 8: EOS: Girder 4: Heavy section loss with 3/4" x 1 1/2" hole in web below haunch. 1LF CS4

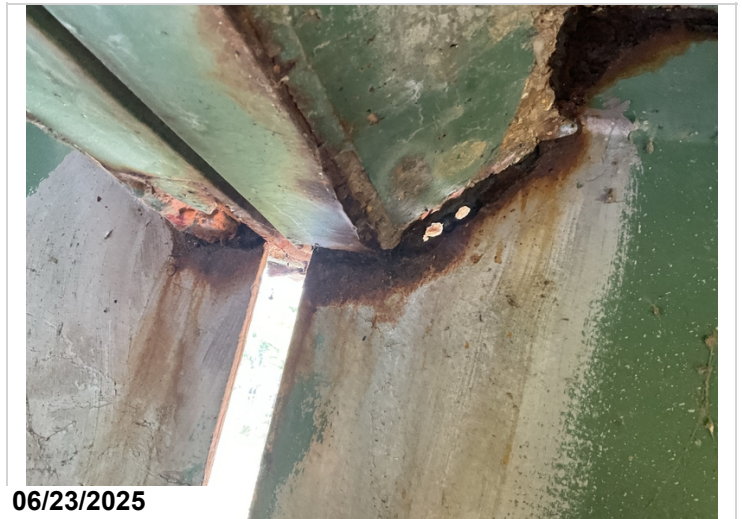
Span 4: EOS: Girder 4: Heavy section loss with 1/2" x 2" hole in web below haunch. 1LF CS4

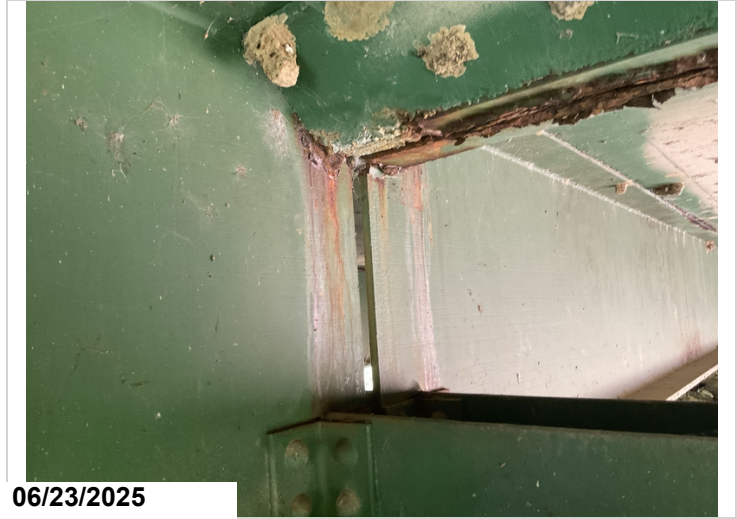
Typical area of minor section loss at the haunches.

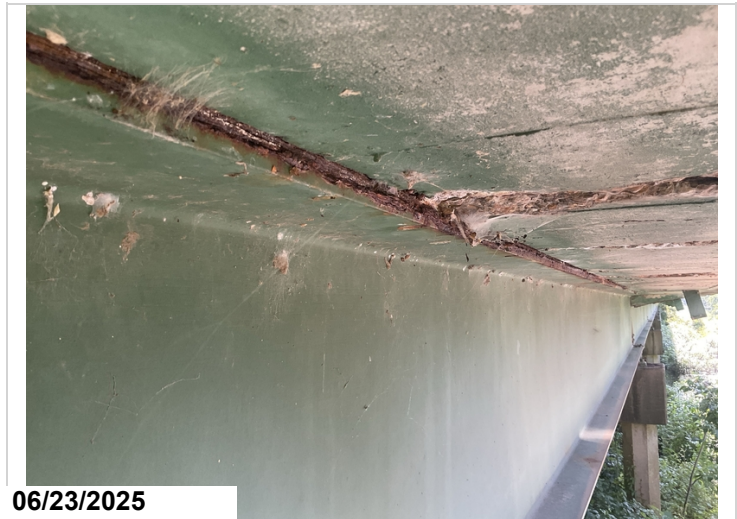
Typical pack rust lifting the deck over the girders.

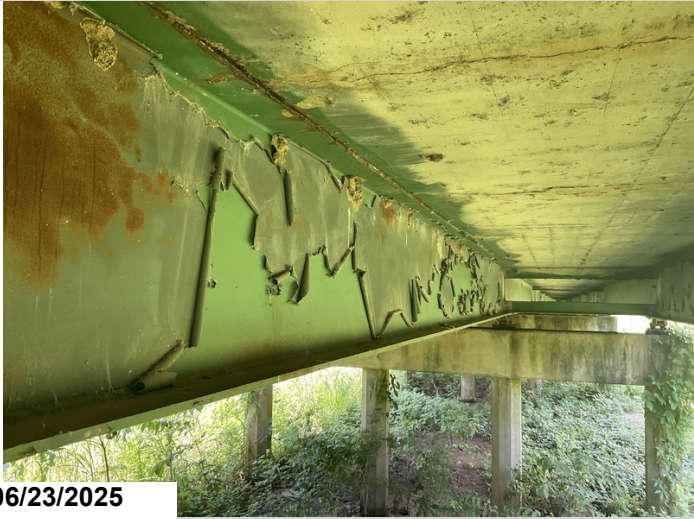
Span 26 paint condition.

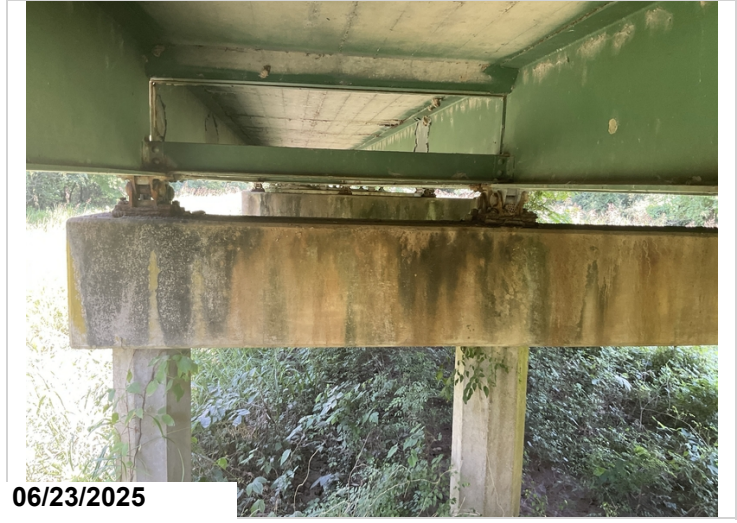
Typical bearings with heavy corrosion.

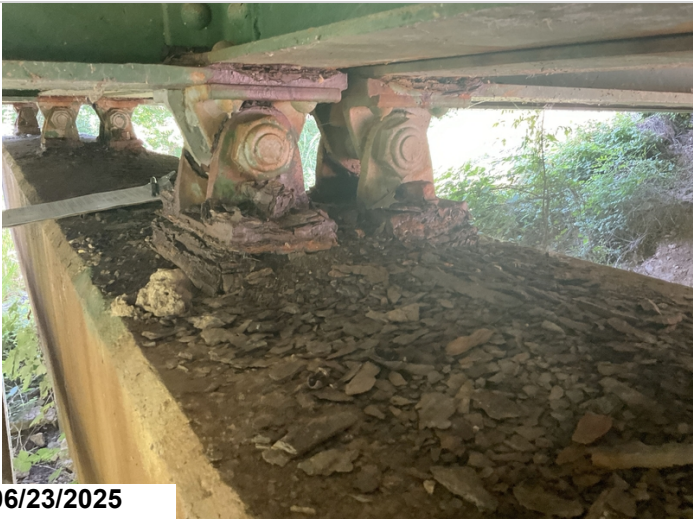
Bent 1: bearings

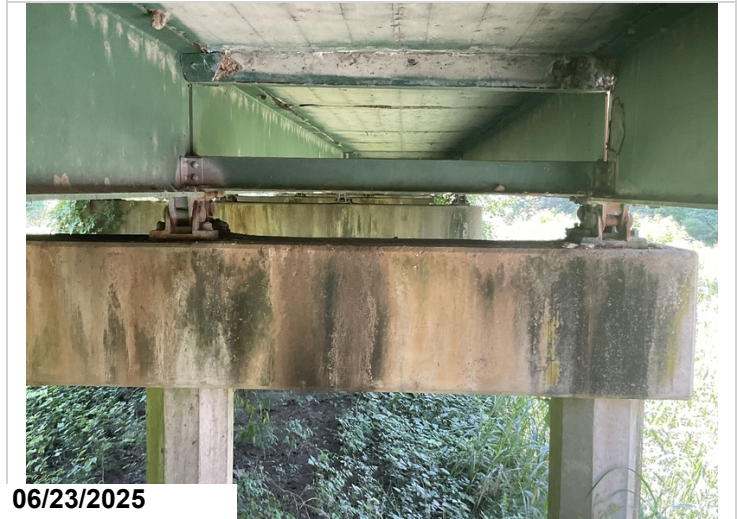
Typical with rust and pack rust

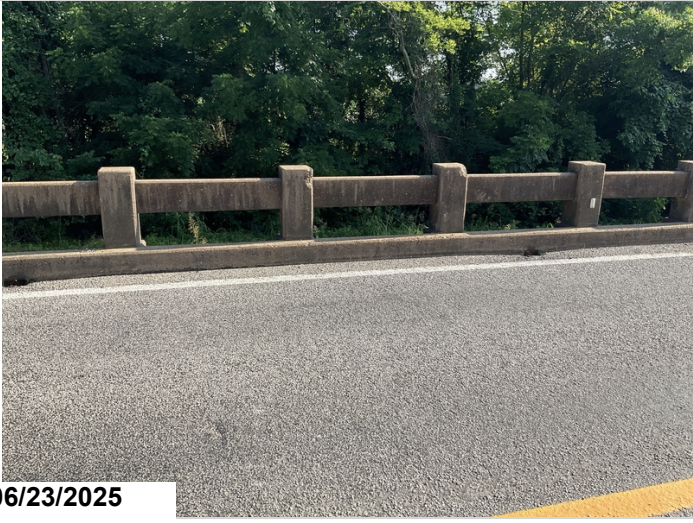
Typical post spalling.

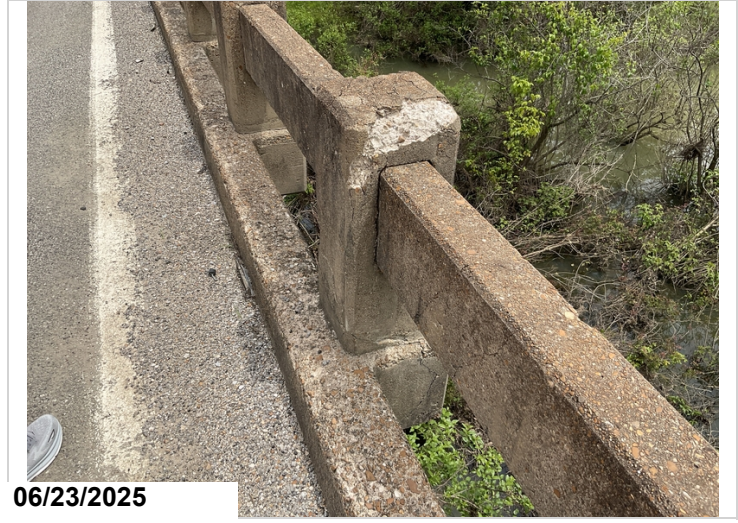
Span 8, right: post 2: spalling

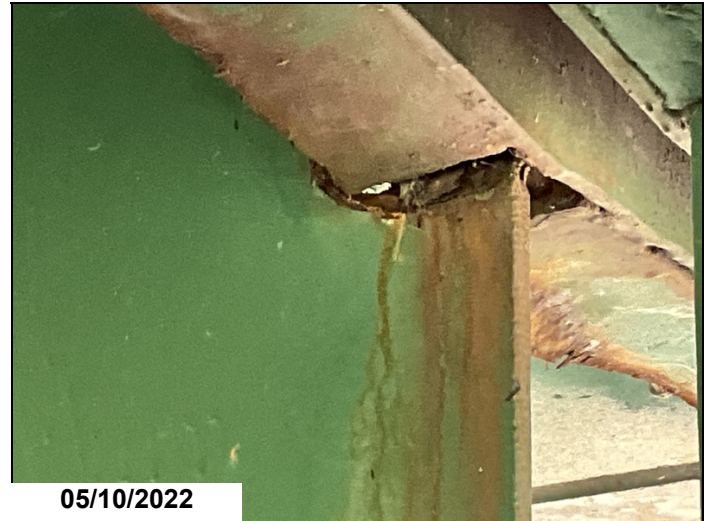
Rust, pack rust, and section loss to ends of girders at web below haunch, Girder 1, end of span 15.

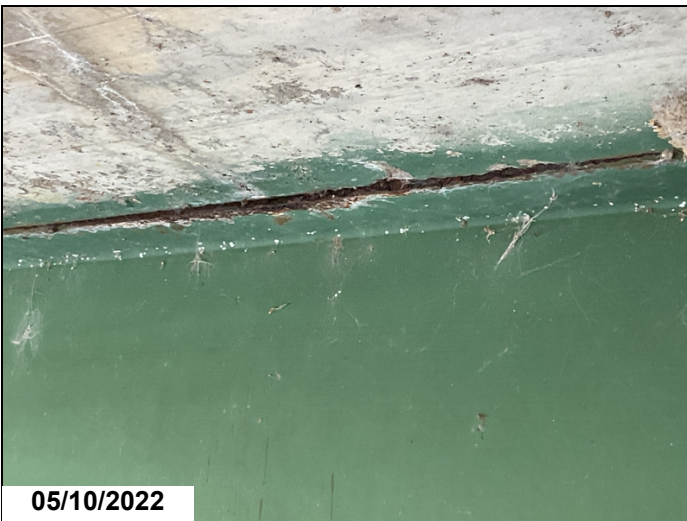
Pack rust along top flange of girders near 1/4, 1/2, and 3/4 points

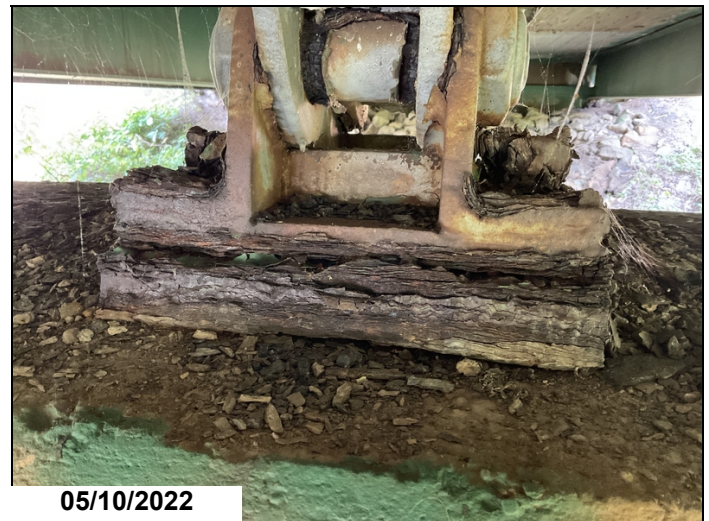
Superstructure at all spans  
Rust, pack rust, and section loss to ends of girders at web below haunch, at diaphragm connections, and bearing assemblies  
Bearing assembly.

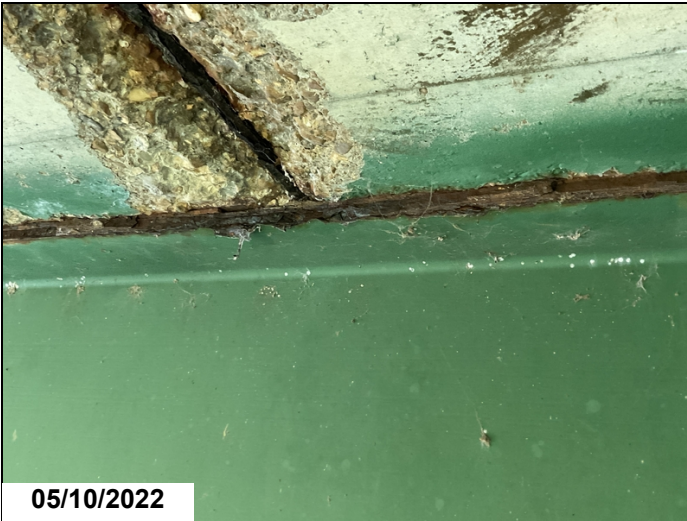
Superstructure at all spans  
Rust, pack rust, and section loss to ends of girders at  
web below haunch, at diaphragm connections, and  
bearing assemblies  
Girders.

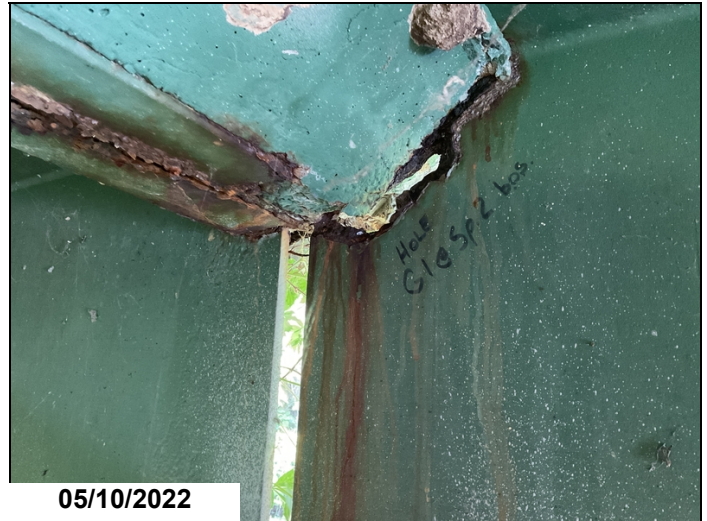
Several holes in ends of girders at the web under the  
haunch.

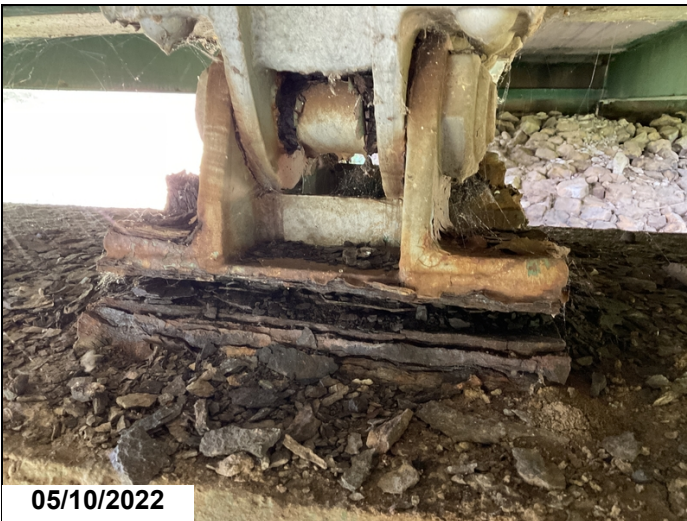
Several anchor bolts missing to bearings.

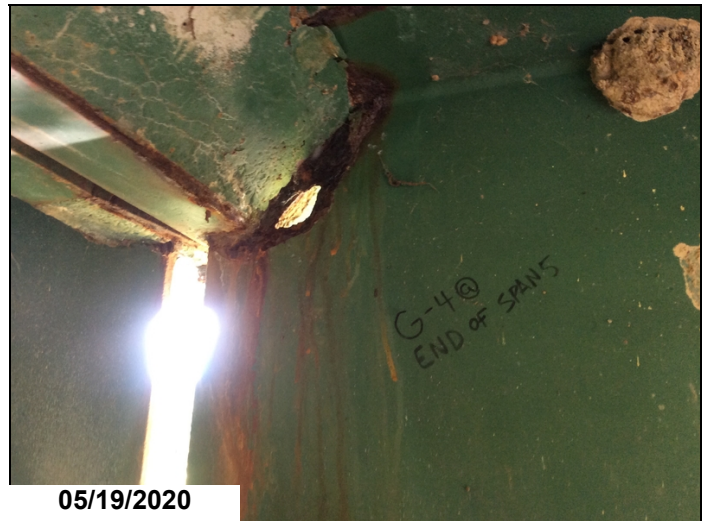
Hole in web below haunch @ Girder 4 EOS 5.

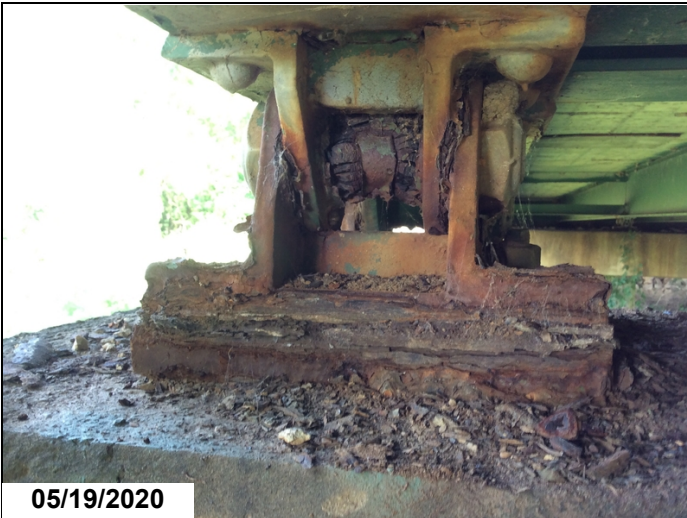
Bearing 4 ahead @ BOS 3 has heavy pack rust with both bolts missing.

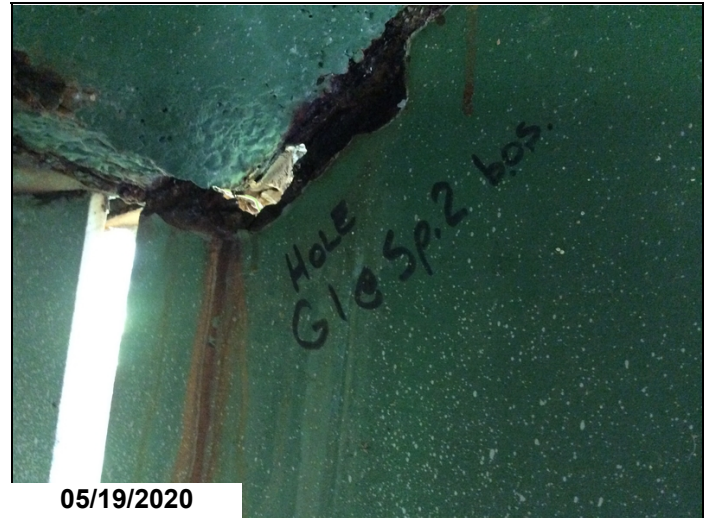
Girder 1 at beginning of Span 2

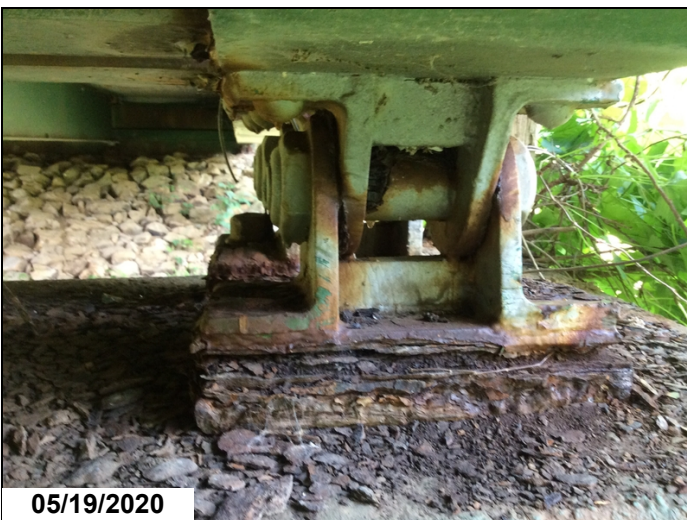
Bearing 1 Bent 1 ahead has bolt missing.

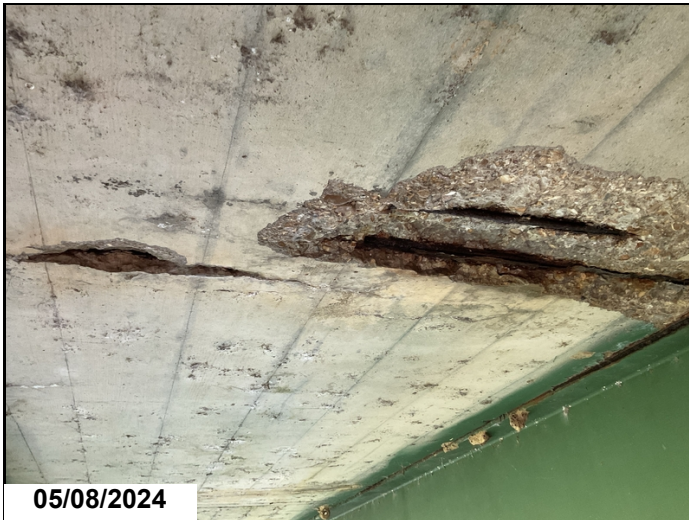
Span 2, Bays 1 - 3: Spalling with 31' of exposed reinforcing steel with section loss.

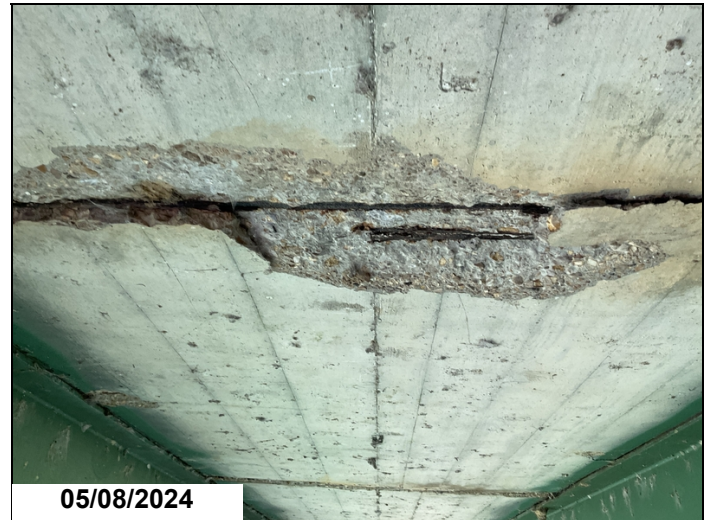
Span 13, Undersurface: Spalling with 40' of exposed reinforcing steel with section loss.

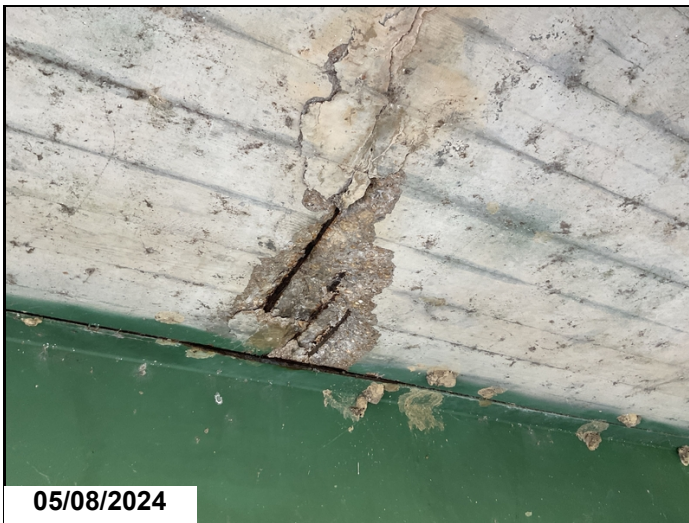
Span 4, undersurface: Spalling with 28' of exposed reinforcing steel with section loss.

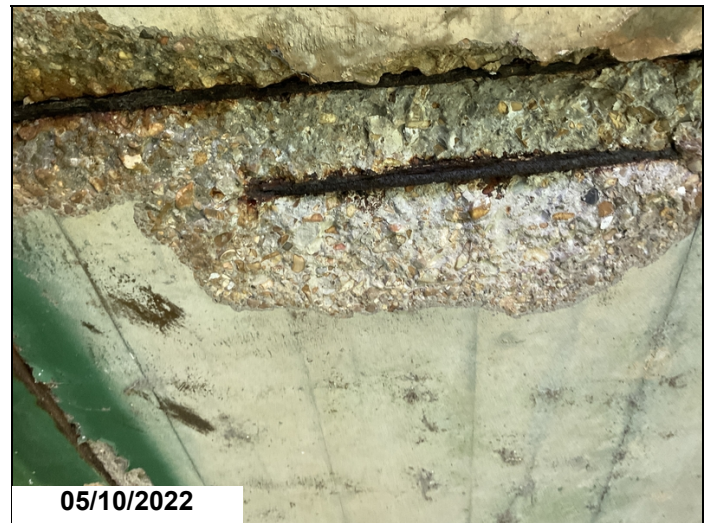
Soffit: Spalls with rebar exposed to soffit and Lt and Rt overhangs at all spans. Soffit @ Span 2.

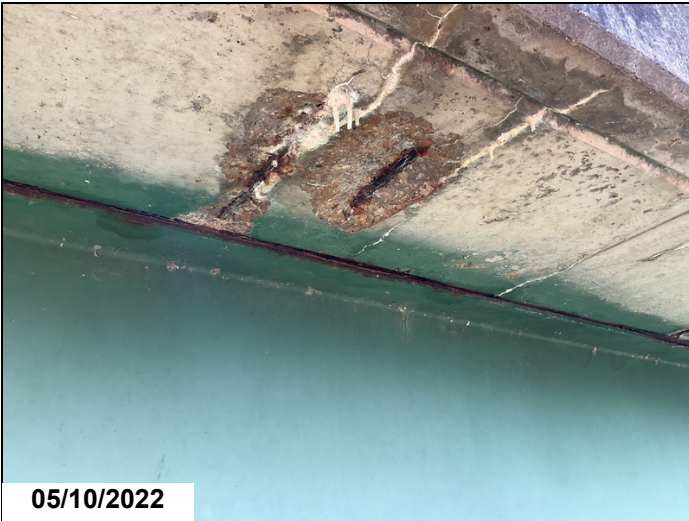
Soffit: Spalls with rebar exposed to soffit and Lt and Rt overhangs at all spans. Span 2, Rt overhang

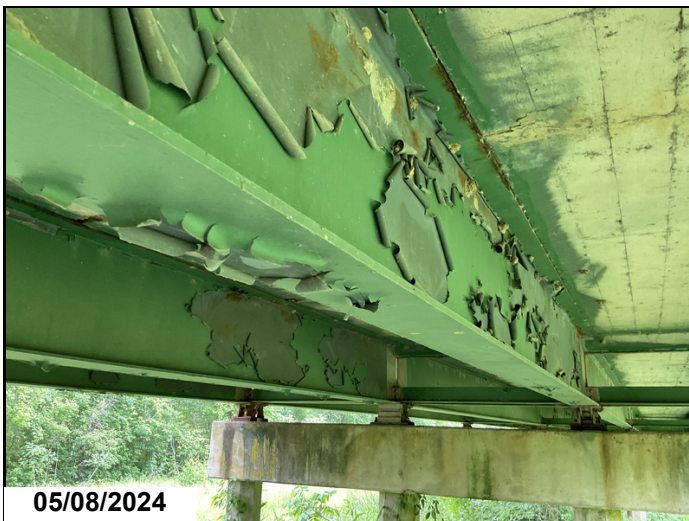
Span 26, Girders: Peeling paint.

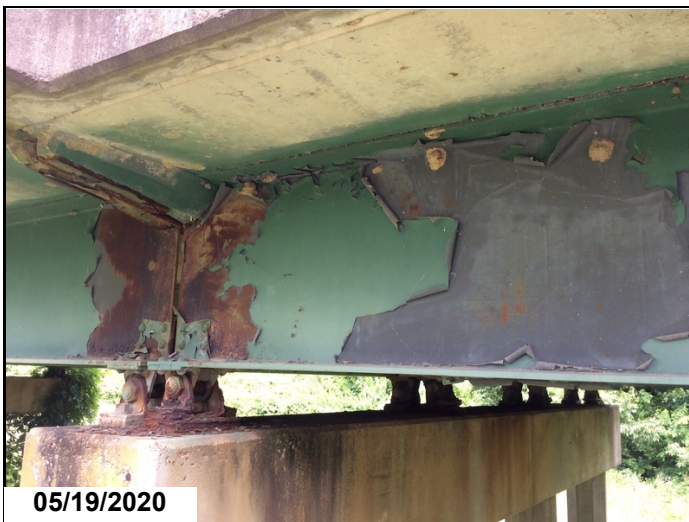
Paint peeling with rust to Girder 4 over Bent 28

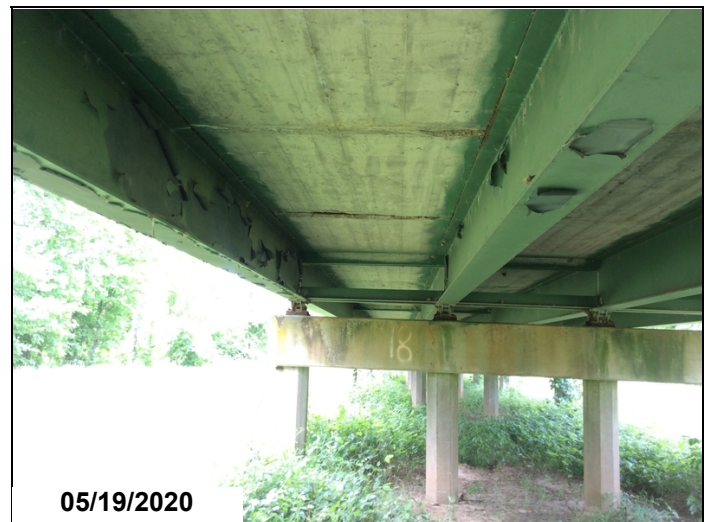
Girders 3 & 4 @ Span 19. Paint peeling.

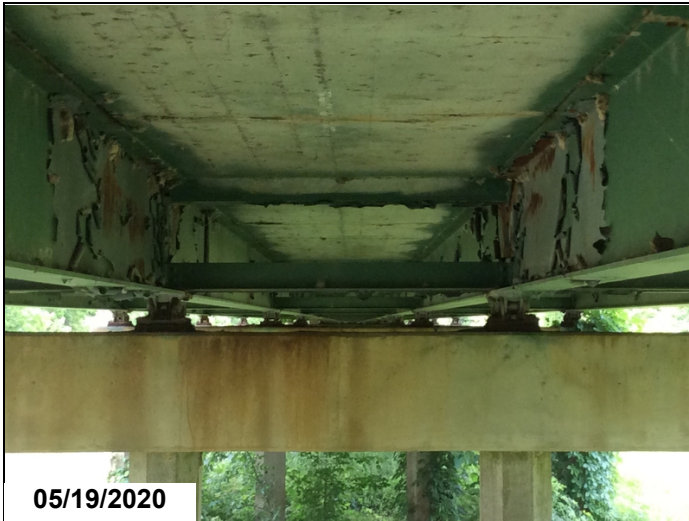
Paint peeling with rust to Girders 2 & 3 @ Span 29.

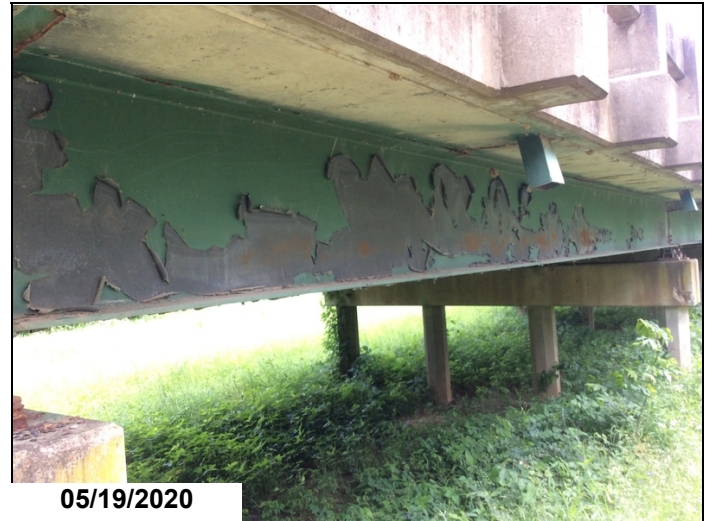
Girder 4 @ Span 19. Paint peeling with rust.

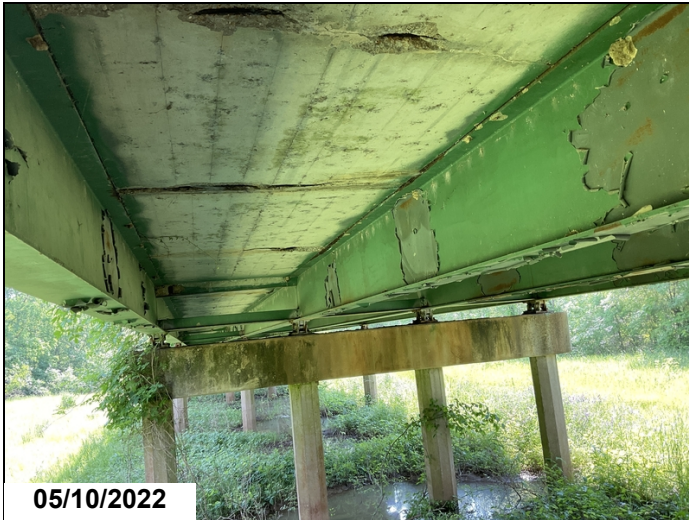
Paint peeling to girders 1-4 @ span 24.

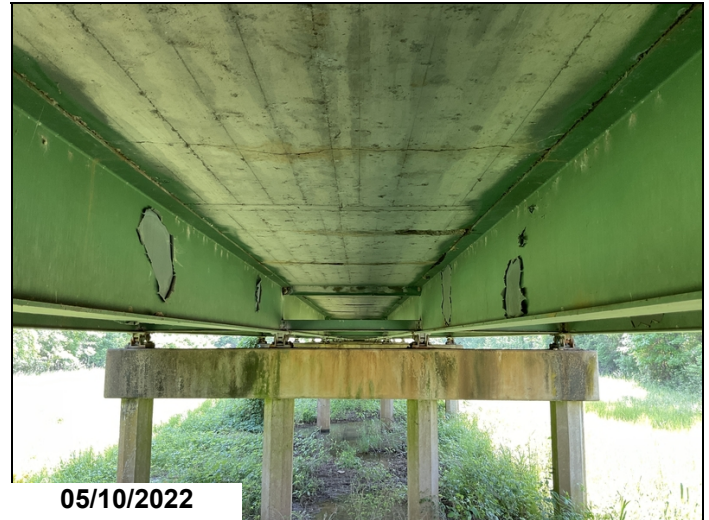
Spans 19 - 24, and 26 - 30  
Paint peeling at girders 1 - 4 with surface rust in exposed areas.  
Girders 2, 3, & 4, span 21.

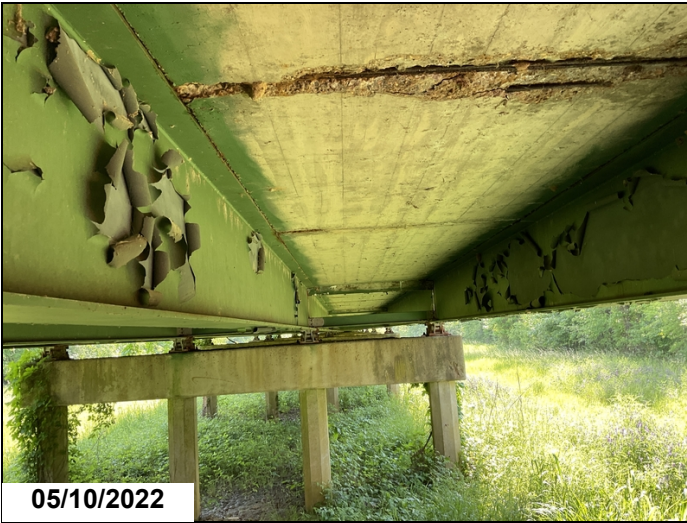
Paint peeling at girders 1 - 4 with surface rust in exposed areas.

Girder 3, span 19.

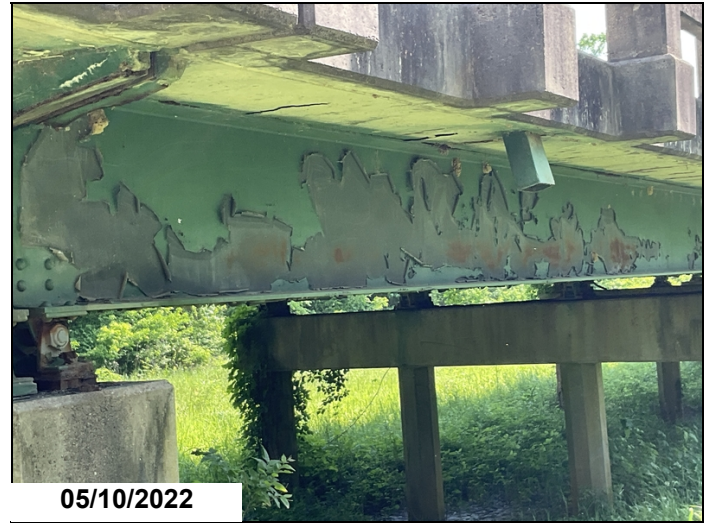
Paint peeling at girders 1 - 4 with surface rust in exposed areas.

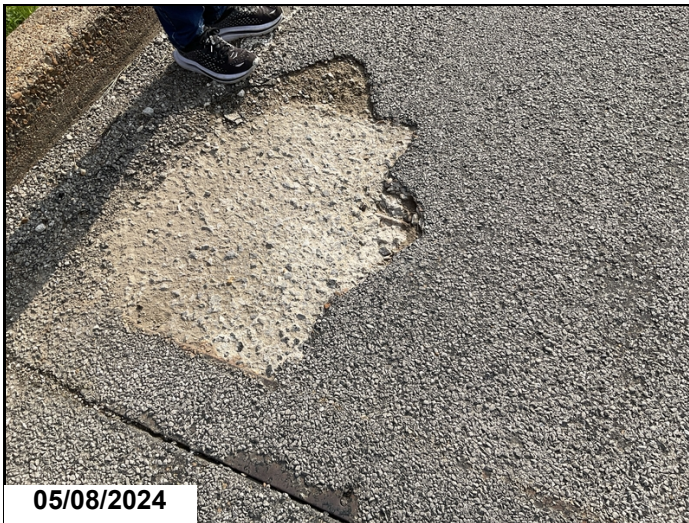
Span 28, Left, adjacent to Bent 27: Spalling with 1' of exposed reinforcing steel with section loss.

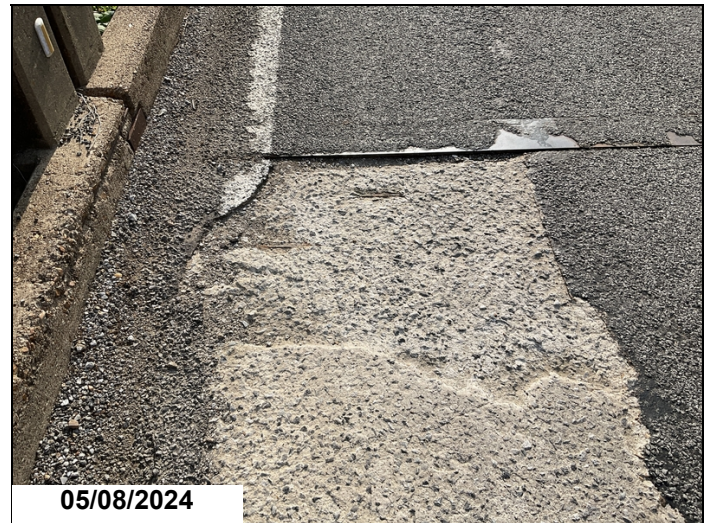
Span 1, Left, adjacent to Bent 1: Spalling with 2' of exposed reinforcing steel with section loss. CS3.

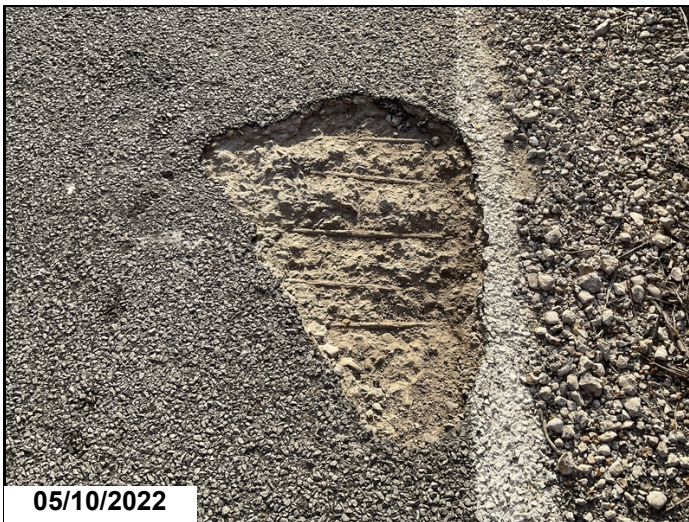
Spall with 3' of rebar exposed to deck @ span 26.

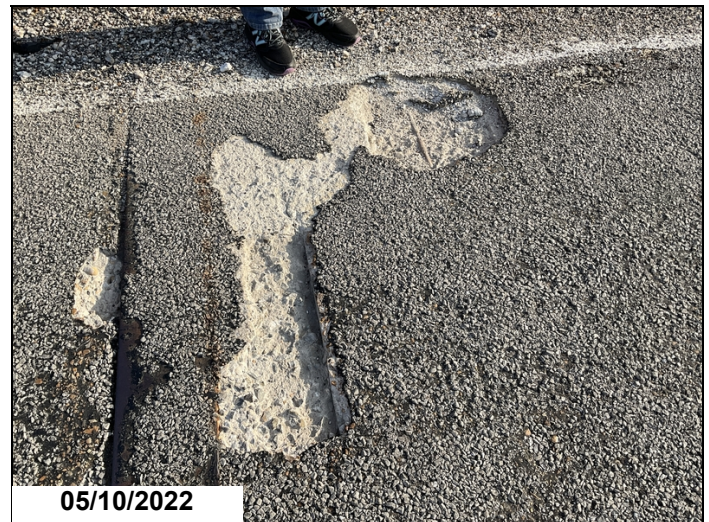
Deep spall with rebar exposed to deck @ span 12.

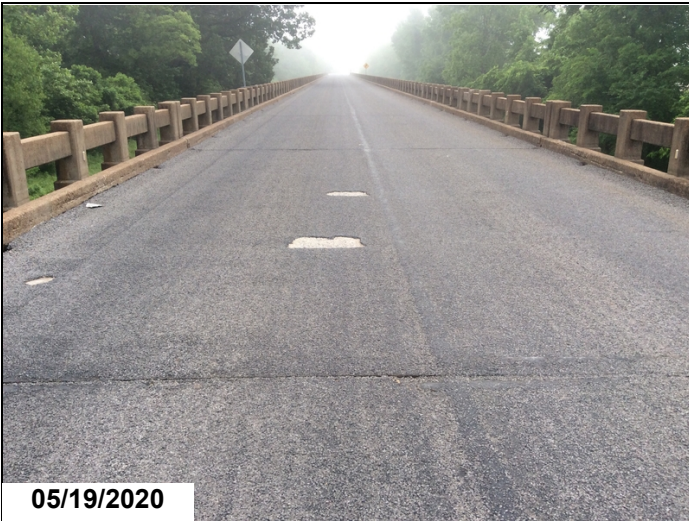
Typical spalls to wearing surface at Spans 4, 5, 8, 16, 20,  
& 30.

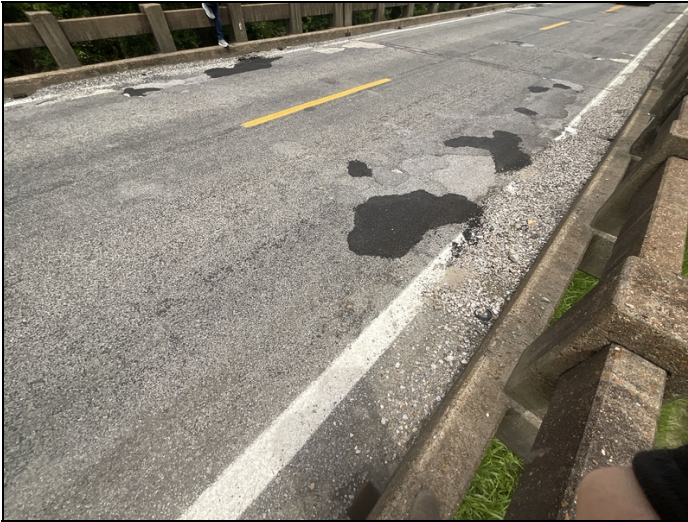
The gutters have widespread debris

**A-55 - Deck Washing Needed (Yes)**
