Bridge 01885 Inspection Report

Route:367 Section:21 Log:6.399

Arnold Road ID:34x367x21xA, Arnold Log mile:6.387

District 05, 67 - Jackson County

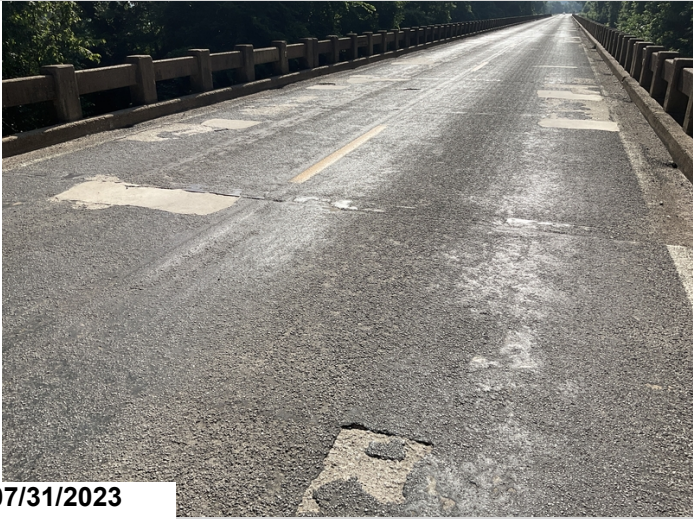
The deck is heavily deteriorated and in need of repair.

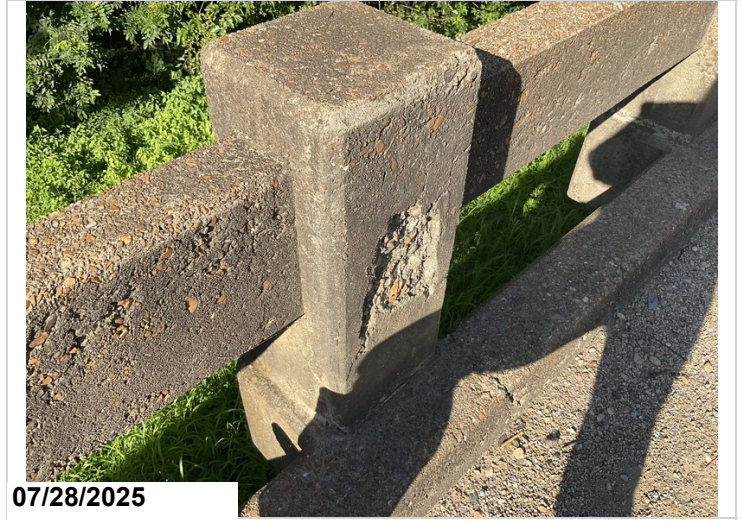
Typical spalling and deterioration of the railing.

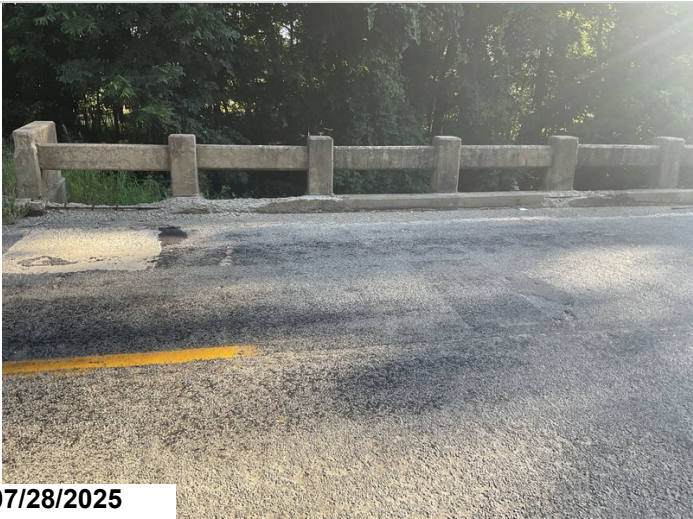
Typical curb condition.

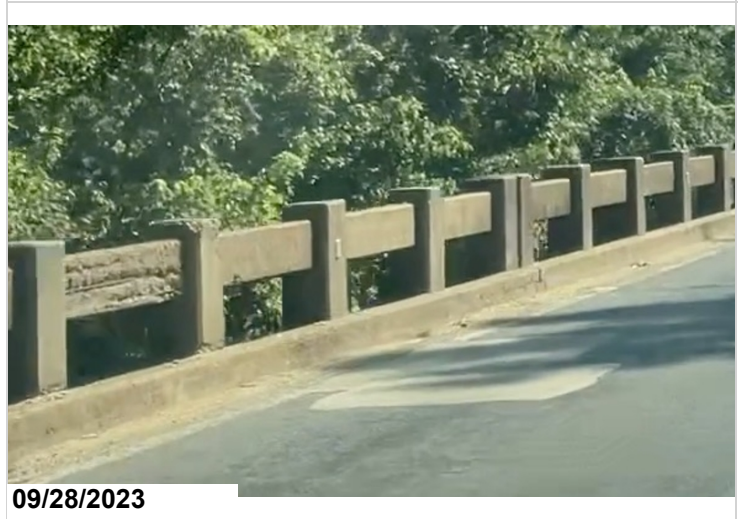
Typical spall with exposed rebar.

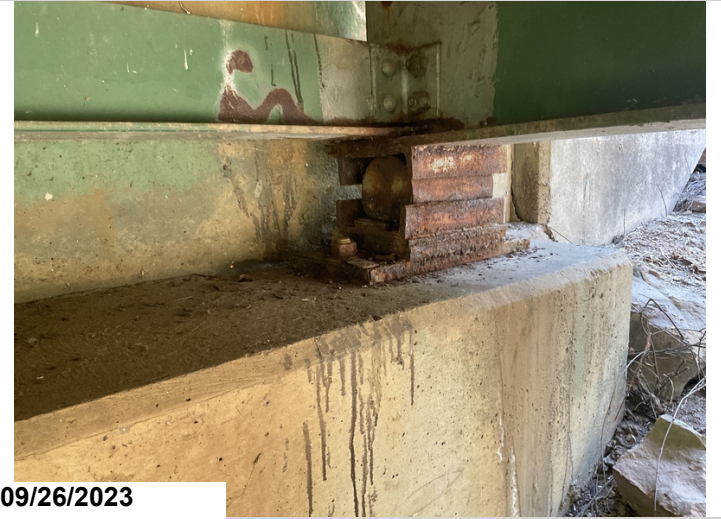
Bent 26, bearing 4: typical flaking rust. CS3.

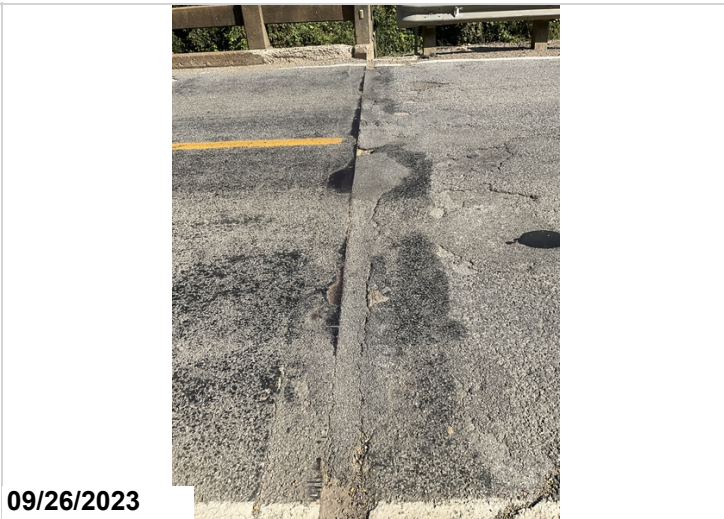
Joint over Bent 26, debris impact due to asphalt overlay, typical.

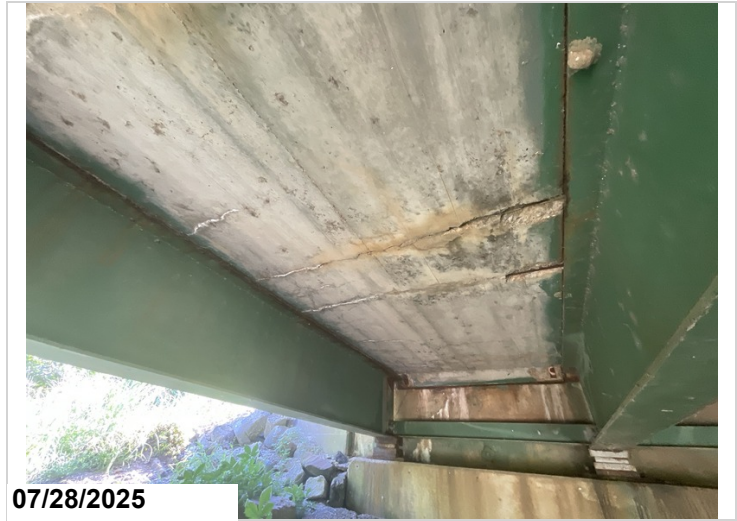
Span 26, bay 1: has typical, widespread efflorescence and rust-stained cracks. 65SF CS3

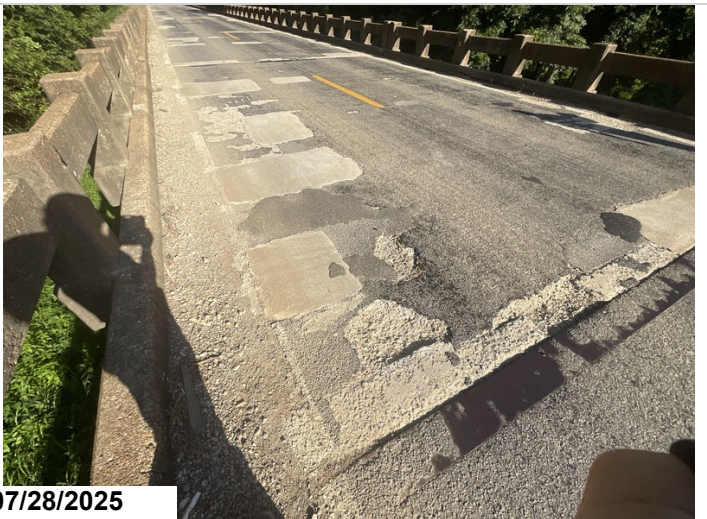
Span 10: has widespread patches and scattered spalls.
81SF CS2 | 27SF CS3

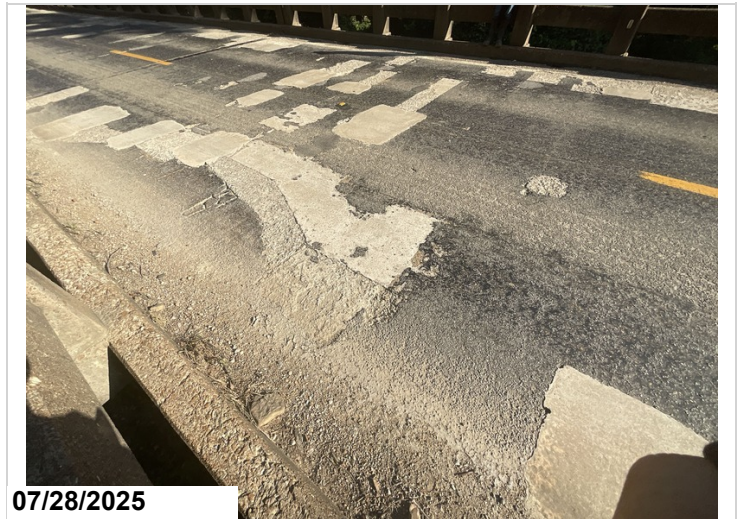
Span 7: has widespread patches and scattered spalls.
102SF CS2 | 24SF CS3

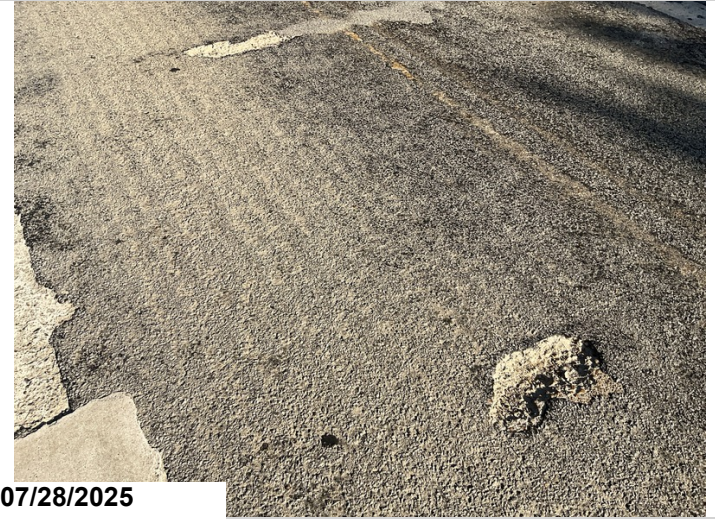
Span 2: has widespread patches and scattered spalls.
118SF CS2 | 10CS3

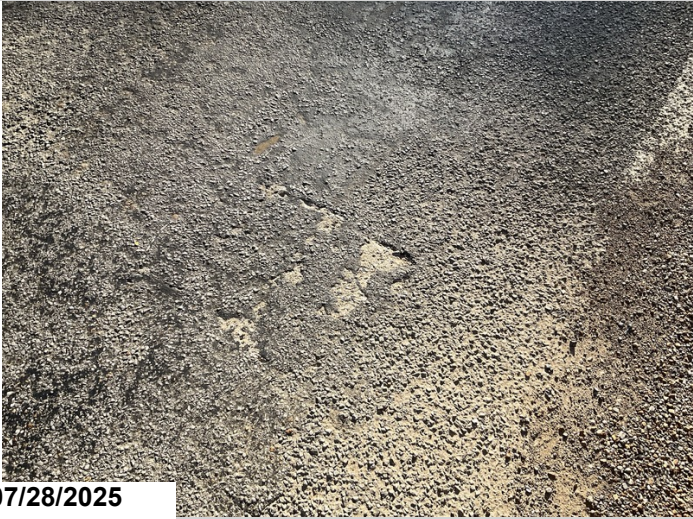
Typical spall on wearing surface

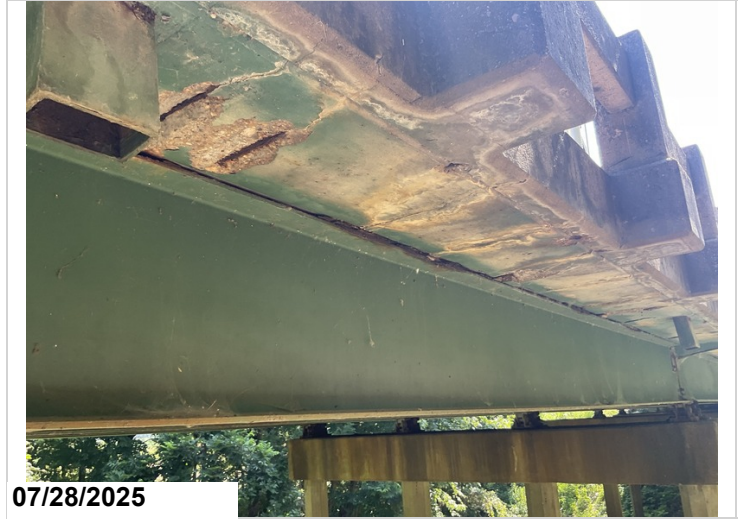
Spans 21-23, girders 1 and 5: have pack rust at the top flange for their full length raising the deck. 64LF CS3

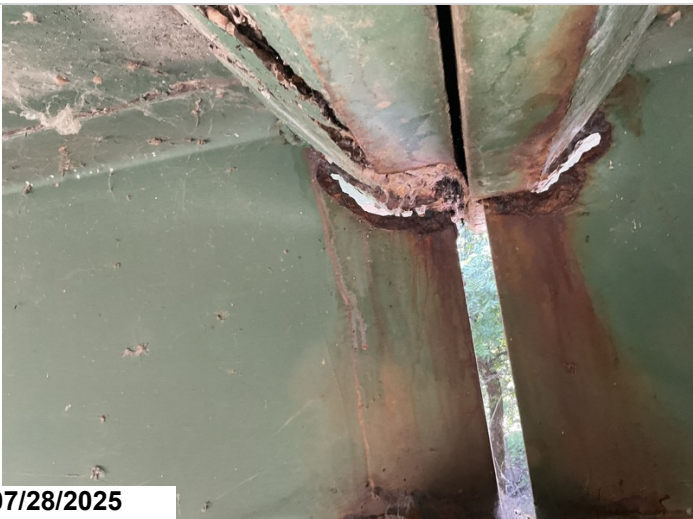
Span 20, bent 19, girder 4: has section loss at the haunch with a 3/4" x 7" hole in the web. 1LF CS4

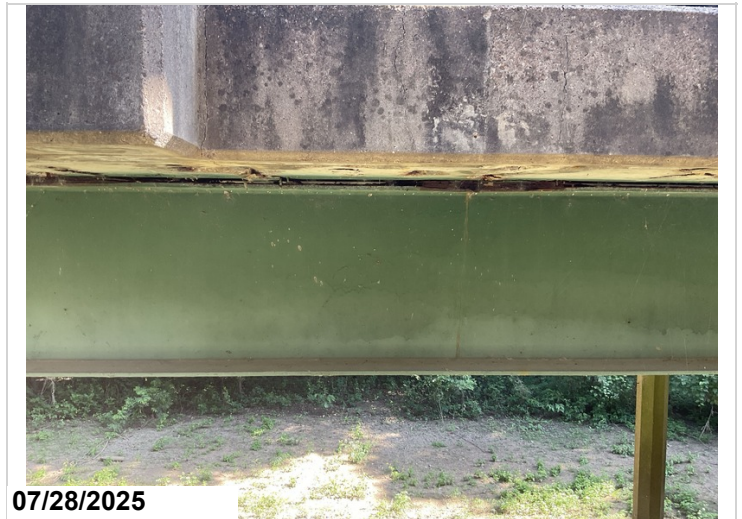
Span 18: all girders have pack rust pushing up on the deck with areas floating. 136LF CS3

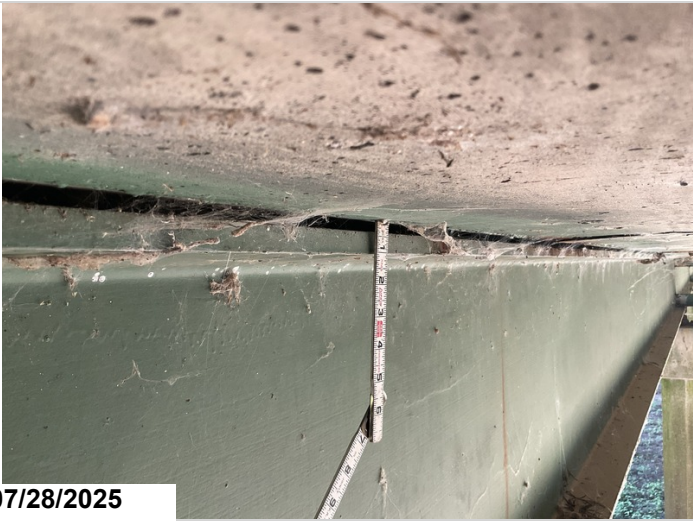
Span 18: all girders have pack rust pushing up on the deck with areas floating. Girder 2, shown, floats for the full span length. 128LF CS3

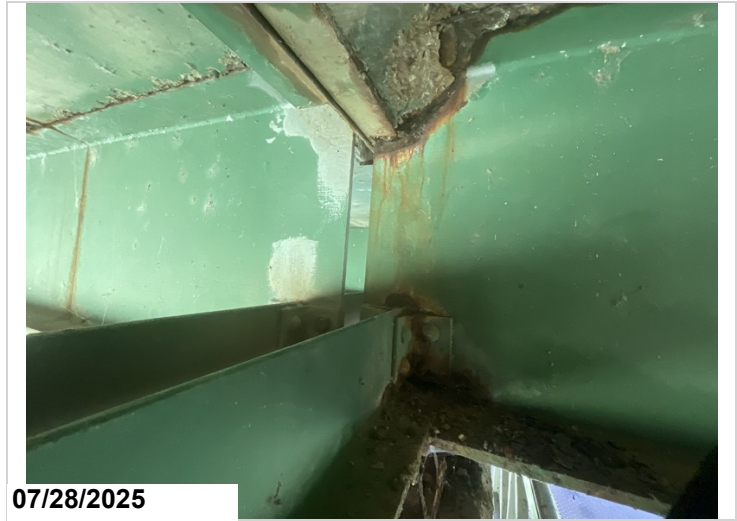
Span 9, bent 9, girder 3: has section loss at the haunch and diaphragm areas with a 1" x 4" hole in the web at the haunch and a 3/4" x 5" hole in the web at the diaphragm. 1LF CS4

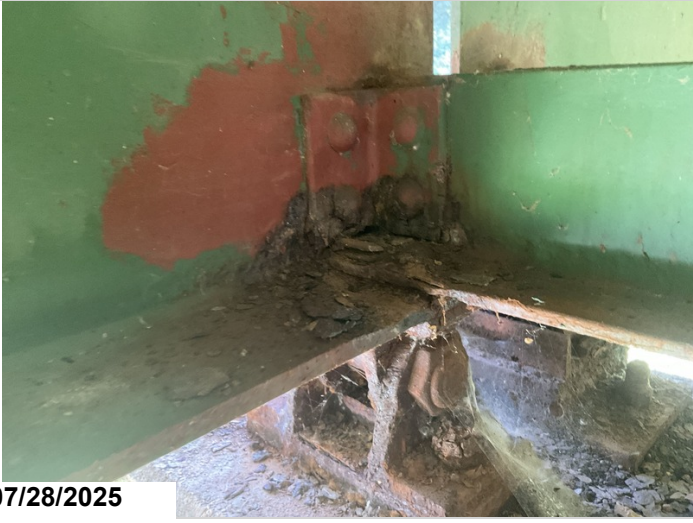
07/28/2025
Typical beam ends have corrosion with 1/8" section loss at the haunch and diaphragm connections. All girders throughout have on average a similar level of deterioration to this, even areas that have been painted or plated in the past, unless otherwise called out. 156LF CS3

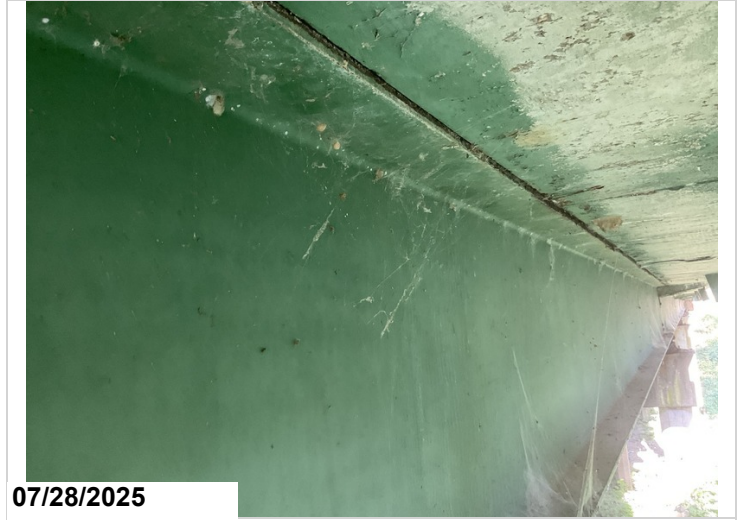
07/28/2025
Span 5, girder 1: has flaking corrosion and pack rust on the top flange for the full girder length. 32LF CS3

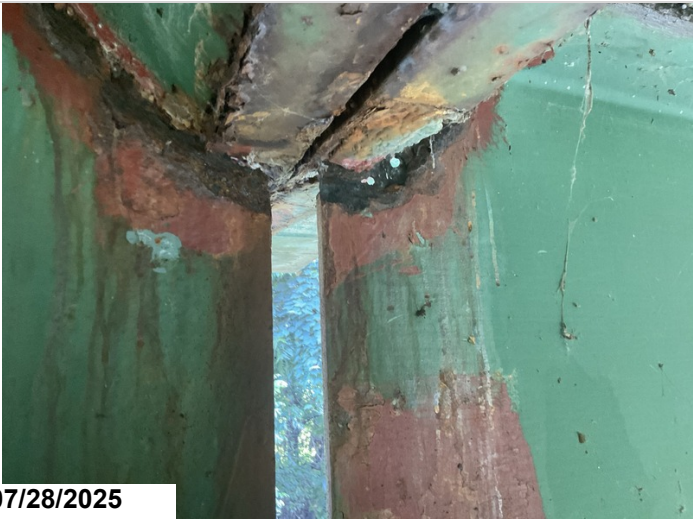
07/28/2025
Span 5, bent 5, girder 1: has section loss at the haunch with a 1/2" x 1" hole in the web. 1LF CS4

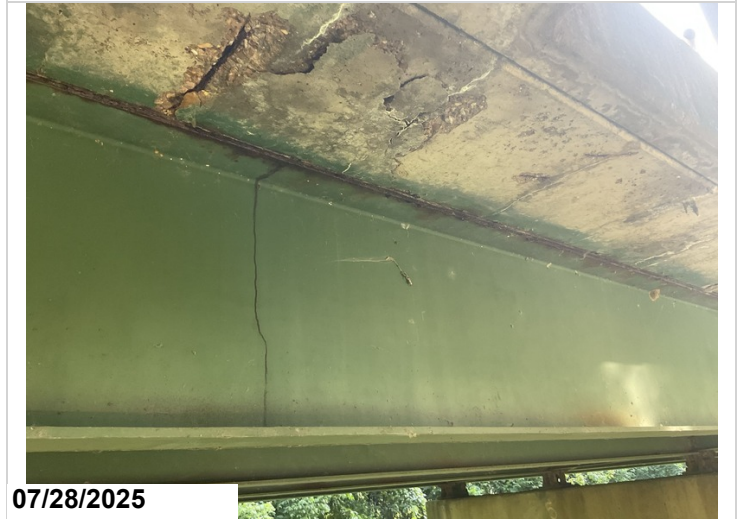
07/28/2025
Span 5, exterior girder: have flaking corrosion and pack rust on the top flanges for 75% of the span. 51LF CS3

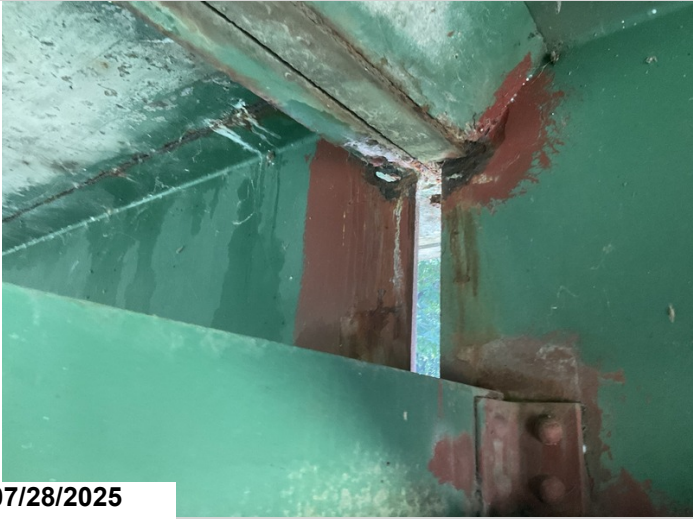
Span 5, bent 4, girder 4: has section loss at the haunch with a 1/2" x 3" hole in the web. 1LF CS4

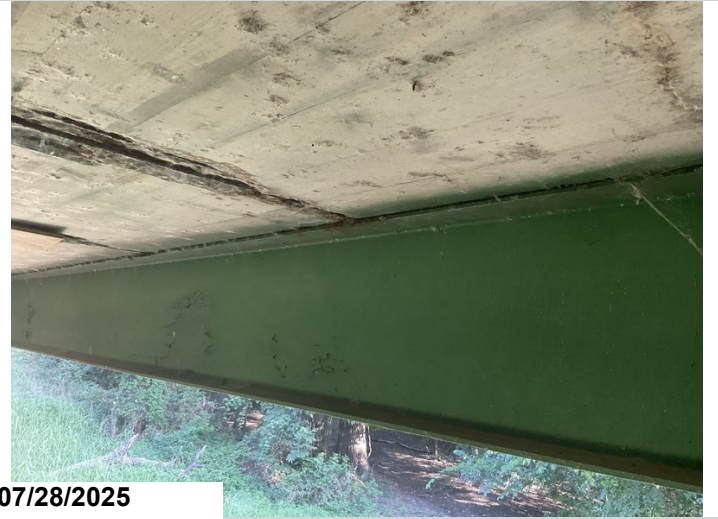
Girders 2 and 3 throughout the structure have minor flaking corrosion along the top flange adjacent to exposed rebar on the undersurface. 416LF CS3

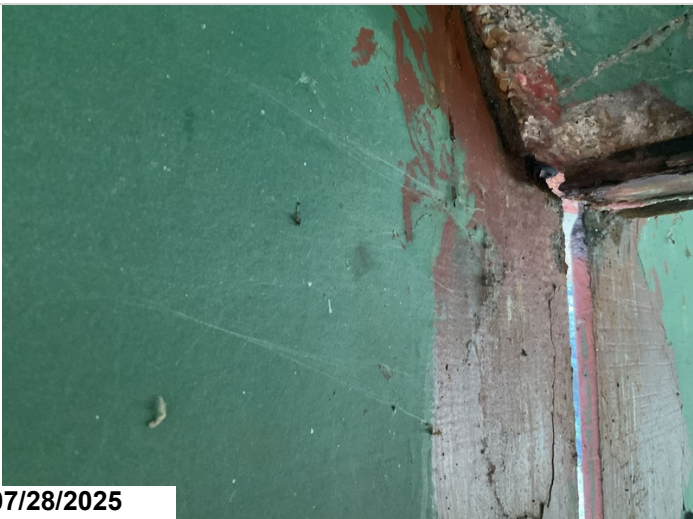
Span 3, bent 3, girder 1: has section loss at the haunch with a 1/2" x 1" hole in the web. 1LF CS4

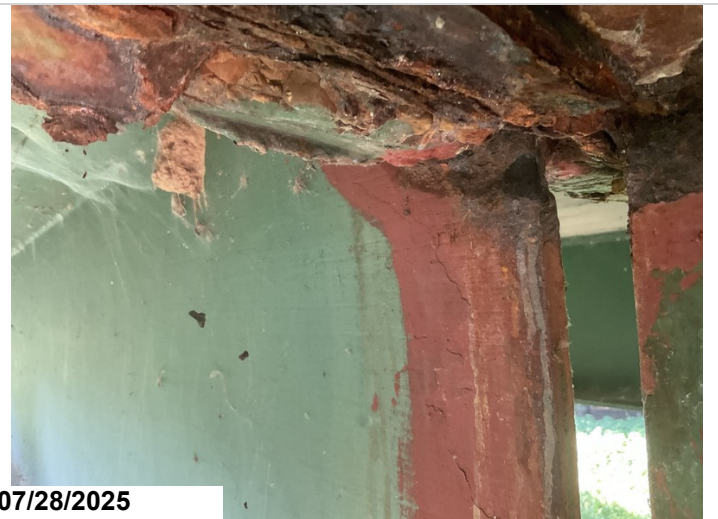
Span 4, bent 3, girder 1: typical beam ends have corrosion with 1/8" section loss at the haunch and diaphragm connections. All girders throughout have on average a similar level of deterioration to this, even areas that have been painted or plated in the past, unless otherwise called out. 156LF CS3

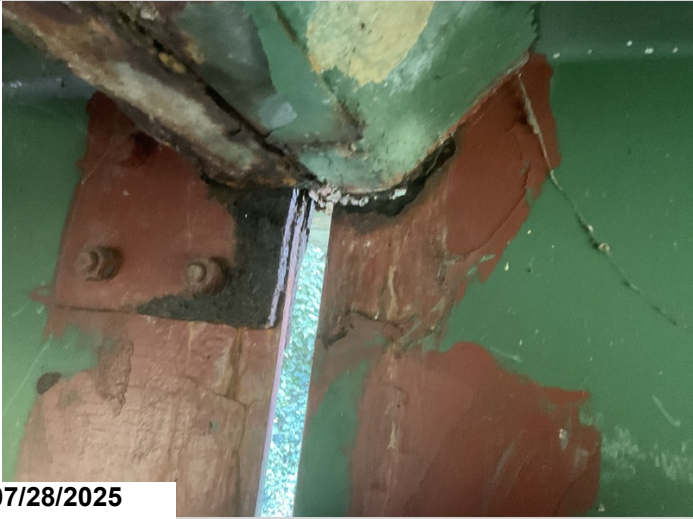
Span 2, bent 1, girder 1: has section loss at the haunch with a 1/2" x 3" hole in the web. 1LF CS4

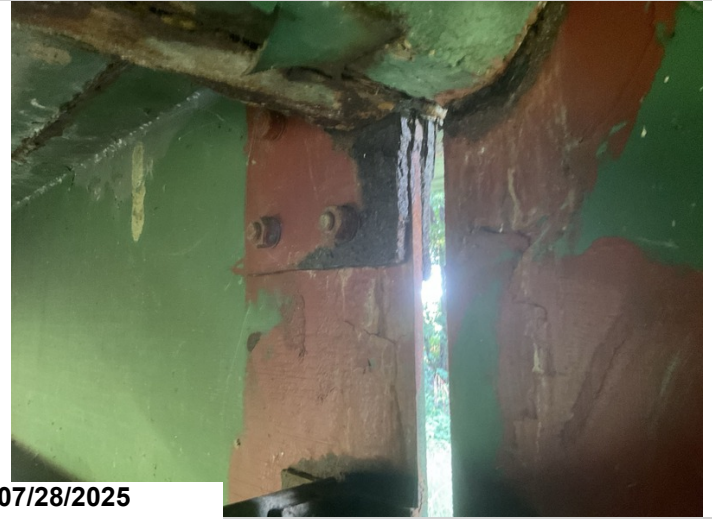
Typical beam ends have corrosion with 1/8" section loss at the haunch and diaphragm connections. All girders throughout have on average a similar level of deterioration to this, even areas that have been painted or plated in the past, unless otherwise called out. 156LF CS3

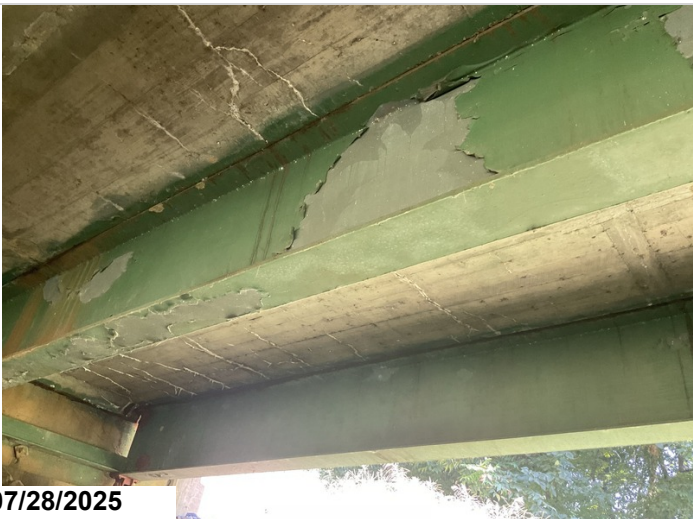
Span 1: all girders have flaking corrosion and pack rust along the top flanges. 128LF CS3

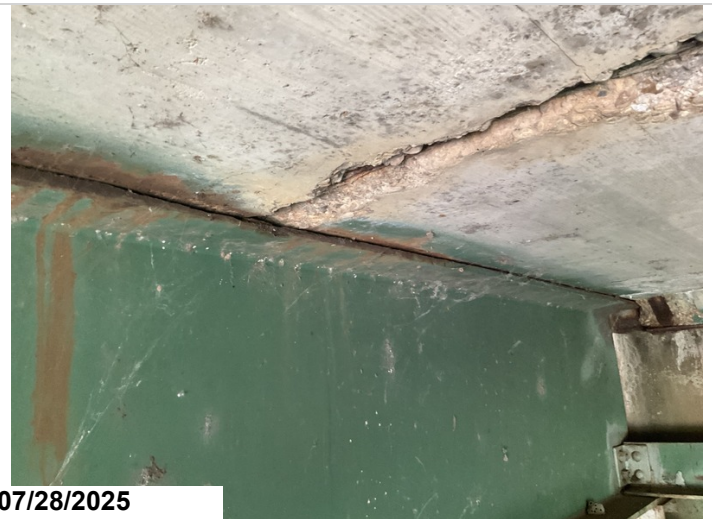
Span 26, girders 1 and 4: have full length pack rust causing the deck to float over girders 2 and 3 for half of the span. 64LF CS3

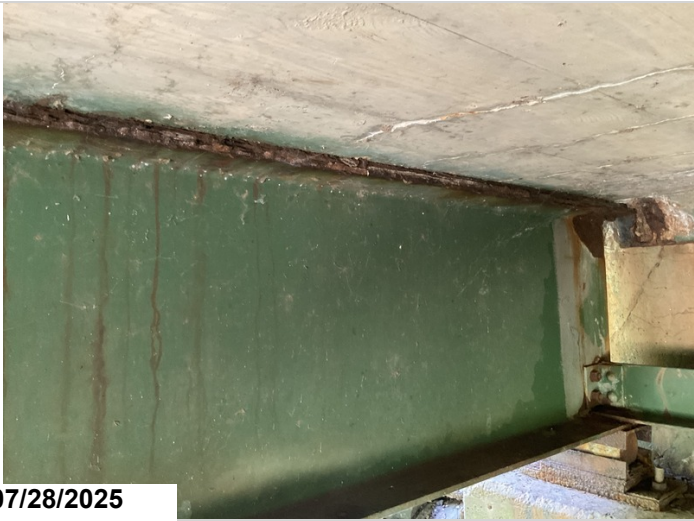
Span 26, girders 1 and 4: have full length pack rust causing the deck to float over girders 2 and 3 for half of the span.
64LF CS3

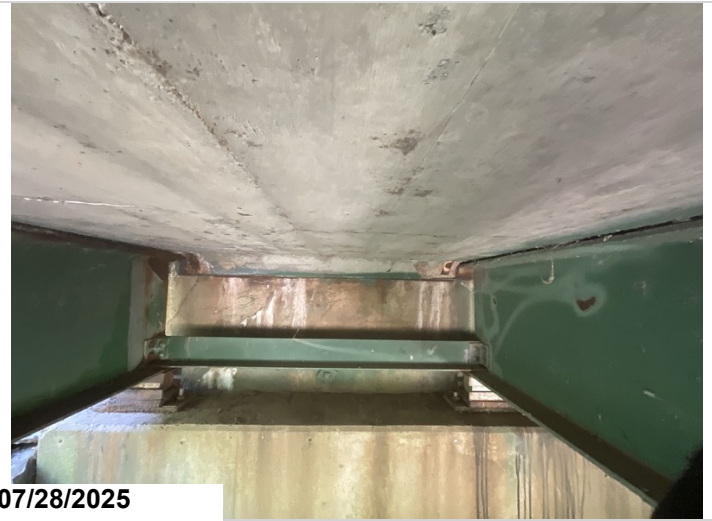
Span 26, girders 1 and 4: have full length pack rust causing the deck to float over girders 2 and 3 for half of the span.
64LF CS3

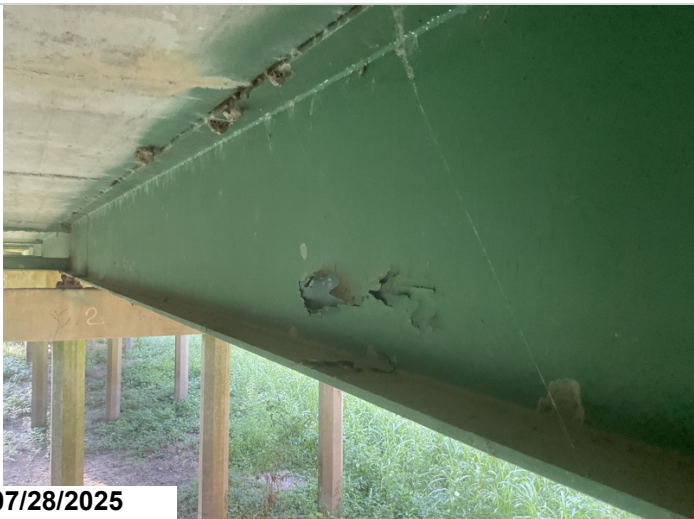
The girders have areas of peeling paint throughout. 1040SF
CS3

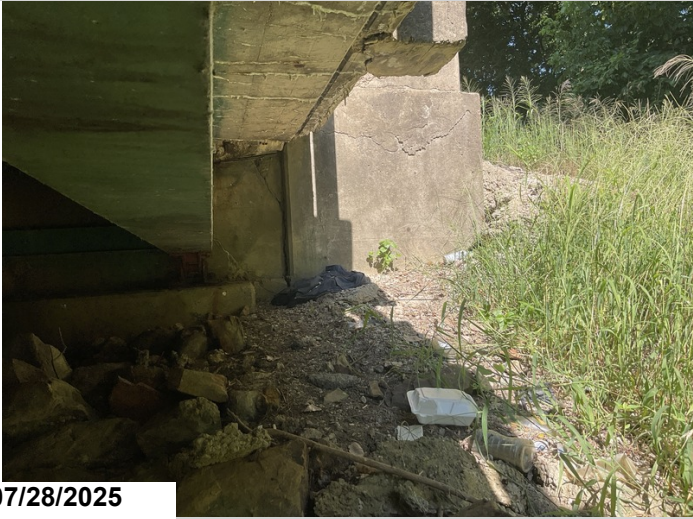
Abutment 1: the left wing has heavy vertical cracks at the abutment connection. 2LF CS3

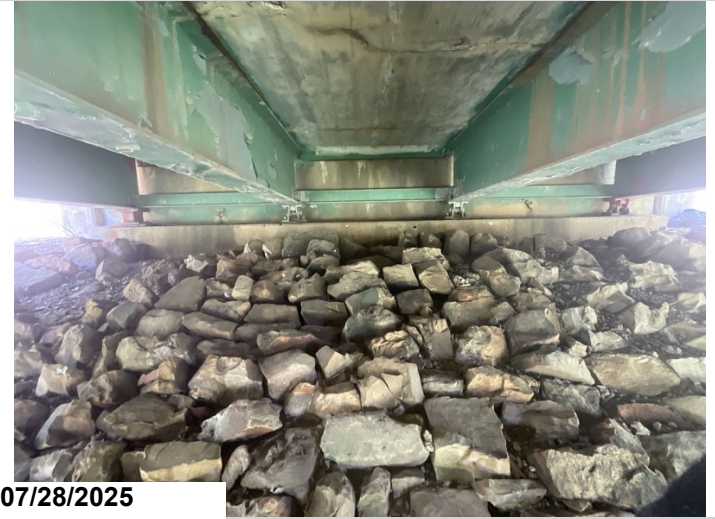
Abutment 1: has diagonal efflorescent map cracks with leaching buildup on the ends and similar vertical cracks in the center. 16LF CS3

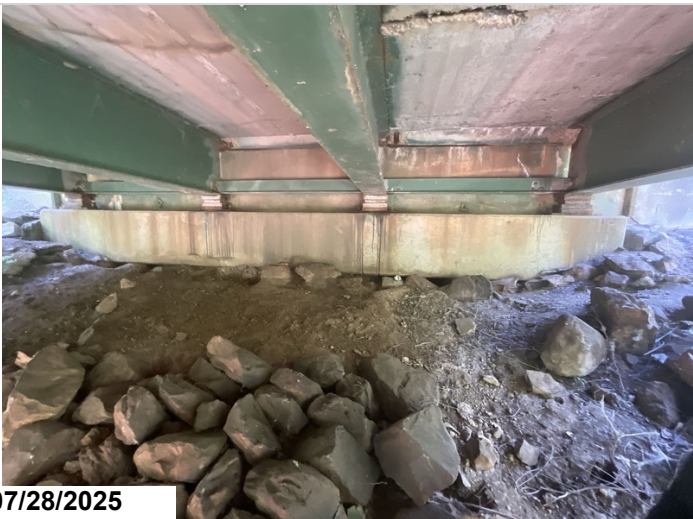
Abutment 2: has diagonal efflorescent map cracks with leaching buildup on the ends. 10LF CS3

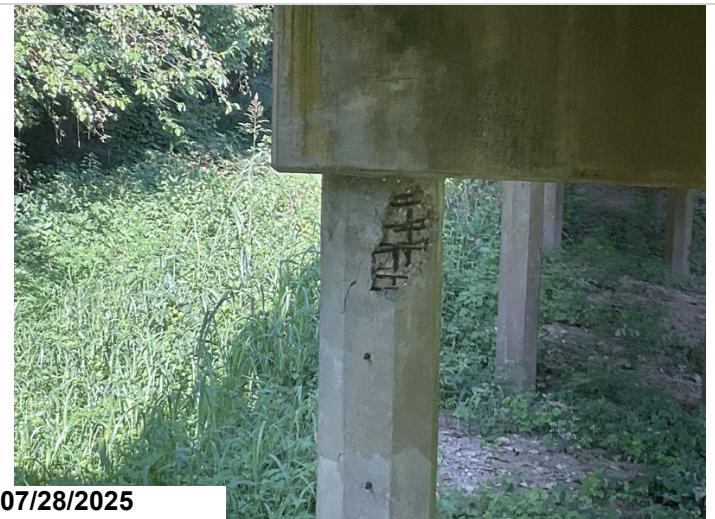
Bent 9, Pile 4 has spalling with exposed rebar and heavy deterioration at the cap connection. 1EA CS3

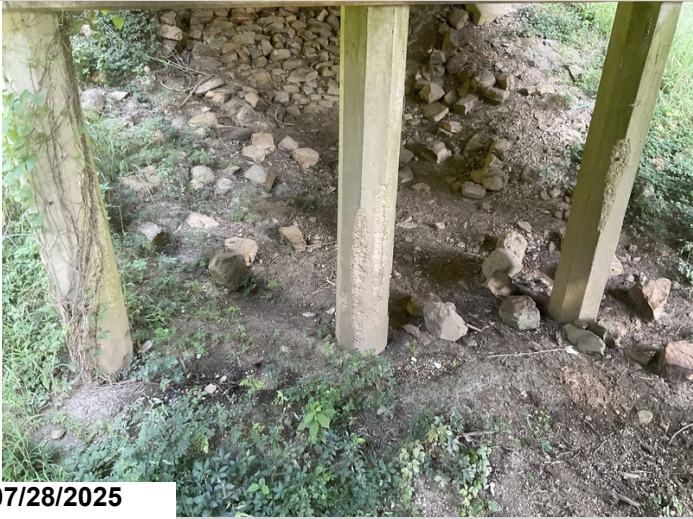
Bent 1, ahead, piles 2-4: have large, shallow, spalls near the ground line. 3EA CS3

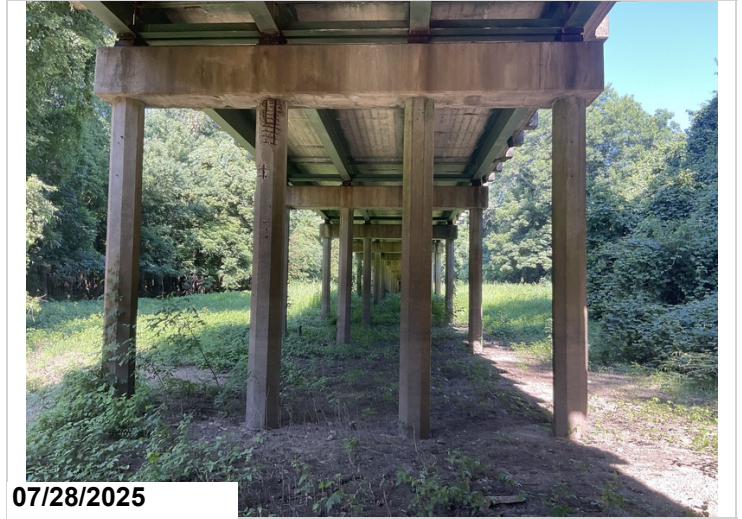
Bent 15, pile 3: has spalling with exposed rebar. 1EA CS3

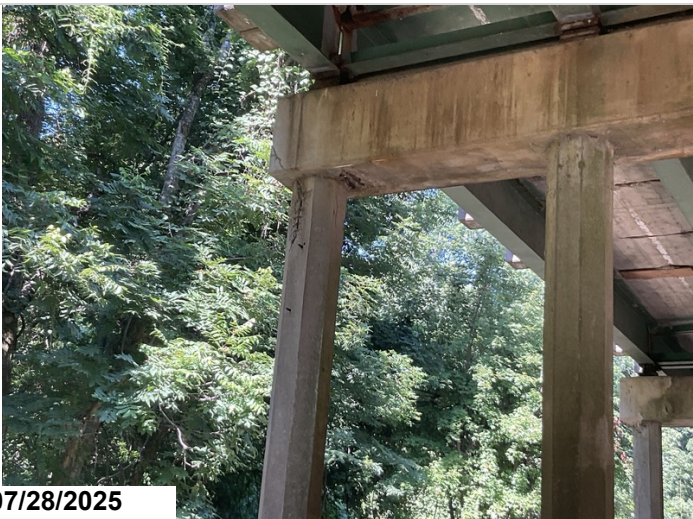
Bent 21, pile 4: has spalling with exposed rebar. 1EA CS3

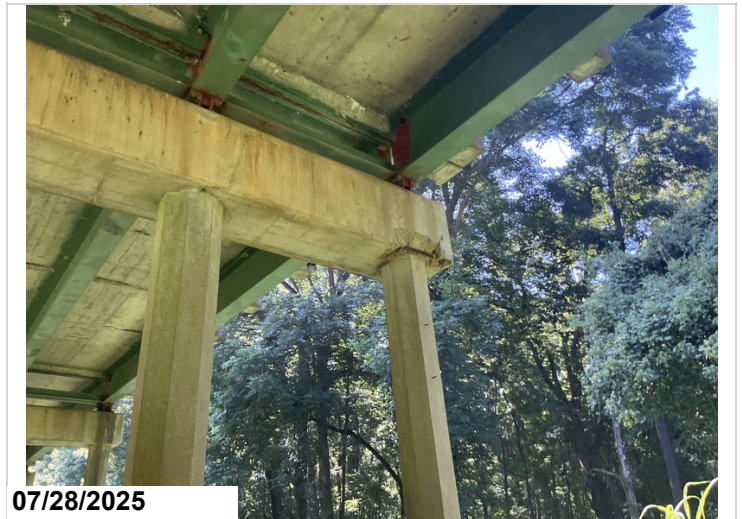
Bent 3 back, right, underside: has spalling with exposed rebar. 2LF CS3

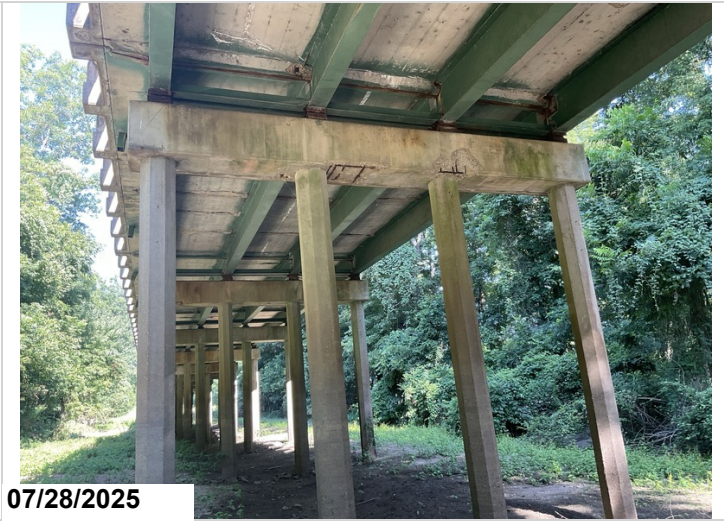
Bent 23 has scattered spalls with exposed rebar. 5LF CS3

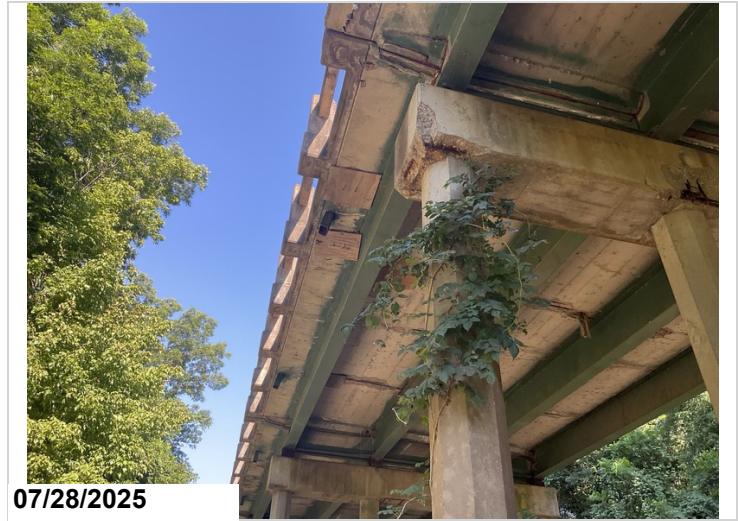
Bent 24 ahead has spalling with exposed rebar. 2LF CS3

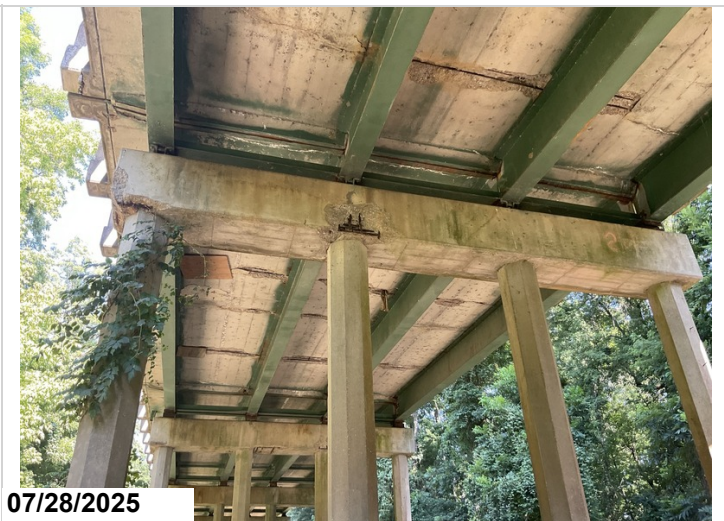
Bent 24 ahead, adjacent to pile 3: has a spall with exposed rebar that has lost adhesion. 2LF CS4

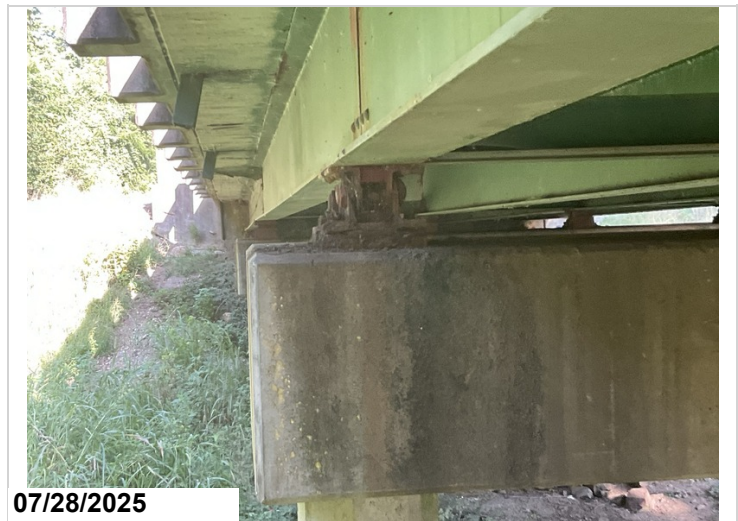
Bent 2, ahead, bearing 4. typical condition of the bearings throughout. CS3

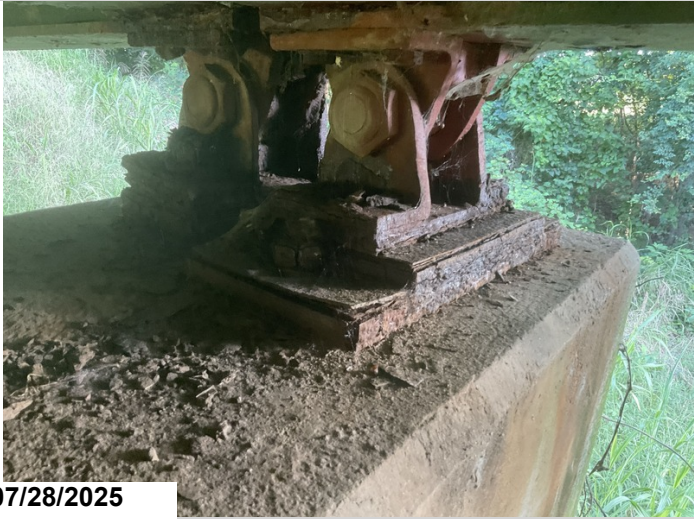
Typical original bearing. CS3

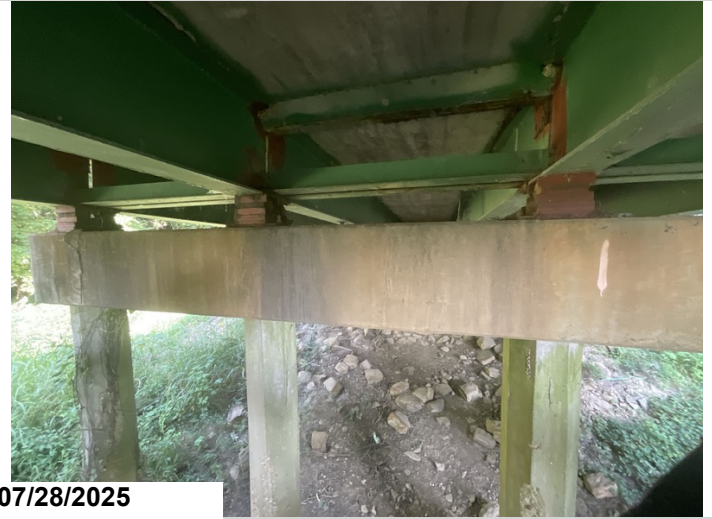
Typical replaced bearings are in better condition than the originals but still have flaking and pack rust between the plates. CS3

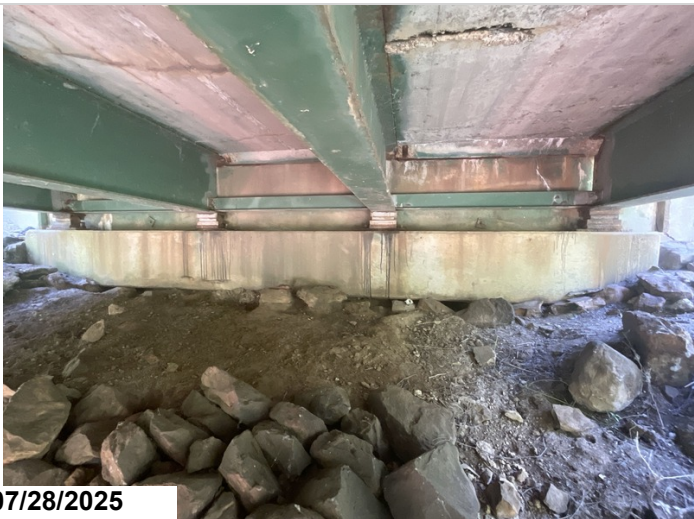
Abutment 2: typical bearings. CS3

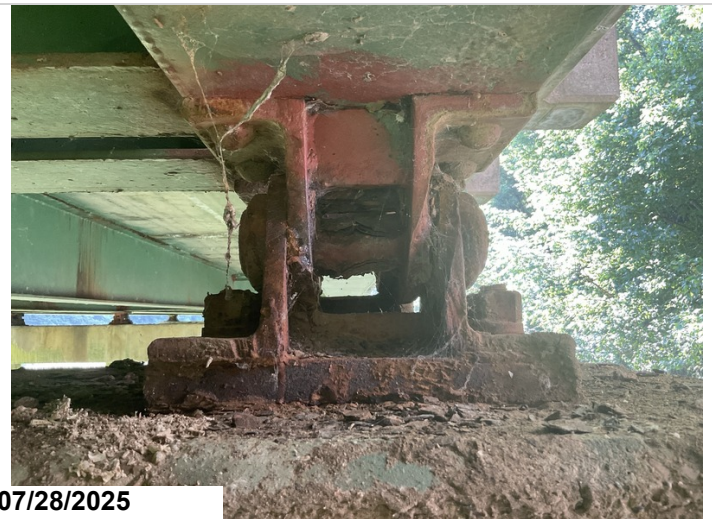
Bent 6, back, bearing 5: typical condition of the bearings. CS3

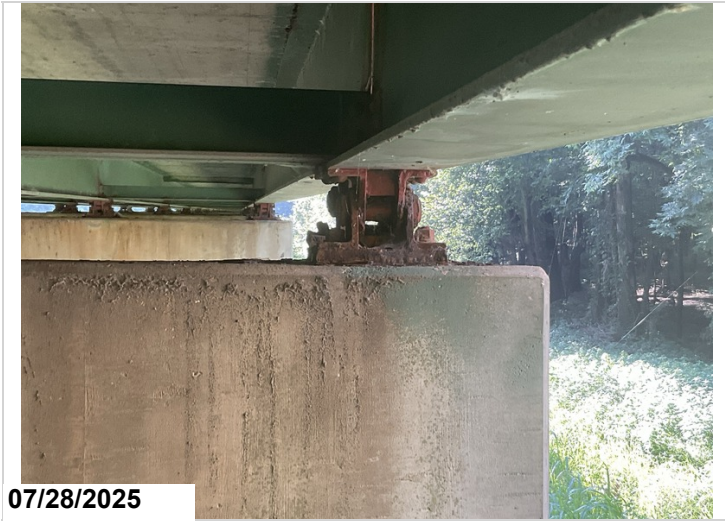
Typical condition of the bearings. CS3

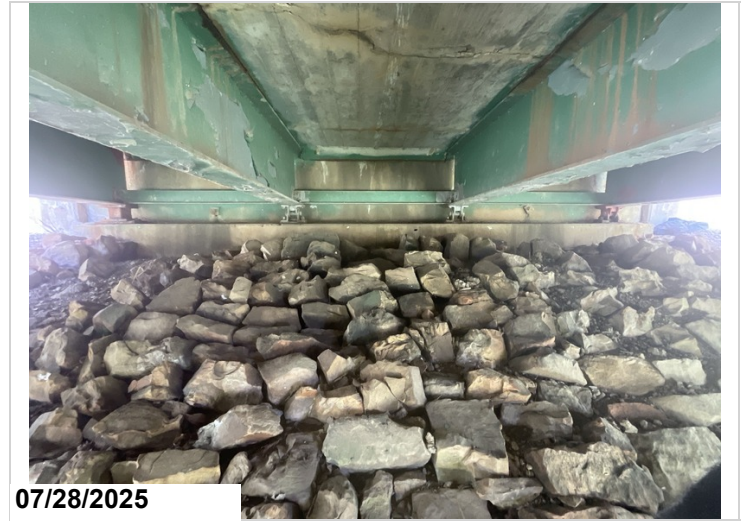
Abutment 1: typical bearings. CS3

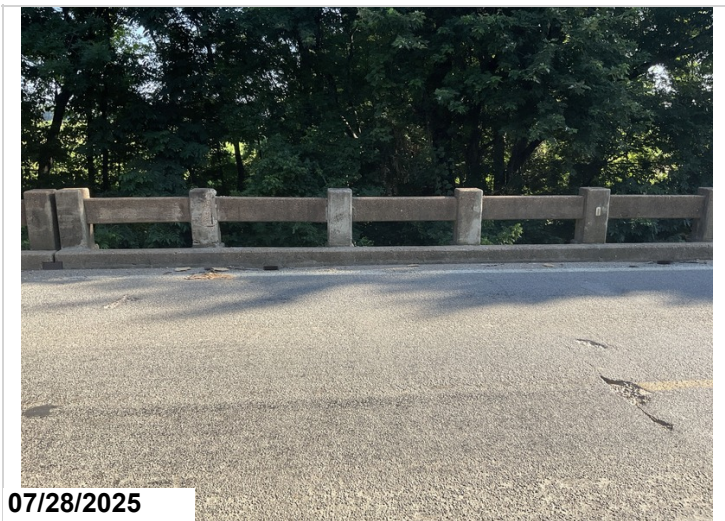
Span 18, left: typical spall with exposed rebar. 1LF CS3

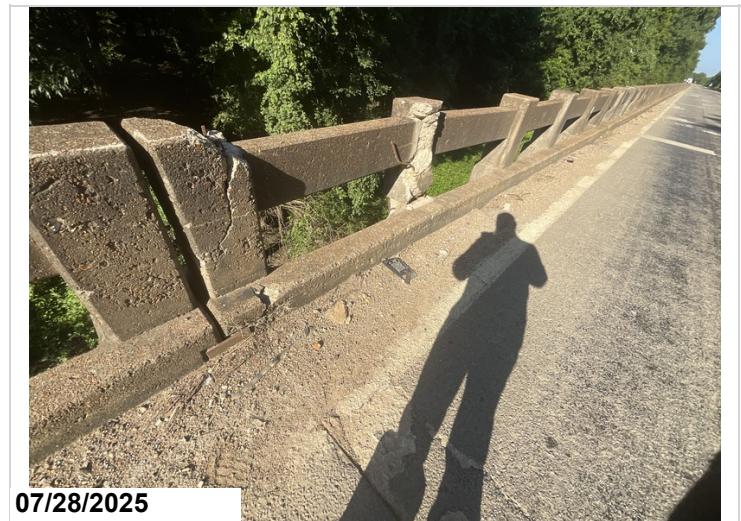
Span 15, right: has a large area of impact damage. 5LF CS3

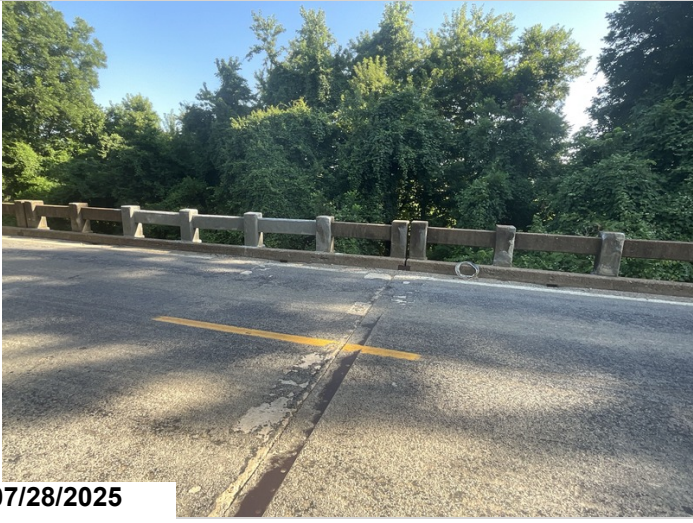
Typical deteriorated areas of the bridge rail with spalling and cracking throughout.

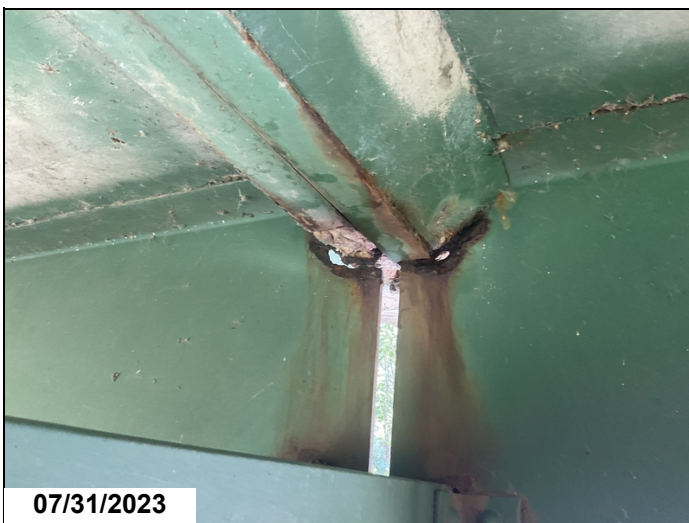
Rust with s/l & 1/2" & 2" hole in web below haunch @ Girder 4 @ end of Span 19 & a 3/4" x 5" hole in web below haunch @ beginning of Span 20.(#4) - 2023

2025 - Span 20, bent 19, girder 4: has section loss at the haunch with a 3/4" x 7" hole in the web. 1LF CS4

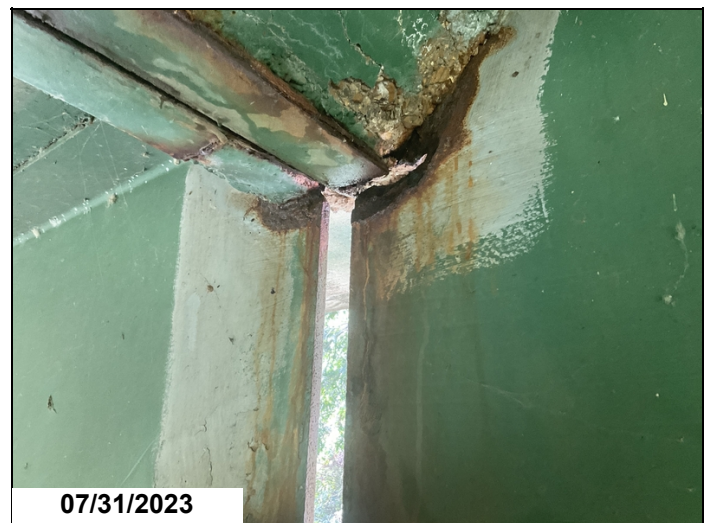
Rust with s/l & 3/4" x 4" hole in web below haunch @ Girder 4 @ end of Span 14.(#4) - 2023

2025 - Span 14, bent 14, girder 4: has section loss at the haunch with a 1" x 4" hole in the web. 1LF CS4

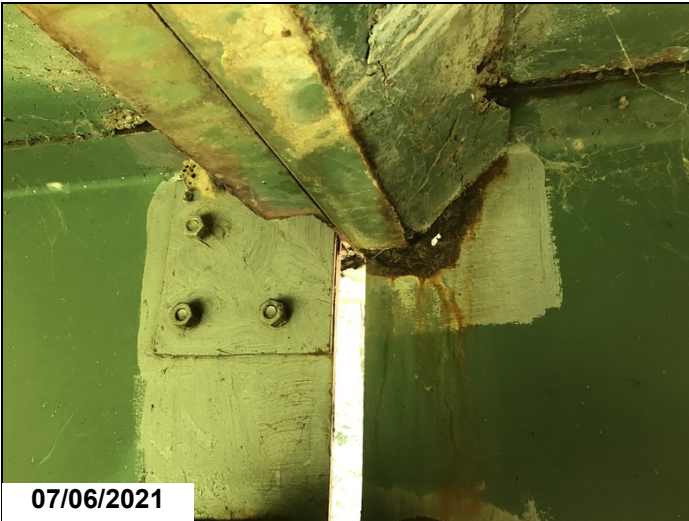
Severe section loss to Girder 3 & 4 with hole in web
below haunch @ Bent 21.
Girder 4. - 2021

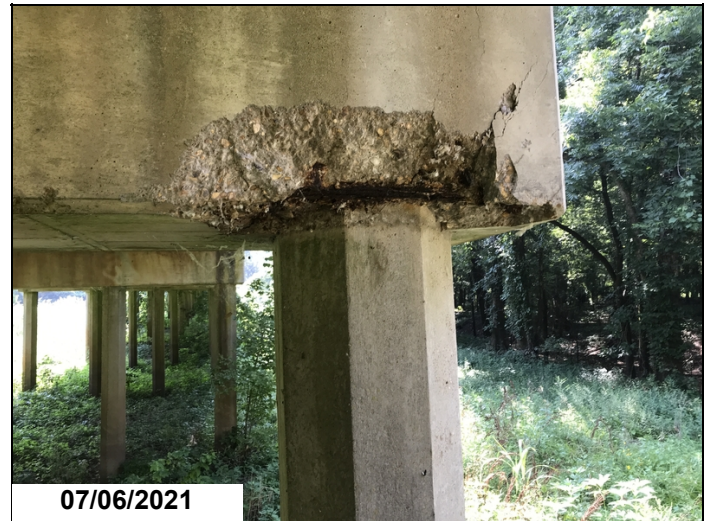
Cracks, delaminated areas & spalls with rebar exposed to caps at Bents 3, 12, 14, 15, 16 - 24.
Bent 3 @ pile 4.

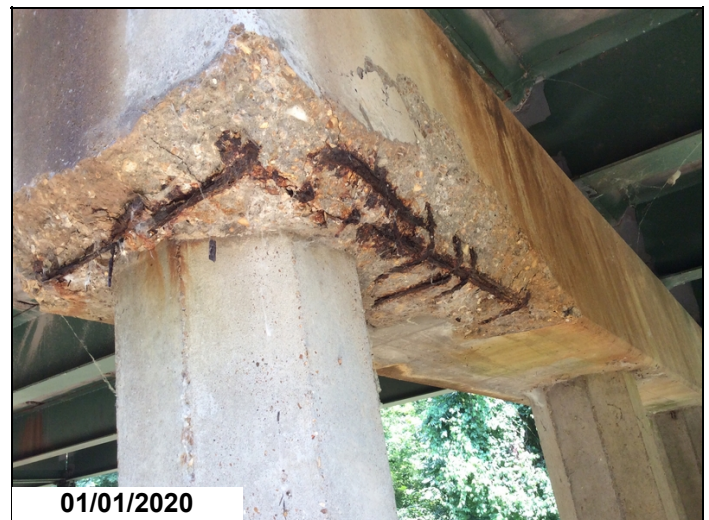
Cap at Bent 22, spalls with exposed rebar at Pile 4.

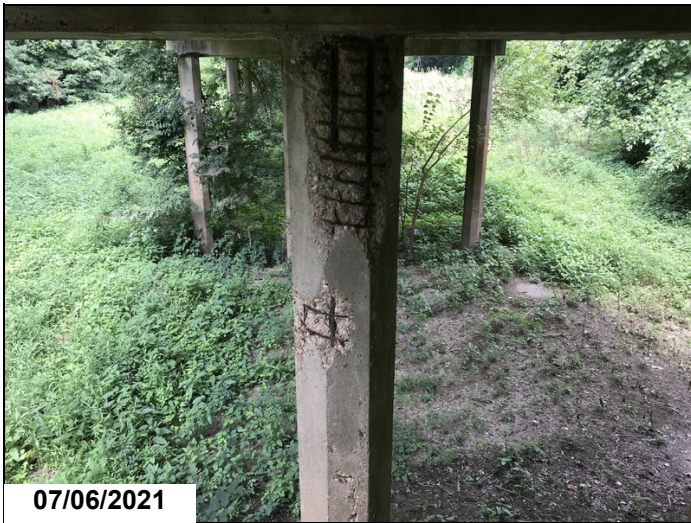
Cracks, delaminated areas & spalls with rebar exposed to
Piles at Bents 1, 2, 6 - 12, 14, 15, 17, 19 - 21, 23.
Bent 15, pile 3 ahead side.
