Bridge 01885 Inspection Report

Route:367 Section:21 Log:6.399

Arnold Road ID:34x367x21xA, Arnold Log mile:6.387

District 05, 67 - Jackson County

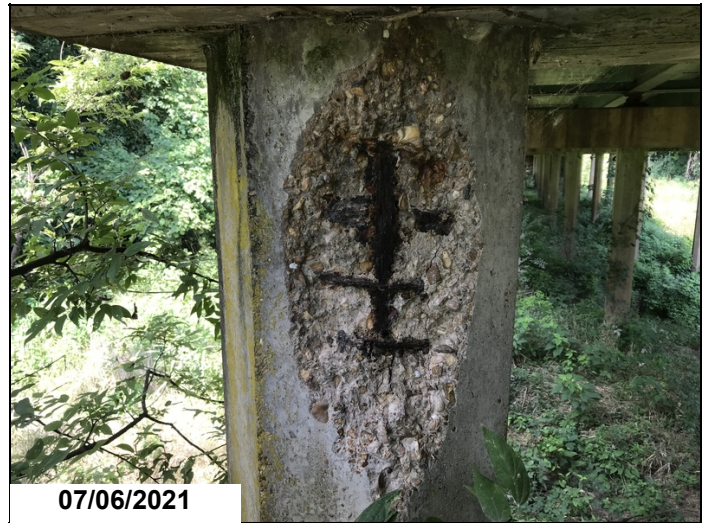
Cracks, delaminated areas & spalls with rebar exposed to
Piles at Bents 1, 2, 6 - 12, 14, 15, 17, 19 - 21, 23.
Bent 8, pile 4 @ ahead side.

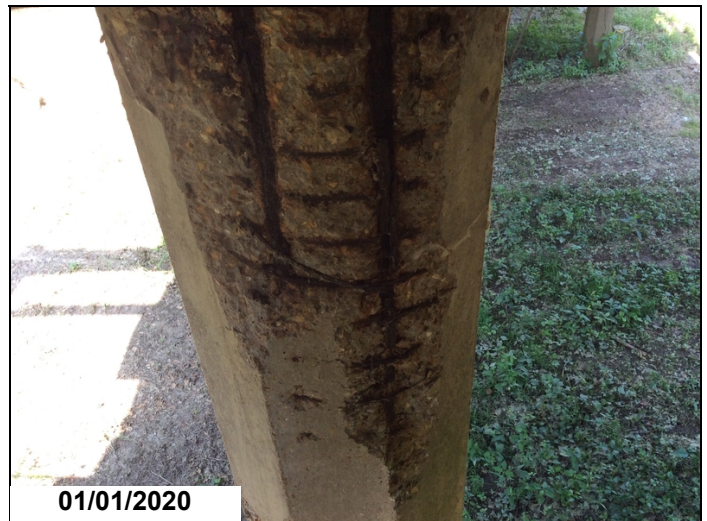
Pile 3 at Bent 15, spalls with exposed rebar with 100%
section loss.

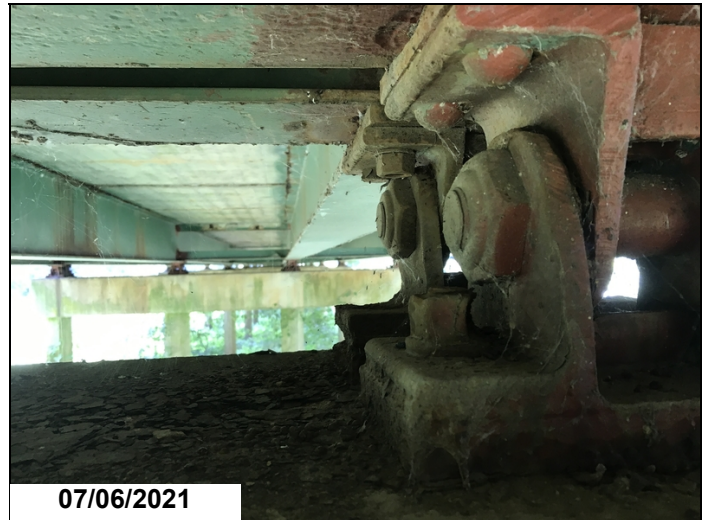
Bent 6 - Girder 3 & 4 has anchor bolt & nuts missing @ ahd. side.
Girder 3.

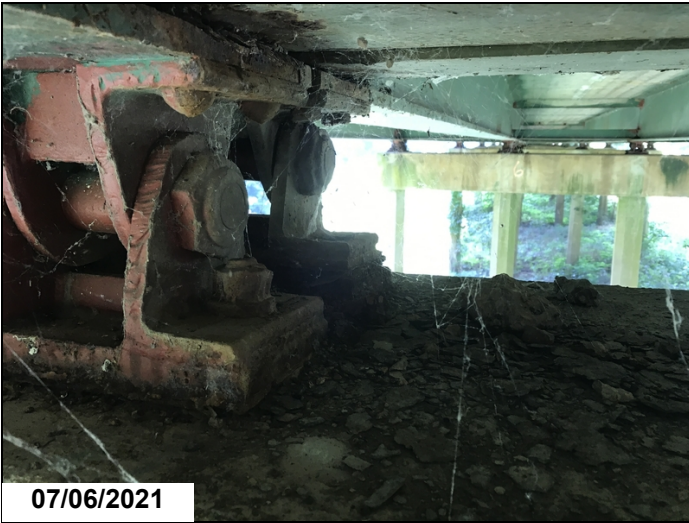
Bearing assem. have heavy rust and section loss & are missing anchor bolts &/or nuts at:

Bent 5 - Girder 2 has anchor bolt nut missing. @ ahd. side.

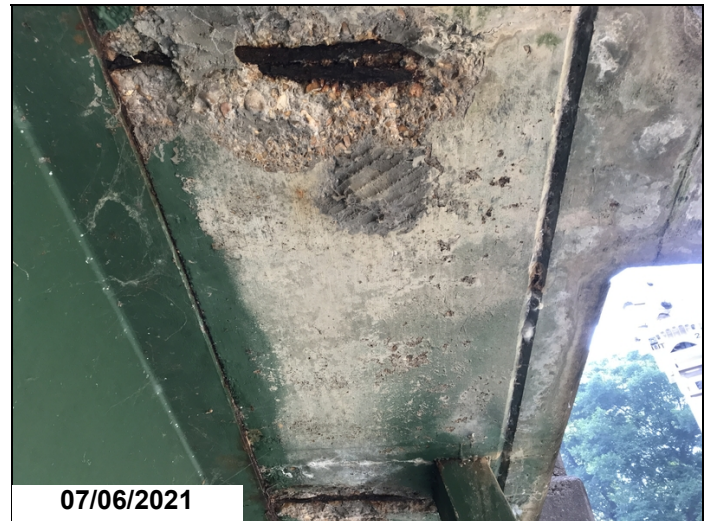
07/06/2021
Spalls with rebar exposed to deck below & to left & right overhang at all spans.
Typical to Lt & Rt overhangs.
Span 2, Rt side.

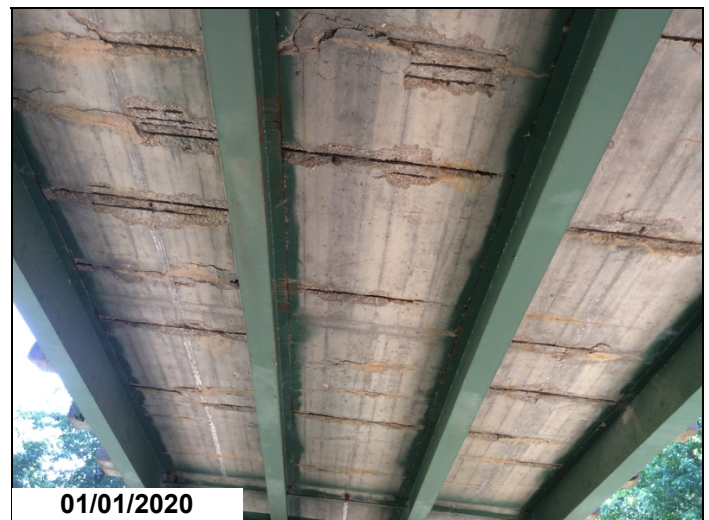
01/01/2020
Span 22. Soffit has 85' of exposed rebar.

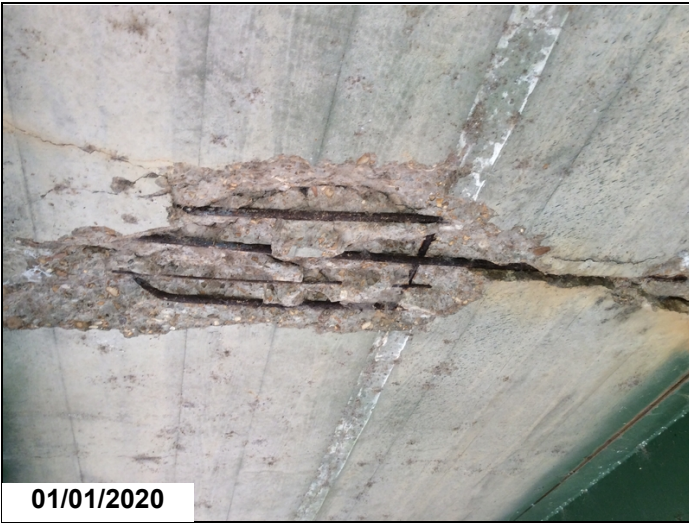
Deep Spall with exposed rebar at Span 19 between
Girders 3 & 4.

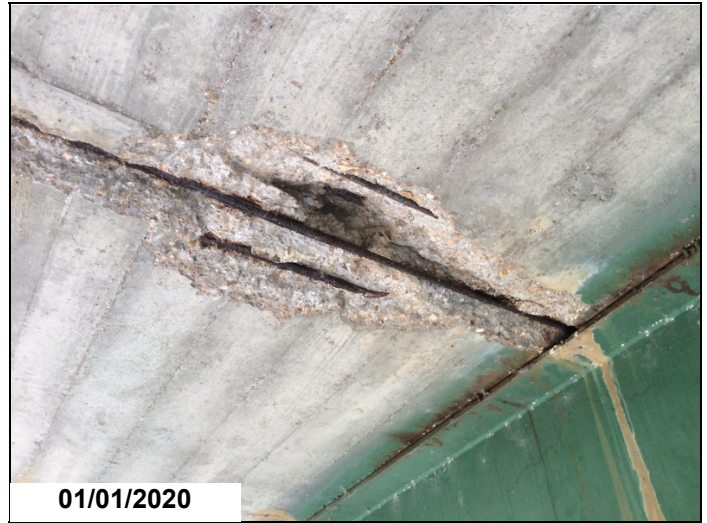
Deep Spall with exposed rebar at Span 18 between
Girders 3 & 4.

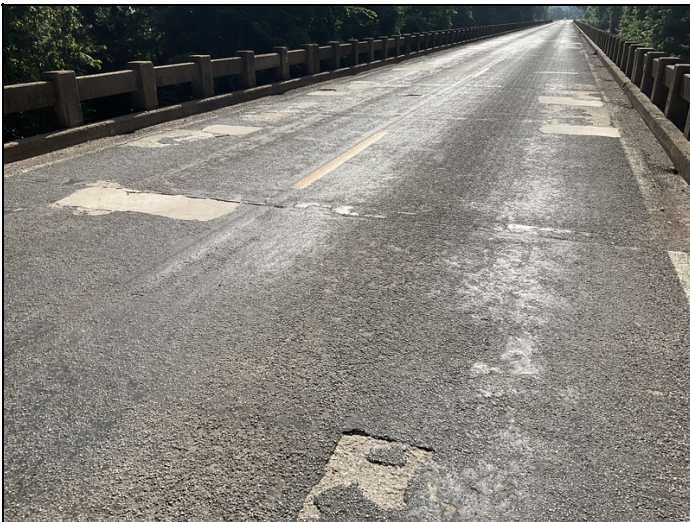
The deck is heavily deteriorated and in need of repair.

A-62 - Hydro and LMC Advised (Yes)
The deck is heavily deteriorated and in need of repair.
