## Bridge M0382 Inspection Report

**Asset #M0382**(Routine)

**SH 14/Indepen Co. over BRANCH**

**Team Lead: Seth Foreman Inspection Date: 04/07/2026**

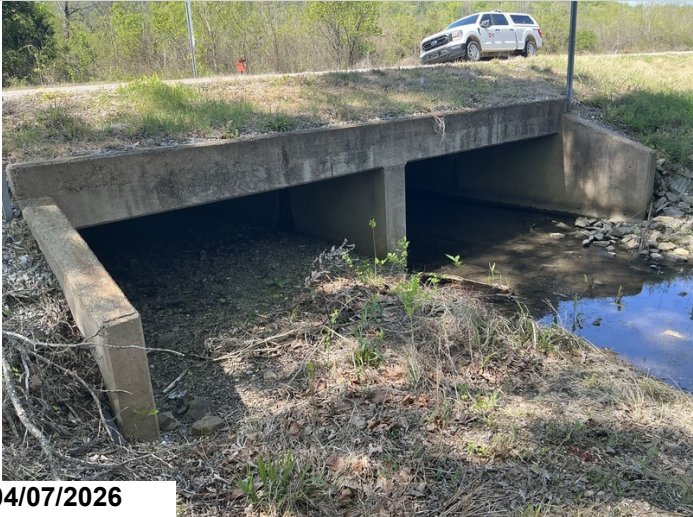
Elevation with Log Mile running to the left.

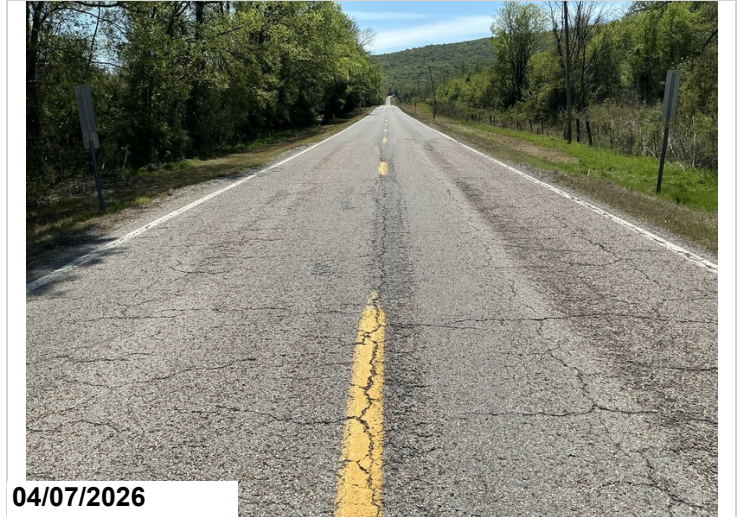
Roadway with Log Mile running Northwest to Southeast.

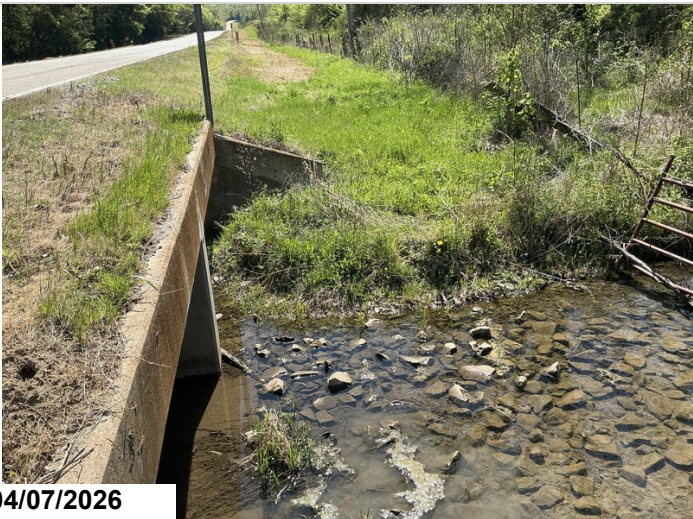
**61 - Channel/Channel Protection** (6 - Bank is beginning to slump. River control devices and embankment protection have widespread minor damage. There is minor stream bed movement evident. Debris is restricting the channel slightly.)  
Overall, the channel/channel protection is in satisfactory condition with:  
A large tree fell over, going over the channel on the Left side of the Culvert.  
Sediment buildup to channel on inlet and outlet ends of barrel 2.

Sediment buildup to channel on inlet and outlet ends of barrel 2.( inlet end)

**Type of Work:** Channel Work/Drift Removal

Sediment buildup to barrel 2.

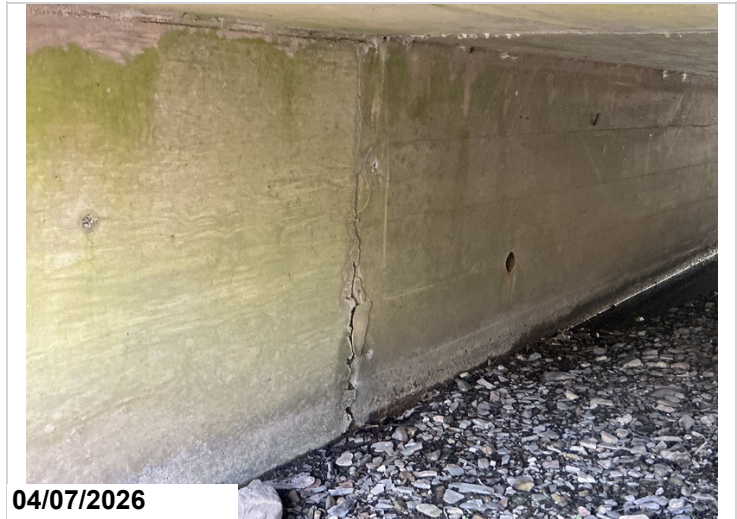
| ELEMENTS | DESCRIPTION | UNITS | TOTAL | CS1 | CS2 | CS3 | CS4 |
|---|---|---|---|---|---|---|---|
| Vertical crack at left construction joint in barrel 2. 1' CS3 | | | | | | | |

Vertical crack at left construction joint in barrel 2.

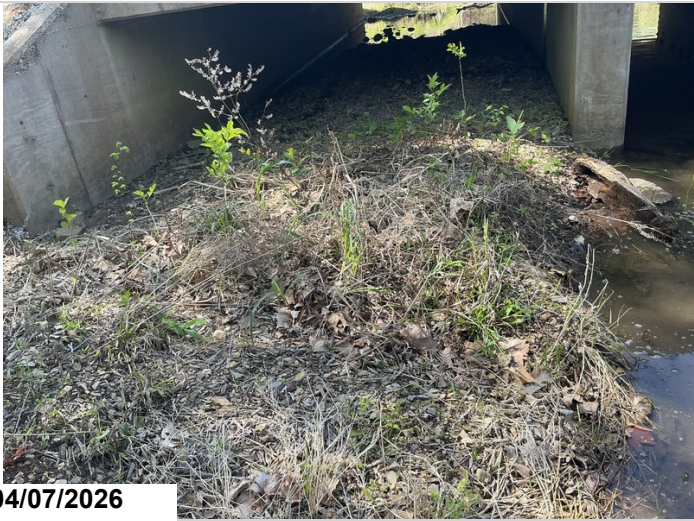
Sediment buildup to channel on inlet and outlet ends of barrel 2.( Outlet end)

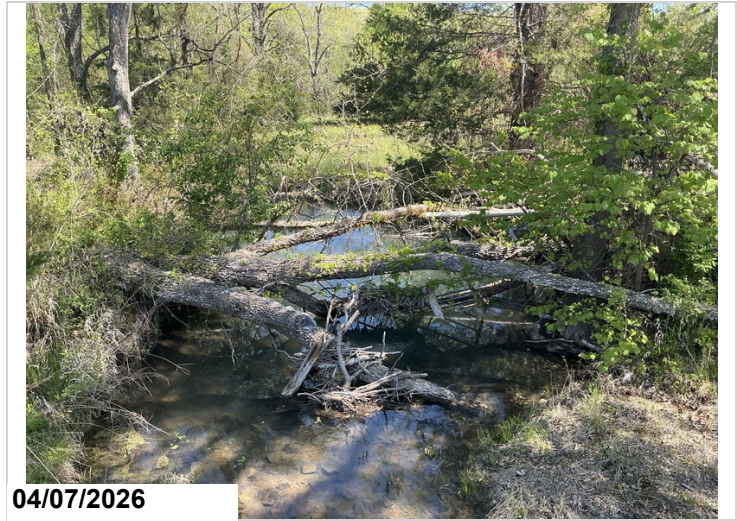
Left channel.

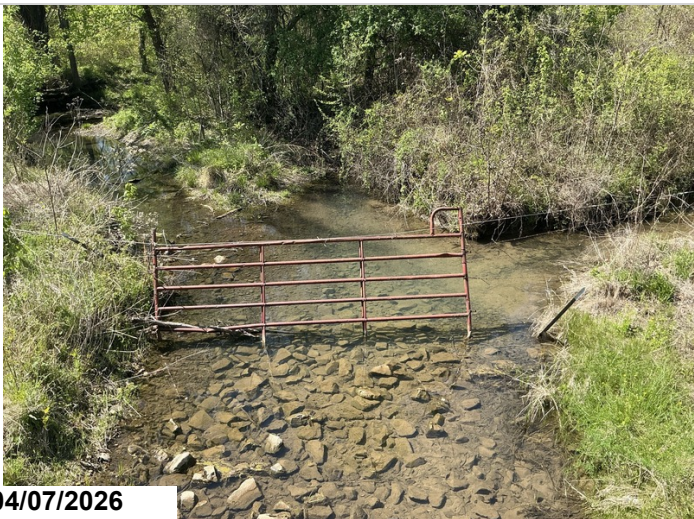
Right channel.

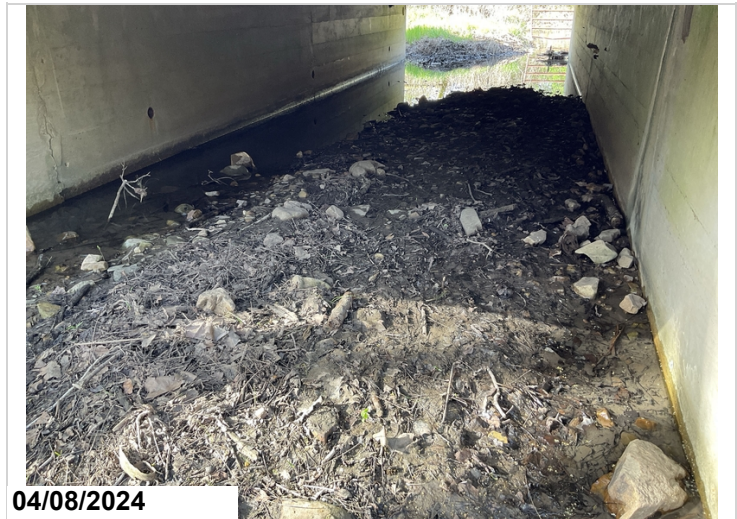
| ELEMENTS | DESCRIPTION | UNITS | TOTAL | CS1 | CS2 | CS3 | CS4 |
|---|---|---|---|---|---|---|---|
| Barrel 2 - 2' +/- sediment buildup to inlet and outlet end restricting flow. | | | | | | | |

Barrel 2: up to 1' of sediment build up.

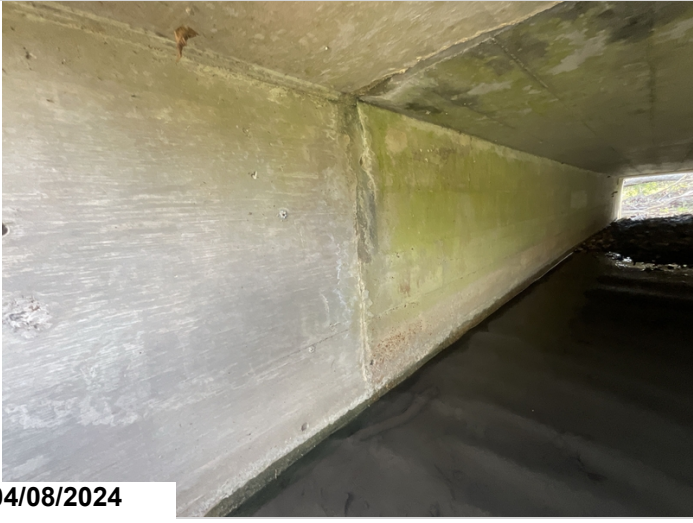
Barrels 1 & 2: efflorescence along construction joints where widened. CS2.

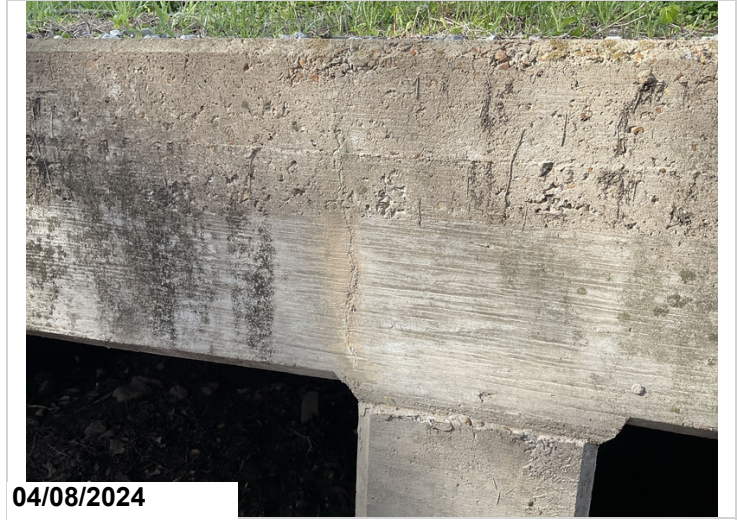
| ELEMENTS | DESCRIPTION | UNITS | TOTAL | CS1 | CS2 | CS3 | CS4 |
|---|---|---|---|---|---|---|---|
| Vertical crack with efflorescence at left construction joint at wall 1 in barrel 2. 1' CS3 | | | | | | | |

Barrel 2, Left, Head Wall: vertical crack with efflorescence. CS2.

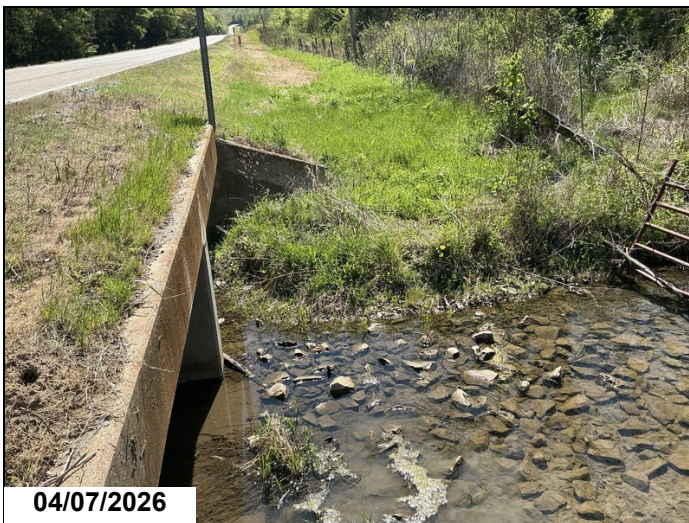
Sediment buildup to channel on inlet and outlet ends of barrel 2.( inlet end)

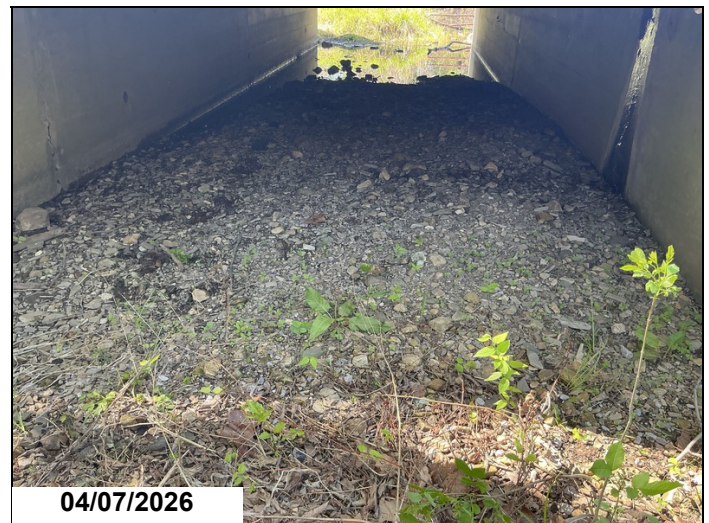
Sediment buildup to barrel 2.

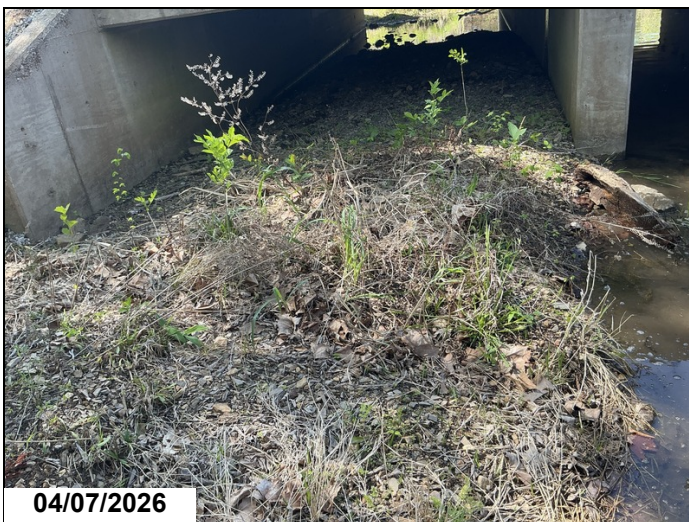
Sediment buildup to channel on inlet and outlet ends of barrel 2.( Outlet end)
