Bridge Inspection Report

06599
US 70 Fourche
over
FOURCHE CREEK

Structure Number: 06599

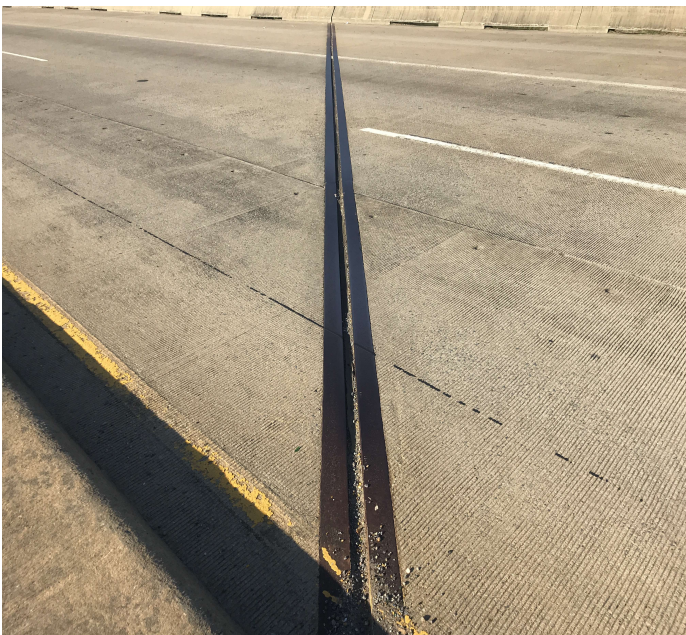
Internal bents

Glue along closed cell joint has lost its bond and is leaking.

PHOTO 1 Description Glue along closed cell joint has lost its bond and is leaking.

Stage: Monitor
