# Bridge Inspection Report

**M1325**  
**US 70 Blakemore**  
**over**  
**BLAKEMORE CREEK**

Structure Number: M1325

IDENTIFICATION		INSPECTIONS	
(1) STATE CODE	056 - Arkansas	(90) INSPECTION DATE	04/11/2018
(8) STRUCTURE NUMBER	M1325	(91) DESIGNATED INSPECTION FREQUENCY	24

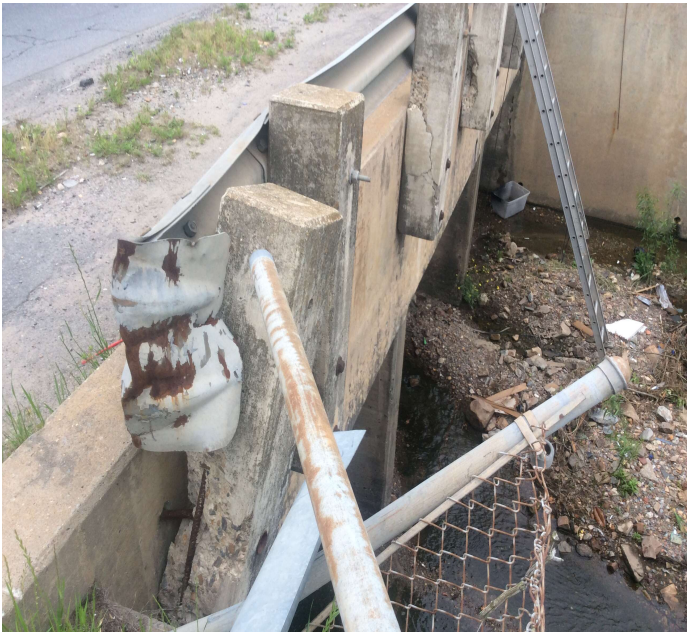
Right bridge rail damaged  
Due to traffic impact.

PHOTO 1      Description      Right bridge rail damaged due to traffic impact.

Assigned District Bridge Crew 06001 5/17/18
